**Flood Control Project Maintenance
Levee Inspections**
LMA District Cover Sheet
Spring 2020 Levee Inspection Results

Reclamation District No. 2092 Dos Rios

Waterway	Bank	Unit Miles
Unit No. 01 San Joaquin River	Right	3.71

Levee Inspection Report By Mile - Spring 2020

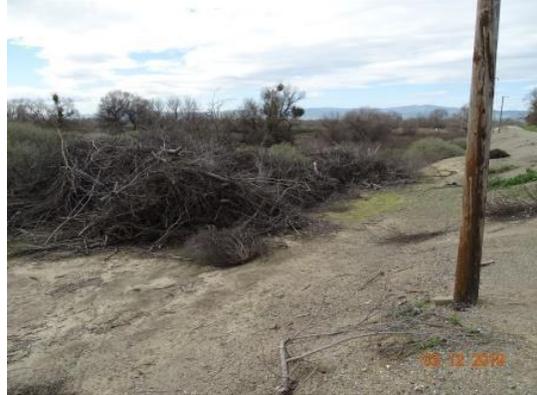
Photo 1 of 1 : SP_2020_RD2092_116_15_20200225_00002.jpg

Large pruning pile along levee slope and toe. (Spring 2019)

LM Start	0.08	Rating **	M	Issue No.	30
LM End	0.65	Issue Type +	Ma	Location *	LS
Category	Earthen Levee		GPS Latitude/Longitude		
			Start	End	
Item	Vegetation		37.602492 °	37.598712 °	
			-121.159582 °	-121.167486 °	
DWR ID	DWR_RD2092_01_s_2020_30				
Comment Code					
V1 : Control annual grass and weeds on the levee slopes and easements.					
Inspector Comment

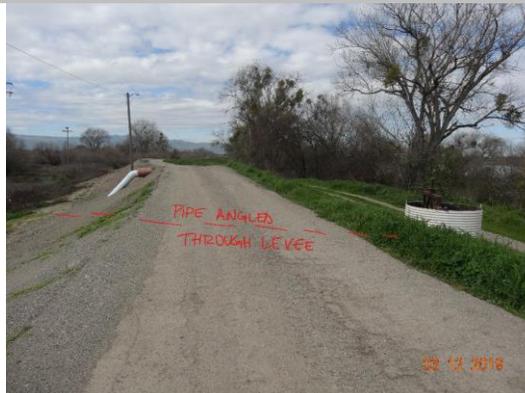
Photo 1 of 3 : UCIP_SP_2020_53799_79055.jpg

Comment Code					
Inspector Comment					
DS_ID:20561 FS_ID:53799 EP_NO: N/A Repair Type: Urgent Crossing Status: Found UCIP Comments: 03/12/2019 A thorough internal evaluation of this crossing is necessary. Pipe shows evidence of pipe integrity (LS) issues (pipe wall sections missing on LS inlet) and levee integrity issues (sink hole visible along LS pipe alignment). Internal inspection is recommended for this crossing to determine the extent of pipe damage through the levee. Pipe crosses the levee at an angle at a depth of about 19 feet. Recommend caution be taken at this crossing when driving over levee until additional information becomes available to determine condition of pipe through levee. Recommend cover be placed on riser to address safety concern (riser is 80 inches in diameter and about 19 feet deep). Slide gate appears to be blocked by sediment/debris preventing slide gate to work properly. Unable to confirm if the flap gate located on the WS is still broken (see photo from 2017). (O. Magana - DWR UCIP)09/24/2013 Pipe rusted through at headwall on LS toe. Good candidate for video inspection. (W. Wylie - DWR UCIP) FIELD_STRUCT_DESC: 60-inch corrugated metal drainage pipe through the levee, 19 feet below the crown. Flap gate on the waterside (WS) end. Slide gate in an 80-inch corrugated metal pipe (CMP) riser on the WS slope. Concrete U-shaped headwalls on both ends. [Additional Reference(s): DWR Levee Log, 2005. USACE San Joaquin O&M Manual 5, August 1961, (HLM 0.18)]. FS Date: 3/12/2019 12:05:00 PM

Overview of levee with approximate pipe alignment (pipe angled through levee).

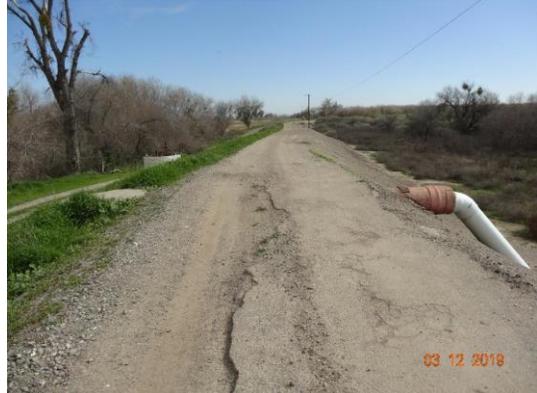
Photo 3 of 3 : UCIP_SP_2020_53815_79064.jpg

Overview of levee crown at pipe crossing, photo taking looking d/s.

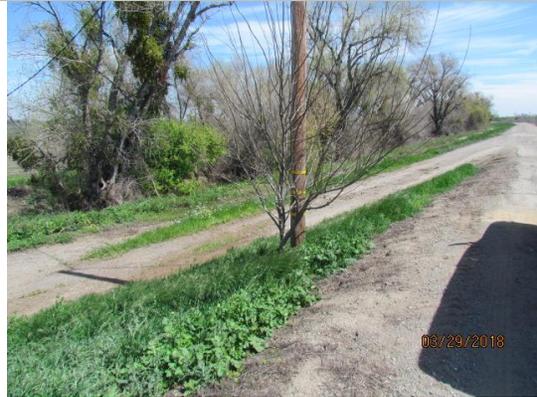
Photo 1 of 1 : SP_2020_RD2092_116_31_20200225_00012.jpg

Looking upstream at small tree on waterward should next to pole.
(Spring 2018)

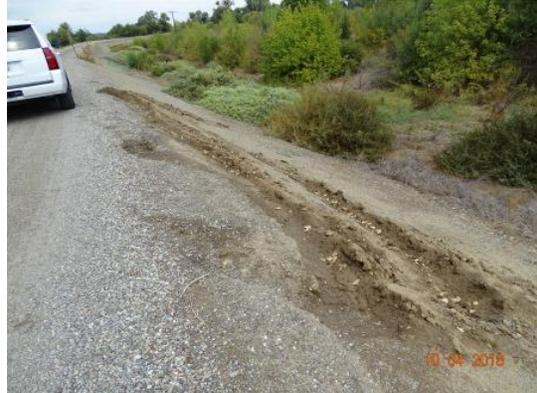
Photo 1 of 1 : SP_2020_RD2092_116_40_20200225_00020.jpg

LM Start	0.59	Rating **	M	Issue No.	40
LM End	0.59	Issue Type +	Ma	Location *	LS
Category	Earthen Levee		GPS Latitude/Longitude		
			Start	End	
Item	Slope Stability		37.599406 °	37.599406 °	
			-121.167083 °	-121.167083 °	
DWR ID	DWR_RD2092_01_f_2018_40				
Comment Code					
S3 : Repair the levee slope damaged by vehicle traffic and prevent access where possible.					
Inspector Comment					
Vehicle tracks on the landside slope should be repaired.

Vehicle tracks on landside slope approximately 6" deep perpendicular to the slope. (Fall 2018)

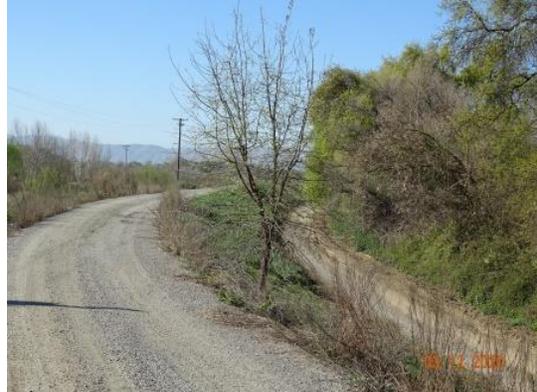
Photo 1 of 2 : SP_2020_RD2092_116_21_20200312_00072.jpg

LM Start	0.61	Rating **	M	Issue No.	21
LM End	0.61	Issue Type +	Ma	Location *	WS
Category	Earthen Levee		GPS Latitude/Longitude		
			Start	End	
Item	Trim / Thin Trees		37.599208 °	37.599208 °	
			-121.167150 °	-121.167150 °	
DWR ID	DWR_RD2092_01_s_2018_21				
Comment Code					
T2 : Thin trees to allow visibility of the ground and room to flood fight.					
Inspector Comment					
Remove small tree on waterward shoulder before tree is established.

Looking upstream at a tree growing in the waterside shoulder. (Spring 2020)

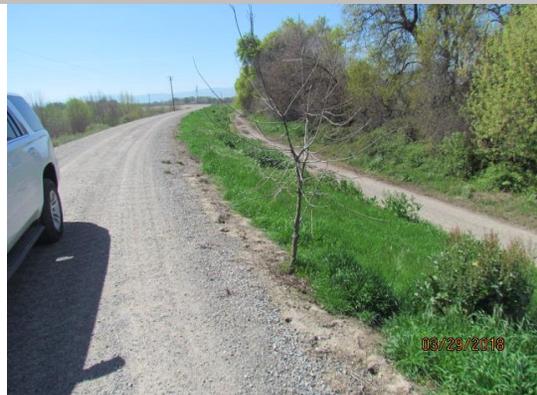
Photo 2 of 2 : SP_2020_RD2092_116_21_20200225_00010.jpg

Looking downstream at small tree on waterward slope. (Spring 2018)

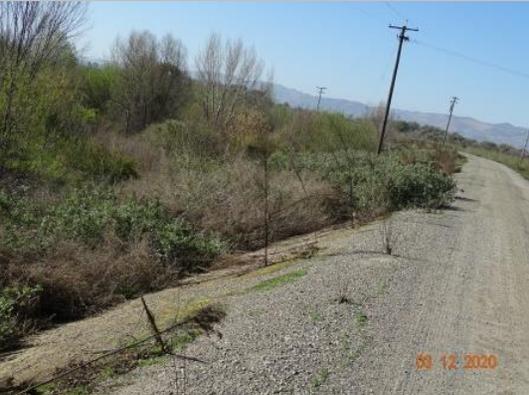
Photo 1 of 1 : SP_2020_RD2092_116_43_20200313_00073.jpg

View along the landside slope looking upstream. (Spring 2020)

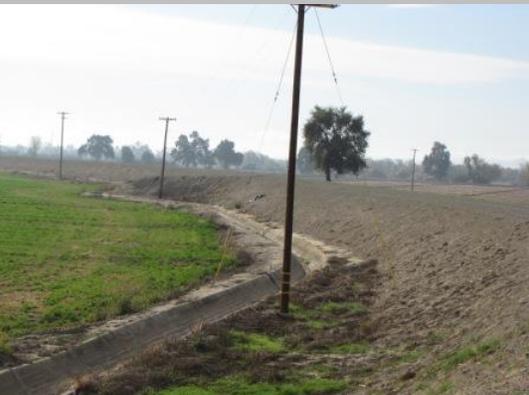
Photo 1 of 1 : SP_2020_RD2092_116_968_20200225_00032.jpg

LM Start	0.76	Rating **	M	Issue No.	968
LM End	1.31	Issue Type +	En	Location *	LS
Category	Earthen Levee			GPS Latitude/Longitude	
				Start	End
Item	Encroachments			37.597291 °	37.590568 °
				-121.168496 °	-121.164028 °
DWR ID	DWR_RD2092_01_s_2012_968				
Comment Code					
DT : Ditch					
Inspector Comment

View of agricultural ditch at the landward toe looking upstream.

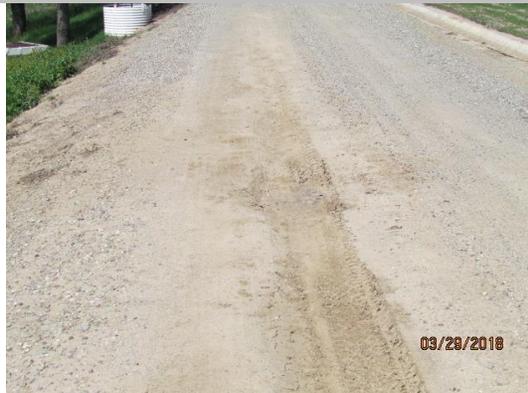
Photo 1 of 1 : SP_2020_RD2092_116_39_20200225_00019.jpg

Looking upstream at rutting and depression on levee crown. (Spring 2018)

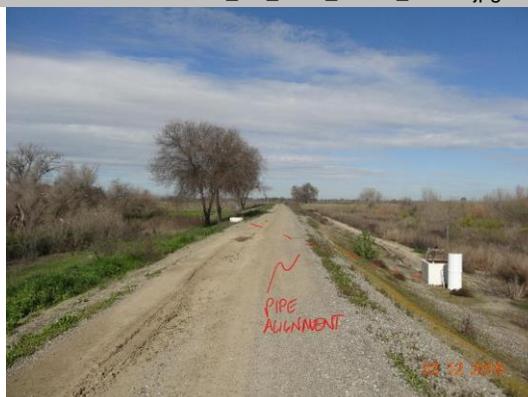
Photo 1 of 3 : UCIP_SP_2020_53820_79073.jpg

Comment Code					
Inspector Comment					
DS_ID:20562 FS_ID:53820 EP_NO: N/A Repair Type: Non-Urgent Crossing Status: Found UCIP Comments: 03/12/2019 During UCIP visual inspection, no pipe or levee integrity issues were observed. Distribution box located on the WS is falling apart (bricks missing). This crossing is an active crossing however, no permit has been found authorizing crossing. Need to determine who maintains and operates this crossing. (O. Magana - DWR UCIP) FIELD_STRUCT_DESC: 36-inch corrugated metal drainage pipe through the levee, 15 feet below the crown. Slide gate in a 48-inch corrugated metal pipe (CMP) riser on the waterside (WS) slope. 4-foot by 6-foot concrete distribution box on the landside (LS) toe. 5-foot by 5-foot concrete riser on the WS toe. [Additional Reference(s): DWR Levee Log, 2005. USACE San Joaquin O&M Manual 5, August 1961, (HLM 1.31)]. FS Date: 3/12/2019 12:06:00 PM

Overview of pipe alignment through levee, photo taking looking d/s toward crossing.

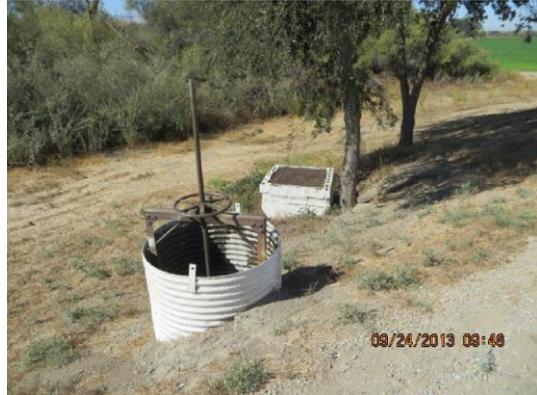
Photo 3 of 3 : UCIP_SP_2020_53820_35213.jpg

Slide gate in 48-inch CMP riser on WS slope.

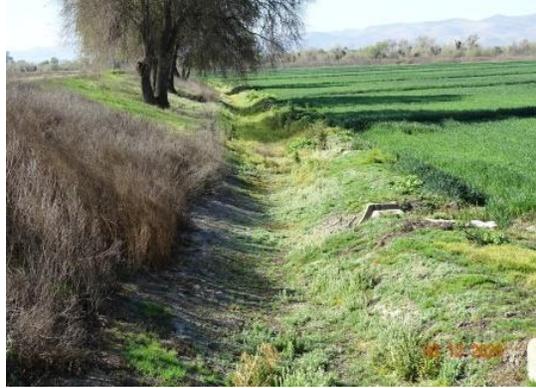
Photo 1 of 2 : SP_2020_RD2092_116_8_20200313_00074.jpg

View of unlined ditch along the waterside toe looking upstream. (Spring 2020)

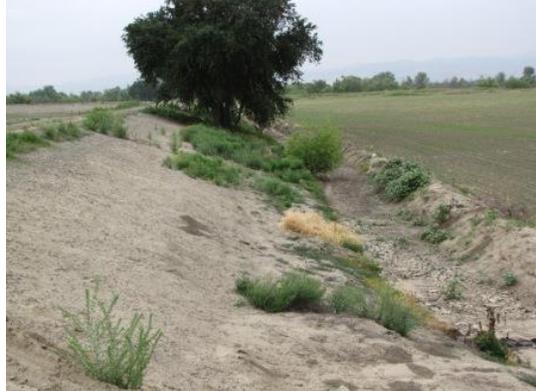
Photo 2 of 2 : SP_2020_RD2092_116_8_20200225_00001.jpg

View of an agricultural ditch at the waterward toe of the slope.

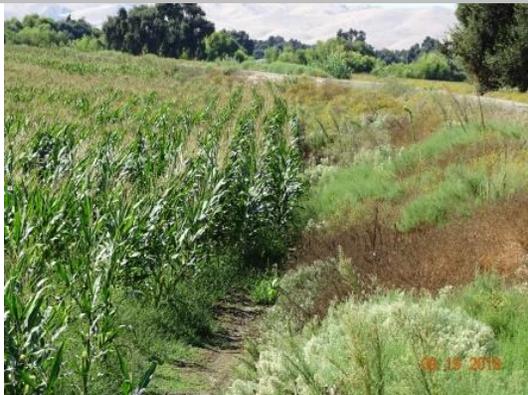
Photo 1 of 2 : SP_2020_RD2092_116_47_20200225_00025.jpg

View of corn plant in landside easement along the levee toe. (Fall 2019)

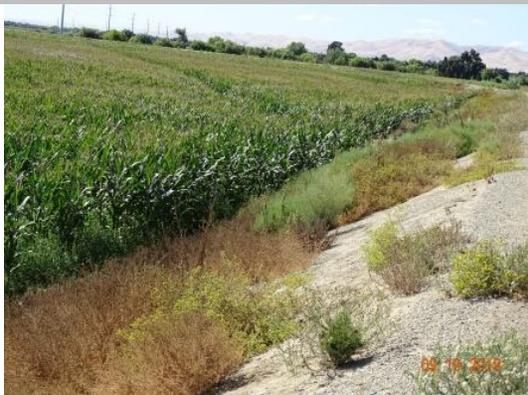
Photo 2 of 2 : SP_2020_RD2092_116_47_20200225_00026.jpg

View of corn planted along the landside levee toe. (Fall 2019)

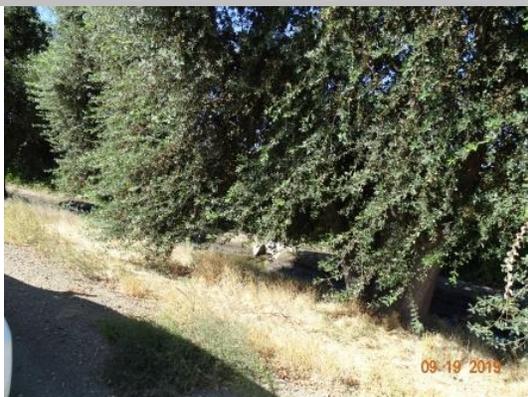
Photo 1 of 1 : SP_2020_RD2092_116_48_20200225_00027.jpg

LM Start	1.60	Rating **	M	Issue No.	48
LM End	1.60	Issue Type +	Ma	Location *	WS
Category	Earthen Levee		GPS Latitude/Longitude		
			Start	End	
Item	Trim / Thin Trees		37.587068 °	37.587068 °	
			-121.162773 °	-121.162773 °	
DWR ID	DWR_RD2092_01_f_2019_48				
Comment Code					
T1 : Trim trees to at least five feet above ground level.					
Inspector Comment

View of branches hanging over waterside slope. (Fall 2019)

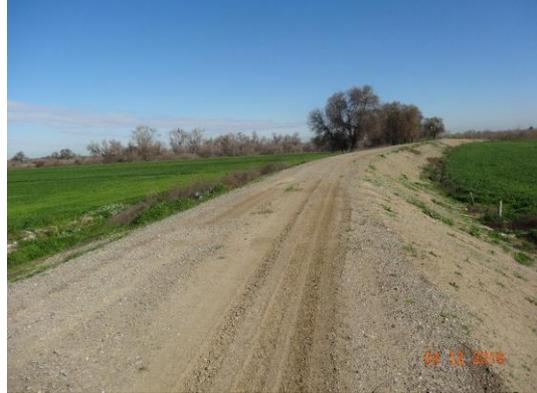
Photo 1 of 3 : UCIP_SP_2020_53817_79086.jpg

Comment Code					
Inspector Comment					
DS_ID:20563 FS_ID:53817 EP_NO: N/A Repair Type: Urgent Crossing Status: Found UCIP Comments: 03/12/2019 A thorough internal evaluation of this crossing is required, pipe shows evidence of pipe integrity (LS) issues (pipe wall sections missing on WS outlet). Internal inspection is recommended for this crossing to determine the extent of pipe damage through the levee. Maintenance issues identified at this crossing include: flap gate missing on WS, debris found inside concrete distribution box, and missing cover on riser. No permit has been identified for this crossing. Need to determine who maintains crossing; crossing appears functional. (O. Magana - DWR UCIP) FIELD_STRUCT_DESC: 24-inch corrugated metal drainage pipe through the levee, 14 feet below the crown. Slide gate in a corrugated metal pipe (CMP) riser on the waterside (WS) slope. Concrete U-shaped headwall at the landside (LS) toe. [Additional Reference(s): DWR Levee Log, 2005. USACE San Joaquin O&M Manual 5, August 1961, (HLM 1.71)]. FS Date: 3/12/2019 12:07:00 PM

Overview of levee crown looking d/s towards pipe crossing.

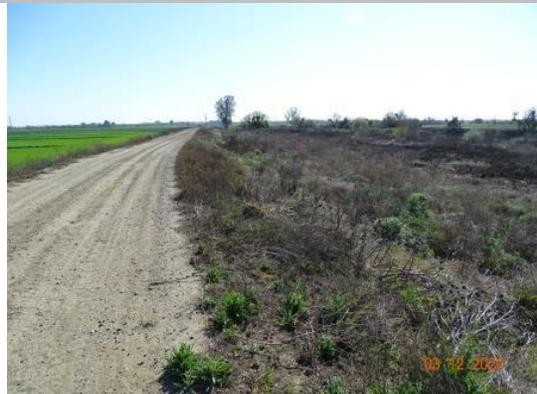
Photo 1 of 1 : SP_2020_RD2092_116_56_20200313_00076.jpg

View of the waterside slope looking upstream. (Spring 2020)

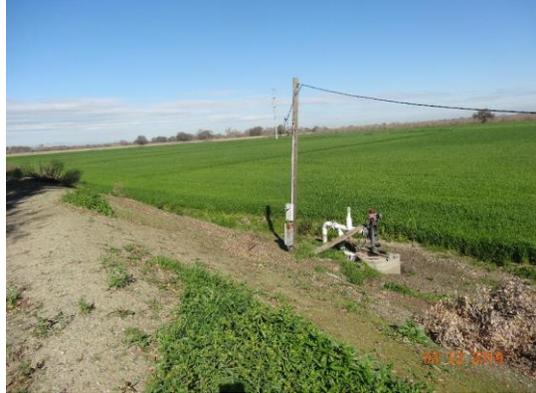
Photo 3 of 3 : UCIP_SP_2020_53814_79093.jpg

LS view: concrete riser, power pole, and groundwater pump station.

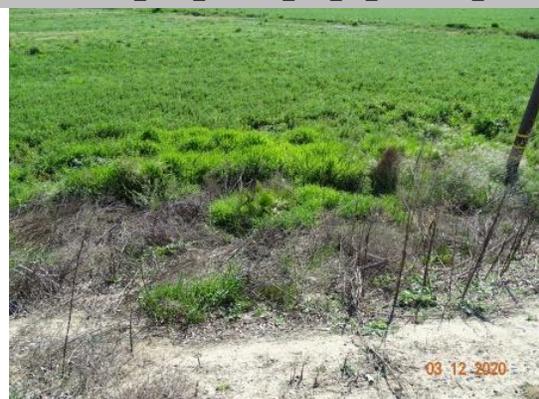
Photo 1 of 2 : SP_2020_RD2092_116_59_20200313_00078.jpg

View of palm tree growing at the landside toe. (Spring 2020)

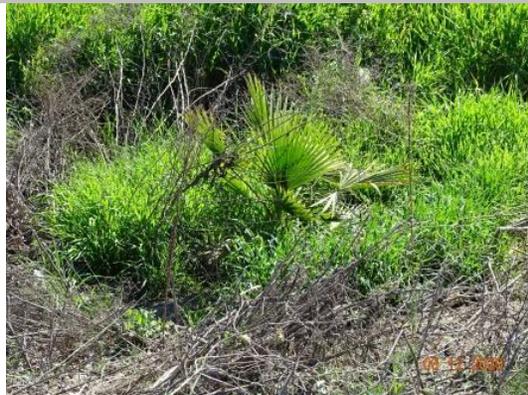
Photo 2 of 2 : SP_2020_RD2092_116_59_20200313_00079.jpg

Upclose view of palm tree growing at the levee toe. (Spring 2020)

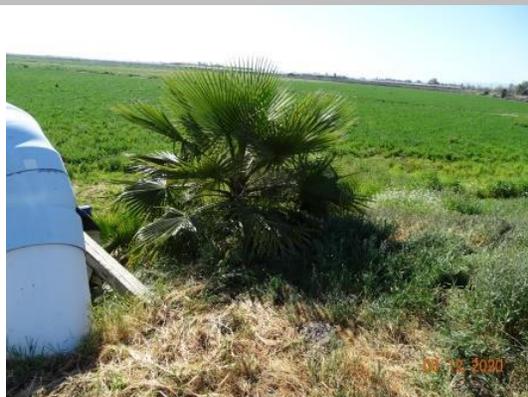
Photo 1 of 1 : SP_2020_RD2092_116_58_20200313_00080.jpg

View of palm tree growing on the landside slope. (Spring 2020)

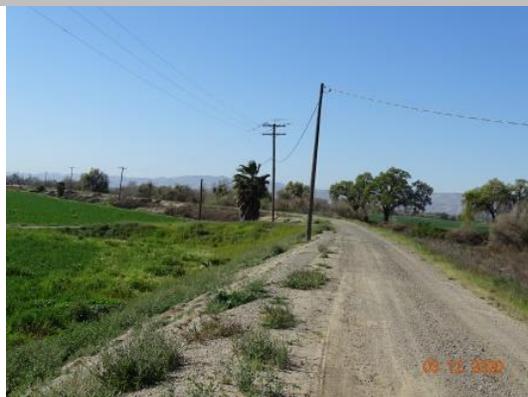
Photo 1 of 1 : SP_2020_RD2092_116_20_20200313_00081.jpg

View of the pole on the landside slope of the levee looking upstream. (Spring 2020)

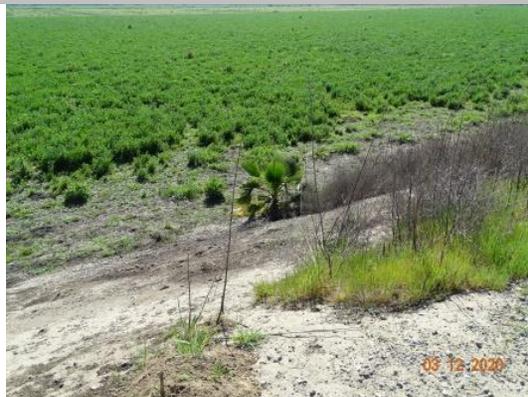
Photo 1 of 1 : SP_2020_RD2092_116_50_20200313_00082.jpg

View of palm tree in the landside slope. (Spring 2020)

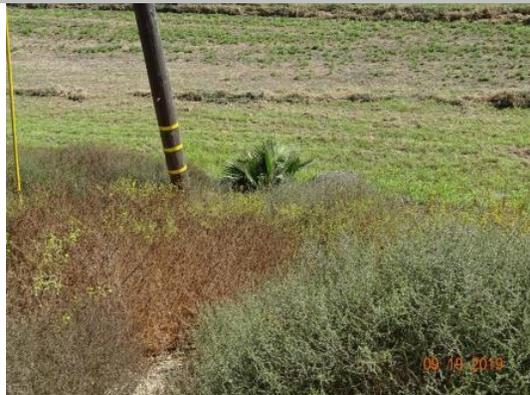
Photo 1 of 1 : SP_2020_RD2092_116_51_20200225_00031.jpg

View of palm tree growing in landside toe. (Fall 2019)

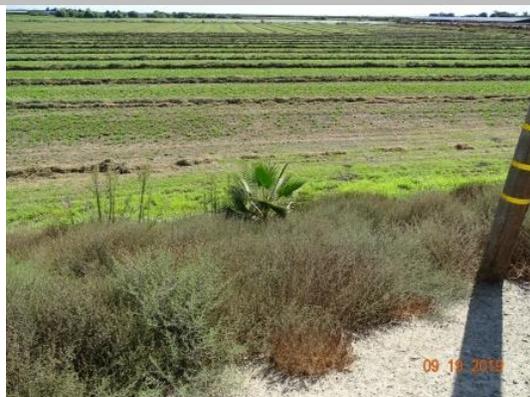
Photo 1 of 2 : SP_2020_RD2092_116_19_20200225_00007.jpg

View of palm tree growing on landside slope. (Fall 2019)

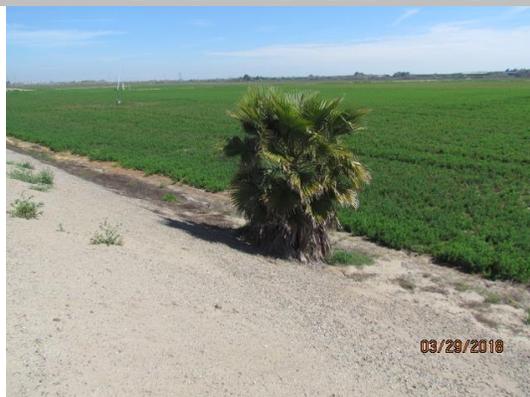
Photo 2 of 2 : SP_2020_RD2092_116_19_20200225_00008.jpg

Looking at Palm tree at landward toe. (Spring 2018)

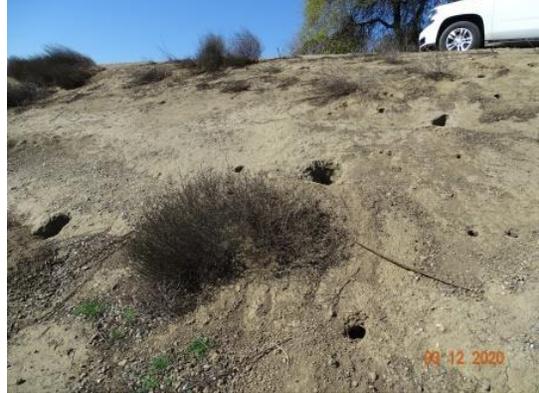
Photo 1 of 2 : SP_2020_RD2092_116_44_20200313_00083.jpg

View of rodent burrows in landside slope. (Spring 2020)

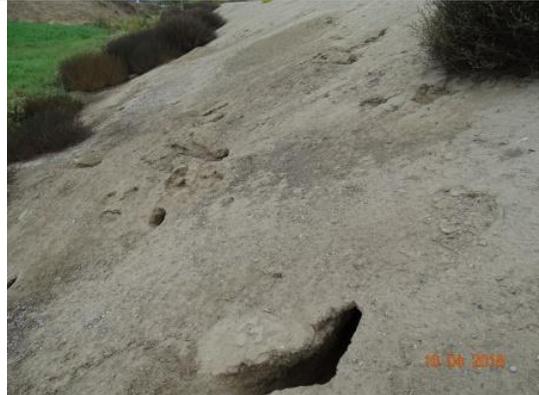
Photo 2 of 2 : SP_2020_RD2092_116_44_20200225_00022.jpg

View of animal burrows looking upstream. (Fall 2018)

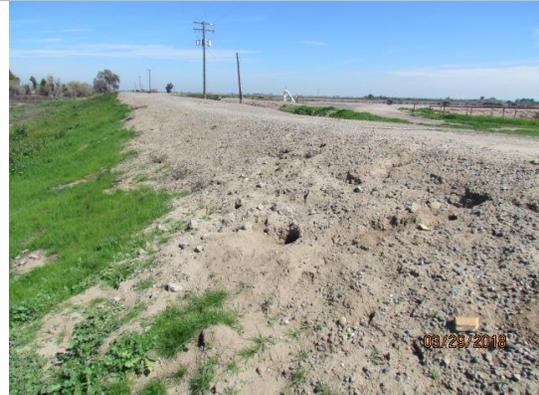
Photo 1 of 4 : SP_2020_RD2092_116_17_20200225_00003.jpg

Looking upstream on waterward slope at several large rodent holes. (Spring 2018)

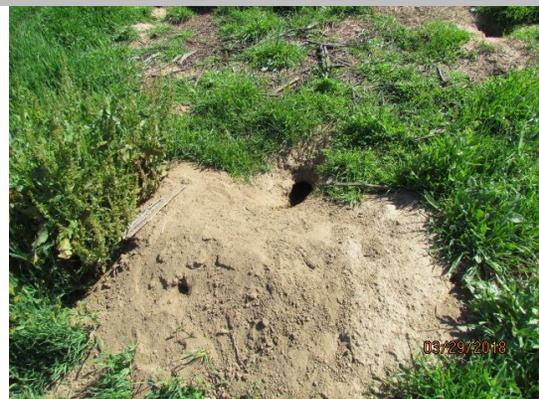
Photo 2 of 4 : SP_2020_RD2092_116_17_20200225_00004.jpg

Looking at typical large rodent holes on waterward slope. (Spring 2018)

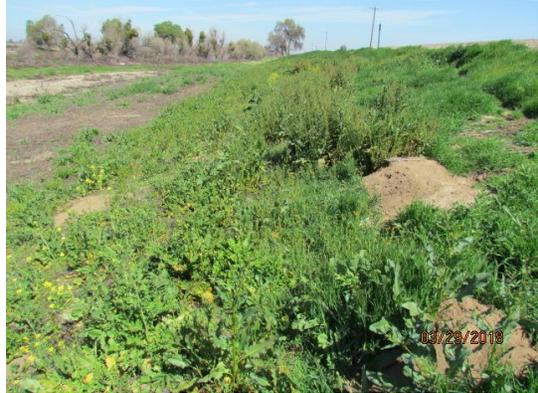
Photo 3 of 4 : SP_2020_RD2092_116_17_20200225_00005.jpg

Looking upstream at large rodent holes on waterward slope. (Spring 2018)

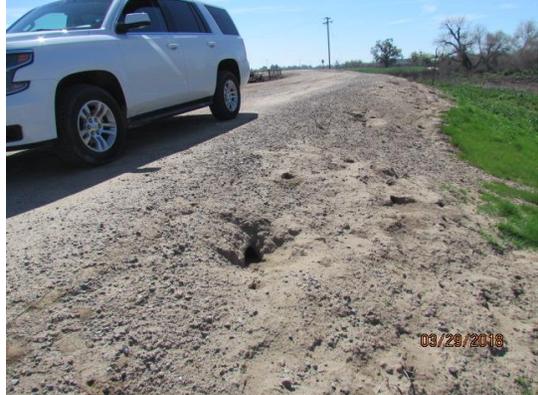
Photo 4 of 4 : SP_2020_RD2092_116_17_20200225_00006.jpg

Looking downstream at several rodent holes on waterward slope. (Spring 2018)

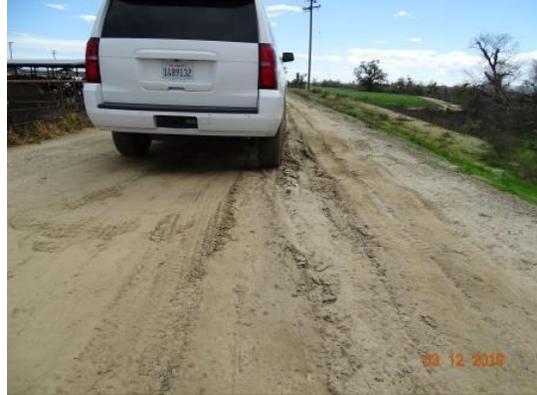
Photo 1 of 2 : SP_2020_RD2092_116_45_20200225_00023.jpg

LM Start	2.74	Rating **	M	Issue No.	45
LM End	2.74	Issue Type +	Ma	Location *	CR
Category	Earthen Levee			GPS Latitude/Longitude	
				Start	End
Item	Crown Surface / Depressions / Rutting			37.575514 °	37.575514 °
				-121.157140 °	-121.157140 °
DWR ID	DWR_RD2092_01_s_2019_45				
Comment Code					
C2 : Repair depressions or ruts in the crown or slope.					
Inspector Comment					
Depression and rutting in levee crown should be repaired.

View of rutting along levee crown. (Spring 2019)

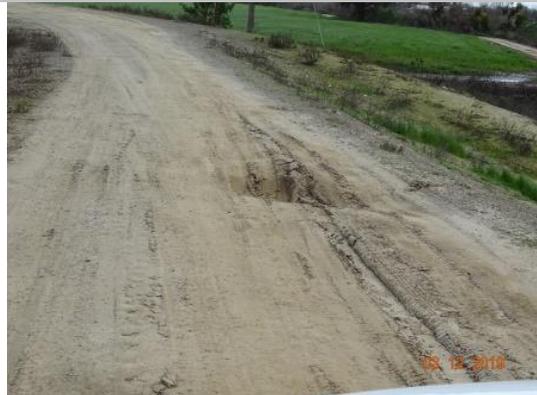
Photo 2 of 2 : SP_2020_RD2092_116_45_20200225_00024.jpg

View of depression in levee crown. (Spring 2019)

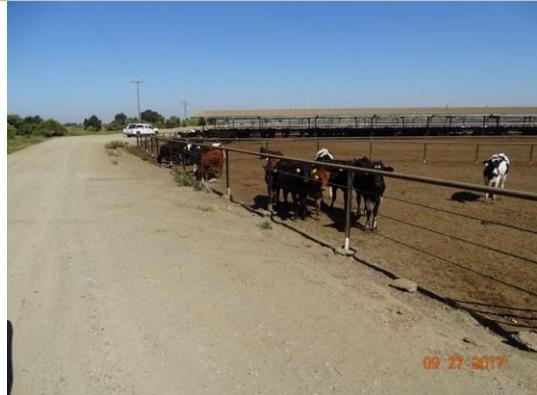
Photo 1 of 1 : SP_2020_RD2092_116_27_20200225_00011.jpg

View of a fence on the landside toe of the levee looking downstream.

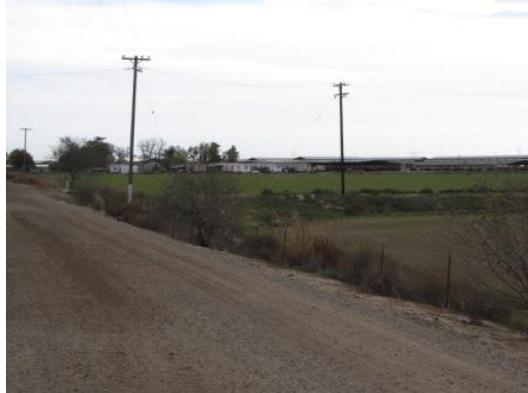
Photo 1 of 1 : SP_2020_RD2092_116_972_20200225_00033.jpg

View of barbed wire fence along the waterward slope looking upstream.

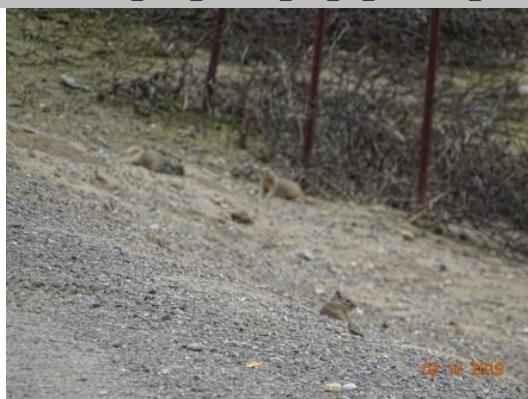
Photo 1 of 1 : SP_2020_RD2092_116_35_20200225_00015.jpg

Squirrels observed along waterside slope. (Spring 2019)

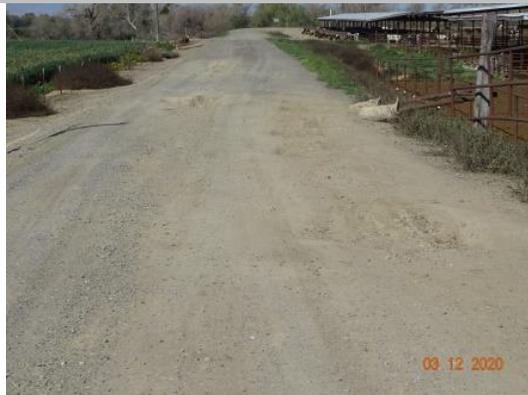
Photo 1 of 1 : SP_2020_RD2092_116_60_20200313_00084.jpg

View of rutting on the levee crown looking downstream. (Spring 2020)
