**Flood Control Project Maintenance
Levee Inspections**
LMA District Cover Sheet
Spring 2020 Levee Inspection Results

Reclamation District No. 2101 Blewett

Waterway		Bank	Unit Miles
Unit No. 01 San Joaquin River		Left	3.16
	Spring (March - May)	Summer (June - August)	(September - November) Fall
Unit Maintenance Rating (Fall Only)			Winter (December - February)
Date of Inspection	4/7/2020 - 4/7/2020		
DWR Inspector	Alberto De Leon		
Accompanied By	Stephen Perez Perez Farms

Levee Inspection Report By Mile - Spring 2020

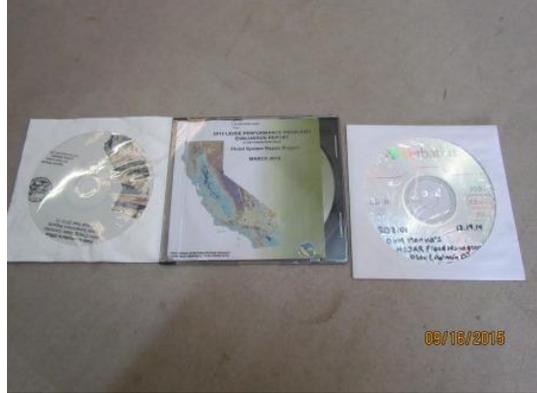
Photo 1 of 1 : SP_2020_RD2101_326_2_20200228_00001.jpg

LM Start		Rating **	A	Issue No.	2
LM End		Issue Type +	Ma	Location *	N/A
Category	Earthen Levee		GPS Latitude/Longitude		
			Start		End
Item	Operations & Maintenance Manuals			o	o
DWR ID	DWR_RD2101_01_s_2013_2			o	o
Comment Code					
Inspector Comment					
The LMA has the O&M Manual available electronically.

View of the O&M manual and other documentation.

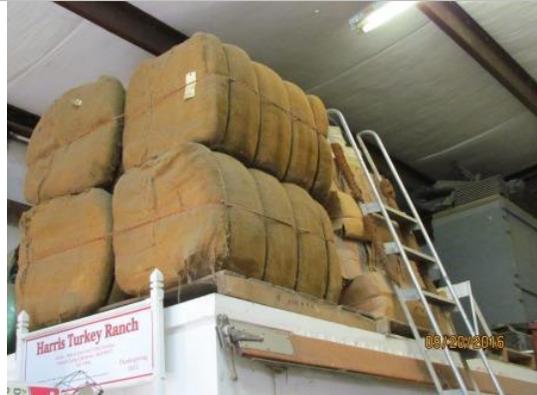
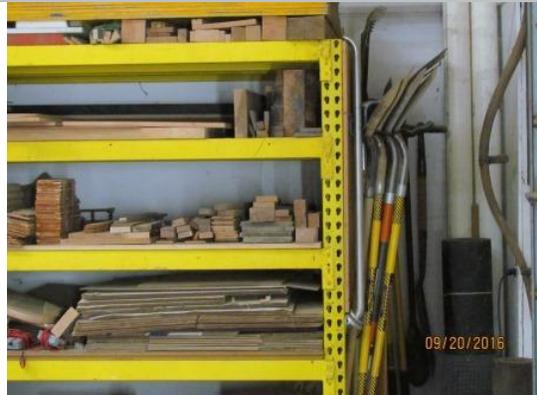
LM Start		Rating **	A	Issue No.	4
LM End		Issue Type +	Ma	Location *	N/A
Category	Earthen Levee		GPS Latitude/Longitude		
			Start		End
Item	Emergency Supplies & Equipment			o	o
DWR ID	DWR_RD2101_01_s_2013_4			o	o
Comment Code					
Inspector Comment					
LMA has emergency supplies on site at the warehouse.

View of the emergency flood fight supplies in the shop.

Another view of the emergency flood fight supplies in the shop.

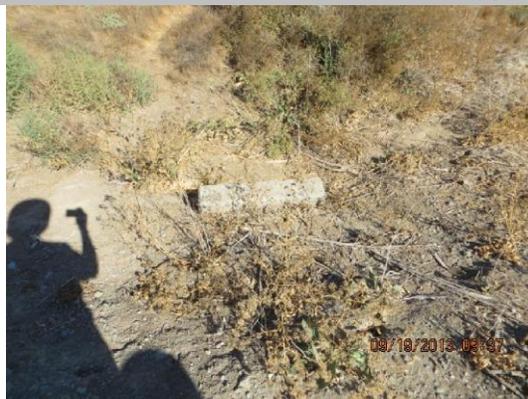
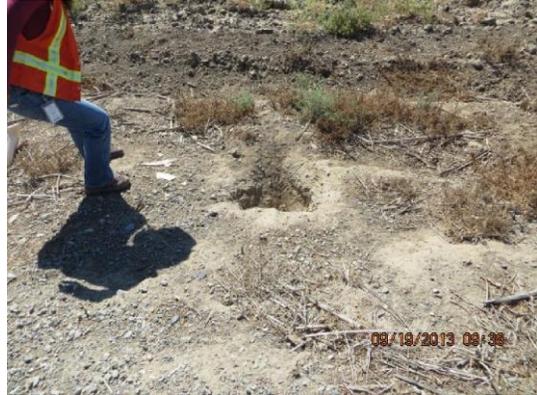
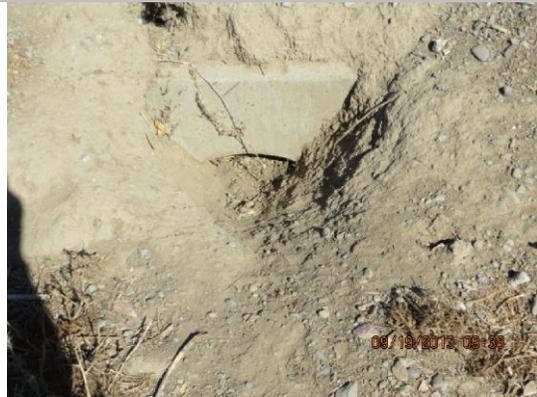
LM Start	0.05	Rating **	M	Issue No.	945
LM End	0.05	Issue Type +	Ma	Location *	
Category	Supplemental		GPS Latitude/Longitude		
			Start	End	
Item	DWR UCIP LMA Responsibility		37.657801	°	37.657801
			-121.253745	°	-121.253745
DWR ID	20699

Comment Code					
Inspector Comment					
DS_ID:20699 FS_ID:53384 EP_NO: N/A Repair Type: Non-Urgent Crossing Status: Found UCIP Comments: 10/10/2018 The levee does not show any signs of integrity issues and the headwalls are in tact, even though the pipe has heavy sediment buildup. Downgrading to Non-Urgent and recommend cleaning out the pipe to allow drainage to pass through unobstructed (D. Sanoski - DWR UCIP). 11/16/2016 Same as previous inspection slide gate still missing. Also dense vegetation prevents access to crossing. Recommend removing vegetation along pipe alignment and both concrete headwalls to conduct proper inspection of structure. (O. Magana - DWR UCIP)09/17/2013 Slide gate missing from WS toe. Pipe has heavy sediment buildup. (W. Wylie - DWR UCIP) FIELD_STRUCT_DESC: 18-inch corrugated metal drainage pipe through the levee, 3 feet below the crown. Concrete headwalls on both ends. Slide gate at the headwall on the waterside (WS) end. [Additional Reference(s): DWR Levee Log, 1992. USACE San Joaquin O&M Manual 12, December 1968, (HLM 0.05), Drawing No. 07-04-1666, Sheets 1666/18 and 1666/52, (Station 00+70)]. FS Date: 10/10/2018 1:39:00 PM

Headwall on WS toe.

Pipe and headwall visible on LS toe.

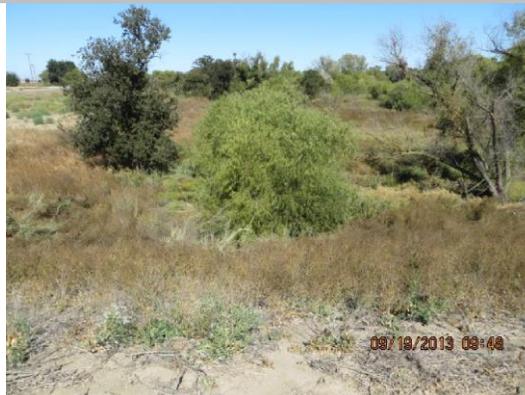
Photo 3 of 3 : UCIP_SP_2020_20752_34978.jpg

LM Start	0.20	Rating **	A/W	Issue No.	946 (cont)
LM End	0.20	Issue Type +	Ma	Location *	
Category	Supplemental			GPS Latitude/Longitude	
				Start	End
Item	DWR UCIP LMA Responsibility			37.657130 °	37.657130 °
				-121.251695 °	-121.251695 °
DWR ID	20700

Concrete U-shaped headwall on LS toe at willow tree on WS toe.

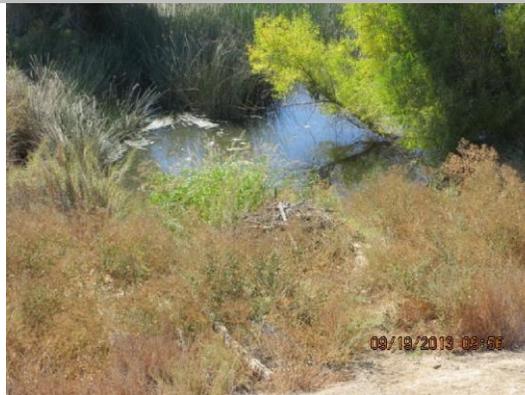
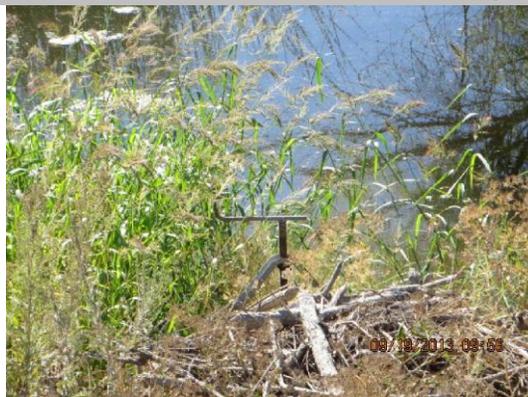
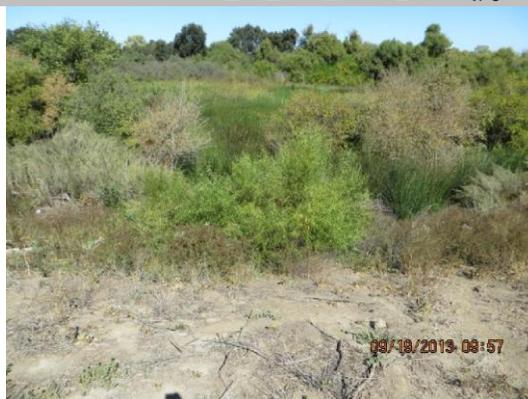
LM Start	0.31	Rating **	M	Issue No.	947
LM End	0.31	Issue Type +	Ma	Location *	
Category	Supplemental			GPS Latitude/Longitude	
				Start	End
Item	DWR UCIP LMA Responsibility			37.658142 °	37.658142 °
				-121.250047 °	-121.250047 °
DWR ID	20701

DS_ID:20701
 FS_ID:20785
 EP_NO: N/A
 Repair Type: Non-Urgent
 Crossing Status: Found
 UCIP Comments: Inlet blocked by soil from beaver activity. Outlet covered in soil.
 FIELD_STRUCT_DESC: 24-inch corrugated metal drainage pipe through the levee, 21 feet below the crown. Headwall and slide gate on the landside (LS) end. Concrete U-shaped headwall and flap gate on the waterside (WS) end. [Additional Reference(s): DWR Levee Log, 1992. USACE San Joaquin O&M Manual 12, December 1968, (HLM 0.31)].
 FS Date: 9/19/2013

Slide gate at concrete headwall on LS toe.

Outlet covered in soil but likely at willow tree on WS slope.

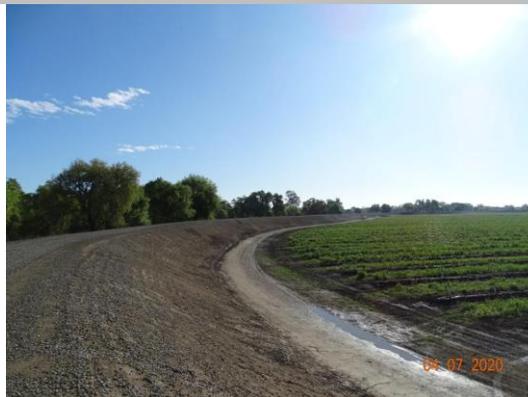
Photo 1 of 1 : SP_2020_RD2101_326_16_20200504_00050.jpg

LM Start	0.44	Rating **	A	Issue No.	16
LM End	2.83	Issue Type +	Ma	Location *	LS
Category	Earthen Levee			GPS Latitude/Longitude	
				Start	End
Item	Vegetation			37.659673 °	37.640425 °
				-121.248715 °	-121.230140 °
DWR ID	DWR_RD2101_01_s_2020_16				
Comment Code					
V1 : Control annual grass and weeds on the levee slopes and easements.					
Inspector Comment

Typical view of vegetation on landside slope. Spring 2020

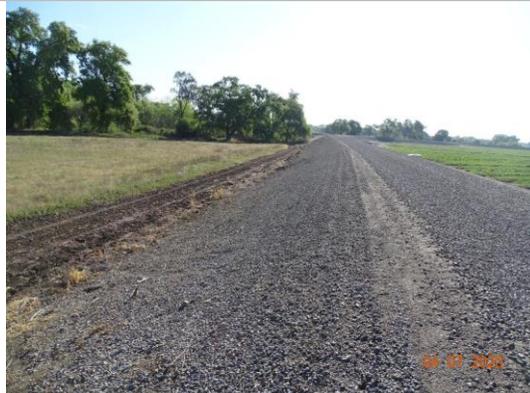
Photo 1 of 1 : SP_2020_RD2101_326_19_20200504_00049.jpg

LM Start	0.44	Rating **	A	Issue No.	19
LM End	2.83	Issue Type +	Ma	Location *	WS
Category	Earthen Levee		GPS Latitude/Longitude		
			Start	End	
Item	Vegetation		37.659673 °	37.640425 °	
			-121.248715 °	-121.230140 °	
DWR ID	DWR_RD2101_01_s_2020_19				
Comment Code					
V1 : Control annual grass and weeds on the levee slopes and easements.					
Inspector Comment

Typical view of vegetation on waterside slope. Spring 2020

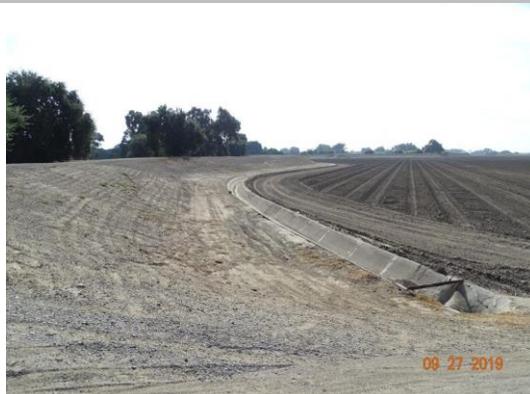
Photo 1 of 1 : SP_2020_RD2101_326_944_20200228_00016.jpg

LM Start	0.73	Rating **	M	Issue No.	944
LM End	1.76	Issue Type +	En	Location *	LS
Category	Earthen Levee		GPS Latitude/Longitude		
			Start	End	
Item	Encroachments		37.659827 °	37.651049 °	
			-121.243675 °	-121.231475 °	
DWR ID	DWR_RD2101_01_s_2012_944				
Comment Code					
DT : Ditch					
Inspector Comment

View of concrete ditch near landside toe. Fall 2019

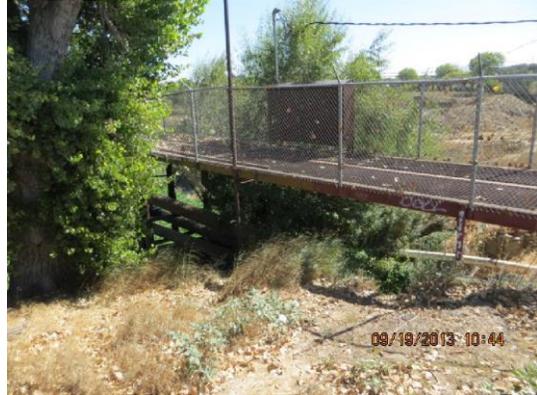
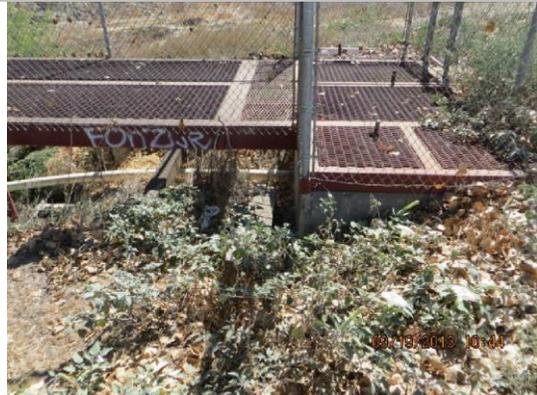
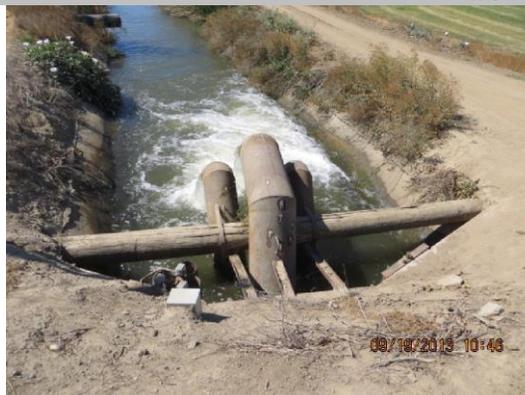
LM Start	2.71	Rating **	M	Issue No.	948
LM End	2.71	Issue Type +	En	Location *	
Category	Supplemental		GPS Latitude/Longitude		
			Start	End	
Item	DWR UCIP Field Study		37.641976 °	37.641976 °	
			-121.229745 °	-121.229745 °	
DWR ID	20711				
Comment Code					
Inspector Comment					
DS_ID:20711 FS_ID:20865 EP_NO: N/A Repair Type: Non-Urgent Crossing Status: Found UCIP Comments: Pipe leaking at pipe/concrete connection on WS slope. FIELD_STRUCT_DESC: 2 of 3: 20-inch concrete encased steel irrigation pipe through the levee, 10 feet below the crown. Pump on steel pier on the waterside (WS). Gate valve in a 16-foot by 7-foot concrete vault on the WS shoulder. Pipes discharge into a concrete canal on the landside (LS) toe. [Additional Reference(s): DWR Levee Log, 1992. USACE San Joaquin O&M Manual 12, December 1968, (HLM 2.73)]. FS Date: 9/19/2013

Pump on metal pier on WS.

Gate valve in concrete vault on WS shoulder.

20-inch steel pipe discharges into concrete channel on LS.

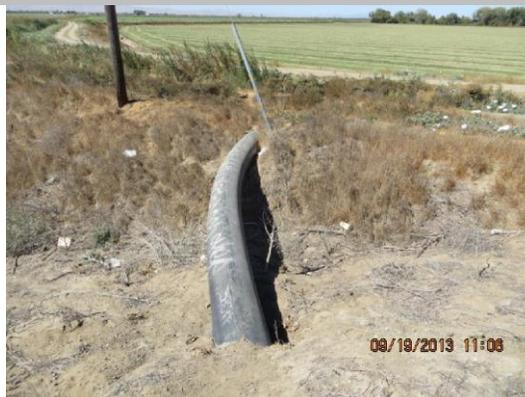
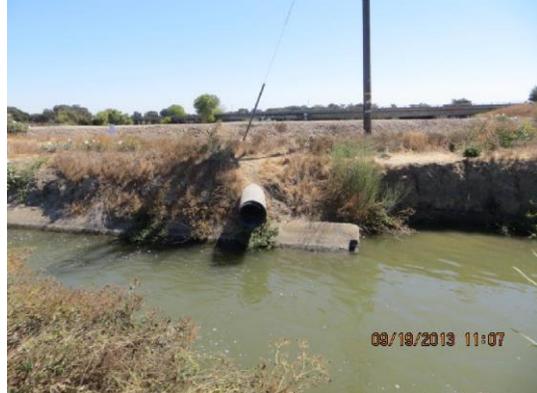
LM Start	2.72	Rating **	M	Issue No.	949
LM End	2.72	Issue Type +	En	Location *	
Category	Supplemental			GPS Latitude/Longitude	
				Start	End
Item	DWR UCIP Field Study			37.641798 °	37.641798 °
				-121.229714 °	-121.229714 °
DWR ID	24679

18-inch PVC pipe visible at LS slope.

Comment Code					
Inspector Comment					
DS_ID:24679 FS_ID:22915 EP_NO: N/A Repair Type: Non-Urgent Crossing Status: Found UCIP Comments: 09/26/2016 - (T. Hatch/UCIP) Inspector indicated that pipe had been removed for several years. Need additional information to determine if the pipe was removed properly and the levee recompacted to specifications. 09/19/2013 - (W. Wylie/UCIP) No permit identified for this crossing. FIELD_STRUCT_DESC: *REMOVED* 18-inch polyvinyl chloride (PVC) irrigation pipe through the levee, 3.5 feet below the crown. No pump or other appurtenances visible. FS Date: 9/19/2013

18-inch PVC pipe visible at outlet to irrigation canal on LS slope.

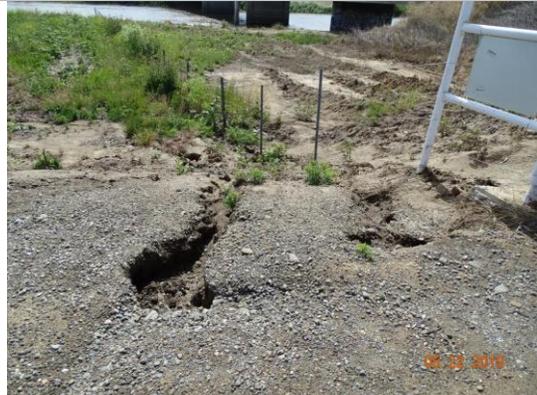
Photo 1 of 1 : SP_2020_RD2101_326_49_20200228_00015.jpg

LM Start	2.74	Rating **	U	Issue No.	49
LM End	2.74	Issue Type +	Ma	Location *	WS
Category	Earthen Levee			GPS Latitude/Longitude	
				Start	End
Item	Erosion / Bank Caving			37.641545 °	37.641545 °
				-121.229744 °	-121.229744 °
DWR ID	DWR_RD2101_01_s_2019_49				
Comment Code					
E2 : Schedule repair of erosion site prior to the next inspection.					
Inspector Comment					
There is erosion on the waterside shoulder extending down the slope. Most likely caused by surface runoff from adjacent highway.

Waterside shoulder erosion most likely caused by surface runoff from adjacent highway. (Spring 2019)

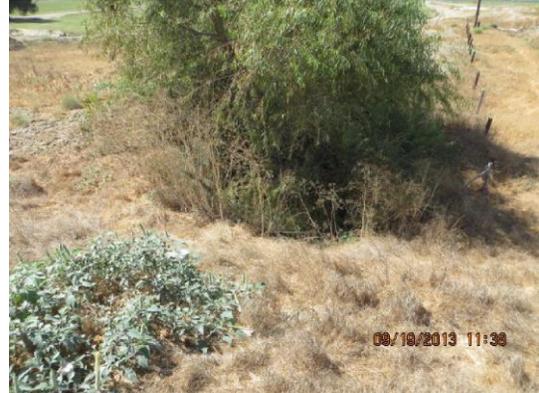
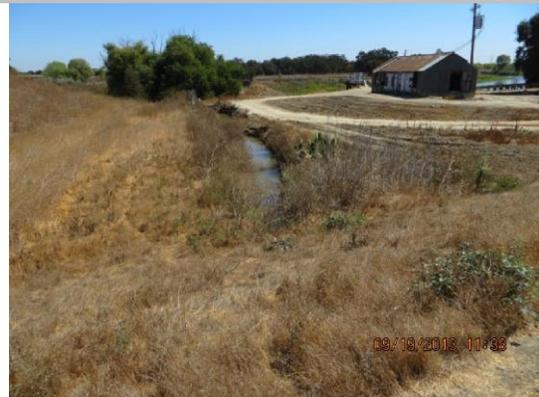
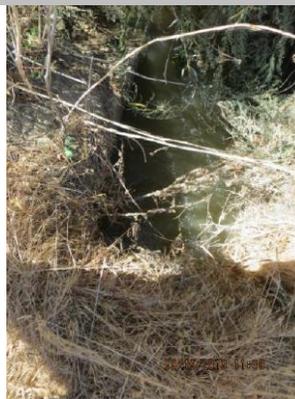
Comment Code					
Inspector Comment					
DS_ID:20705 FS_ID:53201 EP_NO: N/A Repair Type: Non-Urgent Crossing Status: Found UCIP Comments: 10/10/2018 Although there was heavy vegetation, there were no visible levee or pipe threats; downgrading to Non-Urgent (D. Sanoski - DWR UCIP).11/16/2016 No access available. Need to coordinate with LMA to obtain access for proper inspection at a later date. (O. Magana - DWR UCIP)09/19/2013 Flap gate missing from WS headwall. (W. Wylie - DWR UCIP) FIELD_STRUCT_DESC: 24-inch corrugated metal drainage pipe through the levee, 11 feet below the crown. Concrete U-shaped headwalls on both ends. Flap gate on the waterside (WS) end. [Additional Reference(s): DWR Levee Log, 1992. USACE San Joaquin O&M Manual 12, December 1968, (HLM 2.85), Drawing No. 07-04-1666, Sheets 1666/13 and 1666/51, (Station 421+30)]. FS Date: 10/10/2018 2:24:25 PM

Concrete headwall visible at LS toe in ditch.

Concrete headwall visible on WS toe at canal.

Concrete headwall at LS toe.

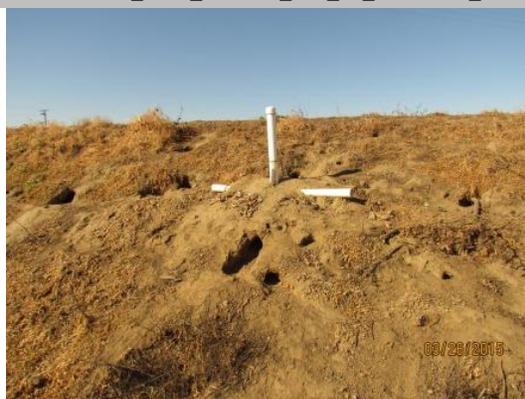
Photo 1 of 1 : SP_2020_RD2101_326_27_20200228_00009.jpg

View of multiple rodent holes on the levee slope.

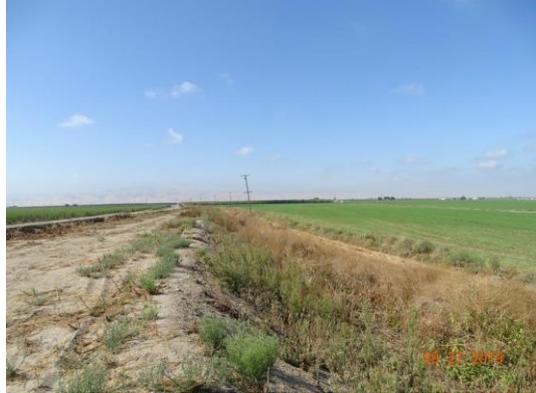
Photo 1 of 1 : SP_2020_RD2101_326_24_20200228_00007.jpg

View of vegetation on landside slope. Fall 2019

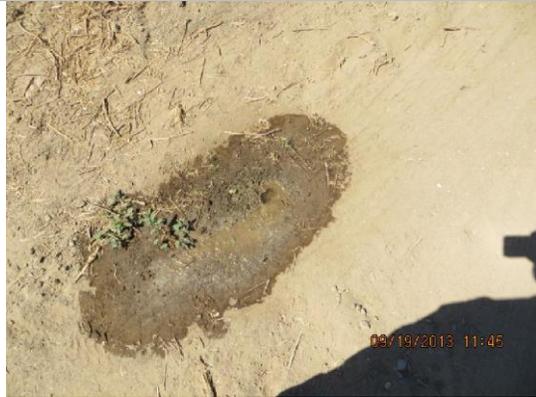
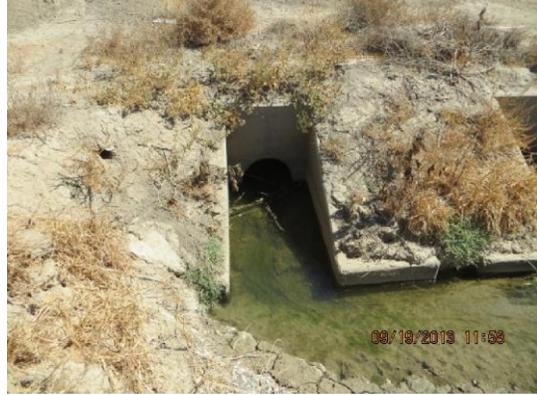
LM Start	2.85	Rating **	M	Issue No.	951
LM End	2.85	Issue Type +	En	Location *	
Category	Supplemental		GPS Latitude/Longitude		
			Start	End	
Item	DWR UCIP Field Study		37.640185 °	37.640185 °	
			-121.230067 °	-121.230067 °	
DWR ID	20706

Comment Code					
Inspector Comment					
DS_ID:20706 FS_ID:20873 EP_NO: N/A Repair Type: Non-Urgent Crossing Status: Found UCIP Comments: Leaks off LS toe may indicate internal failure. Good candidate for video inspection. FIELD_STRUCT_DESC: 1 of 2: 24-inch reinforced concrete irrigation pipe through the levee, 11 feet below the crown. Pump on metal pier at the berm. Screw gates in a 6-foot by 10.5-foot concrete box on the waterside (WS). 12-inch steel riser next to concrete box with slide gates. Abandoned pump house on the WS. [Additional Reference(s): DWR Levee Log, 1992. USACE San Joaquin O&M Manual 12, December 1968, (HLM 2.87)]. FS Date: 9/19/2013

Leak in pipe off LS toe.

Inlet on LS toe with concrete headwall.

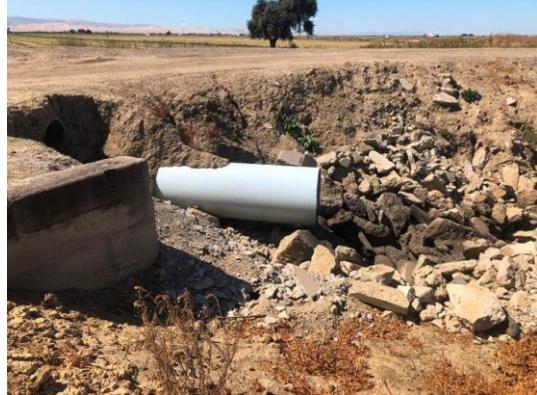
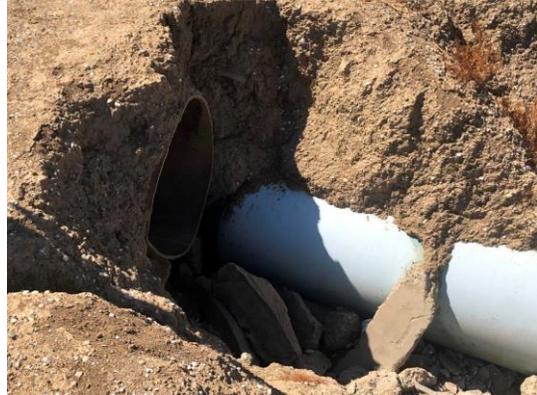
LM Start	2.87	Rating **	U	Issue No.	29
LM End	2.87	Issue Type +	Ma	Location *	WS
Category	Supplemental			GPS Latitude/Longitude	
				Start	End
Item	DWR Erosion Survey			37.639852 °	37.639852 °
				-121.229979 °	-121.229979 °
DWR ID	RD2101U01RM74.97				
Comment Code					
Inspector Comment					
Site ID: RD2101U01RM74.97					
09/17/2019: The erosion has been caused by the irrigation pipe leakage.

Looking at the irrigation pipe outlet on the site.

Close-up view of the erosion.

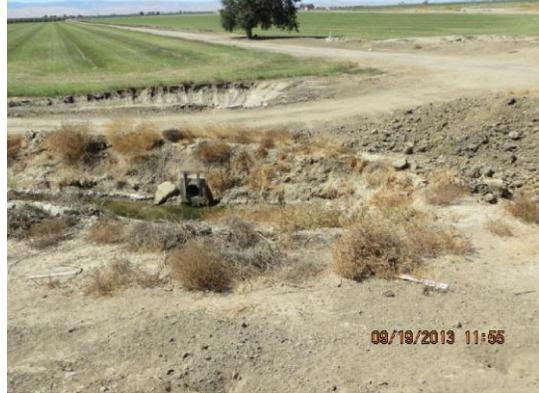
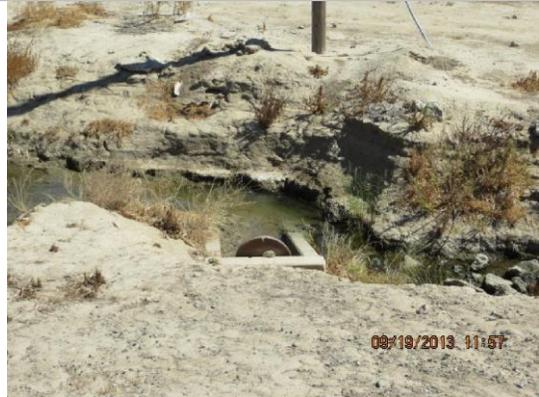
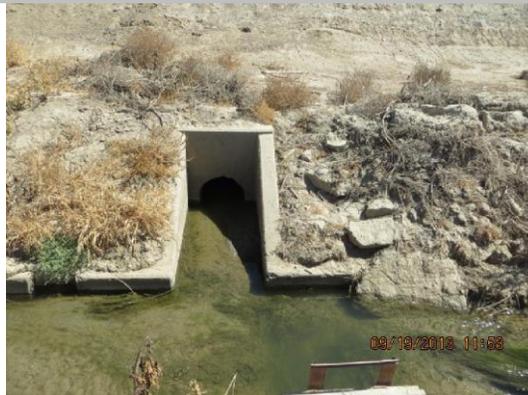
LM Start	2.87	Rating **	A/W	Issue No.	954
LM End	2.87	Issue Type +	Ma	Location *	
Category	Supplemental		GPS Latitude/Longitude		
			Start	End	
Item	DWR UCIP LMA Responsibility		37.639884 °	37.639884 °	
			-121.230008 °	-121.230008 °	
DWR ID	20709				
Comment Code					
Inspector Comment					
DS_ID:20709 FS_ID:20876 EP_NO: N/A Repair Type: No Action Needed Crossing Status: Found UCIP Comments: FIELD_STRUCT_DESC: 2 of 2: 24-inch drainage pipe of an unknown material through the levee, 12.5 feet below the crown. Concrete U-shaped headwalls on each end. Flap gate on the waterside (WS) end. [Additional Reference(s): DWR Levee Log, 1992. USACE San Joaquin O&M Manual 12, December 1968, (HLM 2.89)]. FS Date: 9/19/2013

Concrete inlet on LS toe at canal.

Concrete U-shaped headwall on WS toe with flapgate.

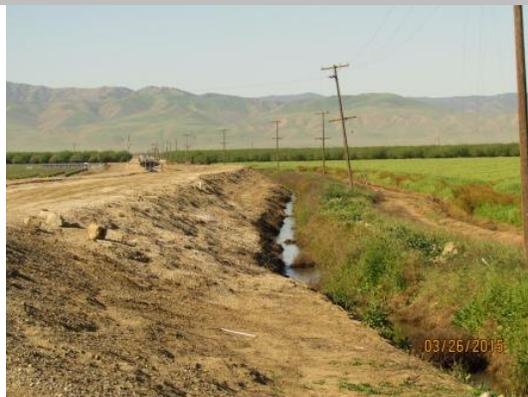
Photo 1 of 1 : SP_2020_RD2101_326_8_20200228_00004.jpg

LM Start	2.88	Rating **	M	Issue No.	8
LM End	3.15	Issue Type +	En	Location *	LS
Category	Earthen Levee			GPS Latitude/Longitude	
				Start	End
Item	Encroachments			37.639780 °	37.637167 °
				-121.230008 °	-121.233715 °
DWR ID	DWR_RD2101_01_f_2013_8				
Comment Code					
DT : Ditch					
Inspector Comment

View of the ditch at the landside levee toe.
