**Flood Control Project Maintenance  
Levee Inspections**

**Maintenance Issue Types Only, Levee Inspection Report By Mile - Fall 2019**

**Reclamation District No. 2101 Blewett**

Waterway	Bank	Unit Miles	Inspection Start/End	Inspector
Unit No. 01 San Joaquin River	Left	3.16	09/27/2019 09/27/2019	Alberto De Leon

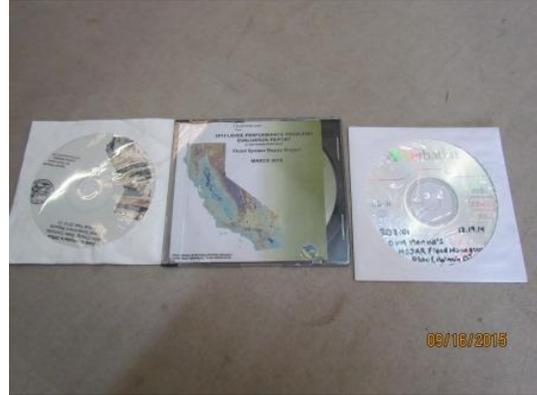
Photo 1 of 1 : FA\_2019\_RD2101\_326\_2\_20190830\_00001.jpg

LM Start		Rating **	A	Issue No.	<b>2</b>
LM End		Issue Type +	Ma	Location *	N/A
Category	Earthen Levee		GPS Latitude/Longitude		
			Start	End	
Item	Operations & Maintenance Manuals				
DWR ID	DWR_RD2101_01_s_2013_2				
Comment Code					
Inspector Comment					
The LMA has the O&M Manual available electronically.

View of the O&M manual and other documentation.

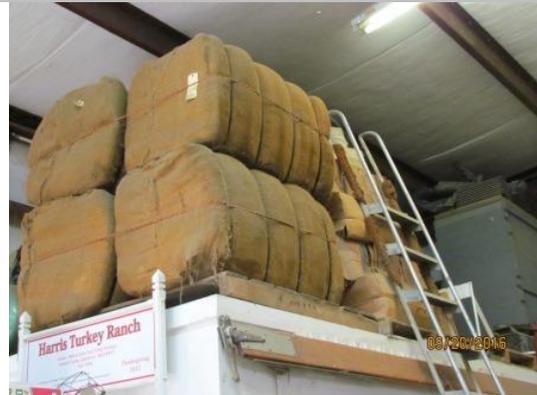
Photo 1 of 2 : FA\_2019\_RD2101\_326\_4\_20190830\_00002.jpg

LM Start		Rating **	A	Issue No.	<b>4</b>
LM End		Issue Type +	Ma	Location *	N/A
Category	Earthen Levee		GPS Latitude/Longitude		
			Start	End	
Item	Emergency Supplies & Equipment				
DWR ID	DWR_RD2101_01_s_2013_4				
Comment Code					
Inspector Comment					
LMA has emergency supplies on site at the warehouse.

View of the emergency flood fight supplies in the shop.

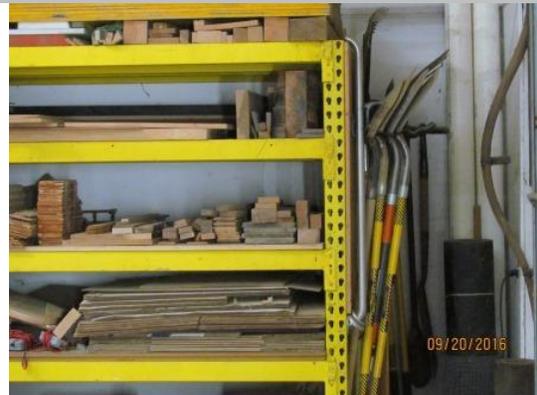
Photo 2 of 2 : FA\_2019\_RD2101\_326\_4\_20190830\_00003.jpg

Another view of the emergency flood fight supplies in the shop.

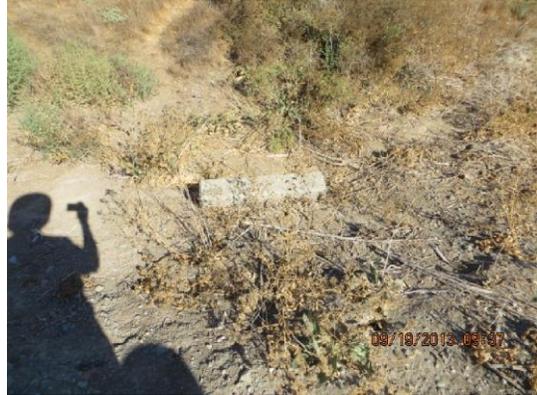
Photo 1 of 3 : UCIP\_FA\_2019\_53384\_47962.jpg

Item	DRAFT DWR UCIP LMA Responsibility		37.657801 °	37.657801 °	
			-121.253745 °	-121.253745 °	
DWR ID	20699				
Comment Code					
Inspector Comment					
DS_ID:20699 FS_ID:53384 EP_NO: N/A Repair Type: Non-Urgent Crossing Status: Found UCIP Comments: 10/10/2018 The levee does not show any signs of integrity issues and the headwalls are in tact, even though the pipe has heavy sediment buildup. Downgrading to Non-Urgent and recommend cleaning out the pipe to allow drainage to pass through unobstructed (D. Sanoski - DWR UCIP). 11/16/2016 Same as previous inspection slide gate still missing. Also dense vegetation prevents access to crossing. Recommend removing vegetation along pipe alignment and both concrete headwalls to conduct proper inspection of structure. (O. Magana - DWR UCIP)09/17/2013 Slide gate missing from WS toe. Pipe has heavy sediment buildup. (W. Wylie - DWR UCIP) FIELD_STRUCT_DESC: 18-inch corrugated metal drainage pipe through the levee, 3 feet below the crown. Concrete headwalls on both ends. Slide gate at the headwall on the waterside (WS) end. [Additional Reference(s): DWR Levee Log, 1992. USACE San Joaquin O&M Manual 12, December 1968, (HLM 0.05), Drawing No. 07-04-1666, Sheets 1666/18 and 1666/52, (Station 00+70)]. FS Date: 10/10/2018 1:39:00 PM

Headwall on WS toe.

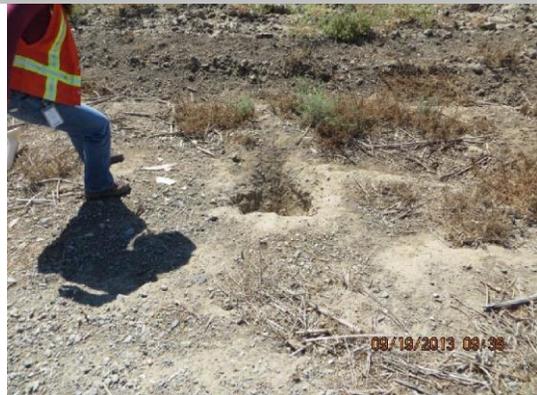
Photo 2 of 3 : UCIP\_FA\_2019\_53384\_47961.jpg

Pipe and headwall visible on LS toe.

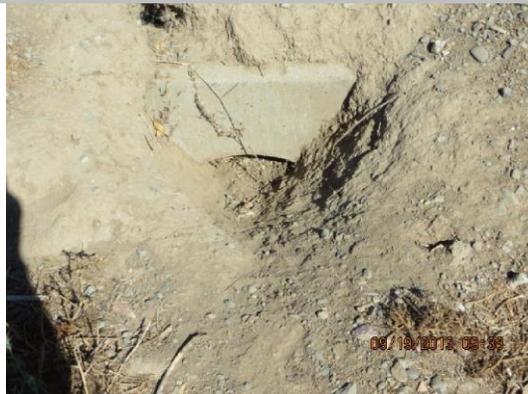
Photo 3 of 3 : UCIP\_FA\_2019\_53384\_47960.jpg

Item	DRAFT DWR UCIP LMA Responsibility			37.657801 °	37.657801 °
				-121.253745 °	-121.253745 °
DWR ID	20699				
Comment Code					
Inspector Comment					
DS_ID:20699 FS_ID:53384 EP_NO: N/A Repair Type: Non-Urgent Crossing Status: Found UCIP Comments: 10/10/2018 The levee does not show any signs of integrity issues and the headwalls are in tact, even though the pipe has heavy sediment buildup. Downgrading to Non-Urgent and recommend cleaning out the pipe to allow drainage to pass through unobstructed (D. Sanoski - DWR UCIP). 11/16/2016 Same as previous inspection slide gate still missing. Also dense vegetation prevents access to crossing. Recommend removing vegetation along pipe alignment and both concrete headwalls to conduct proper inspection of structure. (O. Magana - DWR UCIP)09/17/2013 Slide gate missing from WS toe. Pipe has heavy sediment buildup. (W. Wylie - DWR UCIP) FIELD_STRUCT_DESC: 18-inch corrugated metal drainage pipe through the levee, 3 feet below the crown. Concrete headwalls on both ends. Slide gate at the headwall on the waterside (WS) end. [Additional Reference(s): DWR Levee Log, 1992. USACE San Joaquin O&M Manual 12, December 1968, (HLM 0.05), Drawing No. 07-04-1666, Sheets 1666/18 and 1666/52, (Station 00+70)]. FS Date: 10/10/2018 1:39:00 PM

Pipe and headwall visible on LS toe.

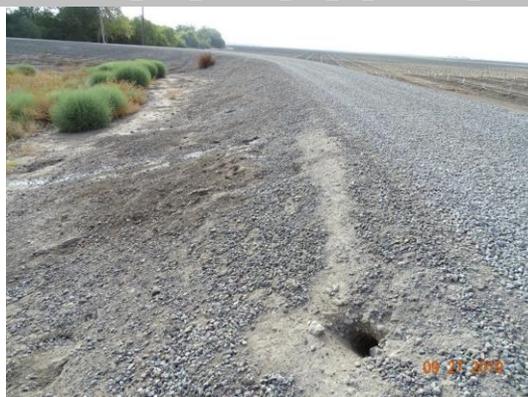
Photo 1 of 1 : FA\_2019\_RD2101\_326\_17\_20191001\_00048.jpg

LM Start	<b>0.14</b>	Rating **	M	Issue No.	<b>17</b>
LM End	<b>0.14</b>	Issue Type +	Ma	Location *	WS
Category	Earthen Levee			GPS Latitude/Longitude	
				Start	End
Item	Animal Control			37.657152 °	37.657152 °
				-121.252447 °	-121.252447 °
DWR ID	DWR_RD2101_01_f_2019_17				
Comment Code					
A3 : No rodents visible, but rodent burrows visible; need to backfill and compact or grout burrows.					
Inspector Comment

View of more than 5 rodent holes on waterside slope. Fall 2019

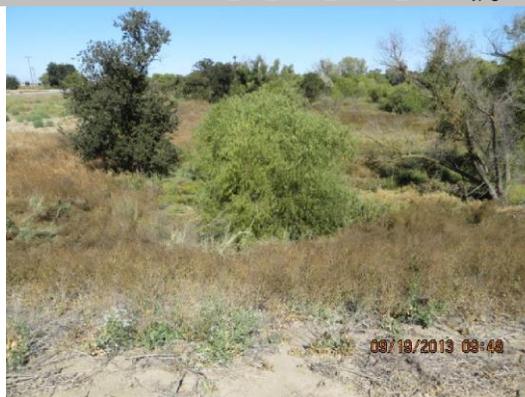
Photo 3 of 3 : UCIP\_FA\_2019\_20752\_34978.jpg

LM Start	<b>0.20</b>	Rating **	A/W	Issue No.	<b>946 (cont)</b>
LM End	<b>0.20</b>	Issue Type +	Ma	Location *	
Category	Supplemental			GPS Latitude/Longitude	
				Start	End
Item	DRAFT DWR UCIP LMA Responsibility			37.657130°	37.657130°
				-121.251695°	-121.251695°
DWR ID	20700				
Comment Code					
Inspector Comment					
DS_ID:20700 FS_ID:20752 EP_NO: N/A Repair Type: No Action Needed Crossing Status: Found UCIP Comments: FIELD_STRUCT_DESC: 20-inch steel drainage pipe through the levee, 2 feet below the crown. Concrete U-shaped headwall and flap gate on the waterside (WS) end. Pump on pile structure on the landside (LS). [Additional Reference(s): DWR Levee Log, 1992. USACE San Joaquin O&M Manual 12, December 1968, (HLM 0.20), 18-inch pipe listed]. FS Date: 9/19/2013

Concrete U-shaped headwall on LS toe at willow tree on WS toe.

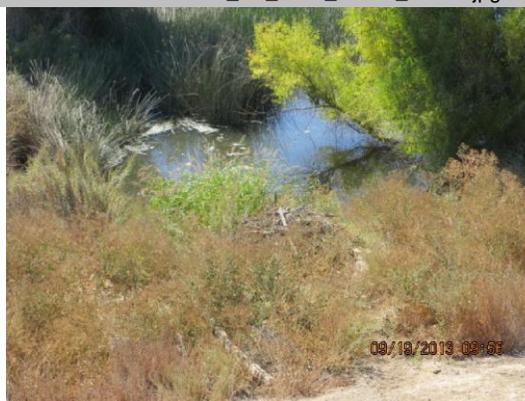
Photo 1 of 3 : UCIP\_FA\_2019\_20785\_35046.jpg

LM Start	<b>0.31</b>	Rating **	M	Issue No.	<b>947</b>
LM End	<b>0.31</b>	Issue Type +	Ma	Location *	
Category	Supplemental			GPS Latitude/Longitude	
				Start	End
Item	DRAFT DWR UCIP LMA Responsibility			37.658142°	37.658142°
				-121.250047°	-121.250047°
DWR ID	20701				
Comment Code					
Inspector Comment					
DS_ID:20701 FS_ID:20785 EP_NO: N/A Repair Type: Non-Urgent Crossing Status: Found UCIP Comments: Inlet blocked by soil from beaver activity. Outlet covered in soil. FIELD_STRUCT_DESC: 24-inch corrugated metal drainage pipe through the levee, 21 feet below the crown. Headwall and slide gate on the landside (LS) end. Concrete U-shaped headwall and flap gate on the waterside (WS) end. [Additional Reference(s): DWR Levee Log, 1992. USACE San Joaquin O&M Manual 12, December 1968, (HLM 0.31)]. FS Date: 9/19/2013

Slide gate at concrete headwall on LS toe.

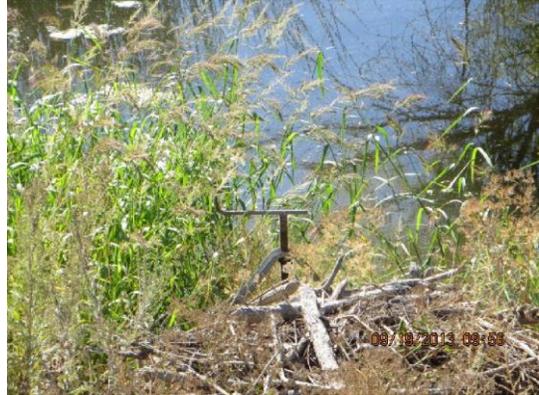
Photo 2 of 3 : UCIP\_FA\_2019\_20785\_35045.jpg

LM Start	<b>0.31</b>	Rating **	M	Issue No.	<b>947 (cont)</b>
LM End	<b>0.31</b>	Issue Type +	Ma	Location *	
Category	Supplemental			GPS Latitude/Longitude	
				Start	End
Item	DRAFT DWR UCIP LMA Responsibility			37.658142°	37.658142°
				-121.250047°	-121.250047°
DWR ID	20701				
Comment Code					
Inspector Comment					
DS_ID:20701 FS_ID:20785 EP_NO: N/A Repair Type: Non-Urgent Crossing Status: Found UCIP Comments: Inlet blocked by soil from beaver activity. Outlet covered in soil. FIELD_STRUCT_DESC: 24-inch corrugated metal drainage pipe through the levee, 21 feet below the crown. Headwall and slide gate on the landside (LS) end. Concrete U-shaped headwall and flap gate on the waterside (WS) end. [Additional Reference(s): DWR Levee Log, 1992. USACE San Joaquin O&M Manual 12, December 1968, (HLM 0.31)]. FS Date: 9/19/2013

Slide gate at concrete headwall on LS toe.

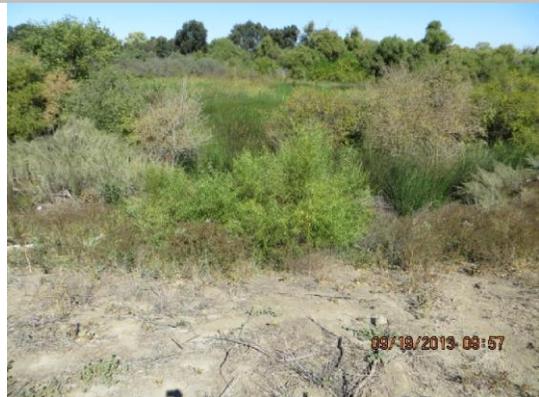
Photo 3 of 3 : UCIP\_FA\_2019\_20785\_35044.jpg

Outlet covered in soil but likely at willow tree on WS slope.

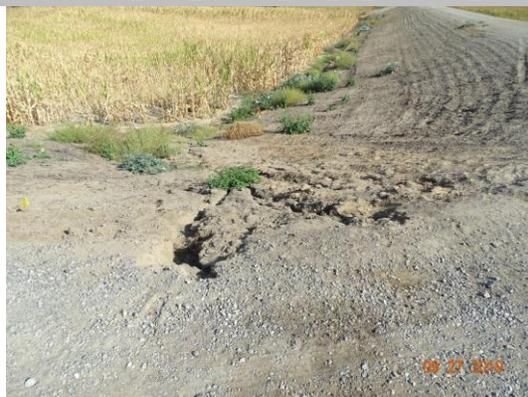
Photo 1 of 1 : FA\_2019\_RD2101\_326\_18\_20191001\_00053.jpg

LM Start	<b>0.73</b>	Rating **	M	Issue No.	<b>18</b>
LM End	<b>0.73</b>	Issue Type +	Ma	Location *	WS
Category	Earthen Levee		GPS Latitude/Longitude		
			Start	End	
Item	Erosion / Bank Caving		37.659815°	37.659815°	
			-121.243640°	-121.243640°	
DWR ID	DWR_RD2101_01_f_2019_18				
Comment Code					
E2 : Schedule repair of erosion site prior to the next inspection.					
Inspector Comment					
Rills on waterside slope due to surface run off.

View of rills on waterside slope due to surface run off. Fall 2019

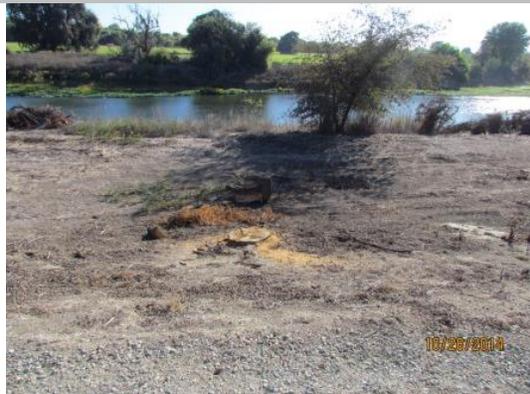
Photo 1 of 1 : FA\_2019\_RD2101\_326\_33\_20190830\_00011.jpg

LM Start	<b>1.02</b>	Rating **	N	Issue No.	<b>33</b>
LM End	<b>1.02</b>	Issue Type +	Ma	Location *	WS
Category	Earthen Levee			GPS Latitude/Longitude	
				Start	End
Item	Trim / Thin Trees			37.656745°	37.656745°
				-121.241104°	-121.241104°
DWR ID	DWR_RD2101_01_f_2014_33				
Comment Code					
T5 : Tree stumps.					
Inspector Comment					
Tree has been removed leaving a stump.

View of the tree stump at the waterside levee toe.

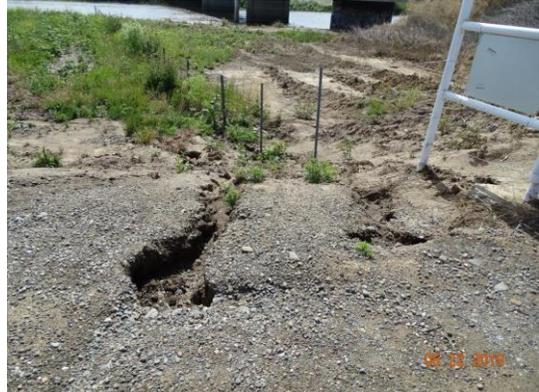
Photo 1 of 1 : FA\_2019\_RD2101\_326\_49\_20190830\_00016.jpg

LM Start	<b>2.74</b>	Rating **	U	Issue No.	<b>49</b>
LM End	<b>2.74</b>	Issue Type +	Ma	Location *	WS
Category	Earthen Levee		GPS Latitude/Longitude		
			Start	End	
Item	Erosion / Bank Caving		37.641545°	37.641545°	
			-121.229744°	-121.229744°	
DWR ID	DWR_RD2101_01_s_2019_49				
Comment Code					
E2 : Schedule repair of erosion site prior to the next inspection.					
Inspector Comment					
There is erosion on the waterside shoulder extending down the slope. Most likely caused by surface runoff from adjacent highway.

Waterside shoulder erosion most likely caused by surface runoff from adjacent highway. (Spring 2019)

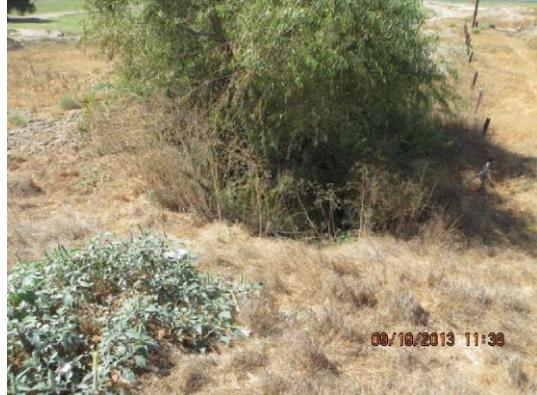
Photo 1 of 3 : UCIP\_FA\_2019\_53201\_35142.jpg

Item	DRAFT DWR UCIP LMA Responsibility		37.640566°	37.640566°	
			-121.230216°	-121.230216°	
DWR ID	20705				
Comment Code					
Inspector Comment					
DS_ID:20705 FS_ID:53201 EP_NO: N/A Repair Type: Non-Urgent Crossing Status: Found UCIP Comments: 10/10/2018 Although there was heavy vegetation, there were no visible levee or pipe threats; downgrading to Non-Urgent (D. Sanoski - DWR UCIP).11/16/2016 No access available. Need to coordinate with LMA to obtain access for proper inspection at a later date. (O. Magana - DWR UCIP)09/19/2013 Flap gate missing from WS headwall. (W. Wylie - DWR UCIP) FIELD_STRUCT_DESC: 24-inch corrugated metal drainage pipe through the levee, 11 feet below the crown. Concrete U-shaped headwalls on both ends. Flap gate on the waterside (WS) end. [Additional Reference(s): DWR Levee Log, 1992. USACE San Joaquin O&M Manual 12, December 1968, (HLM 2.85), Drawing No. 07-04-1666, Sheets 1666/13 and 1666/51, (Station 421+30)]. FS Date: 10/10/2018 2:24:25 PM

Concrete headwall visible at LS toe in ditch.

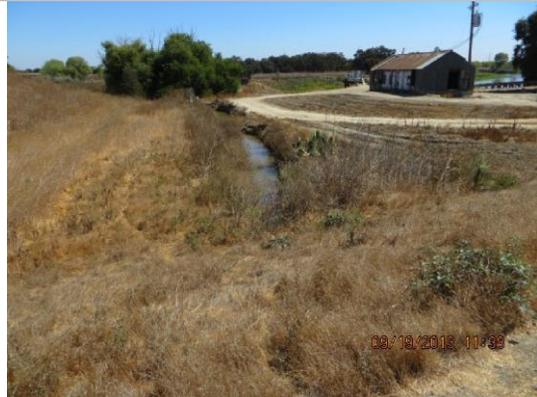
Photo 2 of 3 : UCIP\_FA\_2019\_53201\_35141.jpg

Concrete headwall visible on WS toe at canal.

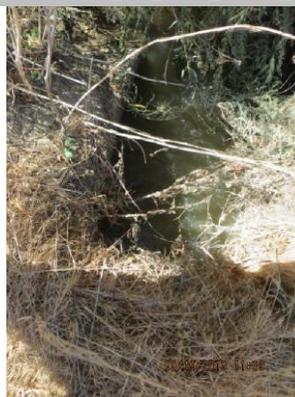
Photo 3 of 3 : UCIP\_FA\_2019\_53201\_35140.jpg

Item	DRAFT DWR UCIP LMA Responsibility			37.640566 °	37.640566 °
				-121.230216 °	-121.230216 °
DWR ID	20705				
Comment Code					
Inspector Comment					
DS_ID:20705 FS_ID:53201 EP_NO: N/A Repair Type: Non-Urgent Crossing Status: Found UCIP Comments: 10/10/2018 Although there was heavy vegetation, there were no visible levee or pipe threats; downgrading to Non-Urgent (D. Sanoski - DWR UCIP).11/16/2016 No access available. Need to coordinate with LMA to obtain access for proper inspection at a later date. (O. Magana - DWR UCIP)09/19/2013 Flap gate missing from WS headwall. (W. Wylie - DWR UCIP) FIELD_STRUCT_DESC: 24-inch corrugated metal drainage pipe through the levee, 11 feet below the crown. Concrete U-shaped headwalls on both ends. Flap gate on the waterside (WS) end. [Additional Reference(s): DWR Levee Log, 1992. USACE San Joaquin O&M Manual 12, December 1968, (HLM 2.85), Drawing No. 07-04-1666, Sheets 1666/13 and 1666/51, (Station 421+30)]. FS Date: 10/10/2018 2:24:25 PM

Concrete headwall at LS toe.

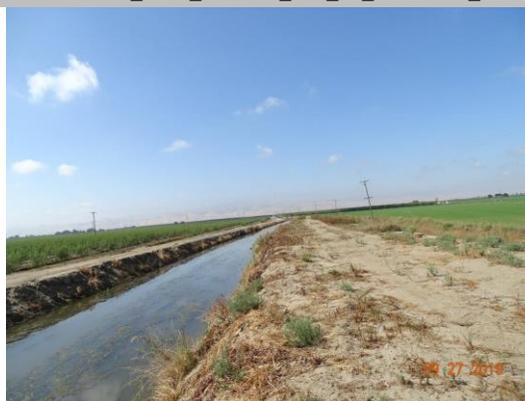
Photo 1 of 1 : FA\_2019\_RD2101\_326\_26\_20191007\_00054.jpg

LM Start	<b>2.83</b>	Rating **	M	Issue No.	<b>26</b>
LM End	<b>3.16</b>	Issue Type +	Ma	Location *	WS
Category	Earthen Levee			GPS Latitude/Longitude	
				Start	End
Item	Vegetation			37.640425 °	37.637084 °
				-121.230140 °	-121.233782 °
DWR ID	DWR_RD2101_01_f_2019_26				
Comment Code					
V2 : Remove the wild growth other than native grasses from the levee slopes.					
Inspector Comment

Typical view of waterside vegetation. Fall 2019

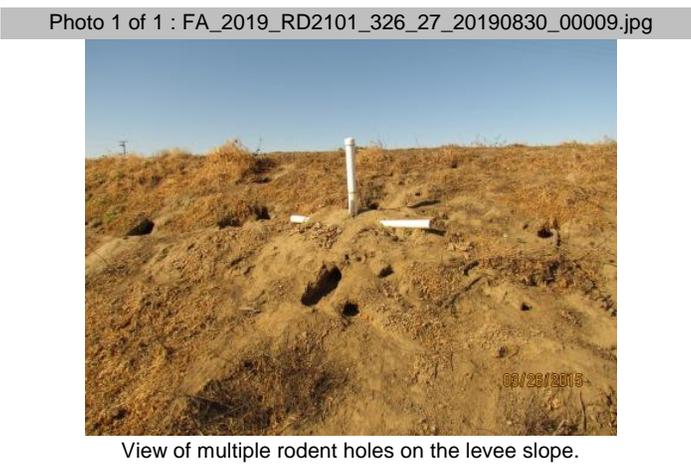
LM Start	<b>2.83</b>	Rating **	U	Issue No.	<b>27</b>
LM End	<b>2.83</b>	Issue Type +	Ma	Location *	WS
Category	Earthen Levee		GPS Latitude/Longitude		
			Start	End	
Item	Animal Control		37.640425°	37.640425°	
			-121.230139°	-121.230139°	
DWR ID	DWR_RD2101_01_s_2012_27				
Comment Code					
A3 : No rodents visible, but rodent burrows visible; need to backfill and compact or grout burrows.					
Inspector Comment					
Rodent holes have not been backfilled. Fall 2019

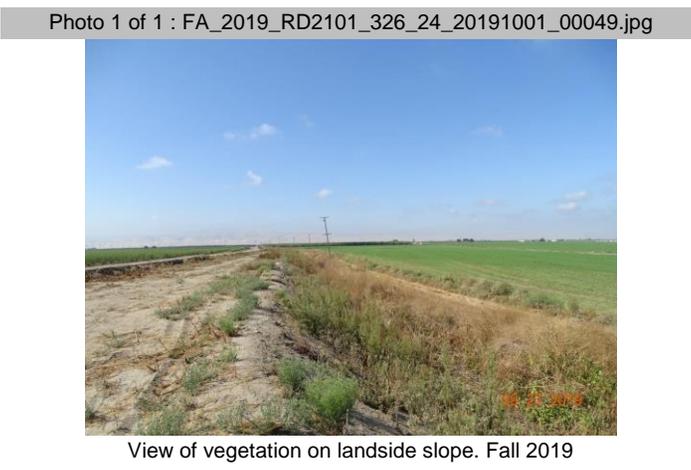
LM Start	<b>2.83</b>	Rating **	M	Issue No.	<b>24</b>
LM End	<b>3.16</b>	Issue Type +	Ma	Location *	LS
Category	Earthen Levee		GPS Latitude/Longitude		
			Start	End	
Item	Vegetation		37.640425°	37.637084°	
			-121.230139°	-121.233782°	
DWR ID	DWR_RD2101_01_f_2019_24				
Comment Code					
V2 : Remove the wild growth other than native grasses from the levee slopes.					
Inspector Comment					
This portion of the District is on a different ranch and has not been maintained by the LMA. Vegetation blocks visibility on both sides of levee.

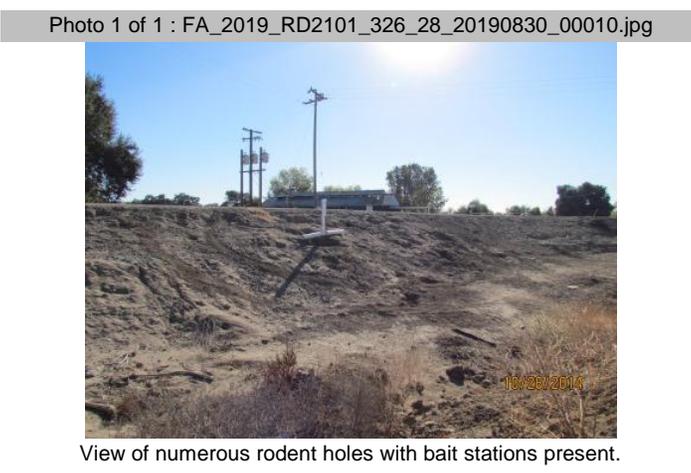
LM Start	<b>2.85</b>	Rating **	M	Issue No.	<b>28</b>
LM End	<b>3.10</b>	Issue Type +	Ma	Location *	LS
Category	Earthen Levee		GPS Latitude/Longitude		
			Start	End	
Item	Animal Control		37.640134°	37.637667°	
			-121.230019°	-121.233062°	
DWR ID	DWR_RD2101_01_s_2012_28				
Comment Code					
A3 : No rodents visible, but rodent burrows visible; need to backfill and compact or grout burrows.					
Inspector Comment					
Rodent holes have not been backfilled. Fall 2019

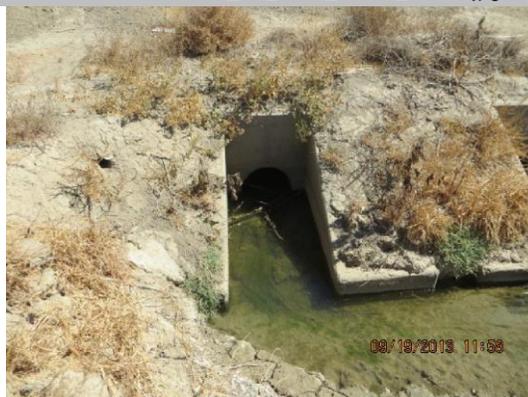
Photo 3 of 3 : UCIP\_FA\_2019\_20875\_35154.jpg

LM Start	<b>2.87</b>	Rating **	A/W	Issue No.	<b>953 (cont)</b>
LM End	<b>2.87</b>	Issue Type +	Ma	Location *	
Category	Supplemental			GPS Latitude/Longitude	
				Start	End
Item	DRAFT DWR UCIP LMA Responsibility			37.639924 °	37.639924 °
				-121.230005 °	-121.230005 °
DWR ID	20707				
Comment Code					
Inspector Comment					
DS_ID:20707 FS_ID:20875 EP_NO: N/A Repair Type: No Action Needed Crossing Status: Found UCIP Comments: FIELD_STRUCT_DESC: 1 of 2: 24-inch corrugated metal drainage pipe through the levee, 12.5 feet below the crown. Concrete U-shaped headwalls on each end. Flap gate on the waterside (WS) end. [Additional Reference(s): DWR Levee Log, 1992. USACE San Joaquin O&M Manual 12, December 1968, (HLM 2.89)]. FS Date: 9/19/2013

Inlet on LS toe with concrete headwall.

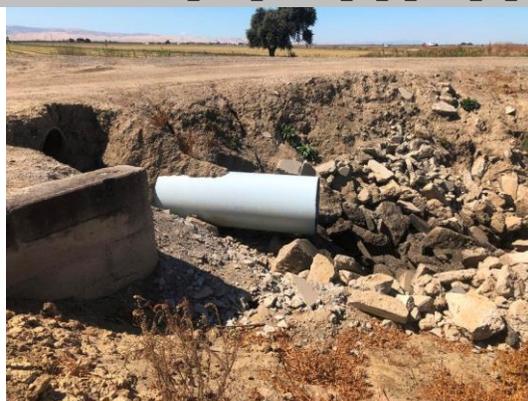
Photo 1 of 3 : SJR2019\_DWR\_RD2101\_01\_s\_2012\_29\_5.JPG

LM Start	<b>2.87</b>	Rating **	U	Issue No.	<b>29</b>
LM End	<b>2.87</b>	Issue Type +	Ma	Location *	
Category	Supplemental			GPS Latitude/Longitude	
				Start	End
Item	DWR Erosion Survey			37.639852 °	37.639852 °
				-121.229979 °	-121.229979 °
DWR ID	RD2101U01RM74.97				
Comment Code					
Inspector Comment					
Site ID: RD2101U01RM74.97 09/17/2019: The erosion has been caused by the irrigation pipe leakage.

Looking at the irrigation pipe outlet on the site.

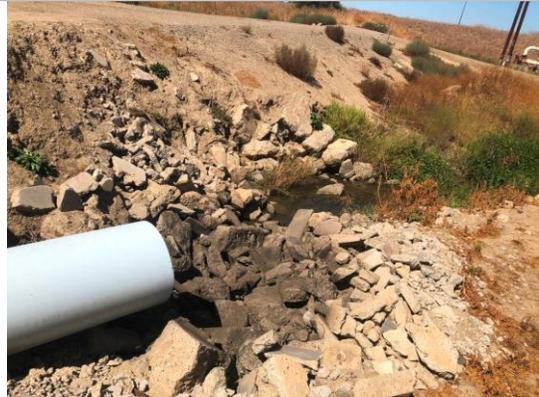
Photo 2 of 3 : SJR2019\_DWR\_RD2101\_01\_s \_ 2012\_29\_4.JPG

LM Start	<b>2.87</b>	Rating **	U	Issue No.	<b>29 (cont)</b>
LM End	<b>2.87</b>	Issue Type +	Ma	Location *	
Category	Supplemental			GPS Latitude/Longitude	
				Start	End
Item	DWR Erosion Survey			37.639852°	37.639852°
				-121.229979°	-121.229979°
DWR ID	RD2101U01RM74.97				
Comment Code					
Inspector Comment					
Site ID: RD2101U01RM74.97 09/17/2019: The erosion has been caused by the irrigation pipe leakage.

Close view of the erosion. Note the broken concrete blocks on the site.

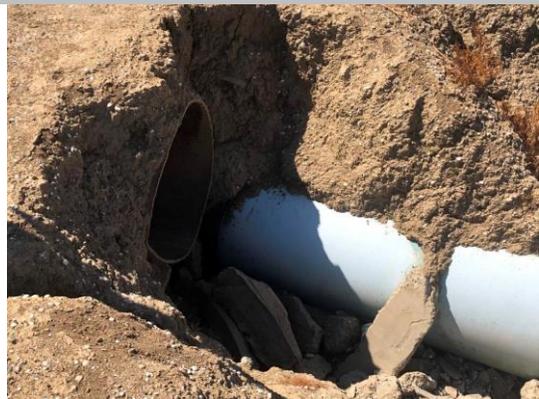
Photo 3 of 3 : SJR2019\_DWR\_RD2101\_01\_s \_ 2012\_29\_2.JPG

Close-up view of the erosion.

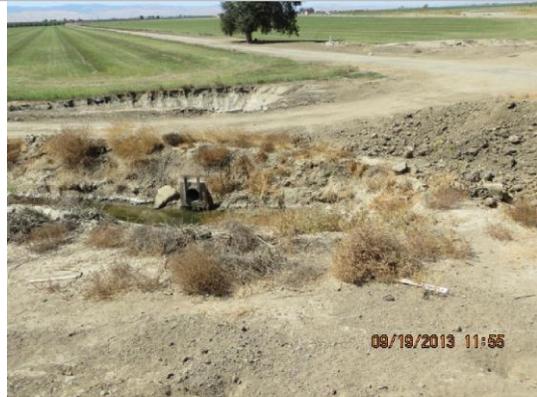
Photo 1 of 3 : UCIP\_FA\_2019\_20876\_35159.jpg

LM Start	<b>2.87</b>	Rating **	A/W	Issue No.	<b>954</b>
LM End	<b>2.87</b>	Issue Type +	Ma	Location *	
Category	Supplemental			GPS Latitude/Longitude	
				Start	End
Item	DRAFT DWR UCIP LMA Responsibility			37.639884 °	37.639884 °
				-121.230008 °	-121.230008 °
DWR ID	20709				
Comment Code					
Inspector Comment					
DS_ID:20709 FS_ID:20876 EP_NO: N/A Repair Type: No Action Needed Crossing Status: Found UCIP Comments: FIELD_STRUCT_DESC: 2 of 2: 24-inch drainage pipe of an unknown material through the levee, 12.5 feet below the crown. Concrete U-shaped headwalls on each end. Flap gate on the waterside (WS) end. [Additional Reference(s): DWR Levee Log, 1992. USACE San Joaquin O&M Manual 12, December 1968, (HLM 2.89)]. FS Date: 9/19/2013

Concrete inlet on LS toe at canal.

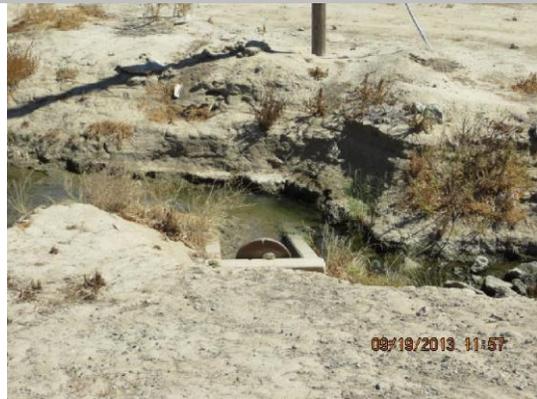
Photo 2 of 3 : UCIP\_FA\_2019\_20876\_35158.jpg

Concrete U-shaped headwall on WS toe with flapgate.

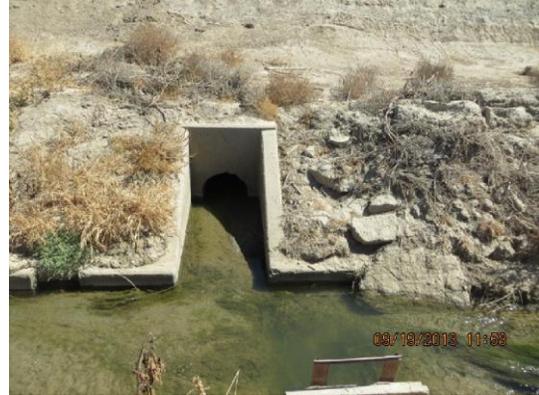
Photo 3 of 3 : UCIP\_FA\_2019\_20876\_35157.jpg

LM Start	<b>2.87</b>	Rating **	A/W	Issue No.	<b>954 (cont)</b>
LM End	<b>2.87</b>	Issue Type +	Ma	Location *	
Category	Supplemental			GPS Latitude/Longitude	
				Start	End
Item	DRAFT DWR UCIP LMA Responsibility			37.639884 °	37.639884 °
				-121.230008 °	-121.230008 °
DWR ID	20709				
Comment Code					
Inspector Comment					
DS_ID:20709 FS_ID:20876 EP_NO: N/A Repair Type: No Action Needed Crossing Status: Found UCIP Comments: FIELD_STRUCT_DESC: 2 of 2: 24-inch drainage pipe of an unknown material through the levee, 12.5 feet below the crown. Concrete U-shaped headwalls on each end. Flap gate on the waterside (WS) end. [Additional Reference(s): DWR Levee Log, 1992. USACE San Joaquin O&M Manual 12, December 1968, (HLM 2.89)]. FS Date: 9/19/2013

Concrete inlet on LS toe at canal.

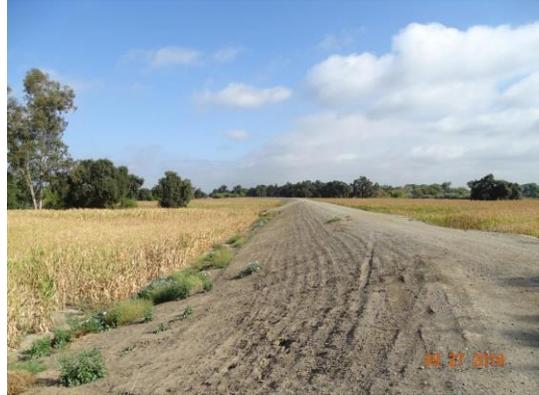
Photo 1 of 1 : FA\_2019\_RD2101\_327\_1\_20191001\_00001.jpg

Typical view of vegetation on landside slope. Fall 2019
