**Flood Control Project Maintenance
Levee Inspections**

Fall 2019 Levee Maintenance Deficiency Summary Report

Reclamation District No. 2103 Wheatland Vicinity

Waterway	Bank	Unit Miles
Unit No. 01 South Dry Creek	Left	4.64

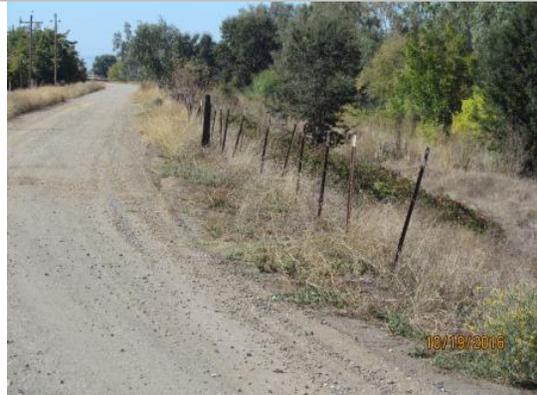
Photo 1 of 1 : FA_2019_RD2103_10_11_20190904_00001.jpg

LM Start	0.00	Rating **	M	Issue No.	28
LM End	0.00	Issue Type +	En	Location *	
Category	Supplemental			GPS Latitude/Longitude	
				Start	End
Item	DRAFT DWR UCIP Field Study			38.998295°	38.998295°
				-121.415186°	-121.415186°
DWR ID	24881				
Comment Code					
Inspector Comment					
DS_ID:24881 FS_ID:39966 EP_NO: N/A Repair Type: Non-Urgent Crossing Status: Indicator Found UCIP Comments: FIELD_STRUCT_DESC: Gas line through levee. Markers visible on both sides. FS Date: 3/4/2014

View of fence along waterside hinge point looking downstream, still exists.

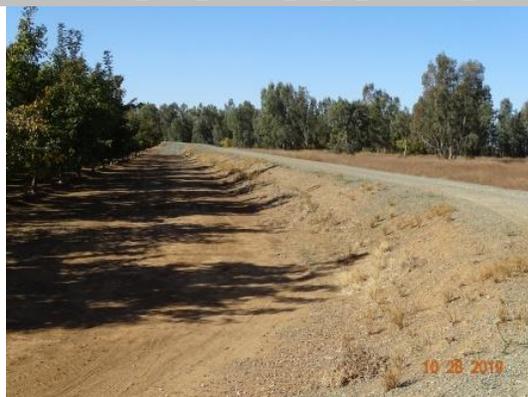
Photo 1 of 1 : FA_2019_RD2103_10_19_20191030_00041.jpg

View looking downstream landside at the well maintained annual vegetation, Fall 2019.

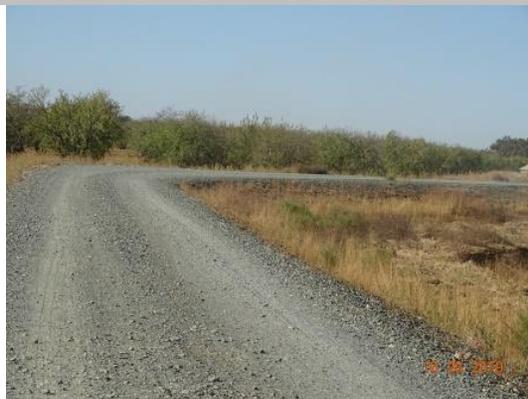
Photo 1 of 1 : FA_2019_RD2103_10_20_20191030_00042.jpg

LM Start	0.02	Rating **	A	Issue No.	20
LM End	3.32	Issue Type +	Ma	Location *	WS
Category	Earthen Levee		GPS Latitude/Longitude		
			Start	End	
Item	Vegetation		39.019652°	39.032882°	
			-121.453446°	-121.401100°	
DWR ID	DWR_RD2103_01_f_2019_20				
Comment Code					
V1 : Control annual grass and weeds on the levee slopes and easements.					
Inspector Comment					
The annual vegetation is well maintained, Fall 2019.

View looking downstream waterside at the well maintained annual vegetation, Fall 2019.

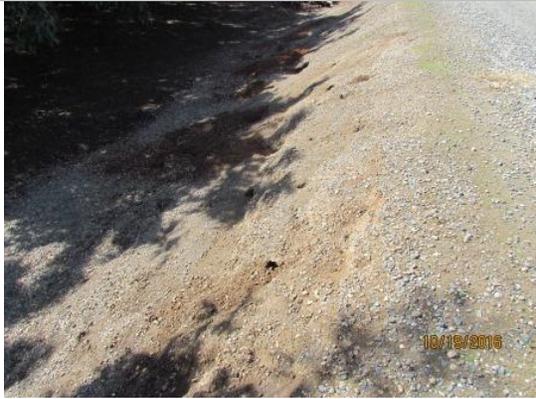
Photo 1 of 1 : FA_2019_RD2103_10_23_20190904_00004.jpg

View of squirrel holes on the landside looking downstream but no evidence of animal activity.

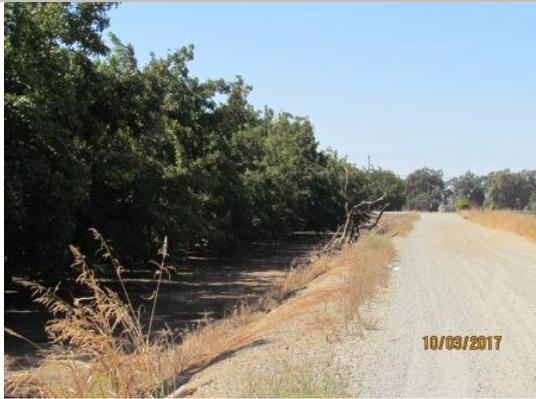
Photo 1 of 1 : FA_2019_RD2103_10_22_20190904_00003.jpg

LM Start	0.22	Rating **	M	Issue No.	22
LM End	0.22	Issue Type +	En	Location *	LS
Category	Earthen Levee			GPS Latitude/Longitude	
				Start	End
Item	Encroachments			39.020937 °	39.020937 °
				-121.450237 °	-121.450237 °
DWR ID	DWR_RD2103_01_f_2015_22				
Comment Code					
PR : Prunings					
Inspector Comment					
Prunings still exist and need to be removed.

View looking downstream landside of prunings that still exist.

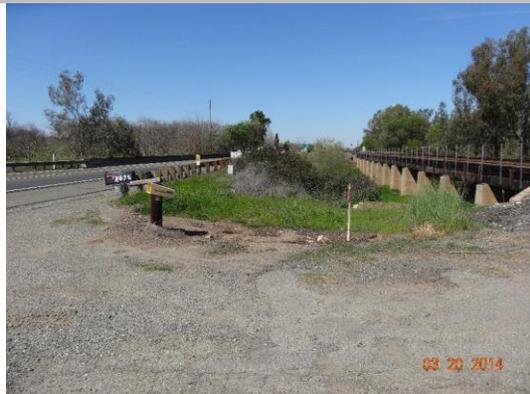
Photo 1 of 3 : UCIP_FA_2019_39985_69852.jpg

Comment Code					
Inspector Comment					
DS_ID:19468 FS_ID:39985 EP_NO: 3659 Repair Type: Non-Urgent Crossing Status: Indicator Found UCIP Comments: 03/04/2014 Need to contact owner to determine status of crossing. Need date of last inspection and confirmation that crossing is still in operable condition. It appears this is the same line as the next entry however, permit calls for Southern Pacific Pipe Lines, Inc as the owner and the sign found in the field indicates Kinder Morgan as owner. Need to contact owner to clarify if 2 crossings exist or if crossing is same owner will need to update permit information. (O. Magana - DWR UCIP) FIELD_STRUCT_DESC: 8.625-inch steel fuel line through the levee, 3 feet below the crown. Cutoff wall around pipe at centerline of levee. Pipe extends through overflow area. Markers visible on both sides. (8.625-inch authorized under Permit No. 3659, 1961-Southern Pacific Pipelines, Inc.) [Additional Reference(s): DWR Levee Logs, 2005. USACE Sacramento O&M Manual Unit No. 146, November 1962, (HLM 0.55)] FS Date: 3/20/2014

Marker visible on toe in between railroad tracks and highway (north).

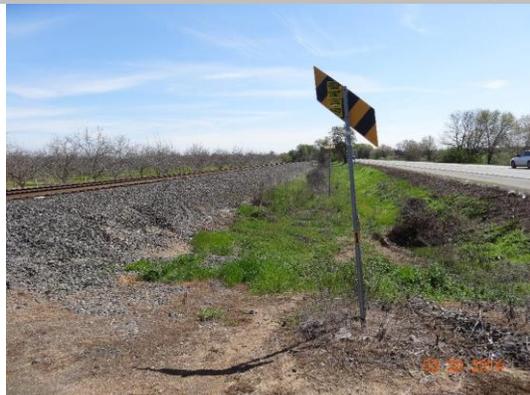
Photo 2 of 3 : UCIP_FA_2019_39985_69851.jpg

Marker visible on toe in between railroad tracks and highway (south).

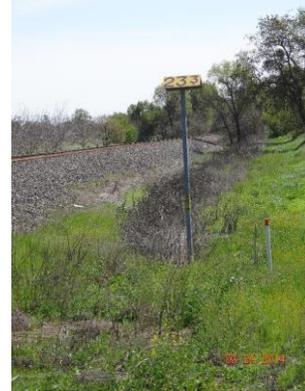
Photo 3 of 3 : UCIP_FA_2019_39985_69853.jpg

Comment Code					
Inspector Comment					
DS_ID:19468 FS_ID:39985 EP_NO: 3659 Repair Type: Non-Urgent Crossing Status: Indicator Found UCIP Comments: 03/04/2014 Need to contact owner to determine status of crossing. Need date of last inspection and confirmation that crossing is still in operable condition. It appears this is the same line as the next entry however, permit calls for Southern Pacific Pipe Lines, Inc as the owner and the sign found in the field indicates Kinder Morgan as owner. Need to contact owner to clarify if 2 crossings exist or if crossing is same owner will need to update permit information. (O. Magana - DWR UCIP) FIELD_STRUCT_DESC: 8.625-inch steel fuel line through the levee, 3 feet below the crown. Cutoff wall around pipe at centerline of levee. Pipe extends through overflow area. Markers visible on both sides. (8.625-inch authorized under Permit No. 3659, 1961-Southern Pacific Pipelines, Inc.) [Additional Reference(s): DWR Levee Logs, 2005. USACE Sacramento O&M Manual Unit No. 146, November 1962, (HLM 0.55)] FS Date: 3/20/2014

Marker visible on toe in between railroad tracks and highway (south).

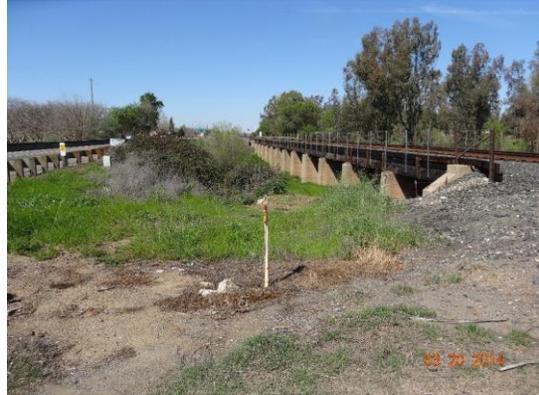
Photo 1 of 3 : UCIP_FA_2019_39986_71882.jpg

Comment Code					
Inspector Comment					
DS_ID:24878 FS_ID:39986 EP_NO: N/A Repair Type: Non-Urgent Crossing Status: Indicator Found UCIP Comments: It appears this is the same line as the next entry however, permit calls for Southern Pacific Pipe Lines, Inc as the owner and the sign found in the field indicates Kinder Morgan as owner. Need to contact owner to clarify if 2 crossings exist or if crossing is same owner will need to update permit information. Also need to contact owner to determine status of crossing. Need date of last inspection and confirmation that crossing is still in operable condition. FIELD_STRUCT_DESC: Kinder Morgan line through levee. Markers visible on both banks. FS Date: 3/4/2014

View of marker visible on waterward side (between HWY 65 and railroad).

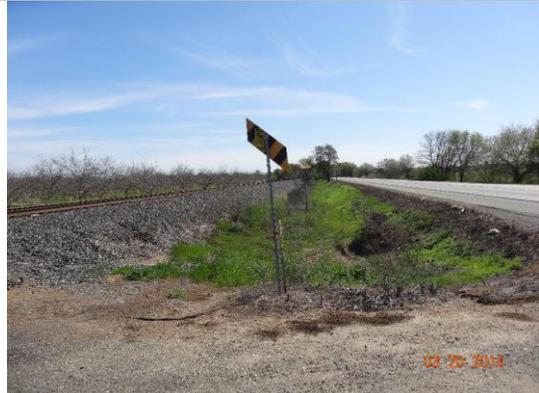
Photo 2 of 3 : UCIP_FA_2019_39986_71881.jpg

Markers visible on landward side.

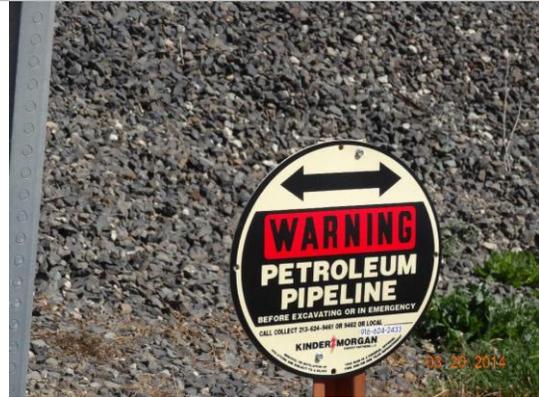
Photo 3 of 3 : UCIP_FA_2019_39986_71880.jpg

Comment Code					
Inspector Comment					
DS_ID:24878 FS_ID:39986 EP_NO: N/A Repair Type: Non-Urgent Crossing Status: Indicator Found UCIP Comments: It appears this is the same line as the next entry however, permit calls for Southern Pacific Pipe Lines, Inc as the owner and the sign found in the field indicates Kinder Morgan as owner. Need to contact owner to clarify if 2 crossings exist or if crossing is same owner will need to update permit information. Also need to contact owner to determine status of crossing. Need date of last inspection and confirmation that crossing is still in operable condition. FIELD_STRUCT_DESC: Kinder Morgan line through levee. Markers visible on both banks. FS Date: 3/4/2014

Petroleum Pipeline owned by Kinder Morgan.

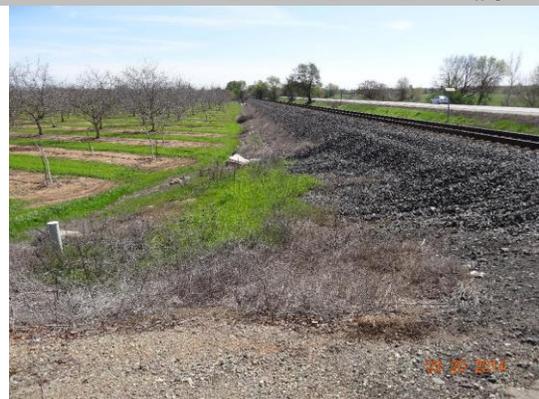
Photo 1 of 1 : UCIP_FA_2019_43823_73340.jpg

LM Start	0.55	Rating **	M	Issue No.	31
LM End	0.55	Issue Type +	En	Location *	
Category	Supplemental			GPS Latitude/Longitude	
				Start	End
Item	DRAFT DWR UCIP Field Study			39.022654 °	39.022654 °
				-121.444665 °	-121.444665 °
DWR ID	19467				
Comment Code					
Inspector Comment					
DS_ID:19467 FS_ID:43823 EP_NO: 16041 Repair Type: Non-Urgent Crossing Status: Indicator Found UCIP Comments: 03/18/2015 Needs markers at levee crossing. (W. Wylie - DWR UCIP) FIELD_STRUCT_DESC: 2-inch steel communication conduit encasing telephone cable through the levee, 2-feet below the crown. Extends to junction box 10-feet from landside (LS) toe, parallel to railroad tracks. (communication conduit authorized under Permit No. 16041, 1993-Pacific Bell). [Additional Reference(s): DWR Levee Logs, 2005] FS Date: 3/18/2015

Junction box visible on LS toe (at lower left of photo).

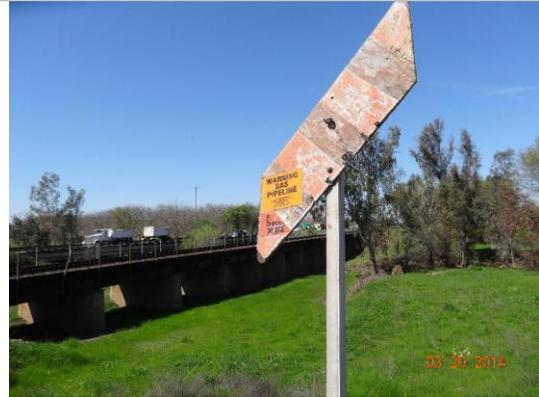
Photo 2 of 3 : UCIP_FA_2019_38323_69859.jpg

Comment Code					
Inspector Comment					
DS_ID:19469 FS_ID:38323 EP_NO: 2098 Repair Type: Non-Urgent Crossing Status: Indicator Found UCIP Comments: 03/20/2014 Need to contact owner to determine status of crossing. Need date of last inspection and confirmation that crossing is still in operable condition. (O. Magana - DWR UCIP) FIELD_STRUCT_DESC: 16-inch steel gas line through the levee, 3 feet below the crown. Marker on waterside (WS) slope. (16-inch line authorized under Permit No. 2098, 1955-Pacific Gas and Electric Company [PG&E]). [Additional Reference(s): DWR Levee Logs, 2005. USACE Sacramento O&M Manual Unit No. 146, November 1962, (HLM 0.56)] FS Date: 3/20/2014

Marker visible waterward side.

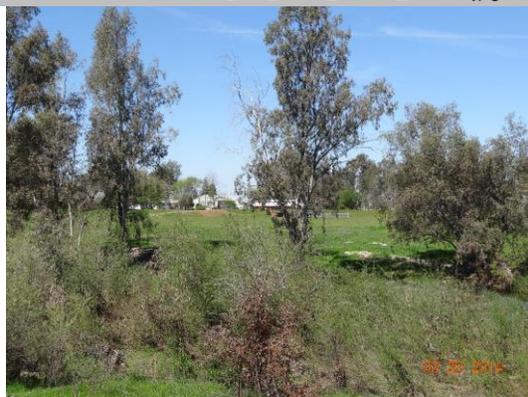
Photo 3 of 3 : UCIP_FA_2019_38324_69862.jpg

Comment Code					
Inspector Comment					
DS_ID:19470 FS_ID:38324 EP_NO: 789 Repair Type: Non-Urgent Crossing Status: Indicator Found UCIP Comments: 03/20/2014 Need to contact owner to determine status of crossing. Need date of last inspection and confirmation that crossing is still in operable condition. (O. Magana - DWR UCIP) FIELD_STRUCT_DESC: 16-inch steel gas line through levee, 3 feet below the crown. Concrete inspection chamber (24-inch by 18-inch box with 4-inch walls) on the waterside (WS) shoulder, covered with dirt. Gas line marker on landside (LS) slope. Extends underneath Dry Creek channel, covered with concrete slab approximately 18-inches wide. (8.625-inch gas line authorized under Permit No. 789, 1939-Pacific Gas and Electric Company [PG&E]). [Additional Reference(s): DWR Levee Logs, 2005, 16-inch gas line. USACE Sacramento O&M Manual Unit No. 146, November 1962, (HLM 0.63), 16-inch gas line] FS Date: 3/20/2014

Overview of gas marker visible on opposite bank.

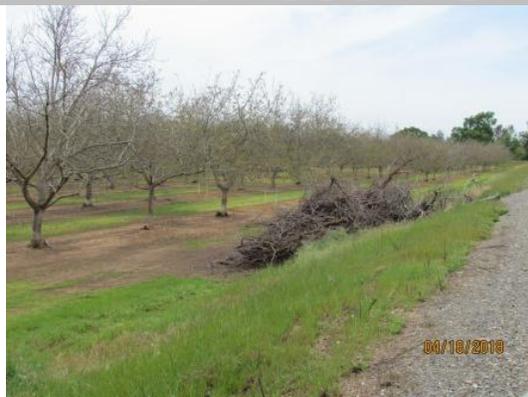
Photo 1 of 1 : FA_2019_RD2103_10_27_20190904_00006.jpg

LM Start	0.78	Rating **	M	Issue No.	27
LM End	0.78	Issue Type +	En	Location *	LS
Category	Earthen Levee			GPS Latitude/Longitude	
				Start	End
Item	Encroachments			39.024546 °	39.024546 °
				-121.441396 °	-121.441396 °
DWR ID	DWR_RD2103_01_s_2017_27				
Comment Code					
PR : Prunings					
Inspector Comment					
Prunings are located on the landside levee slope.

View looking downstream landside of prunings on the levee slope.

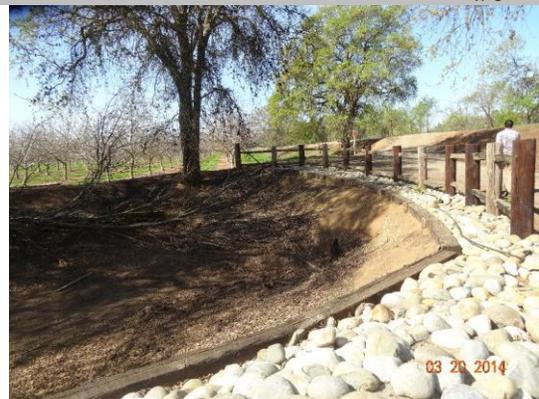
Photo 1 of 3 : UCIP_FA_2019_38325_69869.jpg

LM Start	0.82	Rating **	A/W	Issue No.	36
LM End	0.82	Issue Type +	Ma	Location *	
Category	Supplemental			GPS Latitude/Longitude	
				Start	End
Item	DRAFT DWR UCIP LMA Responsibility			39.024811 °	39.024811 °
				-121.440750 °	-121.440750 °
DWR ID	19471				
Comment Code					
Inspector Comment					
DS_ID:19471 FS_ID:38325 EP_NO: N/A Repair Type: No Action Needed Crossing Status: Found UCIP Comments: FIELD_STRUCT_DESC: 36-inch corrugated metal drainage pipe through the levee, 14.4 feet below the crown. Concrete headwall, flap-gate, and 3-foot by 6-foot concrete splash apron located on the waterside (WS) toe. Outfall drain from old Grasshopper Slough. [Additional Reference(s): DWR Levee Logs, 2005. USACE Sacramento O&M Manual Unit No. 146, November 1962, (HLM 0.83)] FS Date: 3/20/2014

View of CMP crossing located on landward side.

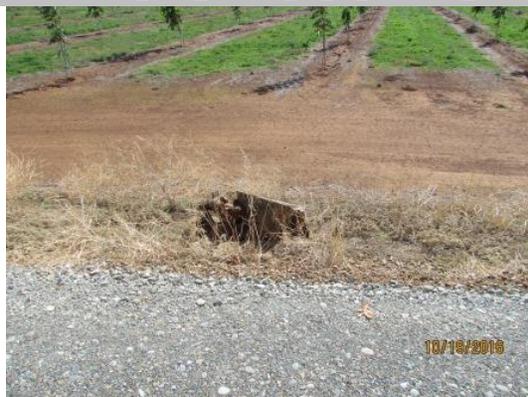
Photo 1 of 1 : FA_2019_RD2103_10_26_20190904_00005.jpg

View of tree stump on landside levee slope, Fall 2016. It still exists as of Fall 2019.

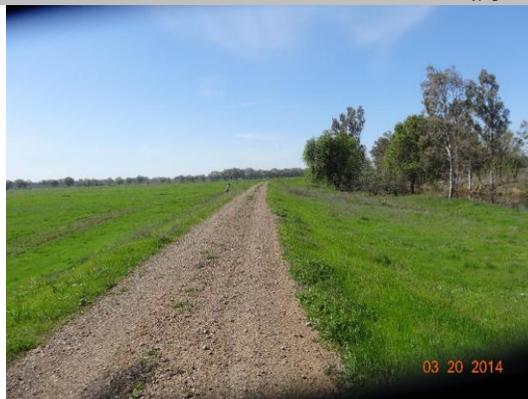
Photo 1 of 3 : UCIP_FA_2019_41183_69917.jpg

Comment Code					
Inspector Comment					
DS_ID:19473 FS_ID:41183 EP_NO: 1886 Repair Type: Non-Urgent Crossing Status: Indicator Found UCIP Comments: 03/20/2014 Need to coordinate with owner. Severely corroded section of steel pipe present on waterward side--no other evidence present at this location. Owner will need to coordinate with CVFPB and DWR-Inspector to determine proper action to abandon crossing. (O. Magana - DWR UCIP) FIELD_STRUCT_DESC: *ABANDONED* 12-inch steel irrigation pipe through the levee, 3.1 feet below the crown. Siphon breaker on the waterward slope. Concrete standpipe at the landward toe. Vertical pump on waterside (WS). Open on WS end. Permit includes gravel dam through channel of Dry Creek. Crossing is angled 45 degrees. (10-inch pipe authorized under Permit No. 1886, 1959-R. H. Blackford, Jr.) [Additional Reference(s): DWR Levee Logs, 2005. USACE Sacramento O&M Manual Unit No. 146, November 1962, (HLM 1.86)] FS Date: 3/20/2014

Overview of levee crown.

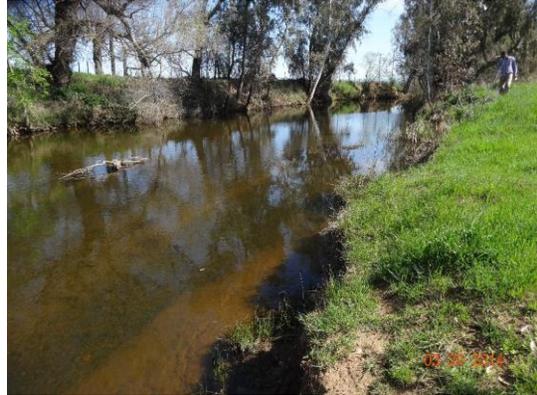
Photo 3 of 3 : UCIP_FA_2019_38327_69879.jpg

LM Start	1.86	Rating **	M	Issue No.	38 (cont)
LM End	1.86	Issue Type +	En	Location *	
Category	Supplemental			GPS Latitude/Longitude	
				Start	End
Item	DRAFT DWR UCIP Field Study			39.029694 °	39.029694 °
				-121.423946 °	-121.423946 °
DWR ID	19512				
Comment Code					
Inspector Comment					
DS_ID:19512 FS_ID:38327 EP_NO: N/A Repair Type: Non-Urgent Crossing Status: Indicator Found UCIP Comments: 03/20/2014 Unable to determine if there is a crossing through pipe. Will need to coordinate with owner to determine additional information about appurtenances found on landward side. (O. Magana - DWR UCIP) FIELD_STRUCT_DESC: Irrigation pump, service pole, and 36-inch concrete standpipe, 5 feet from the landside (LS) toe. No pump was found during field visit 3/20/14. [Additional Reference(s): DWR Levee Logs, 2005] FS Date: 3/20/2014

No crossing visible on waterward side.

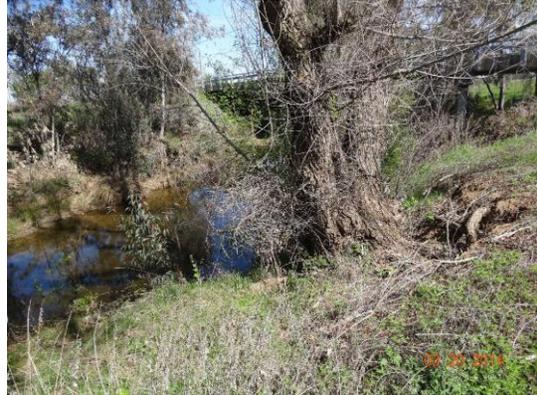
Photo 2 of 3 : UCIP_FA_2019_38331_69893.jpg

Comment Code					
Inspector Comment					
DS_ID:19477 FS_ID:38331 EP_NO: N/A Repair Type: Non-Urgent Crossing Status: Found UCIP Comments: 03/20/2014 Need to contact owner to determine status. (O. Magana - DWR UCIP) FIELD_STRUCT_DESC: 8-inch steel irrigation pipe through the levee, 3.1 feet below the crown. Siphon breaker on the waterward slope. Pump on the landward side. Pipe crosses creek to orchard on north side. (two 12-inch pipes authorized under Permit No. 1887, 1954-H. B. Waltz, HLM 2.41 and 2.68) [Additional Reference(s): DWR Levee Logs, 2005. USACE Sacramento O&M Manual Unit No. 146, November 1962, (HLM 2.68), 8-inch] FS Date: 3/20/2014

Crossing was not visible on waterward side.

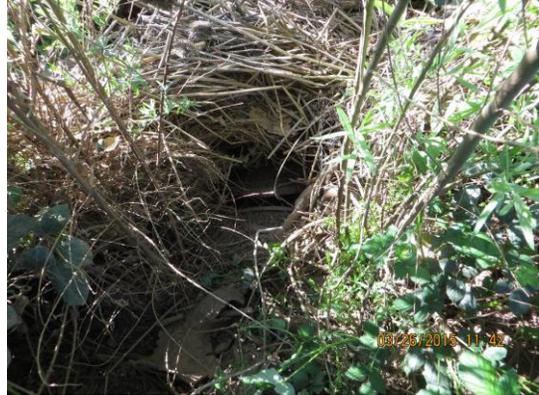
Photo 1 of 3 : UCIP_FA_2019_53435_73429.jpg

Comment Code					
Inspector Comment					
DS_ID:19478 FS_ID:53435 EP_NO: N/A Repair Type: Non-Urgent Crossing Status: Found UCIP Comments: 10/30/2018 Levee slopes have been cleared of dense vegetation. LS inlet has been modified and improved. Corrosion and minor sediment observed inside the pipe. Flap gate on the WS is operable. This crossing is part of DWR's Deferred Maintenance Project (DMP). Crossing has been downgraded from Urgent to Non-Urgent because no integrity issues were observed on the slopes or the pipe. Recommend clearing the sediment from the pipe and complete an internal inspection to determine the integrity of pipe through the levee. Correction to 2016 inspection entry, levee height is about 10-12 feet high instead of the 3-4 feet high previously reported. (O. Magana - DWR UCIP)7/08/2016 Meet with Tom Engler from MBK Engineers, District Engineer, and the District is in the process of trying to deauthorize portion of Unit 1. This section of the levee protects an orchard--levee is approximately 3-4 feet tall. (DWR UCIP - omagana)3/26/2015 Flapgate open and won't close due to vegetation and soil blocking its operation. (DWR UCIP - omagana) FIELD_STRUCT_DESC: 24-inch corrugated metal drainage pipe through the levee, 12 feet below the crown. Flap gate is located on the waterside (WS) end. [Additional Reference(s): DWR Levee Log, 2005]. FS Date: 10/30/2018 1:54:00 PM

Flapgate at WS berm blocked by soil and vegetation buildup.

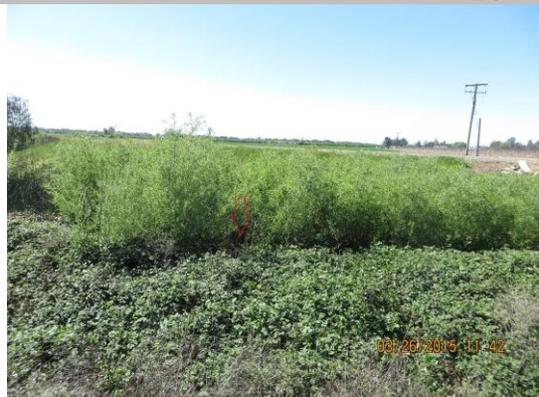
Photo 2 of 3 : UCIP_FA_2019_53435_73428.jpg

Location of pipe and flapgate on WS berm.

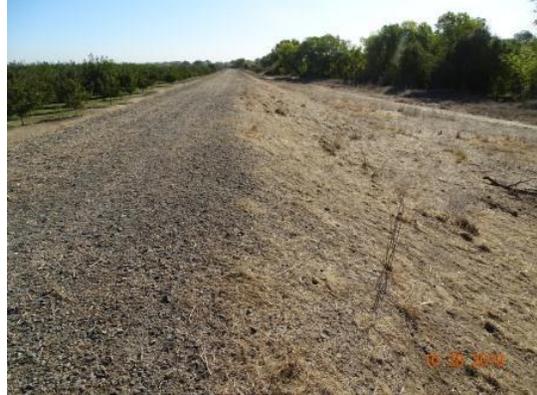
Photo 1 of 1 : FA_2019_RD2103_11_12_20191030_00029.jpg

View looking upstream waterside at the well maintained annual vegetation, Fall 2019.

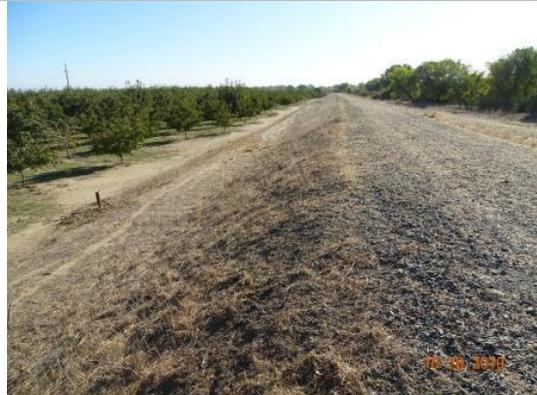
Photo 1 of 1 : FA_2019_RD2103_11_11_20191030_00028.jpg

View looking upstream landside at the well maintained annual vegetation, Fall 2019.

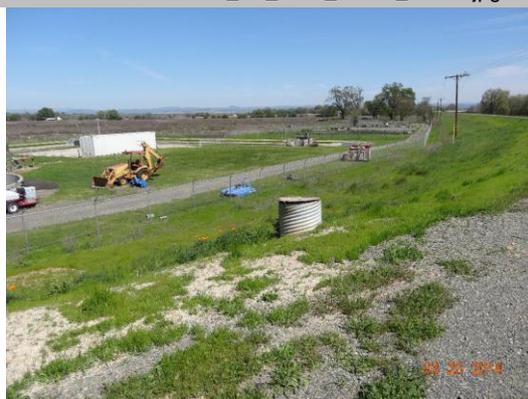
Photo 2 of 2 : UCIP_FA_2019_39993_69911.jpg

CMP riser located on landward side.

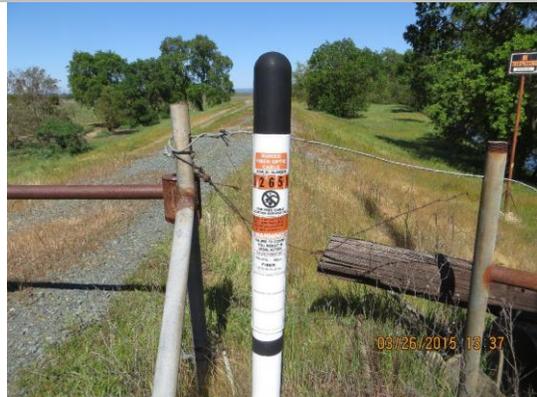
Photo 1 of 3 : UCIP_FA_2019_44089_73568.jpg

Fiber optic line marker on crown of levee

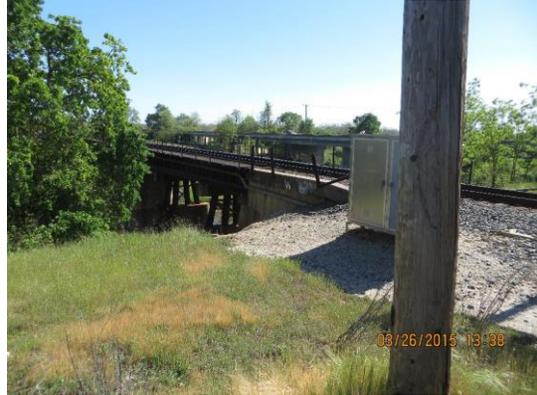
Photo 2 of 3 : UCIP_FA_2019_44089_73567.jpg

6-inch steel conduit visible on upstream side of railroad bridge.

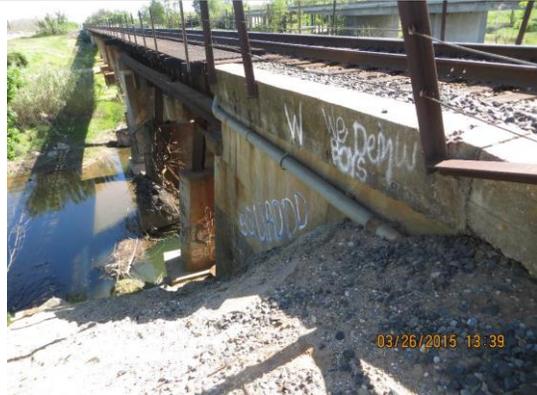
Photo 3 of 3 : UCIP_FA_2019_44089_73566.jpg

6-inch steel conduit visible on upstream side of railroad bridge.

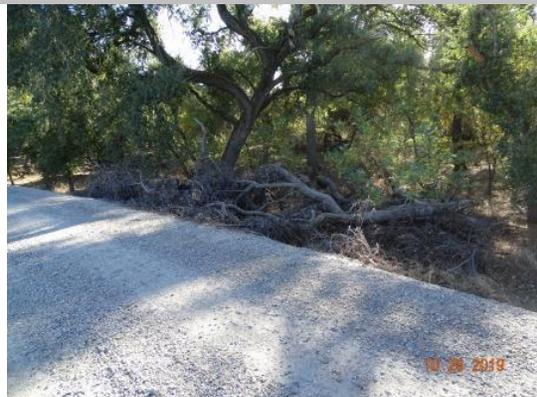
Photo 1 of 1 : FA_2019_RD2103_11_13_20191030_00030.jpg

View looking upstream waterside at a downed tree on the levee slope.

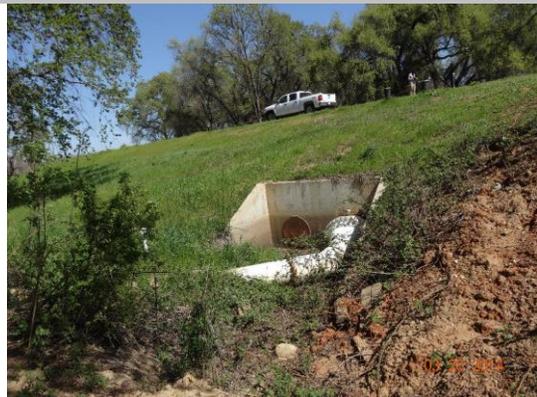
Photo 3 of 3 : UCIP_FA_2019_40046_71919.jpg

Concrete headwall visible on waterward side--white pipe attached to crossing at headwall.

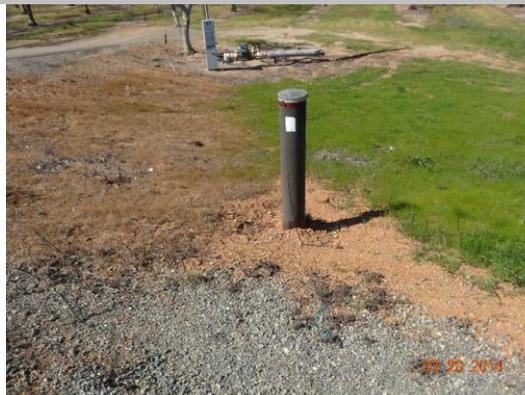
Photo 2 of 3 : UCIP_FA_2019_40048_71921.jpg

Riser located on landward slope.

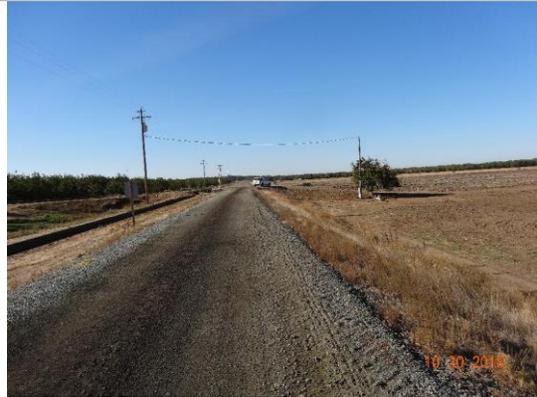
Photo 1 of 2 : UCIP_FA_2019_53438_78444.jpg

Overview of levee where crossing should be. No signs of crossing present.

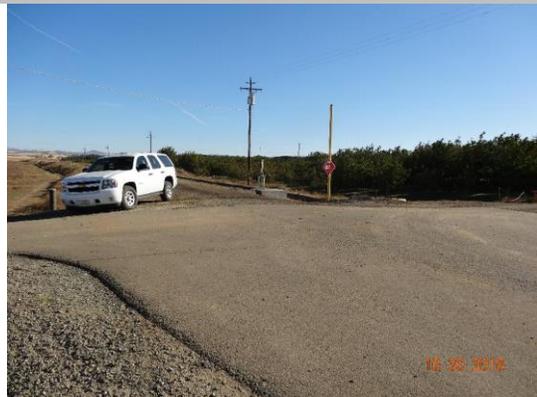
Photo 2 of 2 : UCIP_FA_2019_53438_78445.jpg

No signs of crossing are visible at approximate location.

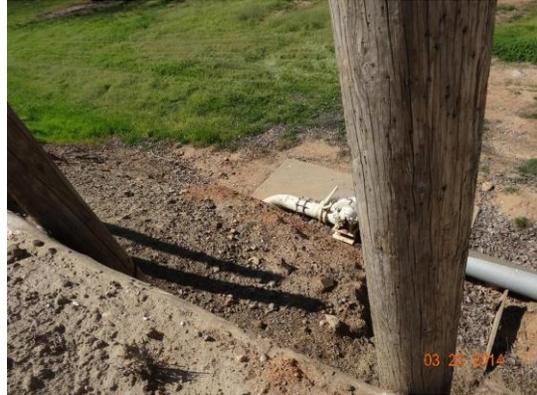
Photo 1 of 3 : UCIP_FA_2019_40049_71928.jpg

Pipe visible on waterward side.

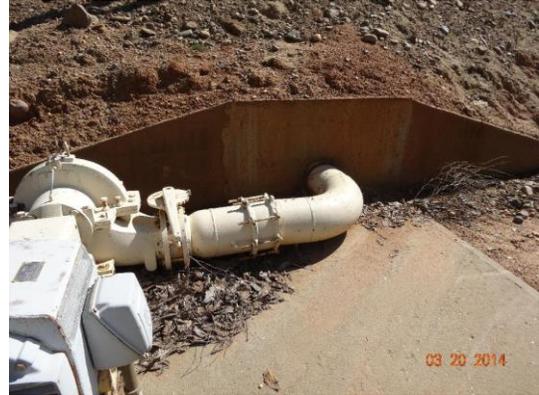
Photo 3 of 3 : UCIP_FA_2019_40049_71932.jpg

Pipe connection at crossing.
