**Flood Control Project Maintenance  
Levee Inspections**

**Maintenance Issue Types Only, Levee Inspection Report By Mile - Spring 2020**

**Reclamation District No. 2103 Wheatland Vicinity**

Waterway	Bank	Unit Miles	Inspection Start/End	Inspector
Unit No. 01 South Dry Creek	Left	4.64	04/16/2020 04/16/2020	Sterling York

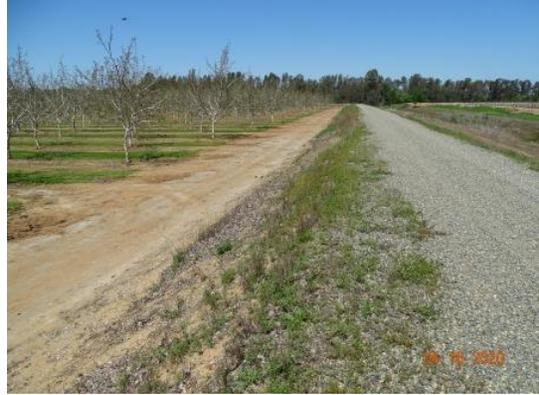
Photo 1 of 1 : SP\_2020\_RD2103\_10\_18\_20200417\_00040.jpg

LM Start	<b>0.01</b>	Rating **	A	Issue No.	<b>18</b>
LM End	<b>4.62</b>	Issue Type +	Ma	Location *	LS
Category	Earthen Levee		GPS Latitude/Longitude		
			Start	End	
Item	Vegetation		39.019835 °	39.041676 °	
			-121.453897 °	-121.392092 °	
DWR ID	DWR_RD2103_01_s_2020_18				
Comment Code					
V1 : Control annual grass and weeds on the levee slopes and easements.					
Inspector Comment					
The annual vegetation is well maintained, Spring 2020.

View looking upstream landside at the well maintained annual vegetation, Spring 2020.

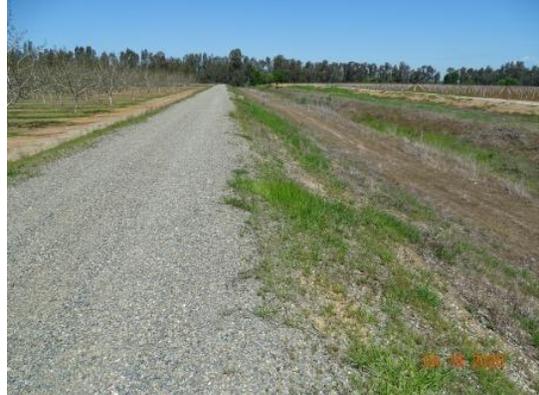
Photo 1 of 1 : SP\_2020\_RD2103\_10\_19\_20200417\_00041.jpg

LM Start	<b>0.01</b>	Rating **	A	Issue No.	<b>19</b>
LM End	<b>4.62</b>	Issue Type +	Ma	Location *	WS
Category	Earthen Levee		GPS Latitude/Longitude		
			Start	End	
Item	Vegetation		39.019835 °	39.041676 °	
			-121.453896 °	-121.392092 °	
DWR ID	DWR_RD2103_01_s_2020_19				
Comment Code					
V1 : Control annual grass and weeds on the levee slopes and easements.					
Inspector Comment					
The annual vegetation is well maintained, Spring 2020.

View looking upstream waterside at the well maintained annual vegetation, Spring 2020.

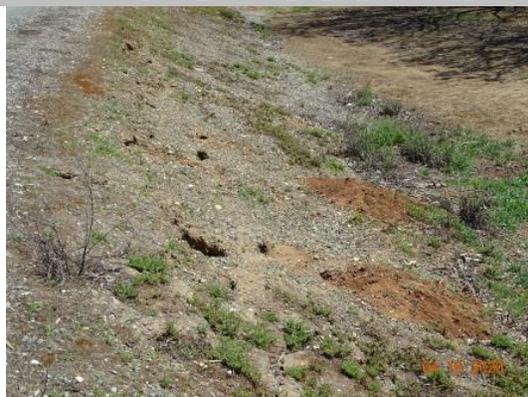
Photo 1 of 1 : SP\_2020\_RD2103\_10\_23\_20200417\_00042.jpg

LM Start	<b>0.20</b>	Rating **	M	Issue No.	<b>23</b>
LM End	<b>0.22</b>	Issue Type +	Ma	Location *	LS
Category	Earthen Levee		GPS Latitude/Longitude		
			Start	End	
Item	Animal Control		39.020856 °	39.020938 °	
			-121.450629 °	-121.450237 °	
DWR ID	DWR_RD2103_01_f_2015_23				
Comment Code					
A3 : No rodents visible, but rodent burrows visible; need to backfill and compact or grout burrows.					
Inspector Comment					
Rodents need to be eradicated and holes in the levee slope need to be backfilled, Spring 2020.

View of active squirrel holes on the landside looking upstream, Spring 2020.

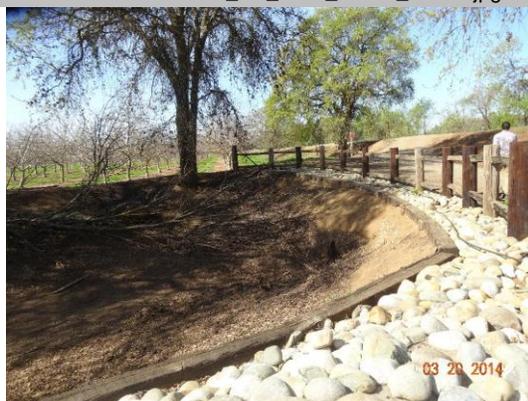
Photo 1 of 3 : UCIP\_SP\_2020\_38325\_69869.jpg

LM Start	<b>0.82</b>	Rating **	A/W	Issue No.	<b>36</b>
LM End	<b>0.82</b>	Issue Type +	Ma	Location *	
Category	Supplemental		GPS Latitude/Longitude		
			Start	End	
Item	DWR UCIP LMA Responsibility		39.024811 °	39.024811 °	
			-121.440750 °	-121.440750 °	
DWR ID	19471				
Comment Code					
Inspector Comment					
DS_ID:19471 FS_ID:38325 EP_NO: N/A Repair Type: No Action Needed Crossing Status: Found UCIP Comments: FIELD_STRUCT_DESC: 36-inch corrugated metal drainage pipe through the levee, 14.4 feet below the crown. Concrete headwall, flap-gate, and 3-foot by 6-foot concrete splash apron located on the waterside (WS) toe. Outfall drain from old Grasshopper Slough. [Additional Reference(s): DWR Levee Logs, 2005. USACE Sacramento O&M Manual Unit No. 146, November 1962, (HLM 0.83)] FS Date: 3/20/2014

View of CMP crossing located on landward side.

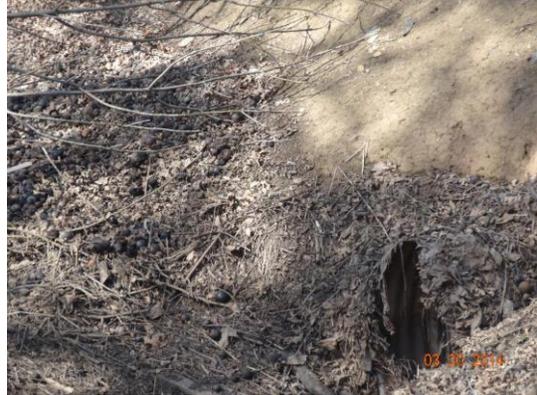
Photo 2 of 3 : UCIP\_SP\_2020\_38325\_69868.jpg

Close up view of crossing from landward side.

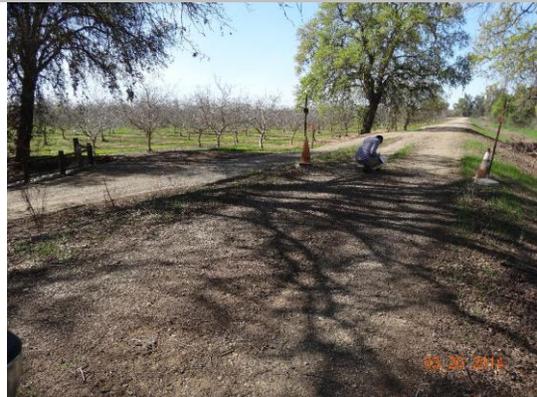
Photo 3 of 3 : UCIP\_SP\_2020\_38325\_69873.jpg

View of levee crown at crossing.

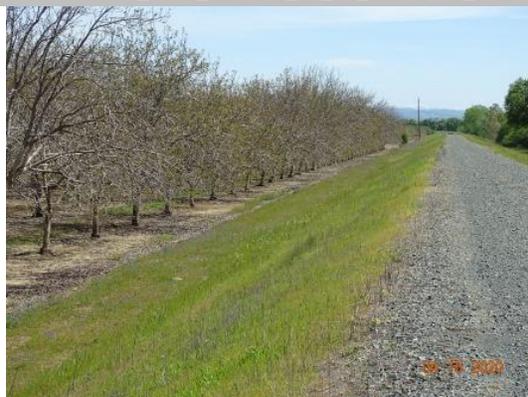
Photo 1 of 1 : SP\_2020\_RD2103\_11\_11\_20200417\_00028.jpg

LM Start	<b>0.00</b>	Rating **	A	Issue No.	<b>11</b>
LM End	<b>4.87</b>	Issue Type +	Ma	Location *	LS
Category	Earthen Levee		GPS Latitude/Longitude		
			Start	End	
Item	Vegetation		38.993381 °	39.031622 °	
			-121.437413 °	-121.366922 °	
DWR ID	DWR_RD2103_02_s_2020_11				
Comment Code					
V1 : Control annual grass and weeds on the levee slopes and easements.					
Inspector Comment					
The annual vegetation is well maintained, Spring 2020.

View looking upstream landside at the well maintained annual vegetation, Spring 2020.

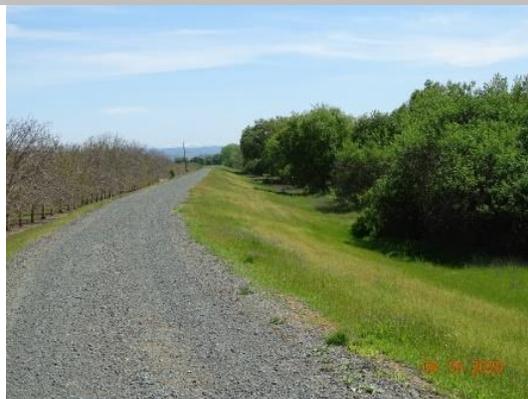
Photo 1 of 1 : SP\_2020\_RD2103\_11\_12\_20200417\_00029.jpg

LM Start	<b>0.00</b>	Rating **	A	Issue No.	<b>12</b>
LM End	<b>4.87</b>	Issue Type +	Ma	Location *	WS
Category	Earthen Levee		GPS Latitude/Longitude		
			Start	End	
Item	Vegetation		38.993380 °	39.031623 °	
			-121.437414 °	-121.366921 °	
DWR ID	DWR_RD2103_02_s_2020_12				
Comment Code					
V1 : Control annual grass and weeds on the levee slopes and easements.					
Inspector Comment					
The annual vegetation is well maintained, Spring 2020.

View looking upstream waterside at the well maintained annual vegetation, Spring 2020.

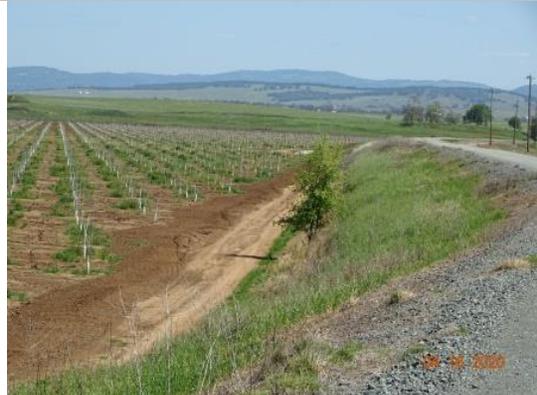
Photo 1 of 1 : SP\_2020\_RD2103\_11\_15\_20200417\_00030.jpg

LM Start	<b>4.05</b>	Rating **	M	Issue No.	<b>15</b>
LM End	<b>4.05</b>	Issue Type +	Ma	Location *	LS
Category	Earthen Levee			GPS Latitude/Longitude	
				Start	End
Item	Trim / Thin Trees			39.023654 °	39.023654 °
				-121.377906 °	-121.377906 °
DWR ID	DWR_RD2103_02_s_2020_15				
Comment Code					
T2 : Thin trees to allow visibility of the ground and room to flood fight.					
Inspector Comment					
Remove small tree from levee toe that is less than 4" in diameter, Spring 2020.

View looking upstream landside at a small tree at the levee toe less than 4" in diameter, Spring 2020.
