**Flood Control Project Maintenance
Levee Inspections**

Maintenance Issue Types Only, Levee Inspection Report By Mile - Fall 2019

Reclamation District No. 2104 Peters Pocket Tract

Waterway	Bank	Unit Miles	Inspection Start/End	Inspector
Unit No. 01 Cache Slough/Unit No. 02 Haas Slough	Left	6.85	10/15/2019 10/15/2019	David Julian

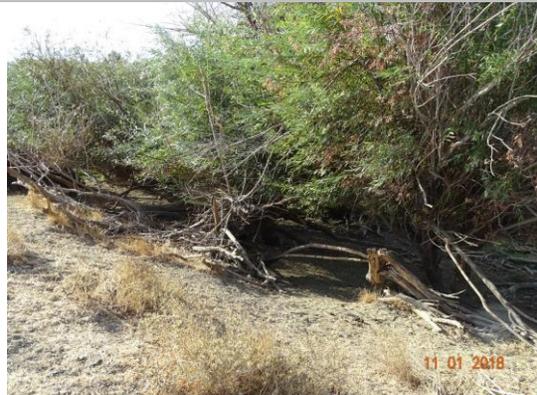
Photo 1 of 1 : FA_2019_RD2104_249_29_20190826_00010.jpg

LM Start	1.26	Rating **	M	Issue No.	29
LM End	1.26	Issue Type +	Ma	Location *	WS
Category	Earthen Levee			GPS Latitude/Longitude	
				Start	End
Item	Encroachments			38.296277°	38.296277°
				-121.744393°	-121.744393°
DWR ID	DWR_RD2104_01_f_2018_29				
Comment Code					
TR : Tree or limb					
Inspector Comment					
Remove down tree branches on waterside slope.

View of tree branches on the waterside slope (November 2018).

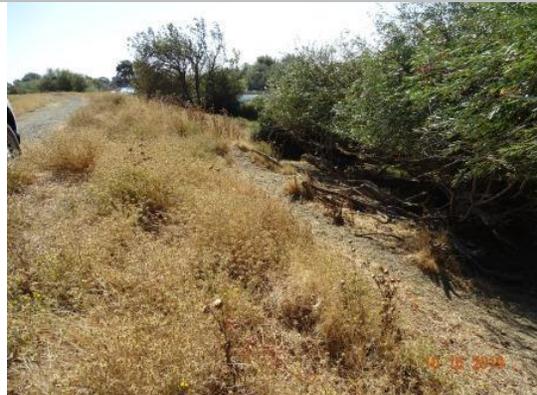
Photo 1 of 1 : FA_2019_RD2104_249_23_20191015_00041.jpg

LM Start	1.27	Rating **	M	Issue No.	23
LM End	1.27	Issue Type +	Ma	Location *	WS
Category	Earthen Levee			GPS Latitude/Longitude	
				Start	End
Item	Slope Stability			38.296182°	38.296182°
				-121.744318°	-121.744318°
DWR ID	DWR_RD2104_01_f_2016_23				
Comment Code					
S2 : Repair the levee slope damaged by foot traffic and prevent access where possible.					
Inspector Comment					
Repair the slope damaged by cows.

View looking downstream at trail caused by cows on the waterside slope (Fall 2019).

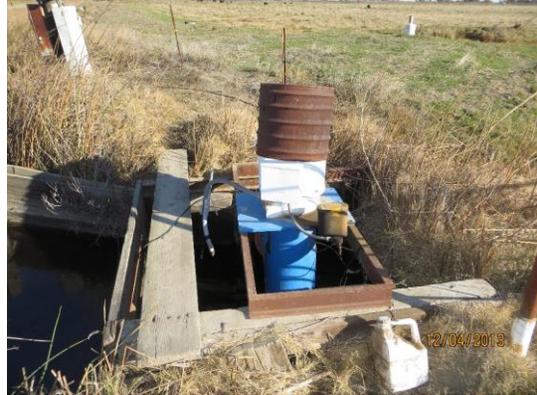
Photo 3 of 3 : UCIP_FA_2019_24984_45040.jpg

LM Start	1.42	Rating **	A/W	Issue No.	56 (cont)
LM End	1.42	Issue Type +	Ma	Location *	
Category	Supplemental			GPS Latitude/Longitude	
				Start	End
Item	DRAFT DWR UCIP LMA Responsibility			38.295668°	38.295668°
				-121.741779°	-121.741779°
DWR ID	24711

Comment Code					
Inspector Comment					
DS_ID:24711 FS_ID:24984 EP_NO: 10185 Repair Type: No Action Needed Crossing Status: Found UCIP Comments: 09/14/2017 Permit is unavailable, missing page 3 official permit documentation. (DWR UCIP - O. Magana) FIELD_STRUCT_DESC: 16-inch steel drainage pipe through the levee, 5.7 feet below the crown. Pump in an irrigation ditch on the landside (LS). Siphon breaker on the waterside (WS) slope. (Automatic Board Order (ABO) issued as Permit No. 10185, 1964 - Erwin E. and Lucy G. Vasser, limited details available electronic permit unavailable). [Additional Reference(s): DWR Levee Log, 2006. USACE Sacramento O&M Manual 108, April 1964, (HLM 1.52), Drawing Nos. 50-04-1977 and 50-04-3379]. FS Date: 12/4/2013

Pump in wooden distribution box off LS toe.

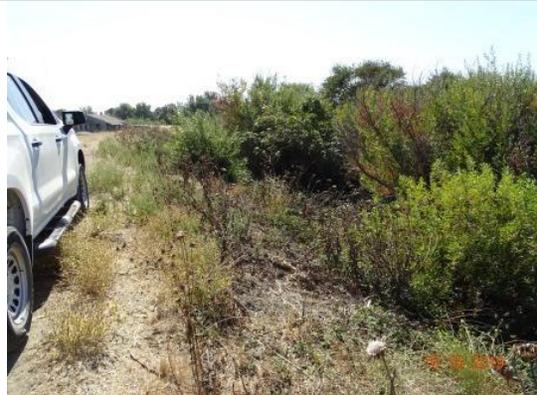
Photo 1 of 1 : FA_2019_RD2104_249_11_20191015_00042.jpg

LM Start	1.44	Rating **	U	Issue No.	11
LM End	1.48	Issue Type +	Ma	Location *	WS
Category	Earthen Levee			GPS Latitude/Longitude	
				Start	End
Item	Vegetation			38.295487°	38.294947°
				-121.741530°	-121.741215°
DWR ID	DWR_RD2104_01_f_2017_11				
Comment Code					
V2 : Remove the wild growth other than native grasses from the levee slopes.					
Inspector Comment

View looking downstream at thick vegetation on the waterside slope (Fall 2019).

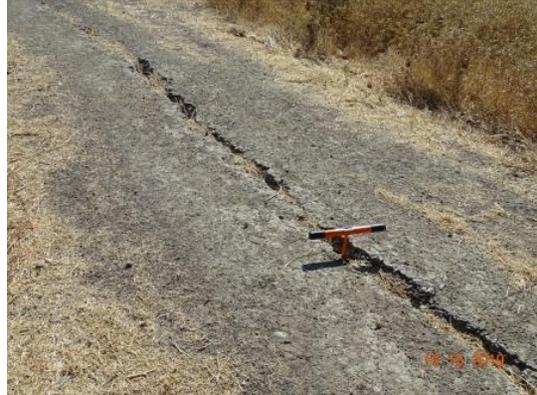
Photo 1 of 1 : FA_2019_RD2104_249_35_20191015_00045.jpg

LM Start	1.60	Rating **	U	Issue No.	35
LM End	1.60	Issue Type +	Ma	Location *	CR
Category	Earthen Levee			GPS Latitude/Longitude	
				Start	End
Item	Cracking			38.294005°	38.294005°
				-121.739810°	-121.739810°
DWR ID	DWR_RD2104_01_f_2019_35				
Comment Code					
CR1 : Monitor and have inspected by geotechnical engineer.					
Inspector Comment					
There is at least a 48" crack through the center of the crown.

View of deep crack with 48" pole stuck all the way into it on the crown (Fall 2019).

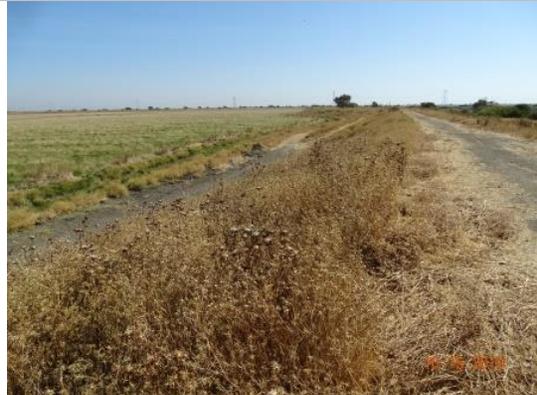
Photo 1 of 1 : FA_2019_RD2104_249_34_20191015_00043.jpg

LM Start	1.60	Rating **	U	Issue No.	34
LM End	2.40	Issue Type +	Ma	Location *	LS
Category	Earthen Levee			GPS Latitude/Longitude	
				Start	End
Item	Vegetation			38.293989°	38.291552°
				-121.739818°	-121.726162°
DWR ID	DWR_RD2104_01_f_2019_34				
Comment Code					
V1 : Control annual grass and weeds on the levee slopes and easements.					
Inspector Comment

View looking downstream at thick annual vegetation on the landside slope (Fall 2019).

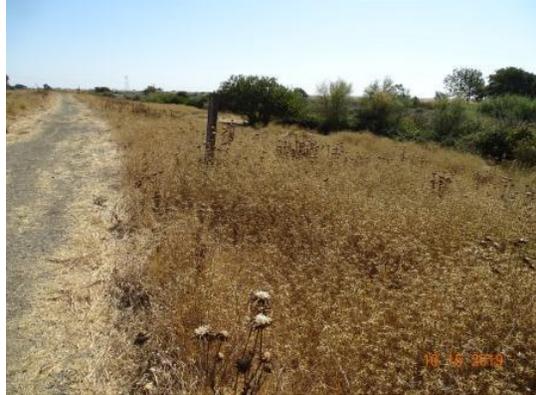
Photo 1 of 1 : FA_2019_RD2104_249_32_20191015_00044.jpg

LM Start	1.60	Rating **	U	Issue No.	32
LM End	2.40	Issue Type +	Ma	Location *	WS
Category	Earthen Levee		GPS Latitude/Longitude		
			Start	End	
Item	Vegetation		38.293966°	38.291552°	
			-121.739808°	-121.726162°	
DWR ID	DWR_RD2104_01_f_2019_32				
Comment Code					
V1 : Control annual grass and weeds on the levee slopes and easements.					
Inspector Comment

View looking downstream at thick annual vegetation on the waterside slope (Fall 2019).

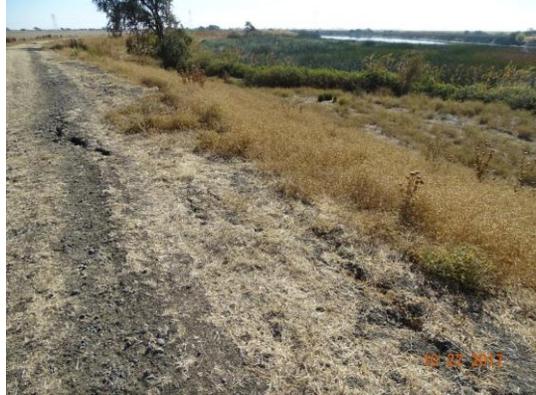
Photo 1 of 1 : FA_2019_RD2104_249_15_20190826_00003.jpg

LM Start	1.72	Rating **	A/W	Issue No.	15
LM End	1.72	Issue Type +	Ma	Location *	WS
Category	Earthen Levee		GPS Latitude/Longitude		
			Start	End	
Item	Cracking		38.293465°	38.293465°	
			-121.737778°	-121.737778°	
DWR ID	DWR_RD2104_01_f_2017_15				
Comment Code					
CR1 : Monitor and have inspected by geotechnical engineer.					
Inspector Comment

Curved cracks in crown indicate possible slope instability on waterside slope. Cracks are 8 feet long x up to 6 inches wide x 3 feet deep. No other indications of slope instability observed. Levee toe is approx 40 feet from channel/slough edge.

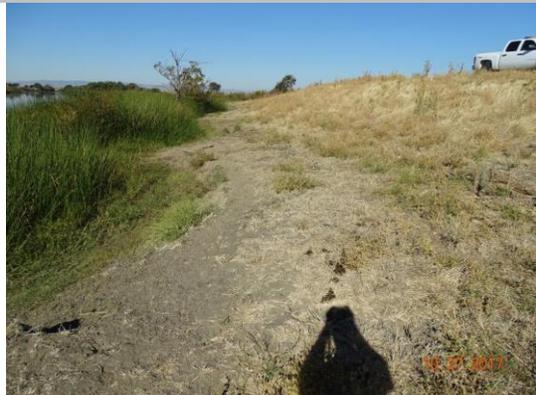
Photo 1 of 1 : FA_2019_RD2104_249_16_20190826_00004.jpg

LM Start	1.93	Rating **	A/W	Issue No.	16
LM End	1.94	Issue Type +	Ma	Location *	WS
Category	Earthen Levee		GPS Latitude/Longitude		
			Start	End	
Item	Erosion / Bank Caving		38.292027°	38.291947°	
			-121.734575°	-121.734453°	
DWR ID	DWR_RD2104_01_s_2012_16				
Comment Code					
E1 : Note and monitor erosion site.					
Inspector Comment					
Erosion is not in levee prism but monitor to see if it moves into prism.

Scalloped bank erosion along slough is approaching levee toe.

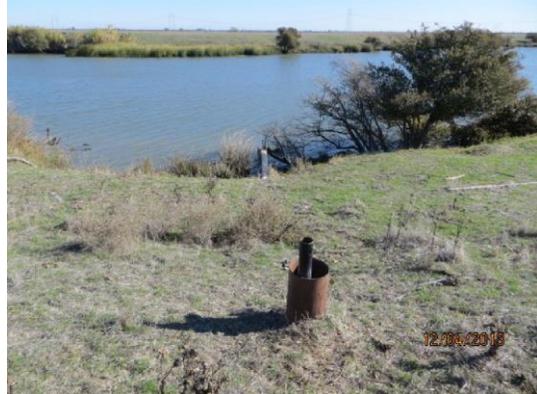
Photo 1 of 2 : UCIP_FA_2019_24990_45047.jpg

LM Start	2.90	Rating **	A/W	Issue No.	58
LM End	2.90	Issue Type +	Ma	Location *	
Category	Supplemental		GPS Latitude/Longitude		
			Start	End	
Item	DRAFT DWR UCIP LMA Responsibility		38.297380°	38.297380°	
			-121.730166°	-121.730166°	
DWR ID	24708

Comment Code					
Inspector Comment					
DS_ID:24708 FS_ID:24990 EP_NO: 10185 Repair Type: No Action Needed Crossing Status: Found UCIP Comments: 09/14/2017 Permit is unavailable, missing page 3 official permit documentation. (DWR UCIP - O. Magana) FIELD_STRUCT_DESC: 12-inch steel drainage pipe through the levee, 4 feet below the crown. Pump on pile structure in drainage canal on the landside (LS). Siphon breaker in a 12-inch steel riser on the waterside (WS) slope. (Automatic Board Order (ABO) issued as Permit No. 10185, 1964 - Erwin E. and Lucy G. Vassar, limited information available electronic version of permit missing. Replaced under Permit No. 4412, 1963 - Ervin E. and Lucy G. Vassar, limited details available electronic permit copy unavailable). [Additional Reference(s): DWR Levee Log, 2006. USACE Sacramento O&M Manual 108, April 1964, (HLM 3.12), Drawing No. 50-04-3379]. FS Date: 12/4/2013

Siphon breaker in steel riser on WS slope with pipe and flap gate visible in background at WS berm.

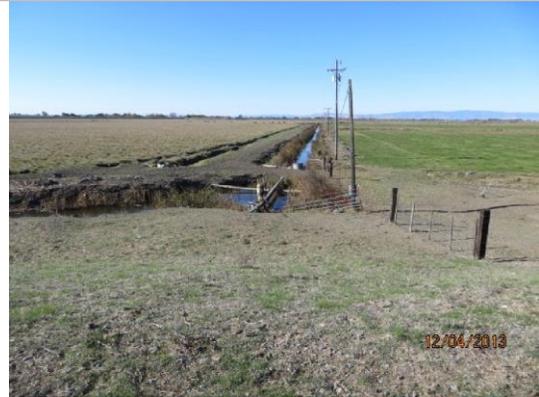
Photo 2 of 2 : UCIP_FA_2019_24990_45046.jpg

LM Start	2.90	Rating **	A/W	Issue No.	58 (cont)
LM End	2.90	Issue Type +	Ma	Location *	
Category	Supplemental			GPS Latitude/Longitude	
				Start	End
Item	DRAFT DWR UCIP LMA Responsibility			38.297380 °	38.297380 °
				-121.730166 °	-121.730166 °
DWR ID	24708

Comment Code					
Inspector Comment					
DS_ID:24708 FS_ID:24990 EP_NO: 10185 Repair Type: No Action Needed Crossing Status: Found UCIP Comments: 09/14/2017 Permit is unavailable, missing page 3 official permit documentation. (DWR UCIP - O. Magana) FIELD_STRUCT_DESC: 12-inch steel drainage pipe through the levee, 4 feet below the crown. Pump on pile structure in drainage canal on the landside (LS). Siphon breaker in a 12-inch steel riser on the waterside (WS) slope. (Automatic Board Order (ABO) issued as Permit No. 10185, 1964 - Erwin E. and Lucy G. Vassar, limited information available electronic version of permit missing. Replaced under Permit No. 4412, 1963 - Ervin E. and Lucy G. Vassar, limited details available electronic permit copy unavailable). [Additional Reference(s): DWR Levee Log, 2006. USACE Sacramento O&M Manual 108, April 1964, (HLM 3.12), Drawing No. 50-04-3379]. FS Date: 12/4/2013

Pump on pier in ditch off LS toe.

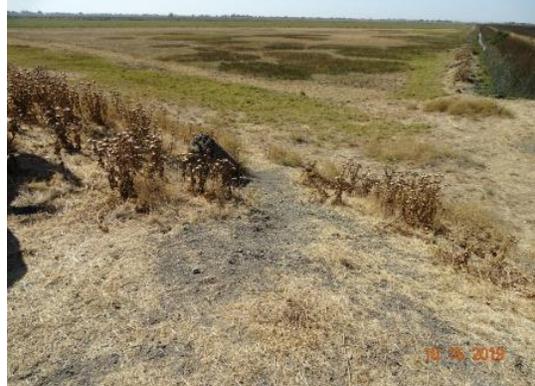
Photo 1 of 1 : FA_2019_RD2104_249_21_20191015_00046.jpg

LM Start	4.00	Rating **	M	Issue No.	21
LM End	4.00	Issue Type +	Ma	Location *	LS
Category	Earthen Levee		GPS Latitude/Longitude		
			Start	End	
Item	Slope Stability		38.310672°	38.310672°	
			-121.736155°	-121.736155°	
DWR ID	DWR_RD2104_01_f_2018_21				
Comment Code					
S2 : Repair the levee slope damaged by foot traffic and prevent access where possible.					
Inspector Comment					
There is a cow path on the landside slope.

View looking downslope at cow path on the landside slope (Fall 2019).

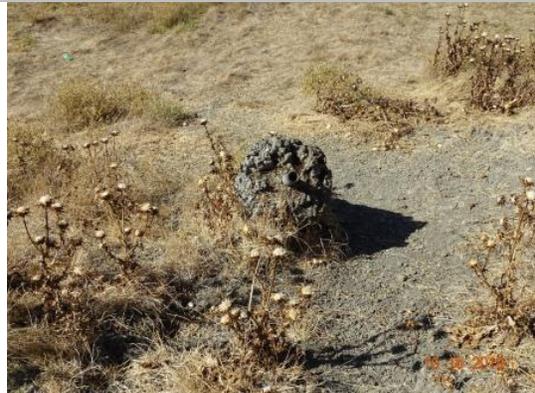
Photo 1 of 1 : FA_2019_RD2104_249_42_20191015_00047.jpg

LM Start	4.00	Rating **	M	Issue No.	42
LM End	4.00	Issue Type +	Ma	Location *	LS
Category	Earthen Levee		GPS Latitude/Longitude		
			Start	End	
Item	Encroachments		38.310682°	38.310682°	
			-121.736152°	-121.736152°	
DWR ID	DWR_RD2104_01_f_2019_42				
Comment Code					
DE : Debris					
Inspector Comment					
Remove concrete block.

View of large concrete block on the landside slope (Fall 2019).

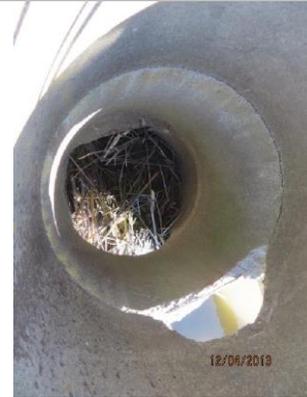
Photo 3 of 3 : UCIP_FA_2019_51459_45060.jpg

LM Start	4.31	Rating **	M	Issue No.	61 (cont)
LM End	4.31	Issue Type +	Ma	Location *	
Category	Supplemental			GPS Latitude/Longitude	
				Start	End
Item	DRAFT DWR UCIP LMA Responsibility			38.313955 °	38.313955 °
				-121.739930 °	-121.739930 °
DWR ID	24705

Comment Code					
Inspector Comment					
<p>DS_ID:24705 FS_ID:51459 EP_NO: 10182 Repair Type: Non-Urgent Crossing Status: Found UCIP Comments: 12/06/2016 Crossing has been downgraded from "Urgent" to "Non-Urgent" no signs of leaks observed along pipe alignment (limited inspection on WS toe). According to LMA representative, this crossing was replaced 6 years ago (2010) at WS concrete apron. Recommend conducting internal inspection of pipe through the levee and LS to determine pipe integrity. (O. Magana - DWR UCIP)12/04/2013 Vegetation and soil buildup throughout pipe preventing flapgate from closing. Remove vegetation to allow gate to close properly. (W. Wylie - DWR UCIP) FIELD_STRUCT_DESC: 24-inch corrugated metal drainage pipe through the levee, 15 feet below the crown. 36-inch concrete standpipe on the landside (LS) toe. Flap gate on the waterside (WS) toe. Two corrugated metal cutoff walls installed. (24-inch pipe [HLM 4.65] authorized under Automatic Board Order (ABO) issued as Permit No. 10182, 1974 - Julia Trust Machado). [Additional Reference(s): DWR Levee Log, 2006. USACE Sacramento O&M Manual 108, April 1964, (HLM 4.65), Drawing No. 50-04-3379]. FS Date: 12/6/2016</p>

36-inch concrete riser with vegetation buildup inside.

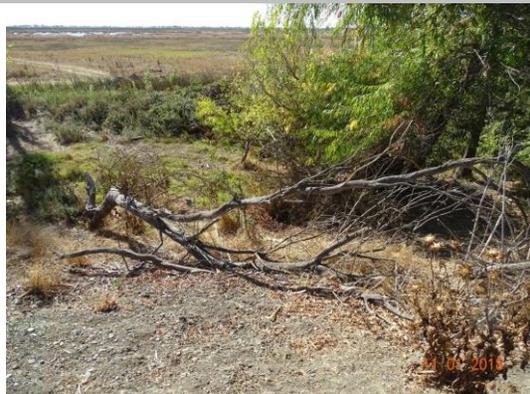
Photo 1 of 1 : FA_2019_RD2104_249_31_20190826_00011.jpg

LM Start	4.71	Rating **	M	Issue No.	31
LM End	4.71	Issue Type +	Ma	Location *	LS
Category	Earthen Levee		GPS Latitude/Longitude		
			Start	End	
Item	Encroachments		38.318407°	38.318407°	
			-121.744495°	-121.744495°	
DWR ID	DWR_RD2104_01_f_2018_31				
Comment Code					
TR : Tree or limb					
Inspector Comment					
Remove tree limb on landside slope.

View of down tree limb on the landside slope (November 2018).

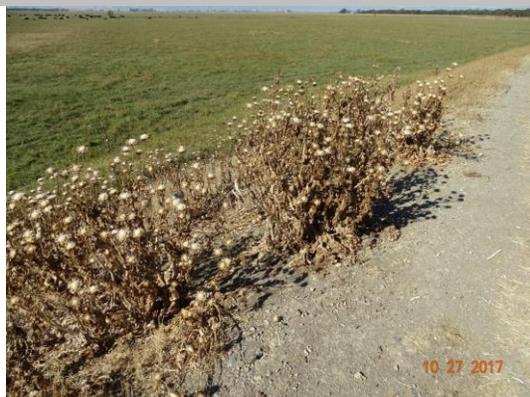
Photo 1 of 1 : FA_2019_RD2104_249_24_20190826_00009.jpg

LM Start	4.96	Rating **	U	Issue No.	24
LM End	4.96	Issue Type +	Ma	Location *	LS
Category	Earthen Levee		GPS Latitude/Longitude		
			Start	End	
Item	Slope Stability		38.320382°	38.320382°	
			-121.748155°	-121.748155°	
DWR ID	DWR_RD2104_01_f_2017_24				
Comment Code					
S1 : Repair slope instability.					
Inspector Comment

Landside levee slope has slumped leaving a 2-foot vertical scarp at the shoulder. Site should be repaired.

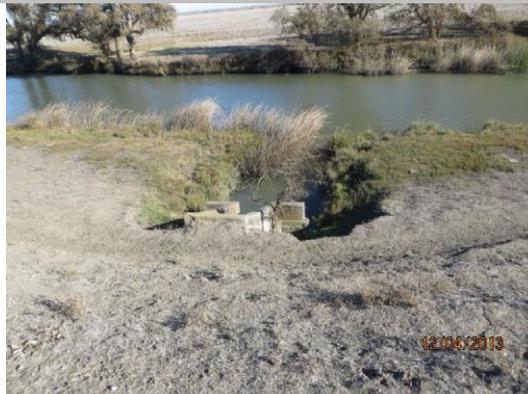
Photo 1 of 3 : UCIP_FA_2019_53387_45090.jpg

Comment Code					
Inspector Comment					
DS_ID:24701 FS_ID:53387 EP_NO: 10182 Repair Type: Urgent Crossing Status: Found UCIP Comments: 10/12/2018 Same as last inspection; concrete headwall on WS still being undermined so crossing remains Urgent (D. Sanoski - DWR UCIP). 12/06/2016 same as last inspection--pipe remains "Urgent" CMP shows holes through wall and concrete headwall is undermined. Need to contact owner. Owner will need to work with the CVFPB to comply with Title 23. (O. Magana - DWR UCIP) 12/04/2013 Footing under headwall on WS toe severely undermined. Pipe rusted heavily with holes at WS and may need replacement. (W. Wylie - DWR UCIP) FIELD_STRUCT_DESC: 24-inch corrugated metal drainage pipe through the levee, 13 feet below the crown. Two cutoff walls. Concrete U-shaped headwalls on both ends. Flap gate on the waterside (WS). (24-inch pipe [HLM 5.50] authorized under Automatic Board Order (ABO) issued as Permit No. 10182, 1974 - Julia Trust Machado). [Additional Reference(s): DWR Levee Log, 2006. USACE Sacramento O&M Manual 108, April 1964, (HLM 5.5), listed as a 12-inch pipe, Drawing No. 50-04-3379, listed as an 18-inch pipe]. FS Date: 10/12/2018 5:06:00 PM

Concrete U-shaped headwall on WS toe. Note erosion scarp around headwall.

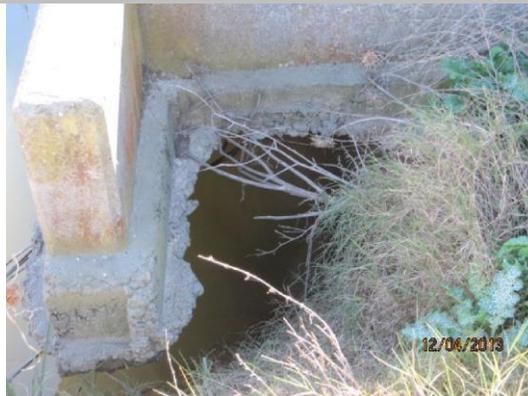
Photo 2 of 3 : UCIP_FA_2019_53387_45089.jpg

Headwall undermined on WS toe.

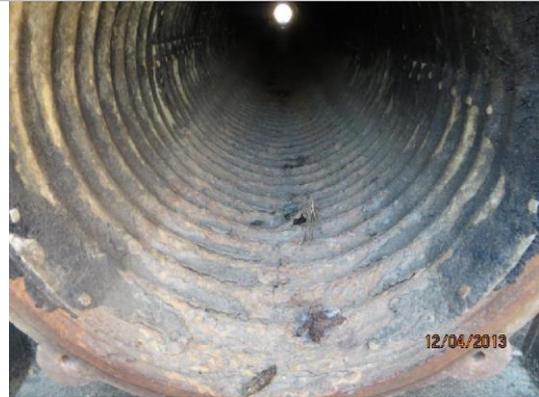
Photo 3 of 3 : UCIP_FA_2019_53387_45088.jpg

Comment Code					
Inspector Comment					
DS_ID:24701 FS_ID:53387 EP_NO: 10182 Repair Type: Urgent Crossing Status: Found UCIP Comments: 10/12/2018 Same as last inspection; concrete headwall on WS still being undermined so crossing remains Urgent (D. Sanoski - DWR UCIP).12/06/2016 same as last inspection--pipe remains "Urgent" CMP shows holes through wall and concrete headwall is undermined. Need to contact owner. Owner will need to work with the CVFPB to comply with Title 23. (O. Magana - DWR UCIP)12/04/2013 Footing under headwall on WS toe severely undermined. Pipe rusted heavily with holes at WS and may need replacement. (W. Wylie - DWR UCIP) FIELD_STRUCT_DESC: 24-inch corrugated metal drainage pipe through the levee, 13 feet below the crown. Two cutoff walls. Concrete U-shaped headwalls on both ends. Flap gate on the waterside (WS). (24-inch pipe [HLM 5.50] authorized under Automatic Board Order (ABO) issued as Permit No. 10182, 1974 - Julia Trust Machado). [Additional Reference(s): DWR Levee Log, 2006. USACE Sacramento O&M Manual 108, April 1964, (HLM 5.5), listed as a 12-inch pipe, Drawing No. 50-04-3379, listed as an 18-inch pipe]. FS Date: 10/12/2018 5:06:00 PM

Corosion through pipe with holes on WS toe.
