**Flood Control Project Maintenance  
Levee Inspections**

**Fall 2019 Levee Maintenance Deficiency Summary Report**

**Reclamation District No. 2107 Mossdale Island**

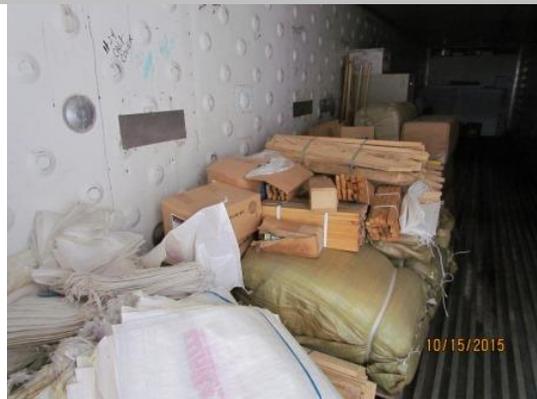
Photo 1 of 1 : FA\_2019\_RD2107\_329\_7\_20190830\_00001.jpg

LM Start		Rating **	A	Issue No.	7
LM End		Issue Type +	Ma	Location *	
Category	Earthen Levee		GPS Latitude/Longitude		
			Start	End	
Item	Emergency Supplies & Equipment		o	o	o
DWR ID	DWR_RD2107_01_s_2013_7				
Comment Code					
Inspector Comment					
Flood fighting supplies are available on-site.

View of the flood fight emergency supplies.

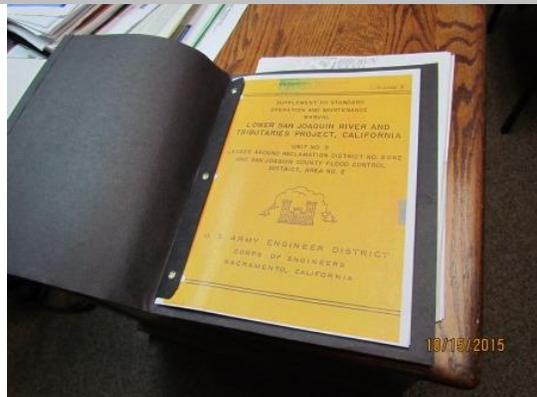
Photo 1 of 1 : FA\_2019\_RD2107\_329\_8\_20190830\_00002.jpg

LM Start		Rating **	A	Issue No.	8
LM End		Issue Type +	Ma	Location *	
Category	Earthen Levee		GPS Latitude/Longitude		
			Start	End	
Item	Operations & Maintenance Manuals		o	o	o
DWR ID	DWR_RD2107_01_s_2013_8				
Comment Code					
Inspector Comment					
The O&M Manual is available at the LMA's office.

View of the O&M Manual.

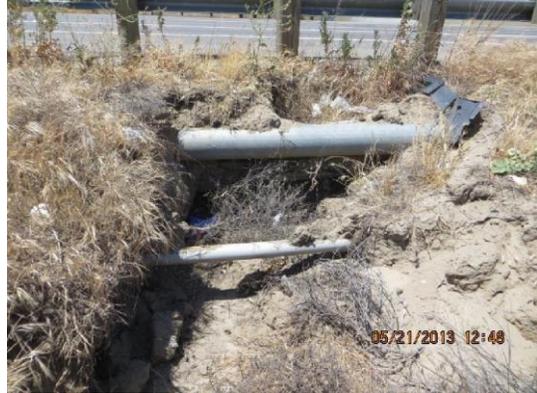
Photo 1 of 1 : UCIP\_FA\_2019\_16187\_27294.jpg

LM Start	<b>0.23</b>	Rating **	M	Issue No.	<b>24</b>
LM End	<b>0.23</b>	Issue Type +	En	Location *	
Category	Supplemental			GPS Latitude/Longitude	
				Start	End
Item	DRAFT DWR UCIP Field Study			37.784586°	37.784586°
				-121.306837°	-121.306837°
DWR ID	23107				
Comment Code					
Inspector Comment					
DS_ID:23107 FS_ID:16187 EP_NO: N/A Repair Type: Non-Urgent Crossing Status: Found UCIP Comments: No permit identified. Erosion exposed pipes on LS. FIELD_STRUCT_DESC: 3-inch polyvinyl chloride (PVC) conduit of an unknown purpose, 1 foot below the road surface, within roadway fill over the levee crown. FS Date: 5/22/2013

Pipes visible on LS next to roadway.

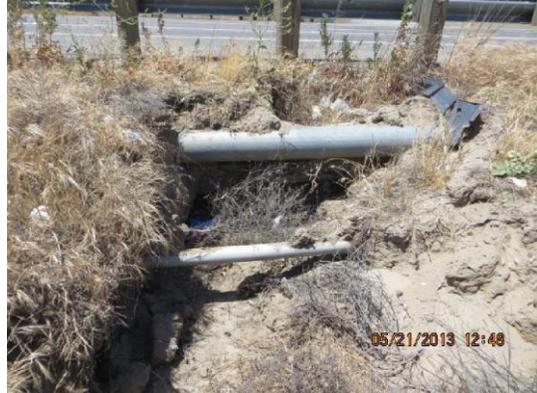
Photo 1 of 1 : UCIP\_FA\_2019\_15175\_24922.jpg

LM Start	<b>0.23</b>	Rating **	M	Issue No.	<b>25</b>
LM End	<b>0.23</b>	Issue Type +	En	Location *	
Category	Supplemental			GPS Latitude/Longitude	
				Start	End
Item	DRAFT DWR UCIP Field Study			37.784586°	37.784586°
				-121.306837°	-121.306837°
DWR ID	23108				
Comment Code					
Inspector Comment					
DS_ID:23108 FS_ID:15175 EP_NO: N/A Repair Type: Non-Urgent Crossing Status: Found UCIP Comments: No permit identified. Erosion exposed pipes on LS. FIELD_STRUCT_DESC: 8-inch steel conduit of an unknown purpose, 1 foot below the road surface, within roadway fill over the levee crown. Visible on the upstream side of the bridge. FS Date: 5/22/2013

Pipes visible on LS next to roadway.

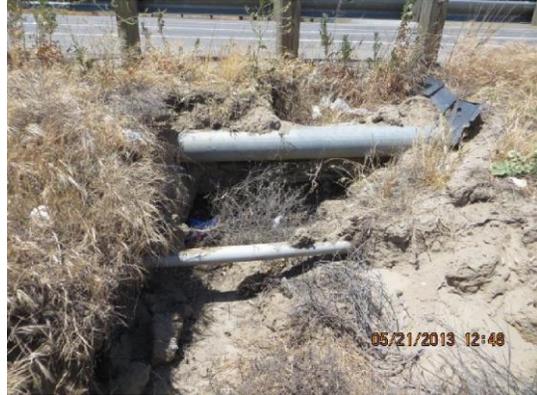
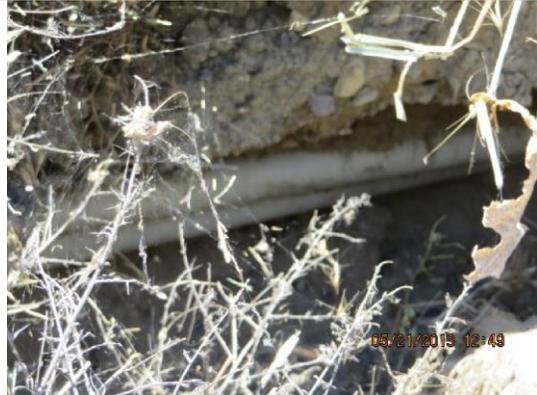
LM Start	<b>0.23</b>	Rating **	M	Issue No.	<b>26</b>
LM End	<b>0.23</b>	Issue Type +	En	Location *	
Category	Supplemental			GPS Latitude/Longitude	
				Start	End
Item	DRAFT DWR UCIP Field Study			37.784586°	37.784586°
				-121.306837°	-121.306837°
DWR ID	23109				
Comment Code					
Inspector Comment					
DS_ID:23109 FS_ID:15173 EP_NO: N/A Repair Type: Non-Urgent Crossing Status: Found UCIP Comments: No permit identified for this crossing. Erosion exposed pipes on LS. FIELD_STRUCT_DESC: 1.5-inch polyvinyl chloride (PVC) conduit of an unknown purpose, 1 foot below the road surface, within roadway fill over the levee crown. FS Date: 5/22/2013

Pipes visible on LS next to roadway.

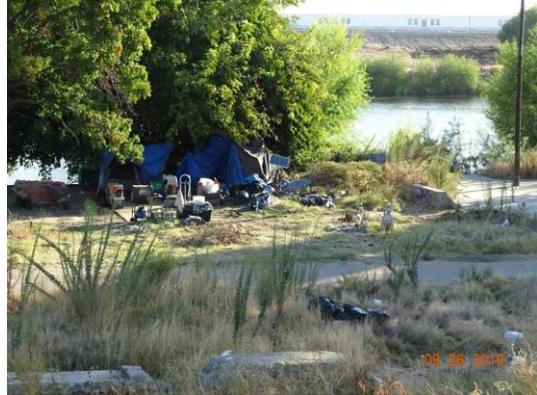
Photo 1 of 1 : FA\_2019\_RD2107\_329\_22\_20190930\_00025.jpg

LM Start	<b>0.26</b>	Rating **	M	Issue No.	<b>22</b>
LM End	<b>0.36</b>	Issue Type +	En	Location *	WS
Category	Earthen Levee		GPS Latitude/Longitude		
			Start	End	
Item	Encroachments		37.784342°	37.783268°	
			-121.306528°	-121.305165°	
DWR ID	DWR_RD2107_01_f_2019_22				
Comment Code					
DE : Debris					
Inspector Comment					
Trash and debris are common on the waterside slope. RD coordinates with local law enforcement to minimize encroachments.

View of debris on waterside slope. Fall 2019

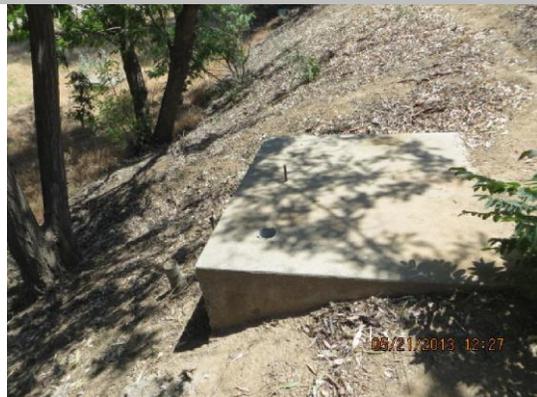
Photo 1 of 1 : UCIP\_FA\_2019\_16188\_27296.jpg

LM Start	<b>0.27</b>	Rating **	M	Issue No.	<b>28</b>
LM End	<b>0.27</b>	Issue Type +	En	Location *	
Category	Supplemental		GPS Latitude/Longitude		
			Start	End	
Item	DRAFT DWR UCIP Field Study		37.784194°	37.784194°	
			-121.306353°	-121.306353°	
DWR ID	19055				
Comment Code					
Inspector Comment					
DS_ID:19055 FS_ID:16188 EP_NO: 12101B Repair Type: Non-Urgent Crossing Status: Found UCIP Comments: Appears abandoned and should be done so properly. FIELD_STRUCT_DESC: 4" electrical conduit through the levee 2.5 feet below the crown. Distribution panel on a 5-foot by 6-foot concrete pad on the WS shoulder (Permit No 12101B, 1979). FS Date: 5/21/2013

5X5 concrete pad with exposed electrical conduit on WS shoulder.

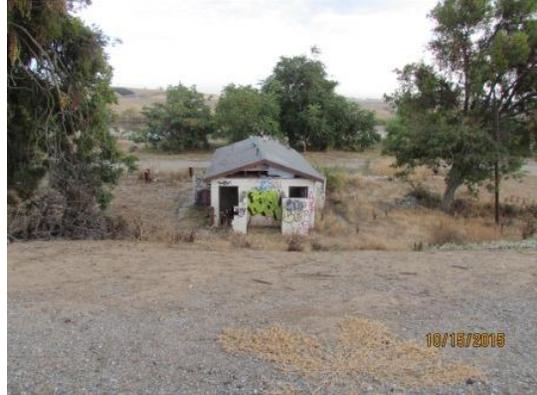
Photo 1 of 1 : FA\_2019\_RD2107\_329\_20\_20190830\_00006.jpg

LM Start	<b>0.32</b>	Rating **	M	Issue No.	<b>20</b>
LM End	<b>0.32</b>	Issue Type +	En	Location *	WS
Category	Earthen Levee		GPS Latitude/Longitude		
			Start	End	
Item	Encroachments		37.783649°	37.783649°	
			-121.305710°	-121.305710°	
DWR ID	DWR_RD2107_01_f_2015_20				
Comment Code					
BU : Building					
Inspector Comment					
Building in the floodway may impede flood flows.

View of the building in the floodway.

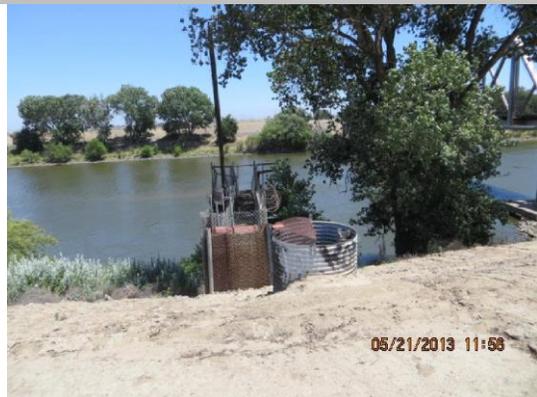
Photo 1 of 3 : UCIP\_FA\_2019\_13684\_22411.jpg

Item	DRAFT DWR UCIP Field Study		37.779486°	37.779486°	
			-121.301961°	-121.301961°	
DWR ID	19036				
Comment Code					
Inspector Comment					
DS_ID:19036 FS_ID:13684 EP_NO: N/A Repair Type: Non-Urgent Crossing Status: Found UCIP Comments: Wooden walkway to pump on platform is in disrepair and may be a hazard. FIELD_STRUCT_DESC: 1 of 2: 14-inch irrigation pipe of an unknown material through the levee, 17 feet below the crown. Pump on pile structure in the stream. Walkway to pump. Slide gate in a 48-inch corrugated metal pipe (CMP) riser on the waterside (WS) shoulder. 36-inch concrete standpipe at the landside (LS) toe. Service pole and circuit panel on the LS toe. [Additional Reference(s): DWR Levee Log, 2005. USACE San Joaquin O&M Manual 9, April 1964, (HLM 0.68), 12-inch pipe listed]. FS Date: 5/21/2013

Pier and 48-inch CMP riser on WS shoulder

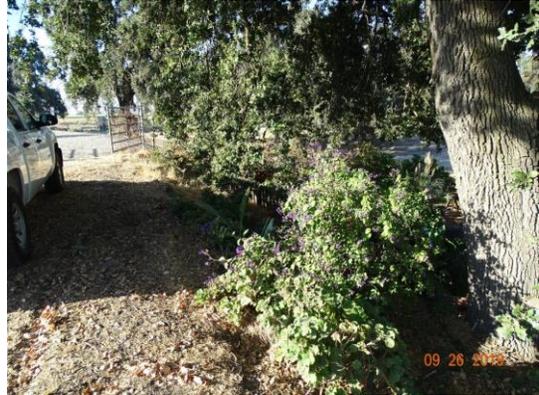
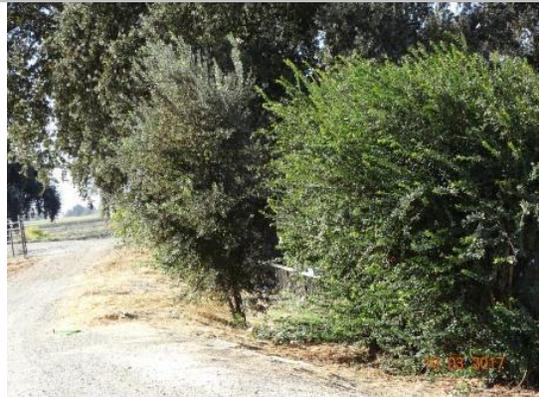
LM Start	<b>1.23</b>	Rating **	M	Issue No.	<b>17</b>
LM End	<b>1.23</b>	Issue Type +	En	Location *	LS
Category	Earthen Levee			GPS Latitude/Longitude	
				Start	End
Item	Vegetation			37.774123°	37.774123°
				-121.307189°	-121.307189°
DWR ID	DWR_RD2107_01_s_2012_17				
Comment Code					
V6 : Landscaping					
Inspector Comment

View of landscape vegetation on landside slope. Fall 2019

View of landscape planted on the landside levee slope and a 3-ft yard fence at the levee toe.

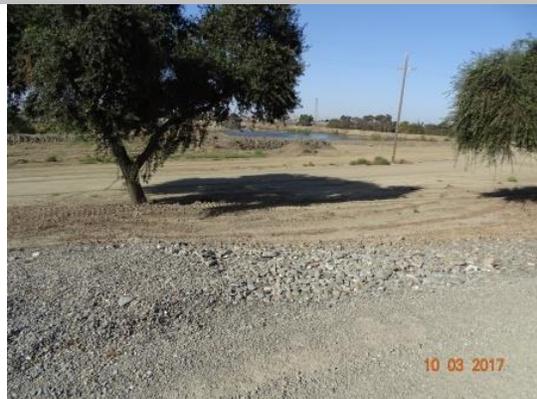
Photo 1 of 1 : FA\_2019\_RD2107\_329\_15\_20190830\_00003.jpg

LM Start	<b>1.34</b>	Rating **	A/W	Issue No.	<b>15</b>
LM End	<b>1.34</b>	Issue Type +	Ob	Location *	
Category	Supplemental		GPS Latitude/Longitude		
			Start	End	
Item	2017 Storm Damage		37.772704°	37.772704°	
			-121.306793°	-121.306793°	
DWR ID	208-4				
Comment Code					
Inspector Comment					
Levee Evaluation Comments					
Description:					
Site ID No:111					
Site Designation:208-4					
Repair Type: Seepage					
Rating:					
Field Date:					
Notes: In 1997 there was heavy seepage at this location. In 2017 there was no seepage observed at this location.

View of the historic seepage site.

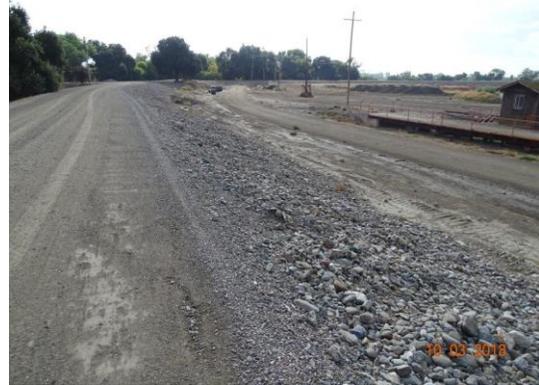
Photo 1 of 1 : FA\_2019\_RD2107\_329\_18\_20190830\_00005.jpg

LM Start	<b>1.35</b>	Rating **	A/W	Issue No.	<b>18</b>
LM End	<b>1.45</b>	Issue Type +	Ob	Location *	
Category	Supplemental			GPS Latitude/Longitude	
				Start	End
Item	2017 Storm Damage			37.772470°	37.771910°
				-121.306820°	-121.304990°
DWR ID	208-1				
Comment Code					
Inspector Comment					
Levee Evaluation Comments					
Description:					
Site ID No:113					
Site Designation:208-1					
Repair Type: Seepage					
Rating:					
Field Date:					
Notes: No seepage observed in 2017.

View of the newly constructed seepage berm on the landside slope. Fall 2018.

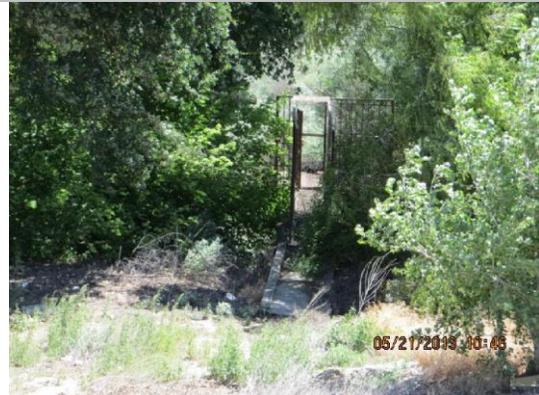
Photo 1 of 3 : UCIP\_FA\_2019\_13650\_22341.jpg

LM Start	<b>1.47</b>	Rating **	M	Issue No.	<b>32</b>
LM End	<b>1.47</b>	Issue Type +	En	Location *	
Category	Supplemental			GPS Latitude/Longitude	
				Start	End
Item	DRAFT DWR UCIP Field Study			37.771735°	37.771735°
				-121.304847°	-121.304847°
DWR ID	19040				
Comment Code					
Inspector Comment					
DS_ID:19040 FS_ID:13650 EP_NO: N/A Repair Type: Non-Urgent Crossing Status: Found UCIP Comments: No pump. Appears abandoned. Large hole under pipe on WS slope from animal activity. FIELD_STRUCT_DESC: 1 of 2: 18-inch polyvinyl chloride (PVC) irrigation pipe through the levee, 2.5 feet below the crown. Pump on pile structure in the stream. Walkway to the pump. [Additional Reference(s): DWR Levee Log, 2005. USACE San Joaquin O&M Manual 9, April 1964, (HLM 1.49)]. FS Date: 5/21/2013

Pumping plant on metal pier on WS toe.

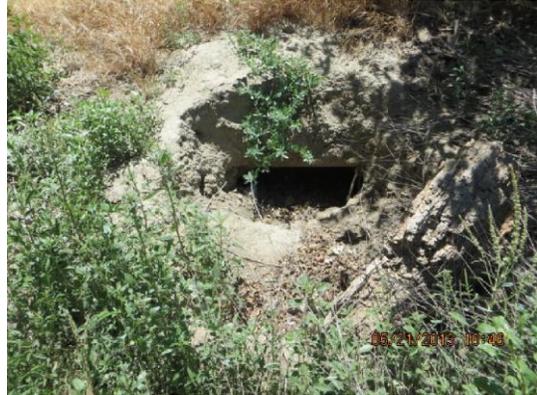
Photo 2 of 3 : UCIP\_FA\_2019\_13650\_22340.jpg

LM Start	<b>1.47</b>	Rating **	M	Issue No.	<b>32 (cont)</b>
LM End	<b>1.47</b>	Issue Type +	En	Location *	
Category	Supplemental			GPS Latitude/Longitude	
				Start	End
Item	DRAFT DWR UCIP Field Study			37.771735°	37.771735°
				-121.304847°	-121.304847°
DWR ID	19040				
Comment Code					
Inspector Comment					
DS_ID:19040 FS_ID:13650 EP_NO: N/A Repair Type: Non-Urgent Crossing Status: Found UCIP Comments: No pump. Appears abandoned. Large hole under pipe on WS slope from animal activity. FIELD_STRUCT_DESC: 1 of 2: 18-inch polyvinyl chloride (PVC) irrigation pipe through the levee, 2.5 feet below the crown. Pump on pile structure in the stream. Walkway to the pump. [Additional Reference(s): DWR Levee Log, 2005. USACE San Joaquin O&M Manual 9, April 1964, (HLM 1.49)]. FS Date: 5/21/2013

Large hole under pipe on WS slope.

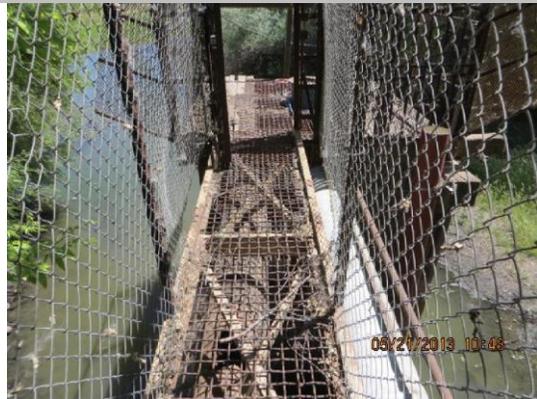
Photo 3 of 3 : UCIP\_FA\_2019\_13650\_22339.jpg

Pumping plant on metal pier on WS toe. Pipe visible on right under walkway.

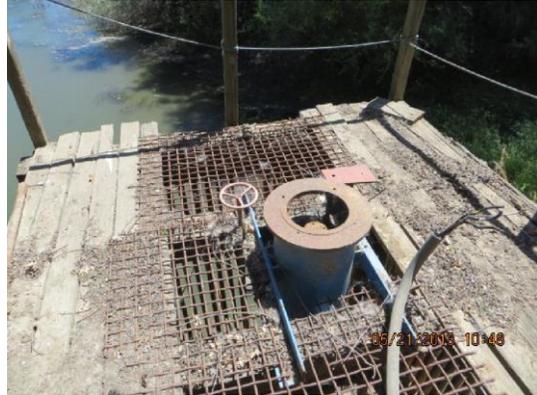
Photo 3 of 3 : UCIP\_FA\_2019\_15179\_24933.jpg

LM Start	<b>1.47</b>	Rating **	M	Issue No.	<b>33 (cont)</b>
LM End	<b>1.47</b>	Issue Type +	En	Location *	
Category	Supplemental			GPS Latitude/Longitude	
				Start	End
Item	DRAFT DWR UCIP Field Study			37.771735°	37.771735°
				-121.304847°	-121.304847°
DWR ID	23106				
Comment Code					
Inspector Comment					
DS_ID:23106 FS_ID:15179 EP_NO: N/A Repair Type: Non-Urgent Crossing Status: Found UCIP Comments: Pipe open on WS toe at the pump on pier. Pipe abandoned and should be done so properly. FIELD_STRUCT_DESC: 16-inch steel irrigation pipe through the levee, 2.5 feet below the crown. Pump on pile structure in the stream. Walkway to the pump. FS Date: 5/21/2013

Pipe open at pump on platform on WS.

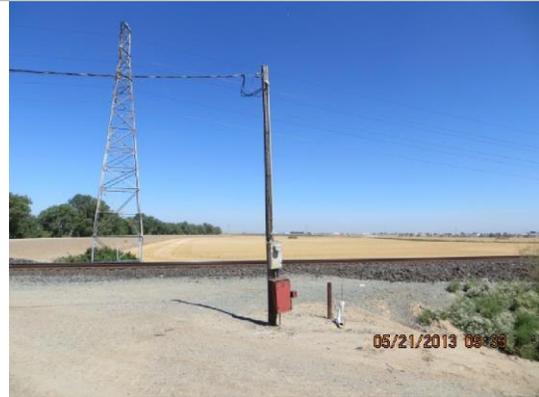
Photo 3 of 3 : UCIP\_FA\_2019\_13636\_22294.jpg

LM Start	<b>0.54</b>	Rating **	M	Issue No.	<b>8 (cont)</b>
LM End	<b>0.54</b>	Issue Type +	En	Location *	
Category	Supplemental			GPS Latitude/Longitude	
				Start	End
Item	DRAFT DWR UCIP Field Study			37.764832°	37.764832°
				-121.317405°	-121.317405°
DWR ID	19058				
Comment Code					
Inspector Comment					
DS_ID:19058 FS_ID:13636 EP_NO: 13161 Repair Type: Non-Urgent Crossing Status: Found UCIP Comments: Some erosion along pipe alignment on WS slope. FIELD_STRUCT_DESC: 10-inch steel drainage pipe through the levee, 5 feet below the crown. Pump located on a 36-inch concrete standpipe at the landside (LS) toe. A polyvinyl chloride (PVC) pipe runs parallel to the waterside (WS) toe to the train tracks. Air relief valve on the WS shoulder. (Permit No. 13161, 1981 - [owner not indicated in permit database]). [Additional Reference(s): DWR Levee Log, 2005]. FS Date: 5/21/2013

JP and meter on LS shoulder.

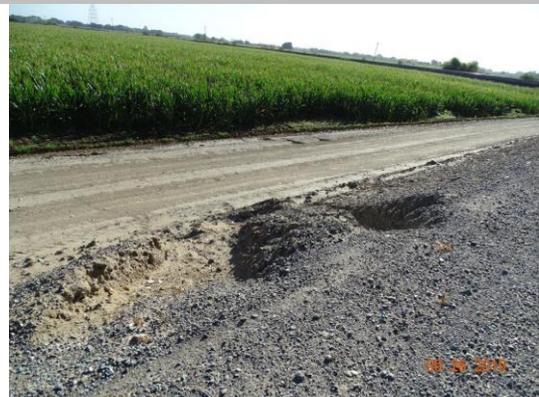
Photo 1 of 1 : FA\_2019\_RD2107\_330\_6\_20190930\_00011.jpg

LM Start	<b>0.66</b>	Rating **	U	Issue No.	<b>6</b>
LM End	<b>0.66</b>	Issue Type +	Ma	Location *	LS
Category	Earthen Levee			GPS Latitude/Longitude	
				Start	End
Item	Crown Surface / Depressions / Rutting			37.765664°	37.765664°
				-121.319015°	-121.319015°
DWR ID	DWR_RD2107_02_f_2019_6				
Comment Code					
C2 : Repair depressions or ruts in the crown or slope.					
Inspector Comment					
Ruts on landside slope caused by farm equipment.

View of ruts caused by farm equipment on landside slope. Fall 2019
