**Flood Control Project Maintenance  
Levee Inspections**  
**LMA District Cover Sheet**  
**Spring 2020 Levee Inspection Results**

**Reclamation District No. 2107 Mossdale Island**

**Levee Inspection Report By Mile - Spring 2020**

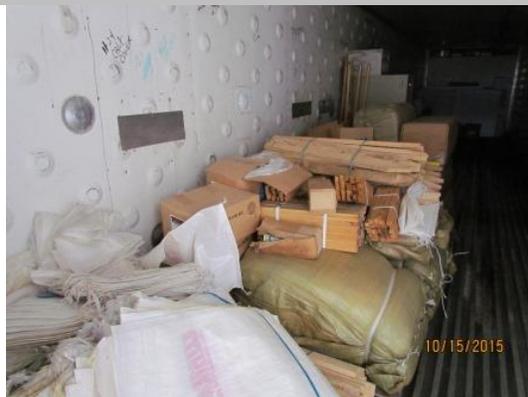
Photo 1 of 1 : SP\_2020\_RD2107\_329\_7\_20200228\_00001.jpg

LM Start		Rating **	A	Issue No.	7
LM End		Issue Type +	Ma	Location *	
Category	Earthen Levee		GPS Latitude/Longitude		
			Start	End	
Item	Emergency Supplies & Equipment		o	o	o
DWR ID	DWR_RD2107_01_s_2013_7				
Comment Code					
Inspector Comment					
Flood fighting supplies are available on-site.

View of the flood fight emergency supplies.

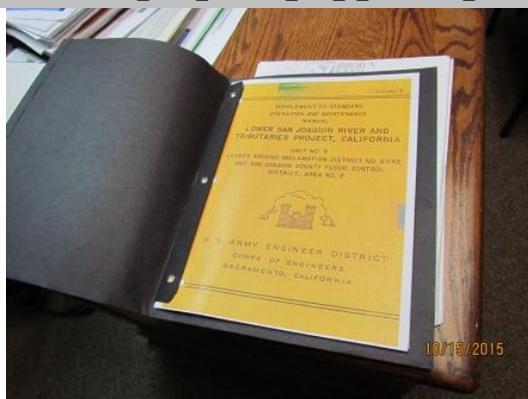
Photo 1 of 1 : SP\_2020\_RD2107\_329\_8\_20200228\_00002.jpg

LM Start		Rating **	A	Issue No.	8
LM End		Issue Type +	Ma	Location *	
Category	Earthen Levee		GPS Latitude/Longitude		
			Start	End	
Item	Operations & Maintenance Manuals		o	o	o
DWR ID	DWR_RD2107_01_s_2013_8				
Comment Code					
Inspector Comment					
The O&M Manual is available at the LMA's office.

View of the O&M Manual.

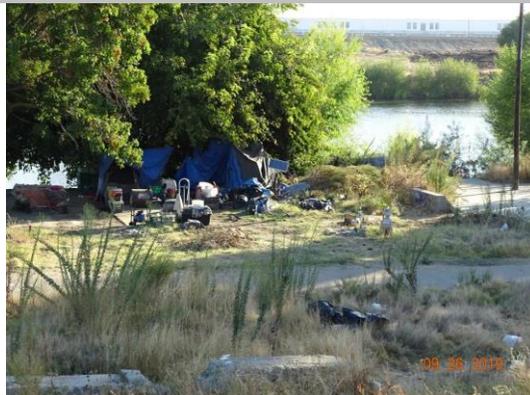
Photo 1 of 1 : SP\_2020\_RD2107\_329\_22\_20200228\_00008.jpg

LM Start	<b>0.26</b>	Rating **	M	Issue No.	<b>22</b>
LM End	<b>0.36</b>	Issue Type +	En	Location *	WS
Category	Earthen Levee		GPS Latitude/Longitude		
			Start	End	
Item	Encroachments		37.784342 °	37.783268 °	
			-121.306528 °	-121.305165 °	
DWR ID	DWR_RD2107_01_f_2019_22				
Comment Code					
DE : Debris					
Inspector Comment					
Trash and debris are common on the waterside slope. RD coordinates with local law enforcement to minimize encroachments.

View of debris on waterside slope. Fall 2019

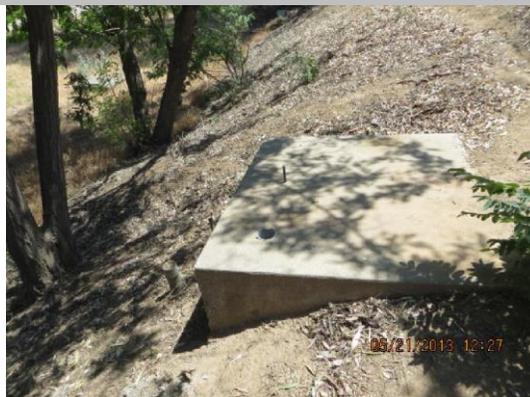
Photo 1 of 1 : UCIP\_SP\_2020\_16188\_27296.jpg

LM Start	<b>0.27</b>	Rating **	M	Issue No.	<b>28</b>
LM End	<b>0.27</b>	Issue Type +	En	Location *	
Category	Supplemental		GPS Latitude/Longitude		
			Start	End	
Item	DWR UCIP Field Study		37.784194 °	37.784194 °	
			-121.306353 °	-121.306353 °	
DWR ID	19055				
Comment Code					
Inspector Comment					
DS_ID:19055 FS_ID:16188 EP_NO: 12101B Repair Type: Non-Urgent Crossing Status: Found UCIP Comments: Appears abandoned and should be done so properly. FIELD_STRUCT_DESC: 4" electrical conduit through the levee 2.5 feet below the crown. Distribution panel on a 5-foot by 6-foot concrete pad on the WS shoulder (Permit No 12101B, 1979). FS Date: 5/21/2013

5X5 concrete pad with exposed electrical conduit on WS shoulder.

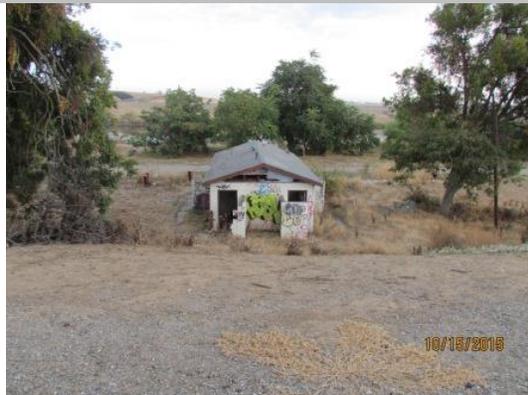
Photo 1 of 1 : SP\_2020\_RD2107\_329\_20\_20200228\_00007.jpg

LM Start	<b>0.32</b>	Rating **	M	Issue No.	<b>20</b>
LM End	<b>0.32</b>	Issue Type +	En	Location *	WS
Category	Earthen Levee		GPS Latitude/Longitude		
			Start	End	
Item	Encroachments		37.783649 °	37.783649 °	
			-121.305710 °	-121.305710 °	
DWR ID	DWR_RD2107_01_f_2015_20				
Comment Code					
BU : Building					
Inspector Comment					
Building in the floodway may impede flood flows.

View of the building in the floodway.

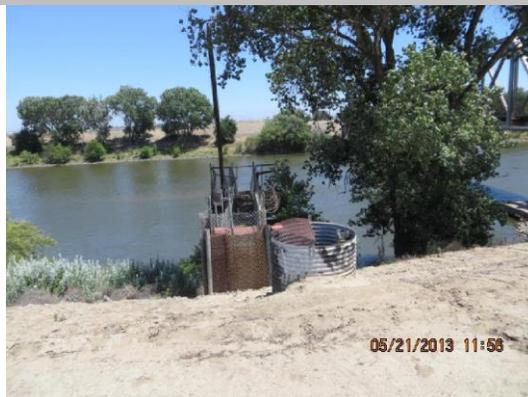
Photo 1 of 3 : UCIP\_SP\_2020\_13684\_22411.jpg

Item	DWR UCIP Field Study		37.779486 °	37.779486 °	
			-121.301961 °	-121.301961 °	
DWR ID	19036				
Comment Code					
Inspector Comment					
DS_ID:19036 FS_ID:13684 EP_NO: N/A Repair Type: Non-Urgent Crossing Status: Found UCIP Comments: Wooden walkway to pump on platform is in disrepair and may be a hazard. FIELD_STRUCT_DESC: 1 of 2: 14-inch irrigation pipe of an unknown material through the levee, 17 feet below the crown. Pump on pile structure in the stream. Walkway to pump. Slide gate in a 48-inch corrugated metal pipe (CMP) riser on the waterside (WS) shoulder. 36-inch concrete standpipe at the landside (LS) toe. Service pole and circuit panel on the LS toe. [Additional Reference(s): DWR Levee Log, 2005. USACE San Joaquin O&M Manual 9, April 1964, (HLM 0.68), 12-inch pipe listed]. FS Date: 5/21/2013

Pier and 48-inch CMP riser on WS shoulder

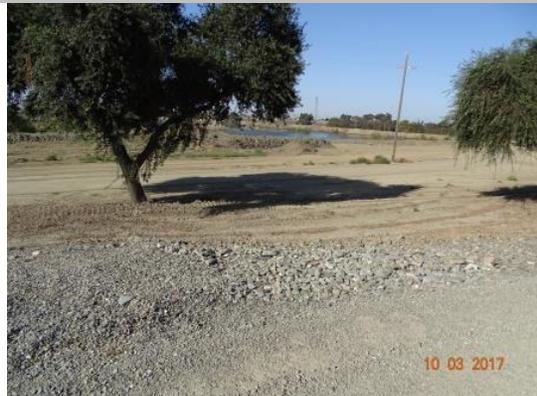
Photo 1 of 1 : SP\_2020\_RD2107\_329\_15\_20200228\_00003.jpg

LM Start	<b>1.34</b>	Rating **	A/W	Issue No.	<b>15</b>
LM End	<b>1.45</b>	Issue Type +	Ob	Location *	LS
Category	Earthen Levee		GPS Latitude/Longitude		
			Start	End	
Item	Seepage / Sandboils		37.772704 °	37.771910 °	
			-121.306793 °	-121.304990 °	
DWR ID	208-4				
Comment Code					
Inspector Comment					
In 1997 there was heavy seepage at this location. In 2017 there was no seepage observed at this location. This is a 2017 Storm Damage site. Site ID No:111 Site Designation: 208-4

View of the historic seepage site.

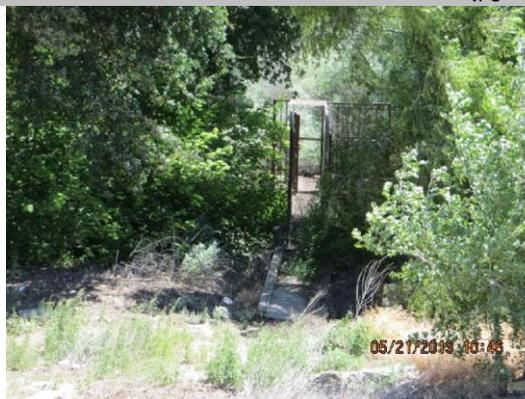
Photo 1 of 3 : UCIP\_SP\_2020\_13650\_22341.jpg

LM Start	<b>1.47</b>	Rating **	M	Issue No.	<b>32</b>
LM End	<b>1.47</b>	Issue Type +	En	Location *	
Category	Supplemental		GPS Latitude/Longitude		
			Start	End	
Item	DWR UCIP Field Study		37.771735 °	37.771735 °	
			-121.304847 °	-121.304847 °	
DWR ID	19040				
Comment Code					
Inspector Comment					
DS_ID:19040 FS_ID:13650 EP_NO: N/A Repair Type: Non-Urgent Crossing Status: Found UCIP Comments: No pump. Appears abandoned. Large hole under pipe on WS slope from animal activity. FIELD_STRUCT_DESC: 1 of 2: 18-inch polyvinyl chloride (PVC) irrigation pipe through the levee, 2.5 feet below the crown. Pump on pile structure in the stream. Walkway to the pump. [Additional Reference(s): DWR Levee Log, 2005. USACE San Joaquin O&M Manual 9, April 1964, (HLM 1.49)]. FS Date: 5/21/2013

Pumping plant on metal pier on WS toe.

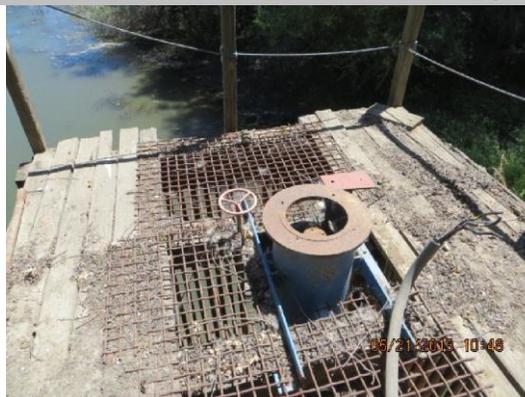
Photo 3 of 3 : UCIP\_SP\_2020\_15179\_24933.jpg

Pipe open at pump on platform on WS.

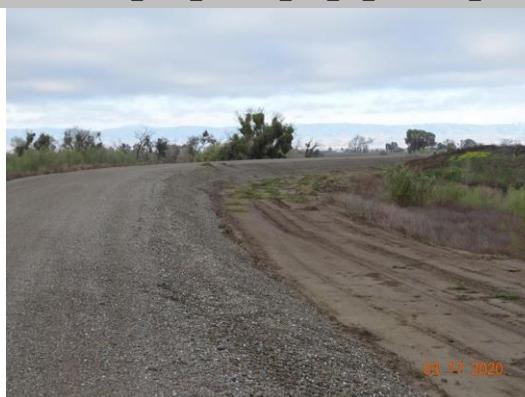
Photo 1 of 1 : SP\_2020\_RD2107\_329\_16\_20200318\_00027.jpg

LM Start	<b>1.60</b>	Rating **	A	Issue No.	<b>16</b>
LM End	<b>1.60</b>	Issue Type +	Ma	Location *	LS
Category	Earthen Levee			GPS Latitude/Longitude	
				Start	End
Item	Vegetation			37.769940 °	37.769940 °
				-121.304865 °	-121.304865 °
DWR ID	DWR_RD2107_01_s_2020_16				
Comment Code					
V1 : Control annual grass and weeds on the levee slopes and easements.					
Inspector Comment

Typical view of well maintained landside slope vegetation. Spring 2020

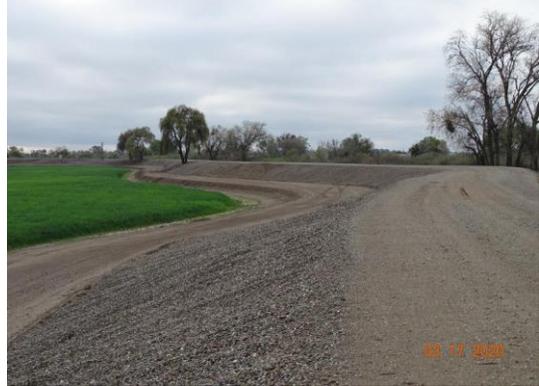
Photo 1 of 1 : SP\_2020\_RD2107\_330\_4\_20200318\_00010.jpg

LM Start	<b>0.28</b>	Rating **	A	Issue No.	<b>4</b>
LM End	<b>0.28</b>	Issue Type +	Ma	Location *	LS
Category	Earthen Levee		GPS Latitude/Longitude		
			Start	End	
Item	Vegetation		37.762685 °	37.762685 °	
			-121.313565 °	-121.313565 °	
DWR ID	DWR_RD2107_02_s_2020_4				
Comment Code					
V1 : Control annual grass and weeds on the levee slopes and easements.					
Inspector Comment					
Annual vegetation is well maintained.

Typical view of well maintained vegetation on landside slope. Spring 2020

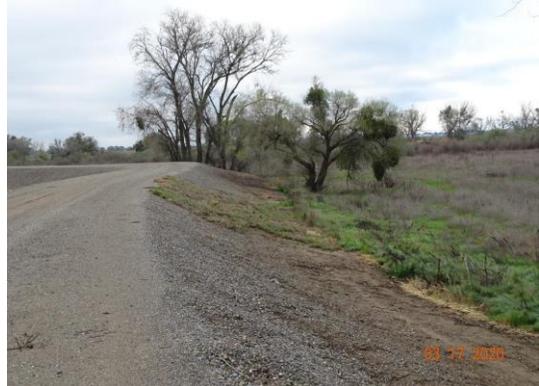
Photo 1 of 1 : SP\_2020\_RD2107\_330\_5\_20200318\_00011.jpg

LM Start	<b>0.28</b>	Rating **	A	Issue No.	<b>5</b>
LM End	<b>0.28</b>	Issue Type +	Ma	Location *	WS
Category	Earthen Levee		GPS Latitude/Longitude		
			Start	End	
Item	Vegetation		37.762686 °	37.762686 °	
			-121.313565 °	-121.313565 °	
DWR ID	DWR_RD2107_02_s_2020_5				
Comment Code					
V1 : Control annual grass and weeds on the levee slopes and easements.					
Inspector Comment					
Annual vegetation is well maintained.

View of typical well maintained vegetation on waterside slope. Spring 2020

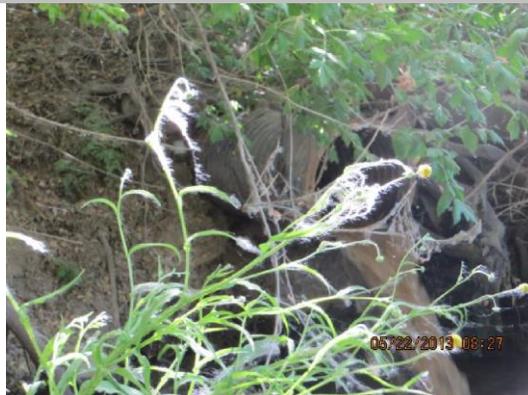
Photo 1 of 3 : UCIP\_SP\_2020\_53388\_22441.jpg

Item	DWR UCIP Field Study		37.774130 °	37.774130 °	
			-121.329896 °	-121.329896 °	
DWR ID	19056				
Comment Code					
Inspector Comment					
<p>DS_ID:19056                  FS_ID:53388                  EP_NO: 2966                  Repair Type: Urgent                  Crossing Status: Found                  UCIP Comments: 10/10/2018 A temporary flexible pvc pipe installed at this location. Although the levee looks to be in good condition, keeping Urgent due to the temporary nature of this pipe and the need for follow up due to potential levee threat (D. Sanoski - DWR UCIP).11/29/2017 Received update from DWR levee inspector M. Khashchuk and pipe is visible on WS toe with flap gate open: back filled during high winter flow to prevent erosion (no photos are available of back fill work). No updates were provided regarding repairs to the sink hole located on LS toe or internal inspection of pipe through the levee, pipe crossing remains urgent. (DWR UCIP - O. Magana)11/16/2016 Visible hole through pipe visible on WS end. Sink hole present at the LS ditch. Evidence of pipe repair visible on LS (see photos) however, no permit was found to document the work. Need to contact owner to determine permit authorizing work. Due to the hole in the pipe recommend internal inspection of the pipe through the levee to determine pipe integrity. (O. Magana - DWR UCIP)05/22/2013 Headwall around pipe at LS toe is failing and should be shored up. Flap gate propped open and should be returned to normal function. (W. Wylie - DWR UCIP)                  FIELD_STRUCT_DESC: 24-inch steel drainage pipe through the levee, 14 feet below the crown. Flap gate on the waterside (WS) end of the pipe. Two standard reinforced concrete cutoff walls around the pipe in line with the levee shoulders. (Permit No. 2966, 1958 - Dell'Osso Brothers).                  FS Date: 10/10/2018 2:37:00 PM</p>

Pipe visible on WS toe with Flap gate open.

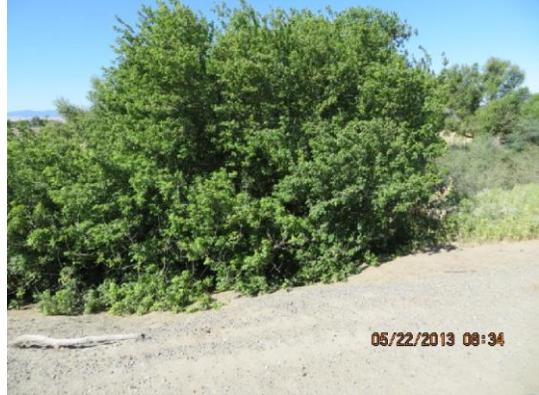
Photo 2 of 3 : UCIP\_SP\_2020\_53388\_22440.jpg

Pipes visible under foliage on WS toe.

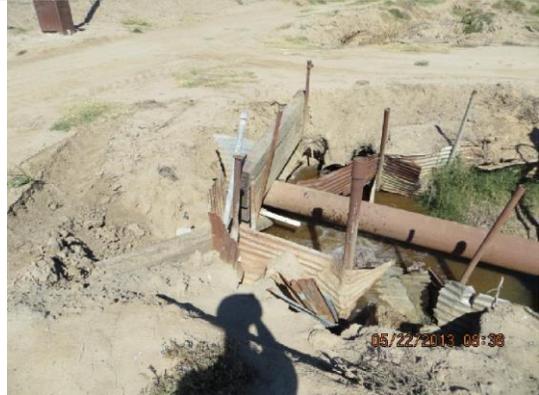
Photo 3 of 3 : UCIP\_SP\_2020\_53388\_22439.jpg

Headwall failing at drainage ditch on LS toe.
