**Flood Control Project Maintenance
Levee Inspections**

Fall 2019 Levee Maintenance Deficiency Summary Report

Sacramento River Basin

Sutter Maintenance Yard East Levee Sutter Bypass

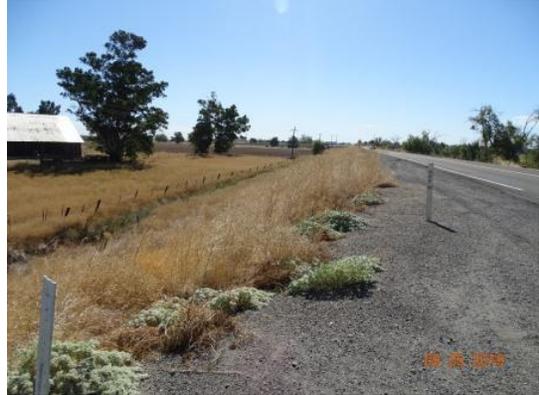
Photo 1 of 1 : FA_2019_ST0002_450_48_20190926_00084.jpg

View of the vegetation along the landside slope. Fall 2019.

LM Start	0.00	Rating **	U	Issue No.	47
LM End	0.25	Issue Type +	Ma	Location *	WS
Category	Earthen Levee		GPS Latitude/Longitude		
			Start	End	
Item	Vegetation		39.151291°	39.148212°	
			-121.832110°	-121.829759°	
DWR ID	DWR_ST0002_01_f_2019_47				
Comment Code					
V1 : Control annual grass and weeds on the levee slopes and easements.					
Inspector Comment

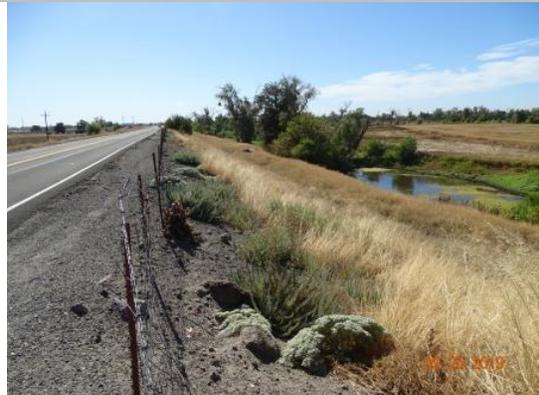
Photo 1 of 1 : FA_2019_ST0002_450_47_20190926_00085.jpg

View of the vegetation along the waterside slope. Fall 2019.

LM Start	0.00	Rating **	M	Issue No.	54
LM End	0.25	Issue Type +	En	Location *	WS
Category	Earthen Levee		GPS Latitude/Longitude		
			Start	End	
Item	Encroachments		39.151291°	39.148212°	
			-121.832110°	-121.829759°	
DWR ID	DWR_ST0002_01_f_2019_54				
Comment Code					
FE : Fence					
Inspector Comment

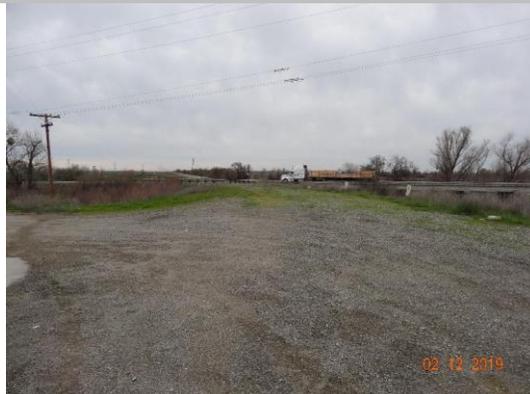
Photo 1 of 3 : UCIP_FA_2019_55013_78814.jpg

Comment Code					
Inspector Comment					
DS_ID:16867 FS_ID:55013 EP_NO: 14802 Repair Type: Non-Urgent Crossing Status: Indicator Found UCIP Comments: 02/12/2019 Record has been updated from No Action Needed to Non-Urgent, need to request maintenance and inspection records to confirm condition of line through levee. Gas line marker previously located on the WS slope has been damaged, recommend replacing. Structure description has been updated based on the permit review of 14802 (dsid 16867) and 768 (dsid 25575). USACE PI issue references Permit No. 768 for this crossing correct Permit No. should be 14802. (O. Magana - DWR UCIP)04/11/2017 Crossing appears to be in good condition. (DWR Sutter Yard- AFreitag)10/10/2016 Crossing appears to be in good condition.(DWR Sutter Yard - afreitag)04/18/2016 Crossing appears in good condition. No noticeable issues to report.05/07/2015 Crossing is in good condition. No noticeable issues to report.11/12/2014 Same as last inspection.05/13/2014 Same as last inspection.10/30/2103 Same as last inspection.05/22/2013 Same as last inspection. FIELD_STRUCT_DESC: 4-inch steel gas line through the levee, 30-inches below the crown. Carsonite marker located on the waterside (WS) shoulder and on road, 200 feet east of levee crossing (4-inch line authorized under Permit No. 14802, 1987 - Pacific Gas and Electric Company [PG&E]; 4-inch line replaces previous 3.5-inch line authorized under Permit No. 768, 1939 - PG&E). FS Date: 2/12/2019 3:01:00 PM

Overview of levee section looking towards HWY 20.

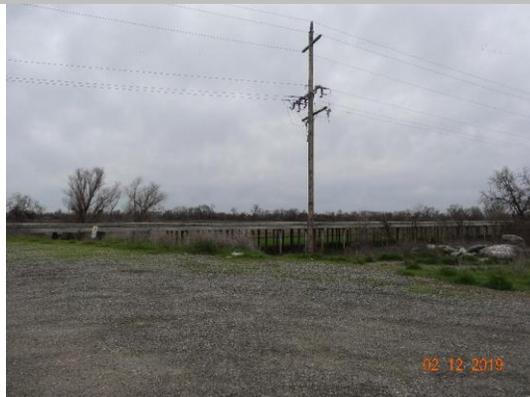
Photo 2 of 3 : UCIP_FA_2019_55013_78812.jpg

WS view: overview of crown.

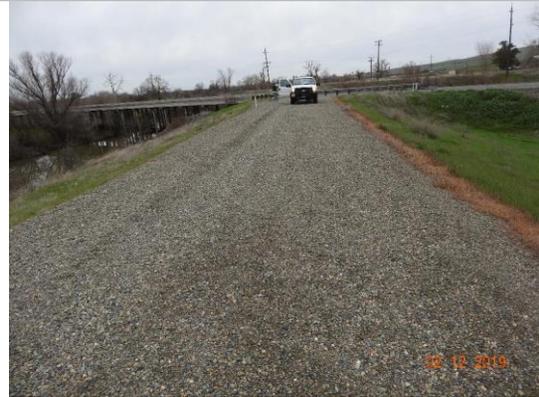
Photo 1 of 3 : UCIP_FA_2019_55983_78815.jpg

Comment Code					
Inspector Comment					
<p>DS_ID:16890 FS_ID:55983 EP_NO: 16850 Repair Type: Non-Urgent Crossing Status: Not Found UCIP Comments: 02/12/2019 Record has been updated from No Action Needed to Non-Urgent, modifications to the encroachment have been made since 2012. Unable to confirm if the line previously recorded in 2012 was removed or if a completely new line was added about 10-feet south of current location. Underground service alert (USA) flag recorded in 2012 shows AT&T line, permit indicates PT&T, and 2019 control box shows CVIC. Need to update permit with current owner. Need contact owner to clarify conduit alignment and modifications completed after 2012. (O. Magana - DWR UCIP)04/11/2017 Crossing appears to be in good condition. (DWR Sutter Yard- AFreitag)10/10/2016 Crossing appears to be in good condition.(DWR Sutter Yard - afreitag)04/18/2016 Crossing appears in good condition. No noticeable issues to report.05/07/2015 Crossing is in good condition. No noticeable issues to report.11/12/2014 Same as last inspection.05/13/2014 Same as last inspection.10/30/2103 Same as last inspection.05/22/2013 Same as last inspection. FIELD_STRUCT_DESC: 4-inch steel communications conduit through the levee, 4 feet below the crown. Design drawings available in permit. (4-inch line authorized under Permit No. 16850, 1998 - Pacific Bell; previous 4-inch line removed under Permit No. 13363 and 16647 in 1998). FS Date: 2/12/2019 3:01:00 PM</p>

Overview of levee crown at line crossing, photo 1 of 2.

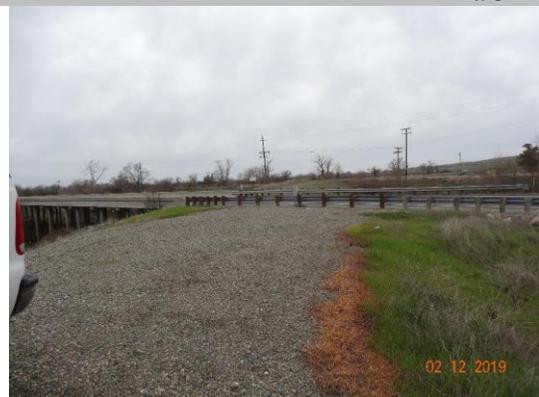
Photo 2 of 3 : UCIP_FA_2019_55983_78822.jpg

Overview of levee crown at line crossing, photo 2 of 2

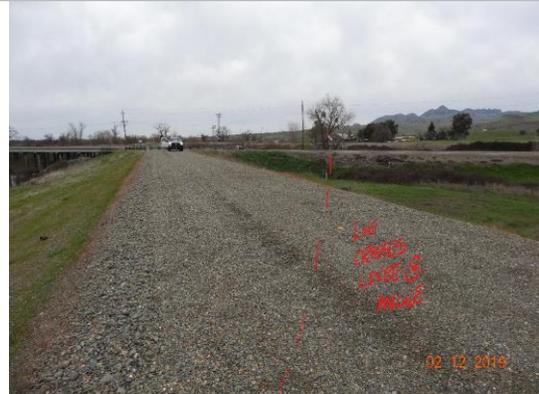
Photo 1 of 3 : UCIP_FA_2019_55017_78827.jpg

Comment Code					
Inspector Comment					
<p>DS_ID:16860 FS_ID:55017 EP_NO: 4795 Repair Type: Non-Urgent Crossing Status: Indicator Found UCIP Comments: 02/12/2019 Record has been updated from No Action Needed to Non-Urgent, need to contact owner to obtain maintenance records for crossing. Markers are present near levee to designate line alignment. (O. Magana - DWR UCIP)01/10/2019 Permit records indicate marker signs were to be placed over the gasoline in the bypass channel and in the levee section - confirm in the field. (O. Magana - DWR UCIP) 04/11/2017 Crossing appears to be in good condition. (DWR Sutter Yard- AFreitag)10/10/2016 Crossing appears to be in good condition.(DWR Sutter Yard - aFreitag)04/18/2016 Crossing appears in good condition. No noticeable issues to report.05/07/2015 Crossing is in good condition. No noticeable issues to report.11/12/2014 Same as last inspection.05/13/2014 Same as last inspection.05/22/2013 Same as last inspection.10/30/2103 Same as last inspection. FIELD_STRUCT_DESC: 10-inch steel gas line through the levee, 4 feet below the crown. Pipe is 0.375 inches thick and soil proofed. Pressure gas line goes through the left bank, under the channel of Sutter Bypass, and right bank. (10-inch line authorized under Permit No. 4795, 1965 - Pacific Gas and Electric Company [PG&E]). [Additional Reference(s): DWR Levee Log, 2005]. FS Date: 2/12/2019 3:02:00 PM</p>

LV crown: assumed gasoline alignment through levee (line goes through levee at an angle)

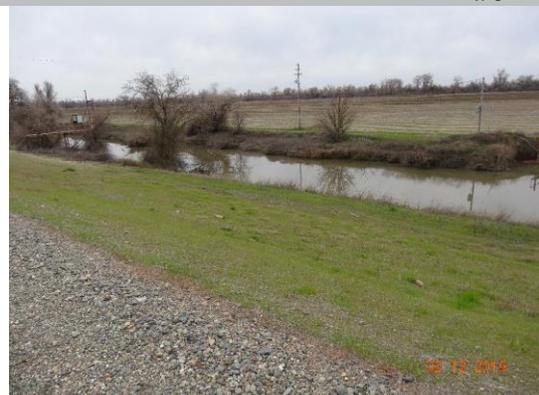
Photo 2 of 3 : UCIP_FA_2019_55017_78826.jpg

WS view: overview of WS. No visible marker found on WS.

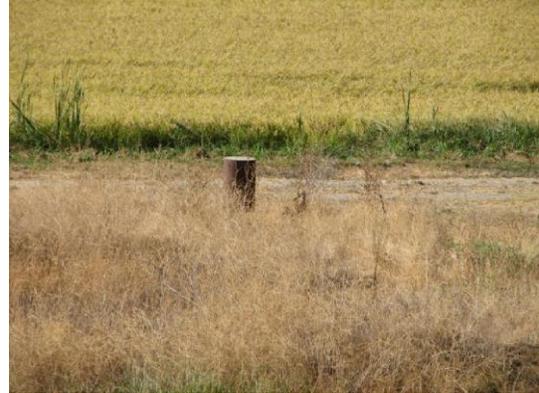
Photo 3 of 3 : UCIP_FA_2019_55017_65220.jpg

Comment Code					
Inspector Comment					
<p>DS_ID:16860 FS_ID:55017 EP_NO: 4795 Repair Type: Non-Urgent Crossing Status: Indicator Found UCIP Comments: 02/12/2019 Record has been updated from No Action Needed to Non-Urgent, need to contact owner to obtain maintenance records for crossing. Markers are present near levee to designate line alignment. (O. Magana - DWR UCIP)01/10/2019 Permit records indicate marker signs were to be placed over the gasoline in the bypass channel and in the levee section - confirm in the field. (O. Magana - DWR UCIP) 04/11/2017 Crossing appears to be in good condition. (DWR Sutter Yard- AFreitag)10/10/2016 Crossing appears to be in good condition.(DWR Sutter Yard - afreitag)04/18/2016 Crossing appears in good condition. No noticeable issues to report.05/07/2015 Crossing is in good condition. No noticeable issues to report.11/12/2014 Same as last inspection.05/13/2014 Same as last inspection.05/22/2013 Same as last inspection.10/30/2103 Same as last inspection. FIELD_STRUCT_DESC: 10-inch steel gas line through the levee, 4 feet below the crown. Pipe is 0.375 inches thick and soil proofed. Pressure gas line goes through the left bank, under the channel of Sutter Bypass, and right bank. (10-inch line authorized under Permit No. 4795, 1965 - Pacific Gas and Electric Company [PG&E]). [Additional Reference(s): DWR Levee Log, 2005]. FS Date: 2/12/2019 3:02:00 PM</p>

Possible vent on WS across channel.

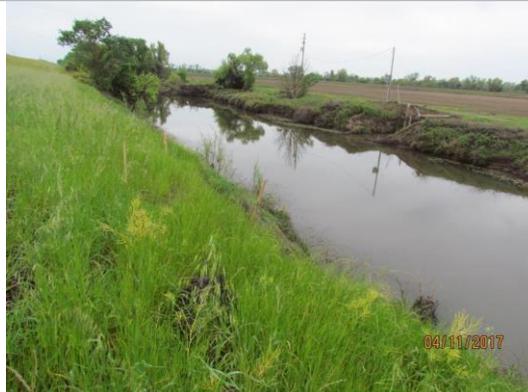
Photo 1 of 1 : FA_2019_ST0002_450_42_20190822_00009.jpg

LM Start	0.36	Rating **	M	Issue No.	42
LM End	0.36	Issue Type +	Ma	Location *	WS
Category	Earthen Levee			GPS Latitude/Longitude	
				Start	End
Item	Erosion / Bank Caving			39.147183 °	39.147183 °
				-121.828142 °	-121.828142 °
DWR ID	DWR_ST0002_01_s_2017_42				
Comment Code					
E2 : Schedule repair of erosion site prior to the next inspection.					
Inspector Comment					
Repair the erosion along the waterside toe.

View of the erosion along the waterside toe.

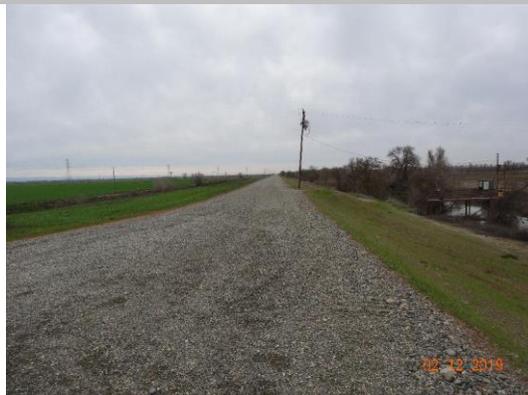
Photo 1 of 3 : UCIP_FA_2019_55986_78829.jpg

Comment Code					
Inspector Comment					
<p>DS_ID:16861 FS_ID:55986 EP_NO: 1890 Repair Type: Non-Urgent Crossing Status: Found UCIP Comments: 02/12/2019 Record has been updated from No Action Needed to Non-Urgent, need to obtain records for the May 2005 emergency repair and current owner. No issues were observed on levee or slopes. (O. Magana - DWR UCIP)04/11/2017 Crossing appears to be in good condition.10/10/2016 Crossing appears to be in good condition.(DWR Sutter Yard - afreitag)04/18/2016 Crossing appears in good condition. No noticeable issues to report.05/07/2015 Crossing is in good condition. No noticeable issues to report.11/12/2014 Same as last inspection.05/13/2014 Same as last inspection.10/30/2103 Same as last inspection.05/22/2013 Same as last inspection.10/08/2012 Old pipe appears to have been removed FIELD_STRUCT_DESC: 18-inch steel irrigation pipe through the levee, 3.8 feet below the crown. Vertical pump and gate valve mounted on a steel structure located on the waterside (WS). Siphon breaker on the landside (LS) shoulder. 36-inch concrete riser unit in field on the LS. (18-inch pipe authorized under Permit No. 1890, 1959 - T. S. Madden). Emergency repair requested May 8, 2005, for replacement of existing pipe with 18-inch steel tar coated pipe. [Additional Reference(s): DWR Levee Log, 2005]. FS Date: 2/12/2019 3:03:00 PM</p>

Overview of levee crown looking at crossing, photo taken u/s.

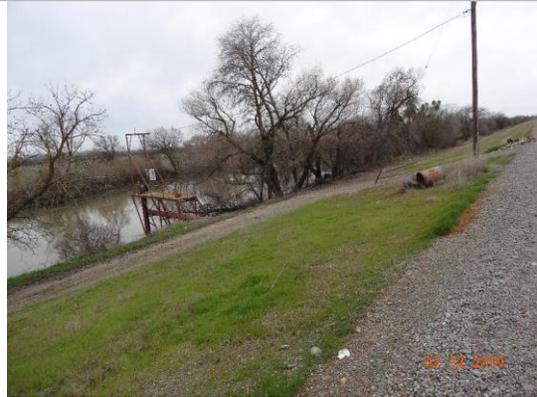
Photo 2 of 3 : UCIP_FA_2019_55020_78842.jpg

Comment Code						
Inspector Comment						
<p>DS_ID:16862 FS_ID:55020 EP_NO: 10932 Repair Type: Non-Urgent Crossing Status: Found UCIP Comments: 02/12/2019 Record remains Non-Urgent due to maintenance issue. Need to contact owner to notify of the maintenance issue with the CMP riser. If crossing is no longer in use owner will need to coordinate with the CVFPB for proper removal or abandonment. (O. Magana - DWR UCIP)04/11/2017 Riser knocked out of place on WS shoulder and no sign of the siphon breaker. Suspect it was buried. (DWR Sutter Yard- AFreitag)10/10/2016 WS CMP riser is still knocked out of place and siphon breaker is suspected to be buried.(DWR Sutter Yard - aFreitag)04/18/2016 CMP riser is still knocked out of place and a siphon breaker cannot be found.05/07/2015 24in. cmp riser and siphon breaker were not found on the WS shoulder.11/12/2014 Same as last inspection.05/13/2014 Same as last inspection.10/30/2013 24in. cmp riser was pulled out of levee and there is no sign of a siphon breaker on WS shoulder.05/22/2013 24in. cmp riser on WS shoulder is full of garbage and dirt and should be cleaned out to inspect siphon breaker.10/08/2012 Pier has no walkway to access pump on pier. This is not necessarily an issue. FIELD_STRUCT_DESC: 16-inch coated steel irrigation pipe through the levee, 6.3 feet below the crown. Vertical pump mounted on a steel structure on the bank. Siphon breaker in a 24-inch corrugated metal pipe riser on the waterside (WS) slope. Concrete distribution box on the landside (LS). Power and communication joint pole (JP) on the WS shoulder. Original equipment in O&M. Hand drawings available in permit. (Original 16-inch O&M pipe removed in 1975 and replaced with a 16-inch pipe under Permit No. 10932, 1976 - Edward Nall) [Additional Reference(s): DWR Levee Log, 2005. USACE Sacramento O&M Manual 315, May 1953 (Station 1094+80)]. FS Date: 2/12/2019 3:03:00 PM</p>

WS view: overview of WS, photo taken d/s looking u/s towards crossing.

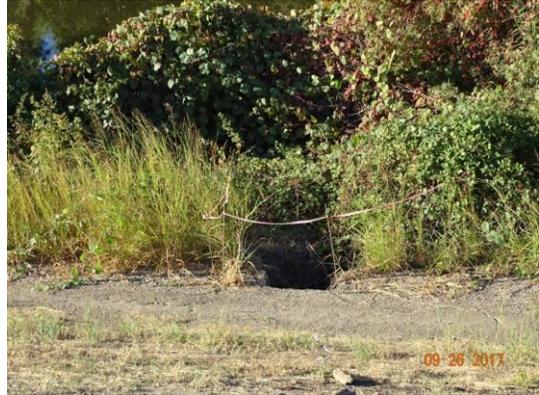
Photo 1 of 1 : FA_2019_ST0002_450_57_20190822_00014.jpg

LM Start	1.53	Rating **	U	Issue No.	57
LM End	1.53	Issue Type +	Ma	Location *	WS
Category	Earthen Levee			GPS Latitude/Longitude	
				Start	End
Item	Erosion / Bank Caving			39.137373°	39.137373°
				-121.810382°	-121.810382°
DWR ID	DWR_ST0002_01_f_2017_57				
Comment Code					
E2 : Schedule repair of erosion site prior to the next inspection.					
Inspector Comment					
Repair the beaver hole along the waterside berm.

View of the beaver hole along the waterside berm.

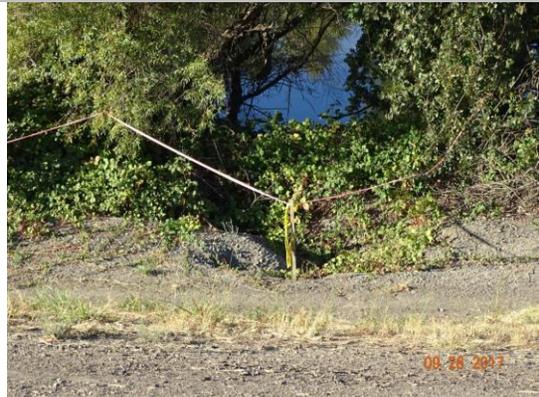
Photo 1 of 1 : FA_2019_ST0002_450_58_20190822_00015.jpg

LM Start	1.57	Rating **	U	Issue No.	58
LM End	1.57	Issue Type +	Ma	Location *	WS
Category	Earthen Levee			GPS Latitude/Longitude	
				Start	End
Item	Erosion / Bank Caving			39.137010°	39.137010°
				-121.809673°	-121.809673°
DWR ID	DWR_ST0002_01_f_2017_58				
Comment Code					
E2 : Schedule repair of erosion site prior to the next inspection.					
Inspector Comment					
Repair the beaver hole along the waterside berm.

View of the beaver hole along the waterside berm.

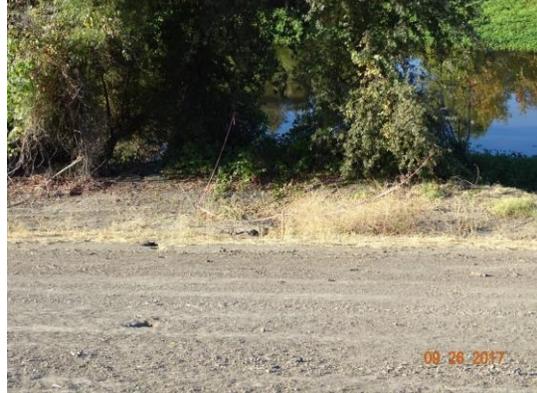
Photo 1 of 1 : FA_2019_ST0002_450_61_20190822_00016.jpg

LM Start	1.61	Rating **	U	Issue No.	61
LM End	1.61	Issue Type +	Ma	Location *	WS
Category	Earthen Levee			GPS Latitude/Longitude	
				Start	End
Item	Erosion / Bank Caving			39.136713°	39.136713°
				-121.809202°	-121.809202°
DWR ID	DWR_ST0002_01_f_2017_61				
Comment Code					
E2 : Schedule repair of erosion site prior to the next inspection.					
Inspector Comment					
Repair the beaver hole along the waterside berm.

View of the beaver hole along the waterside berm.

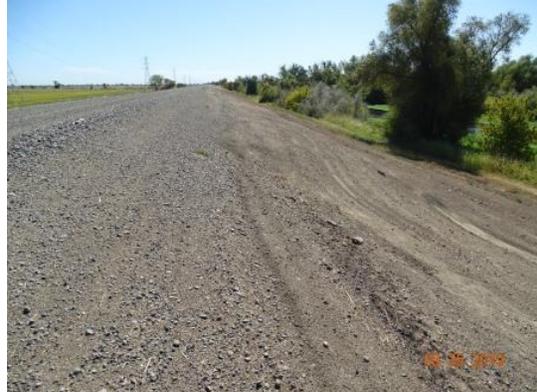
Photo 1 of 1 : FA_2019_ST0002_450_51_20190926_00086.jpg

LM Start	2.32	Rating **	A/W	Issue No.	51
LM End	2.32	Issue Type +	Ma	Location *	WS
Category	Earthen Levee			GPS Latitude/Longitude	
				Start	End
Item	Crown Surface / Depressions / Rutting			39.130704°	39.130704°
				-121.798381°	-121.798381°
DWR ID	DWR_ST0002_01_f_2019_51				
Comment Code					
C2 : Repair depressions or ruts in the crown or slope.					
Inspector Comment

View of the depression on the waterside slope. Fall 2019.

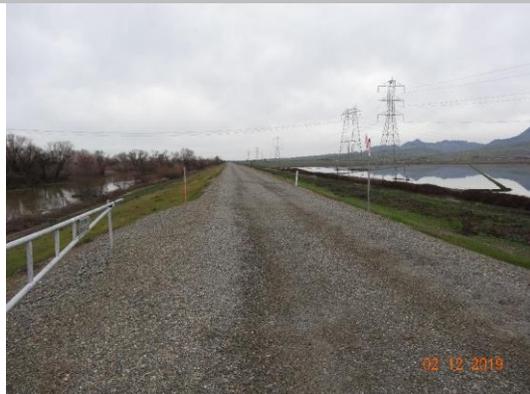
Photo 1 of 3 : UCIP_FA_2019_55023_78848.jpg

Comment Code					
Inspector Comment					
DS_ID:16864 FS_ID:55023 EP_NO: 3890 Repair Type: Non-Urgent Crossing Status: Indicator Found UCIP Comments: 02/12/2019 Record has been updated from No Action Needed to Non-Urgent, no records were made available to determine integrity of line through the levee. Need to contact owner to determine status of crossing. (O. Magana - DWR UCIP)04/11/2017 Crossing appears to be in good condition. (DWR Sutter Yard - AFreitag)10/10/2016 Crossing appears to be in good condition.(DWR Sutter Yard - afreitag)04/18/2016 Crossing appears in good condition. No noticeable issues to report.05/07/2015 Crossing is in good condition. No noticeable issues to report.11/12/2014 Same as last inspection.05/13/2014 Same as last inspection.10/30/2103 Same as last inspection.05/22/2013 Same as last inspection. FIELD_STRUCT_DESC: 10.75-inch steel gas pipeline through the levee, 2.6 feet below the crown. Gas line markers located on the landside (LS) and the waterside (WS) toes. Gas valve in steel riser unit on the LS toe at edge of canal. Line crosses the channel and goes through both Sutter Bypass levees. Design drawings available. (10.75-inch line authorized under Permit No. 3890, 1962 - Pacific Gas and Electric Company [PG&E]). [Additional Reference(s): DWR Levee Log, 2005]. FS Date: 2/12/2019 3:04:00 PM

Overview of levee crown, photo taken d/s looking u/s towards crossing.

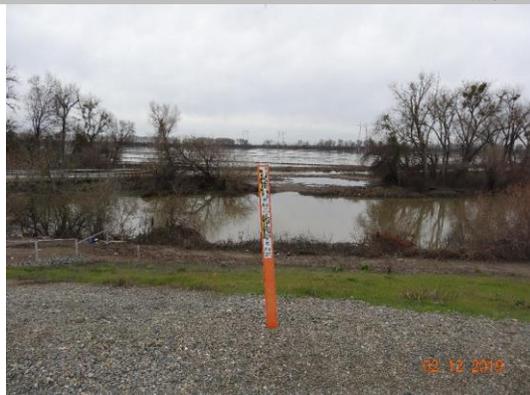
Photo 2 of 3 : UCIP_FA_2019_55023_78851.jpg

WS view: marker located on WS shoulder. Markers photographed in 2012 are no longer present.

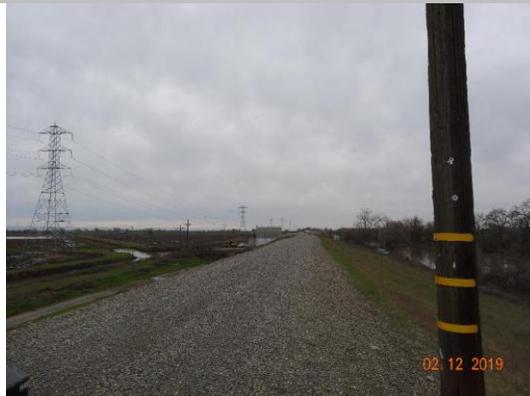
Photo 1 of 3 : UCIP_FA_2019_55218_78856.jpg

Comment Code					
Inspector Comment					
<p>DS_ID:16880 FS_ID:55218 EP_NO: N/A Repair Type: Non-Urgent Crossing Status: Found UCIP Comments: 02/12/2019 Record has been updated from No Action Needed to Non-Urgent, no permit has been identified authoring this pump station. Pumping Plant No. 3 is an active plant that has been converted to a gravity drainage system. This structure is operated and maintained by DWR Sutter Yard. No permit is available for this structure. (O. Magana - DWR UCIP)01/11/2019 Record has been updated to show pumping plant is still in use and not abandoned. (O. Magana - DWR UCIP) 04/11/2017 Not abandoned. good condition. (DWR Sutter Yard-AFreitag)10/10/2016 NOT ABANDONED. The old pumping plant was removed but the culverts are still used as a gravity drain to regulate the water level in the LS ditch.(DWR Sutter Yard - aFreitag)04/18/2016 Crossing is in good condition. The culvert is not abandoned and is used as gravity drain for the LS ditch into the bypass channel.05/07/2015 Concrete culverts are still being used as gravity drains for the LS ditch.11/12/2014 Same as last inspection.05/13/2014 Same as last inspection.10/30/2103 Same as last inspection.05/22/2013 Concrete culvert is being used as gravity drain for LS ditch.10/08/2012 Flap gates left in open position. Unable to determine type of abandonment for concrete culverts. Contact inspector to determine type of abandonment. FIELD_STRUCT_DESC: [Pumping Plant No. 3] 1 of 2: 48-inch by 72-inch reinforced concrete drainage culvert through the levee, 30 feet below the crown. Slide gate in concrete well on the landside (LS) shoulder. Wood flap gate and concrete headwall on the waterside (WS) end. Abandoned State pumping plant on the LS. [Additional Reference(s): DWR Levee Log, 2005. USACE Sacramento O&M Manual 315, May 1953 (Station 966+30)]. FS Date: 2/12/2019 3:05:00 PM</p>

Overview of levee crown looking towards pumping station.

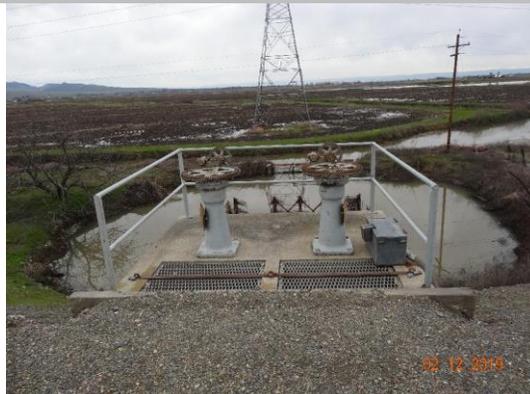
Photo 2 of 3 : UCIP_FA_2019_55218_78857.jpg

LS view: slide gate valves located on LS shoulder.

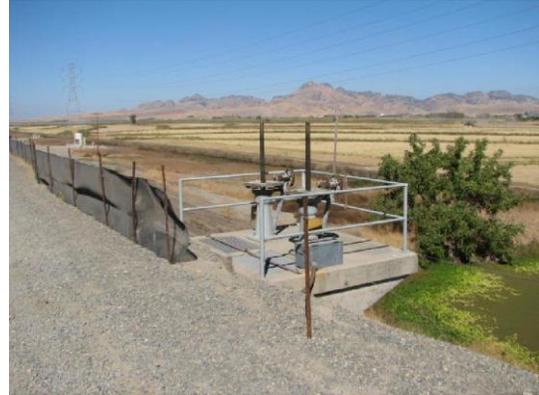
Photo 3 of 3 : UCIP_FA_2019_55218_64815.jpg

Slide gates on LS shoulder.

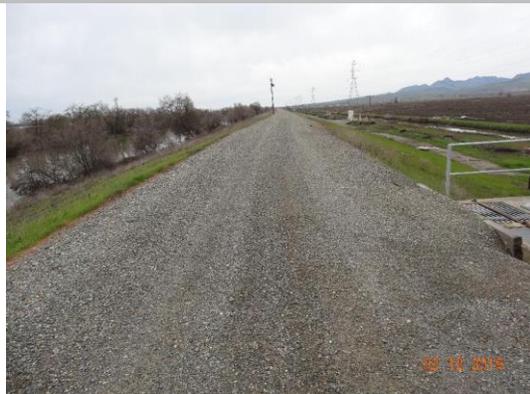
Photo 2 of 3 : UCIP_FA_2019_55219_78866.jpg

Comment Code					
Inspector Comment					
<p>DS_ID:16895 FS_ID:55219 EP_NO: N/A Repair Type: Non-Urgent Crossing Status: Found UCIP Comments: 02/12/2019 Record has been updated from No Action Needed to Non-Urgent, no permit has been identified authoring this pump station. Pumping Plant No. 3 is an active plant that has been converted to a gravity drainage structure. Structure is operated and maintained by DWR Sutter Yard. No permit has been identified for this structure. (O. Magana - DWR UCIP)01/11/2019 Record has been updated to show pumping plant is still in use and not abandoned. (O. Magana - DWR UCIP) 04/11/2017 Not abandoned. Good condition. (DWR Sutter Yard-AFreitag)10/10/2016 NOT ABANDONED. The old pumping plant was removed but the culverts are still used as a gravity drain to regulate the water level in the LS ditch. (DWR Sutter Yard - aFreitag)04/18/2016 Crossing is in good condition. The culvert is not abandoned and is used as gravity drain for the LS ditch into the bypass channel.05/07/2015 Concrete culverts still being used as gravity drains for LS ditch.11/12/2014 Same as last inspection.05/13/2014 Same as last inspection.10/30/2103 Same as last inspection.05/22/2013 Concrete culvert is being used as gravity drain for LS ditch.10/08/2012 Flap gates in open position. Need to determine type of abandonment. Contact inspector to determine abandonment. FIELD_STRUCT_DESC: [Pumping Plant No. 3] 2 of 2: 48-inch by 72-inch reinforced concrete drainage culvert through the levee, 30 feet below the crown. Slide gate in concrete well on the landside (LS) shoulder. Wood flap gate and concrete headwall on the waterside (WS) end. Abandoned State pumping plant on the LS. [Additional Reference(s): DWR Levee Log, 2005. USACE Sacramento O&M Manual 315, May 1953 (Station 966+30)]. FS Date: 2/12/2019 3:06:00 PM</p>

Overview of levee crown, photo taken at crossings looking u/s.

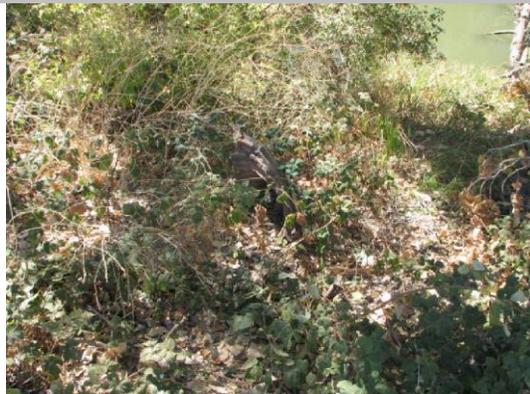
Photo 1 of 3 : UCIP_FA_2019_55998_65211.jpg

Pipe debris near WS creek bank.

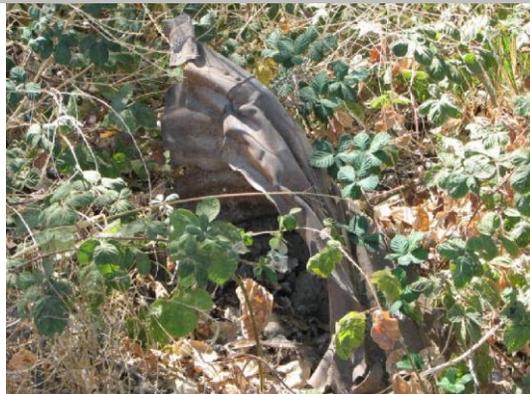
Photo 2 of 3 : UCIP_FA_2019_55998_65210.jpg

Pipe debris near WS creek bank.

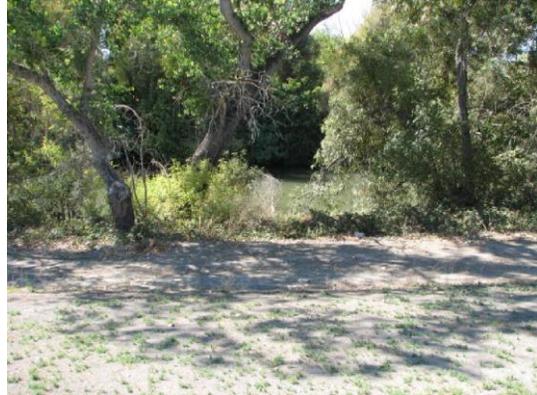
Photo 3 of 3 : UCIP_FA_2019_55998_65209.jpg

Location of pipe debris near base of cottonwood at center of picture.

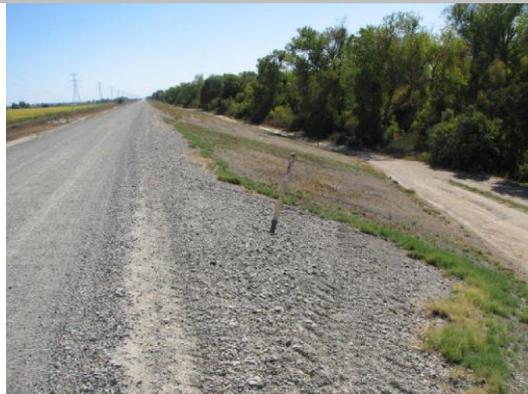
Photo 1 of 3 : UCIP_FA_2019_55238_65213.jpg

Gasline marker on WS shoulder.

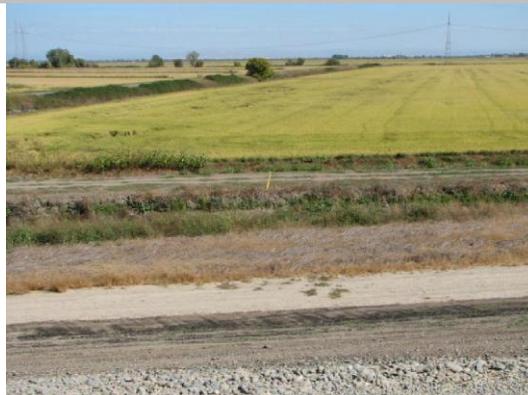
Photo 2 of 3 : UCIP_FA_2019_55238_65212.jpg

Gasline marker on LS toe east of ditch.

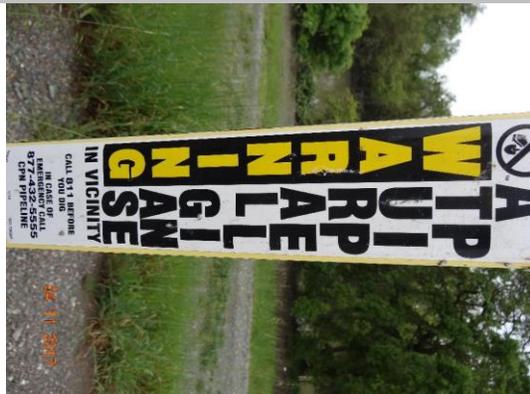
Photo 3 of 3 : UCIP_FA_2019_55238_76970.jpg

Close up of marker

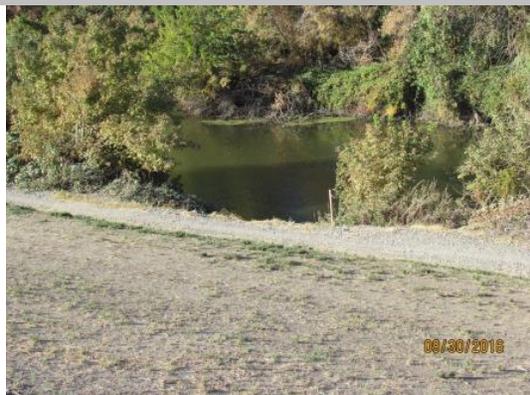
Photo 1 of 1 : FA_2019_ST0002_450_34_20190822_00007.jpg

View of the erosion along the waterside toe.

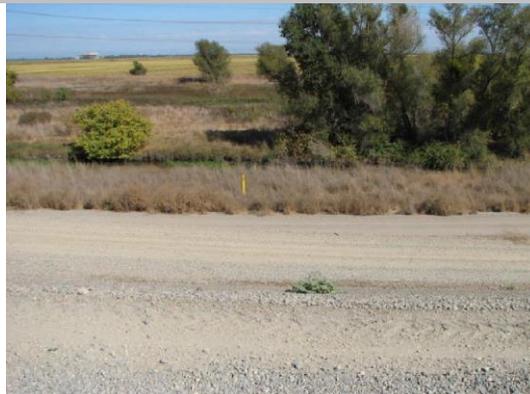
Photo 1 of 3 : UCIP_FA_2019_55241_65217.jpg

Gasline markers on LS toe .

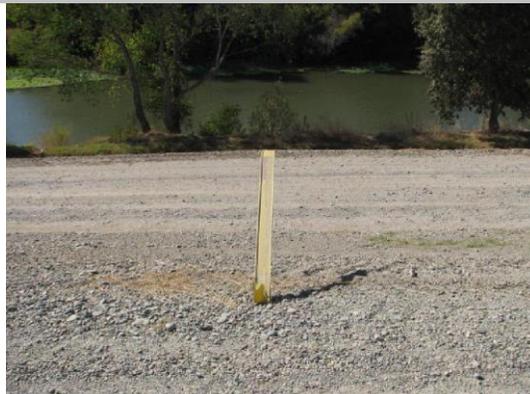
Photo 2 of 3 : UCIP_FA_2019_55241_65216.jpg

Gasline markers on WS shoulder.

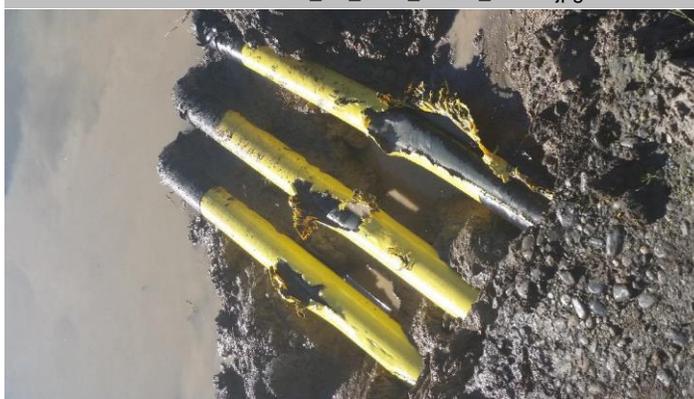
Photo 3 of 3 : UCIP_FA_2019_55241_74958.jpg

Damaged gas lines at the WS berm.

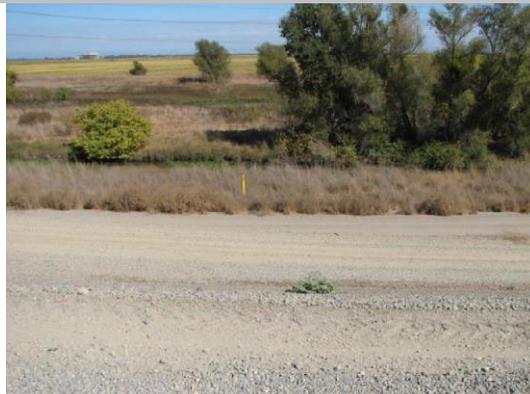
Photo 1 of 3 : UCIP_FA_2019_55242_65219.jpg

Gasline markers on LS toe.

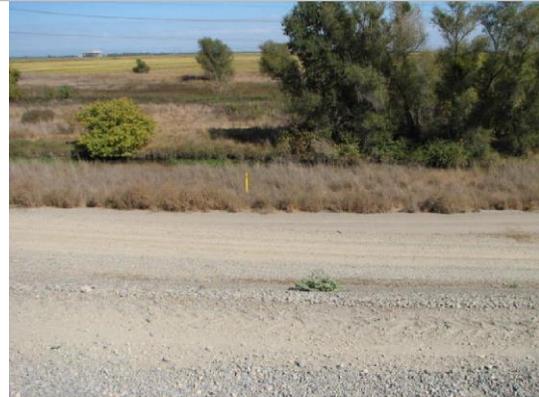
Photo 1 of 3 : UCIP_FA_2019_55243_65224.jpg

Gasline markers on LS toe.

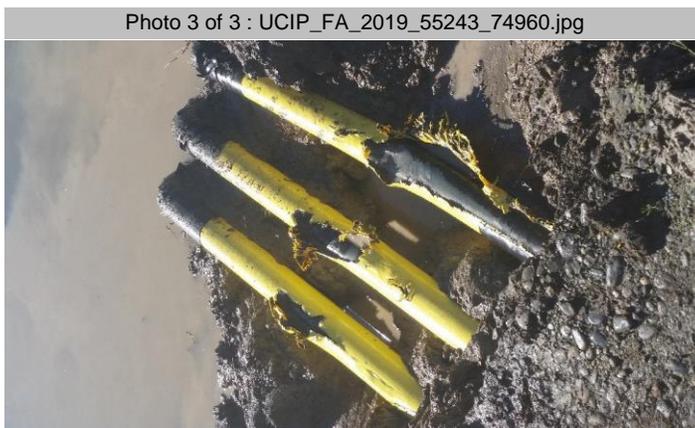
Damaged gas lines at WS berm.

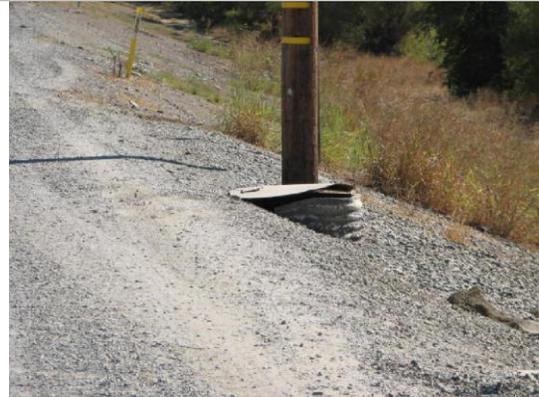
Photo 1 of 3 : UCIP_FA_2019_55275_65264.jpg

Siphon breaker in 36-inch CMP riser on WS shoulder. Pipe visible at siphon breaker.

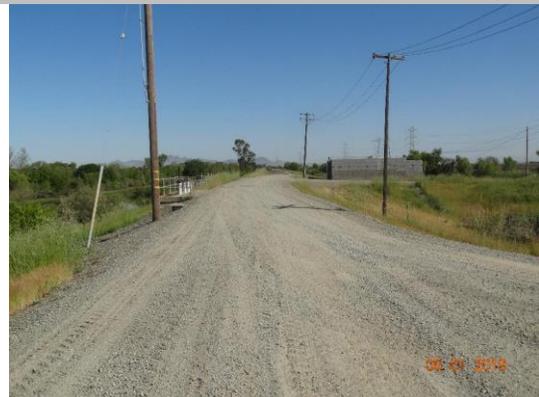
Photo 2 of 3 : UCIP_FA_2019_55275_81420.jpg

Overview of levee crown looking u/s towards pipe crossing, photo 1 of 2.

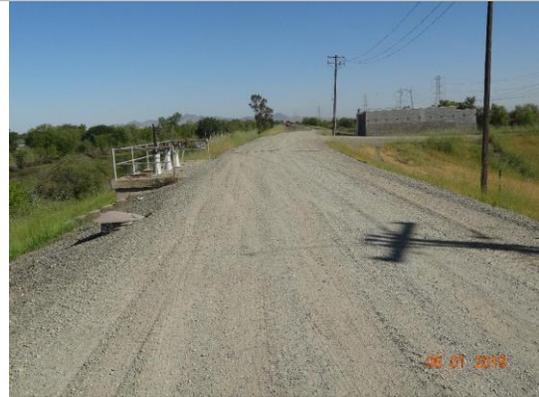
Photo 3 of 3 : UCIP_FA_2019_55275_81421.jpg

Overview of levee crown looking u/s towards pipe crossing, photo 2 of 2.

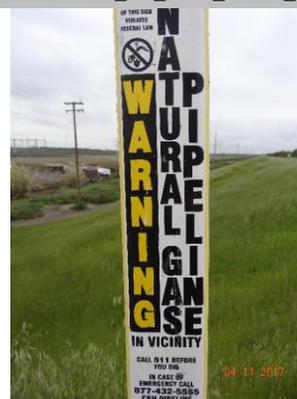
Photo 3 of 3 : UCIP_FA_2019_55276_76971.jpg

Close up of marker

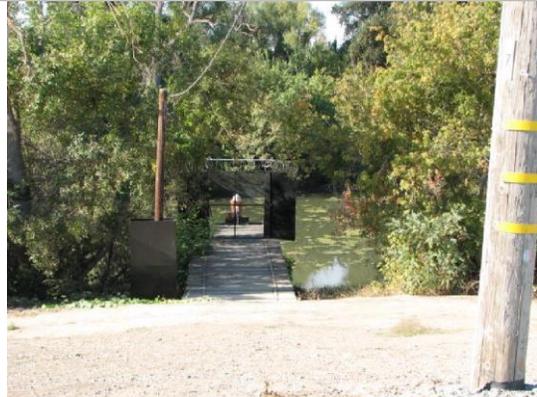
Photo 1 of 3 : UCIP_FA_2019_55278_65302.jpg

Pump on Pier on WS toe.

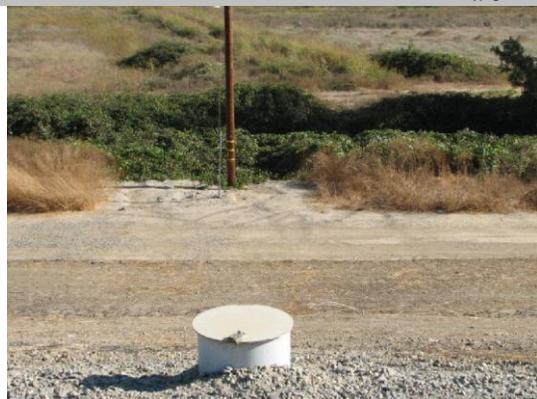
Photo 2 of 3 : UCIP_FA_2019_55278_65301.jpg

Siphon Breaker in 16-inch steel riser on LS shoulder.

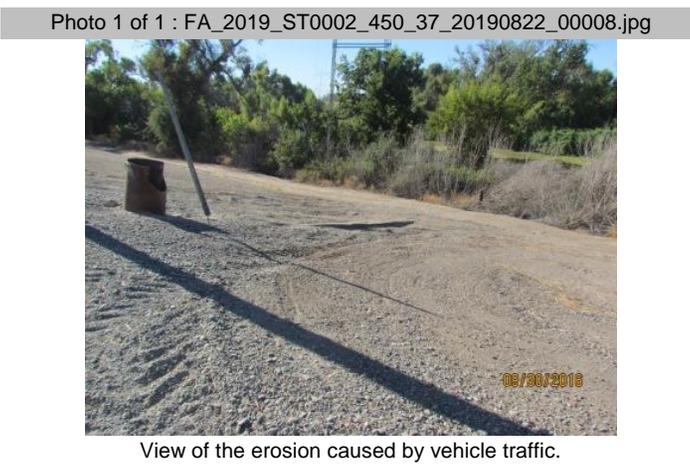
LM Start	14.71	Rating **	M	Issue No.	37
LM End	14.71	Issue Type +	Ma	Location *	WS
Category	Earthen Levee			GPS Latitude/Longitude	
				Start	End
Item	Slope Stability			38.979389 °	38.979389 °
				-121.691923 °	-121.691923 °
DWR ID	DWR_ST0002_01_f_2016_37				
Comment Code					
S3 : Repair the levee slope damaged by vehicle traffic and prevent access where possible.					
Inspector Comment

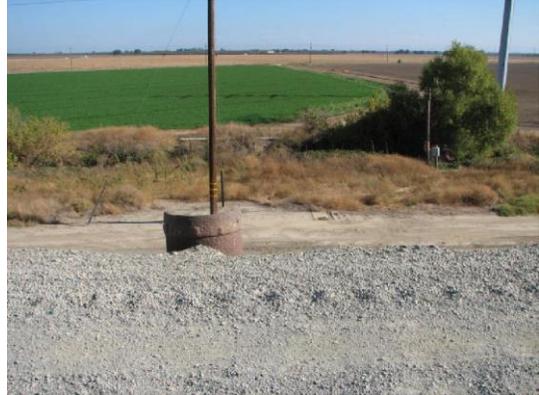
Photo 2 of 3 : UCIP_FA_2019_55280_65313.jpg

Steel riser on LS shoulder.

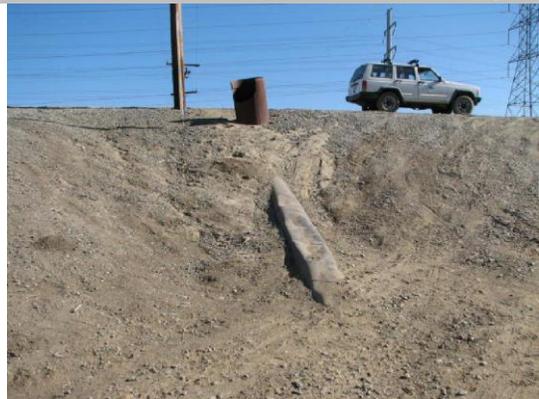
Photo 3 of 3 : UCIP_FA_2019_55280_65312.jpg

Crushed pipe on WS slope.

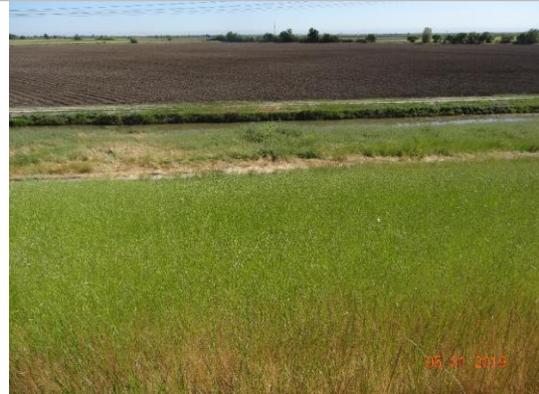
Photo 3 of 3 : UCIP_FA_2019_55281_81459.jpg

LS view: overview of LS where pipe should be.

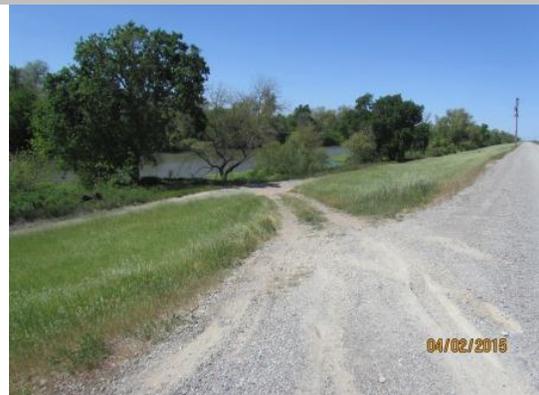
Photo 1 of 2 : FA_2019_ST0002_450_21_20190822_00002.jpg

View of the vehicle erosion along the waterside slope.

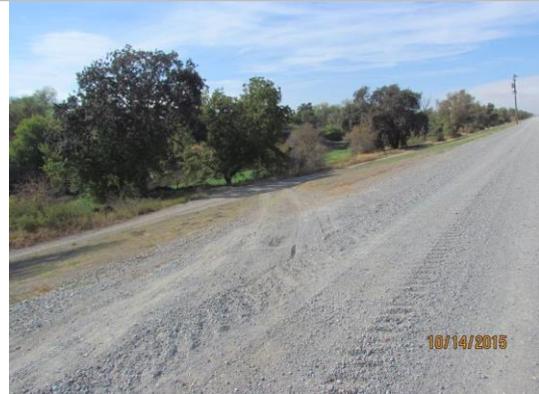
Photo 2 of 2 : FA_2019_ST0002_450_21_20190822_00003.jpg

View of the vehicle erosion along the waterside slope.

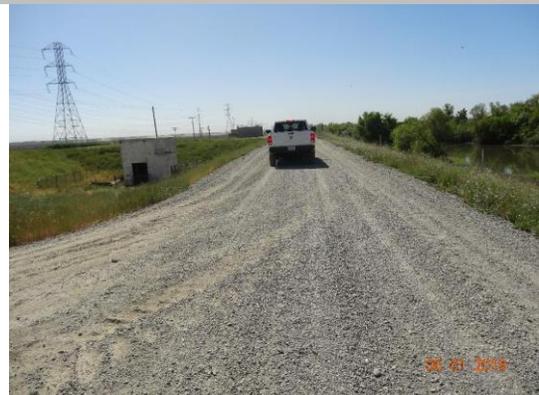
Photo 1 of 3 : UCIP_FA_2019_55284_81467.jpg

Overview of levee crown looking d/s towards where crossing should be.

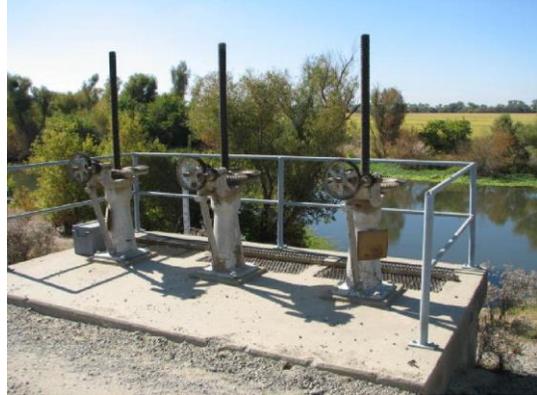
Photo 2 of 3 : UCIP_FA_2019_55287_65332.jpg

Slide gates on WS shoulder.

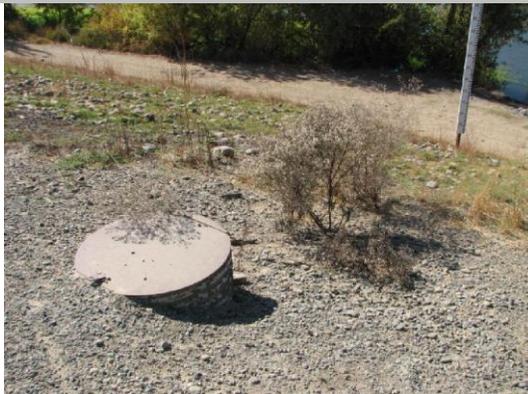
Photo 1 of 3 : UCIP_FA_2019_55288_65334.jpg

36-inch CMP riser on WS shoulder.

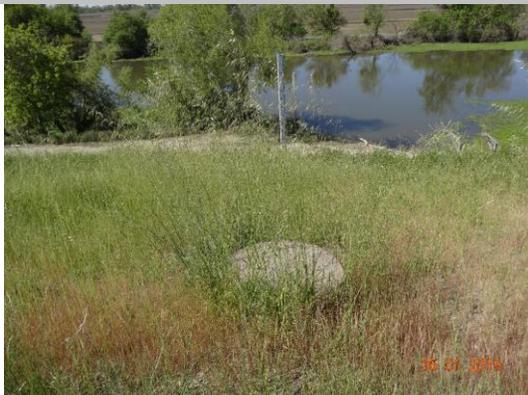
Photo 2 of 3 : UCIP_FA_2019_55288_81497.jpg

WS side: riser cover visible through dense vegetation.

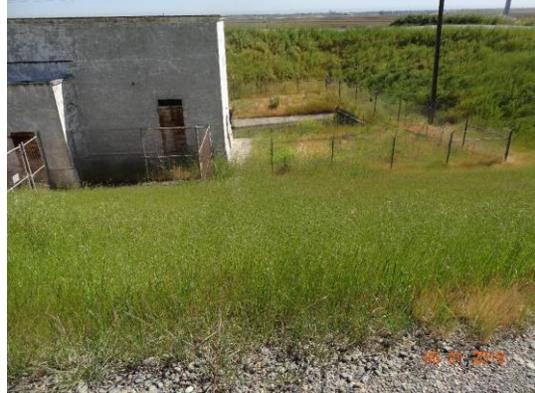
Photo 3 of 3 : UCIP_FA_2019_55288_81498.jpg

LS view: overview of where pipe should be. No signs were found of pipe.

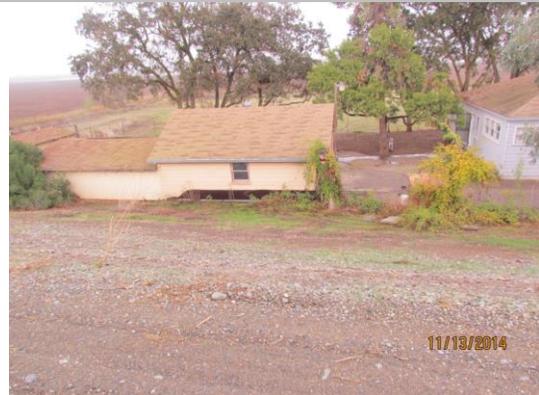
Photo 1 of 1 : FA_2019_ST0002_450_10_20190822_00001.jpg

View of the house next to the toe of the levee.
