**Flood Control Project Maintenance
Levee Inspections**
LMA District Cover Sheet
Spring 2020 Levee Inspection Results

Sutter Maintenance Yard East Levee Sutter Bypass

Spring 2020 Levee Inspection Results

Waterway	Bank	Unit Miles
Unit No. 01 Sutter Bypass Levee	Left	21.68

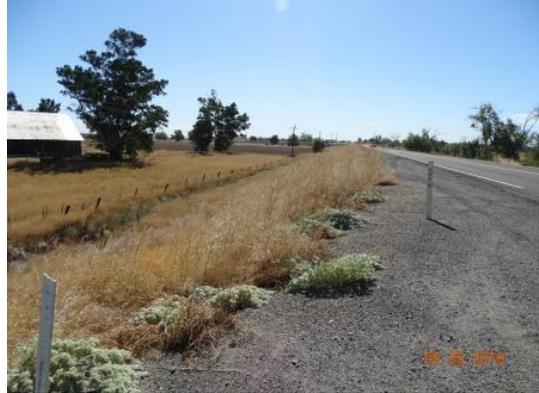
Photo 1 of 1 : SP_2020_ST0002_450_48_20200226_00011.jpg

View of the vegetation along the landside slope. Fall 2019.

LM Start	0.00	Rating **	U	Issue No.	47
LM End	0.25	Issue Type +	Ma	Location *	WS
Category	Earthen Levee		GPS Latitude/Longitude		
			Start	End	
Item	Vegetation		39.151291 °	39.148212 °	
			-121.832110 °	-121.829759 °	
DWR ID	DWR_ST0002_01_f_2019_47				
Comment Code					
V1 : Control annual grass and weeds on the levee slopes and easements.					
Inspector Comment

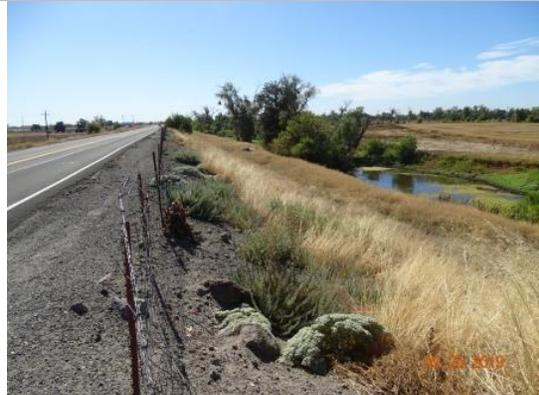
Photo 1 of 1 : SP_2020_ST0002_450_47_20200226_00010.jpg

View of the vegetation along the waterside slope. Fall 2019.

LM Start	0.00	Rating **	M	Issue No.	54
LM End	0.25	Issue Type +	En	Location *	WS
Category	Earthen Levee		GPS Latitude/Longitude		
			Start	End	
Item	Encroachments		39.151291 °	39.148212 °	
			-121.832110 °	-121.829759 °	
DWR ID	DWR_ST0002_01_f_2019_54				
Comment Code					
FE : Fence					
Inspector Comment

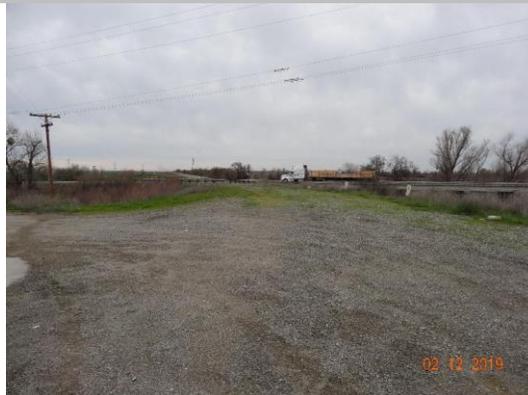
Photo 1 of 3 : UCIP_SP_2020_55013_78814.jpg

Comment Code					
Inspector Comment					
<p>DS_ID:16867 FS_ID:55013 EP_NO: 14802 Repair Type: Non-Urgent Crossing Status: Indicator Found UCIP Comments: 02/12/2019 Record has been updated from No Action Needed to Non-Urgent, need to request maintenance and inspection records to confirm condition of line through levee. Gas line marker previously located on the WS slope has been damaged, recommend replacing. Structure description has been updated based on the permit review of 14802 (dsid 16867) and 768 (dsid 25575). USACE PI issue references Permit No. 768 for this crossing correct Permit No. should be 14802. (O. Magana - DWR UCIP)04/11/2017 Crossing appears to be in good condition. (DWR Sutter Yard- AFreitag)10/10/2016 Crossing appears to be in good condition.(DWR Sutter Yard - afreitag)04/18/2016 Crossing appears in good condition. No noticeable issues to report.05/07/2015 Crossing is in good condition. No noticeable issues to report.11/12/2014 Same as last inspection.05/13/2014 Same as last inspection.10/30/2103 Same as last inspection.05/22/2013 Same as last inspection. FIELD_STRUCT_DESC: 4-inch steel gas line through the levee, 30-inches below the crown. Carsonite marker located on the waterside (WS) shoulder and on road, 200 feet east of levee crossing (4-inch line authorized under Permit No. 14802, 1987 - Pacific Gas and Electric Company [PG&E]; 4-inch line replaces previous 3.5-inch line authorized under Permit No. 768, 1939 - PG&E). FS Date: 2/12/2019 3:01:00 PM</p>

Overview of levee section looking towards HWY 20.

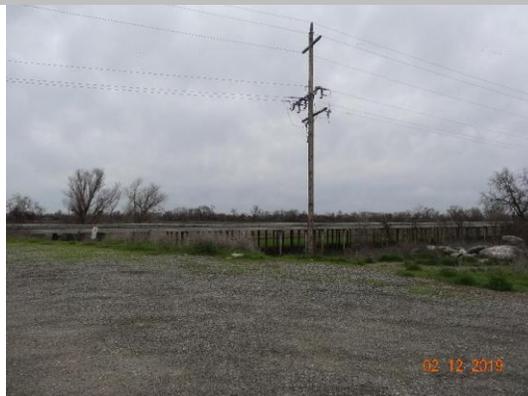
Photo 2 of 3 : UCIP_SP_2020_55013_78812.jpg

WS view: overview of crown.

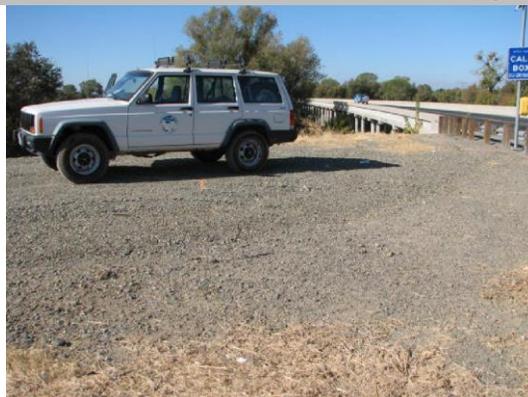
Photo 3 of 3 : UCIP_SP_2020_55983_64778.jpg

Alignment painted on gravel at door of jeep.

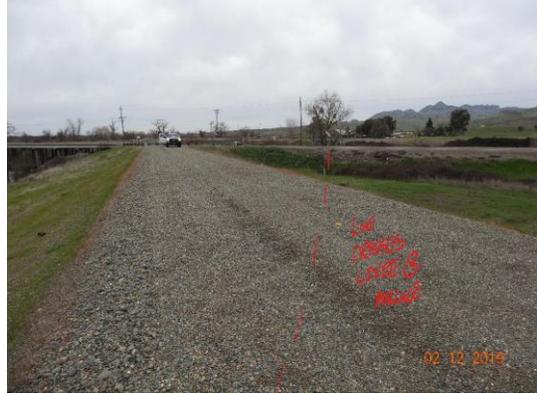
Photo 1 of 3 : UCIP_SP_2020_55017_78827.jpg

Comment Code					
Inspector Comment					
<p>DS_ID:16860 FS_ID:55017 EP_NO: 4795 Repair Type: Non-Urgent Crossing Status: Indicator Found UCIP Comments: 02/12/2019 Record has been updated from No Action Needed to Non-Urgent, need to contact owner to obtain maintenance records for crossing. Markers are present near levee to designate line alignment. (O. Magana - DWR UCIP)01/10/2019 Permit records indicate marker signs were to be placed over the gasoline in the bypass channel and in the levee section - confirm in the field. (O. Magana - DWR UCIP) 04/11/2017 Crossing appears to be in good condition. (DWR Sutter Yard- AFreitag)10/10/2016 Crossing appears to be in good condition.(DWR Sutter Yard - afreitag)04/18/2016 Crossing appears in good condition. No noticeable issues to report.05/07/2015 Crossing is in good condition. No noticeable issues to report.11/12/2014 Same as last inspection.05/13/2014 Same as last inspection.05/22/2013 Same as last inspection.10/30/2103 Same as last inspection. FIELD_STRUCT_DESC: 10-inch steel gas line through the levee, 4 feet below the crown. Pipe is 0.375 inches thick and soil proofed. Pressure gas line goes through the left bank, under the channel of Sutter Bypass, and right bank. (10-inch line authorized under Permit No. 4795, 1965 - Pacific Gas and Electric Company [PG&E]). [Additional Reference(s): DWR Levee Log, 2005 (HLM 0.34)]. FS Date: 2/12/2019 3:02:00 PM</p>

LV crown: assumed gasoline alignment through levee (line goes through levee at an angle)

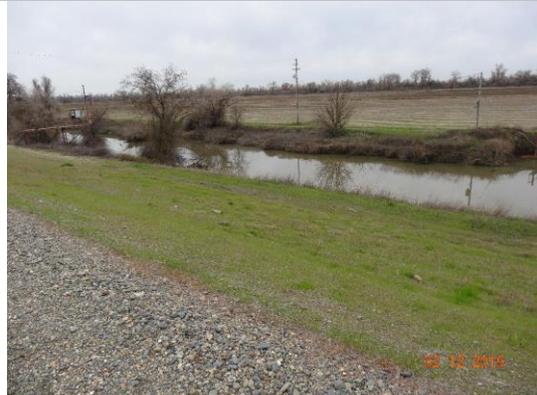
Photo 2 of 3 : UCIP_SP_2020_55017_78826.jpg

WS view: overview of WS. No visible marker found on WS.

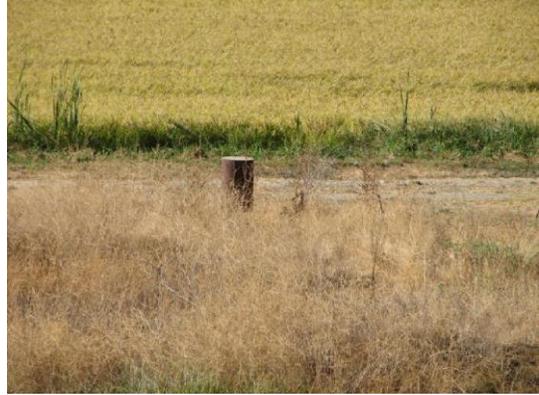
Photo 3 of 3 : UCIP_SP_2020_55017_65220.jpg

Possible vent on WS across channel.

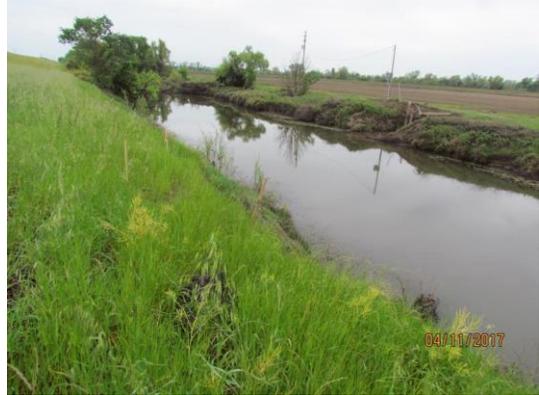
Photo 1 of 1 : SP_2020_ST0002_450_42_20200226_00007.jpg

LM Start	0.36	Rating **	M	Issue No.	42
LM End	0.36	Issue Type +	Ma	Location *	WS
Category	Earthen Levee			GPS Latitude/Longitude	
				Start	End
Item	Erosion / Bank Caving			39.147183 °	39.147183 °
				-121.828142 °	-121.828142 °
DWR ID	DWR_ST0002_01_s_2017_42				
Comment Code					
E2 : Schedule repair of erosion site prior to the next inspection.					
Inspector Comment					
Repair the erosion along the waterside toe.

View of the erosion along the waterside toe.

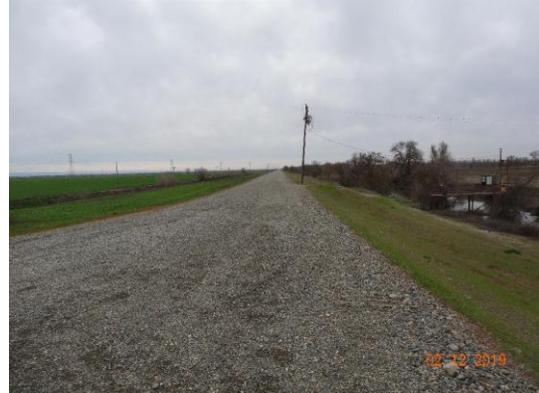
Photo 1 of 3 : UCIP_SP_2020_55986_78829.jpg

Comment Code					
Inspector Comment					
DS_ID:16861 FS_ID:55986 EP_NO: 1890 Repair Type: Non-Urgent Crossing Status: Found UCIP Comments: 02/12/2019 Record has been updated from No Action Needed to Non-Urgent, need to obtain records for the May 2005 emergency repair and current owner. No issues were observed on levee or slopes. (O. Magana - DWR UCIP)04/11/2017 Crossing appears to be in good condition.10/10/2016 Crossing appears to be in good condition.(DWR Sutter Yard - afreitag)04/18/2016 Crossing appears in good condition. No noticeable issues to report.05/07/2015 Crossing is in good condition. No noticeable issues to report.11/12/2014 Same as last inspection.05/13/2014 Same as last inspection.10/30/2103 Same as last inspection.05/22/2013 Same as last inspection.10/08/2012 Old pipe appears to have been removed FIELD_STRUCT_DESC: 18-inch steel irrigation pipe through the levee, 3.8 feet below the crown. Vertical pump and gate valve mounted on a steel structure located on the waterside (WS). Siphon breaker on the landside (LS) shoulder. 36-inch concrete riser unit in field on the LS. (18-inch pipe authorized under Permit No. 1890, 1959 - T. S. Madden). Emergency repair requested May 8, 2005, for replacement of existing pipe with 18-inch steel tar coated pipe. [Additional Reference(s): DWR Levee Log, 2005 (HLM 0.40)]. FS Date: 2/12/2019 3:03:00 PM

Overview of levee crown looking at crossing, photo taken u/s.

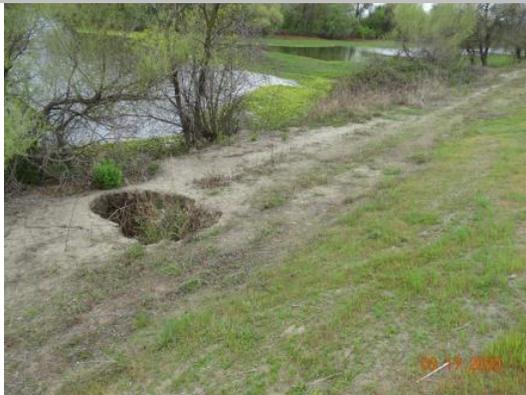
Photo 1 of 1 : SP_2020_ST0002_450_64_20200319_00121.jpg

LM Start	0.99	Rating **	M	Issue No.	64
LM End	0.99	Issue Type +	Ma	Location *	WS
Category	Earthen Levee			GPS Latitude/Longitude	
				Start	End
Item	Erosion / Bank Caving			39.141873 °	39.141873 °
				-121.818520 °	-121.818520 °
DWR ID	DWR_ST0002_01_s_2020_64				
Comment Code					
E2 : Schedule repair of erosion site prior to the next inspection.					
Inspector Comment

View of the erosion at the waterside toe. Spring 2020.

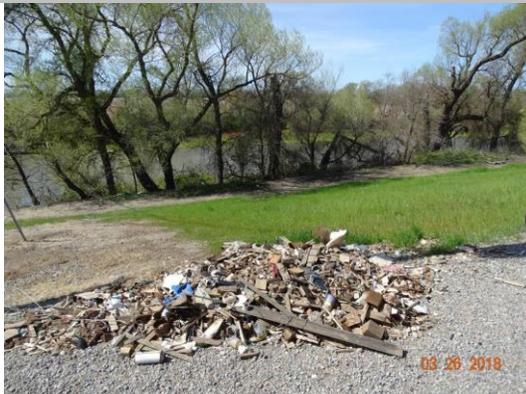
Photo 1 of 1 : SP_2020_ST0002_450_46_20200226_00009.jpg

LM Start	1.11	Rating **	M	Issue No.	46
LM End	1.11	Issue Type +	Ma	Location *	WS
Category	Earthen Levee			GPS Latitude/Longitude	
				Start	End
Item	Encroachments			39.140817 °	39.140817 °
				-121.816848 °	-121.816848 °
DWR ID	DWR_ST0002_01_f_2019_46				
Comment Code					
GA : Garbage					
Inspector Comment					
Remove the garbage from the waterside shoulder.

View of the garbage along the waterside slope.

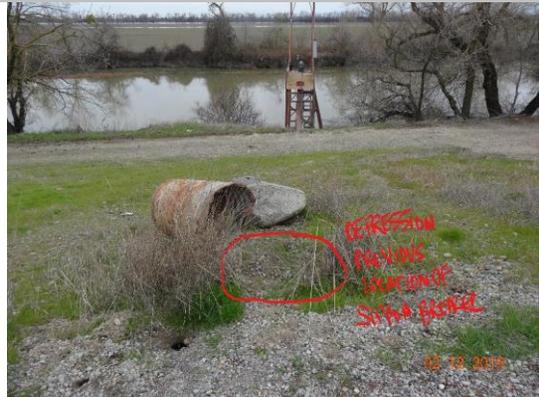
Photo 3 of 3 : UCIP_SP_2020_55020_78845.jpg

WS view: soil disturbance where riser was previously located.

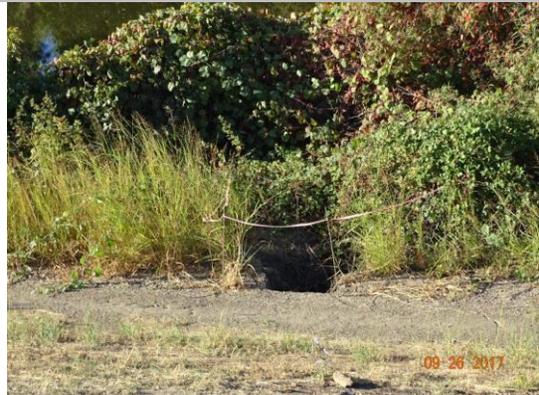
Photo 1 of 1 : SP_2020_ST0002_450_57_20200226_00014.jpg

LM Start	1.53	Rating **	U	Issue No.	57
LM End	1.53	Issue Type +	Ma	Location *	WS
Category	Earthen Levee			GPS Latitude/Longitude	
				Start	End
Item	Erosion / Bank Caving			39.137373 °	39.137373 °
				-121.810382 °	-121.810382 °
DWR ID	DWR_ST0002_01_f_2017_57				
Comment Code					
E2 : Schedule repair of erosion site prior to the next inspection.					
Inspector Comment					
Repair the beaver hole along the waterside berm.

View of the beaver hole along the waterside berm.

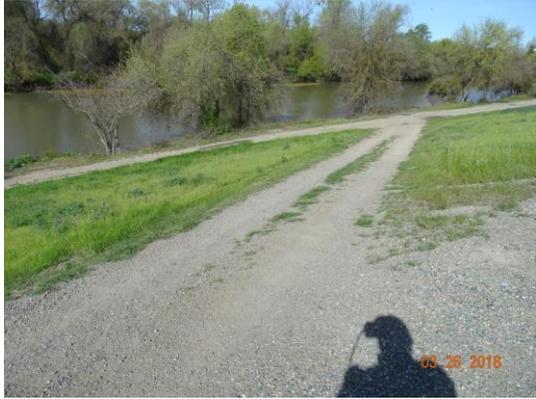
Photo 1 of 1 : SP_2020_ST0002_450_45_20200226_00008.jpg

LM Start	5.19	Rating **	M	Issue No.	45
LM End	5.19	Issue Type +	Ma	Location *	WS
Category	Earthen Levee		GPS Latitude/Longitude		
			Start	End	
Item	Slope Stability		39.103368 °	39.103368 °	
			-121.758760 °	-121.758760 °	
DWR ID	DWR_ST0002_01_s_2018_45				
Comment Code					
S3 : Repair the levee slope damaged by vehicle traffic and prevent access where possible.					
Inspector Comment

View of the vehicle traffic along the waterside slope.

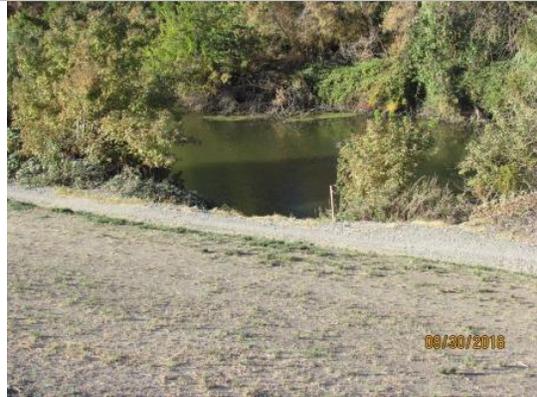
Photo 1 of 1 : SP_2020_ST0002_450_34_20200226_00005.jpg

LM Start	7.83	Rating **	M	Issue No.	34
LM End	7.83	Issue Type +	Ma	Location *	WS
Category	Earthen Levee			GPS Latitude/Longitude	
				Start	End
Item	Erosion / Bank Caving			39.067299 °	39.067299 °
				-121.742851 °	-121.742851 °
DWR ID	DWR_ST0002_01_f_2016_34				
Comment Code					
E2 : Schedule repair of erosion site prior to the next inspection.					
Inspector Comment

View of the erosion along the waterside toe.

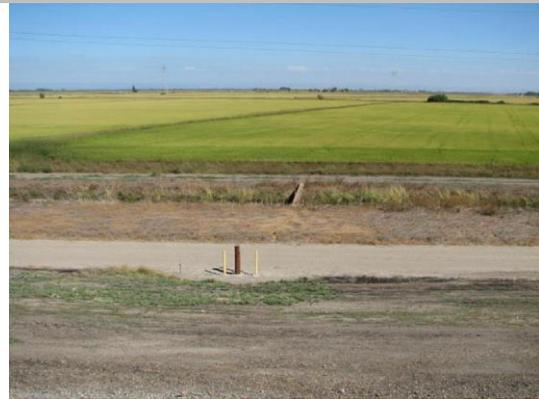
Photo 1 of 3 : UCIP_SP_2020_55999_65215.jpg

Comment Code					
Inspector Comment					
DS_ID:19984 FS_ID:55999 EP_NO: N/A Repair Type: Non-Urgent Crossing Status: Found UCIP Comments: 05/01/2019 Record remains Non-Urgent, no permit has been found authorizing crossing. Need to contact owner to obtain details of installation, permit details, and confirmation that pipe crosses the levee. (O. Magana - DWR UCIP)04/11/2017 Crossing appears to be in good condition. (DWR Sutter Yard- AFreitag)10/10/2016 Crossing appears to be in good condition.(DWR Sutter Yard - afreitag)04/18/2016 Crossing appears in good condition. No noticeable issues to report.05/07/2015 Crossing is in good condition. No noticeable issues to report.11/12/2014 Same as last inspection.05/13/2014 Same as last inspection.10/30/2013 Same as last inspection.05/22/2013 Same as last inspection.10/08/2012 No permit or purpose identified for this crossing. FIELD_STRUCT_DESC: 2.5-inch steel pipe of an unknown purpose bored under the levee, at an unknown depth. Pipe has locked cap on the landside (LS) toe. Steel I-beam stream crossing on the LS toe marks the location of the pipe. Waterside (WS) marker of pipe crossing is not identified. No permit has been identified since crossing was field discovered in 2012. FS Date: 5/1/2019 2:23:00 PM

Pipe at steel i-beam crossing in ditch at LS toe.

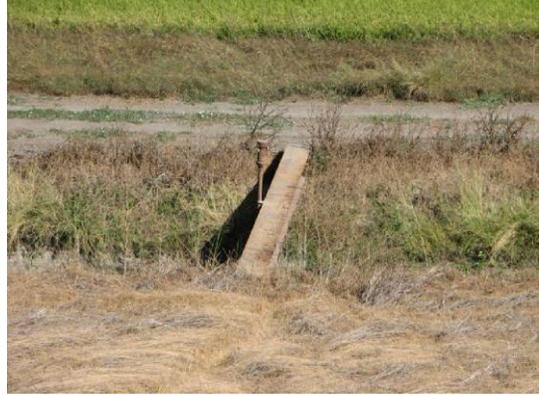
Photo 2 of 3 : UCIP_SP_2020_55999_65214.jpg

Pipe at steel i-beam crossing in ditch at LS toe.

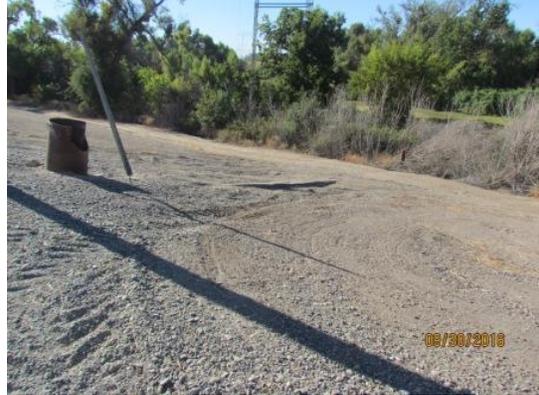
Photo 1 of 1 : SP_2020_ST0002_450_37_20200226_00006.jpg

View of the erosion caused by vehicle traffic.

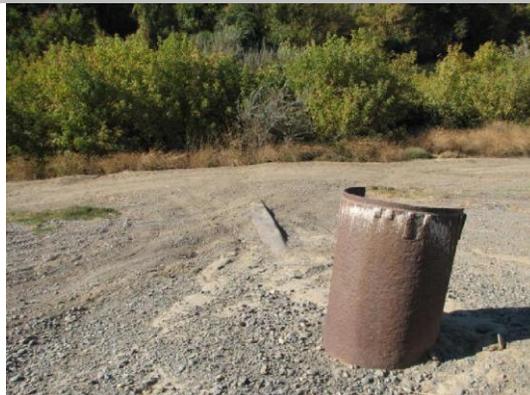
Photo 1 of 3 : UCIP_SP_2020_55280_65314.jpg

Pipe on WS slope exposed and crushed below 30-inch steel riser.

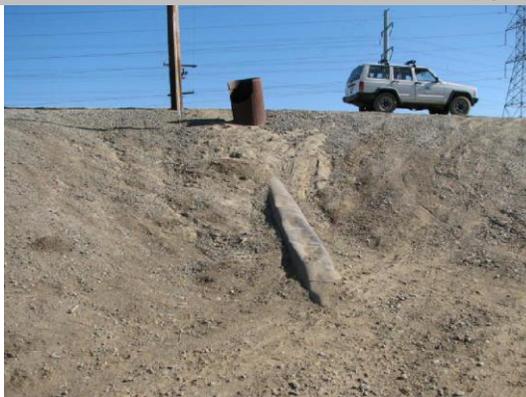
Photo 3 of 3 : UCIP_SP_2020_55280_65312.jpg

Crushed pipe on WS slope.

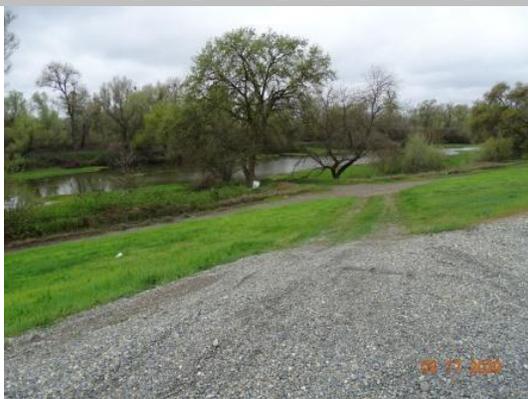
Photo 1 of 1 : SP_2020_ST0002_450_21_20200319_00122.jpg

View of the vehicle erosion along the waterside slope. Spring 2020.

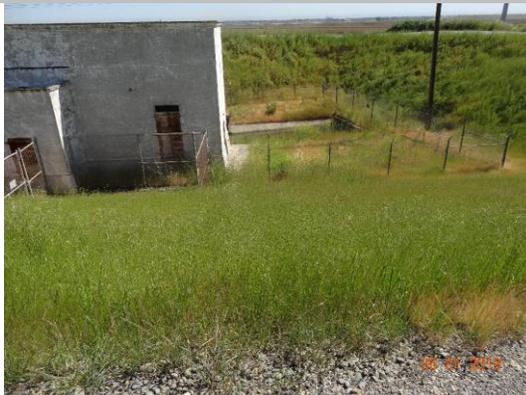
Photo 3 of 3 : UCIP_SP_2020_55288_81498.jpg

LS view: overview of where pipe should be. No signs were found of pipe.

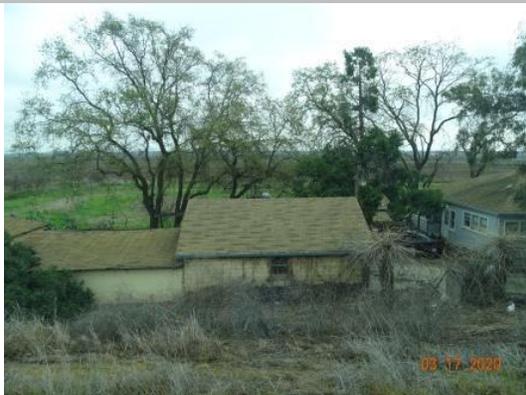
Photo 1 of 1 : SP_2020_ST0002_450_10_20200319_00123.jpg

View of the house next to the landside toe. Spring 2020.
