**Flood Control Project Maintenance  
Levee Inspections**

**Maintenance Issue Types Only, Levee Inspection Report By Mile - Spring 2020**

**Sutter Maintenance Yard East Levee Sutter Bypass**

Waterway	Bank	Unit Miles	Inspection Start/End	Inspector
Unit No. 01 Sutter Bypass Levee	Left	21.68	03/17/2020 03/17/2020	Makar Sokol

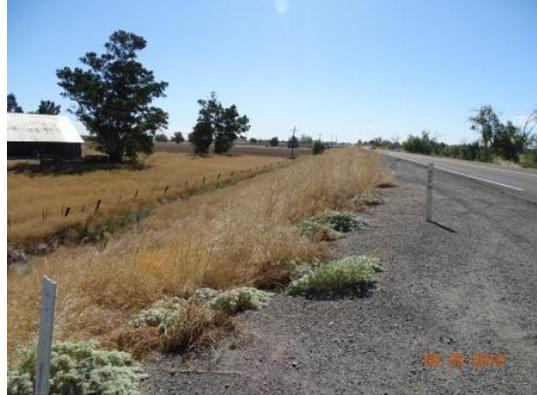
Photo 1 of 1 : SP\_2020\_ST0002\_450\_48\_20200226\_00011.jpg

LM Start	<b>0.00</b>	Rating **	U	Issue No.	<b>48</b>
LM End	<b>0.22</b>	Issue Type +	Ma	Location *	LS
Category	Earthen Levee		GPS Latitude/Longitude		
			Start	End	
Item	Vegetation		39.151291 °	39.148600 °	
			-121.832110 °	-121.830018 °	
DWR ID	DWR_ST0002_01_f_2019_48				
Comment Code					
V1 : Control annual grass and weeds on the levee slopes and easements.					
Inspector Comment

View of the vegetation along the landside slope. Fall 2019.

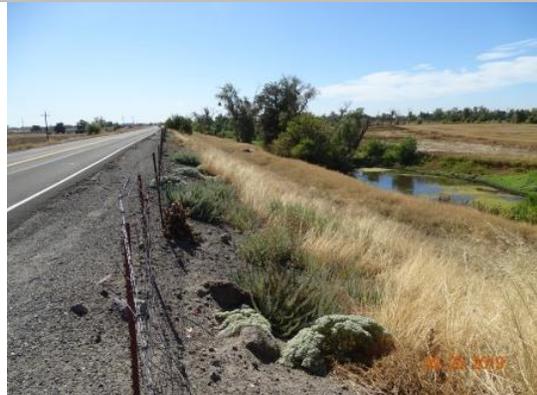
Photo 1 of 1 : SP\_2020\_ST0002\_450\_47\_20200226\_00010.jpg

LM Start	<b>0.00</b>	Rating **	U	Issue No.	<b>47</b>
LM End	<b>0.25</b>	Issue Type +	Ma	Location *	WS
Category	Earthen Levee		GPS Latitude/Longitude		
			Start	End	
Item	Vegetation		39.151291 °	39.148212 °	
			-121.832110 °	-121.829759 °	
DWR ID	DWR_ST0002_01_f_2019_47				
Comment Code					
V1 : Control annual grass and weeds on the levee slopes and easements.					
Inspector Comment

View of the vegetation along the waterside slope. Fall 2019.

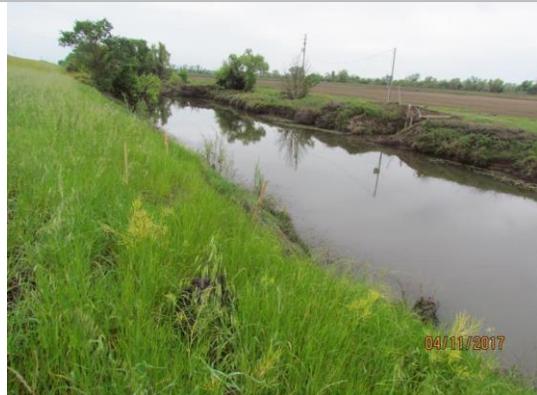
Photo 1 of 1 : SP\_2020\_ST0002\_450\_42\_20200226\_00007.jpg

LM Start	<b>0.36</b>	Rating **	M	Issue No.	<b>42</b>
LM End	<b>0.36</b>	Issue Type +	Ma	Location *	WS
Category	Earthen Levee		GPS Latitude/Longitude		
			Start	End	
Item	Erosion / Bank Caving		39.147183 °	39.147183 °	
			-121.828142 °	-121.828142 °	
DWR ID	DWR_ST0002_01_s_2017_42				
Comment Code					
E2 : Schedule repair of erosion site prior to the next inspection.					
Inspector Comment					
Repair the erosion along the waterside toe.

View of the erosion along the waterside toe.

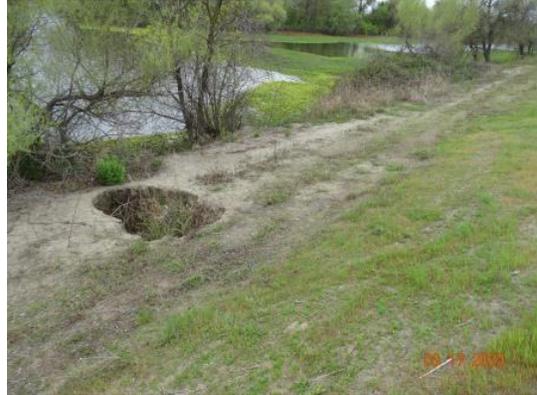
Photo 1 of 1 : SP\_2020\_ST0002\_450\_64\_20200319\_00121.jpg

LM Start	<b>0.99</b>	Rating **	M	Issue No.	<b>64</b>
LM End	<b>0.99</b>	Issue Type +	Ma	Location *	WS
Category	Earthen Levee			GPS Latitude/Longitude	
				Start	End
Item	Erosion / Bank Caving			39.141873 °	39.141873 °
				-121.818520 °	-121.818520 °
DWR ID	DWR_ST0002_01_s_2020_64				
Comment Code					
E2 : Schedule repair of erosion site prior to the next inspection.					
Inspector Comment

View of the erosion at the waterside toe. Spring 2020.

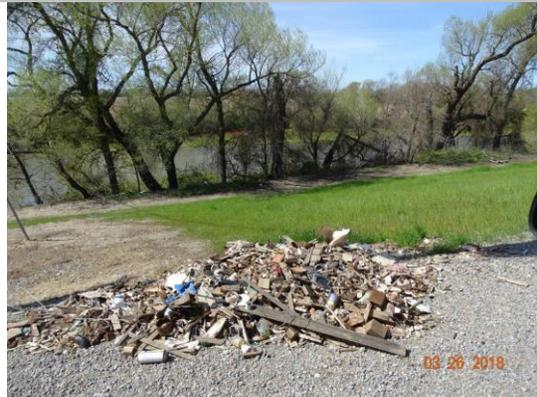
Photo 1 of 1 : SP\_2020\_ST0002\_450\_46\_20200226\_00009.jpg

LM Start	<b>1.11</b>	Rating **	M	Issue No.	<b>46</b>
LM End	<b>1.11</b>	Issue Type +	Ma	Location *	WS
Category	Earthen Levee			GPS Latitude/Longitude	
				Start	End
Item	Encroachments			39.140817 °	39.140817 °
				-121.816848 °	-121.816848 °
DWR ID	DWR_ST0002_01_f_2019_46				
Comment Code					
GA : Garbage					
Inspector Comment					
Remove the garbage from the waterside shoulder.

View of the garbage along the waterside slope.

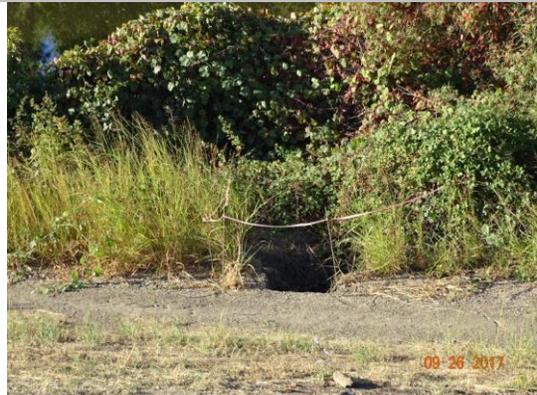
Photo 1 of 1 : SP\_2020\_ST0002\_450\_57\_20200226\_00014.jpg

LM Start	<b>1.53</b>	Rating **	U	Issue No.	<b>57</b>
LM End	<b>1.53</b>	Issue Type +	Ma	Location *	WS
Category	Earthen Levee			GPS Latitude/Longitude	
				Start	End
Item	Erosion / Bank Caving			39.137373 °	39.137373 °
				-121.810382 °	-121.810382 °
DWR ID	DWR_ST0002_01_f_2017_57				
Comment Code					
E2 : Schedule repair of erosion site prior to the next inspection.					
Inspector Comment					
Repair the beaver hole along the waterside berm.

View of the beaver hole along the waterside berm.

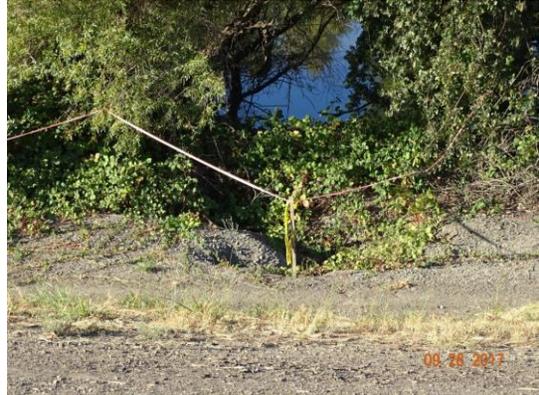
Photo 1 of 1 : SP\_2020\_ST0002\_450\_58\_20200226\_00015.jpg

LM Start	<b>1.57</b>	Rating **	U	Issue No.	<b>58</b>
LM End	<b>1.57</b>	Issue Type +	Ma	Location *	WS
Category	Earthen Levee			GPS Latitude/Longitude	
				Start	End
Item	Erosion / Bank Caving			39.137010 °	39.137010 °
				-121.809673 °	-121.809673 °
DWR ID	DWR_ST0002_01_f_2017_58				
Comment Code					
E2 : Schedule repair of erosion site prior to the next inspection.					
Inspector Comment					
Repair the beaver hole along the waterside berm.

View of the beaver hole along the waterside berm.

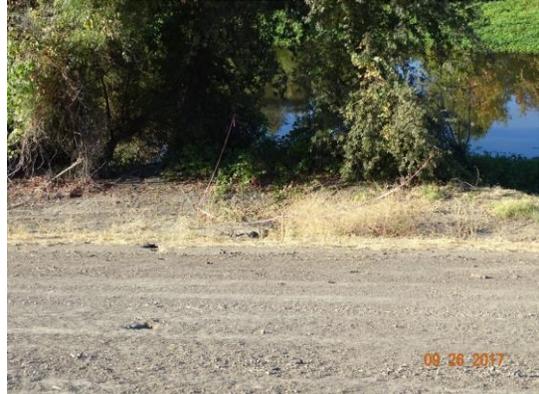
Photo 1 of 1 : SP\_2020\_ST0002\_450\_61\_20200226\_00016.jpg

LM Start	<b>1.61</b>	Rating **	U	Issue No.	<b>61</b>
LM End	<b>1.61</b>	Issue Type +	Ma	Location *	WS
Category	Earthen Levee			GPS Latitude/Longitude	
				Start	End
Item	Erosion / Bank Caving			39.136713 °	39.136713 °
				-121.809202 °	-121.809202 °
DWR ID	DWR_ST0002_01_f_2017_61				
Comment Code					
E2 : Schedule repair of erosion site prior to the next inspection.					
Inspector Comment					
Repair the beaver hole along the waterside berm.

View of the beaver hole along the waterside berm.

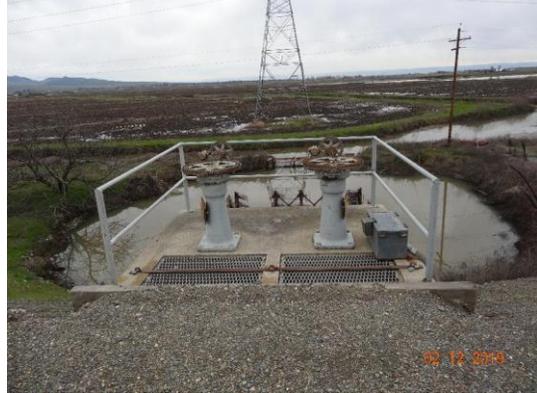
Photo 2 of 3 : UCIP\_SP\_2020\_55218\_78857.jpg

LM Start	<b>3.55</b>	Rating **	M	Issue No.	<b>76 (cont)</b>
LM End	<b>3.55</b>	Issue Type +	Ma	Location *	
Category	Supplemental			GPS Latitude/Longitude	
				Start	End
Item	DWR UCIP LMA Responsibility			39.120372 °	39.120372 °
				-121.779800 °	-121.779800 °
DWR ID	16880

LS view: slide gate valves located on LS shoulder.

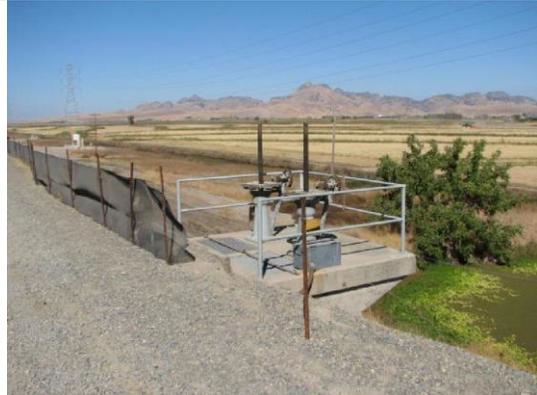
Photo 3 of 3 : UCIP\_SP\_2020\_55218\_64815.jpg

Slide gates on LS shoulder.

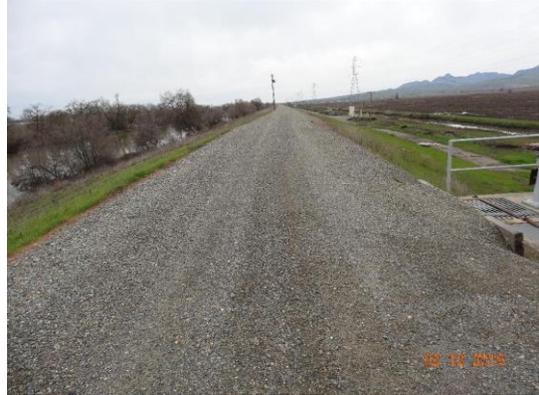
Photo 2 of 3 : UCIP\_SP\_2020\_55219\_78866.jpg

LM Start	<b>3.55</b>	Rating **	M	Issue No.	<b>77 (cont)</b>
LM End	<b>3.55</b>	Issue Type +	Ma	Location *	
Category	Supplemental			GPS Latitude/Longitude	
				Start	End
Item	DWR UCIP LMA Responsibility			39.120358 °	39.120358 °
				-121.779775 °	-121.779775 °
DWR ID	16895

Overview of levee crown, photo taken at crossings looking u/s.

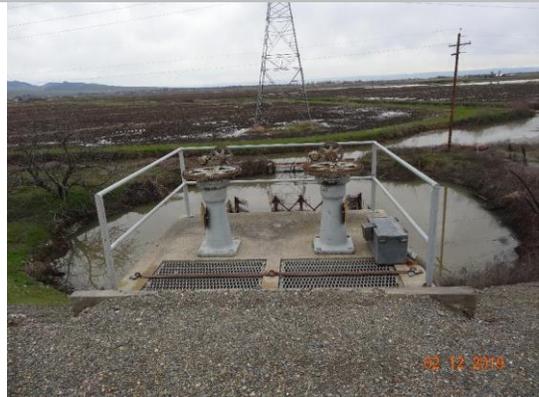
Photo 3 of 3 : UCIP\_SP\_2020\_55219\_78864.jpg

LS view: slide gate valves located on LS shoulder.

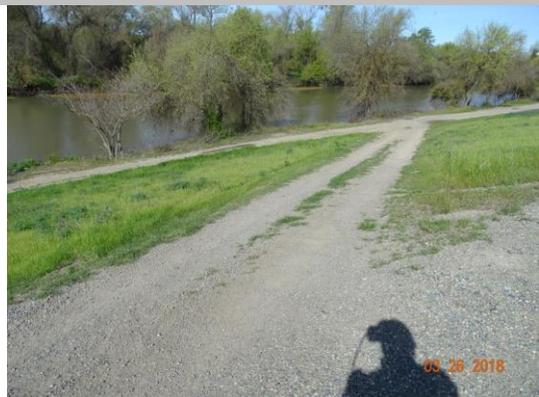
Photo 1 of 1 : SP\_2020\_ST0002\_450\_45\_20200226\_00008.jpg

LM Start	<b>5.19</b>	Rating **	M	Issue No.	<b>45</b>
LM End	<b>5.19</b>	Issue Type +	Ma	Location *	WS
Category	Earthen Levee			GPS Latitude/Longitude	
				Start	End
Item	Slope Stability			39.103368 °	39.103368 °
				-121.758760 °	-121.758760 °
DWR ID	DWR_ST0002_01_s_2018_45				
Comment Code					
S3 : Repair the levee slope damaged by vehicle traffic and prevent access where possible.					
Inspector Comment

View of the vehicle traffic along the waterside slope.

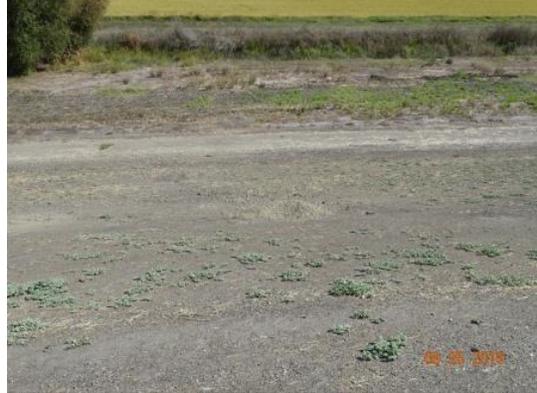
Photo 1 of 1 : SP\_2020\_ST0002\_450\_52\_20200226\_00013.jpg

LM Start	<b>5.85</b>	Rating **	M	Issue No.	<b>52</b>
LM End	<b>5.85</b>	Issue Type +	Ma	Location *	LS
Category	Earthen Levee		GPS Latitude/Longitude		
			Start	End	
Item	Animal Control		39.094508 °	39.094508 °	
			-121.754169 °	-121.754169 °	
DWR ID	DWR_ST0002_01_f_2019_52				
Comment Code					
A3 : No rodents visible, but rodent burrows visible; need to backfill and compact or grout burrows.					
Inspector Comment

View of the rodent burrow on the landside slope. Fall 2019.

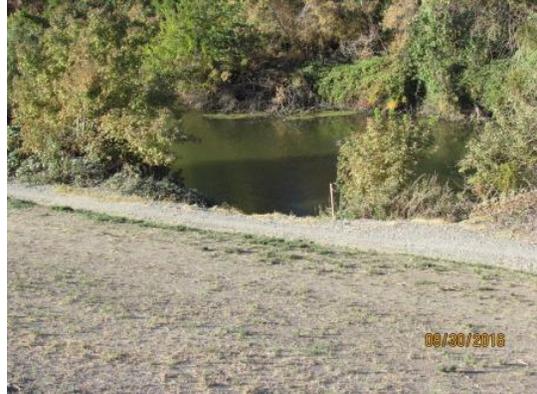
Photo 1 of 1 : SP\_2020\_ST0002\_450\_34\_20200226\_00005.jpg

LM Start	<b>7.83</b>	Rating **	M	Issue No.	<b>34</b>
LM End	<b>7.83</b>	Issue Type +	Ma	Location *	WS
Category	Earthen Levee		GPS Latitude/Longitude		
			Start	End	
Item	Erosion / Bank Caving		39.067299 °	39.067299 °	
			-121.742851 °	-121.742851 °	
DWR ID	DWR_ST0002_01_f_2016_34				
Comment Code					
E2 : Schedule repair of erosion site prior to the next inspection.					
Inspector Comment

View of the erosion along the waterside toe.

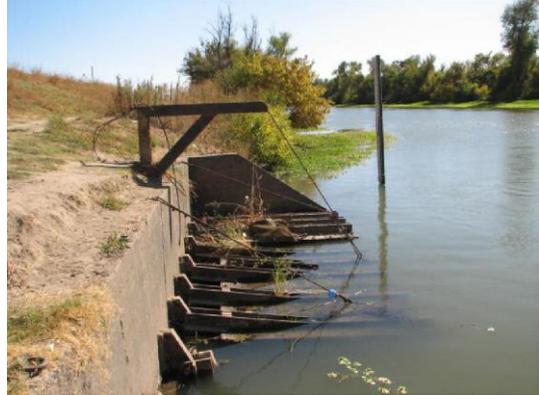
Photo 2 of 3 : UCIP\_SP\_2020\_55257\_65253.jpg

LM Start	<b>10.83</b>	Rating **	M	Issue No.	<b>89 (cont)</b>
LM End	<b>10.83</b>	Issue Type +	Ma	Location *	
Category	Supplemental			GPS Latitude/Longitude	
				Start	End
Item	DWR UCIP LMA Responsibility			39.025683 °	39.025683 °
				-121.726886 °	-121.726886 °
DWR ID	16906

Flap gates on WS toe.

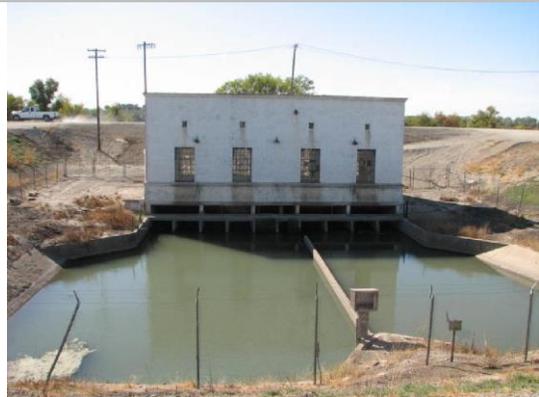
Photo 3 of 3 : UCIP\_SP\_2020\_55257\_65252.jpg

Pumping plant on LS toe.

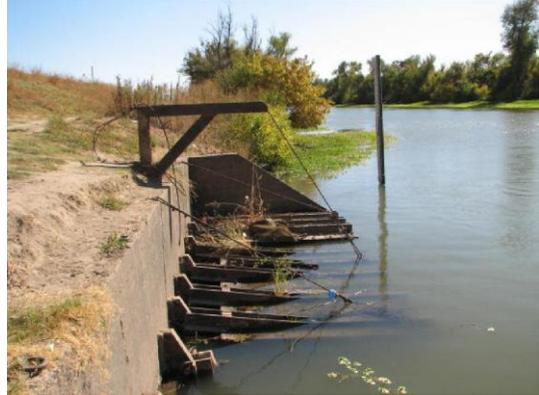
Photo 2 of 3 : UCIP\_SP\_2020\_55256\_65262.jpg

LM Start	<b>10.83</b>	Rating **	M	Issue No.	<b>92 (cont)</b>
LM End	<b>10.83</b>	Issue Type +	Ma	Location *	
Category	Supplemental			GPS Latitude/Longitude	
				Start	End
Item	DWR UCIP LMA Responsibility			39.025639 °	39.025639 °
				-121.726874 °	-121.726874 °
DWR ID	16909

Flap gates on WS Toe.

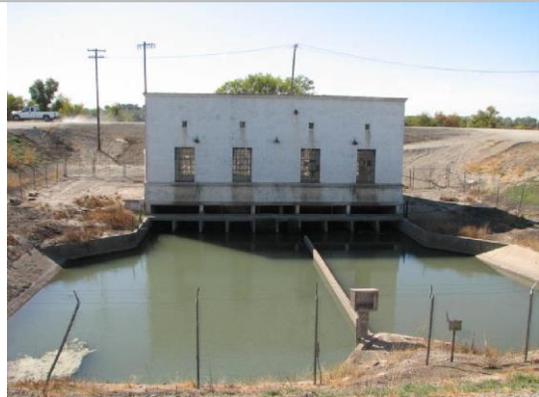
Photo 3 of 3 : UCIP\_SP\_2020\_55256\_65261.jpg

Pumphouse/intake on LS toe.

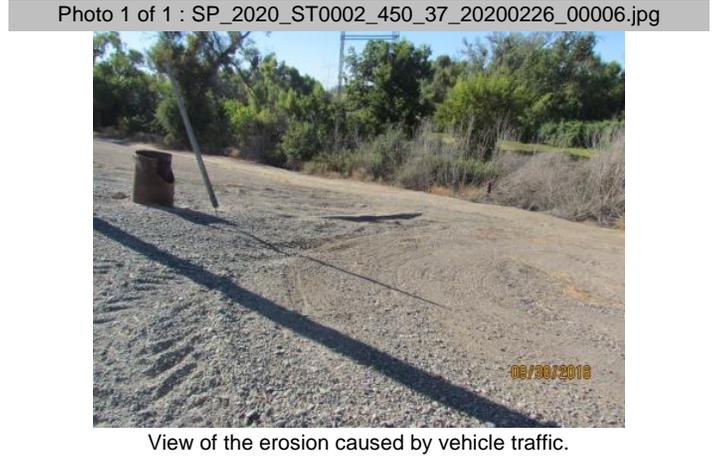
LM Start	<b>14.71</b>	Rating **	M	Issue No.	<b>37</b>
LM End	<b>14.71</b>	Issue Type +	Ma	Location *	WS
Category	Earthen Levee		GPS Latitude/Longitude		
			Start	End	
Item	Slope Stability		38.979389 °	38.979389 °	
			-121.691923 °	-121.691923 °	
DWR ID	DWR_ST0002_01_f_2016_37				
Comment Code					
S3 : Repair the levee slope damaged by vehicle traffic and prevent access where possible.					
Inspector Comment

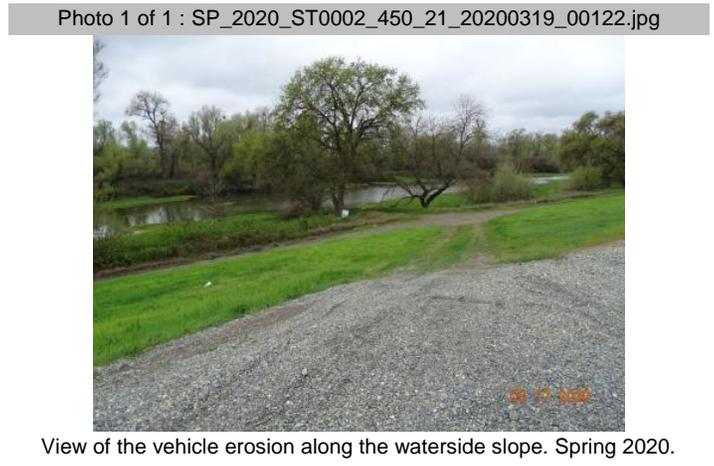
LM Start	<b>17.60</b>	Rating **	M	Issue No.	<b>21</b>
LM End	<b>17.60</b>	Issue Type +	Ma	Location *	WS
Category	Earthen Levee		GPS Latitude/Longitude		
			Start	End	
Item	Slope Stability		38.949965 °	38.949965 °	
			-121.653823 °	-121.653823 °	
DWR ID	DWR_ST0002_01_s_2015_21				
Comment Code					
S3 : Repair the levee slope damaged by vehicle traffic and prevent access where possible.					
Inspector Comment

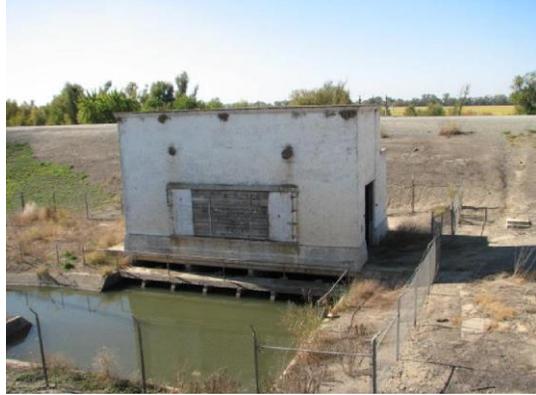
Photo 1 of 3 : UCIP\_SP\_2020\_55285\_65326.jpg

Item	DWR UCIP LMA Responsibility		38.932476 °	38.932476 °	
			-121.635173 °	-121.635173 °	
DWR ID	16877				
Comment Code					
Inspector Comment					
<p>DS_ID:16877                  FS_ID:55285                  EP_NO: N/A                  Repair Type: Non-Urgent                  Crossing Status: Found                  UCIP Comments: 05/01/2019 Record has been updated from No Action Needed to Non-Urgent, no permit has been identified authorizing pump station. As noted back in 2016 by A. Freitag, this pumping plant has been modified to be used as a gravity drain to regulate the water levee in the LS ditch. This pumping station is maintained by DWR Sutter Yard. (O. Magana - DWR UCIP)04/11/2017 Not abandoned. Good condition. (DWR Sutter Yard - AFreitag)10/10/2016 NOT ABANDONED. The old pumping plant was abandoned but the culverts are still used as a gravity drain to regulate the water level in the LS ditch.(DWR Sutter Yard - aFreitag)04/18/2016 Crossing is in good condition. The culvert is not abandoned and is used as gravity drain for the LS ditch into the bypass channel.05/07/2015 Concrete culvert is being used as a gravity drain for LS ditch.11/12/2014 Same as last inspection.05/14/2014 Same as last inspection.10/30/2013 Same as last inspection.05/23/2013 Concrete culvert is being used as gravity drain for LS ditch.10/09/2012 Determine type of abandonment for concrete culvert.                  FIELD_STRUCT_DESC: [Pumping Plant No. 1] 1 of 3: 48-inch by 72-inch reinforced concrete drainage culvert through the levee, 26 feet below the crown. Slide gates in a concrete well on the waterside (WS) shoulder. Wooden flap gates and concrete headwall on the WS end. Concrete steps and staff gage reading to 53 feet on the WS slope.                  [Additional Reference(s): DWR Levee Log, 2005 (HLM 19.47). USACE Sacramento O&amp;M Manual 315, May 1953 (Station 141+46)].                  FS Date: 5/1/2019 2:41:00 PM</p>

Pumphouse on LS toe.

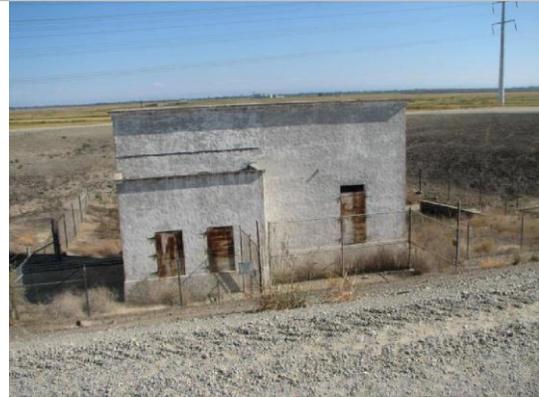
Photo 1 of 3 : UCIP\_SP\_2020\_55286\_65330.jpg

Item	DWR UCIP LMA Responsibility		38.932469 °	38.932469 °	
			-121.635160 °	-121.635160 °	
DWR ID	17027				
Comment Code					
Inspector Comment					
<p>DS_ID:17027                      FS_ID:55286                      EP_NO: N/A                      Repair Type: Non-Urgent                      Crossing Status: Found                      UCIP Comments: 05/01/2019 Record has been updated from No Action Needed to Non-Urgent, no permit has been identified authorizing pump station. As noted back in 2016 by A. Freitag, this pumping plant has been modified to be used as a gravity drain to regulate the water levee in the LS ditch. This pumping station is maintained by DWR Sutter Yard. (O. Magana - DWR UCIP)04/11/2017 Not abandoned. Good Condition. (DWR Sutter Yard- AFreitag)10/10/2016 NOT ABANDONED. The old pumping plant was abandoned but the culverts are still used as a gravity drain to regulate the water level in the LS ditch.(DWR Sutter Yard - aFreitag)04/18/2016 Crossing is in good condition. The culvert is not abandoned and is used as gravity drain for the LS ditch into the bypass channel.05/07/2015 Concrete culvert is being used as a gravity drain for LS ditch.11/12/2014 Same as last inspection.05/14/2014 Same as last inspection.10/30/2013 Same as last inspection.05/23/2013 Concrete culvert is being used as gravity drain for LS ditch.10/09/2012 Determine type of abandonment for concrete culverts.                      FIELD_STRUCT_DESC: [Pumping Plant No. 1] 2 of 3: 48-inch by 72-inch reinforced concrete drainage culvert through the levee, 26 feet below the crown. Slide gates in a concrete well on the waterside (WS) shoulder. Wooden flap gates and concrete headwall on the WS end. Concrete steps and staff gage reading to 53 feet on the WS slope.                      [Additional Reference(s): DWR Levee Log, 2005 (HLM 19.47). USACE Sacramento O&amp;M Manual 315, May 1953 (Station 141+46)].                      FS Date: 5/1/2019 2:42:00 PM</p>

Pumphouse on LS toe.

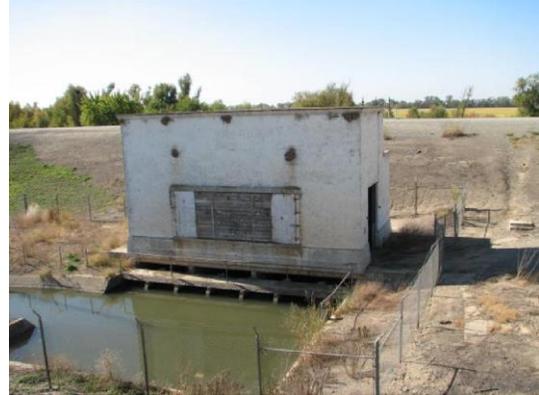
Photo 1 of 3 : UCIP\_SP\_2020\_55287\_65333.jpg

Item	DWR UCIP LMA Responsibility		38.932460 °	38.932460 °	
			-121.635150 °	-121.635150 °	
DWR ID	17028				
Comment Code					
Inspector Comment					
<p>DS_ID:17028                      FS_ID:55287                      EP_NO: N/A                      Repair Type: Non-Urgent                      Crossing Status: Found                      UCIP Comments: 05/01/2019 Record has been updated from No Action Needed to Non-Urgent, no permit has been identified authorizing pump station. As noted back in 2016 by A. Freitag, this pumping plant has been modified to be used as a gravity drain to regulate the water levee in the LS ditch. This pumping station is maintained by DWR Sutter Yard. (O. Magana - DWR UCIP)04/11/2017 Not Abandoned. Good Condition. (DWR Sutter Yard - AFreitag)10/10/2016 NOT ABANDONED. The old pumping plant was abandoned but the culverts are still used as a gravity drain to regulate the water level in the LS ditch.(DWR Sutter Yard - aFreitag)04/18/2016 Crossing is in good condition. The culvert is not abandoned and is used as gravity drain for the LS ditch into the bypass channel.05/07/2015 Concrete culvert is being used as a gravity drain for LS ditch.11/12/2014 Same as last inspection.05/14/2014 Same as last inspection.10/30/2013 Same as last inspection.05/23/2013 Concrete culvert is being used as gravity drain for LS ditch.10/09/2012 Need to determine type of abandonment for concrete culverts.                      FIELD_STRUCT_DESC: [Pumping Plant No. 1] 3 of 3: 48-inch by 72-inch reinforced concrete drainage culvert through the levee, 26 feet below the crown. Slide gates in a concrete well on the waterside (WS) shoulder. Wooden flap gates and concrete headwall on the WS end. Concrete steps and staff gage reading to 53 feet on the WS slope.                      [Additional Reference(s): DWR Levee Log, 2005 (HLM 19.47). USACE Sacramento O&amp;M Manual 315, May 1953 (Station 141+46)].                      FS Date: 5/1/2019 2:43:00 PM</p>

Pumphouse on LS toe.

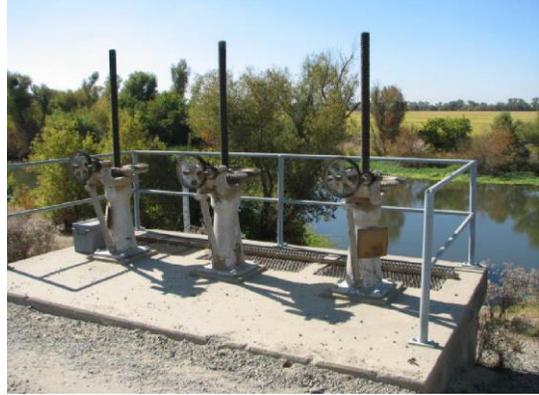
Photo 2 of 3 : UCIP\_SP\_2020\_55287\_65332.jpg

LM Start	<b>19.18</b>	Rating **	M	Issue No.	<b>102 (cont)</b>
LM End	<b>19.18</b>	Issue Type +	Ma	Location *	
Category	Supplemental		GPS Latitude/Longitude		
			Start	End	
Item	DWR UCIP LMA Responsibility		38.932460 °	38.932460 °	
			-121.635150 °	-121.635150 °	
DWR ID	17028

Slide gates on WS shoulder.

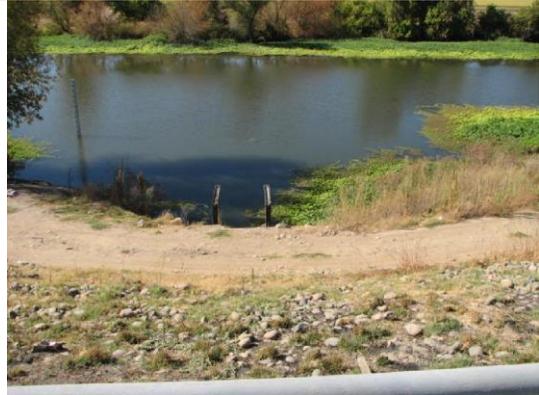
Photo 3 of 3 : UCIP\_SP\_2020\_55287\_65331.jpg

Flap gate at WS toe.
