**Flood Control Project Maintenance
Levee Inspections**

Maintenance Issue Types Only, Levee Inspection Report By Mile - Spring 2020

Sutter Maintenance Yard East Levee Sacramento River

Waterway	Bank	Unit Miles	Inspection Start/End	Inspector
Unit No. 01 Sacramento River	Left	19.85	03/11/2020 03/11/2020	Makar Sokol

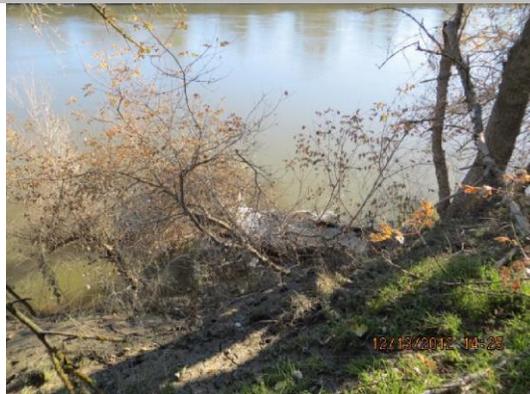
Photo 1 of 3 : UCIP_SP_2020_56013_46992.jpg

DS_ID:17320
 FS_ID:56013
 EP_NO: 9543
 Repair Type: Urgent
 Crossing Status: Found
 UCIP Comments: 07/29/2019 same as 2018 inspection, Urgent. No access is available to WS due to dense vegetation, assume WS pipe is still completely deteriorated. Recommend internal inspection to determine the damage, if any, through the levee. (O. Magana - DWR UCIP)08/30/2018 WS vegetation too thick to clearly inspect WS pipe so assume same condition as last inspections so crossing remains Urgent due to pipe integrity. WS levee slope looks good. No signs of levee threat to the road crown. LS headwall looks in good condition (D. Sanoski - DWR UCIP).04/24/2017 WS was underwater during the site visit but I do not believe that any repairs have been made to this crossing yet. (DWR Sutter Yard- AFreitag)11/07/2016 No repairs have been made here yet. (DWR Sutter Yard- AFreitag)06/17/2016 River levels were down and the WS pipe end was exposed. WS end is completely rotten and damaged and flap gate has fallen off the end of the pipe (see pics). Pipe needs to be replaced or repaired. (DWR Sutter Yard - afreitag)04/05/2016 Erosion on WS slope still present. Pipe still fully submerged on WS and discharging into river during site visit. (DWR UCIP - kfazel)04/06/2015 Pipe leaks during high water. DWR employee said he suspects that the flap gate has rotted and fallen off WS end of pipe. Could not locate WS end of pipe to confirm. Water was flowing through this drain during field survey. (DWR Sutter Yard - afreitag)06/30/2014 Same as last inspection. (DWR Sutter Yard - afreitag)12/30/2013 Same as last inspection. (DWR Sutter Yard - afreitag)07/29/2013 Same as last inspection. (DWR Sutter Yard - afreitag) 12/13/2012 Water was flowing through this drain during field survey. (DWR UCIP - pamatya)

FIELD_STRUCT_DESC: 30-inch corrugated metal drainage pipe (at 45 degrees) through the levee, 25.2 feet below the crown. Flap gate on the waterside (WS), not found in 2016. (30-inch pipe [HLM 1.38] authorized under Automatic Board Order (ABO) issued as Permit No. 9543, 1974 - Harada). [Additional Reference(s): DWR Levee Log, 2002. USACE Sacramento O&M Manual 136, revision March 1960 (HLM 1.38)]
 FS Date: 7/29/2019 11:08:00 AM

WS view: overview of river bank

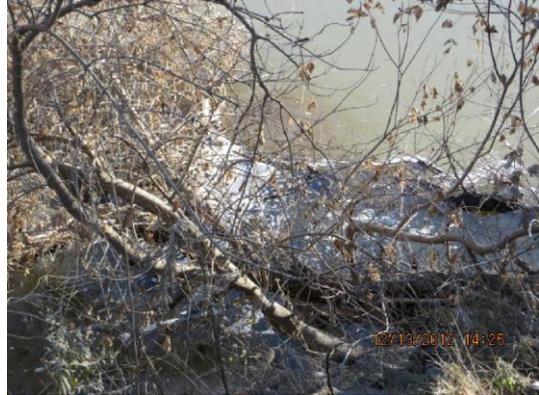
Photo 2 of 3 : UCIP_SP_2020_56013_46991.jpg

WS view: water flowing from outlet pipe (pipe fully submerge)

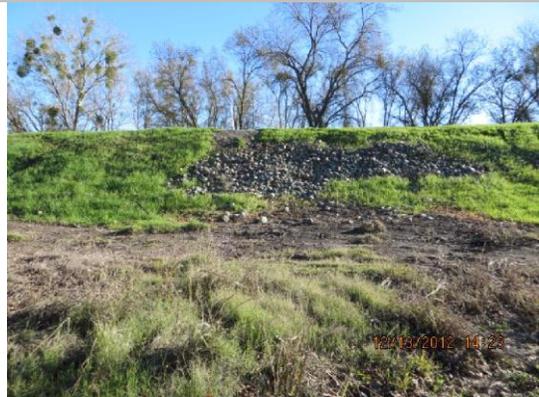
Photo 3 of 3 : UCIP_SP_2020_56013_46990.jpg

LS view: overview of levee slope

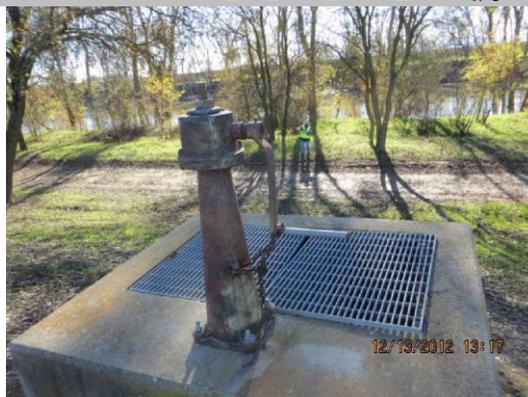
Photo 2 of 3 : UCIP_SP_2020_56018_47026.jpg

WS view: overview- concrete surg tank

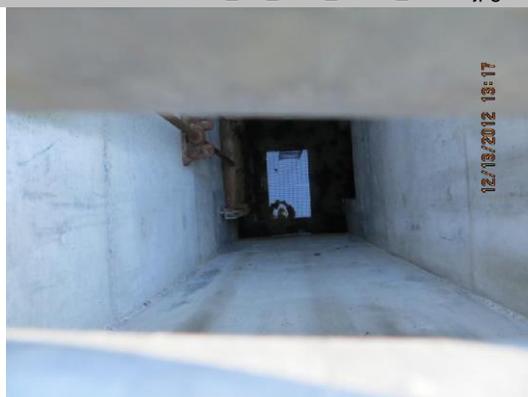
Photo 3 of 3 : UCIP_SP_2020_56018_47025.jpg

WS view: slide gate inside concrete surg tank

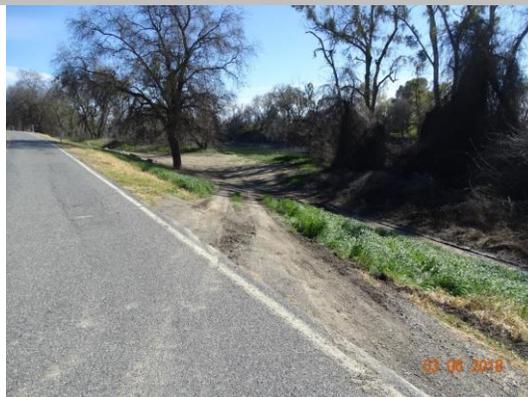
Photo 1 of 1 : SP_2020_ST0003_264_104_20200226_00020.jpg

LM Start	2.84	Rating **	M	Issue No.	104
LM End	2.84	Issue Type +	Ma	Location *	WS
Category	Earthen Levee			GPS Latitude/Longitude	
				Start	End
Item	Slope Stability			39.191162 °	39.191162 °
				-121.980365 °	-121.980365 °
DWR ID	DWR_ST0003_01_s_2018_104				
Comment Code					
S3 : Repair the levee slope damaged by vehicle traffic and prevent access where possible.					
Inspector Comment

View of the erosion along the waterside slope caused by vehicle traffic.

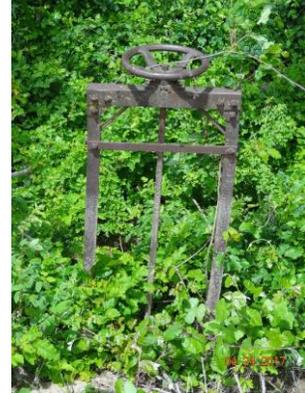
Photo 1 of 3 : UCIP_SP_2020_56022_77004.jpg

Comment Code					
Inspector Comment					
<p>DS_ID:17313 FS_ID:56022 EP_NO: N/A Repair Type: Non-Urgent Crossing Status: Found UCIP Comments: 07/30/2019 Record remains Non-Urgent, pipe has been abandoned. Coordinates have been updated from 39.201831, -121.984006 to 39.2016497, -121.9840750 based on the DMP Geophysics Study and UCIP field confirmation. Per the DMP Geophysics Study the pipe is still present through the levee. LMA will need to monitor levee section until funds become available to remove or properly abandon pipe through the levee. (O. Magana - DWR UCIP)04/24/2017 Slide gate structure found on WS about 10ft from levee toe. Vegetation was too thick to see if there were any more appurtances associated with this crossing visible on the WS. Nothing was visible on the LS. House located above pipe alignment at LS levee toe. Crossing appears abandoned and should be done so properly. (DWR Sutter Yard- AFreitag)11/07/2016 Unable to locate. (DWR Sutter Yard- AFreitag)06/06/2016 Unable to locate.04/06/2015 Unable to locate.06/30/2014 Unable to locate.12/30/2013 Unable to locate07/29/2013 Same as last inspection. Unable to locate. FIELD_STRUCT_DESC: *ABANDONED* 18-inch corrugated metal drainage pipe through the levee, 15 feet below the crown. Slide gate on the waterside (WS) end. [Additional Reference(s): DWR Levee Log, 2002. USACE Sacramento O&M Manual 136, March 1960 (HLM 3.6)]. FS Date: 7/30/2019 10:52:00 AM</p>

Slide gate structure found on WS

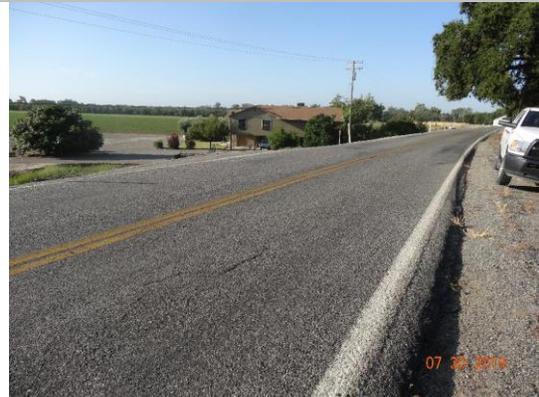
Photo 2 of 3 : UCIP_SP_2020_56022_80177.jpg

Overview of levee crown looking d/s towards crossing.

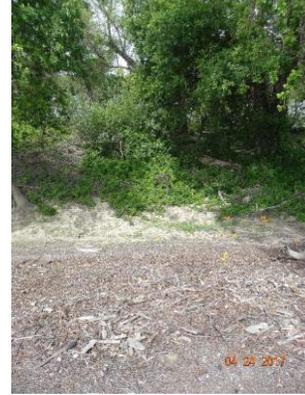
Photo 3 of 3 : UCIP_SP_2020_56022_77005.jpg

View of WS from levee shoulder

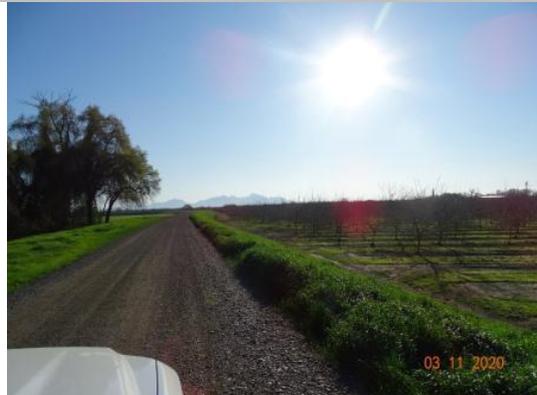
Photo 1 of 1 : SP_2020_ST0003_264_137_20200313_00280.jpg

View of the vegetation along the landside slope. Spring 2020.

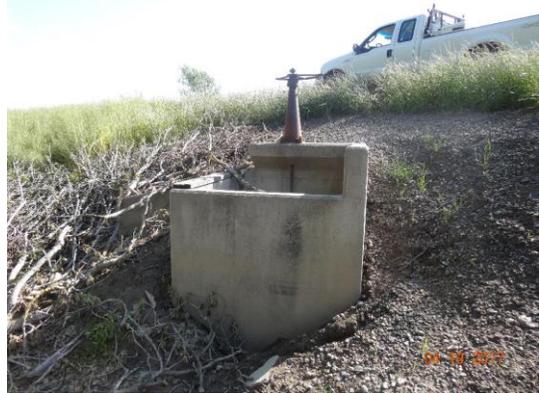
Photo 2 of 3 : UCIP_SP_2020_55543_77009.jpg

Depression around WS concrete box

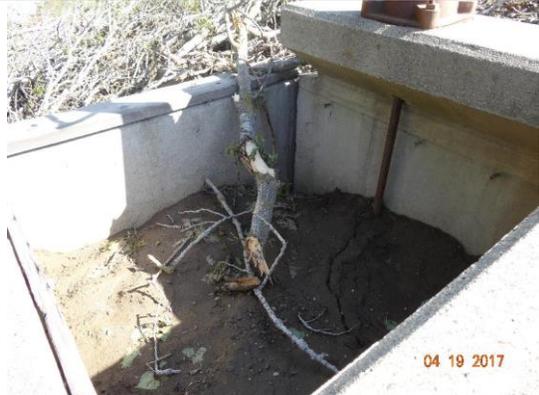
Photo 3 of 3 : UCIP_SP_2020_55543_77010.jpg

WS concrete box full of silt.

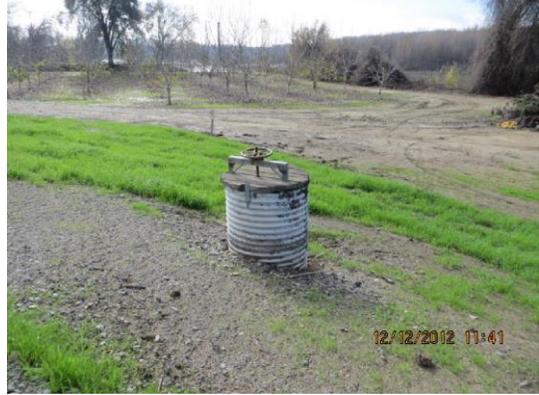
Photo 2 of 3 : UCIP_SP_2020_55547_47201.jpg

WS view: overview of CMP riser

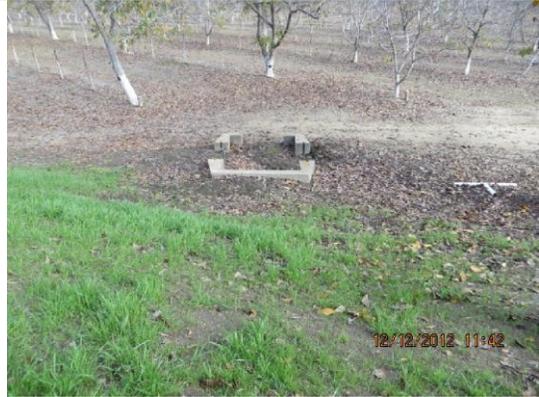
Photo 3 of 3 : UCIP_SP_2020_55547_47200.jpg

LS view: overview of concrete box

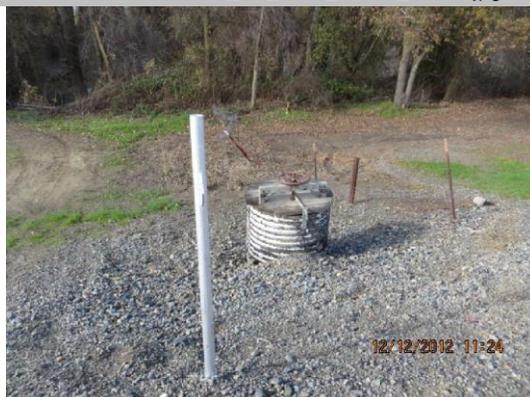
Photo 1 of 3 : UCIP_SP_2020_55550_47208.jpg

DS_ID:17295
 FS_ID:55550
 EP_NO: 9529
 Repair Type: Non-Urgent
 Crossing Status: Found
 UCIP Comments: 07/31/2019 Record has been updated to from No Action Needed to Non-Urgent; internal inspection found some issues with the pipe. Pipe has been noted as abandoned since 2012. Recommend LMA prepare a contingency plan for increased inspections during high-water to identify any pipe integrity or levee integrity issues that might arise with abandoned pipe. Record will remain in UCIP's list as part of future inspections until the pipe is properly removed or abandoned according to Title 23 requirements. Need to clarify ownership for this crossing. (O. Magana - DWR UCIP)09/21/2017 Permit review indicates this 24-inch pipe was authorized as an irrigation and drainage pipe under ABO issued as Permit No. 9529, structure description was updated. Structure type logged as drainage. (DWR UCIP - O. Magana)
 04/19/2017 Abandoned- needs to be done so properly. (DWR Sutter Yard- Afreitag)10/31/2016 Abandoned. (DWR Sutter Yard-Afreitag)06/13/2016 Pipe was exposed and camera inspected by Nor-Cal Pipeline Services 10/29/2015. Photos of the exposed pipe ends were uploaded on 4/1/2015. The internal inspection showed some signs of rust but no visible holes or deterioration were found. After the inspection the pipe ends were capped and reburied.06/09/2016 Khalida Fazel of UCIP requests that any photos of the pipe when it was exposed for a video inspection be kindly uploaded here.04/04/2016 Proper abandonment of pipe is needed. Pipe has been buried again after it was dug up and video inspected, so was not visible on LS. Note that landowner has regraded LS slope so drainage is now to the east (toward LS).04/01/2015 Both WS and LS pipe ends have been dug up in preparation for an internal camera inspection. Pipe shows signs of heavy rust and both ends of pipe are plugged with soil.06/30/2014 Same as last inspection.12/18/2013 Same as last inspection.07/23/2013 Same as last inspection.12/12/2012 Only a CMP riser with slide gate found on WS. (P. Amatya - DWR UCIP) FIELD_STRUCT_DESC: *ABANDONED* 24-inch irrigation and drainage pipe through the levee, invert 11.5 feet below the crown. Slide gate in a corrugated metal pipe (CMP) riser on the waterside (WS) slope. (24-inch pipe [HLM 8.55] authorized under Automatic Board Order (ABO) issued as Permit No. 9529, 1974 - Dorwood Ranching Co.) [Additional Reference(s): DWR Levee Log, 2002. USACE Sacramento O&M Manual 136, March 1960 (HLM 8.55)]

WS view: overview of CMP riser

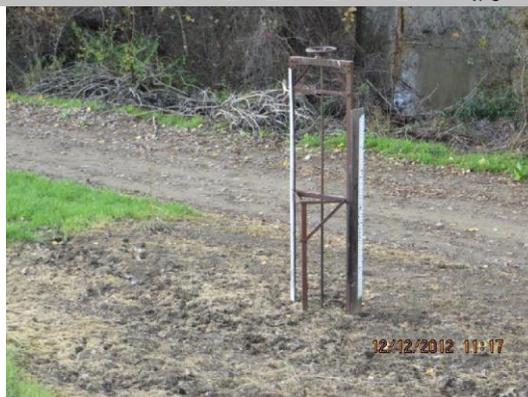
Photo 2 of 3 : UCIP_SP_2020_55552_47209.jpg

WS view: burried slide gate

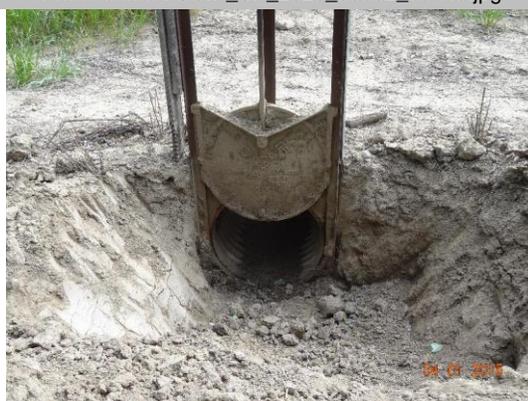
Photo 3 of 3 : UCIP_SP_2020_55552_73649.jpg

WS pipe end

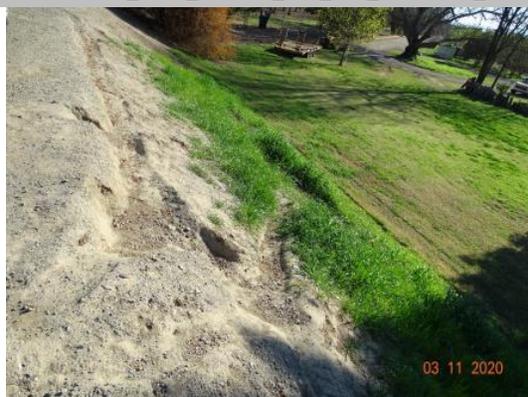
Photo 1 of 1 : SP_2020_ST0003_264_139_20200313_00281.jpg

LM Start	8.63	Rating **	M	Issue No.	139
LM End	8.63	Issue Type +	Ma	Location *	LS
Category	Earthen Levee			GPS Latitude/Longitude	
				Start	End
Item	Slope Stability			39.250656 °	39.250656 °
				-121.998400 °	-121.998400 °
DWR ID	DWR_ST0003_01_s_2020_139				
Comment Code					
S3 : Repair the levee slope damaged by vehicle traffic and prevent access where possible.					
Inspector Comment

View of the levee slope damaged by vehicular traffic. Spring 2020.

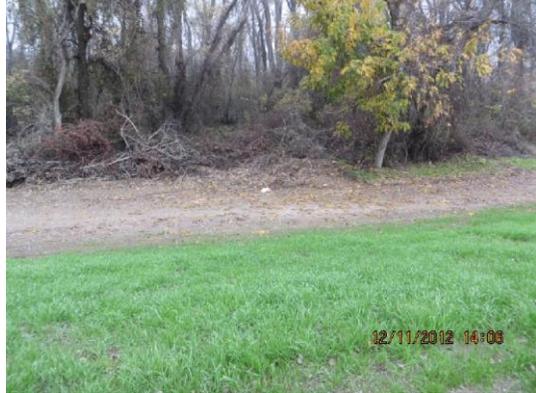
Photo 1 of 3 : UCIP_SP_2020_55554_47242.jpg

Comment Code					
Inspector Comment					
<p>DS_ID:17355 FS_ID:55554 EP_NO: N/A Repair Type: Non-Urgent Crossing Status: Found UCIP Comments: 07/31/2019 Record has been updated to Non-Urgent; internal inspection found some issues with pipe. Pipe has been abandoned since 2012 (both inlet/outlet have been covered to avoid soil buildup inside). Record will remain in UCIP's list as part of future inspections until the pipe is properly removed or abandoned according to Title 23 requirements. Need to clarify ownership for this crossing. (O. Magana - DWR UCIP)04/19/2017 Abandoned- needs to be done so properly. (DWR Sutter Yard- Afreitag)10/31/2016 Abandoned. (DWR Sutter Yard- Afreitag)06/13/2016 Pipe was internally cleaned and camera inspected on 10/30/2015 by Nor-Cal Pipeline Services. WS cap was removed and 100.6ft of pipe were inspected starting from the WS opening. Inspection revealed rusting but no visible holes or other deterioration were found. Pipe was recapped after the inspection. This pipe is always visible so no new photos were taken during the inspection.06/09/2016 Khalida Fazel of UCIP requests that any photos of the pipe when it was exposed for a video inspection be kindly uploaded here.04/01/2015 Pipe is in same condition. It has been selected for an internal camera inspection. New 06/30/2014 Same as last inspection.12/18/2013 Same as last inspection.07/23/2013 Same as last inspection.12/11/2012 CMP pipe on WS capped with steel plate. (P. Amatya - DWR UCIP) FIELD_STRUCT_DESC: *ABANDONED* 24-inch corrugated metal drainage pipe through the levee, 13.5 feet below the crown. Slide gate on the landside (LS) headwall. Steel plate welded on the waterside (WS) end. [Additional Reference(s): DWR Levee Log, 2002. USACE Sacramento O&M Manual 136, March 1960 (HLM 9.4)]. FS Date: 7/31/2019 1:54:00 PM</p>

WS view: overview

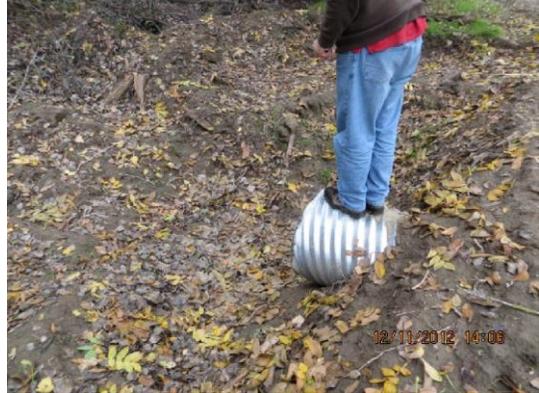
Photo 2 of 3 : UCIP_SP_2020_55554_47241.jpg

WS view: overview of CMP pipe

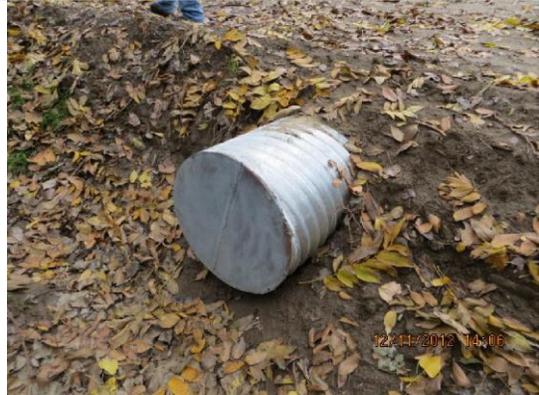
Photo 3 of 3 : UCIP_SP_2020_55554_47240.jpg

WS view: capped CMP pipe

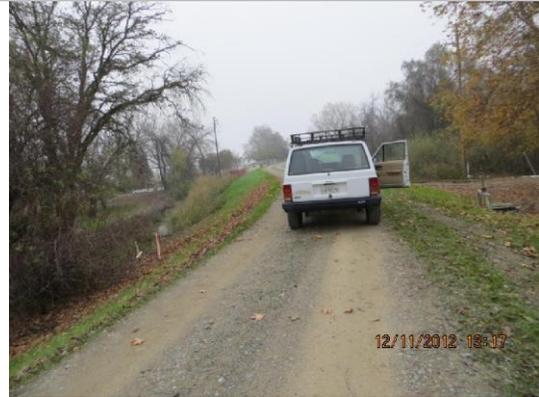
Photo 1 of 3 : UCIP_SP_2020_55558_47263.jpg

Comment Code					
Inspector Comment					
<p>DS_ID:17358 FS_ID:55558 EP_NO: 9517 Repair Type: Non-Urgent Crossing Status: Found UCIP Comments: 07/31/2019 Record has been updated from No Action Needed to Non-Urgent; slide gate handle is still damage and CMP riser lid needs to be repaired. Recommend auditing this record to determine current owner for 48-inch pipe and to obtain maintenance records for ditch and pipes running along LS toe. (O. Magana - DWR UCIP)04/19/2017 No WS end found/ slide gate handle broken. (DWR Sutter Yard- Afreitag)10/31/2016 Slide gate handle is broken and no WS pipe end can be located. (DWR Sutter Yard- Afreitag)06/01/2016 WS slide gate handle is still broken. No WS pipe end was found.04/01/2015 Slide gate handle is still broken. The rest of the pipe appears in good condition. Broken slide gate handle found on WS.06/30/2014 Same as last inspection.12/18/2013 Same as last inspection.07/23/2013 Same as last inspection. FIELD_STRUCT_DESC: 48-inch corrugated metal drainage pipe through the levee, 14 feet below the crown. Slide gate in a 60-inch corrugated metal pipe (CMP) riser on the waterside (WS) slope. Slide gate in a concrete distribution box on the landside (LS) toe. (48-inch pipe [HLM 10.39] authorized under Automatic Board Order (ABO) issued as Permit No. 9517, 1974 - Griffin. [Additional Reference(s): DWR Levee Log, 2002. USACE Sacramento O&M Manual 136, March 1960 (HLM 10.47)]. FS Date: 7/31/2019 1:55:00 PM</p>

Crown view: overview (both sides of the levee)

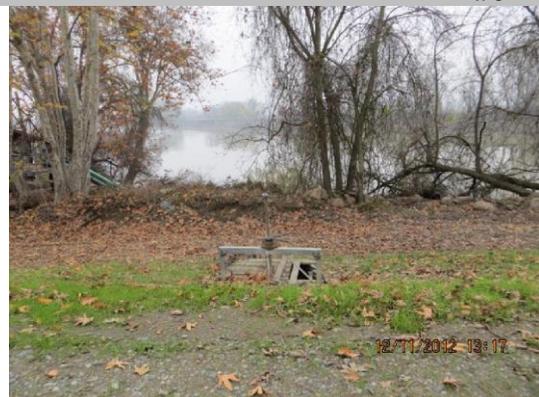
Photo 2 of 3 : UCIP_SP_2020_55558_47262.jpg

WS view: overview of CMP riser

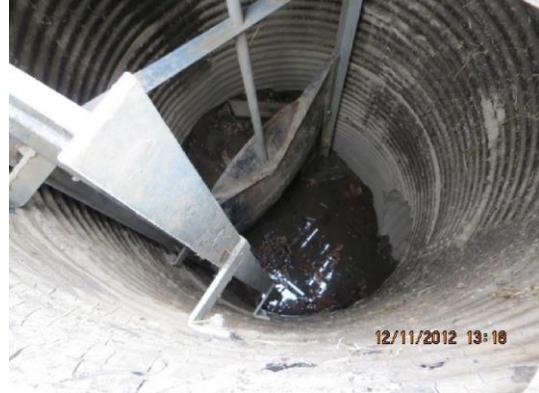
Photo 3 of 3 : UCIP_SP_2020_55558_47268.jpg

WS view: inside CMP riser

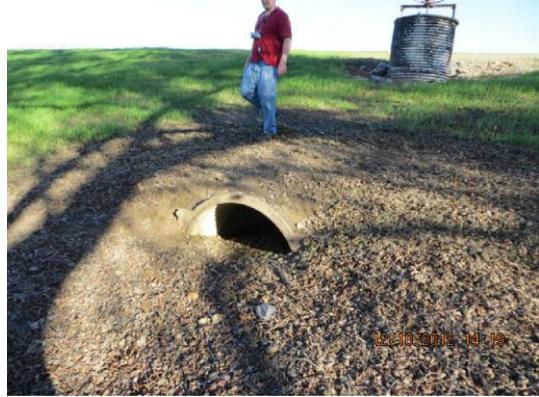
Photo 2 of 3 : UCIP_SP_2020_55576_47342.jpg

WS view: overview of CMP riser and outlet pipe

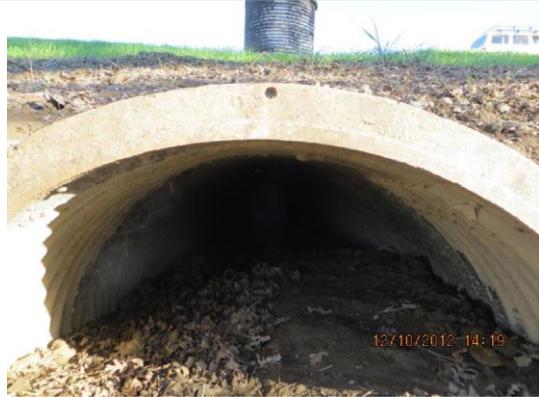
Photo 3 of 3 : UCIP_SP_2020_55576_47341.jpg

WS view: silted concrete lined CMP outlet pipe

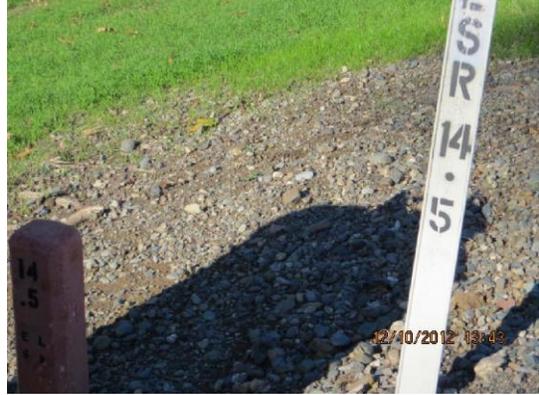
Photo 2 of 3 : UCIP_SP_2020_55579_47361.jpg

WS view: levee mile marker

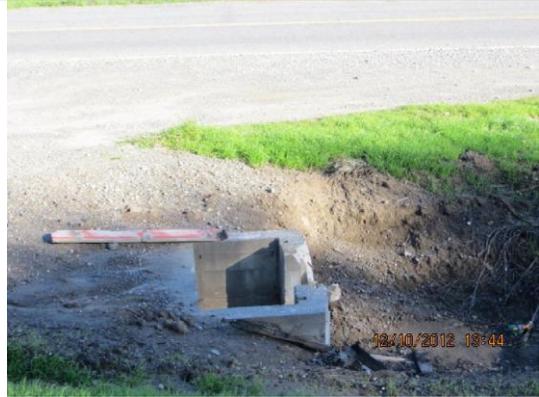
Photo 3 of 3 : UCIP_SP_2020_55579_47360.jpg

LS view: overview of distribution box

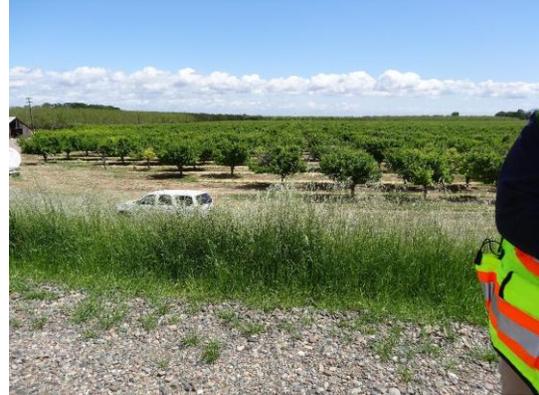
Photo 2 of 3 : UCIP_SP_2020_55591_75097.jpg

View of LS from crown at location of crossing.

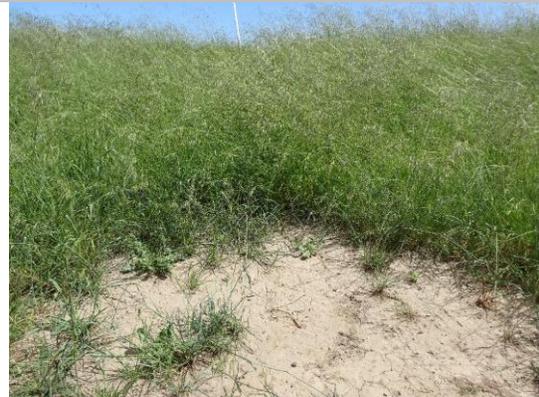
Photo 3 of 3 : UCIP_SP_2020_55591_75098.jpg

Looking up WS slope: bare spot where pipe was previously excavated, video inspected, and backfilled.

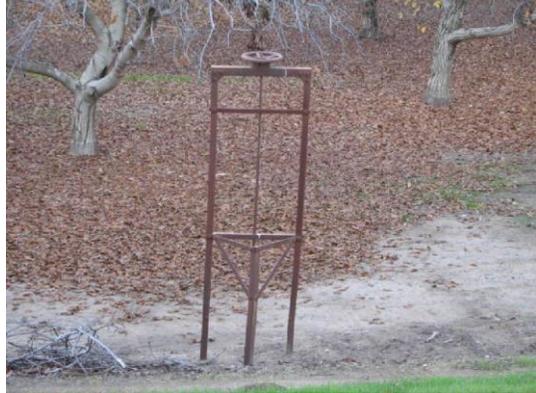
Photo 2 of 3 : UCIP_SP_2020_55599_47386.jpg

WS view: slide gate steel structure

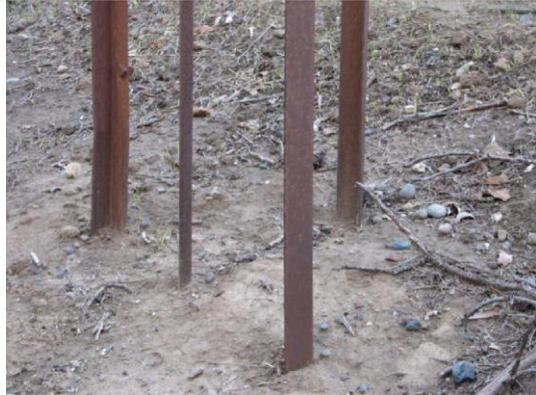
Photo 3 of 3 : UCIP_SP_2020_55599_47385.jpg

WS view: burried slide gate

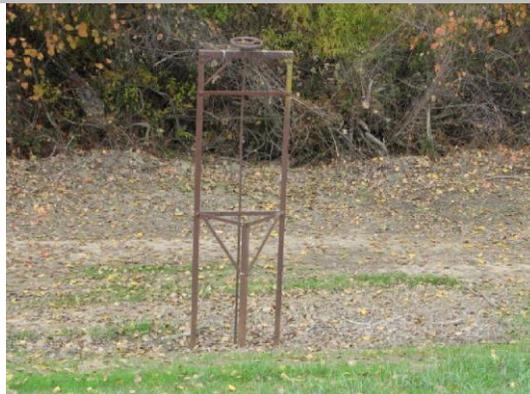
Photo 1 of 3 : UCIP_SP_2020_55616_47447.jpg

DS_ID:17347
 FS_ID:55616
 EP_NO: N/A
 Repair Type: Non-Urgent
 Crossing Status: Found
 UCIP Comments: 08/05/2019 Crossing has been updated from No Action Needed to Non-Urgent due to missing records indicating extent of grout plug through pipe. Only slide gate is visible on the WS. No permit has been identified for this crossing. Need to contact owner to abandon or remove pipe properly according to Title 23 requirements. (O. Magana - DWR UCIP)04/20/2017 Abandoned- plugged. (DWR Sutter Yard- AFreitag)11/01/2016 Abandoned/plugged. (DWR Sutter Yard- AFreitag)06/16/2016 Internal camera inspection was done on 11/19/2015 by Nor-Cal Pipeline Services. Pipe was inspected starting from the WS end and inspected up to the grout plug that is 13.7ft into the pipe. Pipe was then capped and reburied until further abandonment can be achieved.04/02/2015 WS end of pipe was dug up in preparation for internal camera inspection. 07/02/2014 Same as last inspection.12/19/2013 Same as last inspection.07/24/2013 Same as last inspection.12/11/2012 Only steel slide gate structure found on WS. (P. Amatya - DWR UCIP)

WS view: overview of abandoned slide gate structure

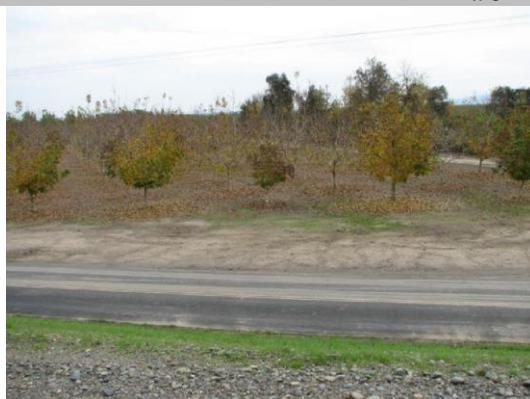
Photo 2 of 3 : UCIP_SP_2020_55616_47446.jpg

LS view: overview (no pipes)

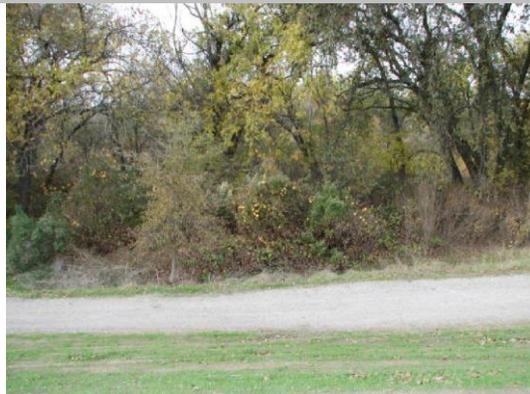
Photo 1 of 3 : UCIP_SP_2020_56037_47449.jpg

Comment Code					
Inspector Comment					
<p>DS_ID:17487 FS_ID:56037 EP_NO: N/A Repair Type: Urgent Crossing Status: Found UCIP Comments: 08/05/2019 Crossing has been upgraded from Non-Urgent to Urgent due to photos taken in 2012 that show deteriorated pipe on the WS. Unable to complete thorough inspection due to dense vegetation on the WS. No permit has been identified authorizing crossing. Crossing has been abandoned, if crossing is no longer used owner will need to coordinate with the CVFPB to remove or abandon according to Title 23 requirements. (O. Magana - DWR UCIP)04/20/2017 Abandoned- needs to be done so properly. (DWR Sutter Yard- AFreitag)11/01/2016 Abandoned.(DWR Sutter Yard- AFreitag)06/03/2016 Abandoned crossing.04/02/2015 Same as last inspection. 07/02/2014 Same as last inspection.12/19/2013 Same as last inspection.07/24/2013 Same as last inspection.12/11/2012 Slide Gate WS not found. An abandoned pump and steel pipe found on WS. A 6 ft x 8 ft concrete distribution box with a CMP found on LS. Box filled with soil. An abandoned crossing. (P. Amatya - DWR UCIP) FIELD_STRUCT_DESC: *ABANDONED* 36-inch corrugated metal drainage pipe through the levee, invert 21.7 feet below the crown. Abandoned pump and steel pipe found on the waterside (WS). 6 foot by 8 foot concrete distribution box with the 36-inch corrugated metal pipe found on the landside (LS). [Additional Reference(s): USACE Sacramento O&M Manual 136, March 1960 (HLM 19.61)]. FS Date: 8/5/2019 3:07:00 PM</p>

WS view: overview

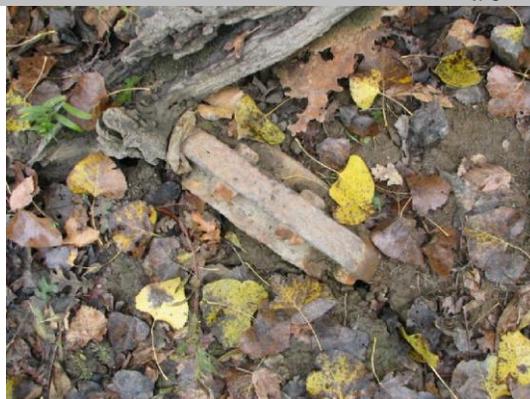
Photo 2 of 3 : UCIP_SP_2020_56037_47448.jpg

WS view: abandoned and ruined pipe

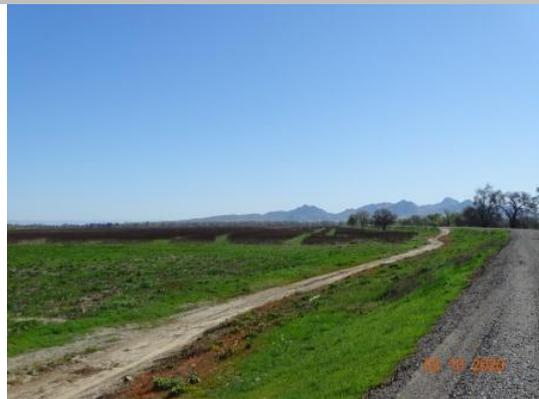
Photo 1 of 1 : SP_2020_ST0003_265_8_20200313_00014.jpg

View of the vegetation on the waterside slope. Spring 2020.

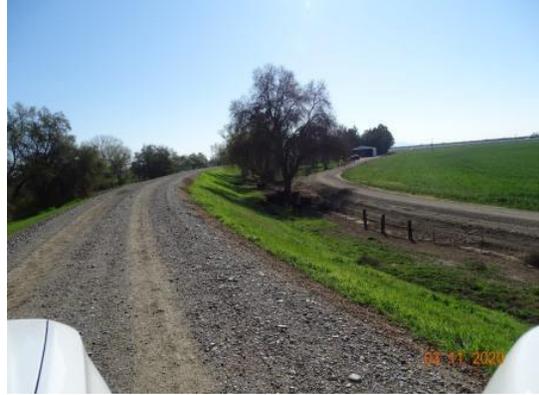
Photo 1 of 1 : SP_2020_ST0003_267_2_20200313_00004.jpg

View of the vegetation on the landside slope. Spring 2020.

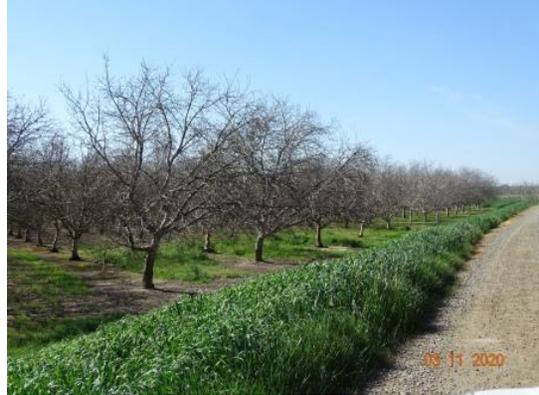
Photo 1 of 1 : SP_2020_ST0003_268_7_20200313_00006.jpg

View of the vegetation on the landside slope. Spring 2020.
