**Flood Control Project Maintenance
Levee Inspections**
LMA District Cover Sheet
Spring 2020 Levee Inspection Results

Sacramento Maintenance Yard East Levee Yolo Bypass

Spring 2020 Levee Inspection Results

Waterway	Bank	Unit Miles
Unit No. 01 Yolo Bypass	Left	2.01

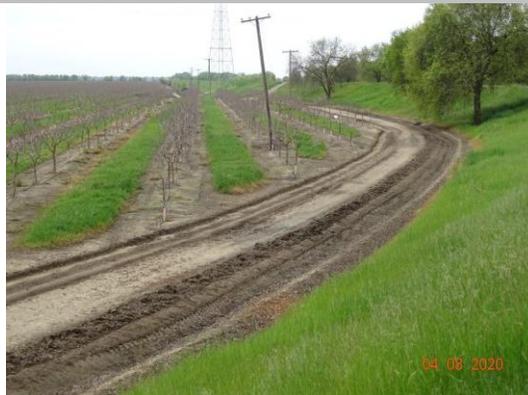
Photo 1 of 1 : SP_2020_ST0004_41_2_20200409_00011.jpg

LM Start	0.01	Rating **	M	Issue No.	2
LM End	0.15	Issue Type +	En	Location *	LS
Category	Earthen Levee		GPS Latitude/Longitude		
			Start	End	
Item	Encroachments		38.765181 °	38.763164 °	
			-121.635131 °	-121.635438 °	
DWR ID	DWR_ST0004_01_f_2018_2				
Comment Code					
DT : Ditch					
Inspector Comment					
Landowner has dug an irrigation ditch within the landside easement.

View of irrigation ditch at landside toe. Spring 2020.

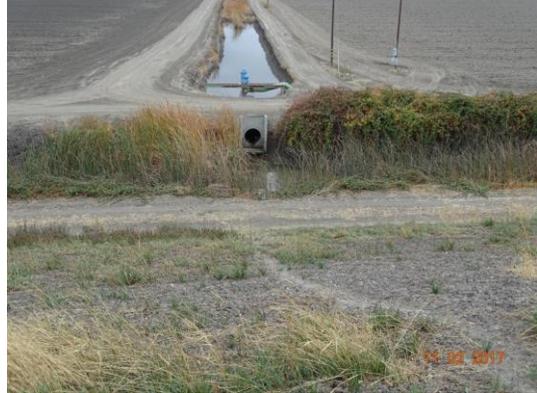
Photo 1 of 2 : SP_2020_ST0004_41_1_20200228_00001.jpg

LM Start	1.51	Rating **	A/W	Issue No.	1
LM End	1.51	Issue Type +	Ob	Location *	LS
Category	Earthen Levee		GPS Latitude/Longitude		
			Start	End	
Item	Erosion / Bank Caving		38.743573 °	38.743573 °	
			-121.634128 °	-121.634128 °	
DWR ID	DWR_ST0004_01_s_2020_1				
Comment Code					
E1 : Note and monitor erosion site.					
Inspector Comment					
Erosion on a side of a ditch toward LS toe caused by water coming out of irrigation canal. Recommend monitoring.

View of erosion on toe road. Fall 2017.

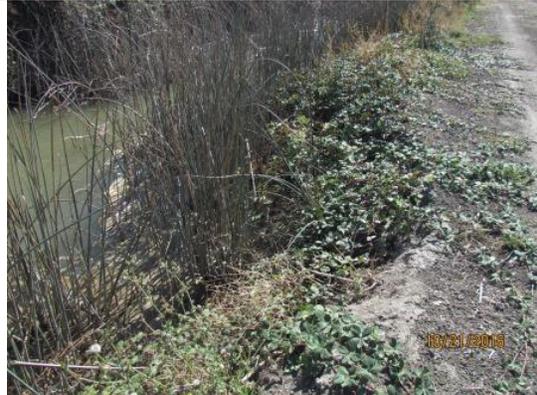
Photo 2 of 2 : SP_2020_ST0004_41_1_20200228_00002.jpg

Irrigation ditch erosion on landward side toward LS levee toe. Fall 2016.

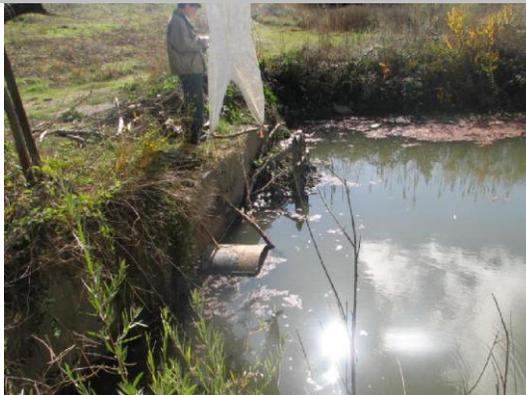
Photo 3 of 3 : UCIP_SP_2020_53253_60259.jpg

Waterside view: overview steel pipes and concrete headwall

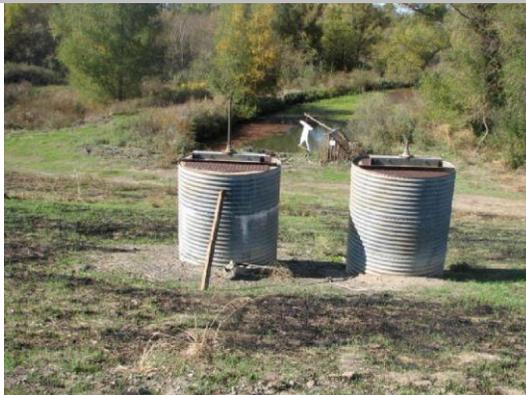
Photo 1 of 3 : UCIP_SP_2020_53254_60269.jpg

Waterside view: overview of CMP standpipe and water body

Comment Code					
Inspector Comment					
DS_ID:840 FS_ID:53254 EP_NO: N/A Repair Type: No Action Needed Crossing Status: Found UCIP Comments: FIELD_STRUCT_DESC: 2 of 2: 48-inch corrugated metal drainage pipe through the levee, 28.5 feet below the crown. 30-inch steel pipe sleeved through the 48-inch pipe. Slide gate in a 60-inch pipe riser on the waterside (WS) slope. [Additional Reference(s): DWR Levee Log, 1981. USACE Sacramento O&M Manual 123, August 1955, (Station 382+85)]. No permit or as-built drawing available. FS Date: 11/21/2018 8:34:20 AM
