**Flood Control Project Maintenance
Levee Inspections**

Fall 2019 Levee Maintenance Deficiency Summary Report

Sutter Maintenance Yard Hamilton Bend

Levee Inspection Report By Mile - Fall 2019

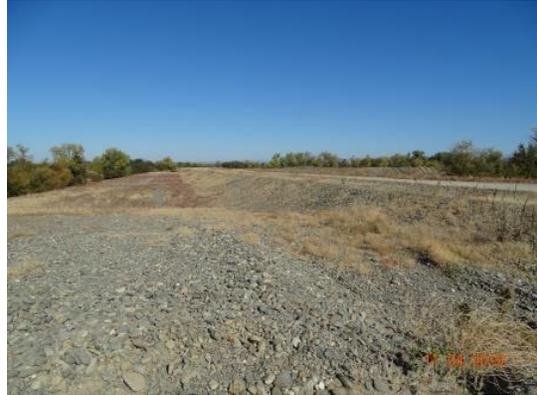
Photo 1 of 1 : FA_2019_ST0005_289_3_20191112_00014.jpg

LM Start	0.01	Rating **	A	Issue No.	3
LM End	1.22	Issue Type +	Ma	Location *	LS
Category	Earthen Levee		GPS Latitude/Longitude		
			Start	End	
Item	Vegetation		39.439751°	39.456833°	
			-121.641555°	-121.639321°	
DWR ID	DWR_ST0005_01_f_2019_3				
Comment Code					
V1 : Control annual grass and weeds on the levee slopes and easements.					
Inspector Comment					
The annual vegetation is well maintained through this section, Fall 2019.

View looking upstream landside at the well maintained annual vegetation, Fall 2019.

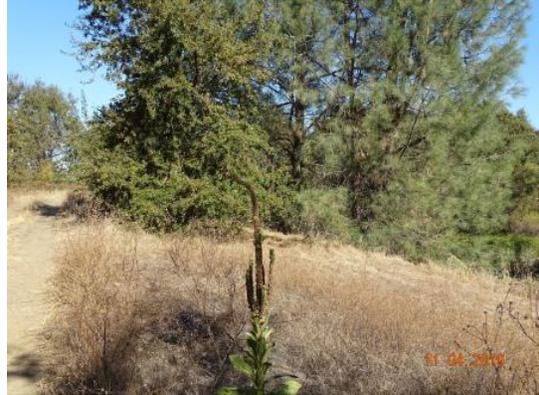
Photo 1 of 1 : FA_2019_ST0005_289_18_20191112_00015.jpg

LM Start	1.48	Rating **	U	Issue No.	18
LM End	1.99	Issue Type +	Ma	Location *	WS
Category	Earthen Levee		GPS Latitude/Longitude		
			Start	End	
Item	Trim / Thin Trees		39.458053°	39.461949°	
			-121.636300°	-121.629563°	
DWR ID	DWR_ST0005_01_s_2017_18				
Comment Code					
T3 : Trim and thin trees to allow visibility of the ground and room to flood fight.					
Inspector Comment					
Trim/Thin Trees from Levee Mile 1.48 to 1.99. The LMA does not maintain the levee from Levee Mile 1.38 to 3.39.

View looking upstream of thick trees and vegetation blocking visibility on waterside, Fall 2019.

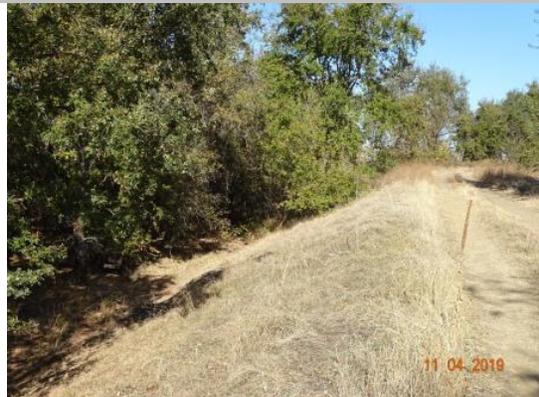
Photo 1 of 1 : FA_2019_ST0005_289_11_20191112_00016.jpg

LM Start	1.48	Rating **	U	Issue No.	11
LM End	3.25	Issue Type +	Ma	Location *	LS
Category	Earthen Levee		GPS Latitude/Longitude		
			Start	End	
Item	Trim / Thin Trees		39.458055°	39.470312°	
			-121.636300°	-121.609242°	
DWR ID	DWR_ST0005_01_s_2017_11				
Comment Code					
T3 : Trim and thin trees to allow visibility of the ground and room to flood fight.					
Inspector Comment					
Trim/Thin Trees from Levee Mile 1.48 to 3.25. The LMA does not maintain the levee from Levee Mile 1.38 to 3.39.

View looking upstream of thick trees blocking visibility on landside, Fall 2019.

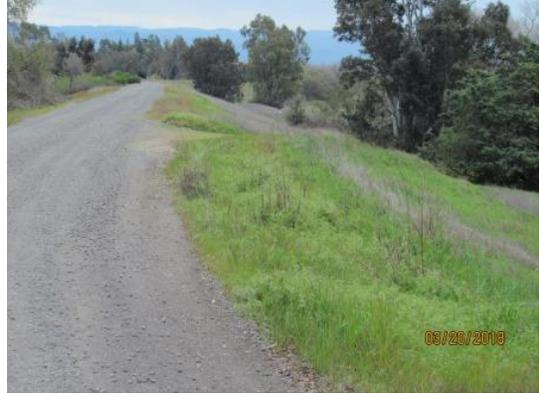
Photo 1 of 1 : FA_2019_ST0005_289_17_20190904_00006.jpg

LM Start	1.50	Rating **	U	Issue No.	17
LM End	1.96	Issue Type +	Ma	Location *	WS
Category	Earthen Levee		GPS Latitude/Longitude		
			Start	End	
Item	Vegetation		39.458131°	39.461634°	
			-121.635916°	-121.629926°	
DWR ID	DWR_ST0005_01_f_2017_17				
Comment Code					
V2 : Remove the wild growth other than native grasses from the levee slopes.					
Inspector Comment					
Maintain annual grasses from Levee Mile 1.50 to 1.96. The LMA does not maintain the levee from Levee Mile 1.38 to 3.39.

View looking upstream waterside of annual grasses that need to be maintained.

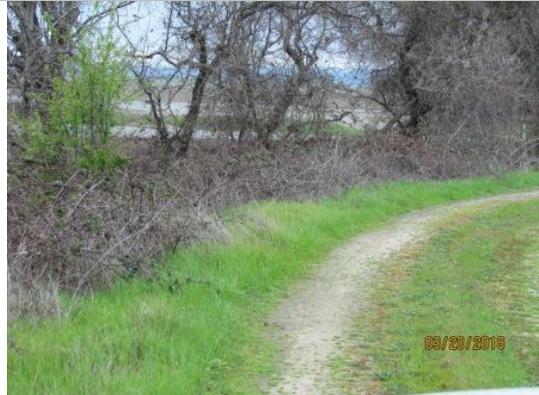
Photo 1 of 1 : FA_2019_ST0005_289_6_20190904_00002.jpg

LM Start	1.50	Rating **	U	Issue No.	6
LM End	2.63	Issue Type +	Ma	Location *	LS
Category	Earthen Levee		GPS Latitude/Longitude		
			Start	End	
Item	Vegetation		39.458132°	39.466025°	
			-121.635914°	-121.618972°	
DWR ID	DWR_ST0005_01_f_2016_6				
Comment Code					
V2 : Remove the wild growth other than native grasses from the levee slopes.					
Inspector Comment					
Blackberries covering slope from Levee Mile 1.50 to 2.63. The LMA does not maintain the levee from Levee Mile 1.38 to 3.39.

View looking upstream landside of blackberries that are covering the landside slope.

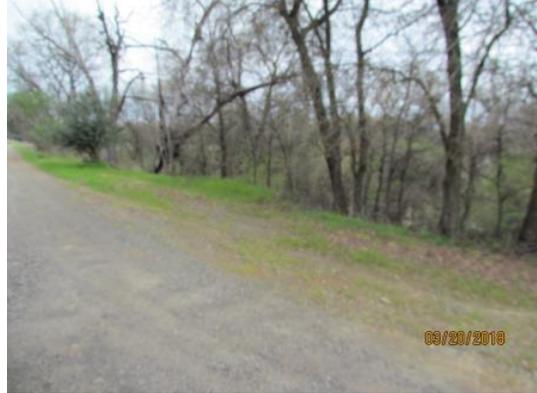
Photo 1 of 1 : FA_2019_ST0005_289_4_20190904_00001.jpg

LM Start	3.23	Rating **	U	Issue No.	4
LM End	3.27	Issue Type +	Ma	Location *	WS
Category	Earthen Levee			GPS Latitude/Longitude	
				Start	End
Item	Trim / Thin Trees			39.470063°	39.470558°
				-121.609264°	-121.609215°
DWR ID	DWR_ST0005_01_s_2013_4				
Comment Code					
T3 : Trim and thin trees to allow visibility of the ground and room to flood fight.					
Inspector Comment					
Small trees 4" in diameter at chest height should be removed before they get too big from Levee Mile 3.23 to 3.27. Levee Mile 1.38 to 3.39 has never been maintained by the LMA.

View looking upstream waterside of small trees 4" in diameter at chest height should be removed before they get too big.

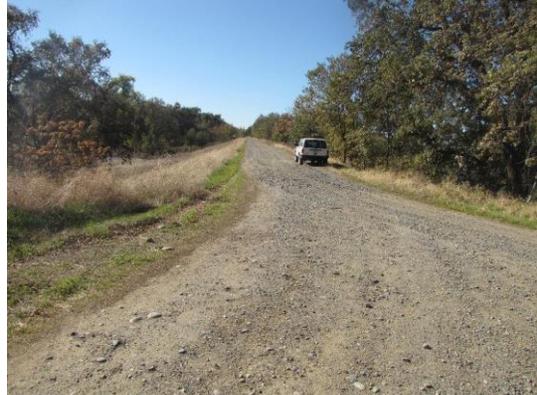
Photo 1 of 3 : UCIP_FA_2019_55888_21682.jpg

Comment Code					
Inspector Comment					
DS_ID:17044 FS_ID:55888 EP_NO: N/A Repair Type: Non-Urgent Crossing Status: Indicator Found UCIP Comments: 05/07/2019 Limited access--Unable to inspect crossing due to steep slopes and dense vegetation. (O. Magana - DWR UCIP)04/26/2016 Unable to access area near structure.05/14/2013 Same as last inspection.11/14/2012 Abandoned Structure: WS-remance of gates and concrete standpipe; LS-remance of concrete headwall and pump station. FIELD_STRUCT_DESC: *ABANDONED* [Western Canal Head Gate Inlet Structure] 1 of 2: 96-inch by 96-inch (8-foot by 8-foot) reinforced concrete culverts through the levee 25 feet below the crown. Three slide gates on the waterside (WS) end. Concrete stairs on the WS slope. Concrete headwall at both WS and landside (LS) toes. [Additional Reference(s): DWR Levee Log, 2005. USACE Sacramento O&M Manual 152, March 1957 (Station 170+00)] FS Date: 5/7/2019 12:36:00 PM

View of levee crown looking downstream.

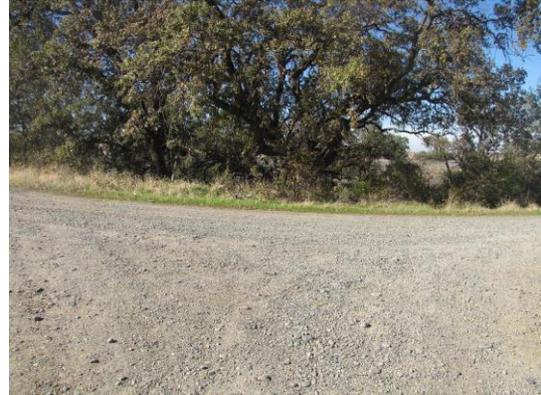
Photo 2 of 3 : UCIP_FA_2019_55888_21681.jpg

Comment Code					
Inspector Comment					
DS_ID:17044 FS_ID:55888 EP_NO: N/A Repair Type: Non-Urgent Crossing Status: Indicator Found UCIP Comments: 05/07/2019 Limited access--Unable to inspect crossing due to steep slopes and dense vegetation. (O. Magana - DWR UCIP)04/26/2016 Unable to access area near structure.05/14/2013 Same as last inspection.11/14/2012 Abandoned Structure: WS-remance of gates and concrete standpipe; LS-remance of concrete headwall and pump station. FIELD_STRUCT_DESC: *ABANDONED* [Western Canal Head Gate Inlet Structure] 1 of 2: 96-inch by 96-inch (8-foot by 8-foot) reinforced concrete culverts through the levee 25 feet below the crown. Three slide gates on the waterside (WS) end. Concrete stairs on the WS slope. Concrete headwall at both WS and landside (LS) toes. [Additional Reference(s): DWR Levee Log, 2005. USACE Sacramento O&M Manual 152, March 1957 (Station 170+00)] FS Date: 5/7/2019 12:36:00 PM

View of levee crown at right bend.

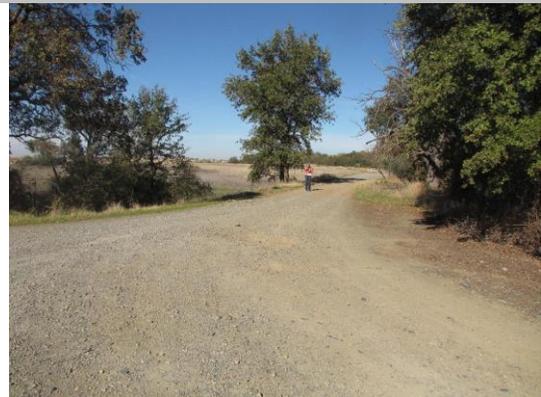
Photo 3 of 3 : UCIP_FA_2019_55888_21680.jpg

View of levee looking upstream.

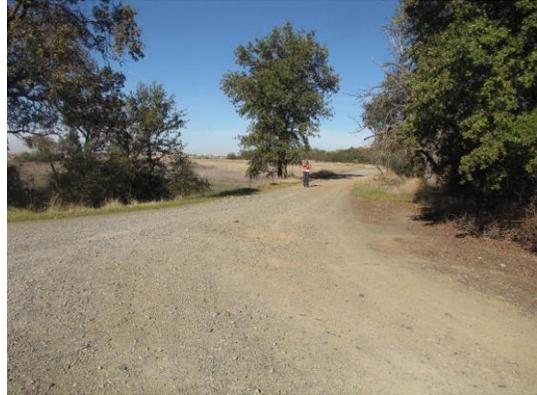
Photo 3 of 3 : UCIP_FA_2019_55889_21695.jpg

Comment Code					
Inspector Comment					
DS_ID:17056 FS_ID:55889 EP_NO: N/A Repair Type: Non-Urgent Crossing Status: Indicator Found UCIP Comments: 05/07/2019 Limited access--Unable to inspect crossing due to steep slopes and dense vegetation. (O. Magana - DWR UCIP)04/26/2016 Unable to access area near structure.05/14/2013 Same as last inspection.11/14/2012 Abandoned Structure: WS-remance of gates and concrete standpipe; LS-remance of concrete headwall and pump station. FIELD_STRUCT_DESC: *ABANDONED* [Western Canal Head Gate Inlet Structure] 2 of 2: 72-inch by 96-inch (8-foot by 8-foot) reinforced concrete culvert through the levee 25 feet below the crown. Three slide gates on the waterside (WS) end. Concrete stairs on the WS slope. Concrete headwall at both WS and landside (LS) toes. [Additional Reference(s): DWR Levee Log, 2005. USACE Sacramento O&M Manual 152, March 1957 (Station 170+00)] FS Date: 5/7/2019 12:37:00 PM

View of levee crown looking upstream at crossing.
