**Flood Control Project Maintenance  
Levee Inspections**

**Fall 2019 Levee Maintenance Deficiency Summary Report**

**Sacramento Maintenance Yard Putah Creek**

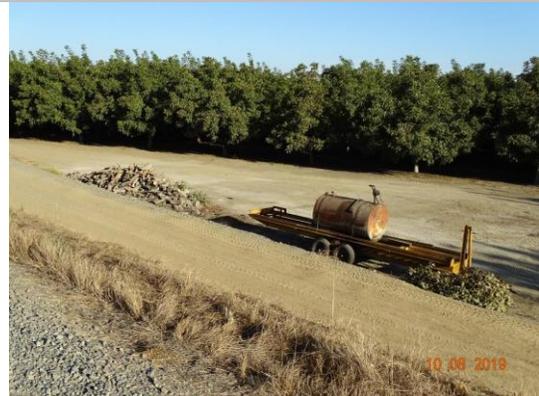
Photo 1 of 1 : FA\_2019\_ST0007\_282\_35\_20191008\_00071.jpg

LM Start	<b>3.05</b>	Rating **	M	Issue No.	<b>35</b>
LM End	<b>3.05</b>	Issue Type +	En	Location *	LS
Category	Earthen Levee			GPS Latitude/Longitude	
				Start	End
Item	Encroachments			38.519205 °	38.519205 °
				-121.682618 °	-121.682618 °
DWR ID	DWR_ST0007_01_s_2018_35				
Comment Code					
EQ : Equipment					
Inspector Comment					
Ag equipment and cut wood pile should be removed from LS toe to allow inspection and access.

View of equipment and large wood pile at the landside toe (Fall 2019).

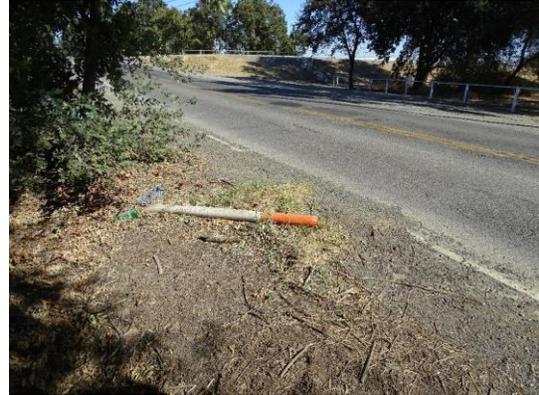
Photo 3 of 3 : UCIP\_FA\_2019\_55454\_81751.jpg

Item	DRAFT DWR UCIP Field Study			38.520250°	38.520250°
				-121.695250°	-121.695250°
DWR ID	589				
Comment Code					
Inspector Comment					
DS_ID:589 FS_ID:55454 EP_NO: 17144 Repair Type: Non-Urgent Crossing Status: Indicator Found UCIP Comments: 10/22/2019 Fiber optic line marker bent and broken near bridge on west side on Macy Blvd. (O.Yakimov - DWR UCIP) FIELD_STRUCT_DESC: 5-inch steel conduit containing fiber optic cables across and under the levee at Mace Boulevard 50 feet below the crown. White and orange paddle marker is located 10 feet West of Mace Boulevard approximately 400 feet north of levee crossing. (5-inch pipe authorized under Permit No. 17144, 2000 - Williams Communications) FS Date: 10/22/2019 3:28:24 PM

Bent to the ground line marker near Macy Blvd bridge

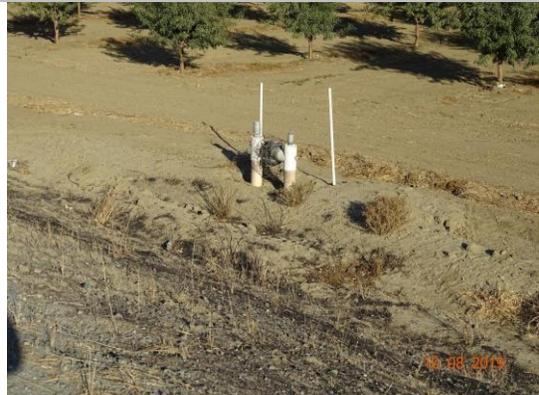
Photo 1 of 1 : FA\_2019\_ST0007\_282\_39\_20191008\_00076.jpg

LM Start	<b>4.32</b>	Rating **	M	Issue No.	<b>39</b>
LM End	<b>4.80</b>	Issue Type +	En	Location *	LS
Category	Earthen Levee			GPS Latitude/Longitude	
				Start	End
Item	Encroachments			38.518280 °	38.518041 °
				-121.704657 °	-121.713680 °
DWR ID	DWR_ST0007_01_s_2018_39				
Comment Code					
PI : Pipe					
Inspector Comment					
<p>Newly planted orchard on LS appears to have installed a water pipe with visible risers parallel to levee approx 8 feet from toe. This pipe should be verified, and owner should contact CVFPB for direction.</p>

View of irrigation riser within 10 feet of the toe (Fall 2019).

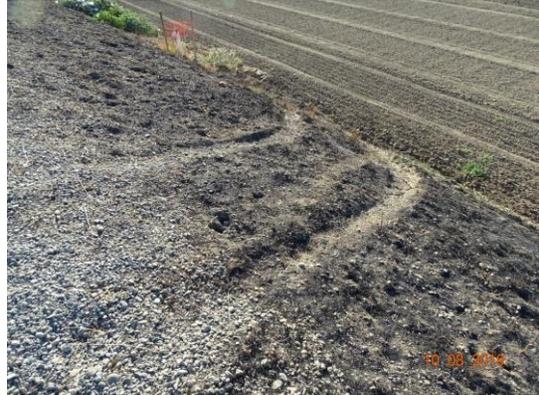
Photo 1 of 1 : FA\_2019\_ST0007\_282\_43\_20191008\_00073.jpg

View of vehicle tracks on the waterside slope (Fall 2019).

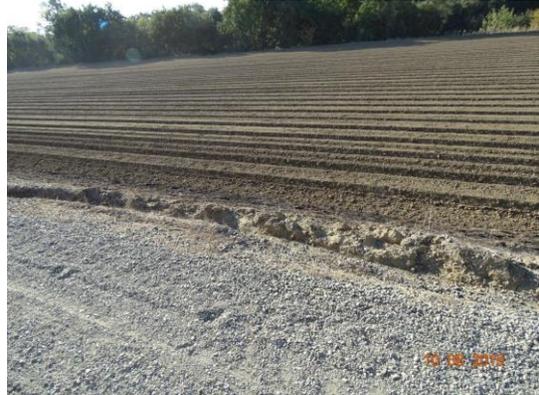
Photo 1 of 1 : FA\_2019\_ST0007\_282\_45\_20191008\_00077.jpg

View of vehicle track depression on waterside shoulder (Fall 2019).

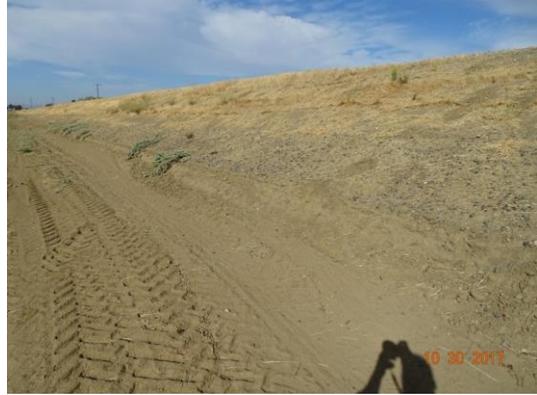
Photo 2 of 2 : FA\_2019\_ST0007\_282\_50\_20190826\_00014.jpg

LM Start	<b>5.31</b>	Rating **	A/W	Issue No.	<b>50</b>
LM End	<b>5.39</b>	Issue Type +	En	Location *	WS
Category	Earthen Levee			GPS Latitude/Longitude	
				Start	End
Item	Encroachments			38.518048 °	38.518132 °
				-121.723033 °	-121.724473 °
DWR ID	DWR_ST0007_01_f_2017_50				
Comment Code					
AT : Agricultural tilling					
Inspector Comment					
Access road now present where agricultural tilling was.

Agricultural tilling has encroached into waterside levee toe. Activity should cease and toe should be repaired.

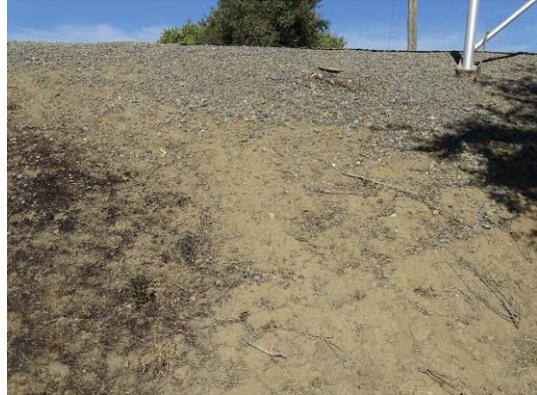
Photo 3 of 3 : UCIP\_FA\_2019\_55462\_81788.jpg

WS levee slope and broken air vent on the top

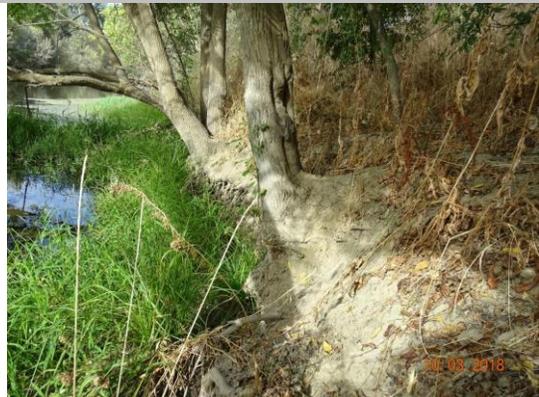
Photo 1 of 1 : FA\_2019\_ST0007\_282\_34\_20190826\_00006.jpg

View looking upstream at erosion at the waterside toe. Tree roots are exposed (September 2018).

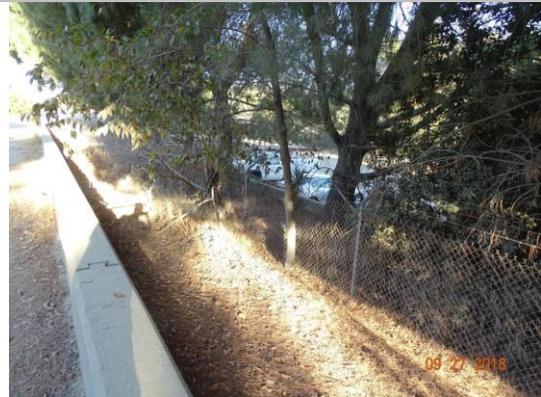
Photo 1 of 1 : FA\_2019\_ST0007\_282\_15\_20190826\_00005.jpg

View of fence (September 2018).

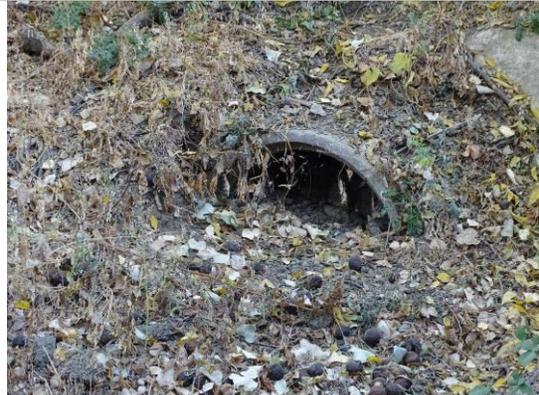
Photo 3 of 3 : UCIP\_FA\_2019\_55678\_82392.jpg

Sediment buildup inside the pipe and in the spillway

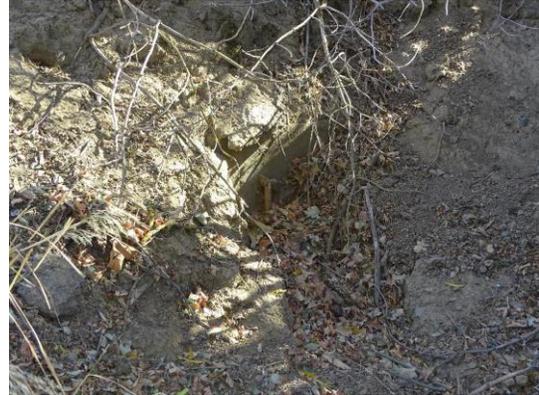
Photo 3 of 3 : UCIP\_FA\_2019\_55681\_82405.jpg

Sediment and debris buildup around flap gate

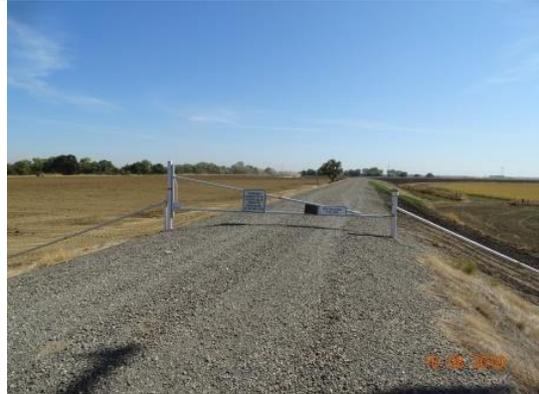
Photo 1 of 1 : FA\_2019\_ST0007\_283\_29\_20191008\_00068.jpg

View looking downstream at gate on the crown (Fall 2019).

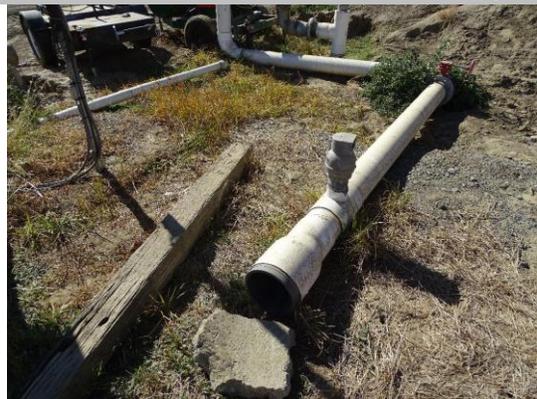
Photo 2 of 3 : UCIP\_FA\_2019\_55432\_81677.jpg

Mobile gas pump outlet pipe is disconnected

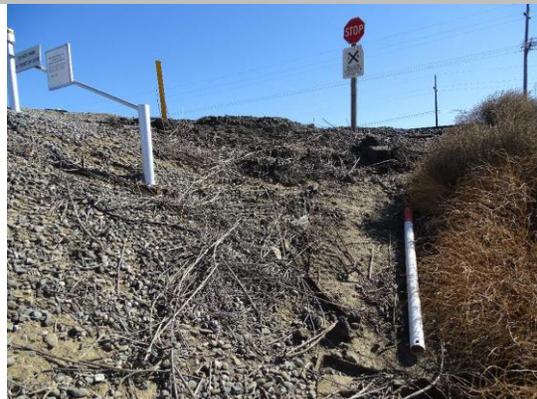
Photo 1 of 2 : UCIP\_FA\_2019\_55445\_81716.jpg

Detached fiber optic line marker on LS slope
