**Flood Control Project Maintenance  
Levee Inspections**  
**LMA District Cover Sheet**  
**Spring 2020 Levee Inspection Results**

**Sacramento Maintenance Yard Putah Creek**

**Spring 2020 Levee Inspection Results**

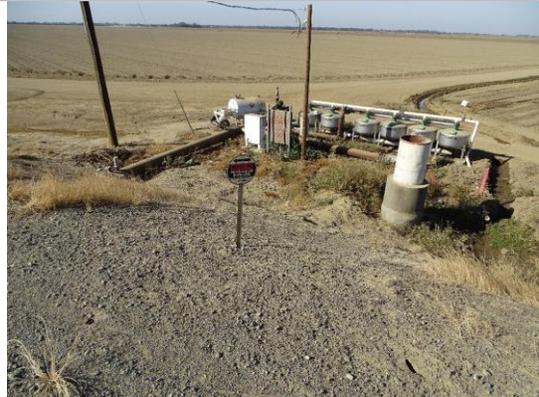
Photo 2 of 3 : UCIP\_SP\_2020\_55590\_82066.jpg

DS\_ID:637  
 FS\_ID:55590  
 EP\_NO: 17717-Rev.  
 Repair Type: Non-Urgent  
 Crossing Status: Indicator Found  
 UCIP Comments: 11/07/2019 In addition to paddle markers on both sides of levee, pipe alignment and mitigation line are marked with flags on WS approximately 320 feet from levee toe. Record updated from No Action Needed to Non-Urgent. No inspection records were available to determine status of line through the levee. (O.Yakimov - DWR UCIP)  
 FIELD\_STRUCT\_DESC: 20-inch petroleum pipeline across the levee, 40 feet below the levee crown. Pipe is bored through Putah Creek at an unknown depth. Paddle markers are located on the landside (LS) and waterside (WS) shoulders. (name change and 20-inch line authorized under Permit No. 17717-Rev., 2004 - SFPP, L.P., Delaware Limited Partnership c/o Paragon Partners Ltd; 20-inch line was authorized under Permit No. 17717, 2004 - Paragon Partners Ltd)

LS levee slope and pipeline marker

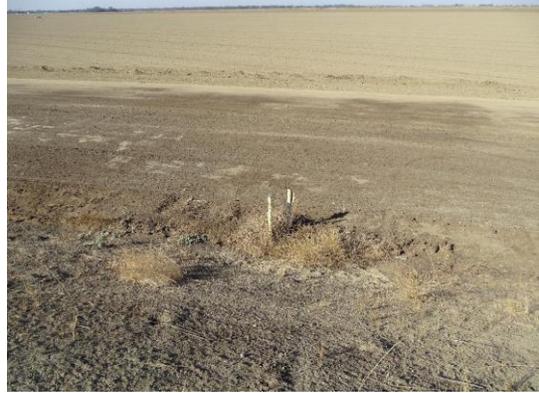
Photo 1 of 2 : UCIP\_SP\_2020\_55594\_82088.jpg

Item	DWR UCIP Field Study		38.516810 °	38.516810 °	
			-121.649600 °	-121.649600 °	
DWR ID	490				
Comment Code					
Inspector Comment					
DS_ID:490 FS_ID:55594 EP_NO: 9801 Repair Type: Non-Urgent Crossing Status: Indicator Found UCIP Comments: 11/07/2019 Record updated from No Action Needed to Non-Urgent. No inspection records were available to determine status of line through the levee. (O.Yakimov - DWR UCIP) FIELD_STRUCT_DESC: 10.625-inch (10-5/8) gas line of unknown material through the levee, 4.2 feet below the crown. Crossing is approximately 2-1/2 miles downstream from Mace Boulevard. Paddle markers are located on the landside (LS) and waterside (WS) toe. (10.625-inch line was authorized under Permit No. 9801, 1974 - Shell Oil Company) [Additional Reference(s): DWR Levee Log, 1981 and 2005, (HLM 1.22)] FS Date: 11/7/2019 10:37:54 AM

Gas line marker on LS

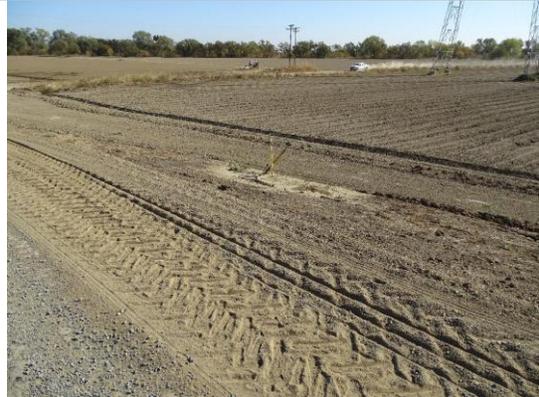
Photo 2 of 2 : UCIP\_SP\_2020\_55594\_82089.jpg

Gas line marker on WS

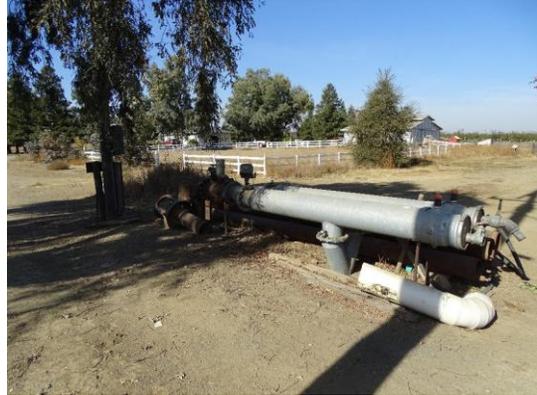
Photo 1 of 3 : UCIP\_SP\_2020\_55608\_82136.jpg

Filter plant on LS toe

Comment Code					
Inspector Comment					
DS_ID:16849 FS_ID:55608 EP_NO: N/A Repair Type: Non-Urgent Crossing Status: Found UCIP Comments: 11/07/2019 Record remains Non-Urgent. Missing permit for this crossing. (O.Yakimov - DWR UCIP)04/03/2012 Old pipe and concrete hauled to county dump. Evidence of the 14-inch pipe is no longer present at site. See new picture. (W. Wylie - DWR UCIP) FIELD_STRUCT_DESC: 10-inch steel irrigation pipe through the levee, 12 feet below the crown. Pipe terminates at standpipe located on the waterside (WS) approximately 500 feet south of levee. Mobile pumping plant is located in the floodway at edge of stream 740 feet south of levee. FS Date: 11/7/2019 1:05:17 PM

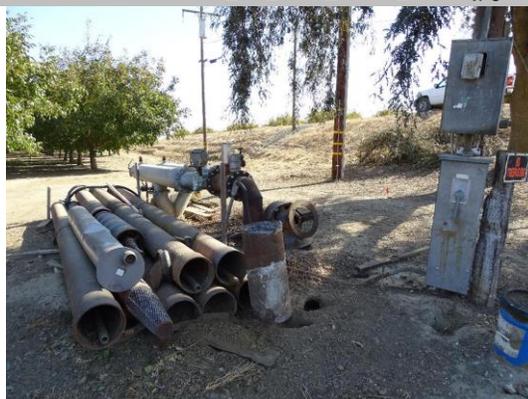
Photo 3 of 3 : UCIP\_SP\_2020\_55608\_82138.jpg

Filter plant and electrical boxes

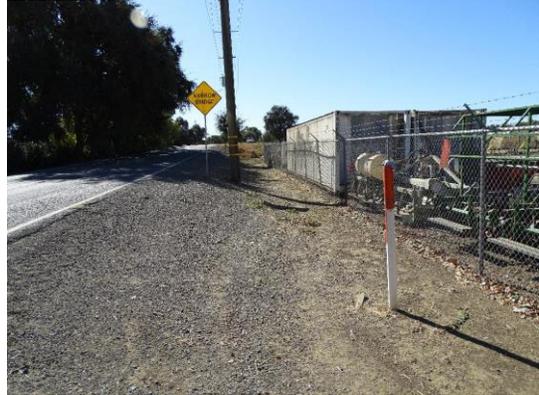
Photo 1 of 3 : UCIP\_SP\_2020\_55454\_81749.jpg

LM Start	<b>3.77</b>	Rating **	M	Issue No.	<b>83</b>
LM End	<b>3.77</b>	Issue Type +	En	Location *	
Category	Supplemental		GPS Latitude/Longitude		
			Start	End	
Item	DWR UCIP Field Study		38.520250 °	38.520250 °	
			-121.695250 °	-121.695250 °	
DWR ID	589				
Comment Code					
Inspector Comment					
DS_ID:589 FS_ID:55454 EP_NO: 17144 Repair Type: Non-Urgent Crossing Status: Indicator Found UCIP Comments: 10/22/2019 Fiber optic line marker bent and broken near bridge on west side on Macy Blvd. (O.Yakimov - DWR UCIP) FIELD_STRUCT_DESC: 5-inch steel conduit containing fiber optic cables across and under the levee at Mace Boulevard 50 feet below the crown. White and orange paddle marker is located 10 feet West of Mace Boulevard approximately 400 feet north of levee crossing. (5-inch pipe authorized under Permit No. 17144, 2000 - Williams Communications) FS Date: 10/22/2019 3:28:24 PM

White and orange marker 400 feet north of levee crossing at Mace Blvd

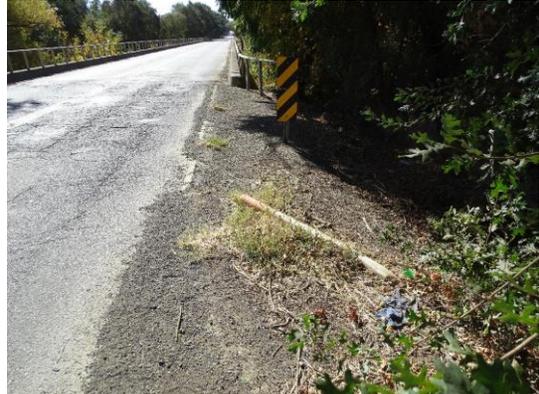
Photo 2 of 3 : UCIP\_SP\_2020\_55454\_81750.jpg

Bent to the ground line marker near Macy Blvd bridge

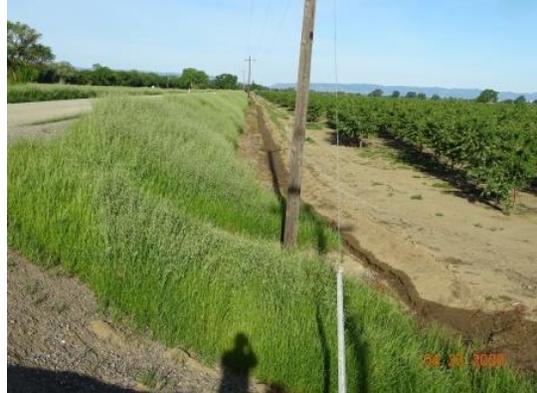
Photo 1 of 1 : SP\_2020\_ST0007\_282\_36\_20200423\_00126.jpg

View looking upstream at small ditch on the landside toe (Spring 2020).

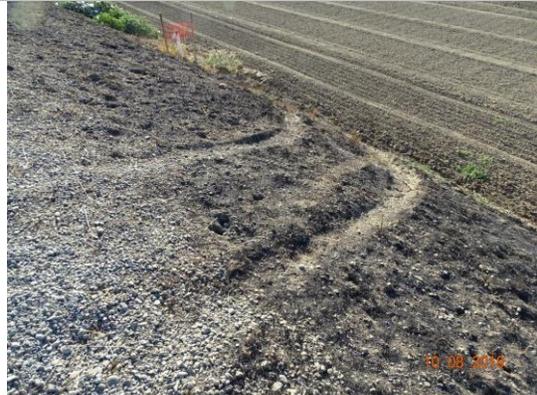
Photo 1 of 1 : SP\_2020\_ST0007\_282\_43\_20200304\_00012.jpg

LM Start	<b>4.57</b>	Rating **	M	Issue No.	<b>43</b>
LM End	<b>4.57</b>	Issue Type +	Ma	Location *	WS
Category	Earthen Levee		GPS Latitude/Longitude		
			Start	End	
Item	Slope Stability		38.518175 °	38.518175 °	
			-121.709270 °	-121.709270 °	
DWR ID	DWR_ST0007_01_f_ 2019_43				
Comment Code					
S3 : Repair the levee slope damaged by vehicle traffic and prevent access where possible.					
Inspector Comment					
Vehicle tracks depressed into slope.

View of vehicle tracks on the waterside slope (Fall 2019).

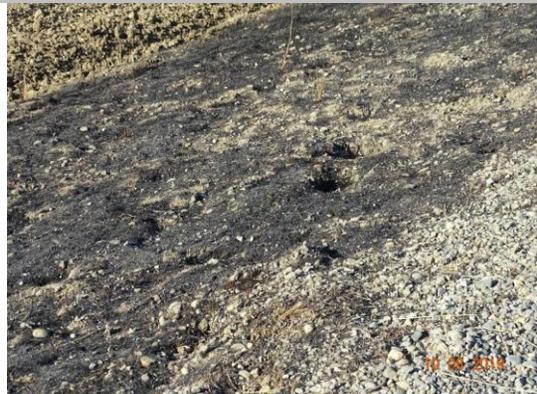
Photo 1 of 1 : SP\_2020\_ST0007\_282\_44\_20200304\_00013.jpg

LM Start	<b>4.57</b>	Rating **	M	Issue No.	<b>44</b>
LM End	<b>4.57</b>	Issue Type +	Ma	Location *	WS
Category	Earthen Levee		GPS Latitude/Longitude		
			Start	End	
Item	Animal Control		38.518175 °	38.518175 °	
			-121.709270 °	-121.709270 °	
DWR ID	DWR_ST0007_01_f_ 2019_44				
Comment Code					
A3 : No rodents visible, but rodent burrows visible; need to backfill and compact or grout burrows.					
Inspector Comment					
Multiple holes. Holes do not look deep.

View of animal holes on the waterside slope (Fall 2019).

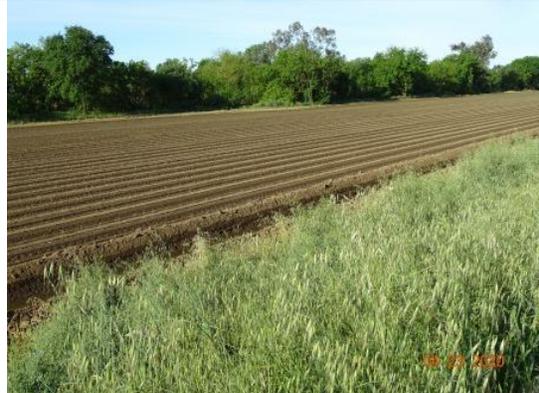
Photo 1 of 1 : SP\_2020\_ST0007\_282\_40\_20200423\_00127.jpg

View looking upstream at new irrigation ditch on the waterside toe (Spring 2020).

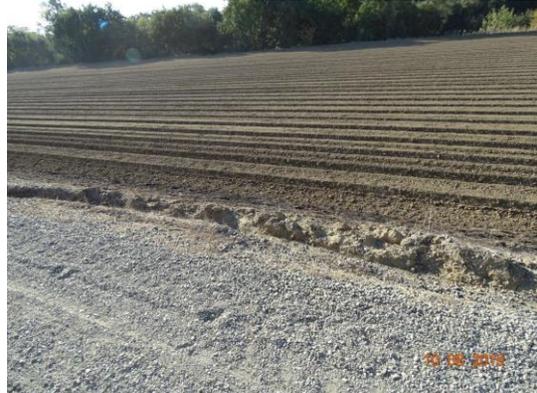
Photo 1 of 1 : SP\_2020\_ST0007\_282\_45\_20200304\_00014.jpg

LM Start	<b>5.24</b>	Rating **	M	Issue No.	<b>45</b>
LM End	<b>5.24</b>	Issue Type +	Ma	Location *	WS
Category	Earthen Levee		GPS Latitude/Longitude		
			Start	End	
Item	Slope Stability		38.518142 °	38.518142 °	
			-121.721778 °	-121.721778 °	
DWR ID	DWR_ST0007_01_f_2019_45				
Comment Code					
S3 : Repair the levee slope damaged by vehicle traffic and prevent access where possible.					
Inspector Comment					
Vehicle depression on the waterside shoulder.

View of vehicle track depression on waterside shoulder (Fall 2019).

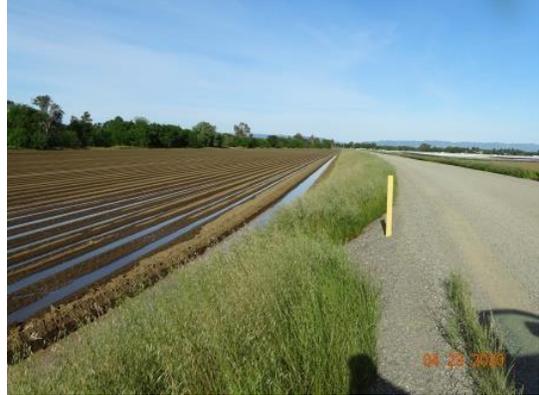
Photo 1 of 1 : SP\_2020\_ST0007\_282\_50\_20200423\_00128.jpg

View looking upstream at irrigation ditch on the waterside toe (Spring 2020).

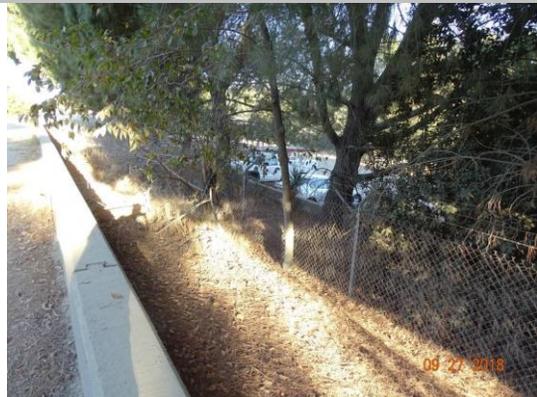
Photo 1 of 1 : SP\_2020\_ST0007\_282\_15\_20200304\_00004.jpg

View of fence (September 2018).

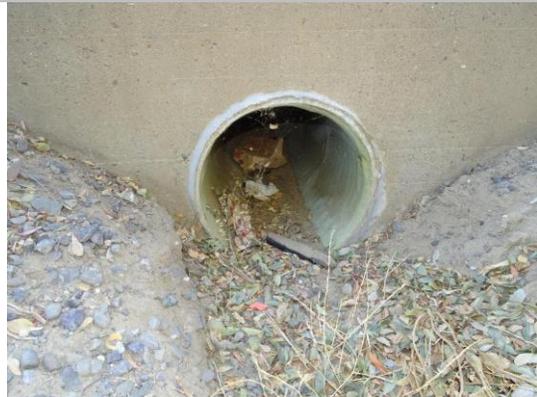
Photo 3 of 3 : UCIP\_SP\_2020\_55667\_82356.jpg

LS levee slope, headwall, and pipe end

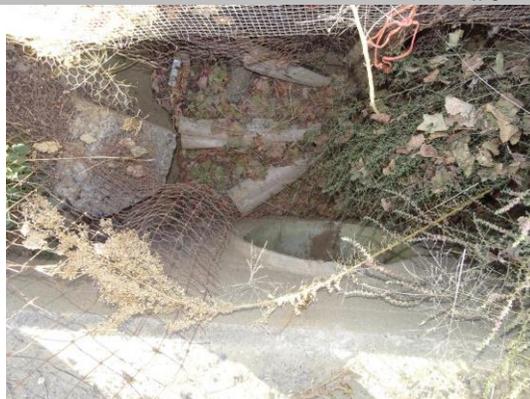
Photo 2 of 3 : UCIP\_SP\_2020\_55675\_82383.jpg

LS: headwall and pipe end near a fence

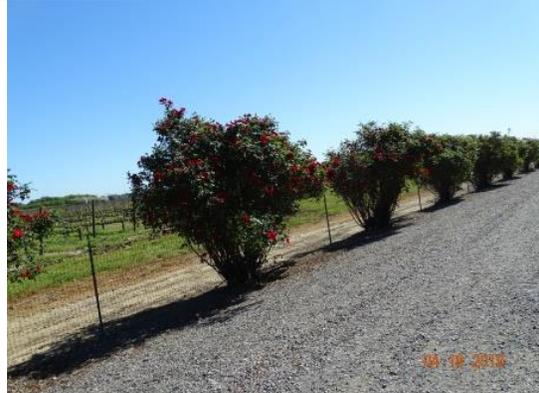
Photo 1 of 1 : SP\_2020\_ST0007\_282\_38\_20200304\_00008.jpg

View looking downstream at barbed wire fence on the landside easment (Spring 2019).

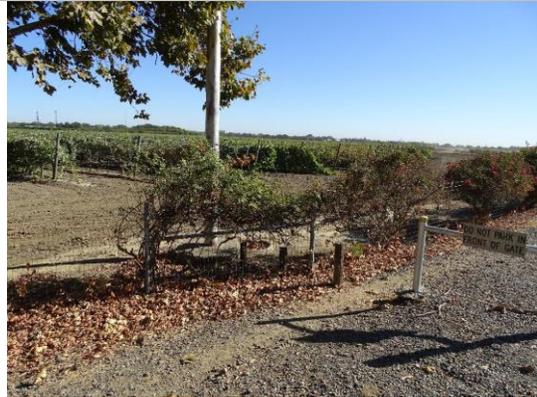
Photo 1 of 3 : UCIP\_SP\_2020\_55682\_82406.jpg

Gate at levee crown, 8-inch standpipe and valve on LS

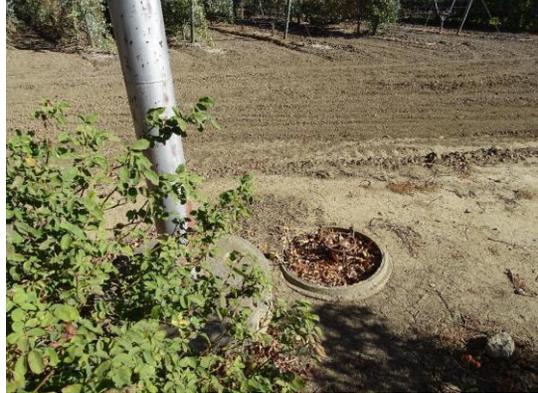
Photo 2 of 3 : UCIP\_SP\_2020\_55682\_82407.jpg

Standpipe and valve on LS at the gate where 8-inch standpipe found

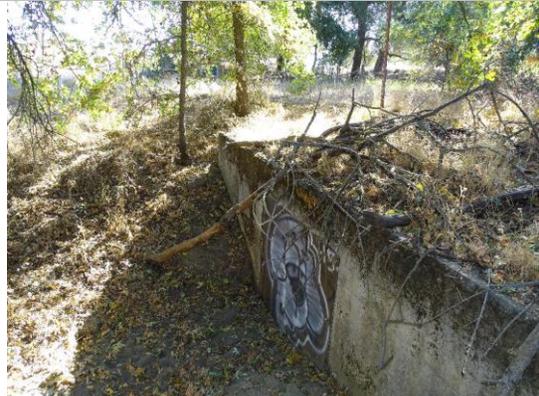
Photo 2 of 3 : UCIP\_SP\_2020\_55684\_82411.jpg

Steel plate installed over pipe off LS toe

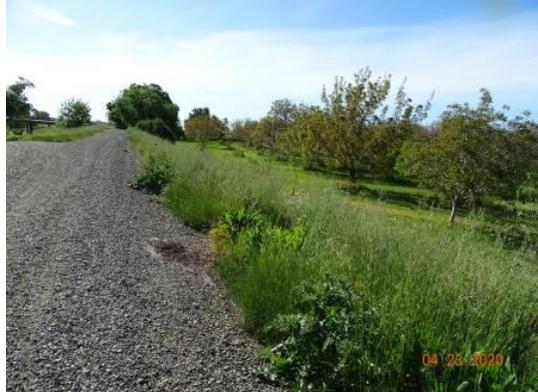
Photo 1 of 1 : SP\_2020\_ST0007\_283\_54\_20200423\_00096.jpg

View looking downstream at annual vegetation on the landside slope (Spring 2020).

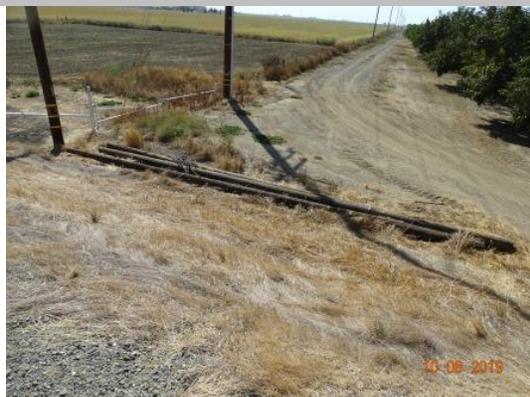
Photo 1 of 1 : SP\_2020\_ST0007\_283\_44\_20200304\_00021.jpg

View of telephone poles at the landside toe (Fall 2019).

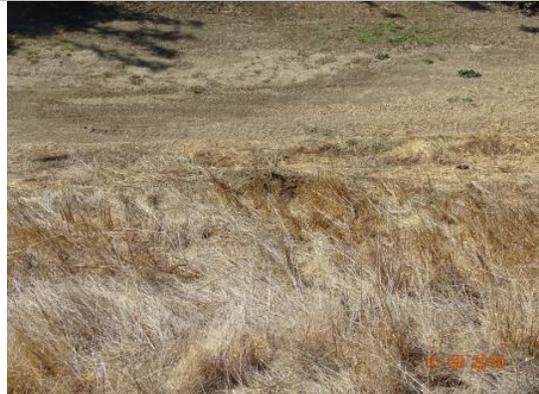
Photo 1 of 1 : SP\_2020\_ST0007\_283\_32\_20200304\_00010.jpg

View looking downslope at animal hole with fresh dirt (Fall 2019).

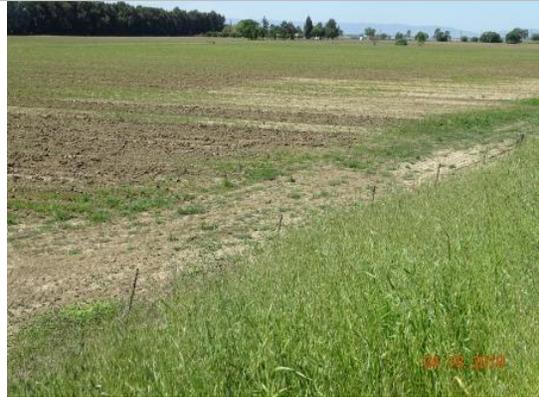
Photo 1 of 1 : SP\_2020\_ST0007\_283\_37\_20200304\_00016.jpg

View looking upstream at barbed wire fence at the landside toe (Spring 2019).

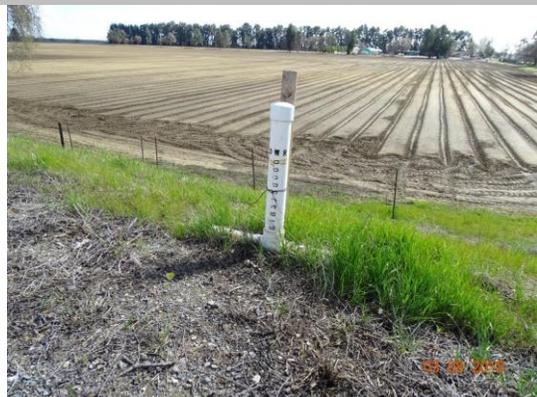
Photo 1 of 1 : SP\_2020\_ST0007\_283\_9\_20200304\_00001.jpg

Rodent bait station at LM 2.09.

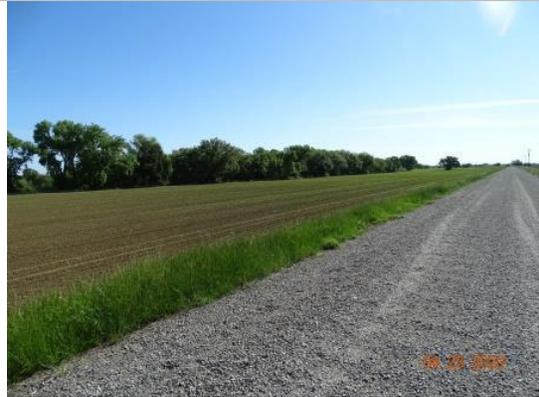
Photo 1 of 1 : SP\_2020\_ST0007\_283\_56\_20200423\_00097.jpg

View looking downstream at annual vegetation on the waterside slope (Spring 2020).

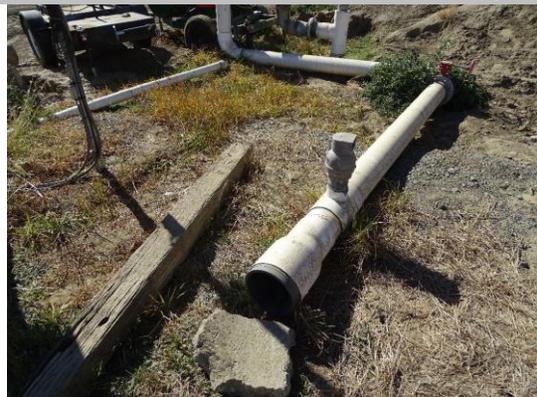
Photo 2 of 3 : UCIP\_SP\_2020\_55432\_81677.jpg

Mobile gas pump outlet pipe is disconnected

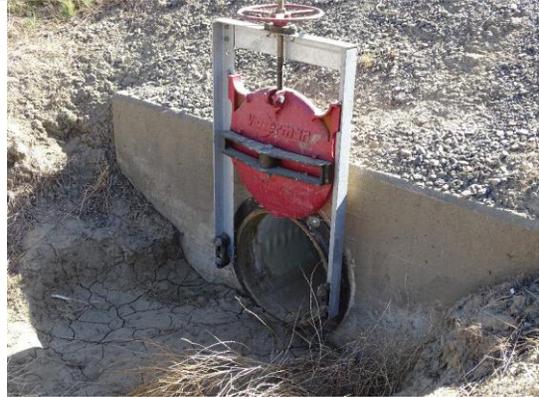
Photo 3 of 3 : UCIP\_SP\_2020\_55433\_81686.jpg

Headwall and slide gate at WS levee toe

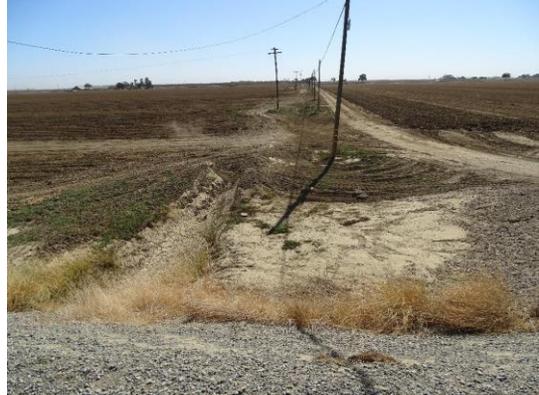
Photo 1 of 3 : UCIP\_SP\_2020\_55435\_81696.jpg

View of LS looking from levee crown. Gas line sign noted in previous inspection has gone.

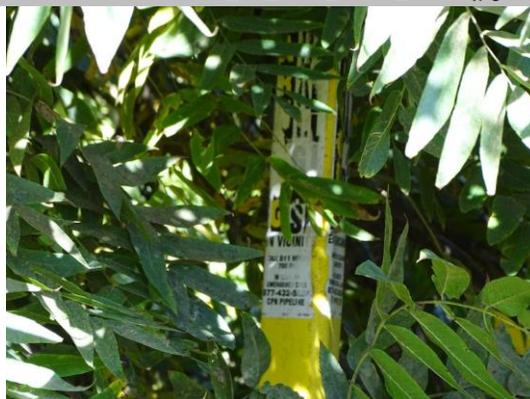
Photo 3 of 3 : UCIP\_SP\_2020\_55435\_81694.jpg

Closeup view of gas line marker

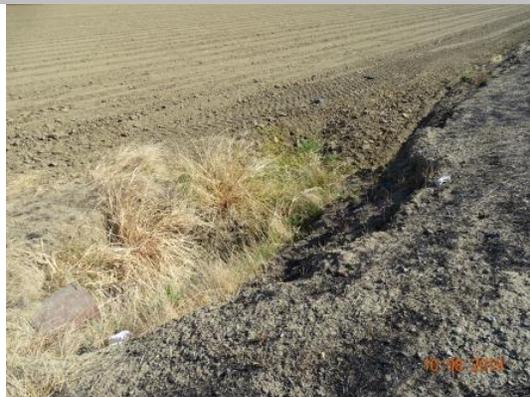
Photo 1 of 2 : SP\_2020\_ST0007\_283\_33\_20200304\_00012.jpg

View of erosion on the levee slope (Fall 2019).

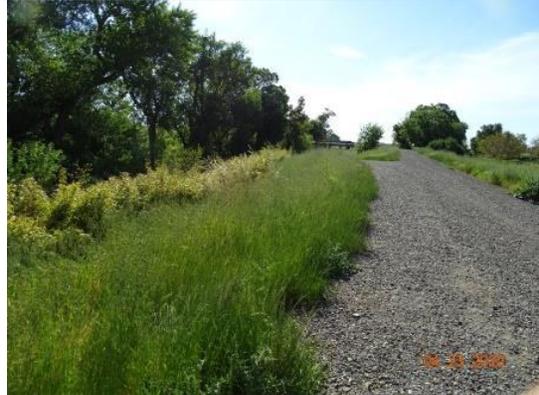
Photo 1 of 1 : SP\_2020\_ST0007\_283\_55\_20200423\_00094.jpg

View looking downstream at annual vegetation on the waterside slope (Spring 2020).

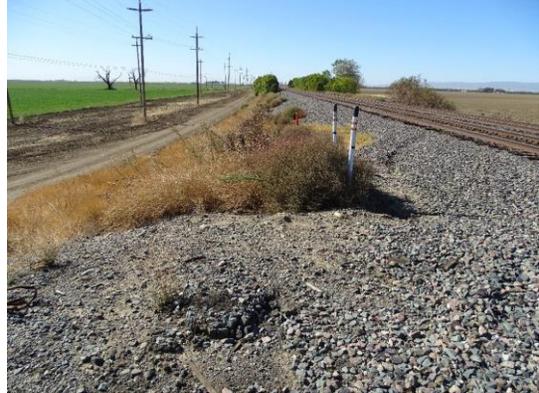
Photo 1 of 2 : UCIP\_SP\_2020\_55444\_81714.jpg

Fiber optics line markers on east side of railroad tracks

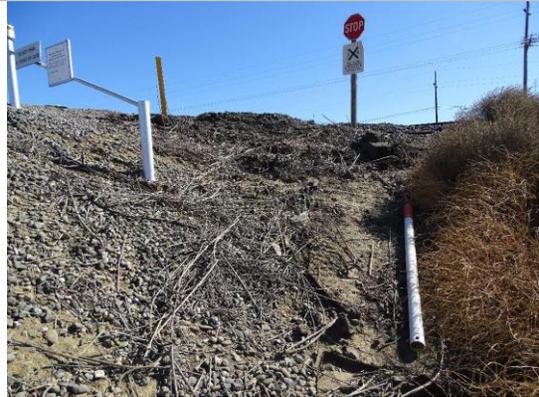
Photo 1 of 2 : UCIP\_SP\_2020\_55445\_81716.jpg

Detached fiber optic line marker on LS slope

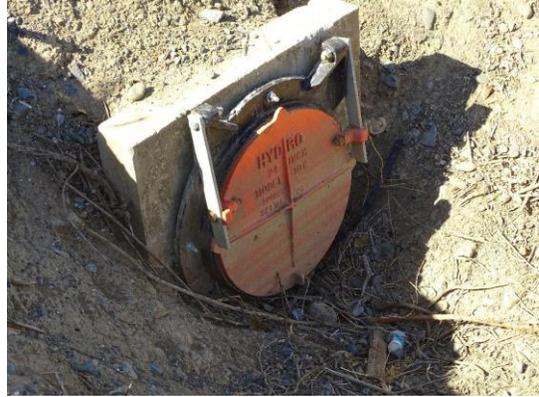
Photo 1 of 3 : UCIP\_SP\_2020\_55446\_81718.jpg

Headwall and flap gate

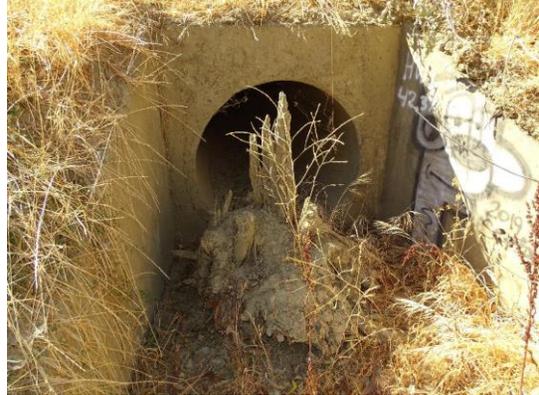
Photo 1 of 3 : UCIP\_SP\_2020\_55451\_81734.jpg

WS headwall and outfall showing rootball blocking pipe

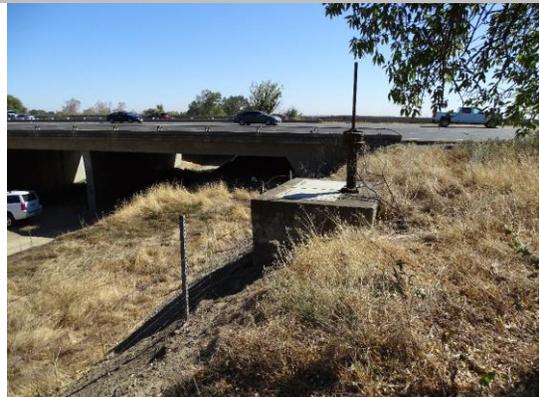
Photo 2 of 3 : UCIP\_SP\_2020\_55451\_81735.jpg

Concrete box with slide gate mechanism on WS shoulder

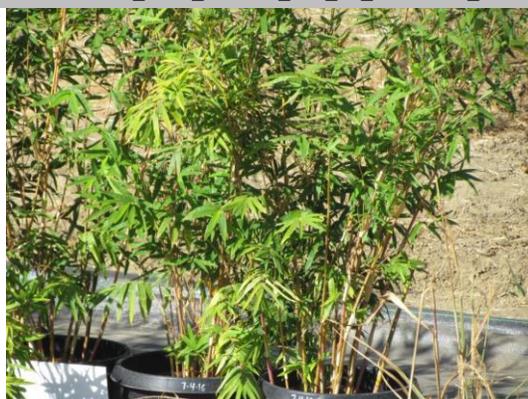
Photo 1 of 2 : SP\_2020\_ST0007\_283\_41\_20200304\_00019.jpg

Bamboo being grown in pots by landowner on the waterside berm.

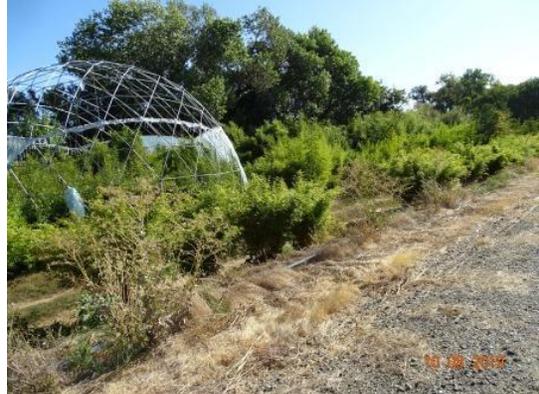
Photo 1 of 1 : SP\_2020\_ST0007\_283\_27\_20200304\_00006.jpg

View of bamboo at the waterside toe (Fall 2019).

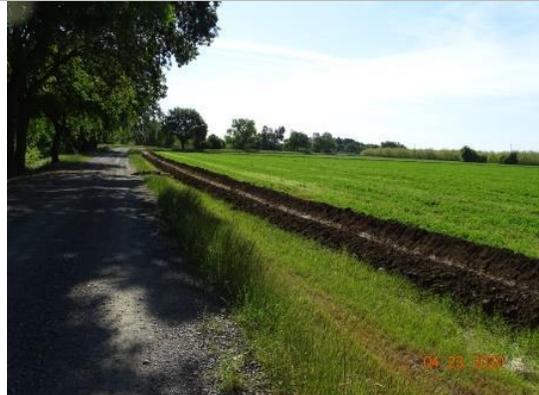
Photo 1 of 1 : SP\_2020\_ST0007\_283\_53\_20200423\_00095.jpg

View looking downstream at new irrigation ditch on the landside toe (Spring 2020).
