**Flood Control Project Maintenance
Levee Inspections**

Maintenance Issue Types Only, Levee Inspection Report By Mile - Fall 2019

Sacramento Maintenance Yard Sacramento Bypass

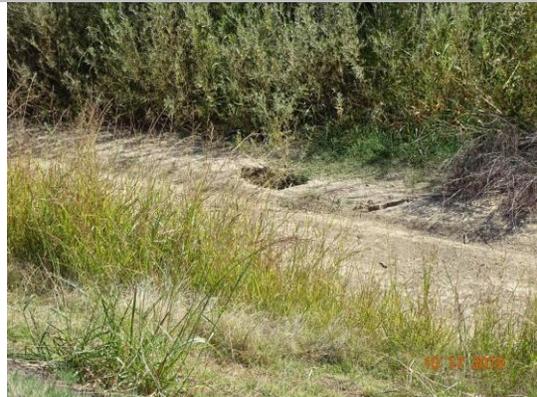
Photo 1 of 1 : FA_2019_ST0008_284_9_20191021_00015.jpg

LM Start	0.87	Rating **	A/W	Issue No.	9
LM End	0.87	Issue Type +	Ma	Location *	WS
Category	Earthen Levee			GPS Latitude/Longitude	
				Start	End
Item	Animal Control			38.602871°	38.602871°
				-121.574960°	-121.574960°
DWR ID	DWR_ST0008_01_f_2018_9				
Comment Code					
A3 : No rodents visible, but rodent burrows visible; need to backfill and compact or grout burrows.					
Inspector Comment					
There possibly is a beaver den on the edge of the waterside berm. It is not within the levee prism. Recommend monitoring for activity.

View of the hole on the waterside toe rode. Fall 2019.

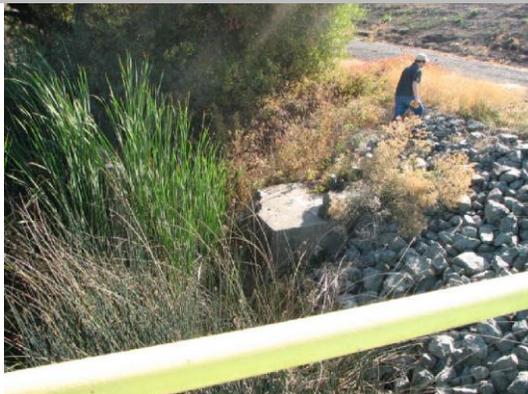
Photo 1 of 3 : UCIP_FA_2019_44787_20605.jpg

LM Start	1.09	Rating **	A/W	Issue No.	16
LM End	1.09	Issue Type +	Ma	Location *	
Category	Supplemental			GPS Latitude/Longitude	
				Start	End
Item	DRAFT DWR UCIP LMA Responsibility			38.602169°	38.602169°
				-121.579000°	-121.579000°
DWR ID	19076				
Comment Code					
Inspector Comment					
DS_ID:19076 FS_ID:44787 EP_NO: N/A Repair Type: No Action Needed Crossing Status: Found UCIP Comments: A concrete saddle found on slough/drainage. No pump was found on LS and no structure/pipe found on WS. FIELD_STRUCT_DESC: *ABANDONED* 36-inch corrugated metal drainage pipe through the levee, at an unknown depth. Grouted in place. Remains of concrete structure found on the landside (LS). [Additional Reference(s): USACE Sacramento O&M Manual 122.1, August 1955, (RM 174)]. FS Date: 4/28/2015 2:44:05 PM

Landside view: overview

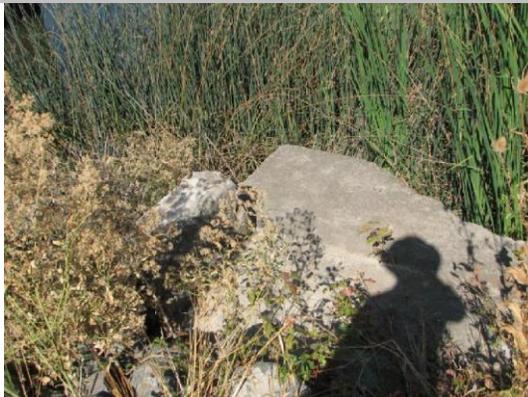
Photo 2 of 3 : UCIP_FA_2019_44787_20604.jpg

Landside view: remaining of concrete structure

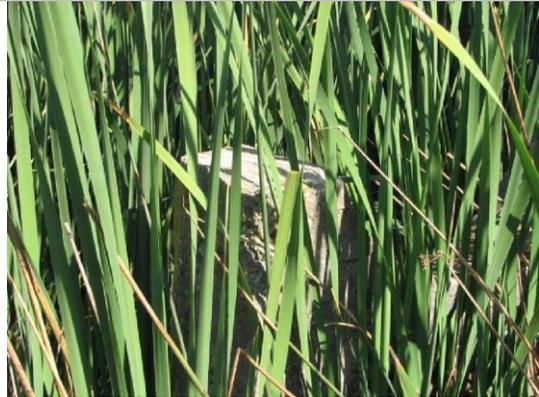
Photo 3 of 3 : UCIP_FA_2019_44787_20606.jpg

LM Start	1.09	Rating **	A/W	Issue No.	16 (cont)
LM End	1.09	Issue Type +	Ma	Location *	
Category	Supplemental			GPS Latitude/Longitude	
				Start	End
Item	DRAFT DWR UCIP LMA Responsibility			38.602169°	38.602169°
				-121.579000°	-121.579000°
DWR ID	19076				
Comment Code					
Inspector Comment					
DS_ID:19076 FS_ID:44787 EP_NO: N/A Repair Type: No Action Needed Crossing Status: Found UCIP Comments: A concrete saddle found on slough/drainage. No pump was found on LS and no structure/pipe found on WS. FIELD_STRUCT_DESC: *ABANDONED* 36-inch corrugated metal drainage pipe through the levee, at an unknown depth. Grouted in place. Remains of concrete structure found on the landside (LS). [Additional Reference(s): USACE Sacramento O&M Manual 122.1, August 1955, (RM 174)]. FS Date: 4/28/2015 2:44:05 PM

Landside view: remaining of concrete structure on drainage/slough

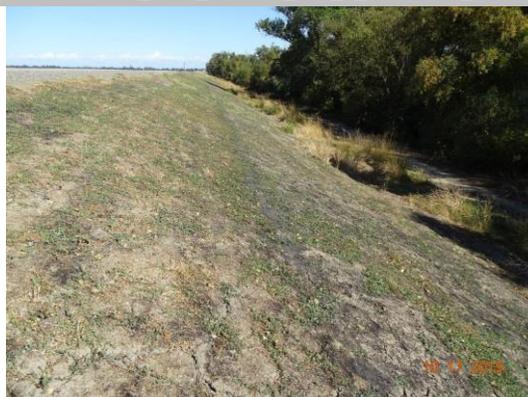
Photo 1 of 2 : FA_2019_ST0008_284_7_20191021_00016.jpg

LM Start	1.43	Rating **	A/W	Issue No.	7
LM End	1.59	Issue Type +	Ma	Location *	WS
Category	Supplemental			GPS Latitude/Longitude	
				Start	End
Item	2017 USACE Erosion Survey			38.600456°	38.599713°
				-121.584883°	-121.587668°
DWR ID	DWR_ST0008_01_f_2018_7				
Comment Code					
Inspector Comment					
2017 Site ID: SAP 1.4 R Status: Critical 2017 Field Notes: New site, immediately upgraded to critical. Start of slump failure, deep cracks along levee crest, concern that a large slump failure will occur from the next heavy rain. Site History:

View of the waterside slope. Fall 2019.

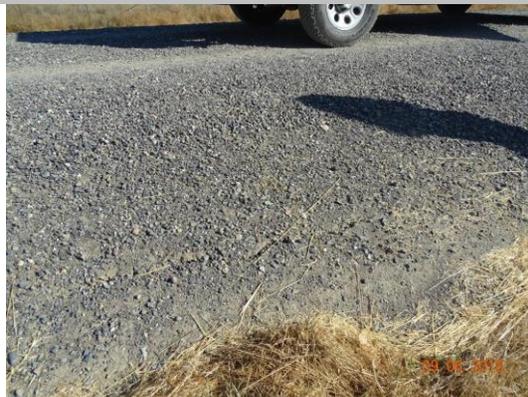
Photo 2 of 2 : FA_2019_ST0008_284_7_20190829_00001.jpg

View of the cracking on the crown. Fall 2018.

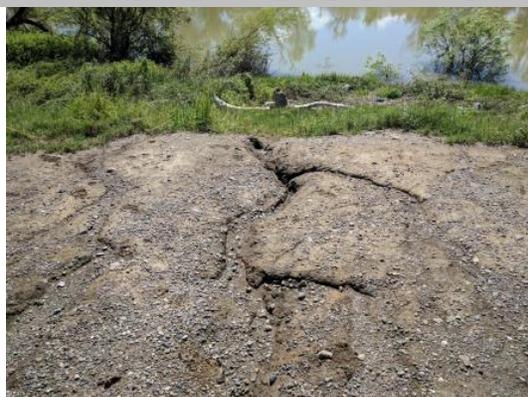
Photo 1 of 1 : FA_2019_ST0008_284_15_20190829_00005.jpg

LM Start	1.74	Rating **	A/W	Issue No.	15
LM End	1.74	Issue Type +	Ma	Location *	WS
Category	Earthen Levee			GPS Latitude/Longitude	
				Start	End
Item	Erosion / Bank Caving			38.599546°	38.599546°
				-121.590235°	-121.590235°
DWR ID	DWR_ST0008_01_s_2018_15				
Comment Code					
E1 : Note and monitor erosion site.					
Inspector Comment					
There is runoff erosion on the oversized levee section located on the waterside levee slope. Recommend monitoring.

View of erosion on waterside slope. Spring 2017.

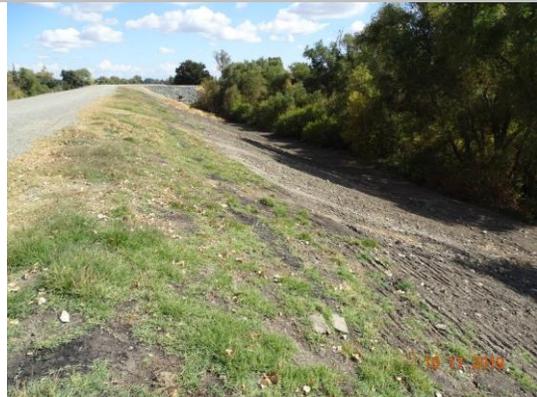
Photo 1 of 1 : FA_2019_ST0008_285_2_20191021_00007.jpg

LM Start	1.33	Rating **	A	Issue No.	2
LM End	1.33	Issue Type +	Ma	Location *	LS
Category	Earthen Levee		GPS Latitude/Longitude		
			Start	End	
Item	Vegetation		38.596876°	38.596876°	
			-121.578873°	-121.578873°	
DWR ID	DWR_ST0008_02_f_2019_2				
Comment Code					
V1 : Control annual grass and weeds on the levee slopes and easements.					
Inspector Comment					
LMA maintains the vegetation at a high level.

View of the maintained landside slope. Fall 2019.

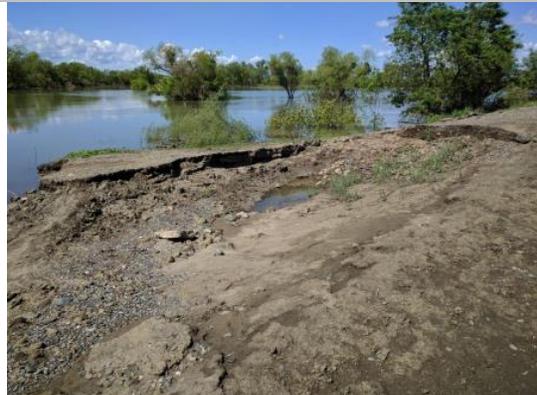
Photo 1 of 1 : FA_2019_ST0008_285_8_20190829_00006.jpg

LM Start	1.77	Rating **	A/W	Issue No.	8
LM End	1.77	Issue Type +	Ma	Location *	WS
Category	Earthen Levee			GPS Latitude/Longitude	
				Start	End
Item	Erosion / Bank Caving			38.594710°	38.594710°
				-121.586582°	-121.586582°
DWR ID	DWR_ST0008_02_s_2019_8				
Comment Code					
E1 : Note and monitor erosion site.					
Inspector Comment					
This is a runoff location, but it is not within the levee prism. Recommend monitoring.

View of erosion on waterside levee slope. Spring 2017.
