**Flood Control Project Maintenance
Levee Inspections**

Maintenance Issue Types Only, Levee Inspection Report By Mile - Spring 2020

Sacramento Maintenance Yard Sacramento Bypass

Waterway	Bank	Unit Miles	Inspection Start/End	Inspector
Unit No. 01 Sacramento Bypass or North Levee	Right	1.74	04/07/2020 04/07/2020	Zach Jojola

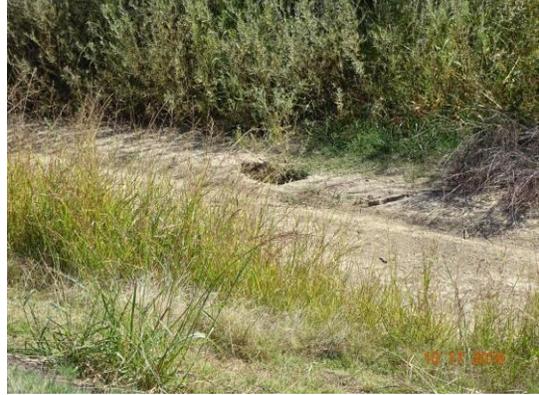
Photo 1 of 1 : SP_2020_ST0008_284_9_20200228_00003.jpg

LM Start	0.87	Rating **	A/W	Issue No.	9
LM End	0.87	Issue Type +	Ma	Location *	WS
Category	Earthen Levee			GPS Latitude/Longitude	
				Start	End
Item	Animal Control			38.602871 °	38.602871 °
				-121.574960 °	-121.574960 °
DWR ID	DWR_ST0008_01_f_2018_9				
Comment Code					
A3 : No rodents visible, but rodent burrows visible; need to backfill and compact or grout burrows.					
Inspector Comment					
There possibly is a beaver den on the edge of the waterside berm. It is not within the levee prism. Recommend monitoring for activity.

View of the hole on the waterside toe rode. Fall 2019.

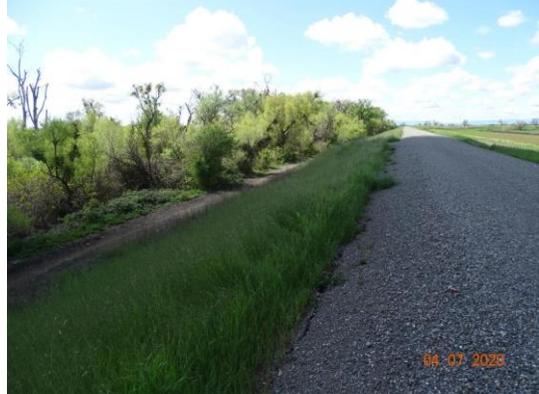
Photo 1 of 1 : SP_2020_ST0008_284_8_20200409_00014.jpg

LM Start	1.15	Rating **	M	Issue No.	8
LM End	1.72	Issue Type +	Ma	Location *	WS
Category	Earthen Levee			GPS Latitude/Longitude	
				Start	End
Item	Vegetation			38.601875 °	38.599391 °
				-121.580007 °	-121.589987 °
DWR ID	DWR_ST0008_01_s_2020_8				
Comment Code					
V1 : Control annual grass and weeds on the levee slopes and easements.					
Inspector Comment

View of vegetation on the waterside slope. Spring 2020.

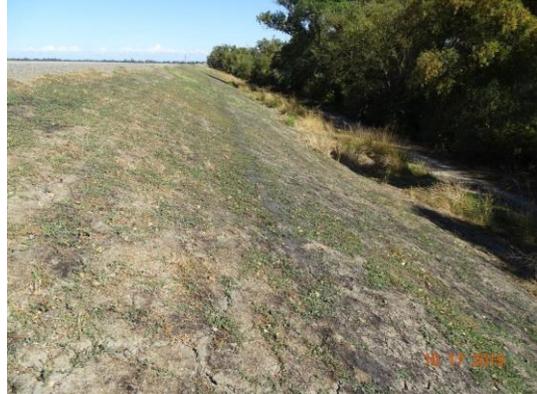
Photo 1 of 2 : SP_2020_ST0008_284_7_20200228_00001.jpg

LM Start	1.43	Rating **	A/W	Issue No.	7
LM End	1.59	Issue Type +	Ma	Location *	WS
Category	Supplemental		GPS Latitude/Longitude		
			Start	End	
Item	2017 USACE Erosion Survey		38.600456 °	38.599713 °	
			-121.584883 °	-121.587668 °	
DWR ID	DWR_ST0008_01_f_2018_7				
Comment Code					
Inspector Comment					
2017 Site ID: SAP 1.4 R Status: Critical 2017 Field Notes: New site, immediately upgraded to critical. Start of slump failure, deep cracks along levee crest, concern that a large slump failure will occur from the next heavy rain. Site History:

View of the waterside slope. Fall 2019.

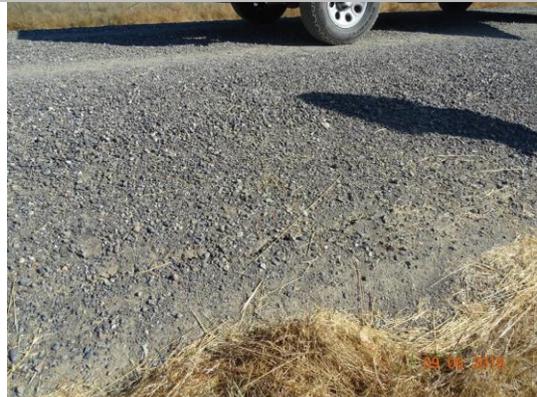
Photo 2 of 2 : SP_2020_ST0008_284_7_20200228_00002.jpg

LM Start	1.43	Rating **	A/W	Issue No.	7 (cont)
LM End	1.59	Issue Type +	Ma	Location *	WS

View of the cracking on the crown. Fall 2018.

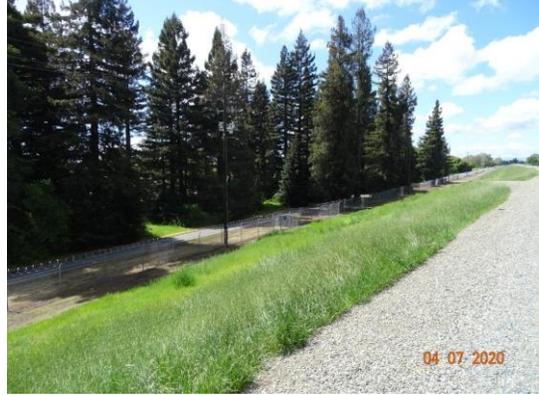
Photo 1 of 1 : SP_2020_ST0008_285_1_20200409_00002.jpg

LM Start	0.03	Rating **	M	Issue No.	1
LM End	0.59	Issue Type +	Ma	Location *	LS
Category	Earthen Levee		GPS Latitude/Longitude		
			Start	End	
Item	Vegetation		38.602589 °	38.599955 °	
			-121.556070 °	-121.565733 °	
DWR ID	DWR_ST0008_02_s_2020_1				
Comment Code					
V1 : Control annual grass and weeds on the levee slopes and easements.					
Inspector Comment

View of vegetation on the landside slope. Spring 2020.
