**Flood Control Project Maintenance
Levee Inspections
LMA District Cover Sheet
Spring 2020 Levee Inspection Results**

Sutter Maintenance Yard Tisdale Bypass

Levee Inspection Report By Mile - Spring 2020

Waterway	Bank	Unit Miles	Inspection Start/End	Inspector
Unit No. 01 Tisdale Bypass	Left	4.51	03/18/2020 03/18/2020	Makar Sokol

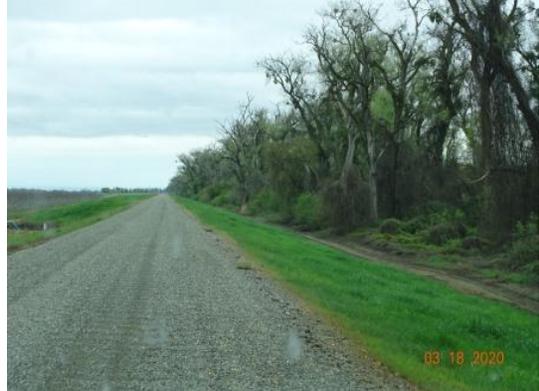
Photo 1 of 1 : SP_2020_ST0009_286_10_20200319_00021.jpg

LM Start	0.55	Rating **	A	Issue No.	10
LM End	0.55	Issue Type +	Ma	Location *	WS
Category	Earthen Levee		GPS Latitude/Longitude		
			Start	End	
Item	Vegetation		39.028362 °	39.028362 °	
			-121.811825 °	-121.811825 °	
DWR ID	DWR_ST0009_01_s_2020_10				
Comment Code					
V1 : Control annual grass and weeds on the levee slopes and easements.					
Inspector Comment					
Good vegetation control on both landside and waterside slopes.

View of the vegetation along the waterside slope. Spring 2020.

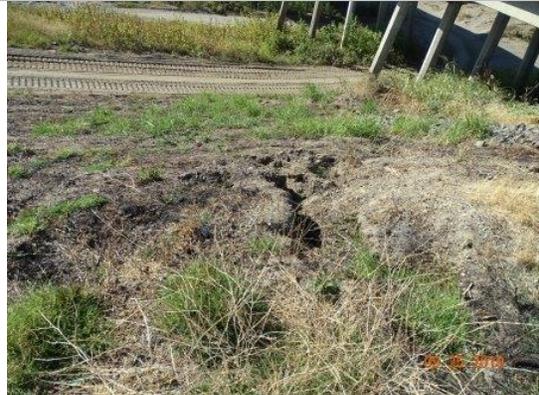
Photo 1 of 1 : SP_2020_ST0009_286_13_20200226_00004.jpg

LM Start	2.07	Rating **	M	Issue No.	13
LM End	2.07	Issue Type +	Ma	Location *	WS
Category	Earthen Levee		GPS Latitude/Longitude		
			Start	End	
Item	Erosion / Bank Caving		39.028165 °	39.028165 °	
			-121.783568 °	-121.783568 °	
DWR ID	DWR_ST0009_01_f_2019_13				
Comment Code					
E1 : Note and monitor erosion site.					
Inspector Comment

View of the erosion along the waterside slope. Fall 2019.

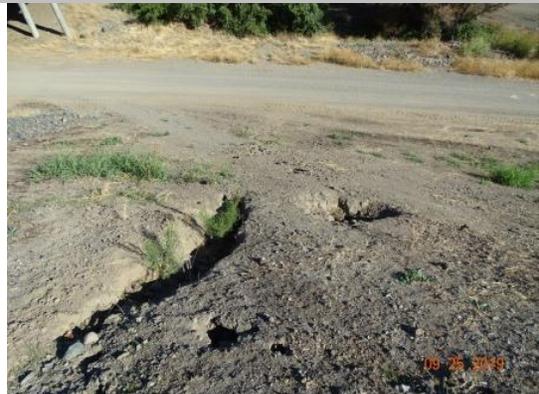
Photo 1 of 1 : SP_2020_ST0009_286_9_20200226_00001.jpg

LM Start	2.07	Rating **	M	Issue No.	9
LM End	2.07	Issue Type +	Ma	Location *	LS
Category	Earthen Levee		GPS Latitude/Longitude		
			Start	End	
Item	Erosion / Bank Caving		39.028165 °	39.028165 °	
			-121.783567 °	-121.783567 °	
DWR ID	DWR_ST0009_01_f_2019_9				
Comment Code					
E2 : Schedule repair of erosion site prior to the next inspection.					
Inspector Comment

View of the erosion along the landside slope. Fall 2019.

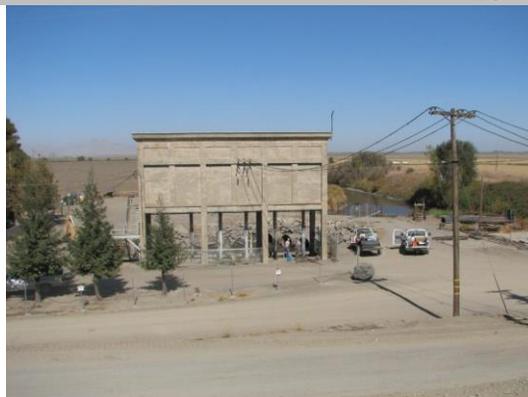
Photo 3 of 3 : UCIP_SP_2020_51484_64224.jpg

LM Start	2.14	Rating **	A/W	Issue No.	20 (cont)
LM End	2.14	Issue Type +	Ma	Location *	
Category	Supplemental			GPS Latitude/Longitude	
				Start	End
Item	DWR UCIP LMA Responsibility			39.028132 °	39.028132 °
				-121.782389 °	-121.782389 °
DWR ID	16591

Pump house on LS toe.

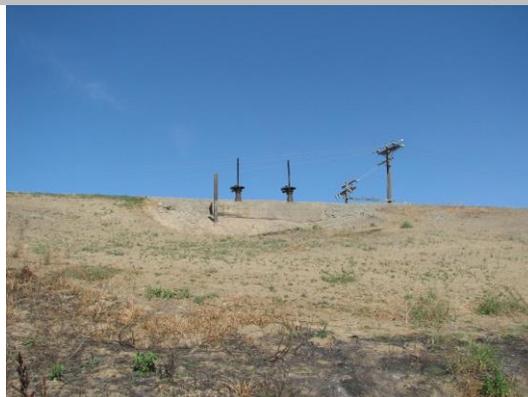
Photo 1 of 3 : UCIP_SP_2020_51485_64230.jpg

LM Start	2.14	Rating **	A/W	Issue No.	21
LM End	2.14	Issue Type +	Ma	Location *	
Category	Supplemental			GPS Latitude/Longitude	
				Start	End
Item	DWR UCIP LMA Responsibility			39.028124 °	39.028124 °
				-121.782344 °	-121.782344 °
DWR ID	16856

Slide gates on WS shoulder.

Comment Code					
Inspector Comment					
DS_ID:16856 FS_ID:51485 EP_NO: 10099 Repair Type: No Action Needed Crossing Status: Found UCIP Comments: 4/10/2017 Crossing appears to be in good condition. (DWR Sutter Yard- AFreitag)10/11/2016 Crossing appears to be in good condition.(DWR Sutter Yard - afreitag)4/18/2016 Crossing appears to be in good condition. No noticeable issues to report.5/7/2015 Crossing is in good condition. No noticeable issues to report.11/13/2014 Same as last inspection.5/12/2014 Same as last inspection.10/30/2013 Same as last inspection.5/20/2013 Same as last inspection. FIELD_STRUCT_DESC: 2 of 2: 4-foot by 7-foot concrete discharge tunnel through the levee, 38 feet below the crown. Slide gate in 4-foot by 15-foot concrete well on the waterside (WS) slope. Pump house located on the landside (LS) toe and wooden flap gates on the WS toe. (two 4-foot by 7-foot tunnel [HLM 2.13] authorized under Automatic Board Order (ABO) issued as Permit No. 10099, 1955 - Reclamation District No. 1660). [Additional Reference(s): DWR Levee Log, 1993. USACE Sacramento O&M Manual 133, August 1955 (Station 1044+60)]. FS Date: 4/12/2017 9:20:37 AM

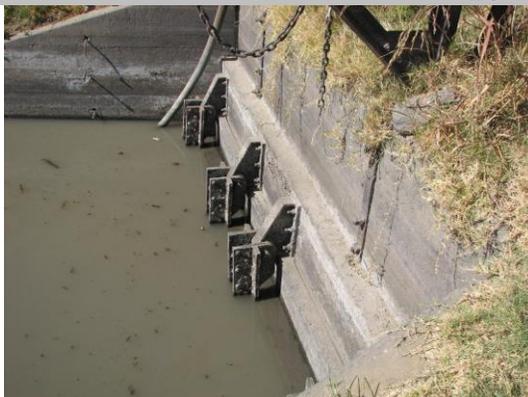
Photo 2 of 3 : UCIP_SP_2020_51485_64229.jpg

Wooden flap gates on WS toe.

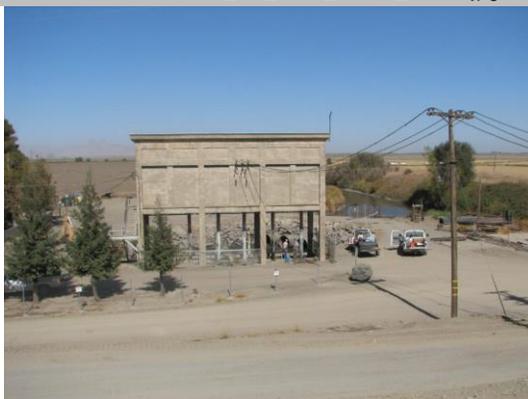
Photo 3 of 3 : UCIP_SP_2020_51485_64228.jpg

Pump house on LS toe.

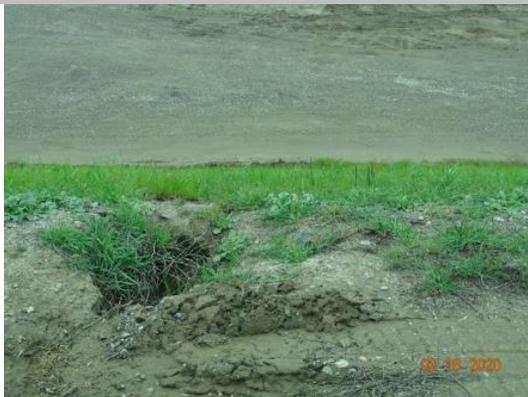
Photo 1 of 1 : SP_2020_ST0009_286_12_20200319_00022.jpg

LM Start	2.16	Rating **	M	Issue No.	12
LM End	2.16	Issue Type +	Ma	Location *	LS
Category	Earthen Levee			GPS Latitude/Longitude	
				Start	End
Item	Animal Control			39.028137 °	39.028137 °
				-121.782020 °	-121.782020 °
DWR ID	DWR_ST0009_01_f_2016_12				
Comment Code					
A3 : No rodents visible, but rodent burrows visible; need to backfill and compact or grout burrows.					
Inspector Comment

View of a rodent hole at the landside levee crown. Spring 2020.

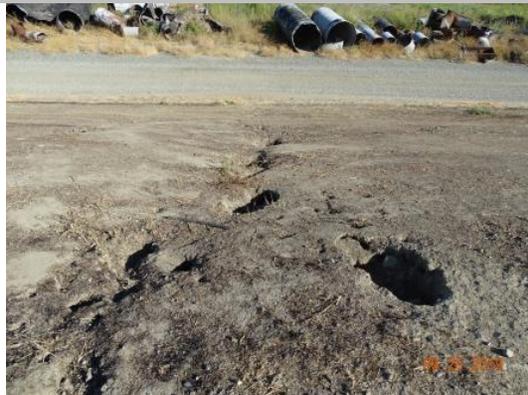
Photo 1 of 1 : SP_2020_ST0009_286_14_20200226_00005.jpg

LM Start	2.23	Rating **	U	Issue No.	14
LM End	2.23	Issue Type +	Ma	Location *	LS
Category	Earthen Levee		GPS Latitude/Longitude		
			Start	End	
Item	Animal Control		39.028145 °	39.028145 °	
			-121.780669 °	-121.780669 °	
DWR ID	DWR_ST0009_01_f_2019_14				
Comment Code					
A3 : No rodents visible, but rodent burrows visible; need to backfill and compact or grout burrows.					
Inspector Comment

View of large animal burrows on the landside slope. Fall 2019.

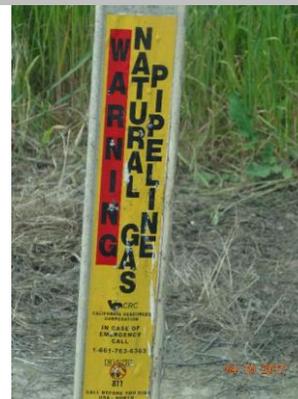
Photo 1 of 2 : UCIP_SP_2020_51486_76941.jpg

LM Start	3.65	Rating **	M	Issue No.	22
LM End	3.65	Issue Type +	En	Location *	
Category	Supplemental		GPS Latitude/Longitude		
			Start	End	
Item	DWR UCIP Field Study		39.027911 °	39.027911 °	
			-121.754224 °	-121.754224 °	
DWR ID	16590

Comment Code					
Inspector Comment					
DS_ID:16590 FS_ID:51486 EP_NO: 14740 Repair Type: Non-Urgent Crossing Status: Indicator Found UCIP Comments: 4/10/2017 Carsonite marker on WS missing. (DWR Sutter Yard- AFreitag)10/11/2016 Carsonite marker on WS shoulder is still missing.(DWR Sutter Yard - afreitag)4/18/2016 Carsonite marker on WS shoulder is missing.5/7/2015 Marker on WS shoulder missing.11/13/2014 Same as last inspection.5/12/2014 Same as last inspection.10/30/2013 Same as last inspection.5/20/2013 Carsonite marker on WS shoulder missing and should be replaced. FIELD_STRUCT_DESC: 4-inch steel gas pipeline through the levee and under channel, 2.5 feet below the crown. Carsonite signs on both the landside (LS) and the waterside (WS) shoulders. Gas wells 200 feet off of the LS toe. (Permit No. 14740, 1988 - Nahama and Weagant Energy Co.) [Additional Reference(s): DWR Levee Log, 1993]. FS Date: 4/12/2017 9:21:13 AM

Close up of LS marker

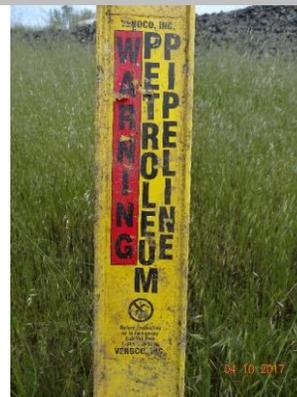
Photo 3 of 3 : UCIP_SP_2020_51487_76942.jpg

LM Start	4.50	Rating **	M	Issue No.	23 (cont)
LM End	4.50	Issue Type +	En	Location *	
Category	Supplemental			GPS Latitude/Longitude	
				Start	End
Item	DWR UCIP Field Study			39.032801 °	39.032801 °
				-121.743360 °	-121.743360 °
DWR ID	16855

Close up of LS marker

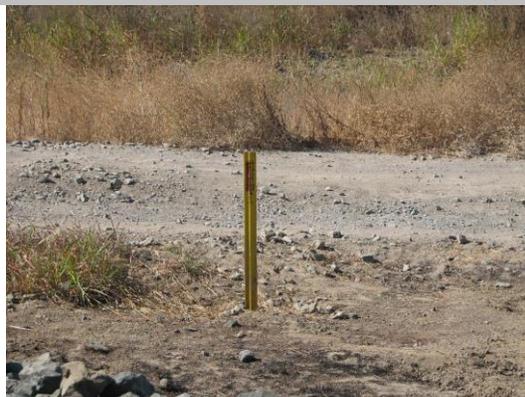
Photo 1 of 3 : UCIP_SP_2020_51488_64233.jpg

LM Start	4.50	Rating **	M	Issue No.	24
LM End	4.50	Issue Type +	En	Location *	
Category	Supplemental			GPS Latitude/Longitude	
				Start	End
Item	DWR UCIP Field Study			39.032801 °	39.032801 °
				-121.743360 °	-121.743360 °
DWR ID	16589

Carsonite sign on LS slope.

DS_ID:16589
 FS_ID:51488
 EP_NO: 14455
 Repair Type: Non-Urgent
 Crossing Status: Indicator Found
 UCIP Comments: 4/10/2017 LS marker still broken and there is no marker on the WS. (DWR Sutter Yard- AFreitag)10/11/2016 Carsonite marker on the LS is still broken.(DWR Sutter Yard - afreitag)4/18/2016 Carsonite marker on LS slope is broken off.5/7/2015 Crossing is in good condition. No noticeable issues to report.11/13/2014 Same as last inspection.5/12/2014 Same as last inspection.10/30/2013 Same as last inspection.5/20/2013 Same as last inspection.
 FIELD_STRUCT_DESC: 2 of 2: 4.5-inch steel natural gas pipeline through the levee, 2 feet below the crown. Line goes across the Sutter Bypass and through both levees. Carsonite sign located on the landside (LS) slope. (Permit No. 14455, 1986 - Depco Inc.). [Additional Reference(s): DWR Levee Log, 1993].
 FS Date: 4/12/2017 9:24:35 AM

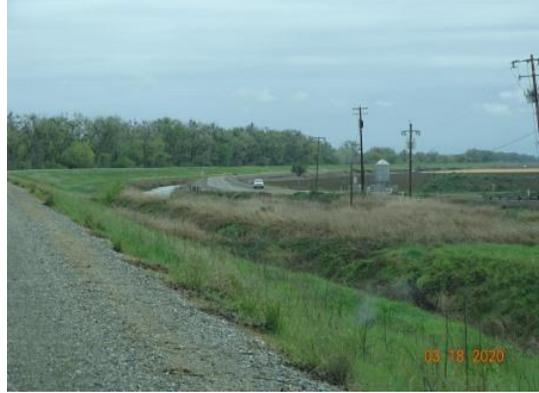
Photo 1 of 1 : SP_2020_ST0009_287_1_20200319_00017.jpg

LM Start	0.11	Rating **	M	Issue No.	1
LM End	0.26	Issue Type +	En	Location *	LS
Category	Earthen Levee		GPS Latitude/Longitude		
			Start	End	
Item	Encroachments		39.023760 °	39.024559 °	
			-121.818875 °	-121.816344 °	
DWR ID	DWR_ST0009_02_s_ 2012_1				
Comment Code					
DT : Ditch					
Inspector Comment

View of the agricultural ditch along the landside toe. Spring 2020.

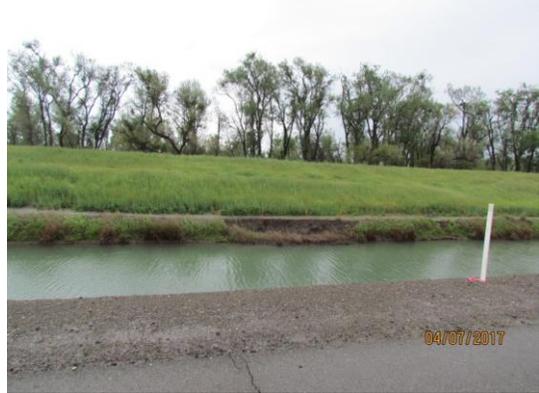
Photo 1 of 1 : SP_2020_ST0009_287_9_20200226_00005.jpg

LM Start	0.69	Rating **	M	Issue No.	9
LM End	0.71	Issue Type +	Ma	Location *	LS
Category	Earthen Levee		GPS Latitude/Longitude		
			Start	End	
Item	Erosion / Bank Caving		39.025602 °	39.025657 °	
			-121.808527 °	-121.808027 °	
DWR ID	DWR_ST0009_02_s_ 2017_9				
Comment Code					
E2 : Schedule repair of erosion site prior to the next inspection.					
Inspector Comment

View of the erosion along the landside toe from the County Road.

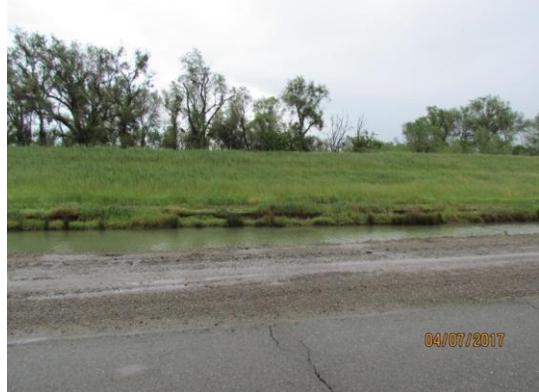
Photo 1 of 1 : SP_2020_ST0009_287_10_20200226_00006.jpg

LM Start	0.97	Rating **	M	Issue No.	10
LM End	0.98	Issue Type +	Ma	Location *	LS
Category	Earthen Levee		GPS Latitude/Longitude		
			Start	End	
Item	Erosion / Bank Caving		39.025540 °	39.025572 °	
			-121.803272 °	-121.802990 °	
DWR ID	DWR_ST0009_02_s_ 2017_10				
Comment Code					
E2 : Schedule repair of erosion site prior to the next inspection.					
Inspector Comment

View of the erosion along the landside toe from the County Road.

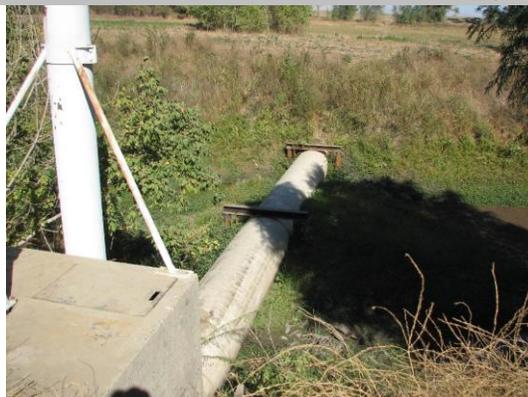
Photo 3 of 3 : UCIP_SP_2020_53047_64673.jpg

LM Start	1.14	Rating **	U	Issue No.	291 (cont)
LM End	1.14	Issue Type +	En	Location *	
Category	Supplemental			GPS Latitude/Longitude	
				Start	End
Item	DWR UCIP Field Study			39.025503 °	39.025503 °
				-121.800053 °	-121.800053 °
DWR ID	16594

Concrete box, vent, and 54-inch steel pipe in WS toe.

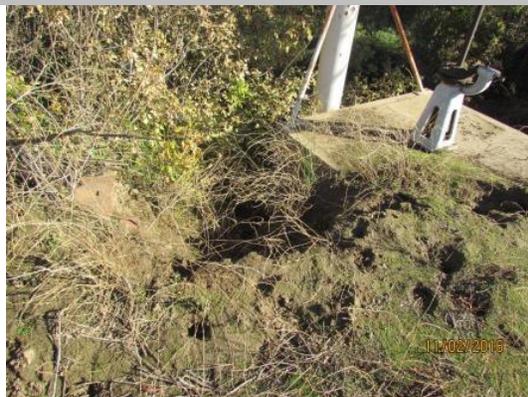
Photo 1 of 2 : SP_2020_ST0009_287_13_20200226_00007.jpg

LM Start	1.14	Rating **	M	Issue No.	13
LM End	1.14	Issue Type +	Ma	Location *	WS
Category	Earthen Levee			GPS Latitude/Longitude	
				Start	End
Item	Erosion / Bank Caving			39.025460 °	39.025460 °
				-121.800022 °	-121.800022 °
DWR ID	DWR_ST0009_02_f_2016_13				
Comment Code					
E2 : Schedule repair of erosion site prior to the next inspection.					
Inspector Comment					
Erosion around the WS concrete vault.

View of the erosion along the concrete vault.

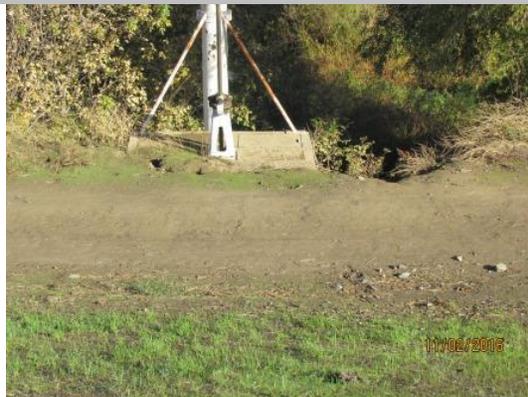
Photo 2 of 2 : SP_2020_ST0009_287_13_20200226_00008.jpg

Another view of the erosion along the concrete vault.

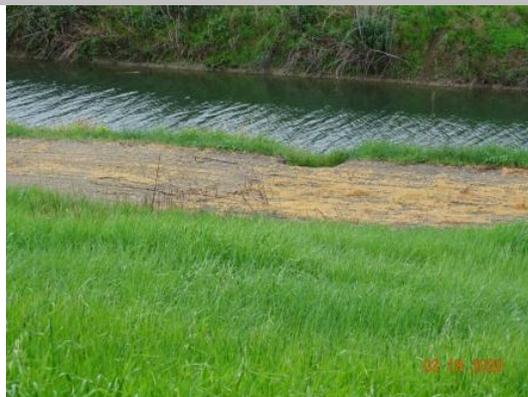
Photo 1 of 1 : SP_2020_ST0009_287_7_20200319_00018.jpg

LM Start	1.17	Rating **	A/W	Issue No.	7
LM End	1.17	Issue Type +	Ma	Location *	LS
Category	Earthen Levee		GPS Latitude/Longitude		
			Start	End	
Item	Erosion / Bank Caving		39.025496 °	39.025496 °	
			-121.799523 °	-121.799523 °	
DWR ID	DWR_ST0009_02_s_ 2020_7				
Comment Code					
E1 : Note and monitor erosion site.					
Inspector Comment

View of the erosion at the landside toe. Spring 2020.

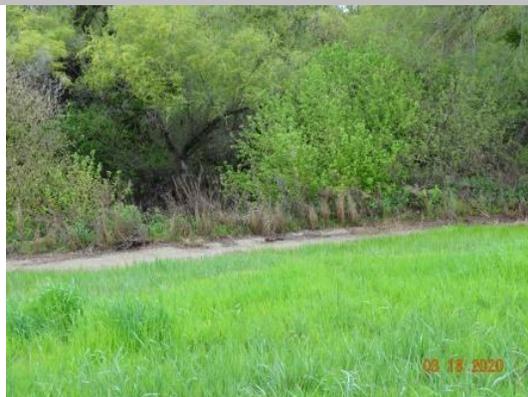
Photo 1 of 1 : SP_2020_ST0009_287_290_20200319_00019.jpg

LM Start	1.19	Rating **	A/W	Issue No.	290
LM End	1.19	Issue Type +	Ma	Location *	WS
Category	Earthen Levee		GPS Latitude/Longitude		
			Start	End	
Item	Erosion / Bank Caving		39.025490 °	39.025490 °	
			-121.799240 °	-121.799240 °	
DWR ID	DWR_ST0009_02_s_ 2015_290				
Comment Code					
E1 : Note and monitor erosion site.					
Inspector Comment					
Sutter Yard needs to monitor the erosion along the berm.

View of the erosion along the waterside berm. Spring 2020.

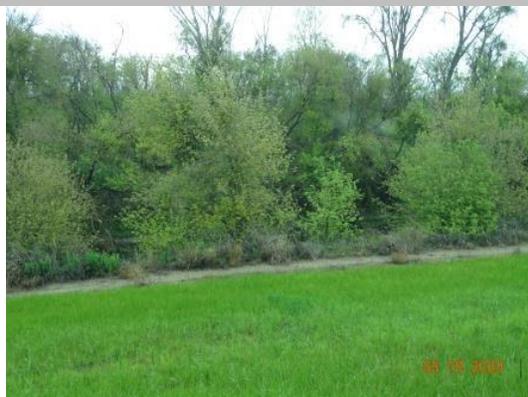
Photo 1 of 1 : SP_2020_ST0009_287_4_20200319_00020.jpg

LM Start	1.29	Rating **	A/W	Issue No.	4
LM End	1.29	Issue Type +	Ma	Location *	WS
Category	Earthen Levee		GPS Latitude/Longitude		
			Start	End	
Item	Erosion / Bank Caving		39.025478 °	39.025478 °	
			-121.797232 °	-121.797232 °	
DWR ID	DWR_ST0009_02_s_ 2013_4				
Comment Code					
E1 : Note and monitor erosion site.					
Inspector Comment					
Sutter Yard needs to monitor the erosion.

View of the erosion along the waterside berm. Spring 2020.

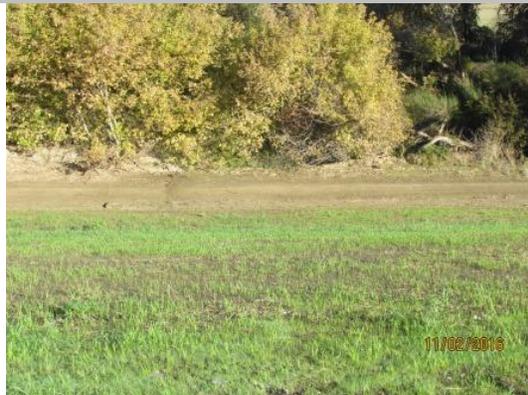
Photo 1 of 1 : SP_2020_ST0009_287_5_20200226_00004.jpg

LM Start	1.48	Rating **	A/W	Issue No.	5
LM End	1.50	Issue Type +	Ma	Location *	WS
Category	Earthen Levee		GPS Latitude/Longitude		
			Start	End	
Item	Erosion / Bank Caving		39.025460 °	39.025446 °	
			-121.793815 °	-121.793347 °	
DWR ID	DWR_ST0009_02_s_2013_5				
Comment Code					
E1 : Note and monitor erosion site.					
Inspector Comment					
Sutter Yard needs to monitor the erosion.

View of the erosion along the waterside berm.

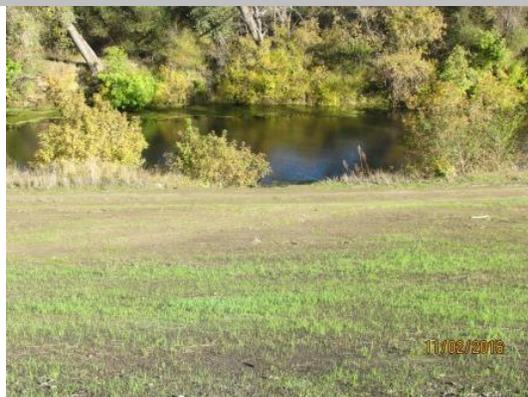
Photo 1 of 1 : SP_2020_ST0009_287_2_20200226_00002.jpg

LM Start	3.93	Rating **	A/W	Issue No.	2
LM End	3.93	Issue Type +	Ma	Location *	WS
Category	Earthen Levee		GPS Latitude/Longitude		
			Start	End	
Item	Erosion / Bank Caving		39.025060 °	39.025060 °	
			-121.748178 °	-121.748178 °	
DWR ID	DWR_ST0009_02_f_2016_2				
Comment Code					
E1 : Note and monitor erosion site.					
Inspector Comment

View of the erosion along the waterside berm.

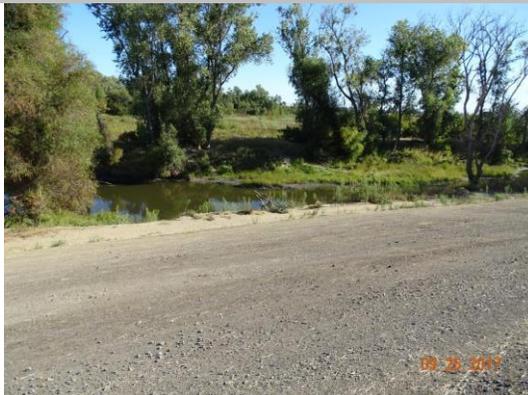
Photo 1 of 1 : SP_2020_ST0009_287_18_20200226_00009.jpg

LM Start	4.09	Rating **	A/W	Issue No.	18
LM End	4.09	Issue Type +	Ma	Location *	WS
Category	Earthen Levee		GPS Latitude/Longitude		
			Start	End	
Item	Erosion / Bank Caving		39.024912 °	39.024912 °	
			-121.745237 °	-121.745237 °	
DWR ID	DWR_ST0009_02_s_ 2020_18				
Comment Code					
E1 : Note and monitor erosion site.					
Inspector Comment

View of the erosion along the waterside berm.

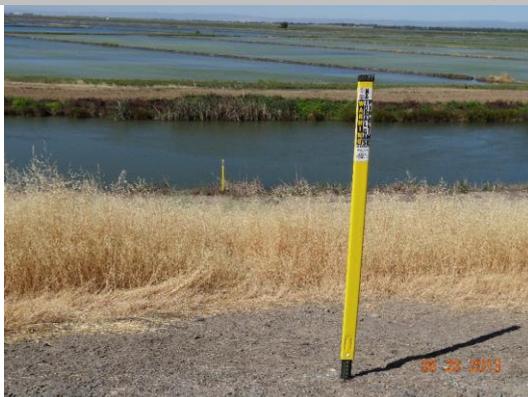
Photo 1 of 3 : UCIP_SP_2020_51491_64681.jpg

LM Start	4.20	Rating **	M	Issue No.	292
LM End	4.20	Issue Type +	En	Location *	
Category	Supplemental		GPS Latitude/Longitude		
			Start	End	
Item	DWR UCIP Field Study		39.024079 °	39.024079 °	
			-121.743420 °	-121.743420 °	
DWR ID	23099

Comment Code					
Inspector Comment					
DS_ID:23099 FS_ID:51491 EP_NO: N/A Repair Type: Non-Urgent Crossing Status: Found UCIP Comments: 4/10/2017 Crossing appears to be in good condition. (DWR Sutter Yard- AFreitag)10/11/2016 Crossing appears to be in good condition but there is no permit on file. Photos of the markers were uploaded on 5/20/2013.(DWR Sutter Yard - afreitag)5/3/2016 Need photos of markers on both WS and LS. 4/18/2016 Crossing appears to be in good condition. No noticeable issues to report.5/7/2015 Crossing is in good condition. No noticeable issues to report.11/13/2014 Same as last inspection.5/12/2014 Same as last inspection.10/30/2013 Same as last inspection.10/17/2012 Need to identify permit for crossing. FIELD_STRUCT_DESC: Steel natural gas pipeline of an unknown size through the levee, at an unknown depth. Markers visible on the landside (LS) shoulder and toe and the waterside (WS) shoulder and toe. No permit has been identified since the crossing was field discovered in 2012. FS Date: 4/12/2017 9:30:05 AM

Marker on LS shoulder and toe
