**Flood Control Project Maintenance
Levee Inspections**

Fall 2019 Levee Maintenance Deficiency Summary Report

Sutter Maintenance Yard Wadsworth Canal

Fall 2019 Levee Inspection Results

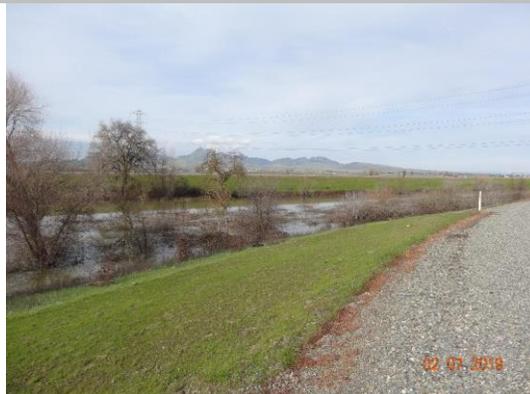
Photo 1 of 3 : UCIP_FA_2019_55976_78653.jpg

Comment Code					
Inspector Comment					
DS_ID:17068 FS_ID:55976 EP_NO: 5296 Repair Type: Non-Urgent Crossing Status: Not Found UCIP Comments: 02/07/2019 Record remains Non-Urgent, unable to locate pipe or any appurtenances on the levee. LMA superintendent, Joel Farias, mentioned that this line has been abandoned and line is only referenced in old PG&E facility maps. Owner to this pipe has been changed at least 4 times. No maintenance records were available to determine the status of the pipe. Unable to confirm how pipe was abandoned. Will need to contact owner. (O. Magana - DWR UCIP)04/10/2017 Unable to locate. (DWR Sutter Yard - AFreitag)10/12/2016 Unable to locate.(DWR Sutter Yard - afreitag)04/19/2016 Unable to locate.05/12/2015 Unable to locate.11/18/2014 Unable to locate.05/13/2014 Same as last inspection.10/29/2013 Same as last inspection.05/16/2013 Same as last inspection.10/09/2012 Need to determine disposition of pipe, contact pipe owner if possible. (W. Wylie - DWR UCIP) FIELD_STRUCT_DESC: 3.5-inch steel gas line through the levee, 3 feet below the crown. Gas line goes through both levees and Wadsworth Canal. Waterside (WS) bank protected by rock. (3-inch line authorized under Permit No. 5296, 1966 - Atlantic Oil Company). [Additional Reference(s): DWR Levee Log, 2005]. FS Date: 2/7/2019 2:48:00 PM

WS view: Clean slope with no evidence of line present.

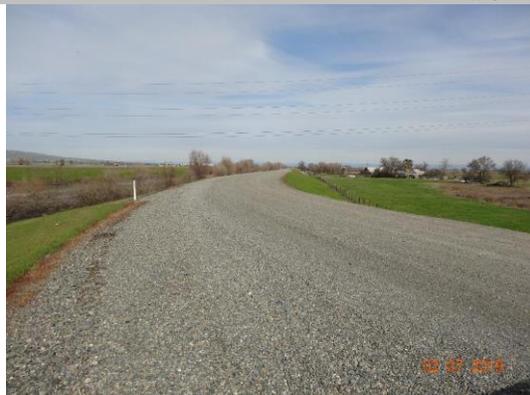
Photo 2 of 3 : UCIP_FA_2019_55976_78654.jpg

LM Start	0.02	Rating **	M	Issue No.	108 (cont)
LM End	0.02	Issue Type +	En	Location *

Overview of levee crown at location where crossing should be.

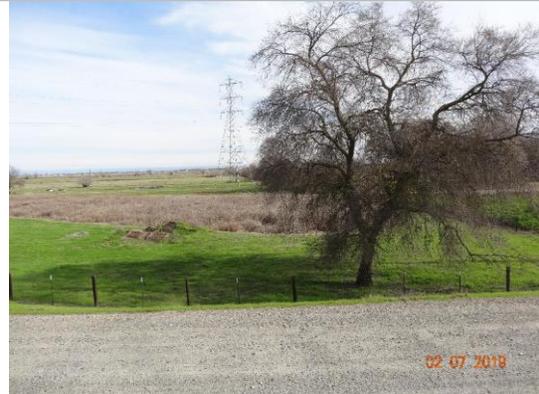
Photo 3 of 3 : UCIP_FA_2019_55976_78655.jpg

Comment Code					
Inspector Comment					
DS_ID:17068 FS_ID:55976 EP_NO: 5296 Repair Type: Non-Urgent Crossing Status: Not Found UCIP Comments: 02/07/2019 Record remains Non-Urgent, unable to locate pipe or any appurtenances on the levee. LMA superintendent, Joel Farias, mentioned that this line has been abandoned and line is only referenced in old PG&E facility maps. Owner to this pipe has been changed at least 4 times. No maintenance records were available to determine the status of the pipe. Unable to confirm how pipe was abandoned. Will need to contact owner. (O. Magana - DWR UCIP)04/10/2017 Unable to locate. (DWR Sutter Yard - AFreitag)10/12/2016 Unable to locate.(DWR Sutter Yard - afreitag)04/19/2016 Unable to locate.05/12/2015 Unable to locate.11/18/2014 Unable to locate.05/13/2014 Same as last inspection.10/29/2013 Same as last inspection.05/16/2013 Same as last inspection.10/09/2012 Need to determine disposition of pipe, contact pipe owner if possible. (W. Wylie - DWR UCIP) FIELD_STRUCT_DESC: 3.5-inch steel gas line through the levee, 3 feet below the crown. Gas line goes through both levees and Wadsworth Canal. Waterside (WS) bank protected by rock. (3-inch line authorized under Permit No. 5296, 1966 - Atlantic Oil Company). [Additional Reference(s): DWR Levee Log, 2005]. FS Date: 2/7/2019 2:48:00 PM

LS view: No markers visible on LS.

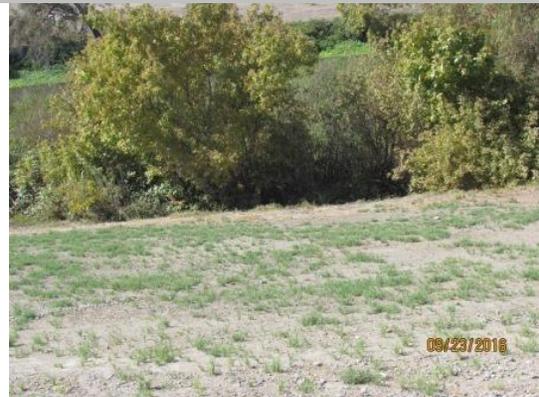
Photo 1 of 1 : FA_2019_ST0010_42_20_20190822_00013.jpg

LM Start	0.06	Rating **	A/W	Issue No.	20
LM End	0.12	Issue Type +	Ma	Location *	WS
Category	Earthen Levee			GPS Latitude/Longitude	
				Start	End
Item	Erosion / Bank Caving			39.114203 °	39.114842 °
				-121.768015 °	-121.767382 °
DWR ID	DWR_ST0010_01_f_2016_20				
Comment Code					
E1 : Note and monitor erosion site.					
Inspector Comment

View of the erosion along the waterside toe.

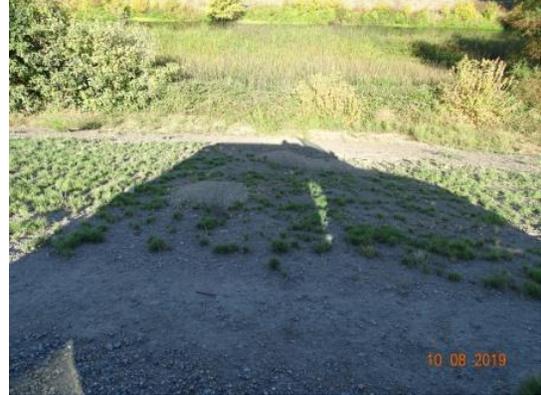
Photo 1 of 1 : FA_2019_ST0010_42_26_20191011_00052.jpg

View of the rodent burrows on the waterside slope. Fall 2019.

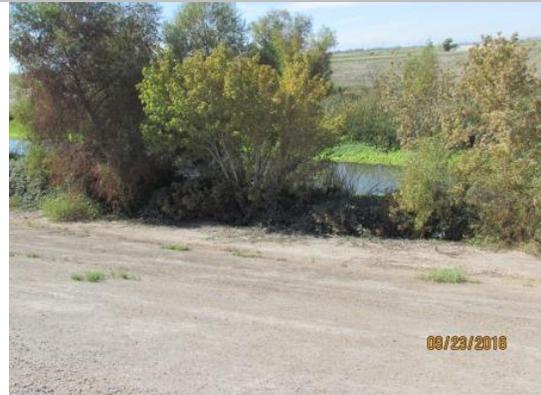
Photo 1 of 1 : FA_2019_ST0010_42_19_20190822_00012.jpg

View of the erosion along the waterside toe.

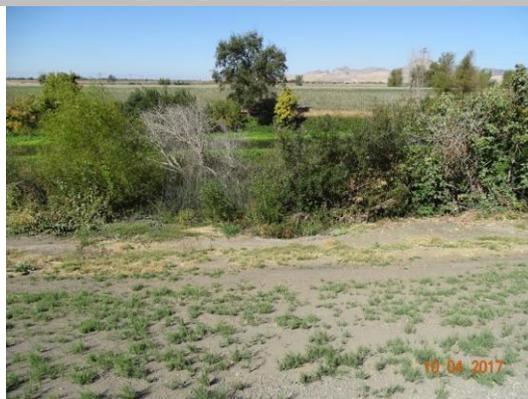
Photo 1 of 1 : FA_2019_ST0010_42_22_20190822_00014.jpg

LM Start	0.50	Rating **	U	Issue No.	22
LM End	0.50	Issue Type +	Ma	Location *	WS
Category	Earthen Levee		GPS Latitude/Longitude		
			Start	End	
Item	Erosion / Bank Caving		39.119348°	39.119348°	
			-121.763120°	-121.763120°	
DWR ID	DWR_ST0010_01_f_2017_22				
Comment Code					
E2 : Schedule repair of erosion site prior to the next inspection.					
Inspector Comment					
Repair the beaver hole along the waterside berm.

View of the beaver hole along the waterside berm.

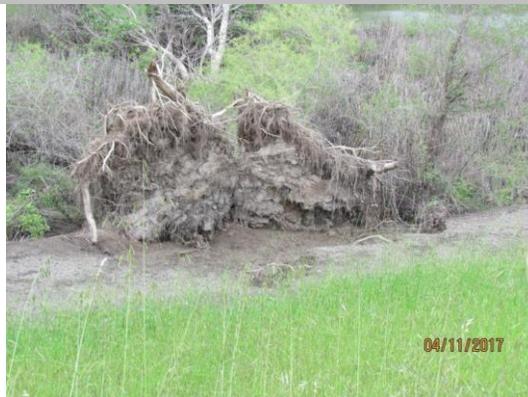
Photo 1 of 1 : FA_2019_ST0010_42_18_20190822_00011.jpg

LM Start	0.56	Rating **	M	Issue No.	18
LM End	0.56	Issue Type +	Ma	Location *	WS
Category	Earthen Levee		GPS Latitude/Longitude		
			Start	End	
Item	Erosion / Bank Caving		39.119985°	39.119985°	
			-121.762600°	-121.762600°	
DWR ID	DWR_ST0010_01_s_2017_18				
Comment Code					
E2 : Schedule repair of erosion site prior to the next inspection.					
Inspector Comment

View of the erosion along the waterside toe caused by a tree that fell into the water.

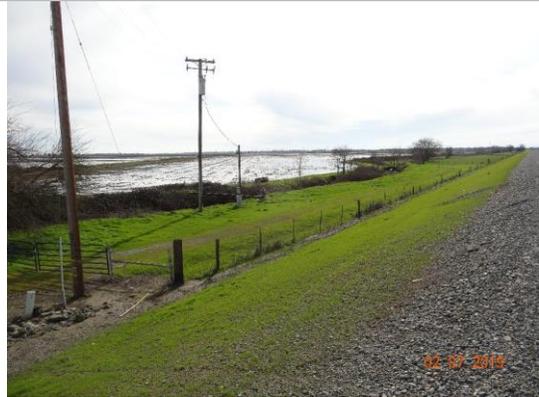
Photo 1 of 3 : UCIP_FA_2019_55977_78658.jpg

Comment Code					
Inspector Comment					
<p>DS_ID:17059 FS_ID:55977 EP_NO: 1605 Repair Type: Non-Urgent Crossing Status: Found UCIP Comments: 02/07/2019 Record remains Non-Urgent, pipe and appurtenances have been abandoned at this location. The pump and power meter have been removed from this location. Owner will need to coordinate with CVFPB to remove pipe according to Title 23 requirements. (O. Magana - DWR UCIP)04/10/2017 Abandoned. (DWR Sutter Yard- AFreitag)10/12/2016 Abandoned crossing.(DWR Sutter Yard - afreitag)04/16/2016 Abandoned crossing. Ws pipe end is open and should be capped.05/12/2015 Abandoned crossing. Needs to be properly abandoned.11/18/2014 Same as last inspection.05/13/2014 Same as last inspection.10/29/2013 Same as last inspection.05/16/2013 Same as last inspection.10/09/2012 No pump on Pier and power lines cut. Apparently abandoned-should be abandoned properly. (W. Wylie - DWR UCIP) FIELD_STRUCT_DESC: *ABANDONED* 18-inch steel irrigation pipe (permit records indicate 16-inch pipe, 18-inch diameter field verified) through the levee, 3.7 feet below the crown. Siphon breaker on the waterside (WS) slope. Pump on channel bank on steel structure. (16-inch pipe authorized under Permit No. 1605, 1959 - Schnabel; Aerial 12 KV power line extension for pump authorized under Permit No. 1631, 1959 - Pacific Gas and Electric Company [PG&E]). [Additional Reference(s): DWR Levee Log, 2005]. FS Date: 2/7/2019 2:48:00 PM</p>

LS view: overview of LS looking downstream.

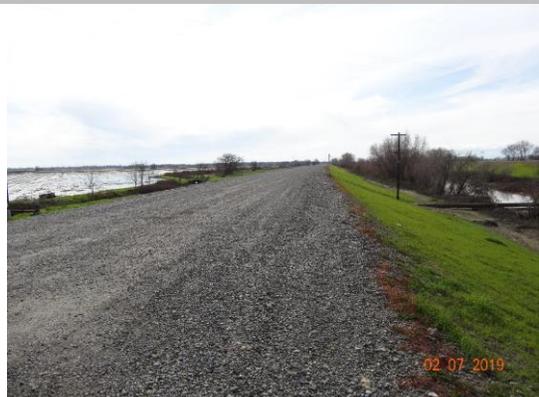
Photo 2 of 3 : UCIP_FA_2019_55977_78656.jpg

LM Start	1.21	Rating **	M	Issue No.	109 (cont)
LM End	1.21	Issue Type +	En	Location *

Overview of levee crown at pipe crossing.

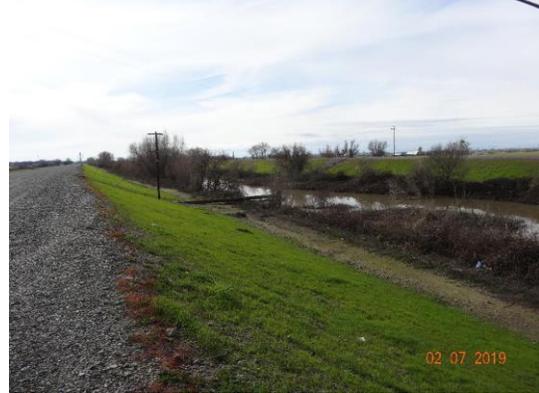
Photo 3 of 3 : UCIP_FA_2019_55977_78657.jpg

Comment Code					
Inspector Comment					
DS_ID:17059 FS_ID:55977 EP_NO: 1605 Repair Type: Non-Urgent Crossing Status: Found UCIP Comments: 02/07/2019 Record remains Non-Urgent, pipe and appurtenances have been abandoned at this location. The pump and power meter have been removed from this location. Owner will need to coordinate with CVFPB to remove pipe according to Title 23 requirements. (O. Magana - DWR UCIP)04/10/2017 Abandoned. (DWR Sutter Yard- AFreitag)10/12/2016 Abandoned crossing.(DWR Sutter Yard - afreitag)04/16/2016 Abandoned crossing. Ws pipe end is open and should be capped.05/12/2015 Abandoned crossing. Needs to be properly abandoned.11/18/2014 Same as last inspection.05/13/2014 Same as last inspection.10/29/2013 Same as last inspection.05/16/2013 Same as last inspection.10/09/2012 No pump on Pier and power lines cut. Apparently abandoned-should be abandoned properly. (W. Wylie - DWR UCIP) FIELD_STRUCT_DESC: *ABANDONED* 18-inch steel irrigation pipe (permit records indicate 16-inch pipe, 18-inch diameter field verified) through the levee, 3.7 feet below the crown. Siphon breaker on the waterside (WS) slope. Pump on channel bank on steel structure. (16-inch pipe authorized under Permit No. 1605, 1959 - Schnabel; Aerial 12 KV power line extension for pump authorized under Permit No. 1631, 1959 - Pacific Gas and Electric Company [PG&E]). [Additional Reference(s): DWR Levee Log, 2005]. FS Date: 2/7/2019 2:48:00 PM

WS view: overview of WS looking downstream.

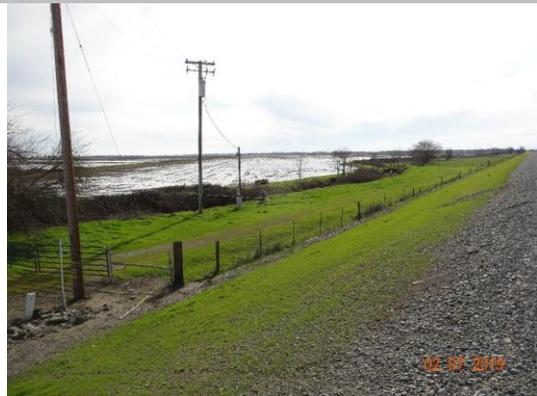
Photo 1 of 3 : UCIP_FA_2019_55978_78664.jpg

Comment Code					
Inspector Comment					
DS_ID:17083 FS_ID:55978 EP_NO: 17478 Repair Type: Non-Urgent Crossing Status: Indicator Found UCIP Comments: 02/07/2019 Record has been updated from No Action Needed to Non-Urgent, no records were made available to confirm the condition of the line through the levee. Will need to coordinate with owner to determine condition of line and obtain maintenance records for this line. (O. Magana - DWR UCIP)04/10/2017 Crossing appears to be in good condition. (DWR Sutter Yard- AFreitag)10/12/2016 Crossing appears to be in good condition.(DWR Sutter Yard - aFreitag)04/19/2016 Crossing appears to be in good condition.05/12/2015 Crossing appears in good condition. No noticeable issues to report.11/18/2014 Same as last inspection.05/13/2014 Same as last inspection.10/29/2013 Same as last inspection.05/16/2013 Same as last inspection. FIELD_STRUCT_DESC: 8-inch steel gas line bored across and under Wadsworth Canal and its levees, approximately 30 and 60 feet below channel and levees. Line was replaced to allow for the county to replace bridge over Wadsworth Canal. Gas line markers present on Franklin Roadside. (8-inch gas line authorized and existing 12-inch line removed under Permit No. 17478 and 17478-R, 2002 - Pacific Gas & Electric Company [PG&E]). FS Date: 2/7/2019 2:49:00 PM

LS view: gas marker visible by gate located on LS toe near first power pole.

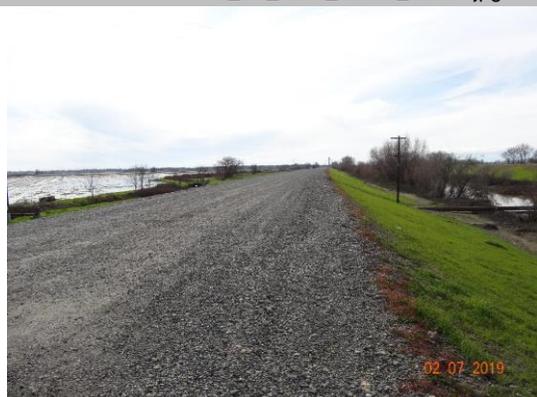
Photo 2 of 3 : UCIP_FA_2019_55978_78662.jpg

LM Start	1.22	Rating **	M	Issue No.	110 (cont)
LM End	1.22	Issue Type +	En	Location *

Overview of levee crown at pipe crossing.

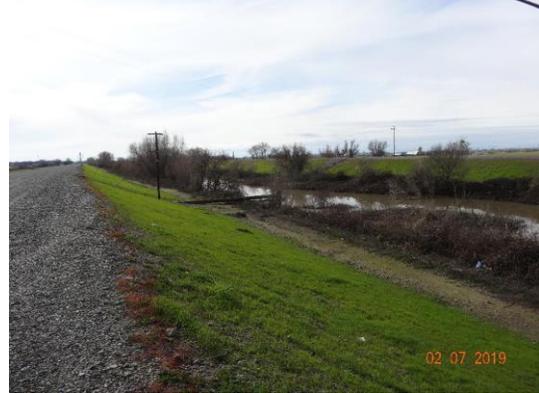
Photo 3 of 3 : UCIP_FA_2019_55978_78663.jpg

Comment Code					
Inspector Comment					
DS_ID:17083 FS_ID:55978 EP_NO: 17478 Repair Type: Non-Urgent Crossing Status: Indicator Found UCIP Comments: 02/07/2019 Record has been updated from No Action Needed to Non-Urgent, no records were made available to confirm the condition of the line through the levee. Will need to coordinate with owner to determine condition of line and obtain maintenance records for this line. (O. Magana - DWR UCIP)04/10/2017 Crossing appears to be in good condition. (DWR Sutter Yard- AFreitag)10/12/2016 Crossing appears to be in good condition.(DWR Sutter Yard - aFreitag)04/19/2016 Crossing appears to be in good condition.05/12/2015 Crossing appears in good condition. No noticeable issues to report.11/18/2014 Same as last inspection.05/13/2014 Same as last inspection.10/29/2013 Same as last inspection.05/16/2013 Same as last inspection. FIELD_STRUCT_DESC: 8-inch steel gas line bored across and under Wadsworth Canal and its levees, approximately 30 and 60 feet below channel and levees. Line was replaced to allow for the county to replace bridge over Wadsworth Canal. Gas line markers present on Franklin Roadside. (8-inch gas line authorized and existing 12-inch line removed under Permit No. 17478 and 17478-R, 2002 - Pacific Gas & Electric Company [PG&E]). FS Date: 2/7/2019 2:49:00 PM

WS view: marker just immediately upstream from 18-inch pipe crossing.

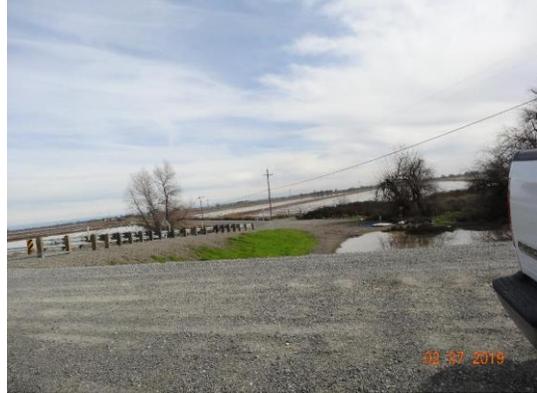
Photo 3 of 3 : UCIP_FA_2019_55979_78668.jpg

Comment Code					
Inspector Comment					
<p>DS_ID:17060 FS_ID:55979 EP_NO: 13362 Repair Type: Non-Urgent Crossing Status: Indicator Found UCIP Comments: 02/07/2019 Record has been updated from No Action Needed to Non-Urgent, unable to determine whether the old authorized conduit line was abandoned through the levee. The conduit appears to be modified to an aerial conduit. Need to contact owner to determine status of authorized line and determine permit issued for modification of the aerial line at the same location. (O. Magana - DWR UCIP)04/11/2017 Aerial lines. (DWR Sutter Yard-AFreitag)10/12/2016 Crossing appears to be in good condition.(DWR Sutter Yard - aFreitag)04/19/2016 Crossing appears to be in good condition.05/12/2015 Crossing appears in good condition. No noticeable issues to report.11/18/2014 Same as last inspection.05/13/2014 Same as last inspection.10/29/2013 Same as last inspection.05/16/2013 Same as last inspection.10/09/2012 No pipe on downstream side of bridge. It is likely that this com line is now an aerial. See photos. (W. Wylie - DWR UCIP) FIELD_STRUCT_DESC: 4-inch steel communication conduit with multiple telephone cables inside through the levee, 2.6 feet below the crown. Telephone cables sleeved through existing 4-inch conduit. The conduit is no longer attached to downstream side of bridge. It is likely that this communication line is now an aerial. (4-inch conduit authorized under Permit No. 6906, 1970 - Pacific Telephone and Telegraph Company [PT&T]. Telephone cables were installed through existing conduit authorized under Permit No. 13362, 1982 - PT&T). [Additional Reference(s): DWR Levee Log, 2005]. FS Date: 2/7/2019 2:49:00 PM</p>

LS view: no markers visible along LS or county road.

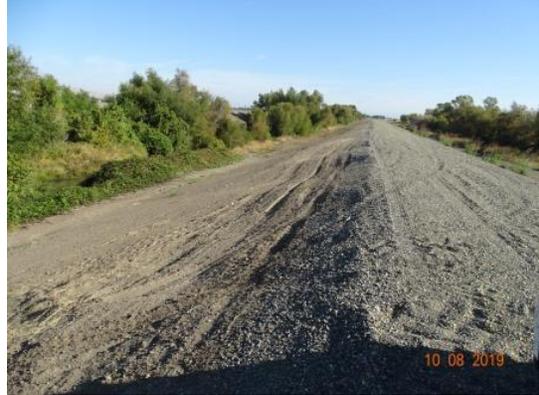
Photo 1 of 1 : FA_2019_ST0010_42_29_20191011_00053.jpg

LM Start	1.28	Rating **	M	Issue No.	29
LM End	1.28	Issue Type +	Ma	Location *	WS
Category	Earthen Levee			GPS Latitude/Longitude	
				Start	End
Item	Slope Stability			39.128352°	39.128352°
				-121.754575°	-121.754575°
DWR ID	DWR_ST0010_01_f_2019_29				
Comment Code					
S3 : Repair the levee slope damaged by vehicle traffic and prevent access where possible.					
Inspector Comment

View of the slope erosion due to vehicle traffic. Fall 2019.

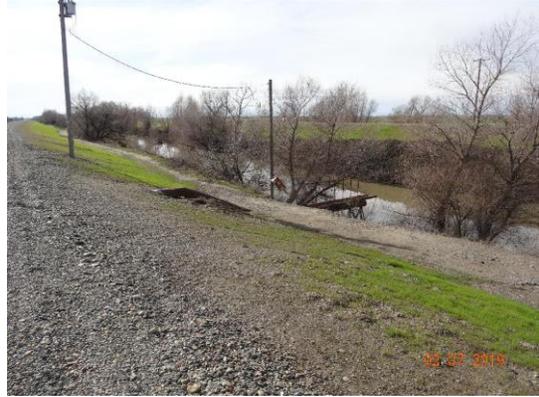
Photo 3 of 3 : UCIP_FA_2019_55500_78677.jpg

Comment Code					
Inspector Comment					
<p>DS_ID:17063 FS_ID:55500 EP_NO: N/A Repair Type: Urgent Crossing Status: Found UCIP Comments: 02/07/2019 Pipe has been upgraded from Non-Urgent to Urgent due to the pipe failure (sink hole) observed on the LS. Need to determine pipe integrity through the levee. Pipe and appurtenances have been abandoned. Power meter has been removed from the WS. Scour hole has developed on the WS berm edge located about 15 feet from WS toe. Owner will need to coordinate with CVFPB to properly remove pipe per Title 23. (O. Magana - DWR UCIP)04/10/2017 Abandoned. 10/12/2016 Abandoned crossing.(DWR Sutter Yard - afreitag)04/19/2016 Abandoned crossing. No noticeable issues to report.05/12/2015 Abandoned crossing. Cap was made and installed on WS open end of pipe.11/18/2014 Same as last inspection.05/13/2014 Cap was made and bolted on to WS open end of pipe.10/29/2013 Same as last inspection.05/16/2013 Same as last inspection. Steve Beckley is looking into finding pipe owner to properly abandon pipe.10/09/2012 Pipe abandoned. Pipe open and not plugged. Pipe should be removed or abandoned properly. Extensive animal burrowing occurring along pipe alignment. (W. Wylie - DWR UCIP) FIELD_STRUCT_DESC: *ABANDONED* 14-inch steel irrigation pipe (permit records reference 24-inch corrugated metal in 1939 and existing 18-inch pipe in 1932 through levee, USACE O&M references 15-inch pipe in 1953) through the levee, 5.7 feet below the crown. Siphon breaker located on the landside (LS). Vertical pump located on the waterside (WS). Meter pole located on the WS berm. (Permit authorized existing 18-inch pipe and new installation of pump under Permit No. 572, 1932 - Joaquin). [Additional Reference(s): DWR Levee Log, 2005. USACE Sacramento O&M Manual 135, May 1953, (Station 98+02), Dwg. No. 50-04-1949, page 1 of 3]. FS Date: 2/7/2019 2:52:00 PM</p>

WS view: overview of WS.

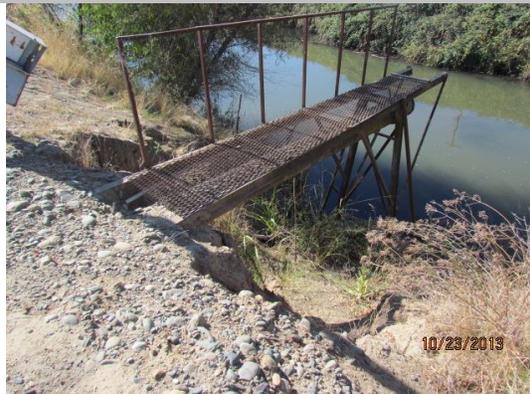
Photo 1 of 3 : FA_2019_ST0010_42_107_20190822_00016.jpg

LM Start	1.85	Rating **	U	Issue No.	107
LM End	1.85	Issue Type +	Ma	Location *	WS
Category	Earthen Levee			GPS Latitude/Longitude	
				Start	End
Item	Erosion / Bank Caving			39.135110°	39.135110°
				-121.748230°	-121.748230°
DWR ID	DWR_ST0010_01_f_2013_107				
Comment Code					
E2 : Schedule repair of erosion site prior to the next inspection.					
Inspector Comment					
Significant erosion is present at this site and should be addressed.

View of the erosion along both sides of the abandoned pump.

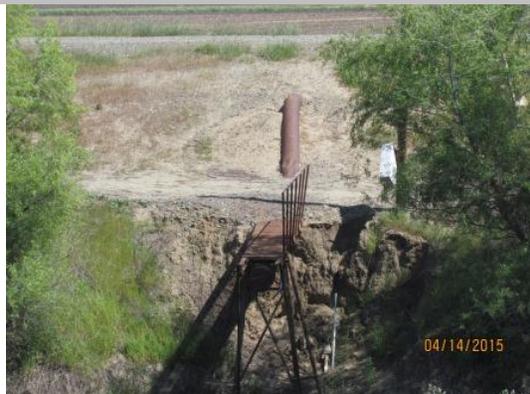
Photo 2 of 3 : FA_2019_ST0010_42_107_20190822_00017.jpg

LM Start	1.85	Rating **	U	Issue No.	107 (cont)
LM End	1.85	Issue Type +	Ma	Location *	WS

View of the erosion along both sides of the abandoned pump.

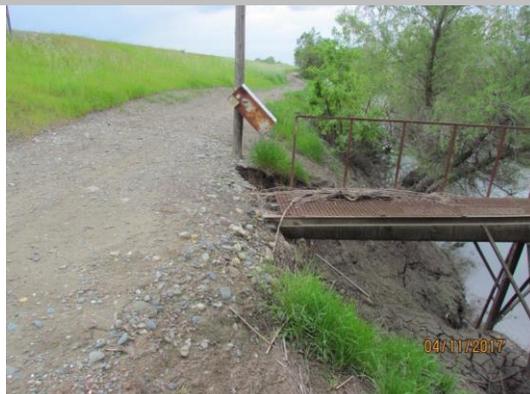
Photo 3 of 3 : FA_2019_ST0010_42_107_20190822_00018.jpg

LM Start	1.85	Rating **	U	Issue No.	107 (cont)
LM End	1.85	Issue Type +	Ma	Location *	WS

View of erosion along both sides of the abandoned pipe.

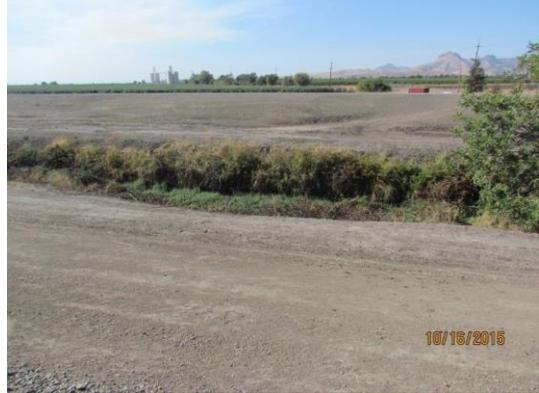
Photo 3 of 4 : FA_2019_ST0010_42_6_20190822_00008.jpg

View of the erosion along the waterside toe.

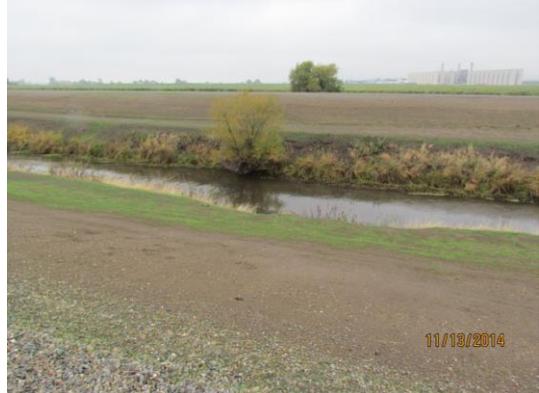
Photo 4 of 4 : FA_2019_ST0010_42_6_20190822_00009.jpg

LM Start	2.43	Rating **	M	Issue No.	6 (cont)
LM End	3.30	Issue Type +	Ma	Location *	WS

View of the erosion along the waterside toe.

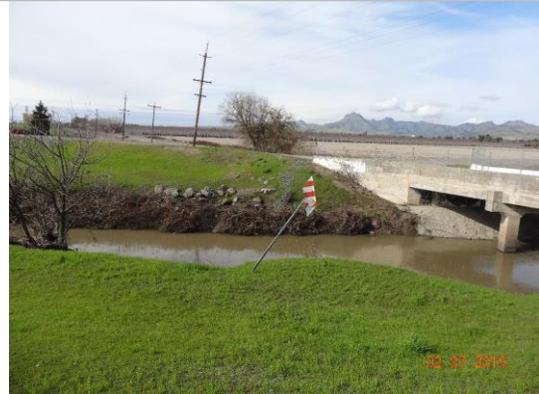
Photo 1 of 3 : UCIP_FA_2019_55501_78683.jpg

Comment Code					
Inspector Comment					
DS_ID:17064 FS_ID:55501 EP_NO: 9191 Repair Type: Non-Urgent Crossing Status: Indicator Found UCIP Comments: 02/07/2019 Record has been updated from No Action Needed to Non-Urgent, no maintenance records were made available to determine condition of line. Need to contact owner to determine status of line through the levee. (O. Magana - DWR UCIP)04/10/2017 Crossing appears to be in good condition. (DWR Sutter Yard- AFreitag)10/12/2016 Crossing appears to be in good condition.(DWR Sutter Yard - afreitag)04/19/2016 Crossing appears to be in good condition.05/12/2015 Crossing appears in good condition. No noticeable issues to report.11/18/2014 Same as last inspection.05/13/2014 Same as last inspection.05/16/2013 Same as last inspection.10/29/2013 Same as last inspection. FIELD_STRUCT_DESC: 6-inch (not 7-inch, as mentioned in the levee log) asphalt coated steel gas line through the levee, 1.1 feet below the crown. Gas line crosses the Wadsworth Canal and its levees. Gas line markers located on the landside (LS) and waterside (WS) toes. (6-inch gas line authorized under Permit No. 764, 1939 - Pacific Gas and Electric Company [PG&E]. Pipe reconstructed under Permit No. 9191, 1974 - PG&E). [Additional Reference(s): DWR Levee Log, 2005. USACE Sacramento O&M Manual 135, May 1953, (Station 159+38), Dwg. No. 50-04-1949, page 2 of 3]. FS Date: 2/7/2019 2:52:00 PM

WS view: line crosses both left and right bank, markers visible on opposite levee.

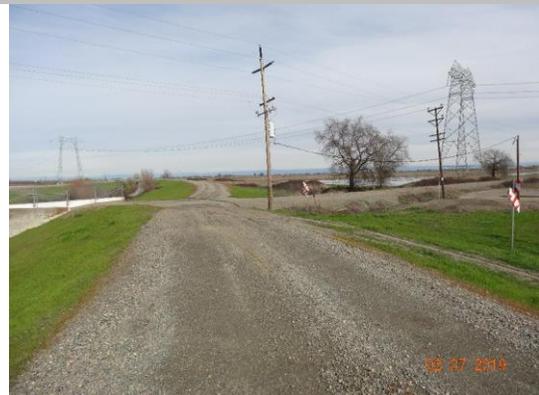
Photo 2 of 3 : UCIP_FA_2019_55501_78681.jpg

LM Start	3.01	Rating **	M	Issue No.	113 (cont)
LM End	3.01	Issue Type +	En	Location *

Overview of levee crown at pipe crossing.

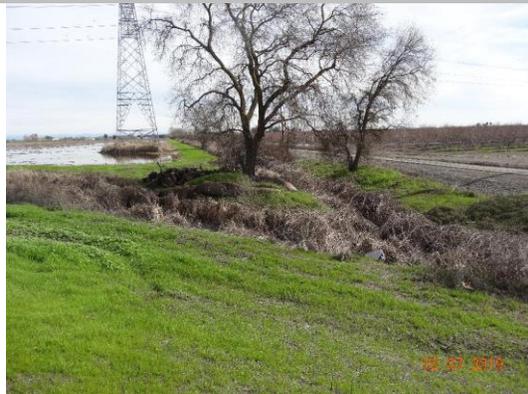
Photo 1 of 3 : UCIP_FA_2019_55502_78688.jpg

Comment Code					
Inspector Comment					
<p>DS_ID:17065 FS_ID:55502 EP_NO: 7209 Repair Type: Non-Urgent Crossing Status: Found UCIP Comments: 02/07/2019 Record remains Non-Urgent due to of few maintenance issues observed during inspection. Pipe is being used as a shooting target. Multiple holes are visible on the exposed WS section of the pipe. The inlet pipe section located on the LS has been damaged (pipe wall section pulled). This pipe qualifies as an LMA responsible crossing as it was originally listed in the USACE O&M manual as a drainage pipe. The CVFPB issued a permit in 1970 for the replacement of the original USACE drainage pipe. (O. Magana - DWR UCIP)04/10/2017 WS pipe end is in good condition. LS pipe end is still deformed and vegetated. (DWR Sutter Yard- AFreitag)10/12/2016 LS inlet is still deformed and being overgrown by vegetation.(DWR Sutter Yard - afreitag)04/19/2016 Crossing appears to be in good condition.05/12/2015 LS inlet still deformed a little but does not affect the crossing function.11/18/2014 Same as last inspection.05/13/2014 Same as last inspection.10/29/2013 Same as last inspection.05/16/2013 Pipe intake on LS appears to be bent and damaged but that does not appear to be affecting water flow or channel bank. FIELD_STRUCT_DESC: 36-inch corrugated metal drainage pipe (permit records indicate 30-inch, USACE O&M pipe replaced with new 30-inch pipe) through the levee, 9 feet below the crown. Flap gate located on the waterside (WS) end. (Original O&M manual crossing was replaced under Permit No. 7209, 1970 - Department of Water Resources [DWR], replacement pipe size not referenced) [Additional Reference(s): DWR Levee Log, 2005. USACE Sacramento O&M Manual 135, May 1953, (Station 160+25), Dwg No. 50-04-1949, sheet 2 of 3]. FS Date: 2/7/2019 2:53:00 PM</p>

LS view: overview of LS.

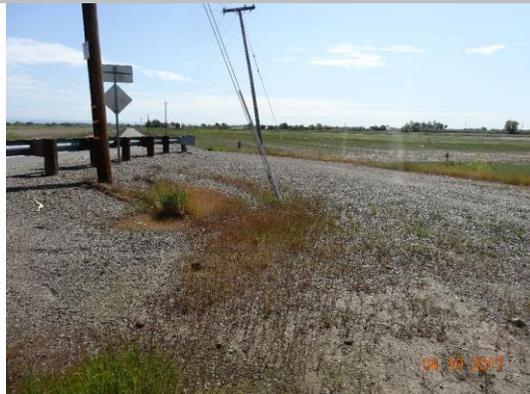
Photo 1 of 3 : UCIP_FA_2019_55503_76957.jpg

Comment Code					
Inspector Comment					
DS_ID:23097 FS_ID:55503 EP_NO: N/A Repair Type: Non-Urgent Crossing Status: Found UCIP Comments: 02/07/2019 Record remains Non-Urgent due to no permit found authorizing conduit through the levee. Carsonite marker lists CVIN as owner. Contact phone number listed on marker to be used before digging is 855-442-6010. Need to contact owner to determine permit used for installation of buried fiber optic cable. (O. Magana - DWR UCIP)04/10/2017 Crossing appears to be in good condition. Photos added. (DWR Sutter Yard- AFreitag)10/12/2016 Crossing appears to be in good condition.(DWR Sutter Yard - afreitag)05/31/2016 Need photos markers and levee overview (O. Magana)04/19/2016 Crossing appears to be in good condition. No permit on file.05/12/2015 No noticeable issues with crossing but no permit on file for it.11/18/2014 Same as last inspection.05/13/2014 Same as last inspection.10/29/2013 Same as last inspection.05/16/2013 No known permit for work. FIELD_STRUCT_DESC: 4-inch steel communication line conduit through the levee, 2 feet below the crown. Fiber optics line attached to bottom of downstream side of South Butte Road bridge. Position marked with orange markers. No permit has been identified since crossing was field discovered in 2012. FS Date: 2/7/2019 2:53:00 PM

LS overview

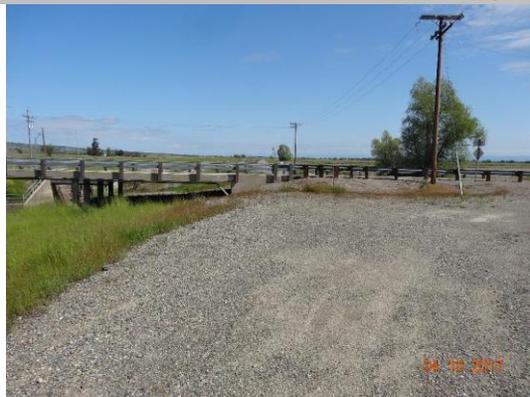
Photo 2 of 3 : UCIP_FA_2019_55503_76953.jpg

Levee overview looking upstream.

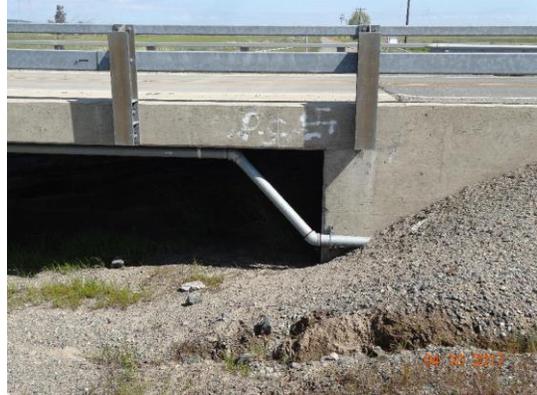
Photo 3 of 3 : UCIP_FA_2019_55503_76954.jpg

Comment Code					
Inspector Comment					
<p>DS_ID:23097 FS_ID:55503 EP_NO: N/A Repair Type: Non-Urgent Crossing Status: Found UCIP Comments: 02/07/2019 Record remains Non-Urgent due to no permit found authorizing conduit through the levee. Carsonite marker lists CVIN as owner. Contact phone number listed on marker to be used before digging is 855-442-6010. Need to contact owner to determine permit used for installation of buried fiber optic cable. (O. Magana - DWR UCIP)04/10/2017 Crossing appears to be in good condition. Photos added. (DWR Sutter Yard- AFreitag)10/12/2016 Crossing appears to be in good condition.(DWR Sutter Yard - afreitag)05/31/2016 Need photos markers and levee overview (O. Magana)04/19/2016 Crossing appears to be in good condition. No permit on file.05/12/2015 No noticeable issues with crossing but no permit on file for it.11/18/2014 Same as last inspection.05/13/2014 Same as last inspection.10/29/2013 Same as last inspection.05/16/2013 No known permit for work. FIELD_STRUCT_DESC: 4-inch steel communication line conduit through the levee, 2 feet below the crown. Fiber optics line attached to bottom of downstream side of South Butte Road bridge. Position marked with orange markers. No permit has been identified since crossing was field discovered in 2012. FS Date: 2/7/2019 2:53:00 PM</p>

Conduit exiting WS slope and attaching to the downstream side of South Butte Rd bridge.

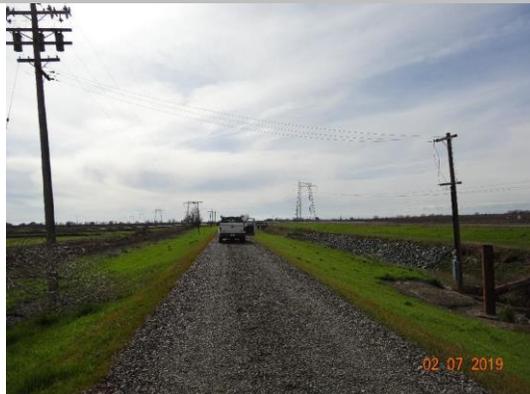
Photo 1 of 3 : UCIP_FA_2019_55504_78704.jpg

DS_ID:17066
 FS_ID:55504
 EP_NO: N/A
 Repair Type: Non-Urgent
 Crossing Status: Found
 UCIP Comments: 02/07/2019 Record remains Non-Urgent, this crossing has been modified. Also, unable to determine if the 24-inch pipe referenced in the levee logs still exists through the levee. There is a 14-inch steel pipe on the WS, a 16-inch steel riser on the WS, and a 16-inch PVC pipe located on the LS. No permit was found authorizing the modifications at this location. The 4-foot by 6-foot concrete distribution box has been removed from the WS. Some settling (minor depression) is present where the distribution box might have been previously located. Need to contact owner to determine CVFPB permit issued for the modifications at this location. (O. Magana - DWR UCIP)01/28/2019 USACE O&M dwg shows 12-inch and 24-inch on LS. (O. Magana - DWR UCIP)
 04/10/2017 LS heavily vegetated but nothing appears to have changed with the crossing. LS headwall still silted in and pipe discharges directly into the rice field. (DWR Sutter Yard- AFreitag)10/12/2016 Crossing appears to be in good condition.04/19/2016 Crossing has not changed since the last inspection. LS headwall is silted in and not being used. LS pipe end discharges into the rice field.05/12/2015 Concrete headwall on LS is completely silted in. LS pipe end is located near the edge of rice field. No issues seen on WS.11/18/2014 Same as last inspection.05/13/2014 Same as last inspection.10/29/2013 Concrete headwall is silted in and appears to be abandoned. Discharge end of pipe is approx. 100ft. from LS toe on the edge of the rice field.05/16/2013 Same as last inspection.

Overview of levee crown lookin downstream towards crossing.

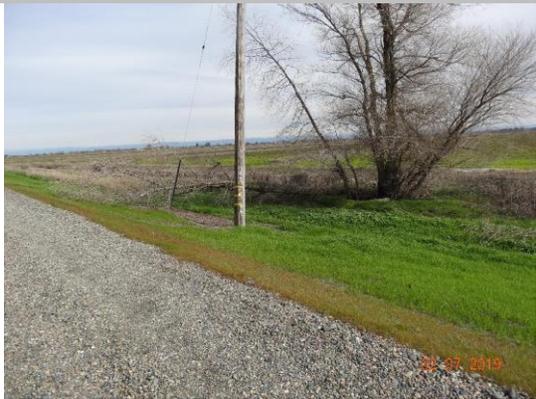
Photo 3 of 3 : UCIP_FA_2019_55504_78702.jpg

DS_ID:17066
 FS_ID:55504
 EP_NO: N/A
 Repair Type: Non-Urgent
 Crossing Status: Found
 UCIP Comments: 02/07/2019 Record remains Non-Urgent, this crossing has been modified. Also, unable to determine if the 24-inch pipe referenced in the levee logs still exists through the levee. There is a 14-inch steel pipe on the WS, a 16-inch steel riser on the WS, and a 16-inch PVC pipe located on the LS. No permit was found authorizing the modifications at this location. The 4-foot by 6-foot concrete distribution box has been removed from the WS. Some settling (minor depression) is present where the distribution box might have been previously located. Need to contact owner to determine CVFPB permit issued for the modifications at this location. (O. Magana - DWR UCIP)01/28/2019 USACE O&M dwg shows 12-inch and 24-inch on LS. (O. Magana - DWR UCIP)
 04/10/2017 LS heavily vegetated but nothing appears to have changed with the crossing. LS headwall still silted in and pipe discharges directly into the rice field. (DWR Sutter Yard- AFreitag)10/12/2016 Crossing appears to be in good condition.04/19/2016 Crossing has not changed since the last inspection. LS headwall is silted in and not being used. LS pipe end discharges into the rice field.05/12/2015 Concrete headwall on LS is completely silted in. LS pipe end is located near the edge of rice field. No issues seen on WS.11/18/2014 Same as last inspection.05/13/2014 Same as last inspection.10/29/2013 Concrete headwall is silted in and appears to be abandoned. Discharge end of pipe is approx. 100ft. from LS toe on the edge of the rice field.05/16/2013 Same as last inspection.

LS view: power pole located on LS.

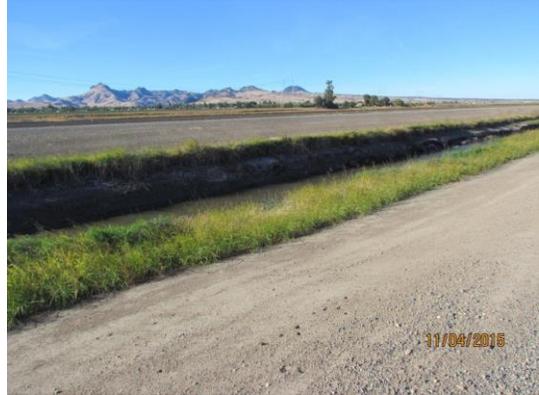
Photo 1 of 1 : FA_2019_ST0010_42_3_20190822_00001.jpg

View of the erosion along the waterside toe.

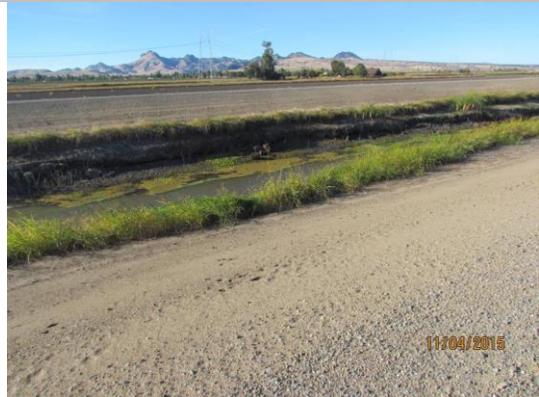
Photo 1 of 1 : FA_2019_ST0010_42_4_20190822_00003.jpg

View of the erosion along the waterside toe.

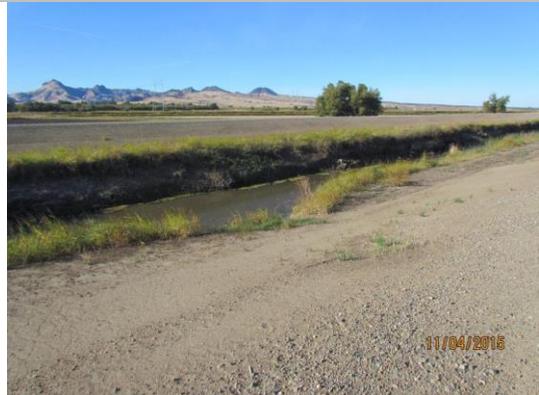
Photo 1 of 1 : FA_2019_ST0010_42_17_20190822_00010.jpg

View of the erosion along the waterside toe.

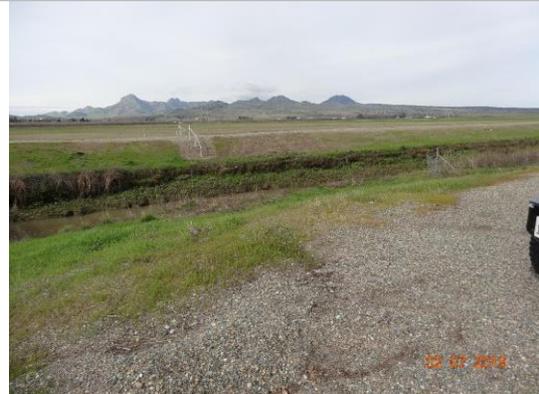
Photo 1 of 3 : UCIP_FA_2019_55506_78707.jpg

WS view: overview of WS, no signs of pipe.

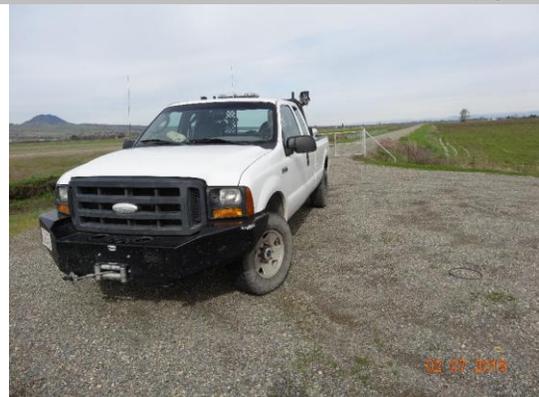
Photo 2 of 3 : UCIP_FA_2019_55506_78708.jpg

Overview of levee crown where crossing should be.

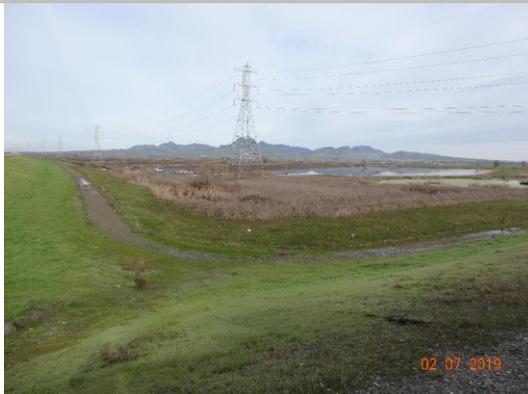
Photo 1 of 3 : UCIP_FA_2019_55507_78711.jpg

LS view: overview of LS; no markers present on LS.

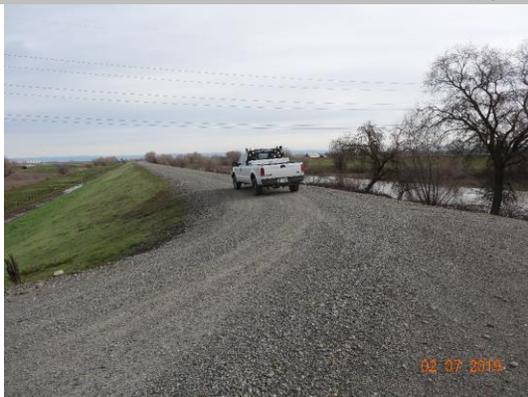
Photo 2 of 3 : UCIP_FA_2019_55507_78712.jpg

Overview of levee crown where crossing should be.

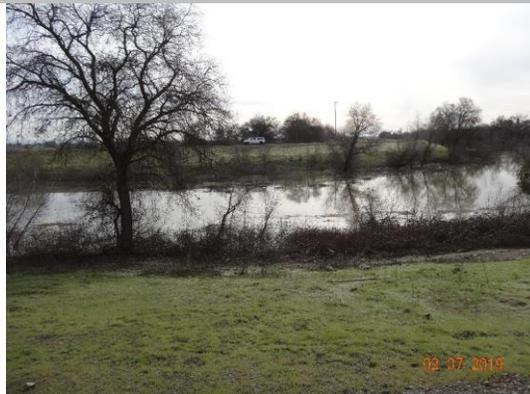
Photo 3 of 3 : UCIP_FA_2019_55507_78710.jpg

WS view: overview of WS; no markers visible of gas line.

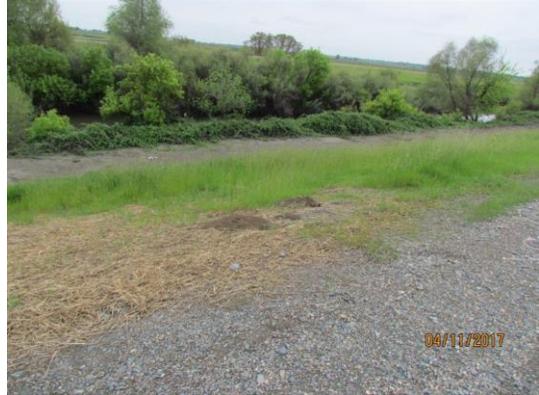
Photo 1 of 2 : FA_2019_ST0010_43_19_20190822_00008.jpg

View of the rodent holes along the waterside slope.

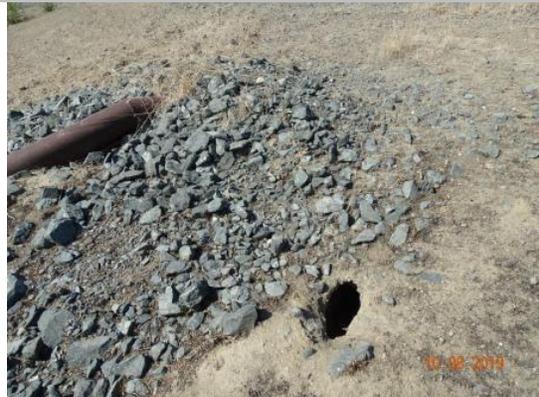
Photo 2 of 2 : FA_2019_ST0010_43_19_20191011_00053.jpg

View of a rodent hole on the waterside slope. Fall 2019.

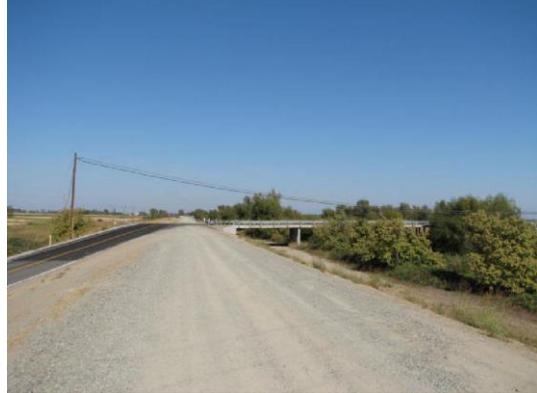
Photo 1 of 3 : UCIP_FA_2019_55510_64732.jpg

Aerial communication line over levee where underground communication line once was.

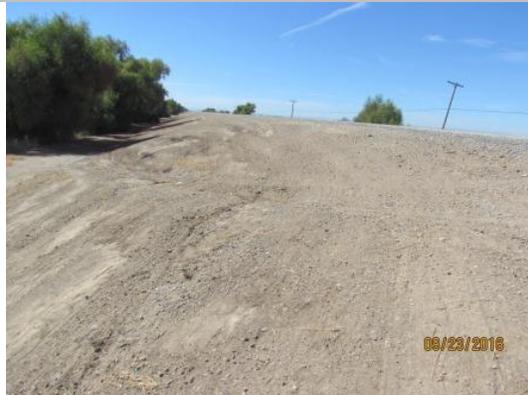
Photo 1 of 1 : FA_2019_ST0010_43_20_20190822_00009.jpg

View of the ramp encroaching into the levee.

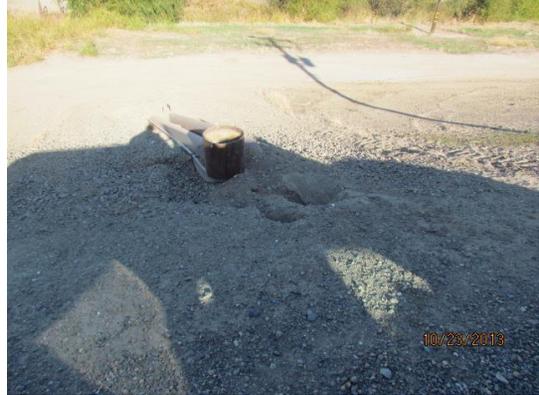
Photo 1 of 2 : FA_2019_ST0010_43_11_20190822_00005.jpg

View of the rodent holes above the irrigation pipe.

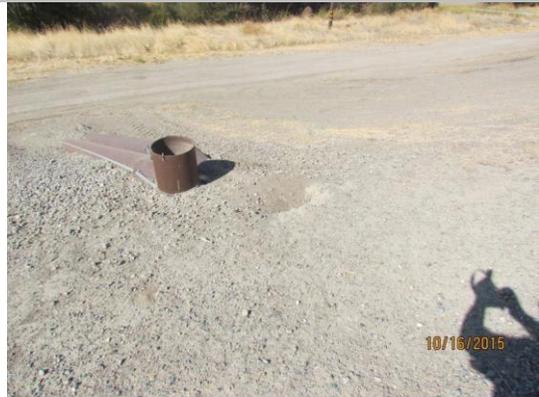
Photo 2 of 2 : FA_2019_ST0010_43_11_20190822_00006.jpg

View of the rodent hole above the irrigation pipe.

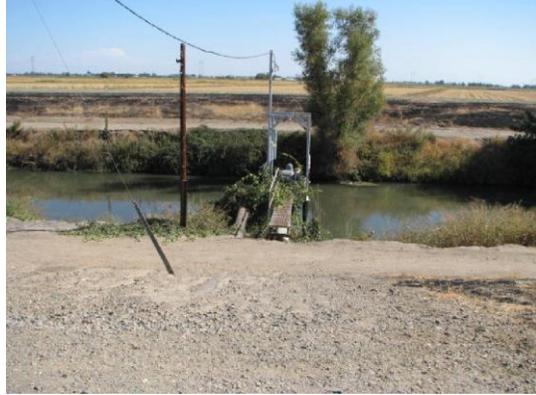
Photo 3 of 3 : UCIP_FA_2019_55514_64734.jpg

Pipe on left without pump.

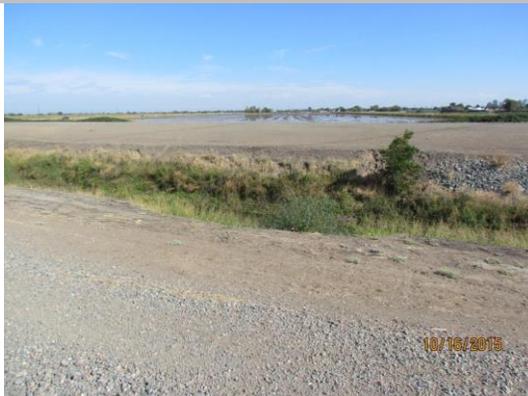
Photo 1 of 2 : FA_2019_ST0010_43_8_20190822_00001.jpg

View of erosion along the waterside toe.

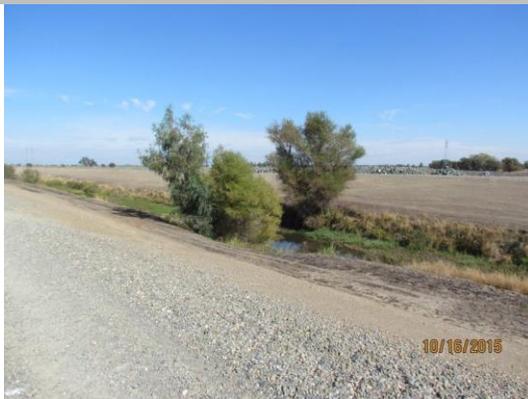
Photo 2 of 2 : FA_2019_ST0010_43_8_20190822_00002.jpg

View of the erosion along the landside toe.

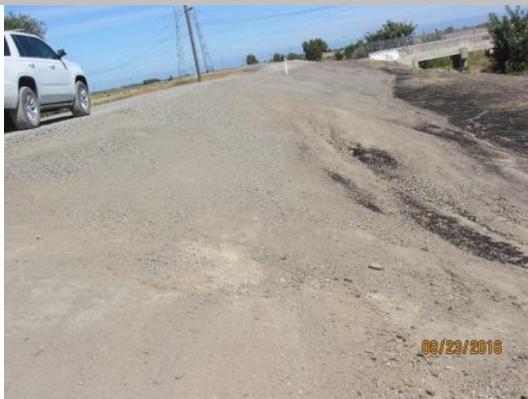
Photo 1 of 1 : FA_2019_ST0010_43_21_20190822_00010.jpg

View of the ramp encroaching into the levee.

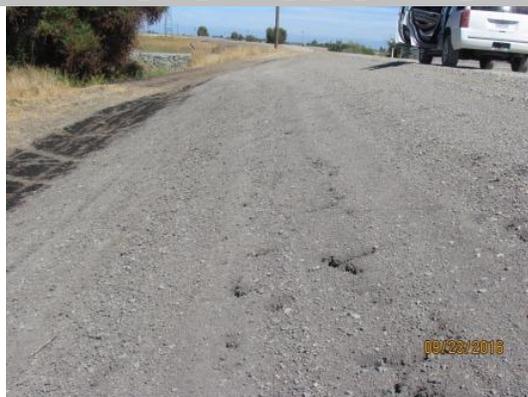
Photo 1 of 1 : FA_2019_ST0010_43_22_20190822_00012.jpg

View of the longitudinal cracks along the landside slope.

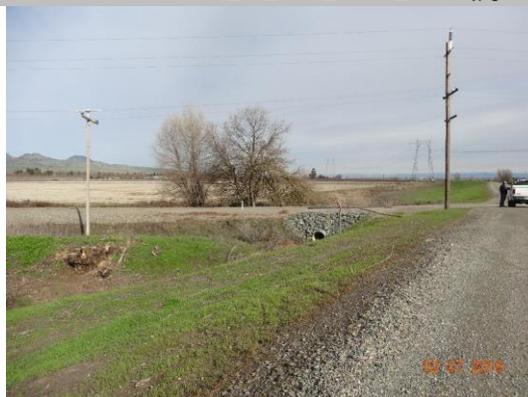
Photo 1 of 3 : UCIP_FA_2019_55516_78767.jpg

LS view: overview of LS.

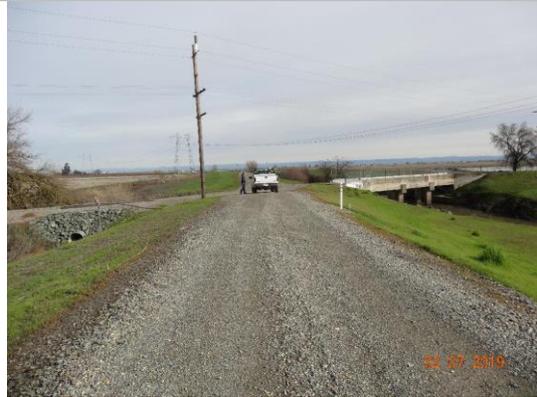
Photo 2 of 3 : UCIP_FA_2019_55516_78765.jpg

Overview of levee crown looking upstream towards crossing.

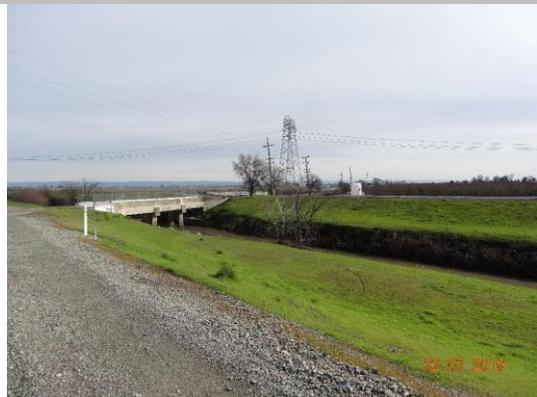
Photo 3 of 3 : UCIP_FA_2019_55516_78766.jpg

WS view: overview of WS.

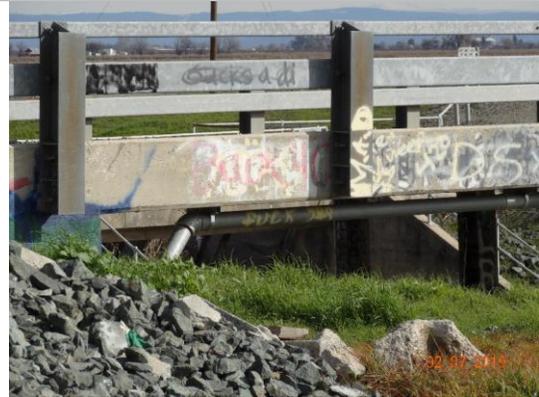
Photo 3 of 3 : UCIP_FA_2019_55518_78780.jpg

WS view: conduit attached to bridge.

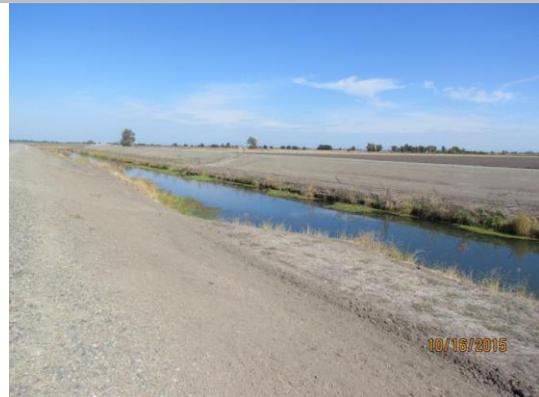
Photo 1 of 2 : FA_2019_ST0010_43_9_20190822_00003.jpg

View of the erosion along the waterside toe.

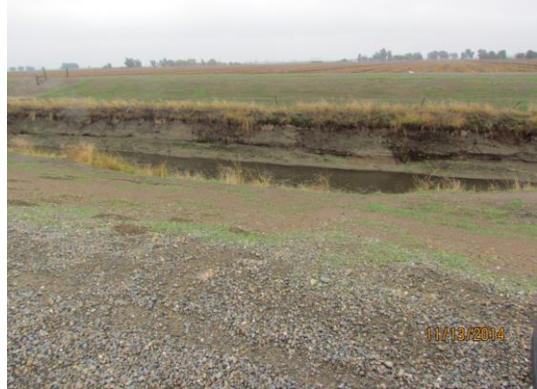
Photo 2 of 2 : FA_2019_ST0010_43_9_20190822_00004.jpg

View of the erosion along the waterside toe.

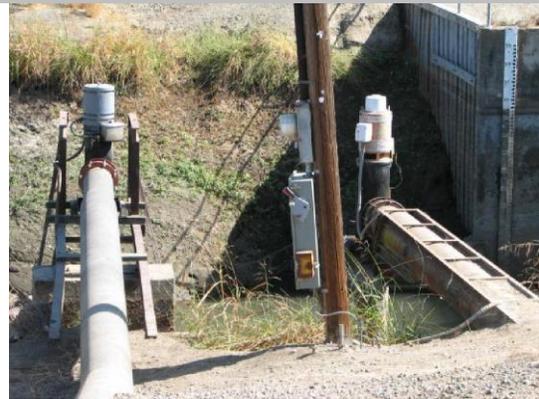
Photo 1 of 3 : UCIP_FA_2019_55519_64761.jpg

Pump on steel pier at WS toe.

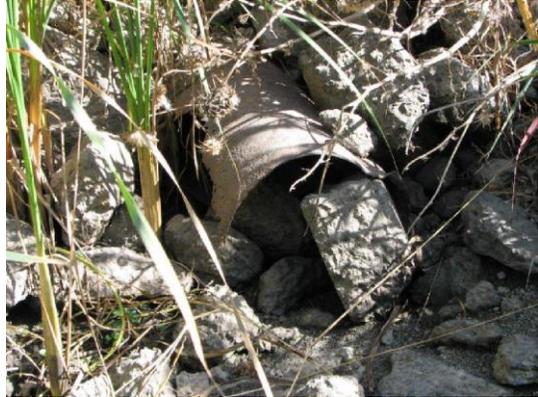
Photo 2 of 3 : UCIP_FA_2019_55519_64760.jpg

Rusted outlet at LS channel. Unclear if this is same pipe as one under investigation.

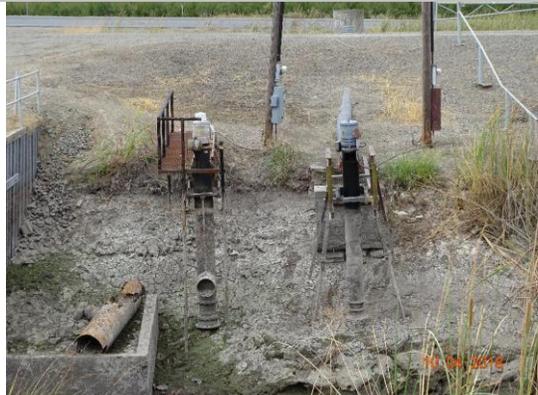
Photo 3 of 3 : UCIP_FA_2019_55519_78288.jpg

Overview photo of crossings from opposite bank. Pipe to left is associated with dsid 17078 and pipe to right is dsid 17081.

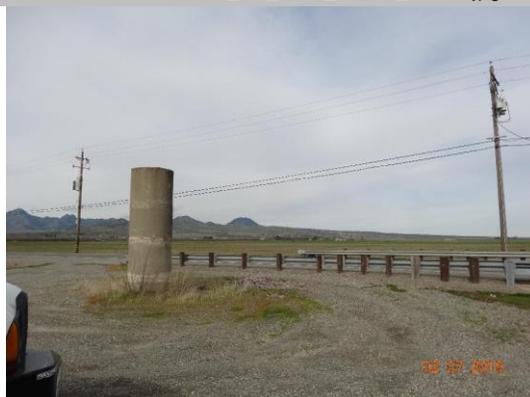
Photo 2 of 3 : UCIP_FA_2019_55523_78805.jpg

WS view: aerial power lines present but no markers of communication line, photo 1 of 2.

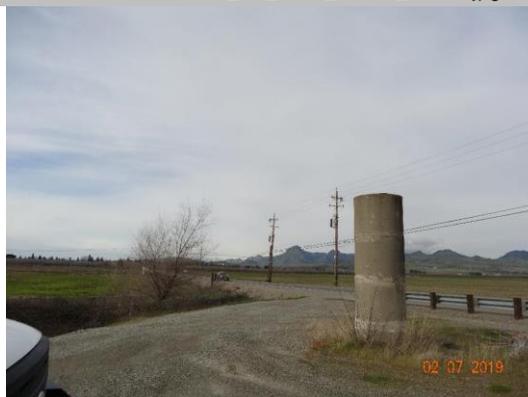
Photo 3 of 3 : UCIP_FA_2019_55523_78806.jpg

WS view: aerial power lines present but no markers of communication line, photo 2 of 2.
