**Flood Control Project Maintenance
Levee Inspections**
LMA District Cover Sheet
Spring 2020 Levee Inspection Results

Sacramento Maintenance Yard West Levee Yolo Bypass

Spring 2020 Levee Inspection Results

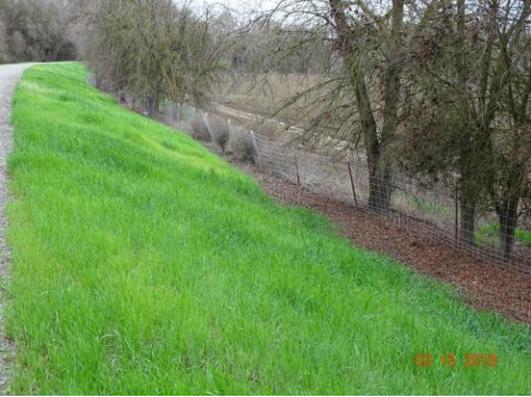
Photo 1 of 3 : SP_2020_ST0011_291_10_20200228_00005.jpg

View of fence at landside toe. Spring 2018.

LM Start	0.12	Rating **	M	Issue No.	10 (cont)
LM End	1.55	Issue Type +	En	Location *	LS

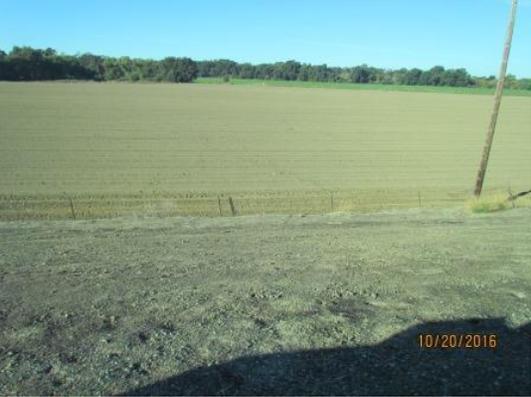
Photo 2 of 3 : SP_2020_ST0011_291_10_20200228_00006.jpg

View of fence located within 10-foot easement of landside toe. Fall 2016.

LM Start	0.12	Rating **	M	Issue No.	10 (cont)
LM End	1.55	Issue Type +	En	Location *	LS

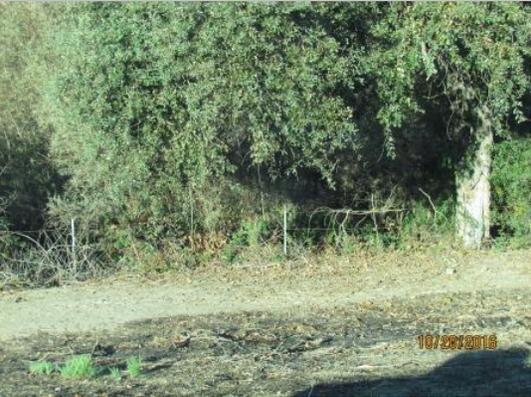
Photo 3 of 3 : SP_2020_ST0011_291_10_20200228_00007.jpg

Another view of fence located within 10-foot easement of landside toe. Fall 2016.

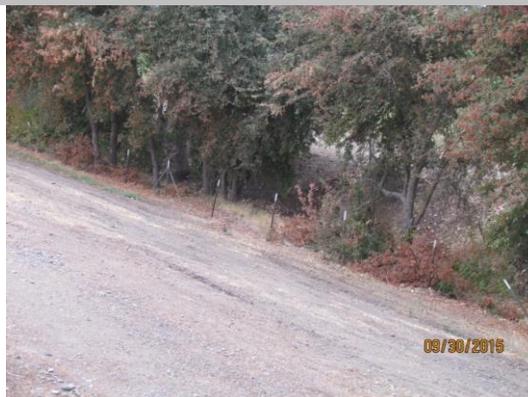
Photo 1 of 1 : SP_2020_ST0011_291_8_20200228_00002.jpg

View of the ditch on the landward side of the levee. Fall 2015.

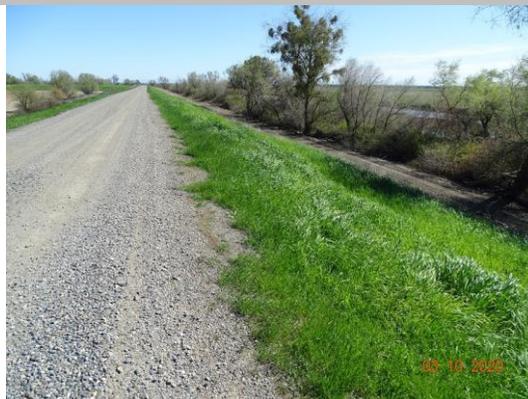
Photo 1 of 1 : SP_2020_ST0011_291_3_20200313_00016.jpg

LM Start	0.94	Rating **	M	Issue No.	3
LM End	2.72	Issue Type +	Ma	Location *	WS
Category	Earthen Levee		GPS Latitude/Longitude		
			Start	End	
Item	Vegetation		38.747793 °	38.724280 °	
			-121.660267 °	-121.66048 °	
DWR ID	DWR_ST0011_01_s_2020_3				
Comment Code					
V1 : Control annual grass and weeds on the levee slopes and easements.					
Inspector Comment

View of vegetation on the waterside slope. Spring 2020.

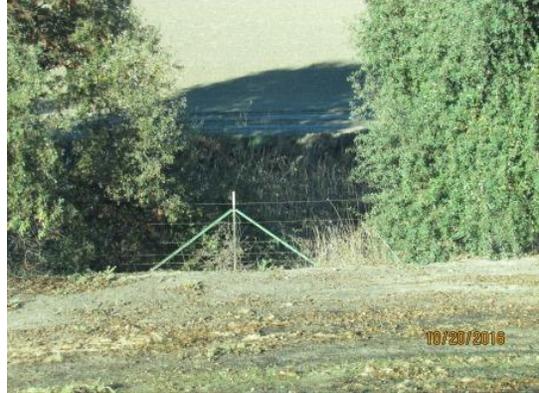
Photo 1 of 2 : SP_2020_ST0011_291_9_20200228_00003.jpg

View of fence along the ditch on landside. Fall 2016.

LM Start	1.70	Rating **	M	Issue No.	9 (cont)
LM End	1.79	Issue Type +	En	Location *	LS

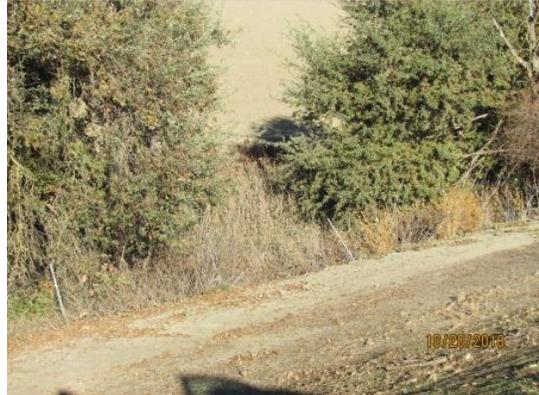
Photo 2 of 2 : SP_2020_ST0011_291_9_20200228_00004.jpg

Another view of fence along the ditch on landside. Fall 2016.

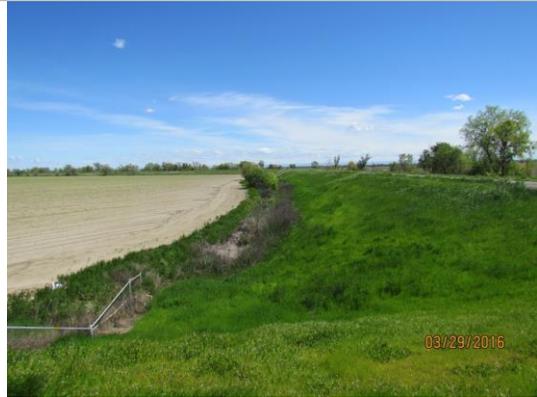
Photo 1 of 1 : SP_2020_ST0011_291_4_20200228_00001.jpg

View of the ditch at the toe of the levee on the landward side. Spring 2016.

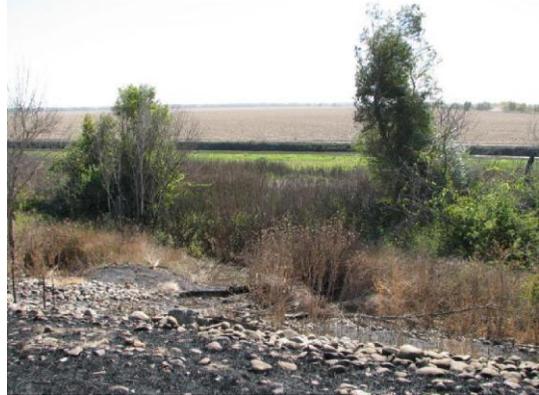
Photo 1 of 3 : UCIP_SP_2020_53233_60309.jpg

Waterside view: overview

Comment Code					
Inspector Comment					
DS_ID:17747 FS_ID:53233 EP_NO: 10284 Repair Type: No Action Needed Crossing Status: Found UCIP Comments: No slide gate found. slide gates and pipes were abandon by farmer, how unknown FIELD_STRUCT_DESC: 2 of 2: 42-inch corrugated metal gravity drainage pipe through the levee, 23.6 feet below the crown. Slide gate on the waterside (WS) slope. Concrete distribution box at the landside (LS) toe. (42-inch pipe [HLM 2.63] authorized under Automatic Board Order (ABO) issued as Permit No. 10284, 1974 - La Borde and Hoover). [Additional Reference(s): DWR Levee Log, 2004. USACE Sacramento O&M Manual 127, June 1953, (Station 133+82)]. FS Date: 11/16/2018 2:19:35 PM

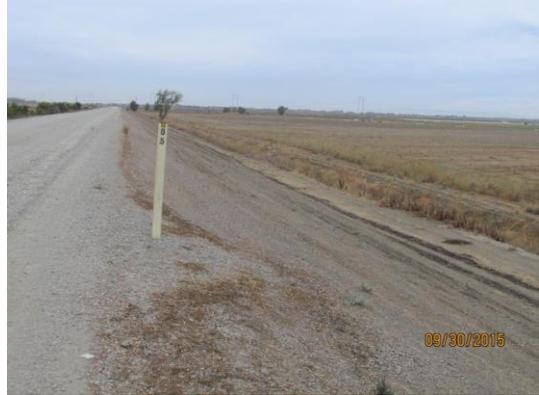
Photo 1 of 3 : SP_2020_ST0011_292_3_20200228_00001.jpg

View of the ditch at the landward side of the levee looking downstream. Fall 2015.

LM Start	0.47	Rating **	M	Issue No.	3 (cont)
LM End	0.97	Issue Type +	En	Location *	LS

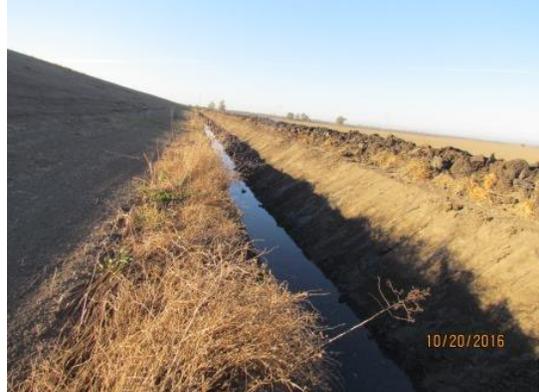
Photo 2 of 3 : SP_2020_ST0011_292_3_20200228_00002.jpg

View of the ditch on landward side. Ditch was deepened to approximately 10 ft. Fall 2016.

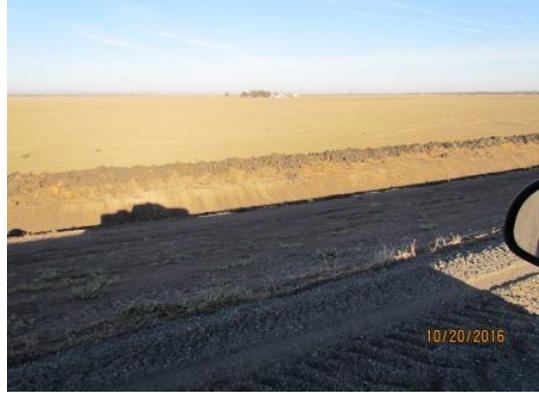
Photo 3 of 3 : SP_2020_ST0011_292_3_20200228_00003.jpg

View of the ditch on landward side. Fall 2016.

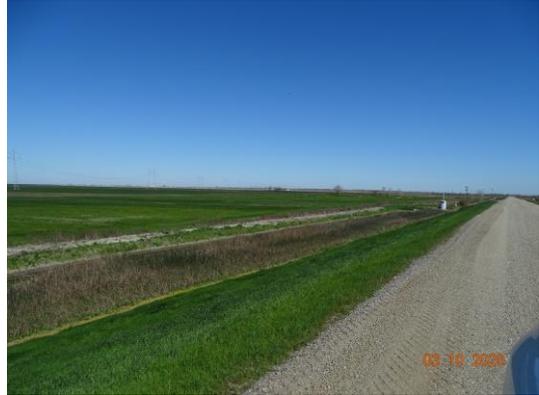
Photo 1 of 1 : SP_2020_ST0011_292_1_20200313_00006.jpg

LM Start	0.99	Rating **	A	Issue No.	1
LM End	0.99	Issue Type +	Ma	Location *	LS
Category	Earthen Levee		GPS Latitude/Longitude		
			Start	End	
Item	Vegetation		38.705741 °	38.705738 °	
			-121.670999 °	-121.671000 °	
DWR ID	DWR_ST0011_02_s_2020_1				
Comment Code					
V1 : Control annual grass and weeds on the levee slopes and easements.					
Inspector Comment					
LMA maintains vegetation at a high level.

View of vegetation on the landside slope. Spring 2020.

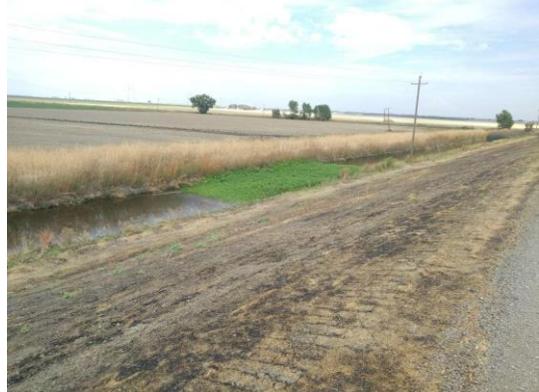
Photo 1 of 2 : SP_2020_ST0011_292_5_20200228_00004.jpg

LM Start	1.01	Rating **	M	Issue No.	5
LM End	1.44	Issue Type +	En	Location *	LS
Category	Earthen Levee		GPS Latitude/Longitude		
			Start	End	
Item	Encroachments		38.705475 °	38.699637 °	
			-121.671135 °	-121.674112 °	
DWR ID	DWR_ST0011_02_s_2012_5				
Comment Code					
DT : Ditch					
Inspector Comment					
The ditch is at the toe of the levee.

View of ditch at landside toe, looking upstream. Fall 2017.

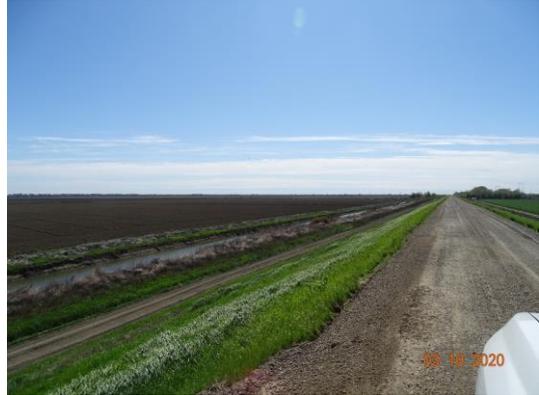
Photo 1 of 1 : SP_2020_ST0011_293_4_20200313_00008.jpg

View of vegetation on the waterside slope. Spring 2020.

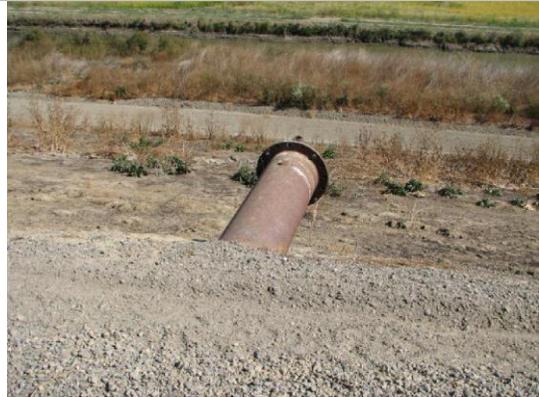
Photo 1 of 3 : UCIP_SP_2020_53252_60378.jpg

LM Start	0.03	Rating **	M	Issue No.	6
LM End	0.03	Issue Type +	En	Location *	
Category	Supplemental		GPS Latitude/Longitude		
			Start	End	
Item	DWR UCIP Field Study		38.698204 °	38.698204 °	
			-121.674080 °	-121.674080 °	
DWR ID	17756				
Comment Code					
Inspector Comment					
DS_ID:17756 FS_ID:53252 EP_NO: N/A Repair Type: Non-Urgent Crossing Status: Found UCIP Comments: Pipe not properly abandoned. FIELD_STRUCT_DESC: *ABANDONED* 18-inch steel irrigation or drainage pipe through the levee, 3 feet below the crown. FS Date: 11/21/2018 8:24:23 AM

Waterside view: an abandoned steel pipe.

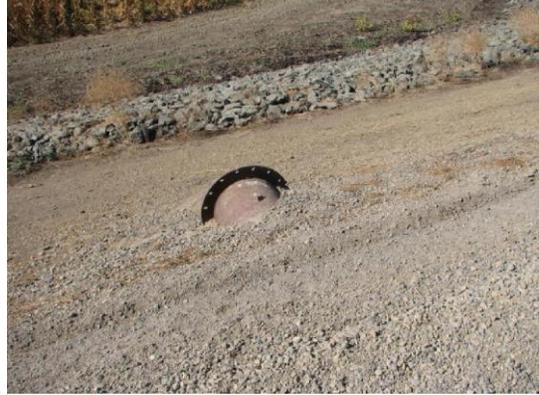
Photo 2 of 3 : UCIP_SP_2020_53252_60377.jpg

Landside view: an abandoned steel pipe.

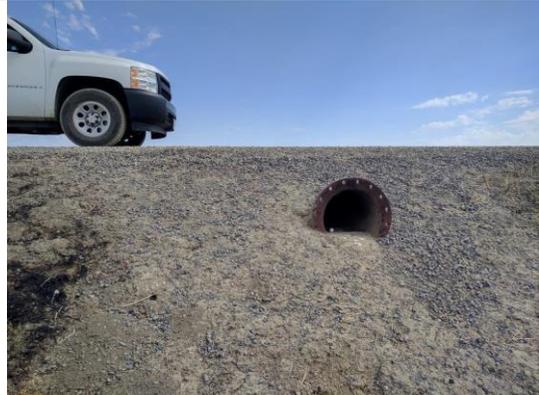
Photo 3 of 3 : UCIP_SP_2020_53252_77496.jpg

LS: straight through pipe without any gates preventing water from WS to LS.

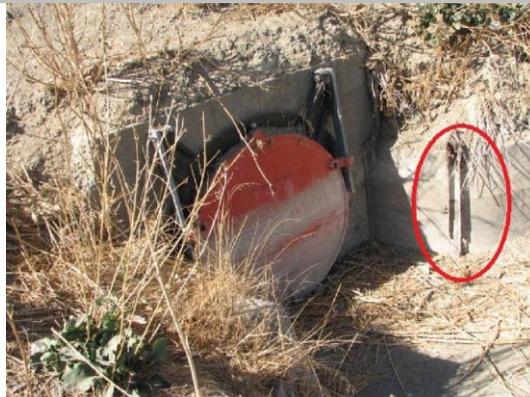
Photo 1 of 3 : UCIP_SP_2020_53860_60391.jpg

Comment Code					
Inspector Comment					
DS_ID:17754 FS_ID:53860 EP_NO: 10295 Repair Type: Urgent Crossing Status: Found UCIP Comments: 04/09/2019 Internal inspection was completed and the inspection shows separation of pipe at 22 degree turn. Sink hole visible on LS slope. Coordinating with DMP - Vince Rodriguez. Recommend repair or replace. (T. Skidgel - DWR Sacramento Yard)Found 48-inch CMP (not concrete culvert) and slide gate not found on LS end. FIELD_STRUCT_DESC: 48-inch corrugated metal pipe (CMP) sewer culvert through the levee, 18 feet below the crown. Slide gate on the landside (LS) end. (48-inch concrete culvert authorized under Automatic Board Order (ABO) issued as Permit No. 10295, 1974 - City of Woodland). [Additional Reference(s): DWR Levee Log, 2004]. FS Date: 4/9/2019 8:58:01 AM

Waterside view: flap gate and concrete headwall. Abandoned slide gate on right.

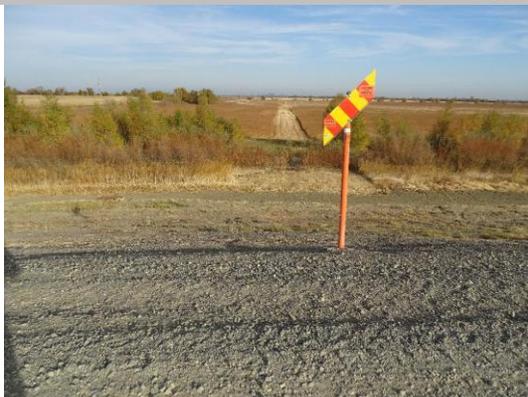
Photo 2 of 3 : UCIP_SP_2020_55934_83275.jpg

Comment Code					
Inspector Comment					
DS_ID:17695 FS_ID:55934 EP_NO: 16309 Repair Type: Non-Urgent Crossing Status: Indicator Found UCIP Comments: 11/07/2019 Record updated from No Action Needed to Non-Urgent. No inspection records were available to determine status of line through the levee. (O.Yakimov - DWR UCIP) FIELD_STRUCT_DESC: 20-inch coated steel natural gas pipeline under both levees and within the Yolo Bypass, at an unknown depth. Indicators found on both sides of the levee. (20-inch pipeline authorized under Permit No. 16309, 1995 - Sacramento Municipal Utility District [SMUD] and Ford, Bacon, and Davis, Inc.). FS Date: 11/7/2019 1:10:47 PM

Waterside view: a gasline marker on WS slope of the levee

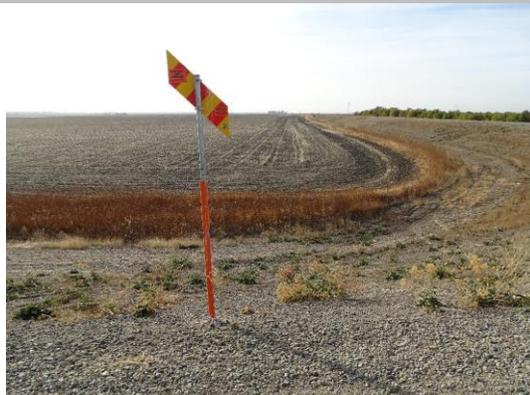
Photo 3 of 3 : UCIP_SP_2020_55934_83276.jpg

Landside view: a gasline marker on LS slope

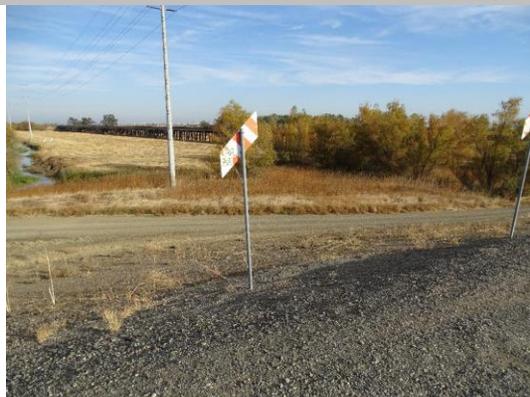
Photo 1 of 2 : UCIP_SP_2020_55935_83277.jpg

Waterside view: gasline marker on WS slope of the levee

Comment Code					
Inspector Comment					
DS_ID:19990 FS_ID:55935 EP_NO: 10821 Repair Type: Non-Urgent Crossing Status: Indicator Found UCIP Comments: 11/07/2019 Record updated from No Action Needed to Non-Urgent. No inspection records were available to determine status of line through the levee. (O.Yakimov - DWR UCIP) FIELD_STRUCT_DESC: 12-inch steel natural gas line crossing under the right bank (west) levee of the Yolo Bypass, at an unknown depth. 5 miles northeasterly of the city of Davis. Indicators found on both sides of the levee. 16-inch gas line was authorized under Permit No. 10821, 1975 - Pacific Gas and Electric Company (PG&E) as a replacement of existing 8-inch gas line. FS Date: 11/7/2019 3:07:13 PM

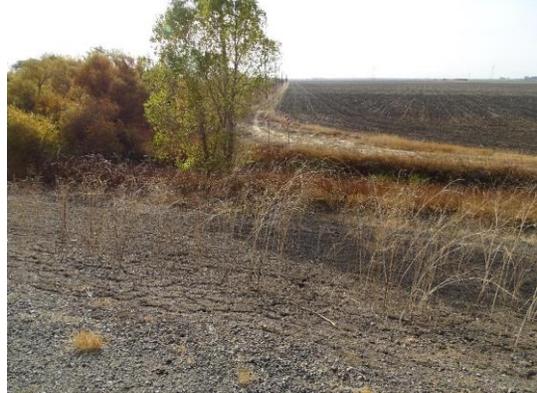
Photo 2 of 2 : UCIP_SP_2020_55935_83278.jpg

Landside view: gasline markers in LS field

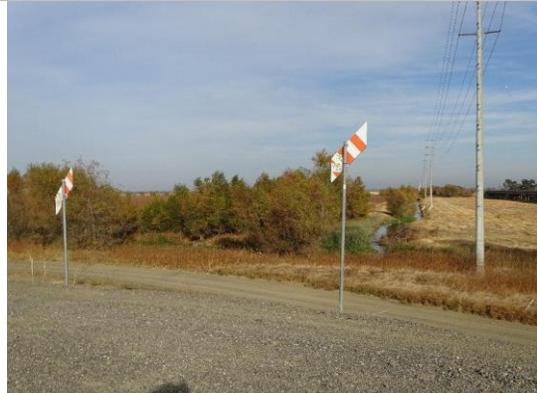
Photo 1 of 2 : UCIP_SP_2020_55936_83279.jpg

DS_ID:524
 FS_ID:55936
 EP_NO: 10821
 Repair Type: Non-Urgent
 Crossing Status: Indicator Found
 UCIP Comments: 11/07/2019 Record updated from No Action Needed to Non-Urgent. No inspection records were available to determine status of line through the levee. (O.Yakimov - DWR UCIP)
 FIELD_STRUCT_DESC: 16-inch steel high-pressure natural gas line through the levee, 4.5 feet below the crown. It is a replacement of a portion of an existing 8-inch gas line with a 16-inch gas line and parallel to existing 12-inch steel gas line. Two gas line markers found on both sides of the levee. (Pipeline replacement authorized under Permit No. 10821, 1975 - Pacific Gas and Electric Company [PG&E]). [Additional Reference(s): DWR Levee Log, 2004 (HLM 0.55)].
 FS Date: 11/7/2019 3:09:50 PM

Waterside view: gasline marker on WS slope of the levee

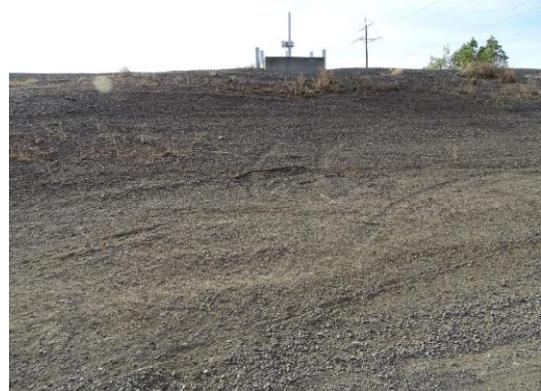
Photo 1 of 3 : UCIP_SP_2020_55938_83281.jpg

Comment Code					
Inspector Comment					
DS_ID:569 FS_ID:55938 EP_NO: 16096 Repair Type: Urgent Crossing Status: Found UCIP Comments: 11/07/2019 Flap gate at WS headwall not closing completely. A wooden stick on the top prevents flap gate closing leaving space for backflow. Provide maintenance on flap gate. About 20-foot long surface cracking observed on levee crown closer to LS shoulder. Not sure if cracking is related to this crossing (potential levee damage concern). (O.Yakimov - DWR UCIP)04/28/2015 The culvert was constructed in 1993. (C. Lund - DWR Sacramento Yard) FIELD_STRUCT_DESC: 60-inch by 60-inch reinforced concrete box gravity drainage culvert through the right bank (west) levee of the Yolo Bypass, 20 feet below the crown. 60-inch by 60-inch culvert replaced an existing 30-inch gravity drain pipeline. (60-inch by 60-inch culvert authorized under Permit No. 16096, 1993 - Yolo County Flood Control and Water Conservation District, square culvert installed about 28 feet south of existing 30-inch pipe). FS Date: 11/7/2019 3:23:43 PM

View of WS slope looking towards levee

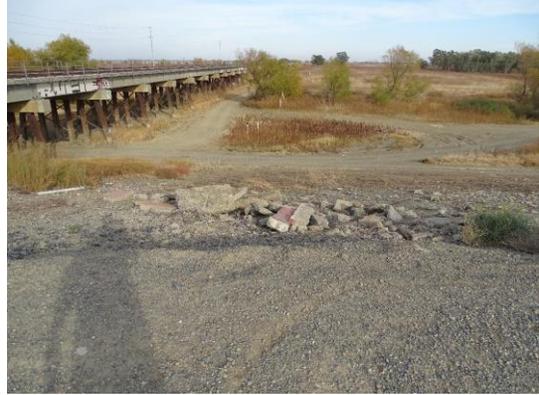
Photo 3 of 3 : UCIP_SP_2020_55944_83294.jpg

Waterside view: marker not found

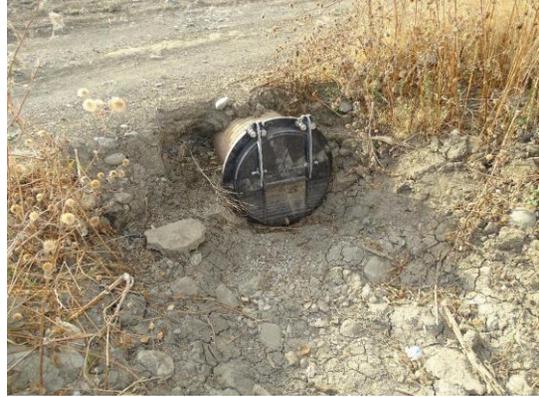
Photo 3 of 3 : UCIP_SP_2020_55949_83299.jpg

Pipe and flap gate at WS levee toe

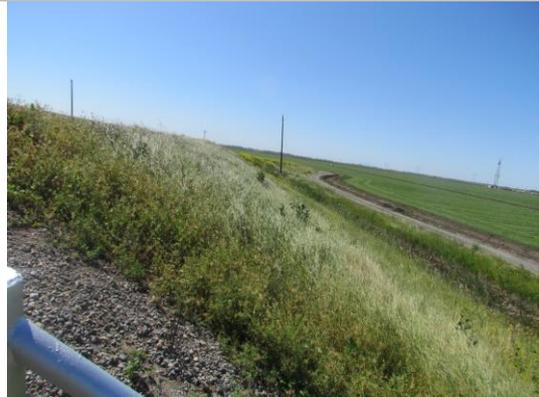
Photo 1 of 1 : SP_2020_ST0011_294_6_20200228_00004.jpg

View of the ditch on the landward side of the levee looking downstream. Spring 2015.

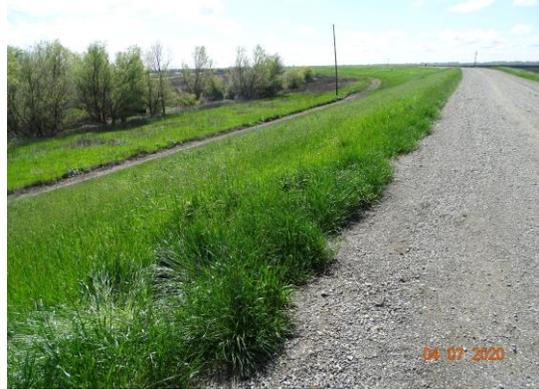
Photo 1 of 1 : SP_2020_ST0011_294_29_20200511_00044.jpg

View of vegetation on the waterside slope. Spring 2020.

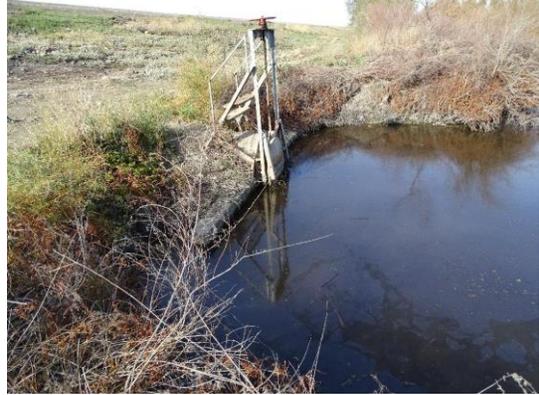
Photo 3 of 3 : UCIP_SP_2020_56030_83251.jpg

Slide gate and pipe outlet on waterside

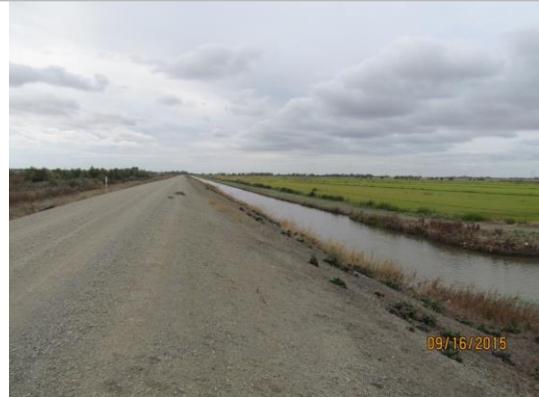
Photo 1 of 1 : SP_2020_ST0011_294_4_20200228_00002.jpg

The ditch is at the levee toe on the landward side of the levee looking downstream. Fall 2015.
