**Flood Control Project Maintenance
Levee Inspections**

Maintenance Issue Types Only, Levee Inspection Report By Mile - Fall 2019

Sacramento Maintenance Yard West Levee Yolo Bypass

Waterway	Bank	Unit Miles	Inspection Start/End	Inspector
Unit No. 01 West Levee	Right	2.73	09/17/2019 09/17/2019	Zach Jojola

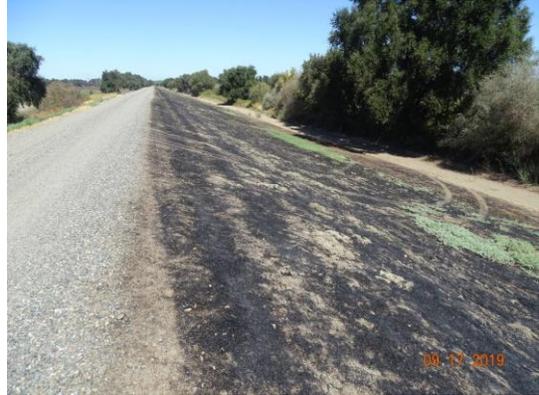
Photo 1 of 1 : FA_2019_ST0011_291_3_20190919_00016.jpg

LM Start	1.80	Rating **	A	Issue No.	3
LM End	1.80	Issue Type +	Ma	Location *	WS
Category	Earthen Levee		GPS Latitude/Longitude		
			Start	End	
Item	Vegetation		38.735348°	38.735348°	
			-121.660340°	-121.660340°	
DWR ID	DWR_ST0011_01_f_2019_3				
Comment Code					
V1 : Control annual grass and weeds on the levee slopes and easements.					
Inspector Comment					
The LMA maintains the vegetation at a high level.

View of the maintained waterside slope. Fall 2019.

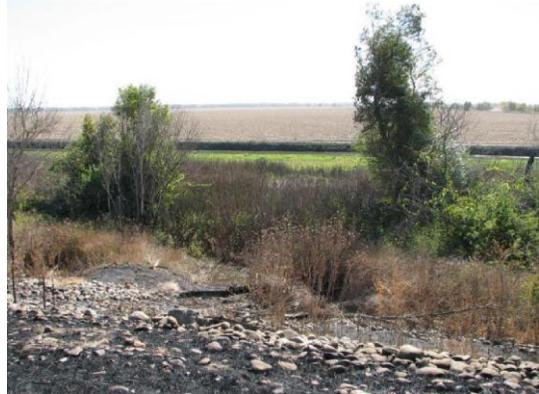
Photo 1 of 3 : UCIP_FA_2019_53232_60304.jpg

Comment Code					
Inspector Comment					
DS_ID:17742 FS_ID:53232 EP_NO: 10284 Repair Type: No Action Needed Crossing Status: Found UCIP Comments: Screw gates where removed and pipe was abanded by farmer, How pipe was abanded is unknown. Pipe is Grouted FIELD_STRUCT_DESC: 1 of 2: 42-inch corrugated metal gravity drainage pipe through the levee, 23.6 feet below the crown. Slide gate on the waterside (WS) slope. Concrete distribution box at the landside (LS) toe. (42-inch pipe [HLM 2.63] authorized under Automatic Board Order (ABO) issued as Permit No. 10284, 1974 - La Borde and Hoover). [Additional Reference(s): DWR Levee Log, 2004. USACE Sacramento O&M Manual 127, June 1953, (Station 133+82)]. FS Date: 11/16/2018 2:17:55 PM

Waterside view: overview (pipe not found)

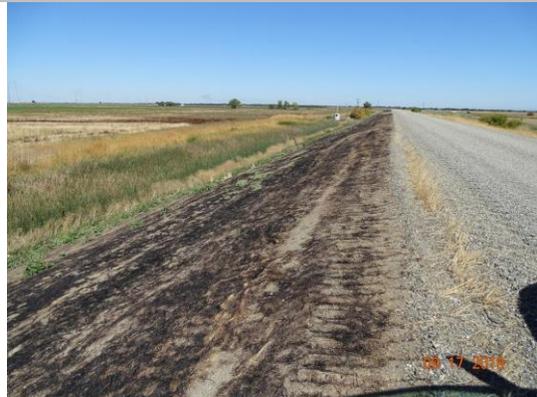
Photo 1 of 1 : FA_2019_ST0011_292_1_20190919_00006.jpg

LM Start	1.41	Rating **	A	Issue No.	1
LM End	1.41	Issue Type +	Ma	Location *	LS
Category	Earthen Levee		GPS Latitude/Longitude		
			Start	End	
Item	Vegetation		38.700172°	38.700172°	
			-121.673928°	-121.673928°	
DWR ID	DWR_ST0011_02_f_2019_1				
Comment Code					
V1 : Control annual grass and weeds on the levee slopes and easements.					
Inspector Comment					
The LMA maintains the vegetation at a high level.

View of the maintained landside slope. Fall 2019.

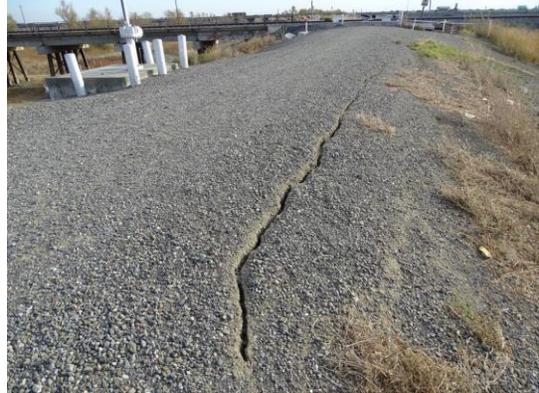
Photo 1 of 2 : FA_2019_ST0011_294_15_20191126_00016.jpg

LM Start	0.54	Rating **	M	Issue No.	15
LM End	0.54	Issue Type +	Ma	Location *	LS
Category	Earthen Levee			GPS Latitude/Longitude	
				Start	End
Item	Cracking			38.566529°	38.566529°
				-121.638869°	-121.638869°
DWR ID	DWR_ST0011_04_f_2019_15				
Comment Code					
CR1 : Monitor and have inspected by geotechnical engineer.					
Inspector Comment					
Appears to be a 50-foot crack on the landside shoulder with minor settlement.

View of the crack on the landside shoulder, facing downstream. Fall 2019.

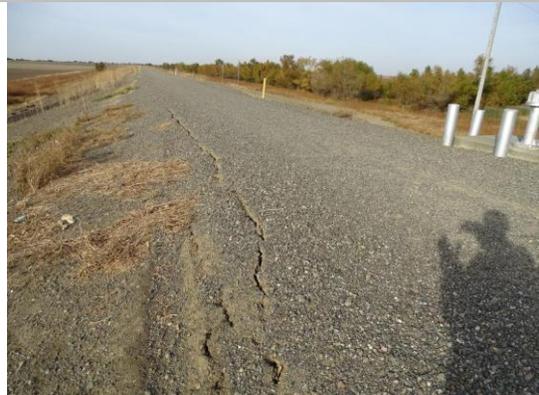
Photo 2 of 2 : FA_2019_ST0011_294_15_20191126_00017.jpg

View of the crack on the landside shoulder, facing upstream. Fall 2019.

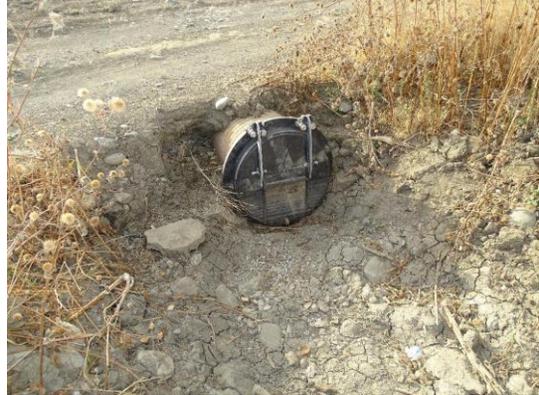
Photo 3 of 3 : UCIP_FA_2019_55949_83299.jpg

Comment Code					
Inspector Comment					
DS_ID:528 FS_ID:55949 EP_NO: 10304 Repair Type: Non-Urgent Crossing Status: Found UCIP Comments: 11/07/2019 No issues recorded during inspection. (O.Yakimov - DWR UCIP) FIELD_STRUCT_DESC: 30-inch CIPP-lined corrugated metal gravity drainage pipe through the levee, 22 feet below the crown. Flap gate on the waterside (WS) end. (30-inch pipe [HLM 0.59] authorized under Automatic Board Order (ABO) issued as Permit No. 10304, 1974 - Southern Pacific Transportation Company). [Additional Reference(s): DWR Levee Log, 2004. USACE Sacramento O&M Manual 120, June 1952, (Station 446+08)]. FS Date: 11/7/2019 8:24:29 AM

Pipe and flap gate at WS levee toe

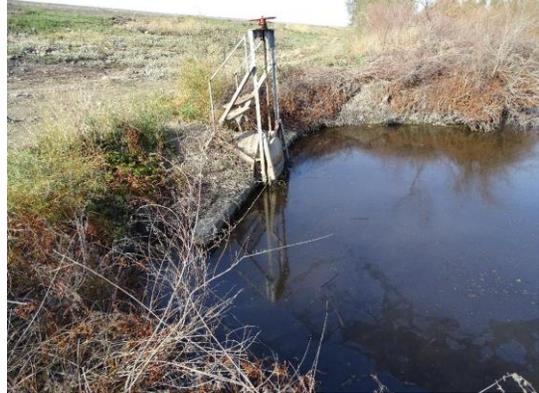
Photo 3 of 3 : UCIP_FA_2019_56030_83251.jpg

Comment Code					
Inspector Comment					
DS_ID:17736 FS_ID:56030 EP_NO: 10306 Repair Type: Non-Urgent Crossing Status: Found UCIP Comments: 11/07/2019 Permit authorizing crossing modification is not available. (O.Yakimov - DWR UCIP)04/28/2015 Farmer cleans this screw gate every year FIELD_STRUCT_DESC: 48-inch corrugated metal gravity drainage pipe through the levee, 21.5 feet below the crown. 42-inch steel pipe inside the 48-inch pipe. Slide gate on the waterside (WS) with two cutoff walls, one headwall, and one saddle and apron. (48-inch pipe [HLM 2.12] authorized under Automatic Board Order (ABO) issued as Permit No. 10306, 1974 - Wells Fargo Bank, Trustees for Cowell Foundation). [Additional Reference(s): USACE Sacramento O&M Manual 119, December 1952, (Station 80+00), dwg no. 50-04-2280, page 1 of 2]. FS Date: 11/7/2019

Slide gate and pipe outlet on waterside

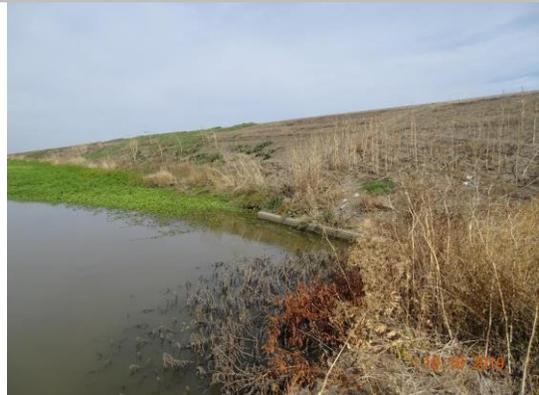
Photo 1 of 2 : FA_2019_ST0011_294_13_20191108_00015.jpg

LM Start	3.61	Rating **	M	Issue No.	13
LM End	3.61	Issue Type +	Ma	Location *	LS
Category	Earthen Levee			GPS Latitude/Longitude	
				Start	End
Item	Erosion / Bank Caving			38.523683°	38.523683°
				-121.631463°	-121.631463°
DWR ID	DWR_ST0011_04_f_2018_13				
Comment Code					
E2 : Schedule repair of erosion site prior to the next inspection.					
Inspector Comment					
There is erosion on the landside toe because of an irrigation canal. Sac Yard is aware of the issue and intends to fix it.

View of erosion on the landside slope. Fall 2019.
