**Flood Control Project Maintenance  
Levee Inspections**  
**LMA District Cover Sheet**  
**Spring 2020 Levee Inspection Results**

**Sutter Maintenance Yard Murphy Slough at M&T Ranch**

**Levee Inspection Report By Mile - Spring 2020**

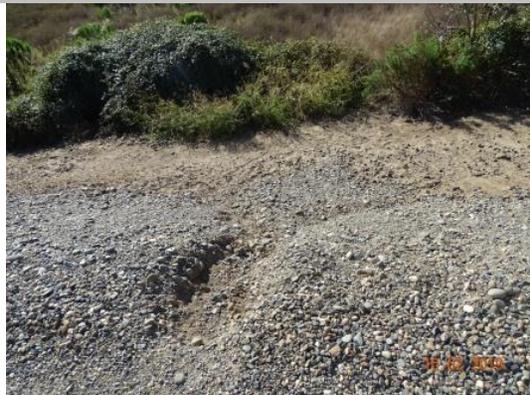
Photo 1 of 1 : SP\_2020\_ST0014\_372\_10\_20200226\_00003.jpg

LM Start	<b>0.24</b>	Rating **	M	Issue No.	<b>10</b>
LM End	<b>0.24</b>	Issue Type +	Ma	Location *	LS
Category	Earthen Levee		GPS Latitude/Longitude		
			Start	End	
Item	Erosion / Bank Caving		39.666506 °	39.666506 °	
			-121.963237 °	-121.963237 °	
DWR ID	DWR_ST0014_01_f_2019_10				
Comment Code					
E2 : Schedule repair of erosion site prior to the next inspection.					
Inspector Comment

View of the erosion at the landside shoulder and slope. Fall 2019.

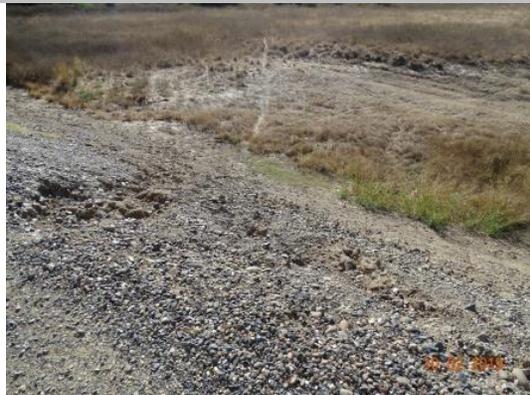
Photo 1 of 1 : SP\_2020\_ST0014\_372\_11\_20200226\_00004.jpg

LM Start	<b>0.28</b>	Rating **	M	Issue No.	<b>11</b>
LM End	<b>0.28</b>	Issue Type +	Ma	Location *	LS
Category	Earthen Levee		GPS Latitude/Longitude		
			Start	End	
Item	Erosion / Bank Caving		39.666403 °	39.666403 °	
			-121.964004 °	-121.964004 °	
DWR ID	DWR_ST0014_01_f_2019_11				
Comment Code					
E2 : Schedule repair of erosion site prior to the next inspection.					
Inspector Comment

View of the erosion at the landside slope. Fall 2019.

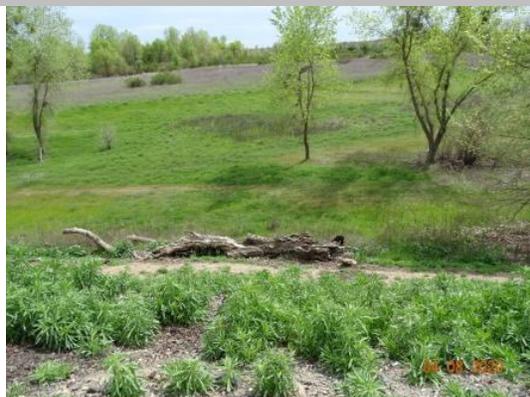
Photo 1 of 1 : SP\_2020\_ST0014\_372\_8\_20200413\_00005.jpg

LM Start	<b>0.31</b>	Rating **	M	Issue No.	<b>8</b>
LM End	<b>0.31</b>	Issue Type +	Ma	Location *	LS
Category	Earthen Levee		GPS Latitude/Longitude		
			Start	End	
Item	Encroachments		39.666319 °	39.666319 °	
			-121.964544 °	-121.964544 °	
DWR ID	DWR_ST0014_01_s_2019_8				
Comment Code					
TR : Tree or limb					
Inspector Comment					
The tree should be removed from the landside toe.

View of the tree at the landside toe. Spring 2020.

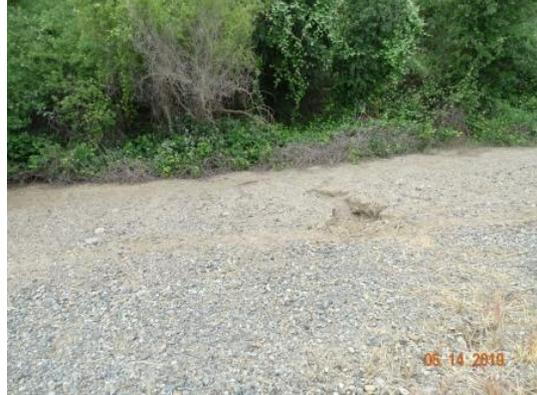
Photo 1 of 1 : SP\_2020\_ST0014\_372\_5\_20200226\_00001.jpg

LM Start	<b>0.56</b>	Rating **	M	Issue No.	<b>5</b>
LM End	<b>0.56</b>	Issue Type +	Ma	Location *	LS
Category	Earthen Levee		GPS Latitude/Longitude		
			Start	End	
Item	Erosion / Bank Caving		39.667026 °	39.667026 °	
			-121.968890 °	-121.968890 °	
DWR ID	DWR_ST0014_01_s_2019_5				
Comment Code					
E2 : Schedule repair of erosion site prior to the next inspection.					
Inspector Comment

View of the erosion on the landside slope. Spring 2019.
