# **Rim Fire: Interactions with BAER Teams**

California Cooperative Snow Survey Meeting  
November 3, 2015

Chris B Graham, PhD  
Water Operations Analyst/Hydrologist  
Hetch Hetchy Water and Power  
Water Enterprise

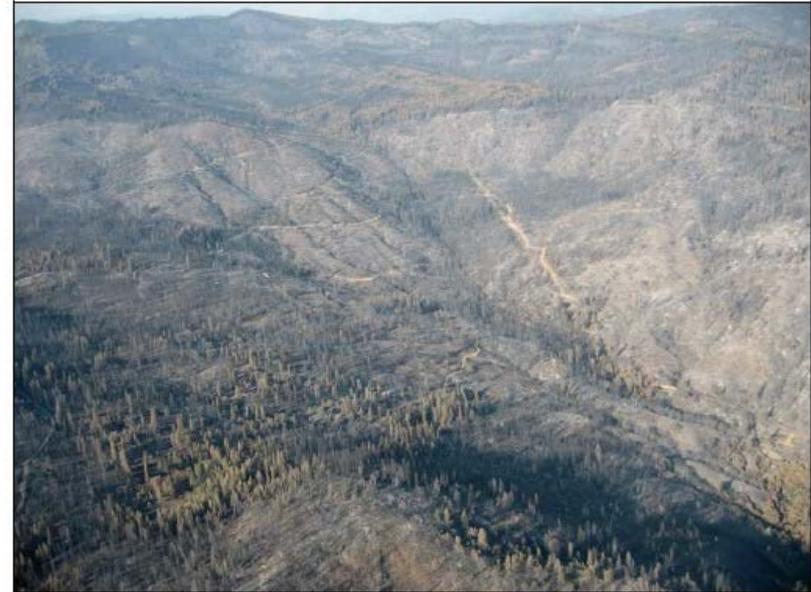
(Granite Creek Watershed above Holm Powerhouse, tributary to Cherry Creek;  
This area burned with similar stand-replacement severity in the 1973 Granite Fire)

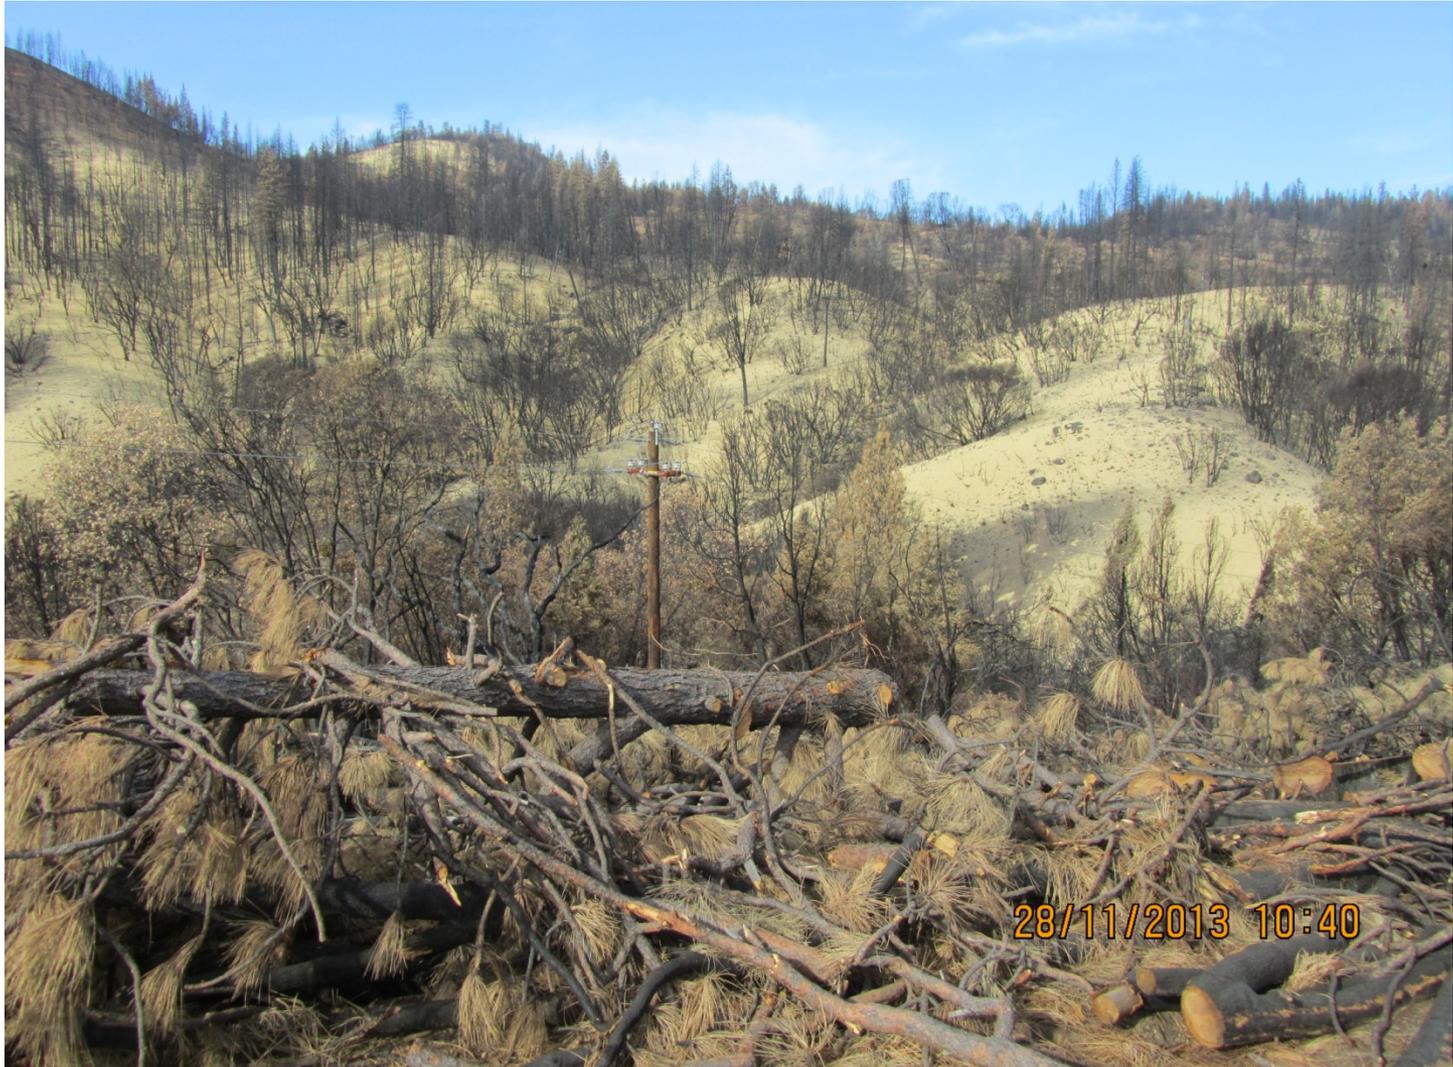
# Hazard Tree Removal

- **BAER team – 5 members**
  - Stanislaus, Tahoe, El Dorado and Cleveland Forest Service
- **Motivation**
  - Identified at damaged recreation facilities
- **Deliverables**
  - Report on damaged resources with recommendations for rehab
  - Summary table of treatments
- **HHWP Response**
  - Hazard tree removal around roadways

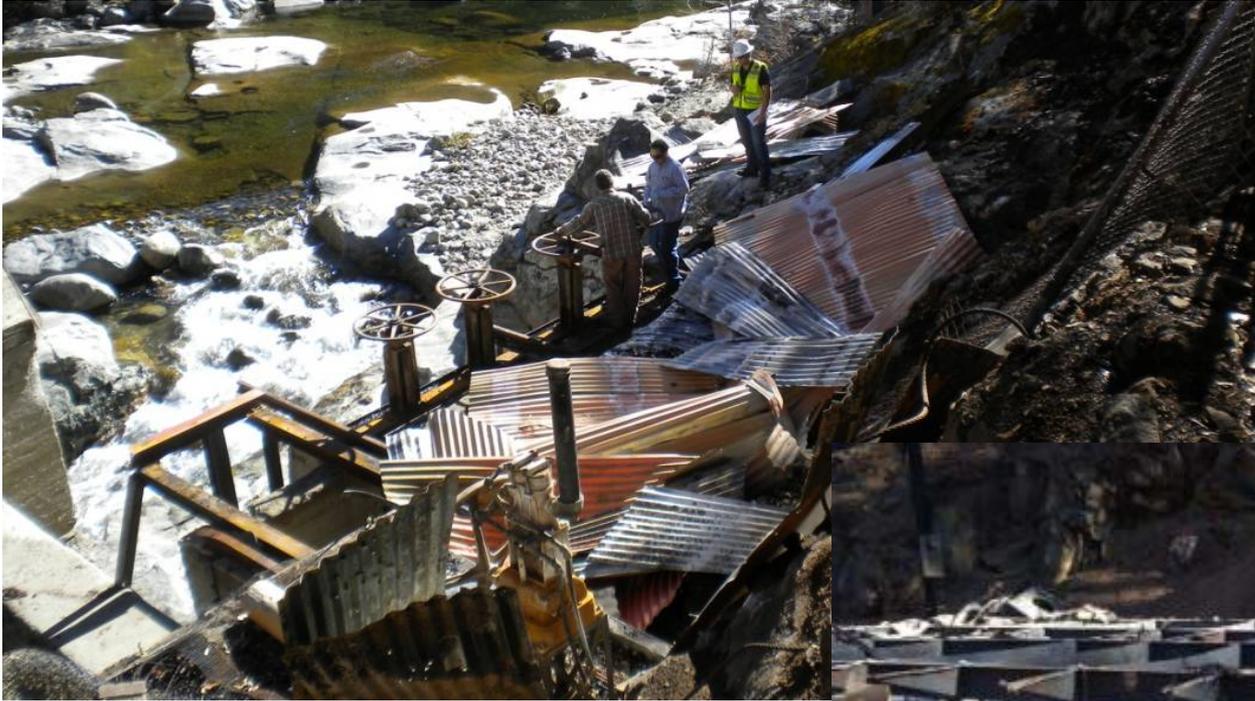
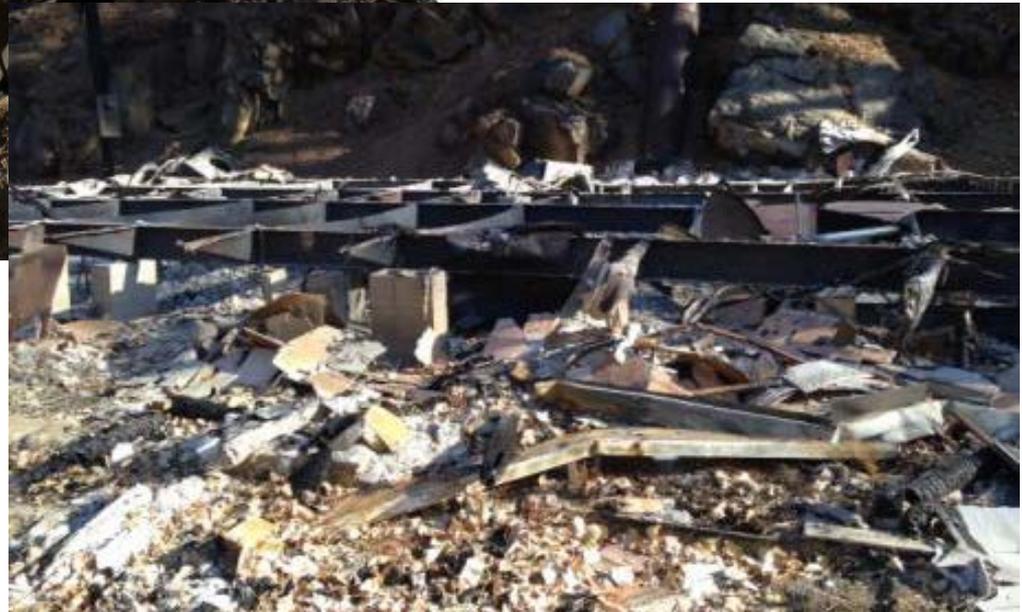
# HHWP Hazardous Materials

- BAER team – 1 members
  - Inyo Forest Service
- Motivation
  - Fire created and revealed hazardous materials throughout fire zone
- Deliverables
  - Identified 4 potential hazardous material sites and recommendations for remediation
- HHWP Response
  - None of the identified sites were on HHWP property
  - We did remove / remediate several hazardous material sites

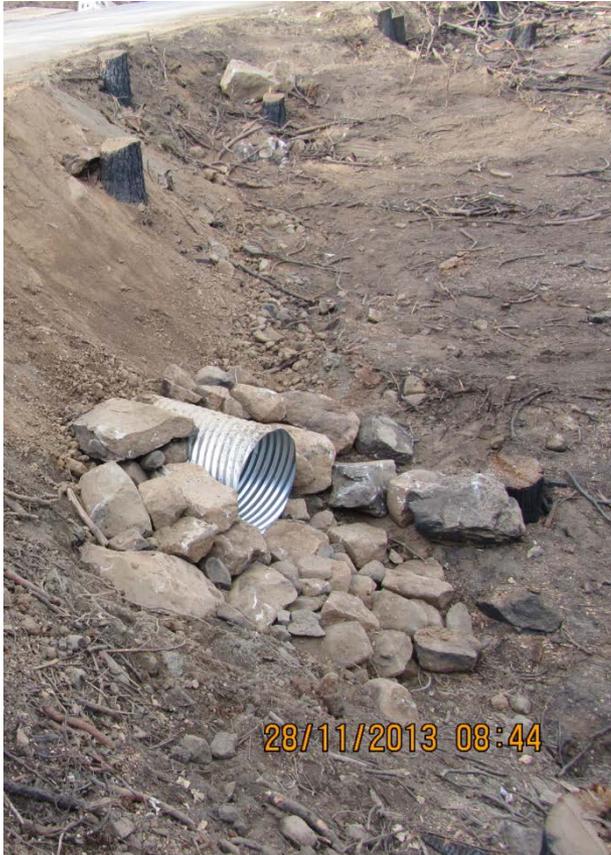
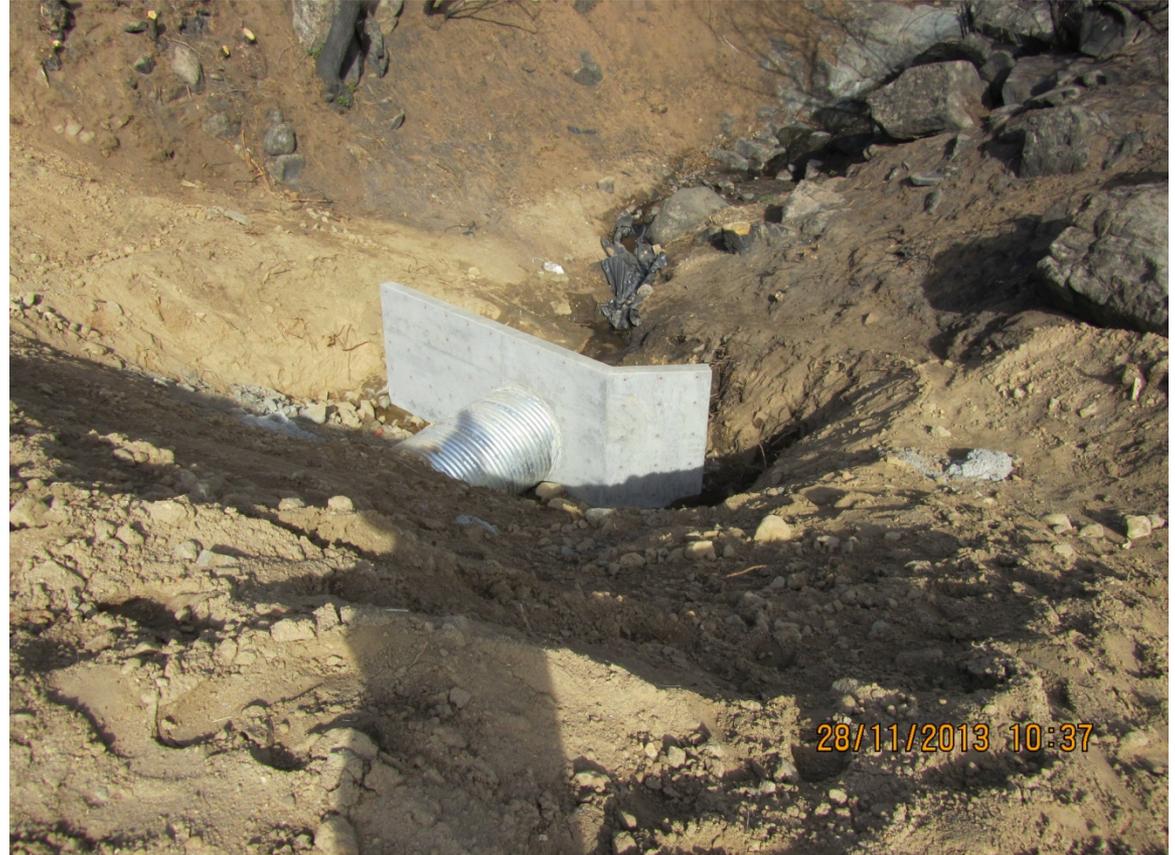
# Resized Culverts with Headwalls and Grizzlies

- **BAER team – 8 members**
  - Tahoe, Plumas, Klamath, Lassen and Stanislaus National Forests
- **Motivation**
  - Fires damage bridges, increase runoff
- **Deliverables**
  - Matrix of locations and remediation needed
- **HHWP Response**
  - HHWP installed culverts, regraded roads, cleaned drainages

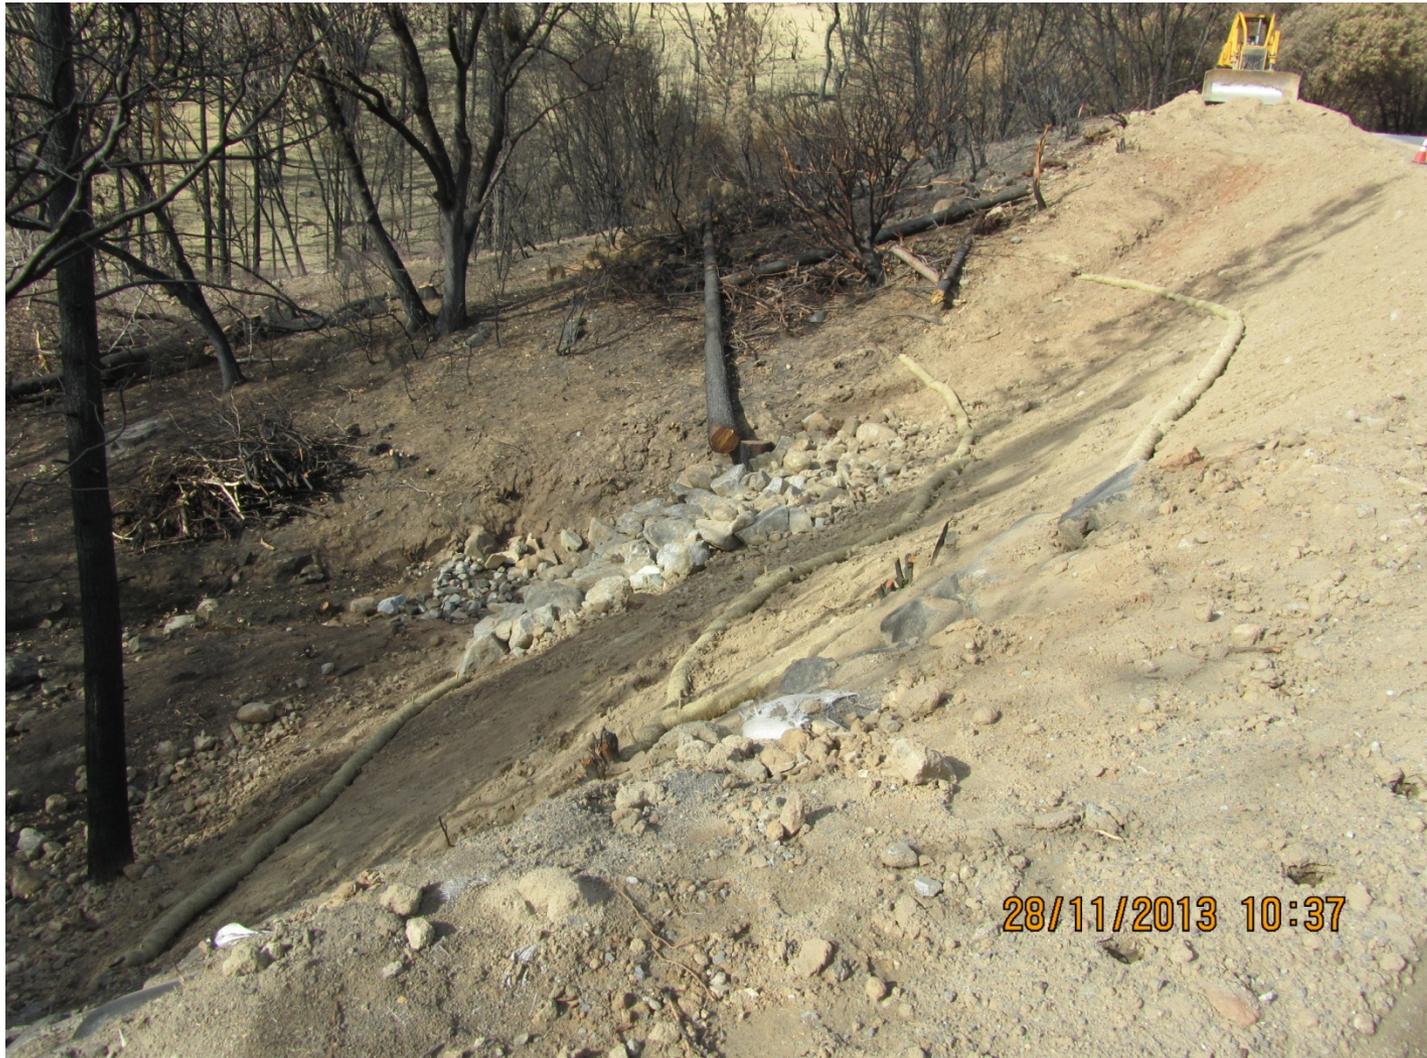
# Bank Stabilization

- BAER team – 4 members
  - FS geologists
- Motivation
  - Fires lead to rockslides / debris flows / etc...
- Deliverables
  - Matrix of potential values at risk, and remediation strategies
  - Notifications to HHWP about potential rockfall sites
- HHWP Response
  - Slope treatment
  - Culverts

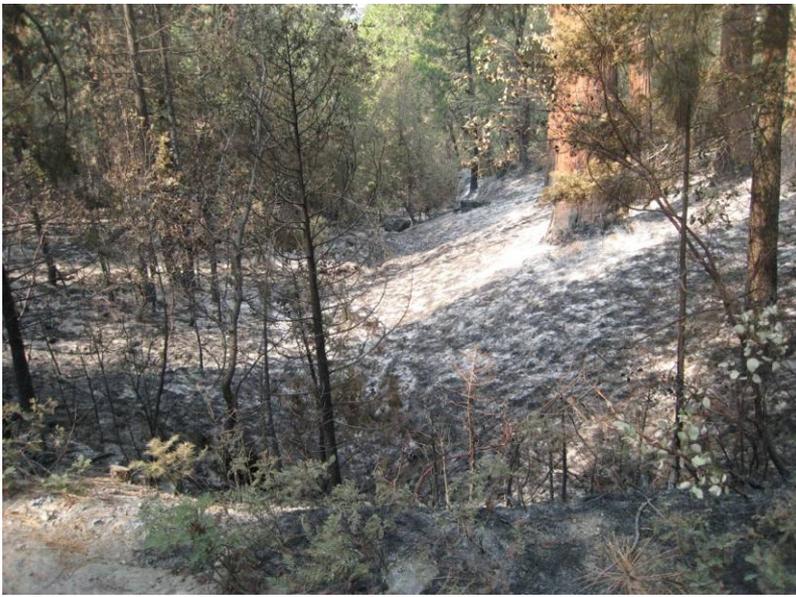
← Low: *surface material is not completely burned, structural stability of soil is unchanged*

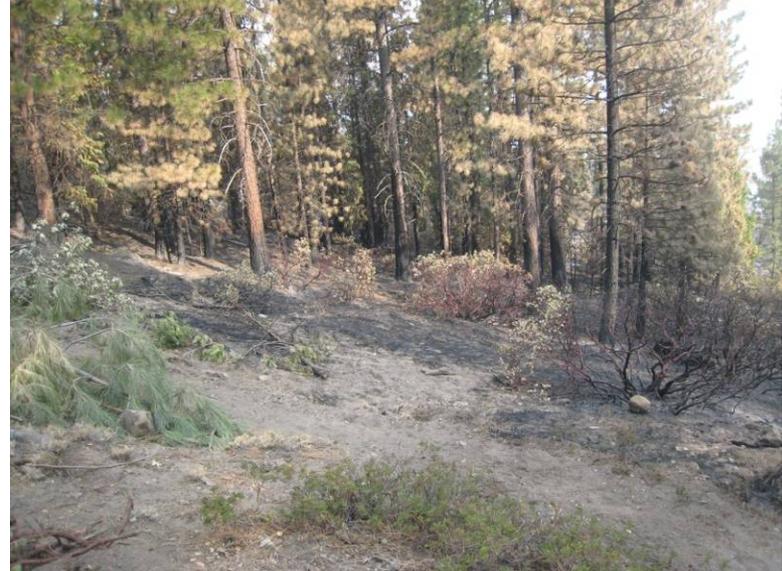
Moderate: *ground cover is consumed, ash may be blackened with patches of gray* →

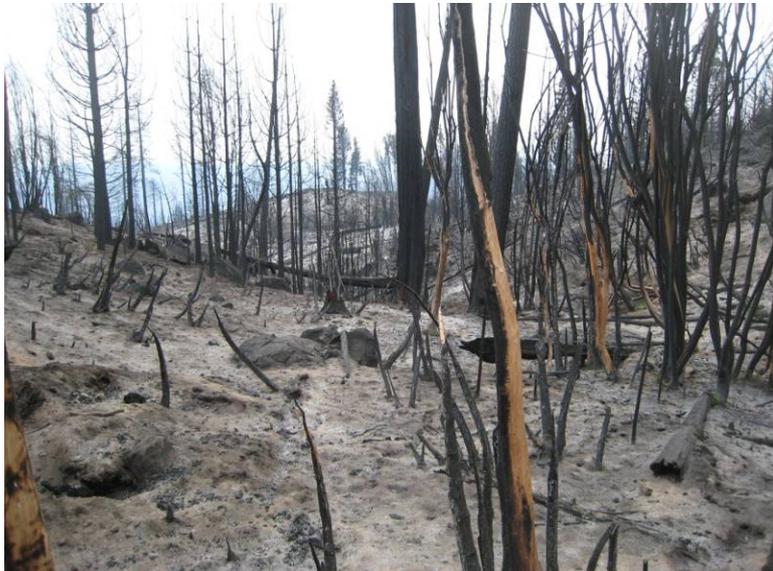
← High: *all of the ground cover is consumed, bare soil and ash, loss of soil structure*

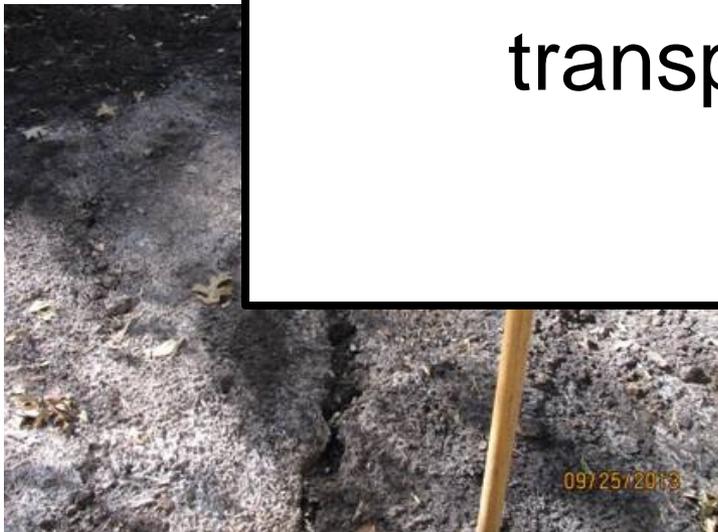
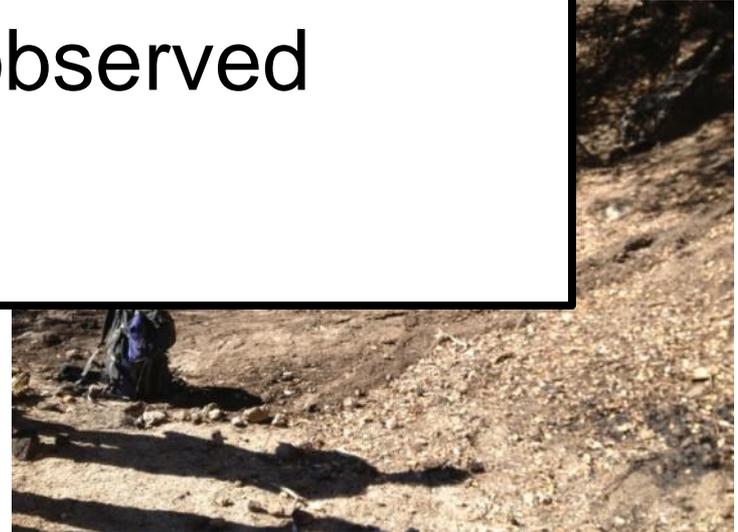
# Rill Erosion Observations – 9/25 & 9/26

Little hillslope scale solute  
transport observed
