**Flood Control Project Maintenance
Levee Inspections**

**Fall 2015 Levee Maintenance Deficiency Summary Report
Overall LMA & Unit Ratings, including USACE Erosion Survey**

**Flood Control Project Maintenance
Levee Inspections**
LMA District Cover Sheet
Fall 2015 Levee Inspection Results

Levee District No. 0001 (Sutter County)

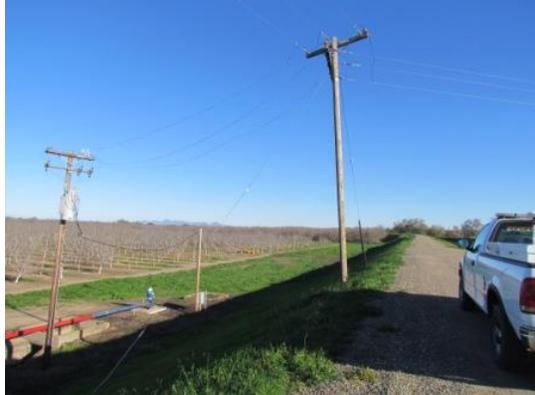
Photo 1 of 1 : FA_2015_LD0001S_433_8_20151106_00001.jpg

This photo was taken from the crown of the levee facing north looking at a power pole set in the landward levee slope. Spring 2014

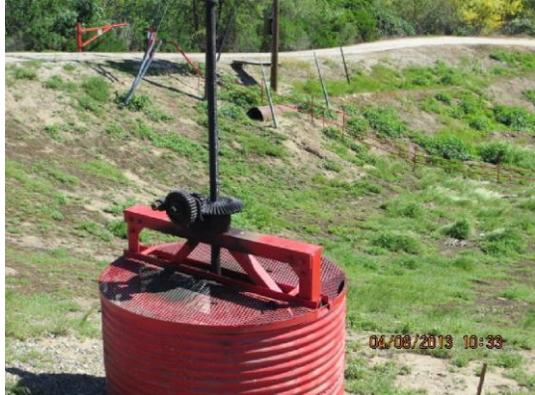
Photo 1 of 3 : UCIP_FA_2015_0446.jpg

LM Start	0.36	Rating **	M	Issue No.	490
LM End	0.36	Issue Type +	En	Location *	LS
Category	Supplemental		GPS Latitude/Longitude		
			Start	End	
Item	DWR UCIP Field Study		38.956192 °	38.956192 °	
			-121.585510 °	-121.585510 °	
DWR ID					
Action/Comments					
Inspector Comments: FS_ID:41624 DS_ID:18653 EP_NO: 4667 FS_HLM: 0.351 Repair Type: Non-Urgent Crossing Status: Found UCIP Comments: Abandoned crossing. Concrete box on both sides found. Pipe remainings are found on WS. FIELD_STRUCT_DESC: Abandoned crossing. Concrete box on both sides found. Pipe remainings are found on WS after the removal of 40 feet of 36" steel pipe from a spur levee and 20 feet of 36" steel pipe from the landside slope of Feather River Levee. Pipe depth 10.0 ft below crown. Application No. 4667, 1964.O&M Manual Sac 144, August 1955, Revision Year 2011. FS Date: 04/12/2013

WS- abandoned pipe near power pole (top)

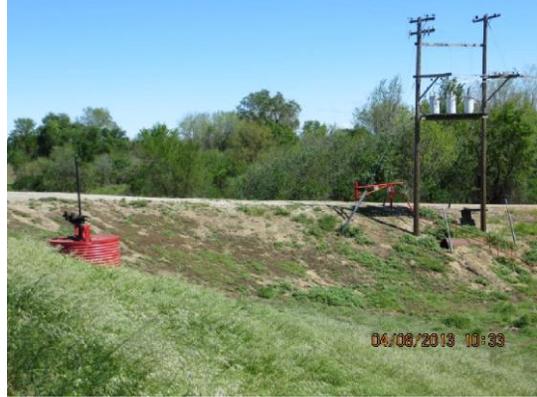
Photo 2 of 3 : UCIP_FA_2015_0447.jpg

LM Start	0.36	Rating **	M	Issue No.	490 (cont)
LM End	0.36	Issue Type +	En	Location *	LS
Category	Supplemental			GPS Latitude/Longitude	
				Start	End
Item	DWR UCIP Field Study			38.956192 °	38.956192 °
				-121.585510 °	-121.585510 °
DWR ID					
Action/Comments					
Inspector Comments: FS_ID:41624 DS_ID:18653 EP_NO: 4667 FS_HLM: 0.351 Repair Type: Non-Urgent Crossing Status: Found UCIP Comments: Abandoned crossing. Concrete box on both sides found. Pipe remainings are found on WS. FIELD_STRUCT_DESC: Abandoned crossing. Concrete box on both sides found. Pipe remainings are found on WS after the removal of 40 feet of 36" steel pipe from a spur levee and 20 feet of 36" steel pipe from the landside slope of Feather River Levee. Pipe depth 10.0 ft below crown. Application No. 4667, 1964.O&M Manual Sac 144, August 1955, Revision Year 2011. FS Date: 04/12/2013

WS- abandoned pipe near power pole (right)

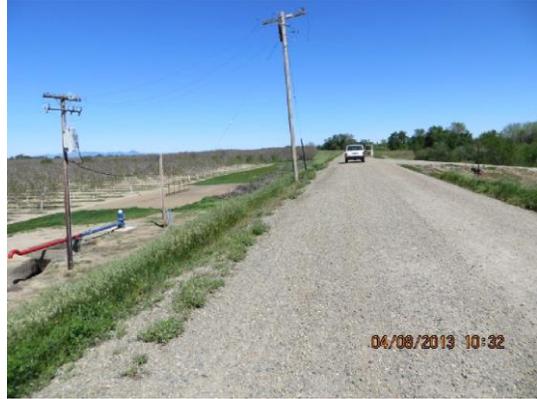
Photo 3 of 3 : UCIP_FA_2015_0448.jpg

Crown view- overview of both sides of the levee

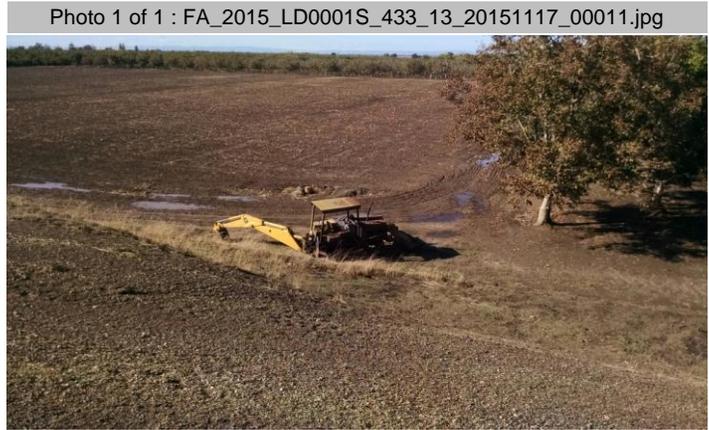
LM Start	0.68	Rating **	M	Issue No.	13
LM End	0.68	Issue Type +	En	Location *	LS
Category	Earthen Levee		GPS Latitude/Longitude		
			Start	End	
Item	Encroachments		38.960772 °	38.960772 °	
			-121.585943 °	-121.585943 °	
DWR ID	DWR_LD0001S_01_f_2015_13				
Action/Comments					
Equipment Inspector Comments: backhoe burned at toe of levee

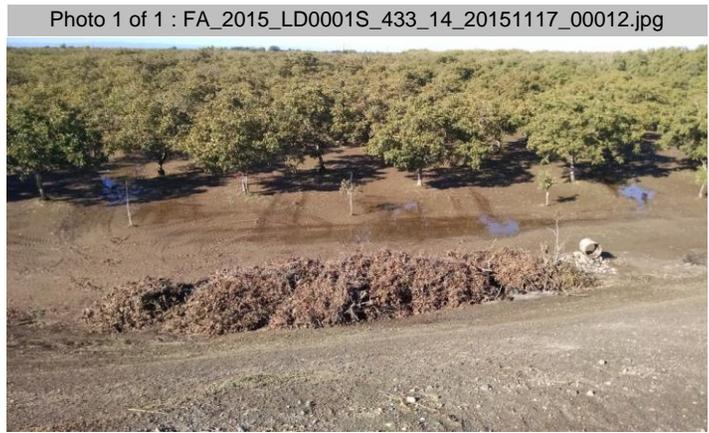
LM Start	1.12	Rating **	M	Issue No.	14
LM End	1.12	Issue Type +	En	Location *	LS
Category	Earthen Levee		GPS Latitude/Longitude		
			Start	End	
Item	Encroachments		38.966868 °	38.966868 °	
			-121.587230 °	-121.587230 °	
DWR ID	DWR_LD0001S_01_f_2015_14				
Action/Comments					
Prunings

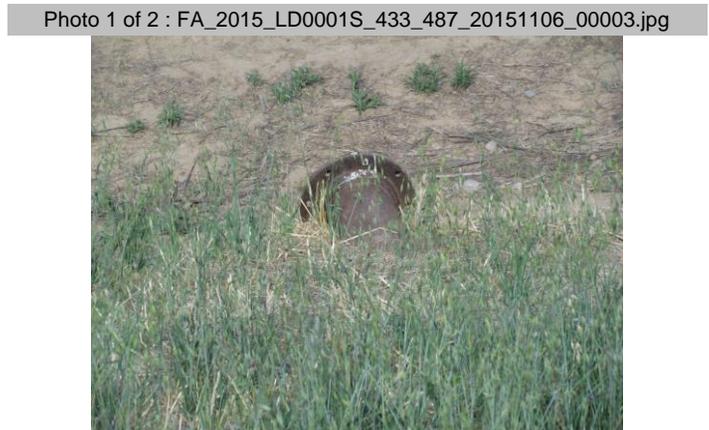
LM Start	1.85	Rating **	M	Issue No.	487
LM End	1.85	Issue Type +	Ma	Location *	LS
Category	Interior Drainage & Piping Systems		GPS Latitude/Longitude		
			Start	End	
Item	Metal Pipes		38.976927 °	38.976927 °	
			-121.591210 °	-121.591210 °	
DWR ID	DWR_LD0001S_01_s_2012_487				
Action/Comments					
Inspector Comments: Abandoned pipe. This pipe is listed in our levee log as an abandoned pipe, no date listed. No permit number. Corp pipe.

View of the pipe on the landside of the levee from the crown.

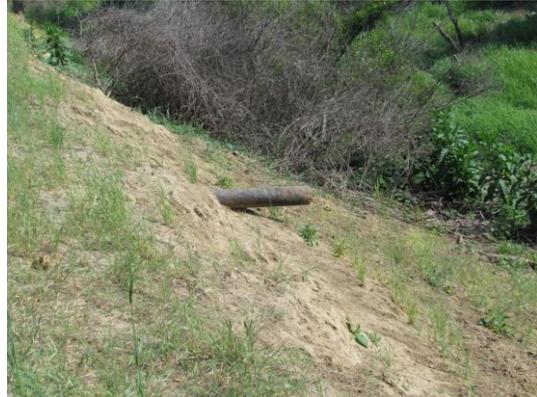
Photo 2 of 2 : FA_2015_LD0001S_433_487_20151106_00004.jpg

View of the pipe on the waterside of the levee from the crown facing upstream.

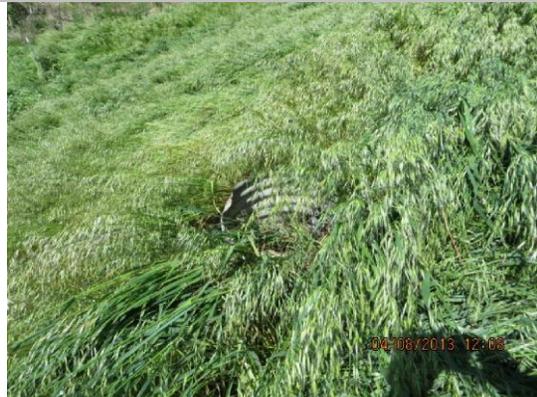
Photo 1 of 3 : UCIP_FA_2015_0449.jpg

LM Start	2.21	Rating **	M	Issue No.	491
LM End	2.21	Issue Type +	En	Location *	LS
Category	Supplemental		GPS Latitude/Longitude		
			Start	End	
Item	DWR UCIP Field Study		38.982135 °	38.982135 °	
			-121.591974 °	-121.591974 °	
DWR ID					
Action/Comments					
Inspector Comments: FS_ID:11383 DS_ID:17915 EP_NO: N/A FS_HLM: 2.1984 Repair Type: Non-Urgent Crossing Status: Found UCIP Comments: Siphon breaker cap missing. Sump pump and gate valve at landward toe not found may be due to dense vegetation. FIELD_STRUCT_DESC: A 8-inch steel pipe through levee, 4.6-feet below the crown. Siphon breaker in corrugated metal riser on landward slope.O&M Manual Sac 144, August 1955, Revision Year 2011. FS Date: 04/12/2013

LS- CMP riser on levee slope with dense vegetation.

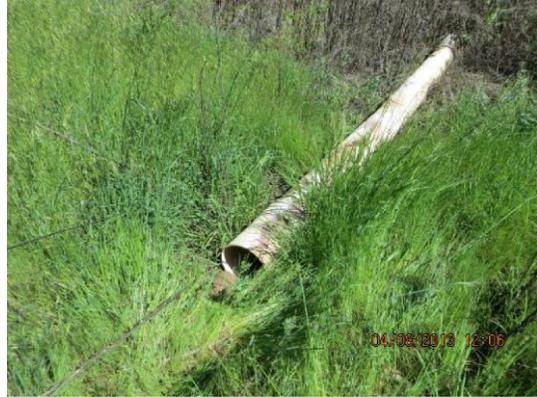
Photo 2 of 3 : UCIP_FA_2015_0450.jpg

LM Start	2.21	Rating **	M	Issue No.	491 (cont)
LM End	2.21	Issue Type +	En	Location *	LS
Category	Supplemental			GPS Latitude/Longitude	
				Start	End
Item	DWR UCIP Field Study			38.982135 °	38.982135 °
				-121.591974 °	-121.591974 °
DWR ID					
Action/Comments					
Inspector Comments: FS_ID:11383 DS_ID:17915 EP_NO: N/A FS_HLM: 2.1984 Repair Type: Non-Urgent Crossing Status: Found UCIP Comments: Siphon breaker cap missing. Sump pump and gate valve at landward toe not found may be due to dense vegetation. FIELD_STRUCT_DESC: A 8-inch steel pipe through levee, 4.6-feet below the crown. Siphon breaker in corrugated metal riser on landward slope.O&M Manual Sac 144, August 1955, Revision Year 2011. FS Date: 04/12/2013

WS-a disconnected pvc pipe on levee slope

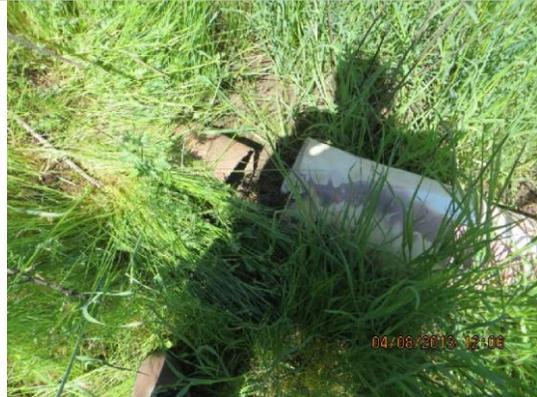
Photo 3 of 3 : UCIP_FA_2015_0451.jpg

WS- 8-inch steel pipe and disconnected pvc pipe on levee slope

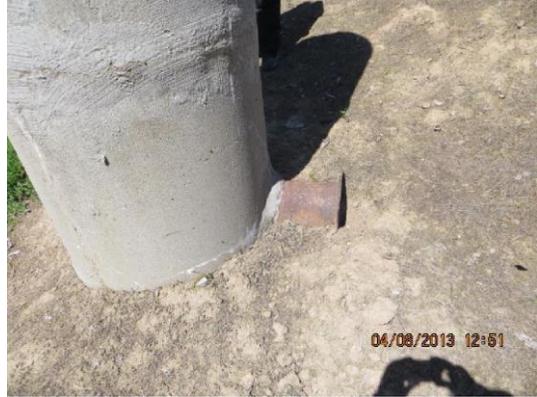
Photo 1 of 3 : UCIP_FA_2015_0454.jpg

LM Start	2.42	Rating **	M	Issue No.	492
LM End	2.42	Issue Type +	En	Location *	LS
Category	Supplemental			GPS Latitude/Longitude	
				Start	End
Item	DWR UCIP Field Study			38.985223 °	38.985223 °
				-121.591922 °	-121.591922 °
DWR ID					
Action/Comments					
Inspector Comments: FS_ID:41787 DS_ID:18667 EP_NO: N/A FS_HLM: 2.412 Repair Type: Non-Urgent Crossing Status: Found

LS- concrete standpipe with disconnected steel pipe

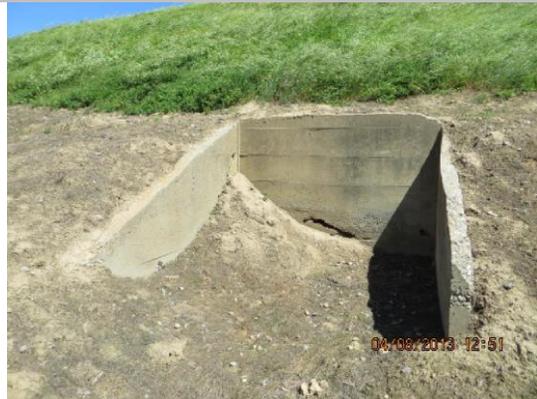
Photo 2 of 3 : UCIP_FA_2015_0455.jpg

LS- abandoned wing wall- no pipe

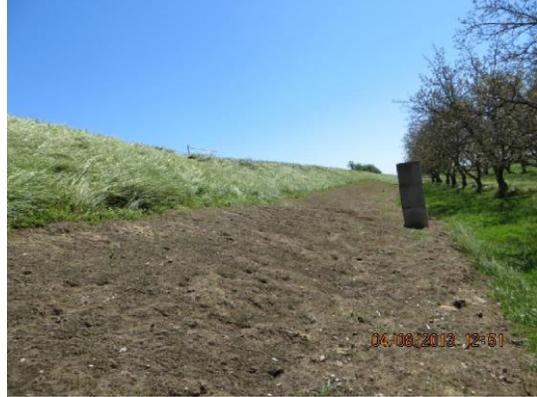
Photo 3 of 3 : UCIP_FA_2015_0456.jpg

LS- overview of landside with concrete standpipe

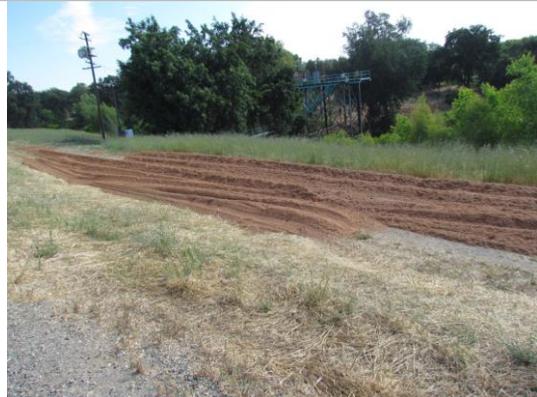
Photo 1 of 1 : FA_2015_LD0001S_433_16_20151106_00002.jpg

LM Start	2.44	Rating **	M	Issue No.	16
LM End	2.44	Issue Type +	Ma	Location *	WS
Category	Earthen Levee			GPS Latitude/Longitude	
				Start	End
Item	Encroachments			38.985446 °	38.985446 °
				-121.591930 °	-121.591930 °
DWR ID	DWR_LD0001S_01_s_2015_16				
Action/Comments					
Material Inspector Comments: Walnut holes left on waterside of the levee.

View of the material on the waterside of the levee facing upstream.

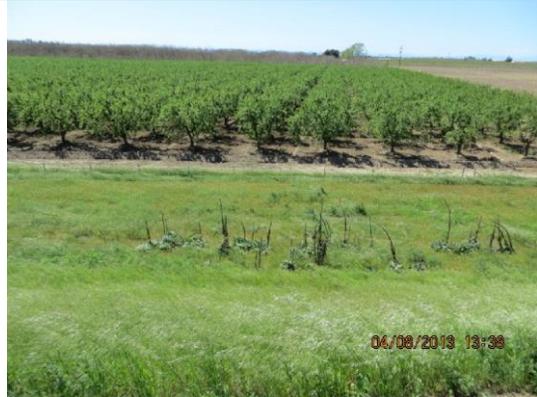
Photo 1 of 3 : UCIP_FA_2015_0492.jpg

LM Start	3.41	Rating **	M	Issue No.	493
LM End	3.41	Issue Type +	En	Location *	CR
Category	Supplemental			GPS Latitude/Longitude	
				Start	End
Item	DWR UCIP Field Study			38.998858 °	38.998858 °
				-121.596746 °	-121.596746 °
DWR ID					
Action/Comments					
Inspector Comments: FS_ID:41348 DS_ID:17918 EP_NO: N/A FS_HLM: 3.407 Repair Type: Non-Urgent Crossing Status: Indicator Found UCIP Comments: Only an abandoned steel structure on water and a concrete structure on WS Levee slope found. Need to verify pipe was properly abandoned. FIELD_STRUCT_DESC: Abandoned steel 8-inch drainpipe through levee, 4.1 feet below crown. Siphon breaker on landward slope. Butterfly shutoff valve on landward slope, concrete stand pipe and pump at toe of landward slope. Discharges into borrow pit on waterward side. O&M Manual Sac 144, August 1955, Revision Year 2011.. FS Date: 04/08/2013

Overview of landside of the levee- no pipes visible. Dense vegetation.

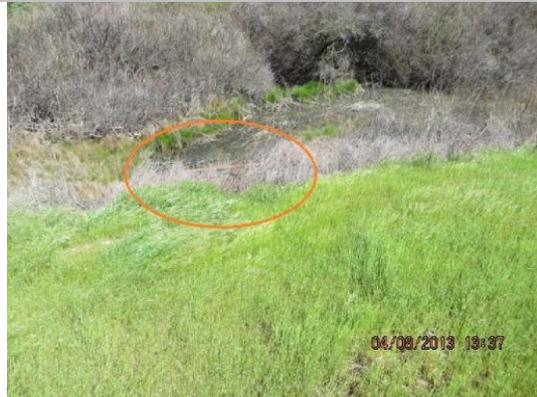
Photo 2 of 3 : UCIP_FA_2015_0493.jpg

WS- abandoned steel structure on waterway

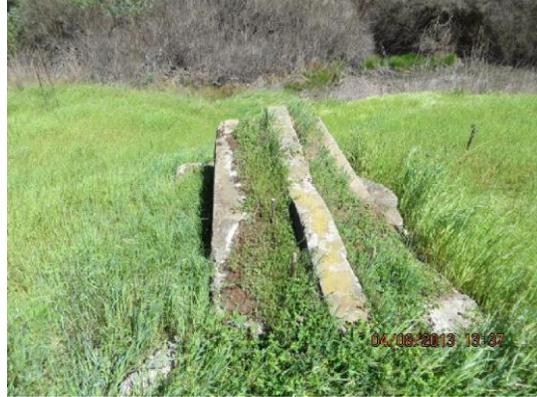
Photo 3 of 3 : UCIP_FA_2015_0494.jpg

WS- abandoned concrete structure on levee slope

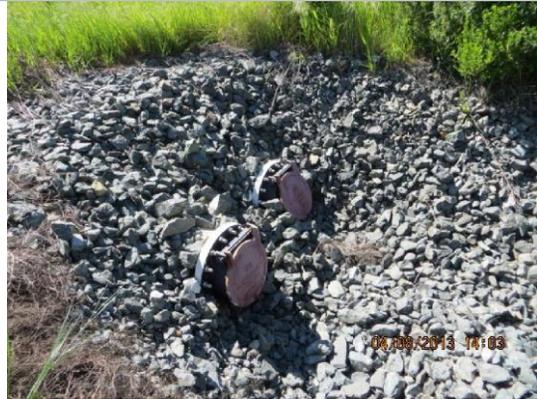
Photo 1 of 3 : UCIP_FA_2015_0178.jpg

LM Start	4.40	Rating **	M	Issue No.	494
LM End	4.40	Issue Type +	En	Location *	CR
Category	Supplemental			GPS Latitude/Longitude	
				Start	End
Item	DWR UCIP Field Study			39.011340 °	39.011340 °
				-121.603474 °	-121.603474 °
DWR ID					
Action/Comments					
Inspector Comments: FS_ID:11505 DS_ID:22971 EP_NO: 18438 FS_HLM: 4.579 Repair Type: Non-Urgent Crossing Status: Found UCIP Comments: Needs removal of blockage by riprap rubbles. FIELD_STRUCT_DESC: 1 of 2. 2- 16-inch steel drainage pipe. Riprap discharge structure on WS. Flap gate not properly closed. Pump station on LS concrete sump. FS Date: 04/08/2013

WS- flap gates, pipes and discharge channel

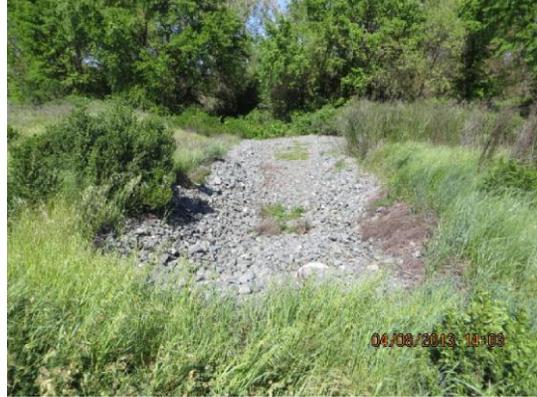
Photo 2 of 3 : UCIP_FA_2015_0179.jpg

WS- discharge riprap/rubble channel

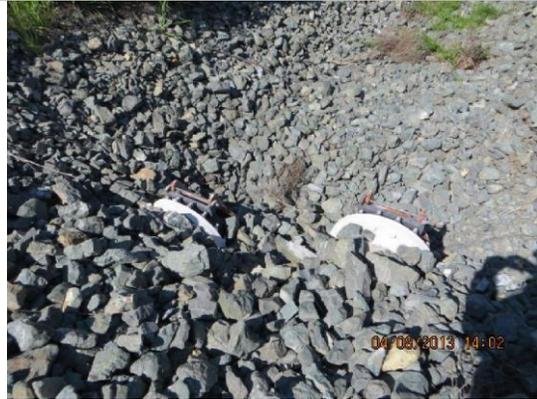
Photo 3 of 3 : UCIP_FA_2015_0180.jpg

WS- drainage pipe on riprap

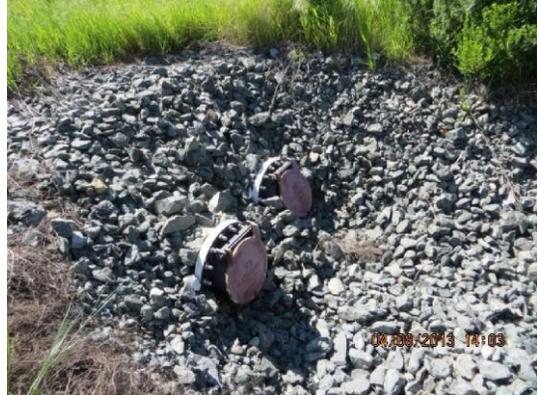
Photo 1 of 3 : UCIP_FA_2015_0245.jpg

LM Start	4.40	Rating **	U	Issue No.	495
LM End	4.40	Issue Type +	En	Location *	CR
Category	Supplemental			GPS Latitude/Longitude	
				Start	End
Item	DWR UCIP Field Study			39.011354 °	39.011354 °
				-121.603488 °	-121.603488 °
DWR ID					
Action/Comments					
Inspector Comments: FS_ID:40799 DS_ID:22970 EP_NO: 18438 FS_HLM: 4.58 Repair Type: Urgent Crossing Status: Found

WS- steel discharge pipes, flap gates and discharge area

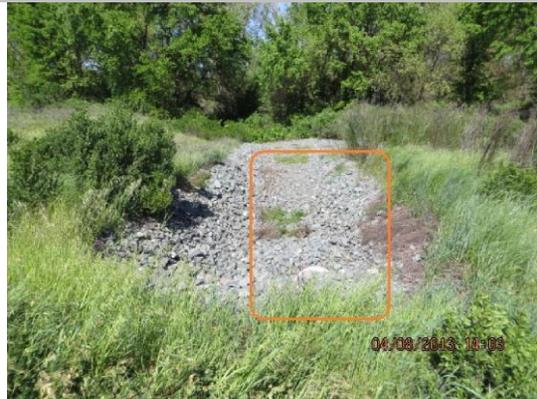
Photo 2 of 3 : UCIP_FA_2015_0246.jpg

WS- discharge pipes and riprap discharge area

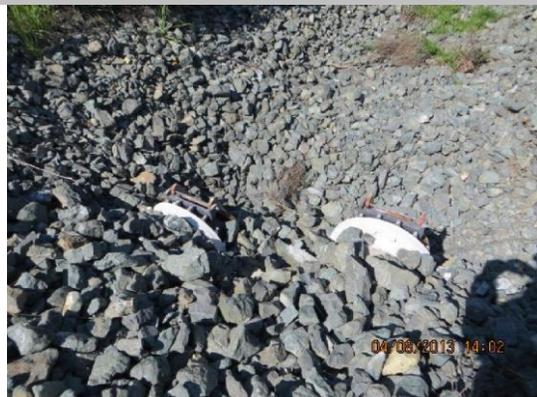
Photo 3 of 3 : UCIP_FA_2015_0247.jpg

WS- steel discharge pipes and riprap discharge area

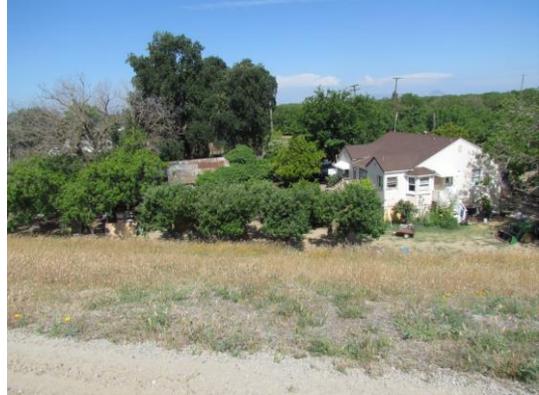
Photo 1 of 1 : FA_2015_LD0001S_433_489_20151106_00005.jpg

LM Start	9.16	Rating **	M	Issue No.	489
LM End	9.16	Issue Type +	En	Location *	LS
Category	Earthen Levee		GPS Latitude/Longitude		
			Start	End	
Item	Vegetation		39.076558 °	39.076558 °	
			-121.605837 °	-121.605837 °	
DWR ID	DWR_LD0001S_01_s_2012_489				
Action/Comments					
Landscaping Inspector Comments: Landscaping on landward levee toe.

View of the vegetation on the landside of the levee from the crown.

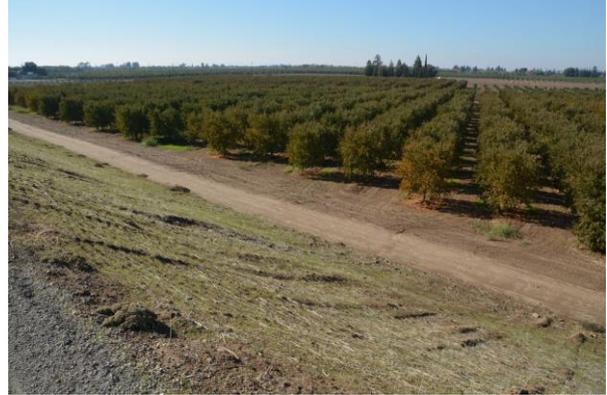
Photo 1 of 1 : FA_2015_LD0001S_433_25_20151117_00023.jpg

LM Start	9.84	Rating **	M	Issue No.	25
LM End	9.84	Issue Type +	Ma	Location *	LS
Category	Earthen Levee			GPS Latitude/Longitude	
				Start	End
Item	Slope Stability			39.085915 °	39.085915 °
				-121.603733 °	-121.603733 °
DWR ID	DWR_LD0001S_01_f_2015_25				
Action/Comments					
Repair the levee slope damaged by vehicle traffic and prevent access where possible. Inspector Comments: Track walking ruts on landside slope.

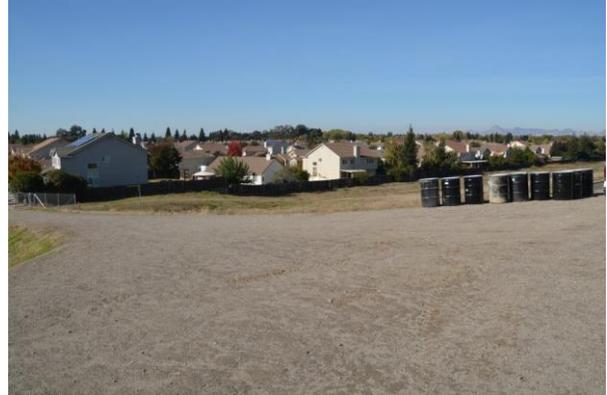
Photo 1 of 1 : FA_2015_LD0001S_433_15_20151117_00024.jpg

LM Start	10.71	Rating **	M	Issue No.	15
LM End	10.71	Issue Type +	En	Location *	CR
Category	Earthen Levee			GPS Latitude/Longitude	
				Start	End
Item	Encroachments			39.097573 °	39.097573 °
				-121.601869 °	-121.601869 °
DWR ID	DWR_LD0001S_01_f_2015_15				
Action/Comments					
Material Inspector Comments: Nine 55-gal drums related to drilling of monitoring well.

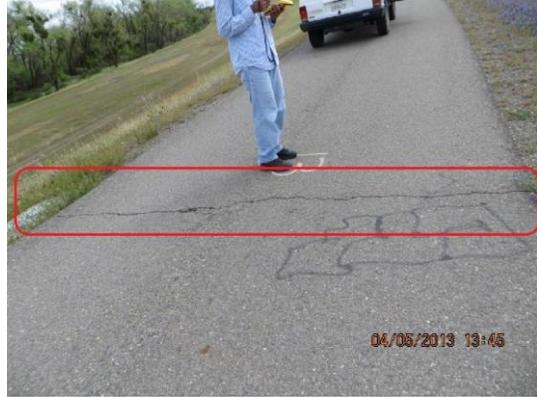
Photo 1 of 2 : UCIP_FA_2015_0920.jpg

LM Start	11.39	Rating **	U	Issue No.	496
LM End	11.39	Issue Type +	En	Location *	CR
Category	Supplemental			GPS Latitude/Longitude	
				Start	End
Item	DWR UCIP Field Study			39.106261 °	39.106261 °
				-121.607535 °	-121.607535 °
DWR ID					
Action/Comments					
Inspector Comments: FS_ID:42824 DS_ID:17935 EP_NO: N/A FS_HLM: 11.891 Repair Type: Urgent Crossing Status: Found UCIP Comments: No flap gates on waterward end. Road pavement cracked along pipe, it needs more investigation. FIELD_STRUCT_DESC: 1 of 2. A 6-inch pipe (of 6-inch and 16-inch-pipes) through levee, 6.0 feet below crown. Siphon breakers in corrugated metal pipe risers on waterward shoulder. Pump house at landward toe. FS Date: 04/09/2013

Cracked levee crown. Needs more investigation.

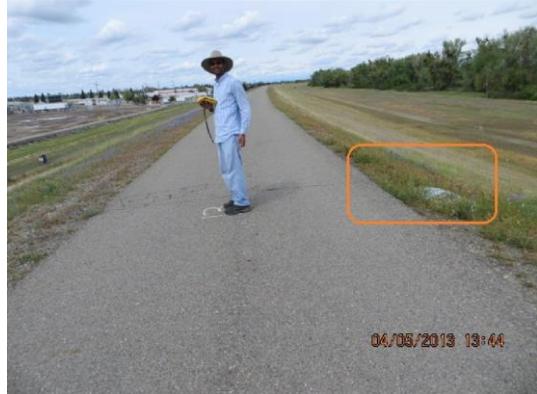
Photo 2 of 2 : UCIP_FA_2015_0921.jpg

Levee Crown: overview. Siphon breaker on waterside shoulder

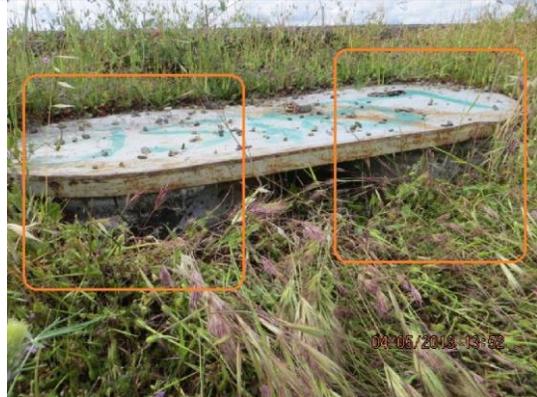
Photo 1 of 3 : UCIP_FA_2015_0900.jpg

LM Start	11.39	Rating **	M	Issue No.	497
LM End	11.39	Issue Type +	En	Location *	CR
Category	Supplemental			GPS Latitude/Longitude	
				Start	End
Item	DWR UCIP Field Study			39.106261 °	39.106261 °
				-121.607535 °	-121.607535 °
DWR ID					
Action/Comments					
Inspector Comments: FS_ID:11983 DS_ID:18879 EP_NO: N/A FS_HLM: 11.8912 Repair Type: Non-Urgent Crossing Status: Found

WS- two siphon breaker in CMP riser

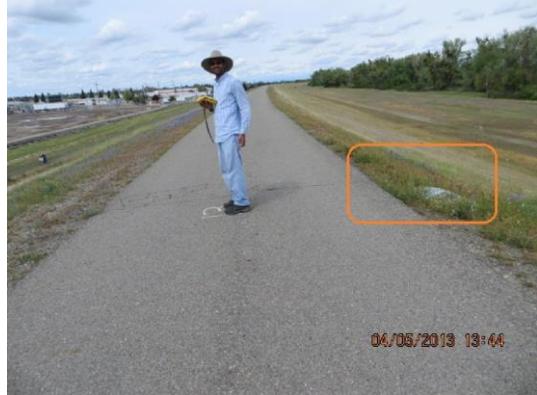
Photo 3 of 3 : UCIP_FA_2015_0902.jpg

Levee crown overview- siphon breaker on right

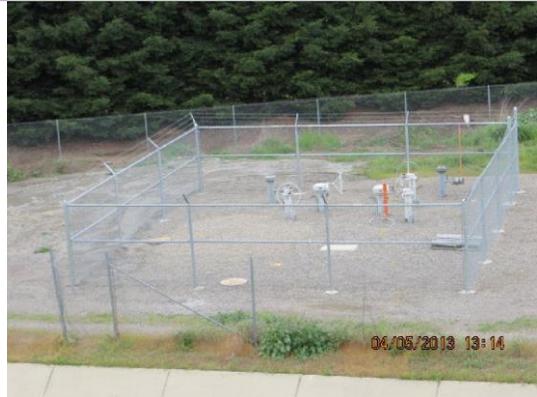
Photo 1 of 3 : UCIP_FA_2015_0248.jpg

LM Start	11.99	Rating **	M	Issue No.	498
LM End	11.99	Issue Type +	En	Location *	CR
Category	Supplemental			GPS Latitude/Longitude	
				Start	End
Item	DWR UCIP Field Study			39.114856 °	39.114856 °
				-121.605821 °	-121.605821 °
DWR ID					
Action/Comments					
Inspector Comments: FS_ID:41841 DS_ID:17932 EP_NO: N/A FS_HLM: 12.498 Repair Type: Non-Urgent Crossing Status: Indicator Found UCIP Comments: Need to install Gasline Markers.Fenced control station.Indicator on LS across concrete ditch.Found road markings. FIELD_STRUCT_DESC: 1 of 2. One 16-inch pipe of two 16-inch gas lines through levee, 3 feet below crown. PG&E gas line-crossing sign on waterward shoulder. FS Date: 04/05/2013

LS- fenced control station with indicators

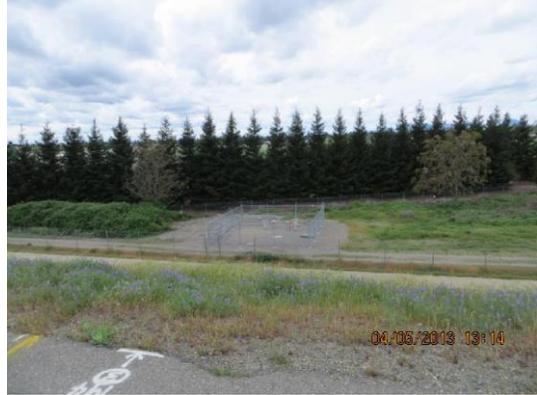
Photo 2 of 3 : UCIP_FA_2015_0249.jpg

LS- fenced control station across concrete ditch

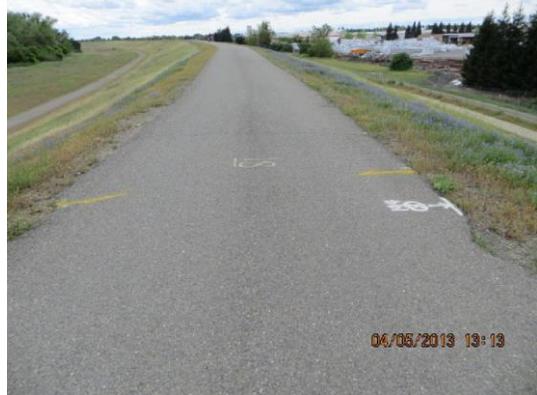
Photo 3 of 3 : UCIP_FA_2015_0250.jpg

Levee Crown: gasline indicator/markings on crown road.

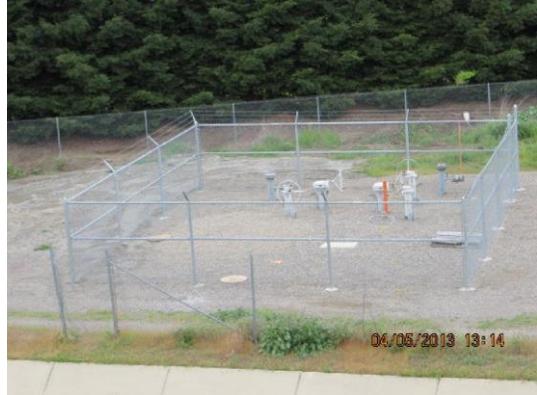
Photo 1 of 3 : UCIP_FA_2015_0251.jpg

LM Start	11.99	Rating **	M	Issue No.	499
LM End	11.99	Issue Type +	En	Location *	CR
Category	Supplemental			GPS Latitude/Longitude	
				Start	End
Item	DWR UCIP Field Study			39.114856 °	39.114856 °
				-121.605821 °	-121.605821 °
DWR ID					
Action/Comments					
Inspector Comments: FS_ID:41889 DS_ID:18880 EP_NO: N/A FS_HLM: 12.498 Repair Type: Non-Urgent Crossing Status: Indicator Found

LS- fenced control station with gasline indicator across concrete ditch.

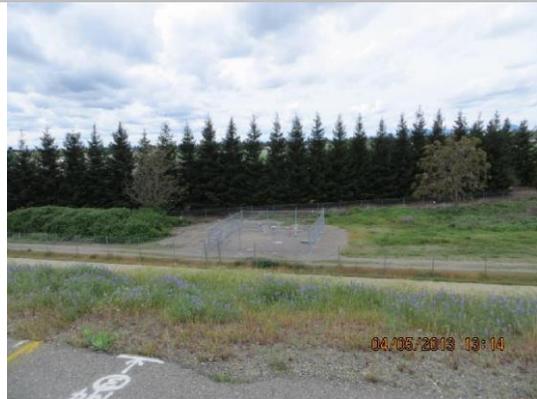
Photo 2 of 3 : UCIP_FA_2015_0252.jpg

LS- fenced control station across concrete ditch.

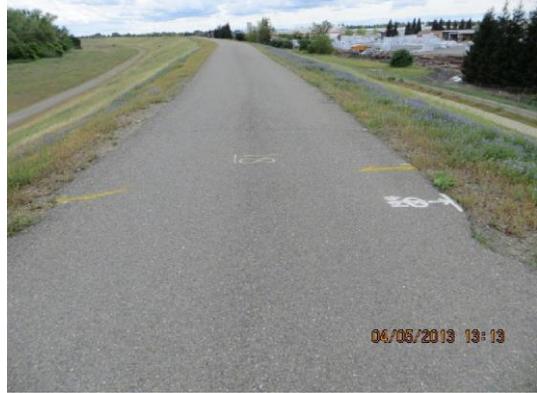
Photo 3 of 3 : UCIP_FA_2015_0253.jpg

Levee Crown: road markings on road pavement

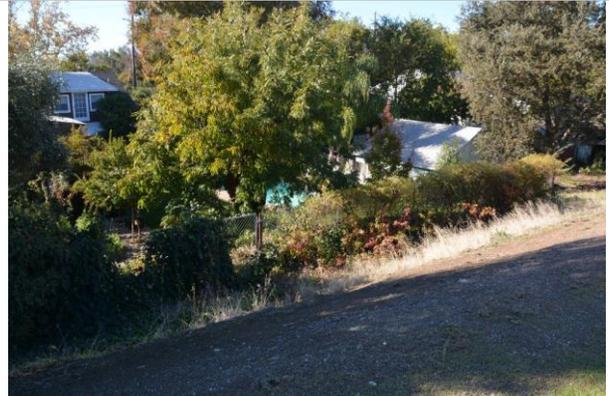
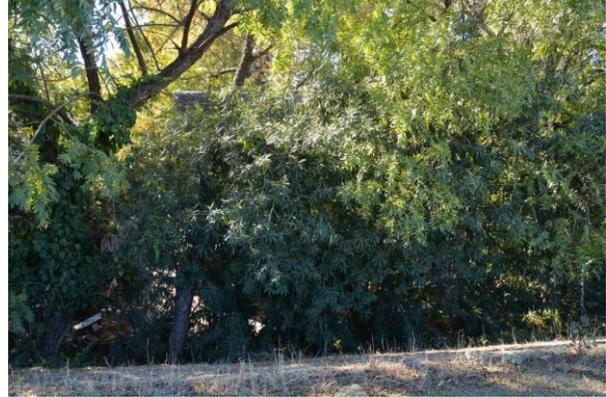
LM Start	13.42	Rating **	U	Issue No.	24
LM End	13.42	Issue Type +	Ma	Location *	LS
Category	Earthen Levee		GPS Latitude/Longitude		
			Start	End	
Item	Vegetation		39.134119 °	39.134119 °	
			-121.604213 °	-121.604213 °	
DWR ID	DWR_LD0001S_01_f_2015_24				
Action/Comments					
Trees / Woody Vegetation Inspector Comments: Vegetation on chainlink fence obscuring visibility. Oleander touching levee.

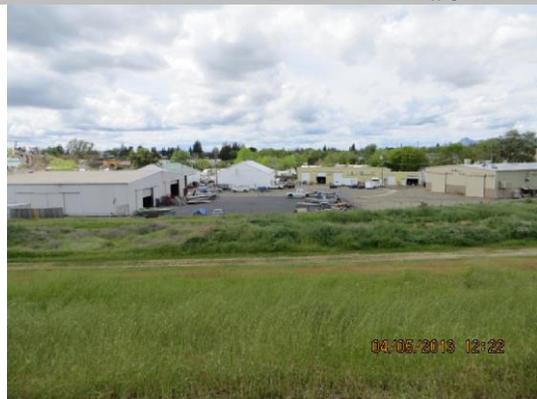
Photo 1 of 3 : UCIP_FA_2015_0254.jpg

LM Start	14.35	Rating **	M	Issue No.	500
LM End	14.35	Issue Type +	En	Location *	LS
Category	Supplemental		GPS Latitude/Longitude		
			Start	End	
Item	DWR UCIP Field Study		39.146494 °	39.146494 °	
			-121.609715 °	-121.609715 °	
DWR ID					
Action/Comments					
Inspector Comments: FS_ID:41887 DS_ID:18640 EP_NO: N/A FS_HLM: 14.874 Repair Type: Non-Urgent Crossing Status: Indicator Found UCIP Comments: Need to contact ownder to determin status of crossing and install signs if appropriate. FIELD_STRUCT_DESC: A 18-inch steel; Gas Line. O&M Manual Sac 144, August 1955, Revision Year 2011. FS Date: 04/05/2013

LS- overview. No sign post or indicator found.

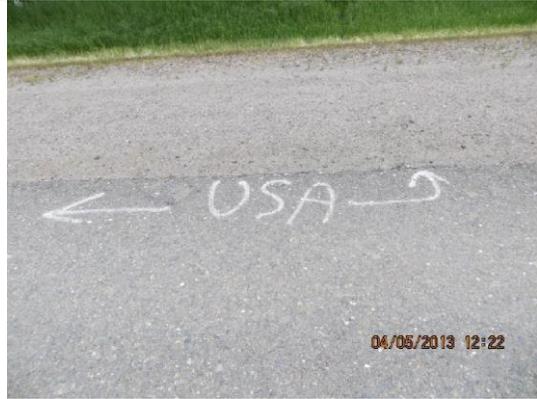
Photo 2 of 3 : UCIP_FA_2015_0255.jpg

WS- USA road marking on pavement

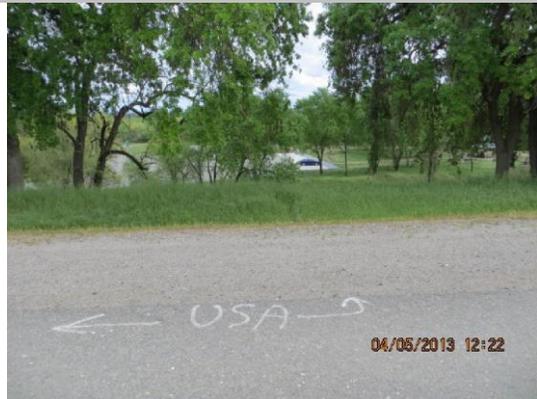
Photo 3 of 3 : UCIP_FA_2015_0256.jpg

WS- USA road marking and floodway area

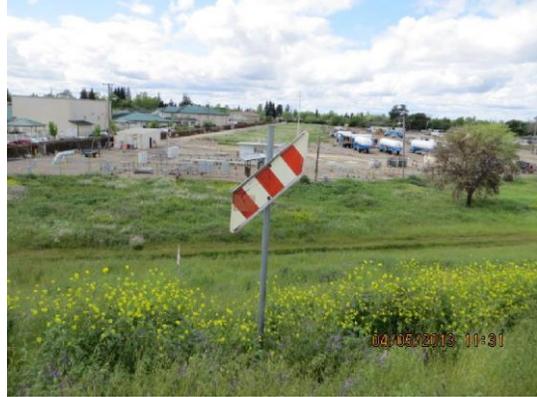
Photo 1 of 2 : UCIP_FA_2015_0636.jpg

LS- gasoline marker on levee slope

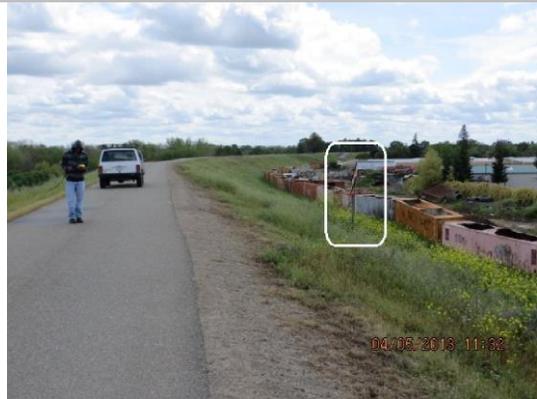
Photo 2 of 2 : UCIP_FA_2015_0744.jpg

LS- overview of gasoline marker on levee slope

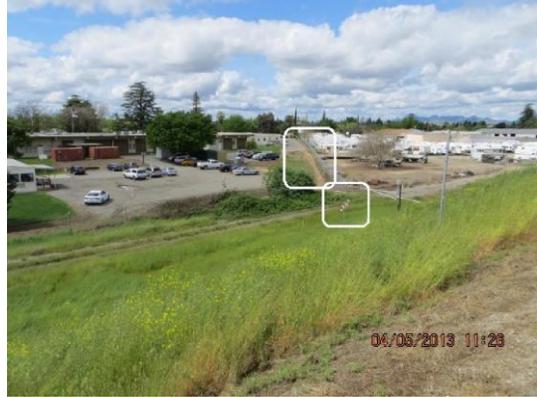
Photo 1 of 3 : UCIP_FA_2015_0745.jpg

LS- overview of gasoline indicators on levee slope and across.

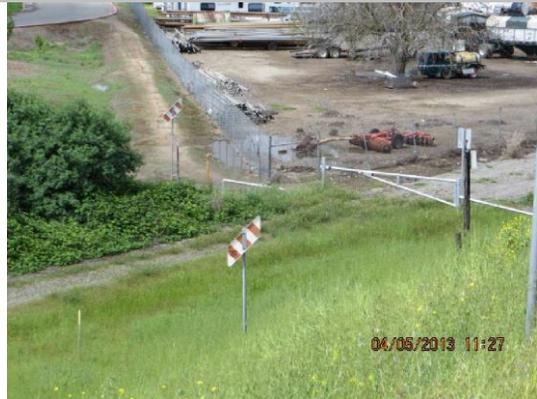
Photo 2 of 3 : UCIP_FA_2015_0746.jpg

LS- gasoline indicators on levee slope and across.

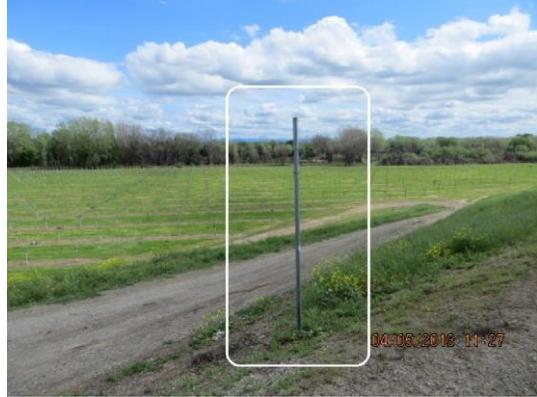
Photo 3 of 3 : UCIP_FA_2015_0747.jpg

WS- needs a gasoline indicator.

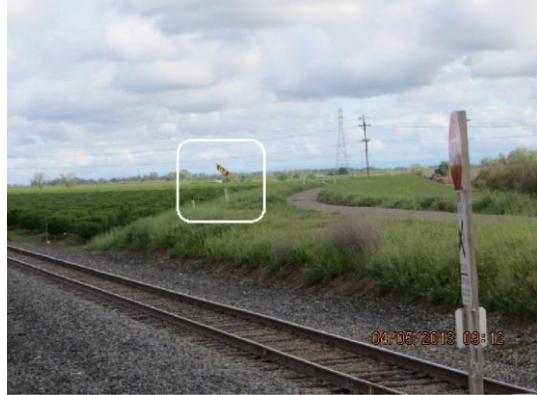
Photo 1 of 2 : UCIP_FA_2015_0797.jpg

Gasline sign across the railway

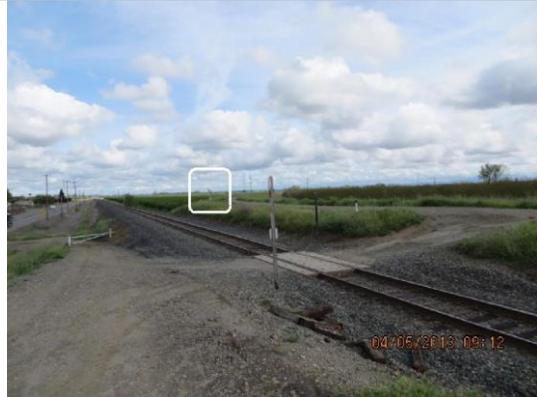
Photo 2 of 2 : UCIP_FA_2015_0798.jpg

Railway and levee crossing and gasline sign across the railway
