**Flood Control Project Maintenance
Levee Inspections**
LMA District Cover Sheet
Spring 2016 Levee Inspection Results

Levee District No. 0001 (Sutter County)

Spring 2016 Levee Inspection Results

Waterway		Bank	Unit Miles
Unit No. 01 Feather River		Right	16.11

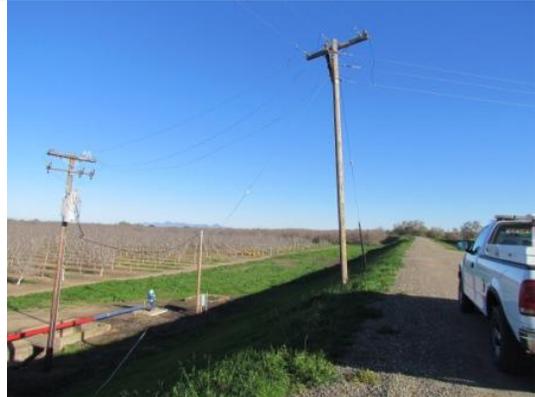
Photo 1 of 1 : SP_2016_LD0001S_433_8_20160307_00001.jpg

This photo was taken from the crown of the levee facing north looking at a power pole set in the landward levee slope. Spring 2014

LM Start	0.36	Rating **	M	Issue No.	499
LM End	0.36	Issue Type +	En	Location *	LS
Category	Supplemental		GPS Latitude/Longitude		
			Start	End	
Item	DWR UCIP Field Study		38.956192 °	38.956192 °	
			-121.585510 °	-121.585510 °	
DWR ID					
Comment Code					
Inspector Comment					
FS_ID:41624 DS_ID:18653 EP_NO: 4667 Repair Type: Non-Urgent Crossing Status: Found UCIP Comments: Abandoned crossing. Concrete box on both sides found. Pipe remainings are found on WS. FIELD_STRUCT_DESC: Abandoned crossing. Concrete box on both sides found. Pipe remainings are found on WS after the removal of 40 feet of 36" steel pipe from a spur levee and 20 feet of 36" steel pipe from the landside slope of Feather River Levee. Pipe depth 10.0 ft below crown. Application No. 4667, 1964.O&M Manual Sac 144, August 1955, Revision Year 2011. FS Date: 4/12/2013

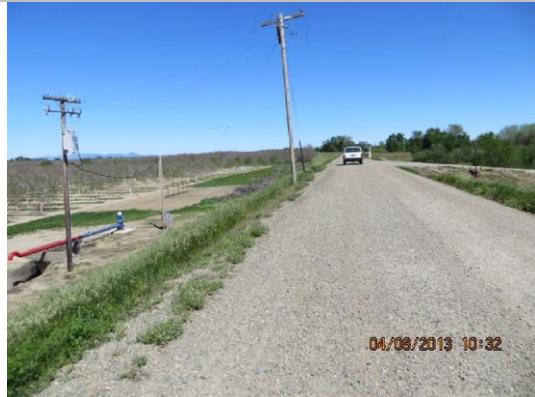
Photo 1 of 2 : UCIP_SP_2016_41624_18769.jpg

Crown view- overview of both sides of the levee

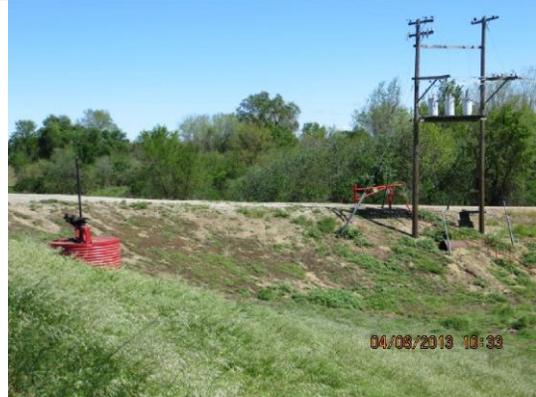
Photo 2 of 2 : UCIP_SP_2016_41624_18768.jpg

LM Start	0.36	Rating **	M	Issue No.	499 (cont)
LM End	0.36	Issue Type +	En	Location *	LS
Category	Supplemental			GPS Latitude/Longitude	
				Start	End
Item	DWR UCIP Field Study			38.956192 °	38.956192 °
				-121.585510 °	-121.585510 °
DWR ID					
Comment Code					
Inspector Comment					
FS_ID:41624 DS_ID:18653 EP_NO: 4667 Repair Type: Non-Urgent Crossing Status: Found UCIP Comments: Abandoned crossing. Concrete box on both sides found. Pipe remainings are found on WS. FIELD_STRUCT_DESC: Abandoned crossing. Concrete box on both sides found. Pipe remainings are found on WS after the removal of 40 feet of 36" steel pipe from a spur levee and 20 feet of 36" steel pipe from the landside slope of Feather River Levee. Pipe depth 10.0 ft below crown. Application No. 4667, 1964.O&M Manual Sac 144, August 1955, Revision Year 2011. FS Date: 4/12/2013

WS- abandoned pipe near power pole (right)

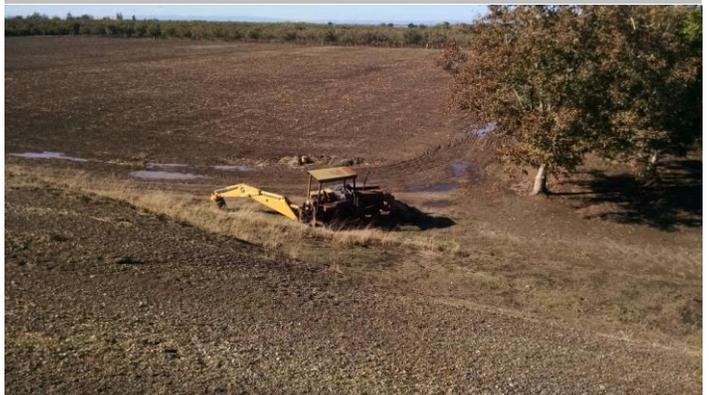
Photo 1 of 1 : SP_2016_LD0001S_433_13_20160307_00002.jpg

LM Start	0.68	Rating **	M	Issue No.	13
LM End	0.68	Issue Type +	En	Location *	LS
Category	Earthen Levee			GPS Latitude/Longitude	
				Start	End
Item	Encroachments			38.960772 °	38.960772 °
				-121.585943 °	-121.585943 °
DWR ID	DWR_LD0001S_01_f_2015_13				
Comment Code					
EQ : Equipment					
Inspector Comment					
backhoe burned at toe of landside levee.

This picture was from Fall 2015 Inspection but the backhoe is still there and the picture is the same for Spring of 2016. The backhoe was location on the landside toe of the levee.

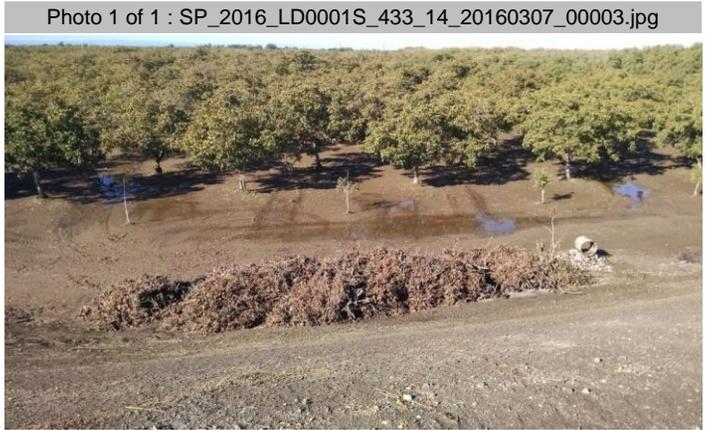
LM Start	1.12	Rating **	M	Issue No.	14
LM End	1.12	Issue Type +	En	Location *	LS
Category	Earthen Levee		GPS Latitude/Longitude		
			Start	End	
Item	Encroachments		38.966868 °	38.966868 °	
			-121.587230 °	-121.587230 °	
DWR ID	DWR_LD0001S_01_f_2015_14				
Comment Code					
PR : Prunings					
Inspector Comment

Prunings on the landside toe blocking visibility. Spring 2016.

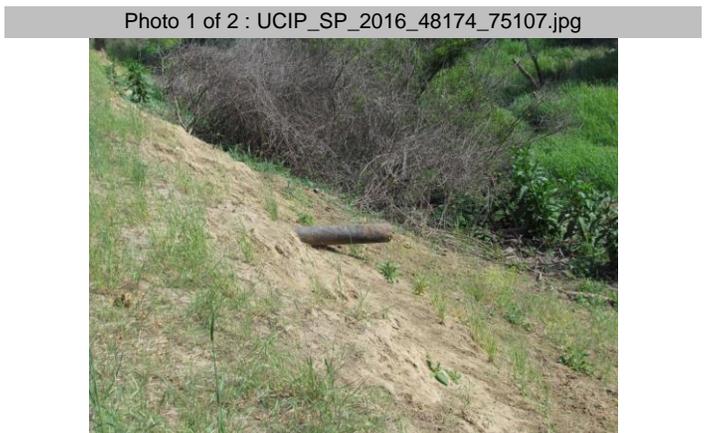
LM Start	1.85	Rating **	U	Issue No.	504
LM End	1.85	Issue Type +	En	Location *	LS
Category	Supplemental		GPS Latitude/Longitude		
			Start	End	
Item	DWR UCIP Field Study		38.977002 °	38.977002 °	
			-121.591199 °	-121.591199 °	
DWR ID					
Comment Code					
Inspector Comment					
FS_ID:48174 DS_ID:17917 EP_NO: N/A Repair Type: Urgent Crossing Status: Found UCIP Comments: Needs proper abandonment; pipe open on both ends. FIELD_STRUCT_DESC: *ABANDONED* 8-inch steel pipe through the levee, 4.6 feet below the crown. Siphon breaker in 24-inch corrugated metal riser on landside (LS) shoulder, not found. Pipe open on both ends. Sacramento O&M Manual 144, August 1955, Revision Year 2011. FS Date: 5/23/2016

Pipe visible on WS slope. Photo courtesy of Sterling York, DWR Inspector.

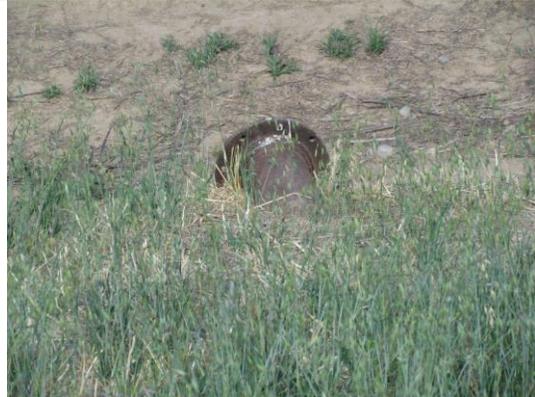
Photo 2 of 2 : UCIP_SP_2016_48174_75108.jpg

LM Start	1.85	Rating **	U	Issue No.	504 (cont)
LM End	1.85	Issue Type +	En	Location *	LS
Category	Supplemental			GPS Latitude/Longitude	
				Start	End
Item	DWR UCIP Field Study			38.977002 °	38.977002 °
				-121.591199 °	-121.591199 °
DWR ID					
Comment Code					
Inspector Comment					
FS_ID:48174 DS_ID:17917 EP_NO: N/A Repair Type: Urgent Crossing Status: Found UCIP Comments: Needs proper abandonment; pipe open on both ends. FIELD_STRUCT_DESC: *ABANDONED* 8-inch steel pipe through the levee, 4.6 feet below the crown. Siphon breaker in 24-inch corrugated metal riser on landside (LS) shoulder, not found. Pipe open on both ends. Sacramento O&M Manual 144, August 1955, Revision Year 2011. FS Date: 5/23/2016

Pipe open on LS end. Photo courtesy of Sterling York, DWR Inspector.

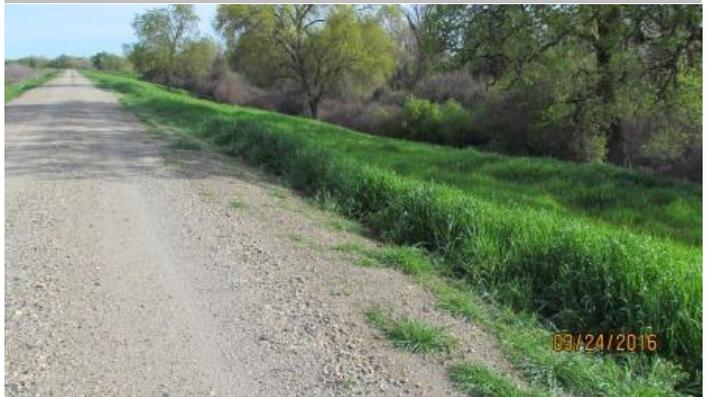
Photo 1 of 1 : SP_2016_LD0001S_433_36_20160328_00060.jpg

LM Start	2.17	Rating **	M	Issue No.	36
LM End	3.49	Issue Type +	Ma	Location *	WS
Category	Earthen Levee			GPS Latitude/Longitude	
				Start	End
Item	Vegetation			38.981559 °	38.999973 °
				-121.591996 °	-121.597019 °
DWR ID	DWR_LD0001S_01_s_2016_36				
Comment Code					
V2 : Remove the wild growth other than native grasses from the levee slopes.					
Inspector Comment

View of waterside vegetation looking upstream.

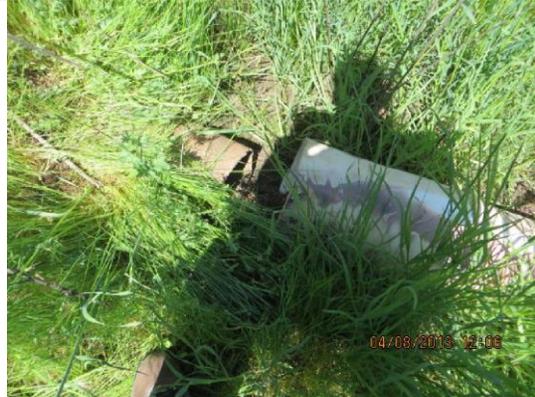
Photo 1 of 2 : UCIP_SP_2016_11383_18782.jpg

LM Start	2.21	Rating **	M	Issue No.	493
LM End	2.21	Issue Type +	En	Location *	WS
Category	Supplemental			GPS Latitude/Longitude	
				Start	End
Item	DWR UCIP Field Study			38.982135 °	38.982135 °
				-121.591974 °	-121.591974 °
DWR ID					
Comment Code					
Inspector Comment					
FS_ID:11383 DS_ID:17915 EP_NO: N/A Repair Type: Non-Urgent Crossing Status: Found UCIP Comments: Siphon breaker cap missing. Sump pump and gate valve at landward toe not found may be due to dense vegetation. FIELD_STRUCT_DESC: A 8-inch steel pipe through levee, 4.6-feet below the crown. Siphon breaker in corrugated metal riser on landward slope.O&M Manual Sac 144, August 1955, Revision Year 2011. FS Date: 4/12/2013

WS- 8-inch steel pipe and disconnected pvc pipe on levee slope

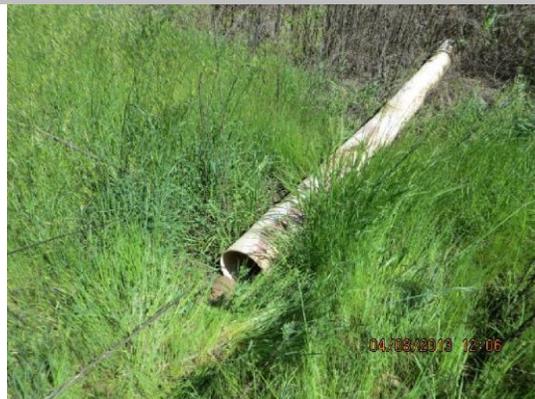
Photo 2 of 2 : UCIP_SP_2016_11383_18781.jpg

WS-a disconnected pvc pipe on levee slope

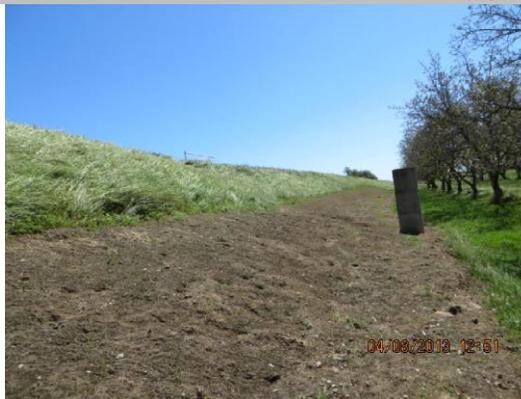
Photo 1 of 2 : UCIP_SP_2016_41787_18793.jpg

LM Start	2.42	Rating **	M	Issue No.	501
LM End	2.42	Issue Type +	En	Location *	WS
Category	Supplemental			GPS Latitude/Longitude	
				Start	End
Item	DWR UCIP Field Study			38.985223 °	38.985223 °
				-121.591922 °	-121.591922 °
DWR ID					
Comment Code					
Inspector Comment					
FS_ID:41787 DS_ID:18667 EP_NO: N/A Repair Type: Non-Urgent Crossing Status: Found UCIP Comments: Pipe appears to be abandoned and should be verified as having been done so properly. - concrete standpipe with 10-inch steel pipe.- concrete wing wall- no pipe- abandoned structure- a pump found on other side of the levee (WS) but not sure whether it is associated with this crossing. FIELD_STRUCT_DESC: 24" pipe under landside approach and install 10-inch corrugated iron pipe under landside approach(culvert). Not found in O&M Manual. FS Date: 4/12/2013

LS- overview of landside with concrete standpipe

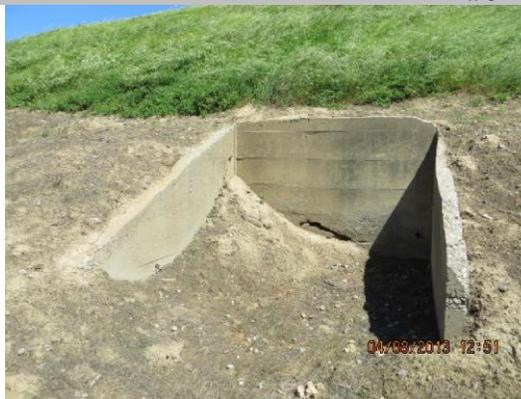
Photo 2 of 2 : UCIP_SP_2016_41787_18792.jpg

LS- abandoned wing wall- no pipe

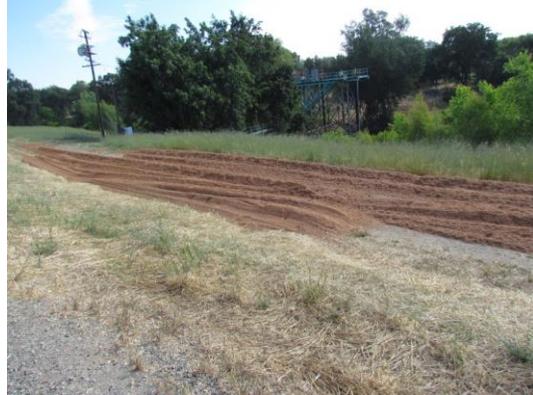
Photo 1 of 1 : SP_2016_LD0001S_433_16_20160307_00005.jpg

View of the material on the waterside of the levee facing upstream.

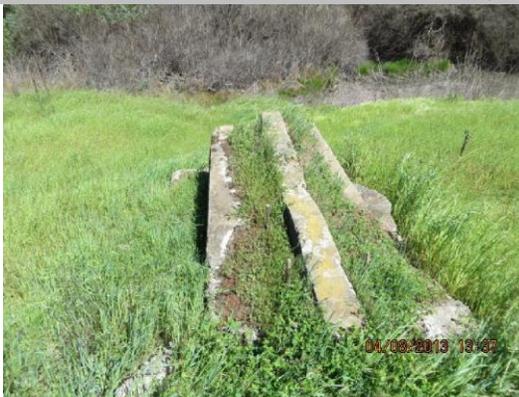
Photo 1 of 2 : UCIP_SP_2016_41348_18882.jpg

LM Start	3.42	Rating **	M	Issue No.	495
LM End	3.42	Issue Type +	En	Location *	CR
Category	Supplemental			GPS Latitude/Longitude	
				Start	End
Item	DWR UCIP Field Study			38.998858 °	38.998858 °
				-121.596746 °	-121.596746 °
DWR ID					
Comment Code					
Inspector Comment					
FS_ID:41348 DS_ID:17918 EP_NO: N/A Repair Type: Non-Urgent Crossing Status: Indicator Found UCIP Comments: Only an abandoned steel structure on water and a concrete structure on WS Levee slope found. Need to verify pipe was properly abandoned. FIELD_STRUCT_DESC: *Abandoned* steel 8-inch drainpipe through levee, 4.1 feet below crown. Siphon breaker on landward slope. Butterfly shutoff valve on landward slope, concrete stand pipe and pump at toe of landward slope. Discharges into borrow pit on waterward side. O&M Manual Sac 144, August 1955, Revision Year 2011. FS Date: 4/8/2013

WS- abandoned concrete structure on levee slope

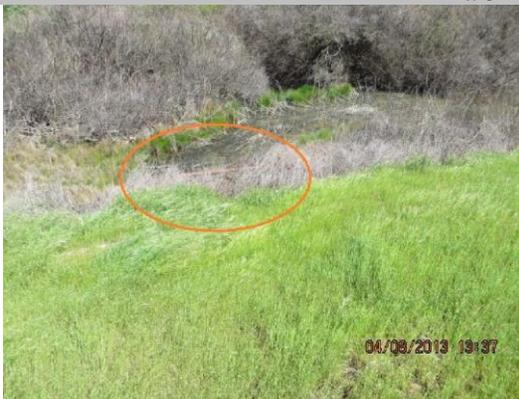
Photo 2 of 2 : UCIP_SP_2016_41348_18881.jpg

WS- abandoned steel structure on waterway

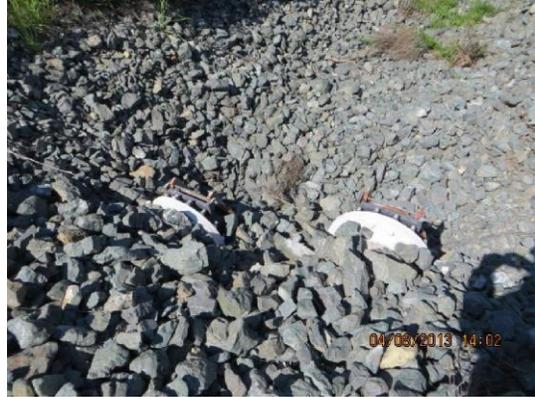
Photo 1 of 2 : UCIP_SP_2016_11505_18909.jpg

LM Start	4.40	Rating **	M	Issue No.	490
LM End	4.40	Issue Type +	En	Location *	CR
Category	Supplemental			GPS Latitude/Longitude	
				Start	End
Item	DWR UCIP Field Study			39.011340 °	39.011340 °
				-121.603474 °	-121.603474 °
DWR ID					
Comment Code					
Inspector Comment					
FS_ID:11505 DS_ID:22971 EP_NO: 18438 Repair Type: Non-Urgent Crossing Status: Found UCIP Comments: Needs removal of blockage by riprap rubbles. FIELD_STRUCT_DESC: 1 of 2. 2- 16-inch steel drainage pipe. Riprap discharge structure on WS. Flap gate not properly closed. Pump station on LS concrete sump. FS Date: 4/8/2013

WS- drainage pipe on riprap

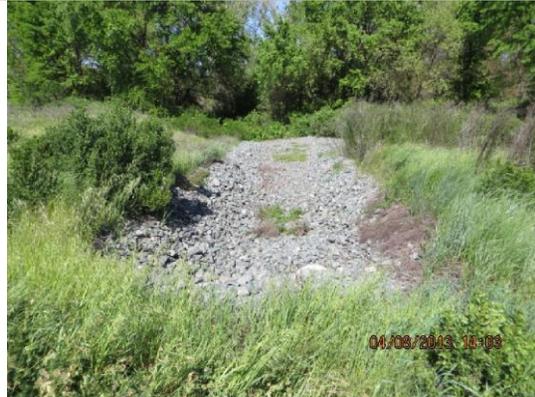
Photo 2 of 2 : UCIP_SP_2016_11505_18908.jpg

WS- discharge riprap/rubble channel

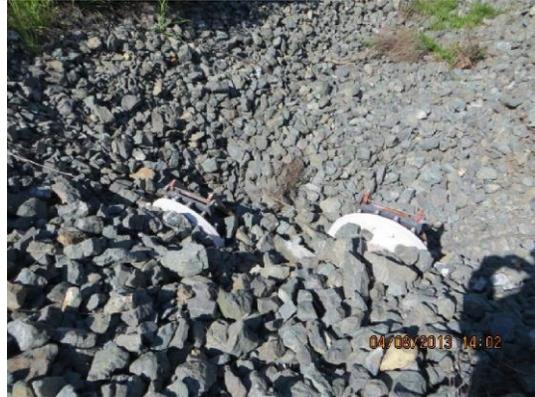
Photo 1 of 2 : UCIP_SP_2016_40799_19326.jpg

LM Start	4.40	Rating **	U	Issue No.	503
LM End	4.40	Issue Type +	En	Location *	CR
Category	Supplemental			GPS Latitude/Longitude	
				Start	End
Item	DWR UCIP Field Study			39.011354 °	39.011354 °
				-121.603488 °	-121.603488 °
DWR ID					
Comment Code					
Inspector Comment					
FS_ID:40799 DS_ID:22970 EP_NO: 18438 Repair Type: Urgent Crossing Status: Found UCIP Comments: Flap gate operation blocked by riprap and does not properly close. FIELD_STRUCT_DESC: 2 of 2- 16-inch steel drainage pipe. Riprap discharge structure on WS. Pump station on LS concrete sump. FS Date: 4/8/2013

WS- steel discharge pipes and riprap discharge area

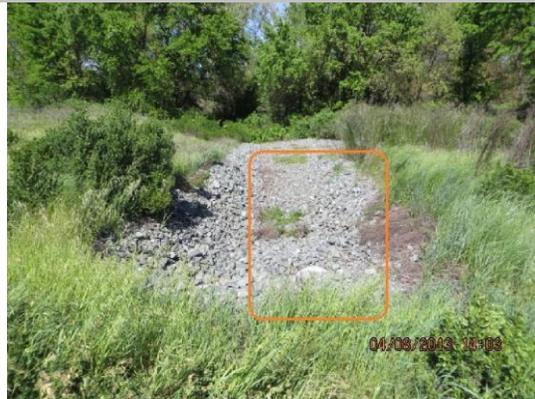
Photo 2 of 2 : UCIP_SP_2016_40799_19325.jpg

WS- discharge pipes and riprap discharge area

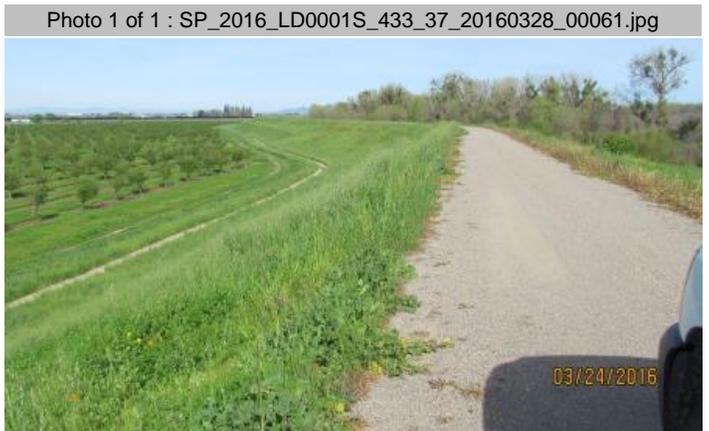
LM Start	4.42	Rating **	M	Issue No.	37
LM End	6.10	Issue Type +	Ma	Location *	LS
Category	Earthen Levee			GPS Latitude/Longitude	
				Start	End
Item	Vegetation			39.011638 °	39.033070 °
				-121.603729 °	-121.610990 °
DWR ID	DWR_LD0001S_01_s_2016_37				
Comment Code					
V1 : Control annual grass and weeds on the levee slopes and easements.					
Inspector Comment

View of landside vegetation looking upstream.

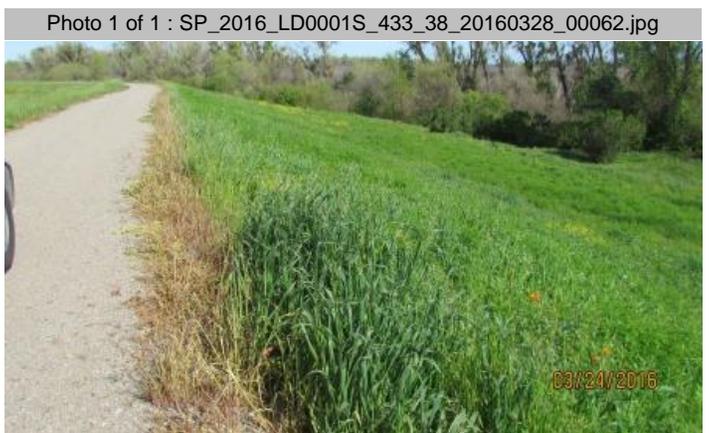
LM Start	4.42	Rating **	M	Issue No.	38
LM End	6.10	Issue Type +	Ma	Location *	WS
Category	Earthen Levee			GPS Latitude/Longitude	
				Start	End
Item	Vegetation			39.011639 °	39.033070 °
				-121.603729 °	-121.610990 °
DWR ID	DWR_LD0001S_01_s_2016_38				
Comment Code					
V1 : Control annual grass and weeds on the levee slopes and easements.					
Inspector Comment

View of waterside vegetation looking upstream.

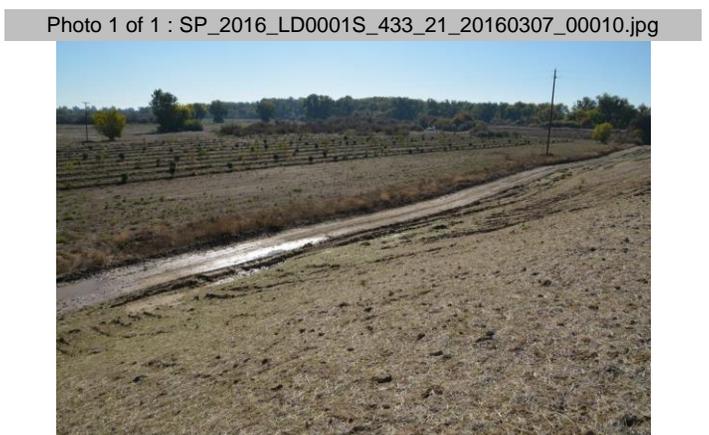
LM Start	6.00	Rating **	M	Issue No.	21
LM End	6.00	Issue Type +	Ma	Location *	WS
Category	Earthen Levee			GPS Latitude/Longitude	
				Start	End
Item	Slope Stability			39.031780 °	39.031780 °
				-121.611811 °	-121.611811 °
DWR ID	DWR_LD0001S_01_s_2015_21				
Comment Code					
S3 : Repair the levee slope damaged by vehicle traffic and prevent access where possible.					
Inspector Comment					
Track-walking on slope and tire ruts at waterside toe.

Slope instability was found on the waterside slope of the levee during fall 2015 inspection.

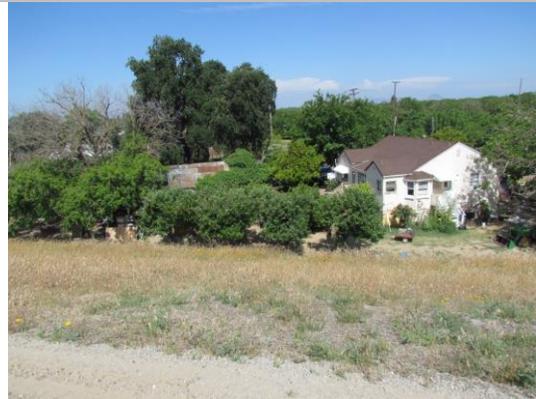
Photo 1 of 1 : SP_2016_LD0001S_433_489_20160307_00019.jpg

View of the vegetation on the landside of the levee from the crown.

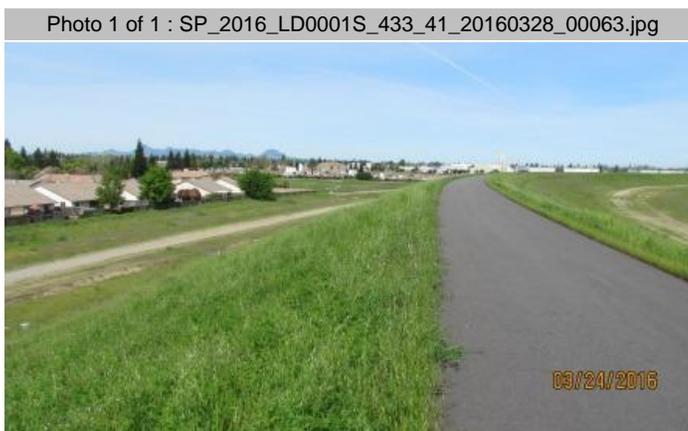
LM Start	11.18	Rating **	M	Issue No.	41
LM End	12.30	Issue Type +	Ma	Location *	LS
Category	Earthen Levee		GPS Latitude/Longitude		
			Start	End	
Item	Vegetation		39.103298 °	39.118812 °	
			-121.606473 °	-121.603287 °	
DWR ID	DWR_LD0001S_01_s_2016_41				
Comment Code					
V1 : Control annual grass and weeds on the levee slopes and easements.					
Inspector Comment

View of vegetation on landside looking upstream. Spring 2016.

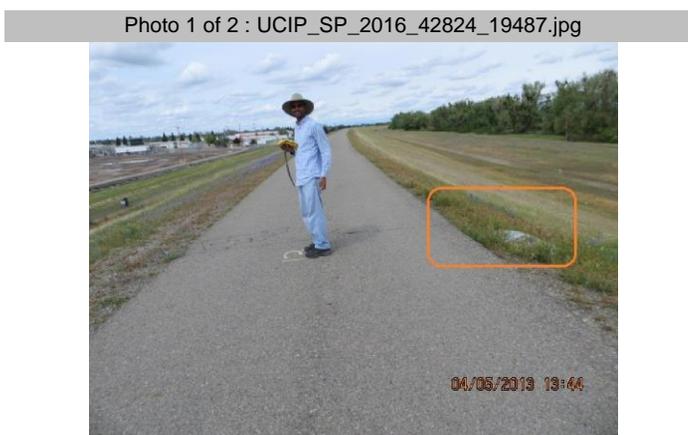
LM Start	11.39	Rating **	U	Issue No.	502
LM End	11.39	Issue Type +	En	Location *	LS
Category	Supplemental		GPS Latitude/Longitude		
			Start	End	
Item	DWR UCIP Field Study		39.106261 °	39.106261 °	
			-121.607535 °	-121.607535 °	
DWR ID					
Comment Code					
Inspector Comment					
FS_ID:42824 DS_ID:17935 EP_NO: N/A Repair Type: Urgent Crossing Status: Found UCIP Comments: No flap gates on waterward end. Road pavement cracked along pipe, it needs more investigation. FIELD_STRUCT_DESC: 1 of 2. A 6-inch pipe (of 6-inch and 16-inch-pipes) through levee, 6.0 feet below crown. Siphon breakers in corrugated metal pipe risers on waterward shoulder. Pump house at landward toe. FS Date: 4/9/2013

Levee Crown: overview. Siphon breaker on waterside shoulder

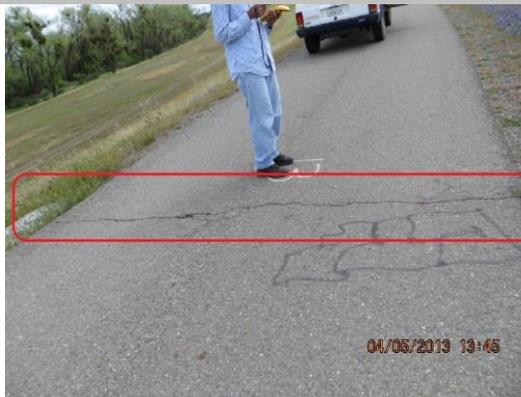
Photo 2 of 2 : UCIP_SP_2016_42824_19486.jpg

LM Start	11.39	Rating **	U	Issue No.	502 (cont)
LM End	11.39	Issue Type +	En	Location *	LS
Category	Supplemental			GPS Latitude/Longitude	
				Start	End
Item	DWR UCIP Field Study			39.106261 °	39.106261 °
				-121.607535 °	-121.607535 °
DWR ID					
Comment Code					
Inspector Comment					
FS_ID:42824 DS_ID:17935 EP_NO: N/A Repair Type: Urgent Crossing Status: Found UCIP Comments: No flap gates on waterward end. Road pavement cracked along pipe, it needs more investigation. FIELD_STRUCT_DESC: 1 of 2. A 6-inch pipe (of 6-inch and 16-inch-pipes) through levee, 6.0 feet below crown. Siphon breakers in corrugated metal pipe risers on waterward shoulder. Pump house at landward toe. FS Date: 4/9/2013

Cracked levee crown. Needs more investigation.

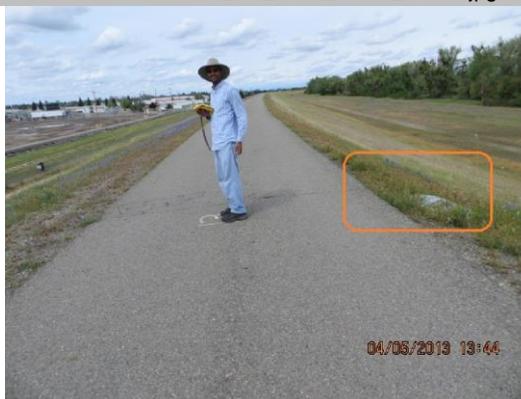
Photo 1 of 2 : UCIP_SP_2016_11983_19462.jpg

LM Start	11.39	Rating **	M	Issue No.	492
LM End	11.39	Issue Type +	En	Location *	LS
Category	Supplemental			GPS Latitude/Longitude	
				Start	End
Item	DWR UCIP Field Study			39.106261 °	39.106261 °
				-121.607535 °	-121.607535 °
DWR ID					
Comment Code					
Inspector Comment					
FS_ID:11983 DS_ID:18879 EP_NO: N/A Repair Type: Non-Urgent Crossing Status: Found UCIP Comments: Road pavement cracked along pipe line, needs more investigation. FIELD_STRUCT_DESC: 2 of 2. A 16-inch pipe (of 6-inch and 16-inch-pipes) through levee, 6.0 feet below crown. Flap gates on waterward end. Siphon breakers in corrugated metal pipe risers on waterward shoulder. Pump house at landward toe. FS Date: 4/9/2013

Levee crown overview- siphon breaker on right

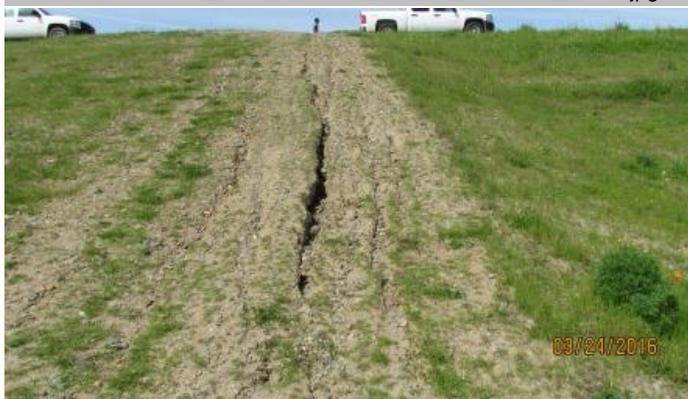
Photo 1 of 1 : SP_2016_LD0001S_433_42_20160328_00064.jpg

LM Start	11.63	Rating **	U	Issue No.	42
LM End	11.63	Issue Type +	Ma	Location *	WS
Category	Earthen Levee			GPS Latitude/Longitude	
				Start	End
Item	Slope Stability			39.109692 °	39.109692 °
				-121.607142 °	-121.607142 °
DWR ID	DWR_LD0001S_01_s_2016_42				
Comment Code					
S1 : Repair slope instability.					
Inspector Comment					
Erosion on the waterside slope caused by rain.

Slope erosion due to rain on the waterside.

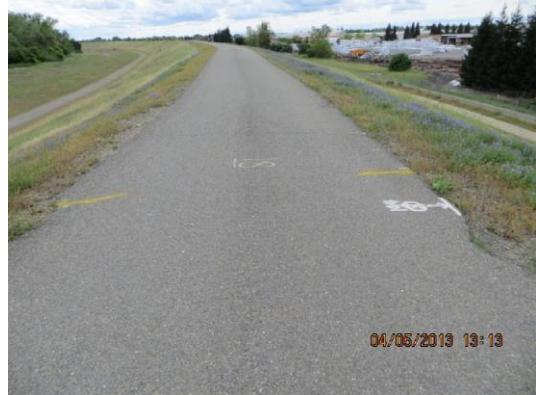
Photo 1 of 2 : UCIP_SP_2016_41841_19538.jpg

LM Start	11.99	Rating **	M	Issue No.	500
LM End	11.99	Issue Type +	En	Location *	WS
Category	Supplemental			GPS Latitude/Longitude	
				Start	End
Item	DWR UCIP Field Study			39.114856 °	39.114856 °
				-121.605821 °	-121.605821 °
DWR ID					
Comment Code					
Inspector Comment					
FS_ID:41841 DS_ID:17932 EP_NO: N/A Repair Type: Non-Urgent Crossing Status: Indicator Found UCIP Comments: Need to install Gasline Markers.Fenced control station.Indicator on LS across concrete ditch.Found road markings. FIELD_STRUCT_DESC: 1 of 2. One 16-inch pipe of two 16-inch gas lines through levee, 3 feet below crown. PG&E gas line-crossing sign on waterward shoulder. FS Date: 4/5/2013

Levee Crown: gasoline indicator/markings on crown road.

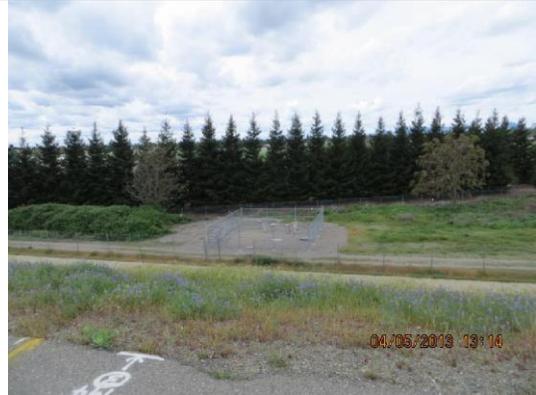
Photo 2 of 2 : UCIP_SP_2016_41841_19537.jpg

LS- fenced control station across concrete ditch

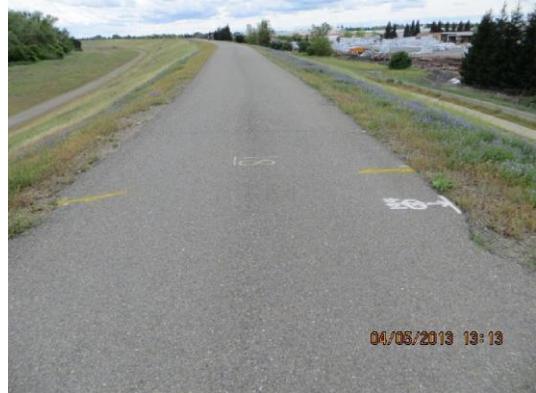
Photo 1 of 2 : UCIP_SP_2016_41889_19566.jpg

LM Start	12.00	Rating **	M	Issue No.	498
LM End	12.00	Issue Type +	En	Location *	WS
Category	Supplemental			GPS Latitude/Longitude	
				Start	End
Item	DWR UCIP Field Study			39.114856 °	39.114856 °
				-121.605821 °	-121.605821 °
DWR ID					
Comment Code					
Inspector Comment					
FS_ID:41889 DS_ID:18880 EP_NO: N/A Repair Type: Non-Urgent Crossing Status: Indicator Found UCIP Comments: Need to contact owner to install gasline markers.Fenced control station on LS.Indicator on LS across concrete channel.Road markings. FIELD_STRUCT_DESC: 2 of 2. One 16-inch pipe of two 16-inch gas lines through levee, 3 feet below crown. PG&E gas line-crossing sign on waterward shoulder. FS Date: 4/5/2013

Levee Crown: road markings on road pavement

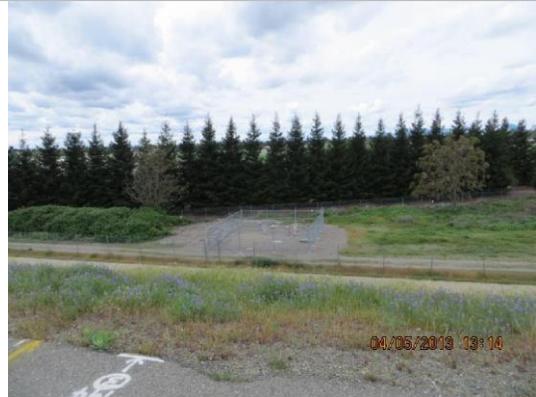
Photo 2 of 2 : UCIP_SP_2016_41889_19565.jpg

LS- fenced control station across concrete ditch.

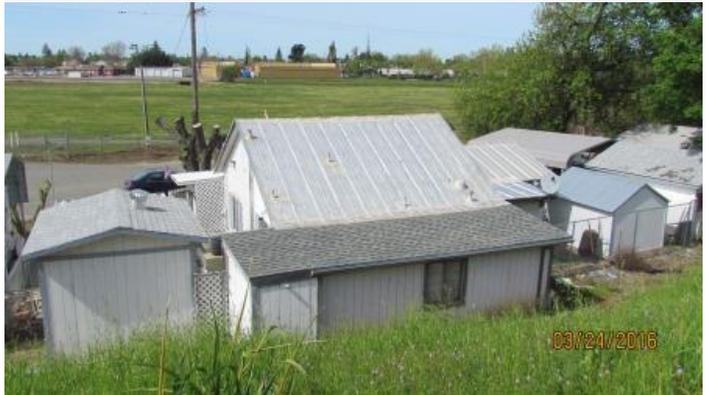
Photo 1 of 2 : SP_2016_LD0001S_433_3_20160328_00065.jpg

Building at landside levee toe.

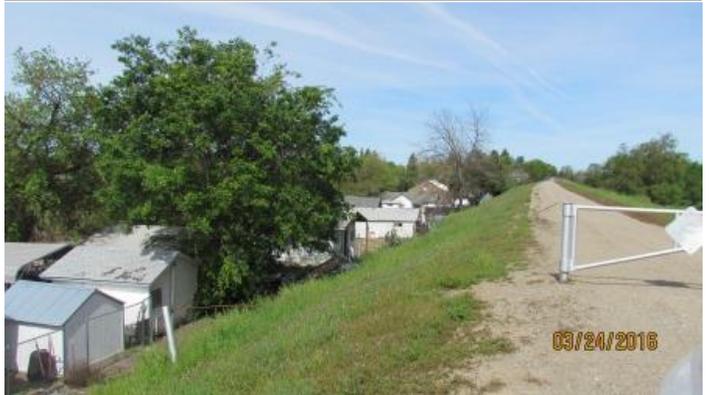
Photo 2 of 2 : SP_2016_LD0001S_433_3_20160328_00067.jpg

Houses encroaching landside levee toe.

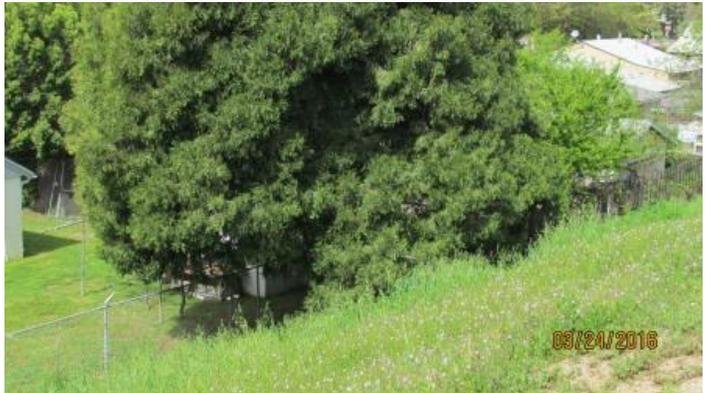
Photo 1 of 1 : SP_2016_LD0001S_433_27_20160328_00068.jpg

Tree at landside levee toe obstructing visibility. Spring 2016.

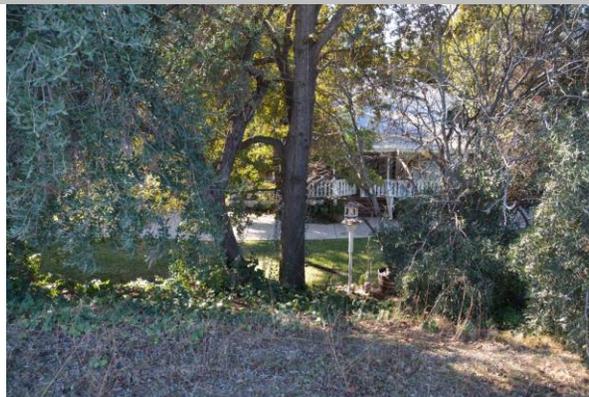
Photo 1 of 2 : SP_2016_LD0001S_433_18_20160307_00006.jpg

Trees and vegetation blocking visibility on the landside slope of the levee. Spring 2016.

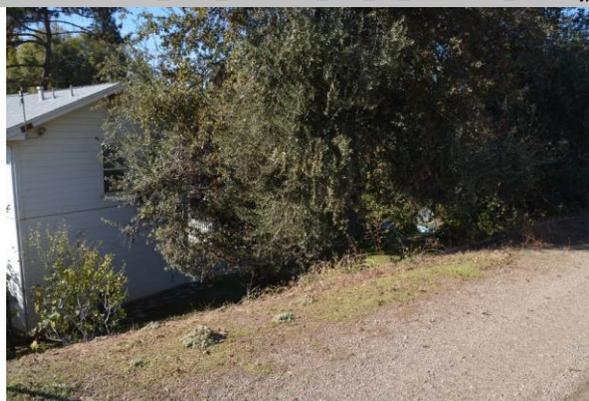
Photo 2 of 2 : SP_2016_LD0001S_433_18_20160307_00007.jpg

Trees and vegetation blocking visibility. Spring 2016.

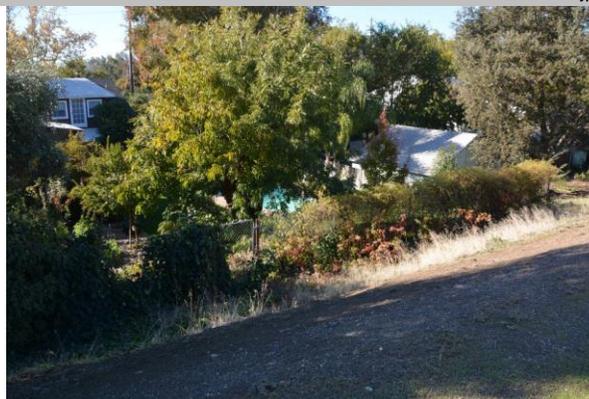
Photo 1 of 2 : SP_2016_LD0001S_433_24_20160307_00013.jpg

Trees and vegetation blocking visibility on the landside toe of the levee. Spring 2016.

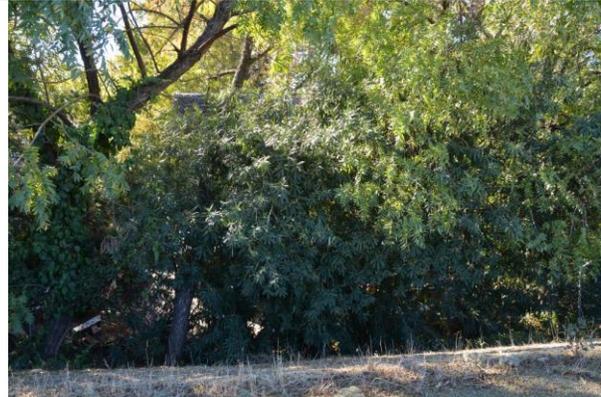
Photo 2 of 2 : SP_2016_LD0001S_433_24_20160307_00014.jpg

Trees and vegetation blocking visibility. Spring 2016.

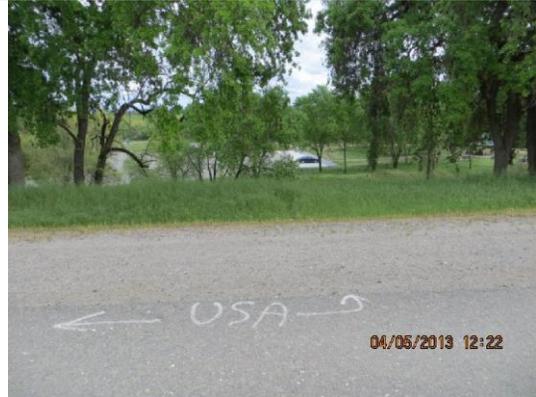
Photo 1 of 2 : UCIP_SP_2016_41887_19571.jpg

LM Start	14.35	Rating **	M	Issue No.	496
LM End	14.35	Issue Type +	En	Location *	LS
Category	Supplemental			GPS Latitude/Longitude	
				Start	End
Item	DWR UCIP Field Study			39.146494 °	39.146494 °
				-121.609715 °	-121.609715 °
DWR ID					
Comment Code					
Inspector Comment					
FS_ID:41887 DS_ID:18640 EP_NO: N/A Repair Type: Non-Urgent Crossing Status: Indicator Found UCIP Comments: Need to contact owner to determine status of crossing and install signs if appropriate. FIELD_STRUCT_DESC: A 18-inch steel; Gas Line. O&M Manual Sac 144, August 1955, Revision Year 2011. FS Date: 4/5/2013

WS- USA road marking and floodway area

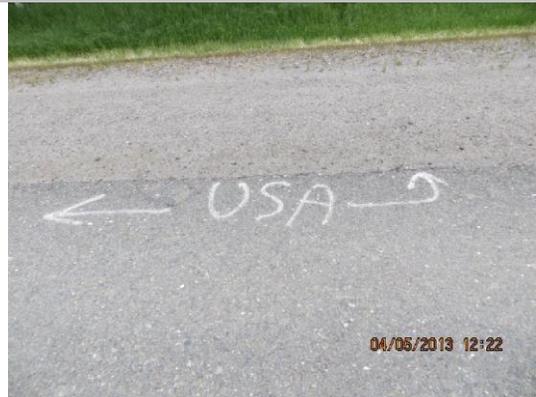
Photo 2 of 2 : UCIP_SP_2016_41887_19570.jpg

WS- USA road marking on pavement

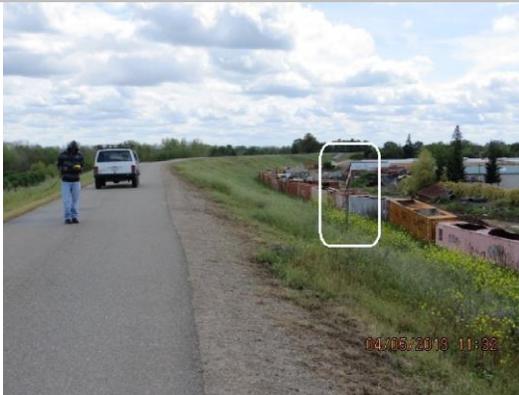
Photo 1 of 2 : UCIP_SP_2016_12092_19624.jpg

LS- overview of gasline marker on levee slope

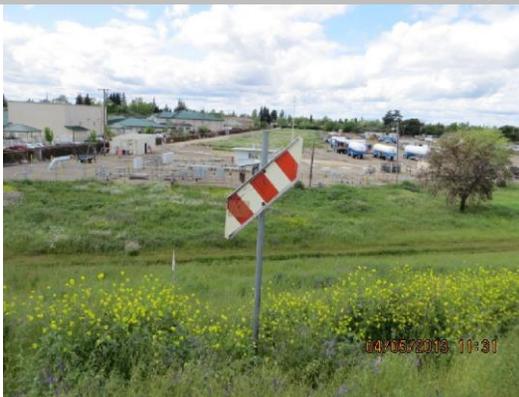
Photo 2 of 2 : UCIP_SP_2016_12092_19623.jpg

LS- gasline marker on levee slope

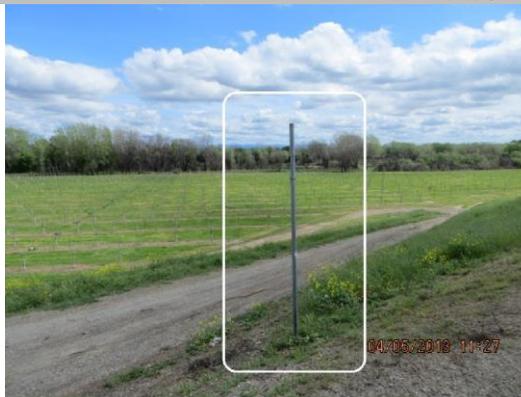
Photo 1 of 2 : UCIP_SP_2016_12104_19642.jpg

WS- needs a gasoline indicator.

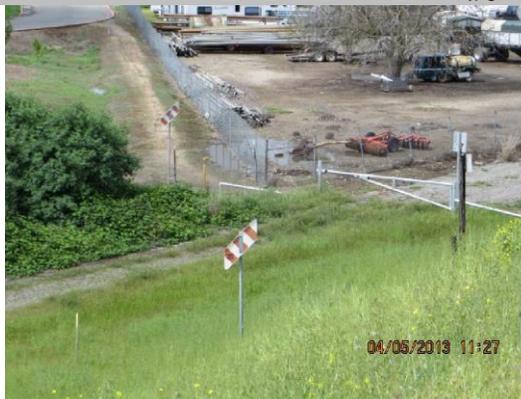
Photo 2 of 2 : UCIP_SP_2016_12104_19641.jpg

LS- gasoline indicators on levee slope and across.

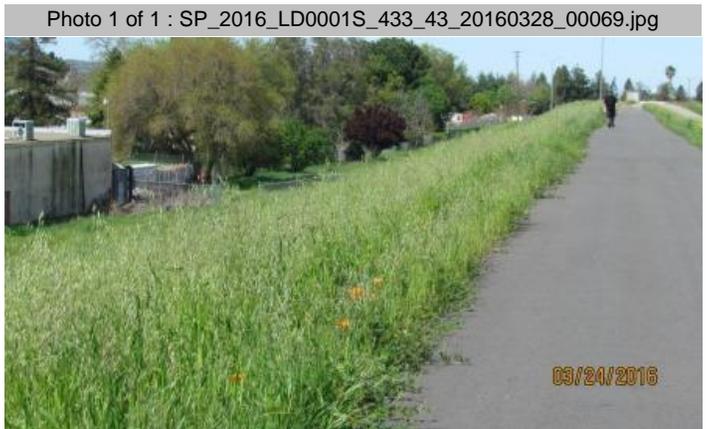
LM Start	15.21	Rating **	M	Issue No.	43
LM End	16.11	Issue Type +	Ma	Location *	LS
Category	Earthen Levee		GPS Latitude/Longitude		
			Start	End	
Item	Vegetation		39.156922 °	39.168830 °	
			-121.617960 °	-121.622630 °	
DWR ID	DWR_LD0001S_01_s_2016_43				
Comment Code					
V1 : Control annual grass and weeds on the levee slopes and easements.					
Inspector Comment

View of landside vegetation looking upstream.

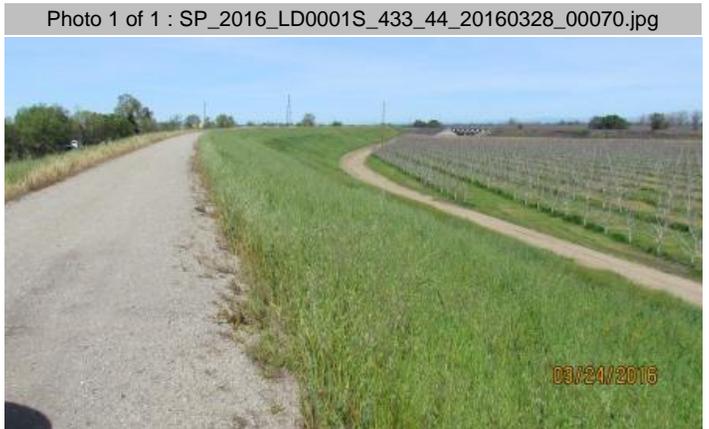
LM Start	15.53	Rating **	M	Issue No.	44
LM End	16.11	Issue Type +	Ma	Location *	WS
Category	Earthen Levee		GPS Latitude/Longitude		
			Start	End	
Item	Vegetation		39.160594 °	°	
			-121.621573 °	°	
DWR ID	DWR_LD0001S_01_s_2016_44				
Comment Code					
V1 : Control annual grass and weeds on the levee slopes and easements.					
Inspector Comment

View of waterside vegetation looking upstream.

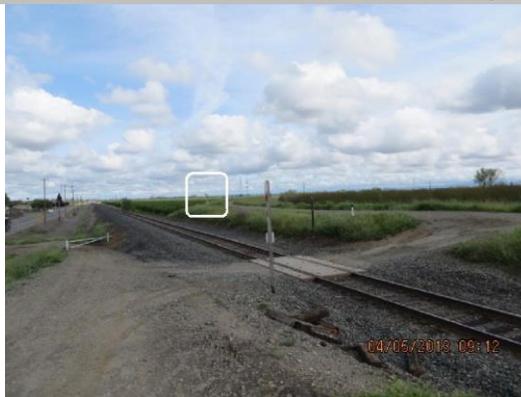
Photo 1 of 2 : UCIP_SP_2016_41888_19709.jpg

Railway and levee crossing and gasline sign across the railway

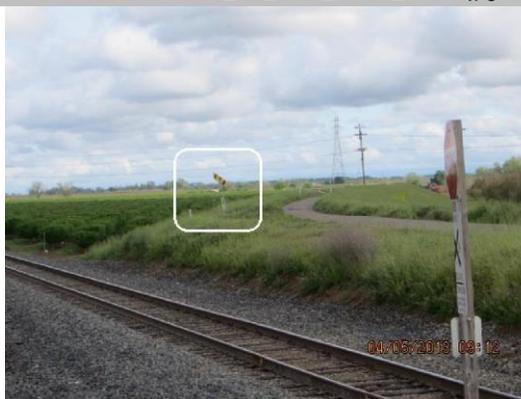
Photo 2 of 2 : UCIP_SP_2016_41888_19708.jpg

Gasline sign across the railway
