**Flood Control Project Maintenance
Levee Inspections
LMA District Cover Sheet
Spring 2016 Levee Inspection Results**

Levee District No. 0009 (Sutter County)

Levee Inspection Report By Mile - Spring 2016

Waterway	Bank	Unit Miles	Inspection Start/End	Inspector
Unit No. 01 Sutter County, Feather River	Right	6.25	04/05/2016 04/07/2016	Sterling York

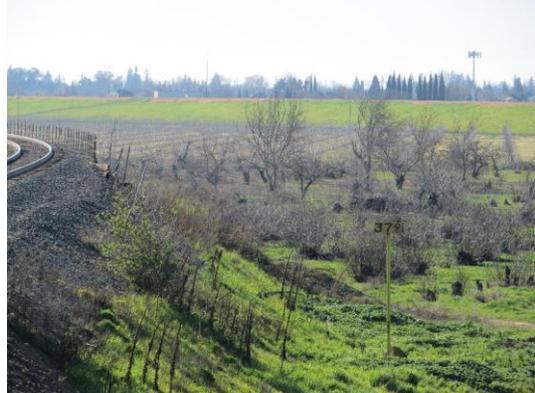
Photo 1 of 1 : UCIP_SP_2016_47098_16629.jpg

LM Start	0.00	Rating **	M	Issue No.	32
LM End	0.00	Issue Type +	En	Location *	WS
Category	Supplemental			GPS Latitude/Longitude	
				Start	End
Item	DWR UCIP Field Study			39.168909 °	39.168909 °
				-121.622629 °	-121.622629 °
DWR ID					
Comment Code					
Inspector Comment					
FS_ID:47098 DS_ID:17793 EP_NO: N/A Repair Type: Non-Urgent Crossing Status: Indicator Found UCIP Comments: Need better gas-line markings at levees. FIELD_STRUCT_DESC: 8-5/8-inch fuel line thru levee. Gasline marker found appr. 650 ft south of crossing on west side of RR. At location of sign, pipe assumed to run parrallel along west side of RR tracks before it crosses levee at LM 0, per Permit No. 3823. FS Date: 3/1/2013

Gasline marker found appr. 650 ft south of crossing at beginning of curve in RR bridge (west of RR).

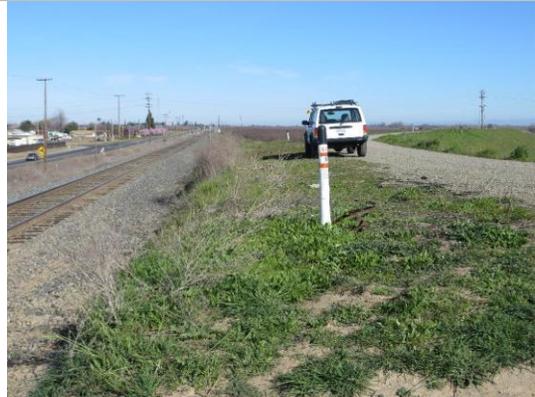
Photo 1 of 2 : UCIP_SP_2016_47090_40171.jpg

LM Start	0.01	Rating **	M	Issue No.	31
LM End	0.01	Issue Type +	En	Location *	WS
Category	Supplemental			GPS Latitude/Longitude	
				Start	End
Item	DWR UCIP Field Study			39.168871 °	39.168871 °
				-121.622514 °	-121.622514 °
DWR ID					
Comment Code					
Inspector Comment					
FS_ID:47090 DS_ID:22685 EP_NO: N/A Repair Type: Non-Urgent Crossing Status: Found UCIP Comments: No permit identified. FIELD_STRUCT_DESC: Fiber optic communication line at unknown depth below the crown. FS Date: 3/3/2013

Fiber optic line marker on LS shoulder.

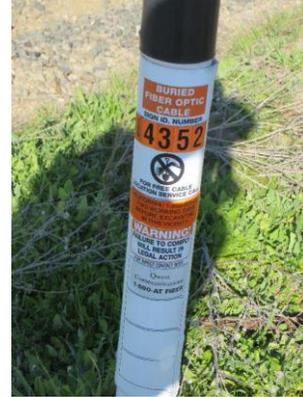
Photo 2 of 2 : UCIP_SP_2016_47090_40170.jpg

LM Start	0.01	Rating **	M	Issue No.	31 (cont)
LM End	0.01	Issue Type +	En	Location *	WS
Category	Supplemental			GPS Latitude/Longitude	
				Start	End
Item	DWR UCIP Field Study			39.168871 °	39.168871 °
				-121.622514 °	-121.622514 °
DWR ID					
Comment Code					
Inspector Comment					
FS_ID:47090 DS_ID:22685 EP_NO: N/A Repair Type: Non-Urgent Crossing Status: Found UCIP Comments: No permit identified. FIELD_STRUCT_DESC: Fiber optic communication line at unknown depth below the crown. FS Date: 3/3/2013

Fiber optic line marker on LS shoulder.

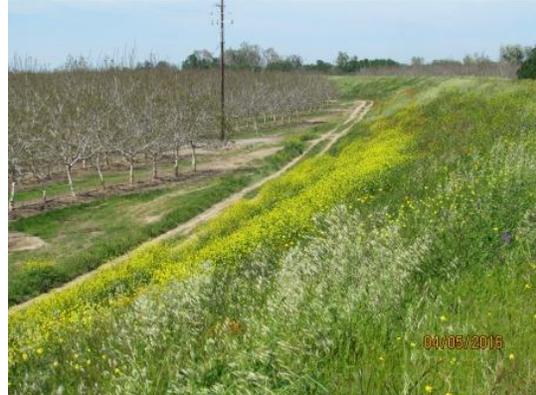
Photo 1 of 1 : SP_2016_LD0009_202_17_20160418_00029.jpg

LM Start	0.02	Rating **	M	Issue No.	17
LM End	6.24	Issue Type +	Ma	Location *	LS
Category	Earthen Levee			GPS Latitude/Longitude	
				Start	End
Item	Vegetation			39.168989 °	39.255713 °
				-121.622552 °	-121.636361 °
DWR ID	DWR_LD0009_01_s_2016_17				
Comment Code					
V1 : Control annual grass and weeds on the levee slopes and easements.					
Inspector Comment

Typical vegetation landside looking upstream.

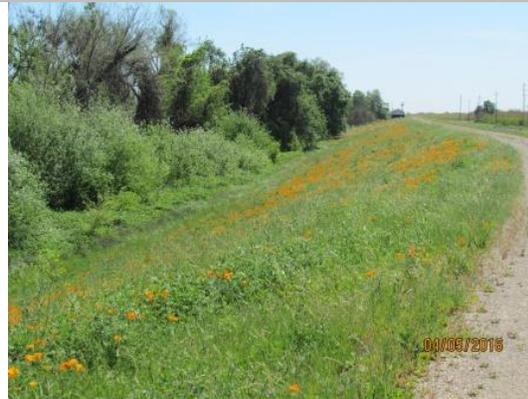
Photo 1 of 1 : SP_2016_LD0009_202_22_20160418_00028.jpg

LM Start	0.02	Rating **	M	Issue No.	22
LM End	6.24	Issue Type +	Ma	Location *	WS
Category	Earthen Levee		GPS Latitude/Longitude		
			Start	End	
Item	Vegetation		39.168989°	39.255713°	
			-121.622552°	-121.636361°	
DWR ID	DWR_LD0009_01_s_2016_22				
Comment Code					
V1 : Control annual grass and weeds on the levee slopes and easements.					
Inspector Comment

Typical vegetation waterside looking downstream.

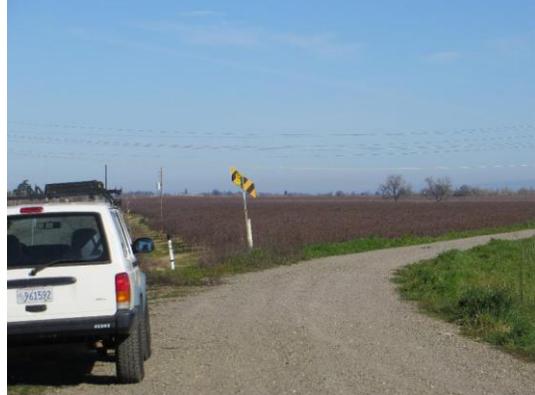
Photo 1 of 2 : UCIP_SP_2016_47099_16631.jpg

LM Start	0.05	Rating **	M	Issue No.	33
LM End	0.05	Issue Type +	En	Location *	WS
Category	Supplemental			GPS Latitude/Longitude	
				Start	End
Item	DWR UCIP Field Study			39.169419 °	39.169419 °
				-121.622631 °	-121.622631 °
DWR ID					
Comment Code					
Inspector Comment					
FS_ID:47099 DS_ID:17792 EP_NO: 3823 Repair Type: Non-Urgent Crossing Status: Indicator Found UCIP Comments: Need better gas-line markings at levees. FIELD_STRUCT_DESC: 8-5/8-inch fuel line along the landward shoulder, 2.6 feet below the crown. Gasline marker found on LS shoulder indicating location of crossing. Gasline marker also found appr. 650 ft south of crossing on west side of RR tracks at beginning of curve in RR bridge, indicating location where pipe runs parallel to RR before it crosses levee at this location. FS Date: 3/1/2013

Gasline marker found on LS shoulder.

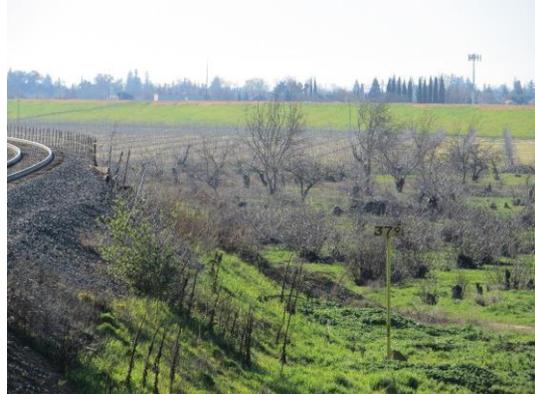
Photo 2 of 2 : UCIP_SP_2016_47099_74900.jpg

Gasline marker found appr. 650 ft south of crossing on west side of RR.

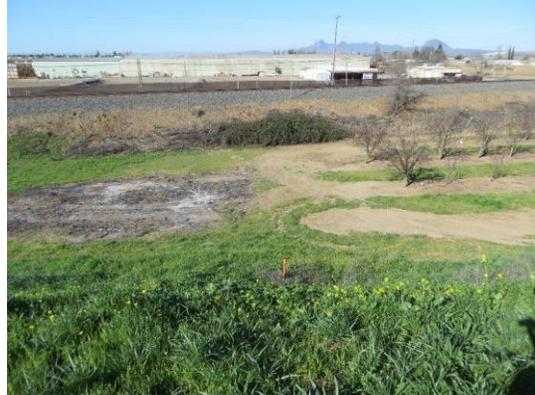
Photo 1 of 2 : UCIP_SP_2016_9596_16633.jpg

LM Start	0.10	Rating **	M	Issue No.	24
LM End	0.10	Issue Type +	En	Location *	WS
Category	Supplemental			GPS Latitude/Longitude	
				Start	End
Item	DWR UCIP Field Study			39.170153 °	39.170153 °
				-121.622546 °	-121.622546 °
DWR ID					
Comment Code					
Inspector Comment					
FS_ID:9596 DS_ID:17790 EP_NO: N/A Repair Type: Non-Urgent Crossing Status: Indicator Found UCIP Comments: Need better gas-line markings at levees. FIELD_STRUCT_DESC: 16-inch gas line through the levee, 3.5 feet below the crown. Marker on LS toe. Permit No. 1913, 1954, PG&E. FS Date: 3/1/2013

Gasline marker at LS toe.

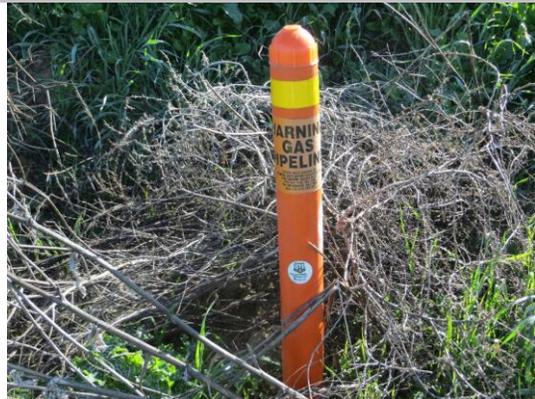
Photo 2 of 2 : UCIP_SP_2016_9596_16632.jpg

Close up of Gasline marker at LS toe.

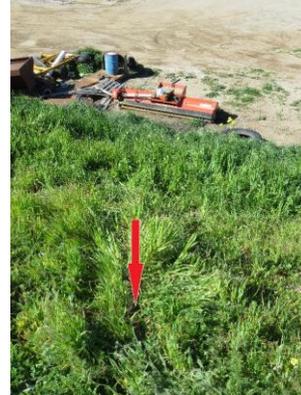
Photo 1 of 2 : UCIP_SP_2016_9598_16635.jpg

LM Start	0.96	Rating **	M	Issue No.	25
LM End	0.96	Issue Type +	En	Location *	WS
Category	Supplemental			GPS Latitude/Longitude	
				Start	End
Item	DWR UCIP Field Study			39.182607 °	39.182607 °
				-121.620775 °	-121.620775 °
DWR ID					
Comment Code					
Inspector Comment					
FS_ID:9598 DS_ID:17788 EP_NO: N/A Repair Type: Non-Urgent Crossing Status: Found UCIP Comments: Pipe needs to be removed from levee crown. FIELD_STRUCT_DESC: 3-inch steel pipe through the levee at LS crown elevation. FS Date: 3/1/2013

Pipe at crown on LS shoulder.

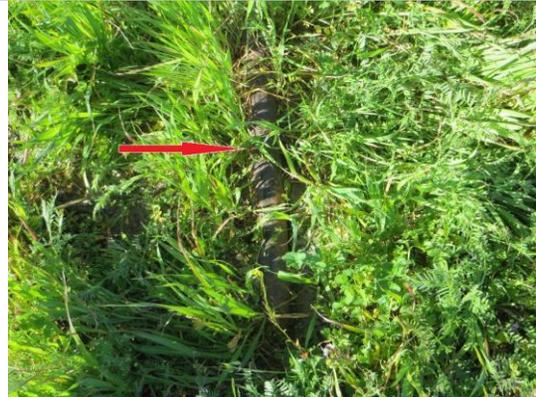
Photo 2 of 2 : UCIP_SP_2016_9598_16634.jpg

Pipe at crown on LS shoulder.

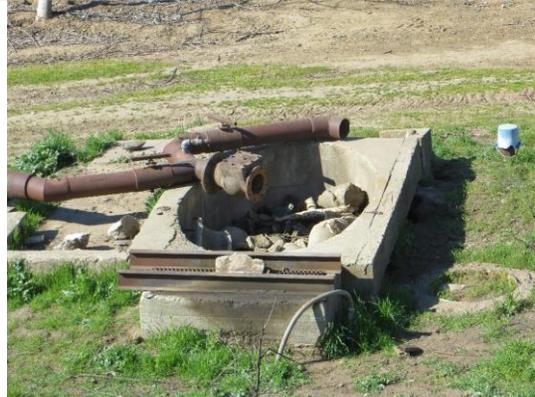
Photo 1 of 2 : UCIP_SP_2016_9601_16637.jpg

LM Start	1.33	Rating **	M	Issue No.	26
LM End	1.33	Issue Type +	En	Location *	WS
Category	Supplemental			GPS Latitude/Longitude	
				Start	End
Item	DWR UCIP Field Study			39.187995 °	39.187995 °
				-121.620706 °	-121.620706 °
DWR ID					
Comment Code					
Inspector Comment					
FS_ID:9601 DS_ID:17785 EP_NO: N/A Repair Type: Non-Urgent Crossing Status: Indicator Found UCIP Comments: Unable to determine type of abandonment. FIELD_STRUCT_DESC: *Abandoned* 10-inch steel pipe through the levee, 2.8 feet below the crown. Waterward end open. Steel plate welded on landward end. Pump and standpipe at the landward toe. Permit No. 1407, 1949. FS Date: 3/1/2013

Abandoned Pump platform on LS toe.

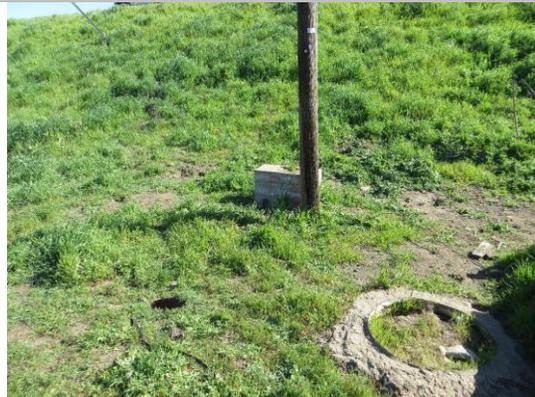
Photo 2 of 2 : UCIP_SP_2016_9601_16636.jpg

JP at pump on LS toe.

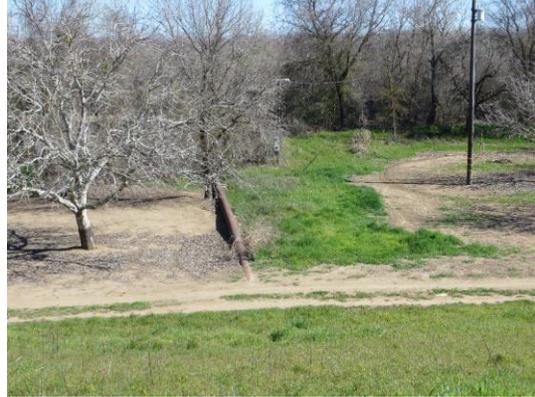
Photo 1 of 2 : UCIP_SP_2016_41063_16640.jpg

LM Start	1.88	Rating **	M	Issue No.	29
LM End	1.88	Issue Type +	En	Location *	WS
Category	Supplemental			GPS Latitude/Longitude	
				Start	End
Item	DWR UCIP Field Study			39.195241 °	39.195241 °
				-121.624165 °	-121.624165 °
DWR ID					
Comment Code					
Inspector Comment					
FS_ID:41063 DS_ID:17784 EP_NO: 1119 Repair Type: Non-Urgent Crossing Status: Found UCIP Comments: Pipe needs to be repaired or properly abandoned. FIELD_STRUCT_DESC: 16-inch steel pipe through levee, 3.0 feet below crown. Pump in pump house on channel bank. Gate valve on the waterward end. Concrete standpipe and distribution box at the landward toe. (Permit No. 1119, 06/08/1946) FS Date: 3/1/2013

Pipe on WS toe.

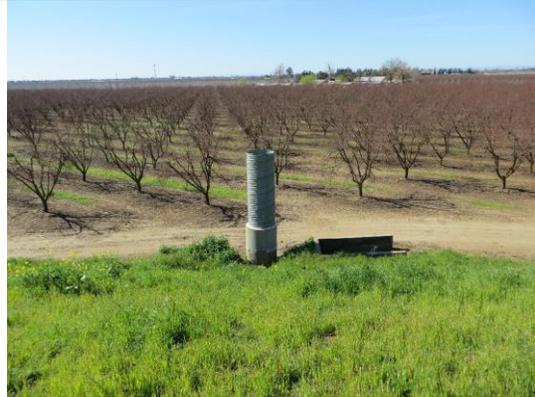
Photo 2 of 2 : UCIP_SP_2016_41063_16639.jpg

Concrete and CMP riser on LS toe.

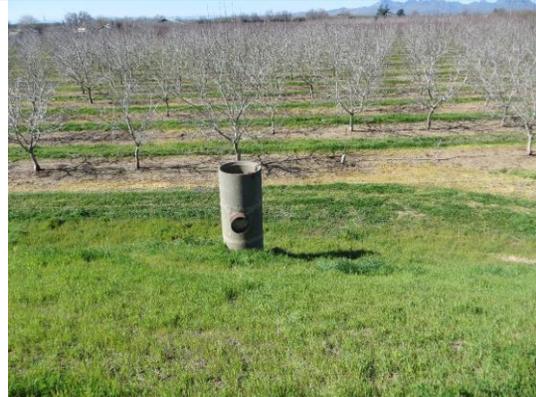
Photo 1 of 2 : UCIP_SP_2016_9604_16649.jpg

LM Start	2.56	Rating **	U	Issue No.	27
LM End	2.56	Issue Type +	En	Location *	WS
Category	Supplemental			GPS Latitude/Longitude	
				Start	End
Item	DWR UCIP Field Study			39.203936 °	39.203936 °
				-121.629521 °	-121.629521 °
DWR ID					
Comment Code					
Inspector Comment					
FS_ID:9604 DS_ID:17783 EP_NO: N/A Repair Type: Urgent Crossing Status: Found UCIP Comments: Pipe appears abandoned as pump is disconnected and open on waterside. Pipe should be properly abandoned. FIELD_STRUCT_DESC: 18-inch steel pipe through levee, 8 feet below crown Pump and gate valve in pump house on channel bank. Concrete well on the bank. Siphon breaker in CMP riser on landward slope. (O+M 1955) FS Date: 3/1/2013

CMP riser on LS toe.

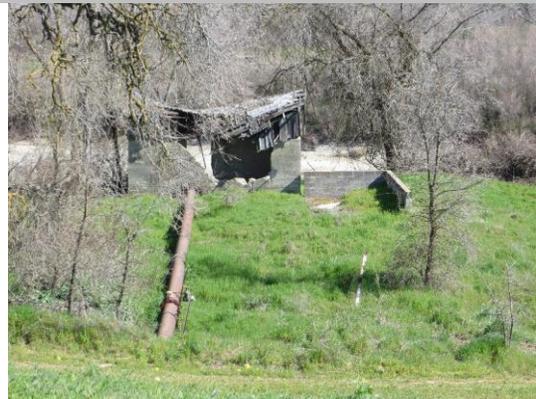
Photo 2 of 2 : UCIP_SP_2016_9604_16648.jpg

Pipe and pumphouse on WS toe/bench.

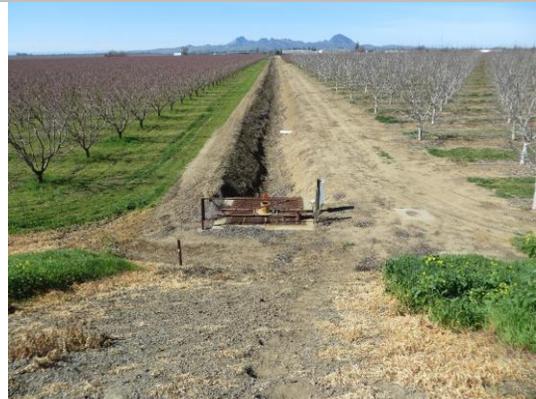
Photo 1 of 2 : UCIP_SP_2016_41223_16653.jpg

LM Start	3.49	Rating **	U	Issue No.	28
LM End	3.49	Issue Type +	En	Location *	LS
Category	Supplemental		GPS Latitude/Longitude		
			Start	End	
Item	DWR UCIP Field Study		39.217363 °	39.217363 °	
			-121.628434 °	-121.628434 °	
DWR ID					
Comment Code					
Inspector Comment					
FS_ID:41223 DS_ID:17782 EP_NO: 13657 Repair Type: Urgent Crossing Status: Found UCIP Comments: Needs flapgate on WS outlet. Pump is missing. FIELD_STRUCT_DESC: 20-inch pipe through levee, 2 feet below levee crown. Siphon breaker on waterward shoulder. Pump with trash rack at landward toe. (Permit No. 13657 - Micheli) FS Date: 10/15/2014

LS at trash rack and pumping plant.

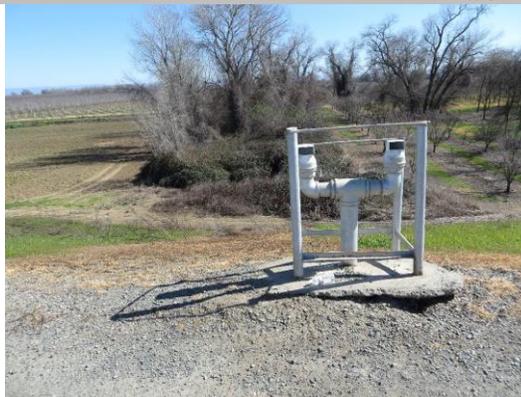
Photo 2 of 2 : UCIP_SP_2016_41223_16652.jpg

LM Start	3.49	Rating **	U	Issue No.	28 (cont)
LM End	3.49	Issue Type +	En	Location *	LS
Category	Supplemental			GPS Latitude/Longitude	
				Start	End
Item	DWR UCIP Field Study			39.217363 °	39.217363 °
				-121.628434 °	-121.628434 °
DWR ID					
Comment Code					
Inspector Comment					
FS_ID:41223 DS_ID:17782 EP_NO: 13657 Repair Type: Urgent Crossing Status: Found UCIP Comments: Needs flapgate on WS outlet. Pump is missing. FIELD_STRUCT_DESC: 20-inch pipe through levee, 2 feet below levee crown. Siphon breaker on waterward shoulder. Pump with trash rack at landward toe. (Permit No. 13657 - Micheli) FS Date: 10/15/2014

Siphon Breakers on WS shoulder.

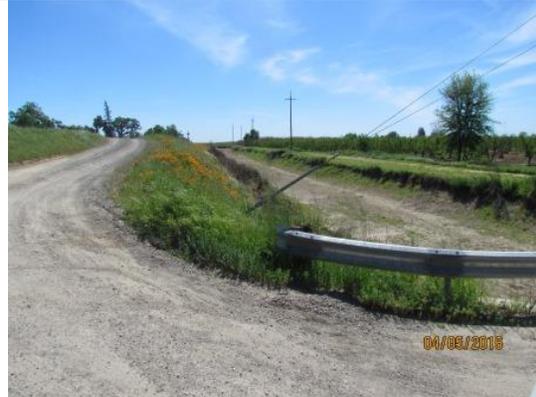
Photo 1 of 1 : SP_2016_LD0009_202_23_20160418_00030.jpg

LM Start	4.83	Rating **	M	Issue No.	23
LM End	6.02	Issue Type +	En	Location *	LS
Category	Earthen Levee		GPS Latitude/Longitude		
			Start	End	
Item	Encroachments		39.235919 °	39.252616 °	
			-121.633623 °	-121.636953 °	
DWR ID	DWR_LD0009_01_s_2016_23				
Comment Code					
DT : Ditch					
Inspector Comment

Ditch on landside looking downstream.

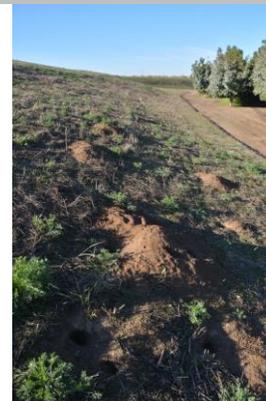
Photo 1 of 1 : SP_2016_LD0009_202_19_20160307_00004.jpg

LM Start	5.32	Rating **	A	Issue No.	19
LM End	5.32	Issue Type +	Ma	Location *	CR
Category	Earthen Levee		GPS Latitude/Longitude		
			Start	End	
Item	Animal Control		39.242582 °	39.242582 °	
			-121.637032 °	-121.637032 °	
DWR ID	DWR_LD0009_01_f_2015_19				
Comment Code					
A3 : No rodents visible, but rodent burrows visible; need to backfill and compact or grout burrows.					
Inspector Comment					
This rodent site has been repaired by the LMA and there is no new evidence of rodent activity at this location. The picture was taken during the 2015 Fall Inspection.

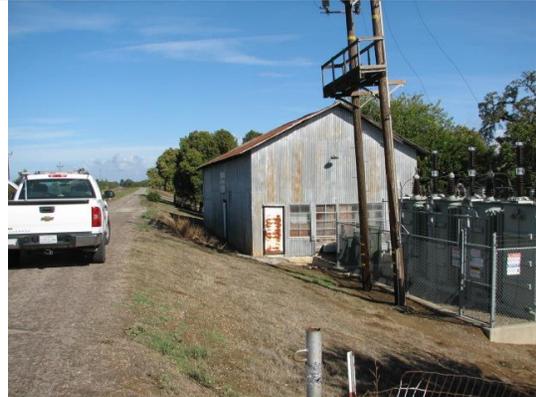
Photo 1 of 1 : SP_2016_LD0009_202_11_20160307_00002.jpg

LM Start	5.68	Rating **	M	Issue No.	11
LM End	5.68	Issue Type +	En	Location *	WS
Category	Earthen Levee		GPS Latitude/Longitude		
			Start	End	
Item	Encroachments		39.247697 °	39.247697 °	
			-121.637312 °	-121.637312 °	
DWR ID	DWR_LD0009_01_s_2012_21				
Comment Code					
BU : Building					
Inspector Comment

Building at the waterside toe.

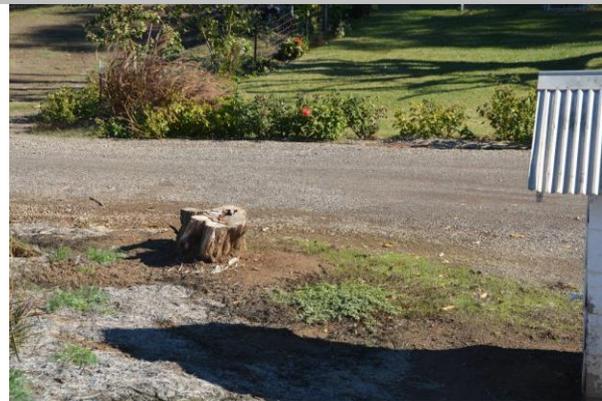
Photo 1 of 1 : SP_2016_LD0009_202_21_20160307_00006.jpg

LM Start	5.71	Rating **	N	Issue No.	21
LM End	5.71	Issue Type +	Ma	Location *	WS
Category	Earthen Levee		GPS Latitude/Longitude		
			Start	End	
Item	Trim / Thin Trees		39.248009 °	39.248009 °	
			-121.637306 °	-121.637306 °	
DWR ID	DWR_LD0009_01_f_2015_21				
Comment Code					
T5 : Tree stumps.					
Inspector Comment					
Tree stump

Stump at waterside toe.
