**Flood Control Project Maintenance  
Levee Inspections**

**Fall 2015 Levee Maintenance Deficiency Summary Report  
Overall LMA & Unit Ratings, including USACE Erosion Survey**

**Sutter Maintenance Yard Maintenance Area 0003**

**Levee Inspection Report By Mile - Fall 2015**

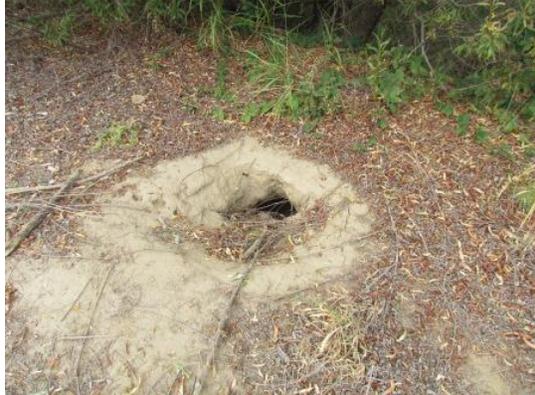
Photo 1 of 2 : FA\_2015\_MA0003\_195\_140\_20151106\_00010.jpg

LM Start	<b>0.78</b>	Rating **	M	Issue No.	<b>140</b>
LM End	<b>0.78</b>	Issue Type +	Ma	Location *	LS
Category	Earthen Levee			GPS Latitude/Longitude	
				Start	End
Item	Animal Control			38.903339 °	38.903339 °
				-121.606209 °	-121.606209 °
DWR ID	DWR_MA0003_01_f_2014_140				
Action/Comments					
No rodents visible, but rodent burrows visible; need to backfill and compact or grout burrows. Inspector Comments: There is a rodent hole on the landward toe road approximately 6" in diameter.

This photo was taken from the landward levee slope near the toe road facing north looking at an approximately 6" rodent hole. Fall 2014.

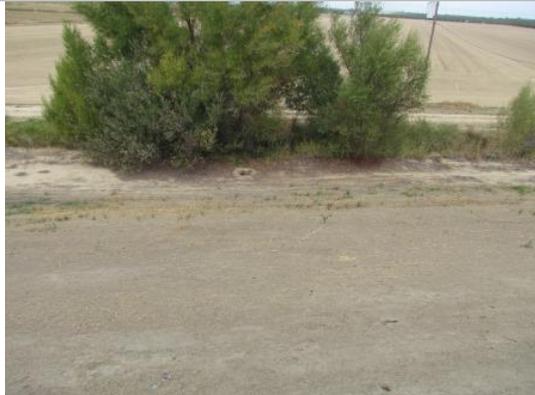
Photo 2 of 2 : FA\_2015\_MA0003\_195\_140\_20151106\_00011.jpg

This is another photo of the rodent hole to show its relationship to to levee toe, toe road, and drainage ditch. Fall 2014.

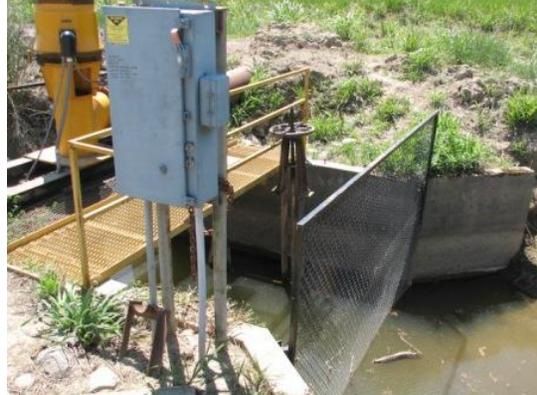
Photo 1 of 1 : FA\_2015\_MA0003\_195\_5\_20151106\_00001.jpg

LM Start	<b>0.80</b>	Rating **	M	Issue No.	<b>5</b>
LM End	<b>0.80</b>	Issue Type +	Ma	Location *	LS
Category	Interior Drainage & Piping Systems		GPS Latitude/Longitude		
			Start	End	
Item	Sluice / Slide Gates		38.903291 °	38.903291 °	
			-121.605747 °	-121.605747 °	
DWR ID	DWR_MA0003_01_s_2012_5				
Action/Comments					
Inspector Comments: This pipe leaked during the high water event of 2010/2011.

Levee mile 0.80, this photo is looking at the landside toe, one of these pipes leaked during the high water event of 2010/2011. A flap gate prevents flow from the waterward side to the landward side of the levee.

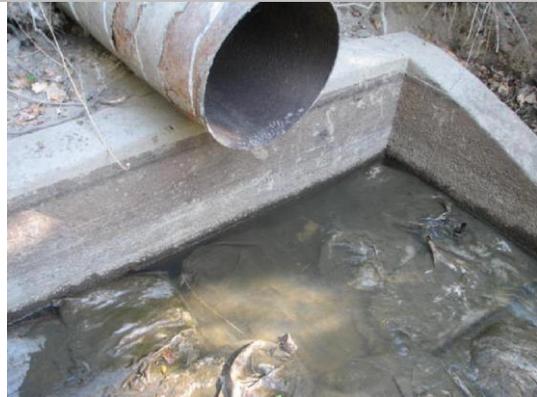
Photo 1 of 3 : UCIP\_FA\_2015\_5303.jpg

Item	DWR UCIP Field Study		38.903264 °	38.903264 °	
			-121.605698 °	-121.605698 °	
DWR ID					
Action/Comments					
Inspector Comments: FS_ID:45165 DS_ID:17136 EP_NO: N/A FS_HLM: 0.804 Repair Type: Urgent Crossing Status: Found UCIP Comments: 5/12/2015 Watelevel high in WS ditch so could not see WS end of crossing. Do not believe that repairs have been made yet. Flap gates not visible on waterward headwall and it appears as though they have been replaced by sandbags. Slide gates on LS appear to be closed yet water leaks excessively from the WS at the sandbagged headwall. 5/21/2013 SBFCA project recommends replacing in accordance with title 23.5/21/2013 High water levels in WS ditch have pipe ends underwater but repairs have not yet been completed but are planned for when water levels drop. 10/30/2013 Same as last inspection. 5/14/2014 Same as last inspection. 11/17/2014 Same as last inspection. FIELD_STRUCT_DESC: 2 of 2. 18-inch pipe through the levee, 32.0 feet below the crown. Flap gate on the waterward end. Slide gate on the landward end at concrete headwall. Concrete "U" headwall at the waterward toe. Originally included in O+M manual (1955). FS Date: 05/14/2015

Flap gates appear to be missing from U shaped headwall. Sandbags fill headwall but water flows heavily from LS.

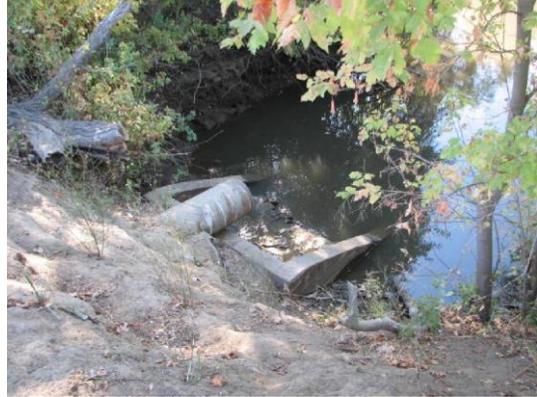
Photo 2 of 3 : UCIP\_FA\_2015\_5304.jpg

Inspector Comments: FS\_ID:45165  
 DS\_ID:17136  
 EP\_NO: N/A  
 FS\_HLM: 0.804  
 Repair Type: Urgent  
 Crossing Status: Found  
 UCIP Comments: 5/12/2015 Watelevel high in WS ditch so could not see WS end of crossing. Do not believe that repairs have been made yet. Flap gates not visible on waterward headwall and it appears as though they have been replaced by sandbags. Slide gates on LS appear to be closed yet water leaks excessively from the WS at the sandbagged headwall. 5/21/2013 SBFCA project recommends replacing in accordance with title 23.5/21/2013 High water levels in WS ditch have pipe ends underwater but repairs have not yet been completed but are planned for when water levels drop. 10/30/2013 Same as last inspection. 5/14/2014 Same as last inspection. 11/17/2014 Same as last inspection.  
 FIELD\_STRUCT\_DESC: 2 of 2. 18-inch pipe through the levee, 32.0 feet below the crown. Flap gate on the waterward end. Slide gate on the landward end at concrete headwall. Concrete "U" headwall at the waterward toe. Originally included in O+M manual (1955).

Concrete U shaped headwall on WS toe filled with sandbags.

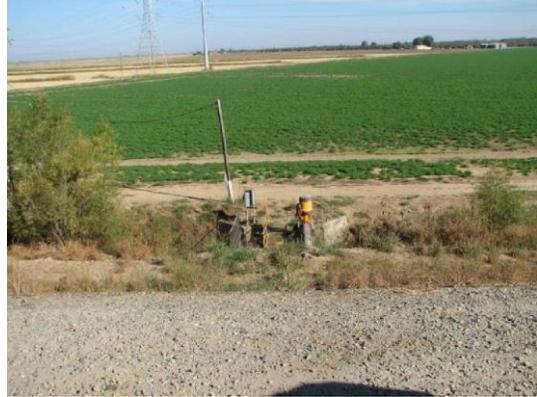
Photo 3 of 3 : UCIP\_FA\_2015\_5338.jpg

UCIP Comments: 5/12/2015 Watelevel high in WS ditch so could not see WS end of crossing. Do not believe that repairs have been made yet. Flap gates not visible on waterward headwall and it appears as though they have been replaced by sandbags. Slide gates on LS appear to be closed yet water leaks excessively from the WS at the sandbagged headwall. 5/21/2013 SBFCA project recommends replacing in accordance with title 23.5/21/2013 High water levels in WS ditch have pipe ends underwater but repairs have not yet been completed but are planned for when water levels drop. 10/30/2013 Same as last inspection. 5/14/2014 Same as last inspection. 11/17/2014 Same as last inspection.

Concrete headwall, slidegates, and metal walkway on LS toe.

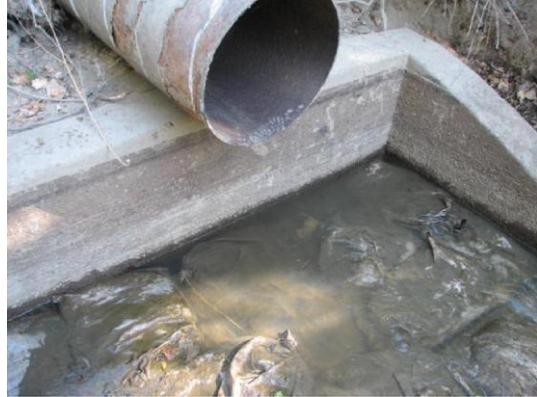
Photo 1 of 3 : UCIP\_FA\_2015\_5300.jpg

Action/Comments					
Inspector Comments: FS_ID:45164 DS_ID:17091 EP_NO: 13624 FS_HLM: 0.804 Repair Type: Urgent Crossing Status: Found UCIP Comments: 5/12/2015 Watelevel high in WS ditch so could not see WS end of crossing. Do not believe that repairs have been made yet.5/21/2013 SBFCA project recommends replacing in accordance with title 23.5/21/2013 Hole in slope along outside of standpipe thats about 1 foot deep with moisture in the bottom. Dirt inside standpipe around siphon breaker also wet indicating there may be a leak. Need to investigate source or moisture.10/30/2013 Same as last inspection.5/14/2014 Pipe section that was suspected of leaking was dug up and deemed to be in good condition. No signs of leaks were found.11/17/2014 Same as last inspection. FIELD_STRUCT_DESC: 20-inch pipe through the levee 3 feet below the crown. Siphon breaker on the waterward shoulder. Open on waterward end. Pump in ditch on landward side. (Permit No. 13624-D & D, Inc.) FS Date: 05/14/2015

Pipe at outlet on WS toe

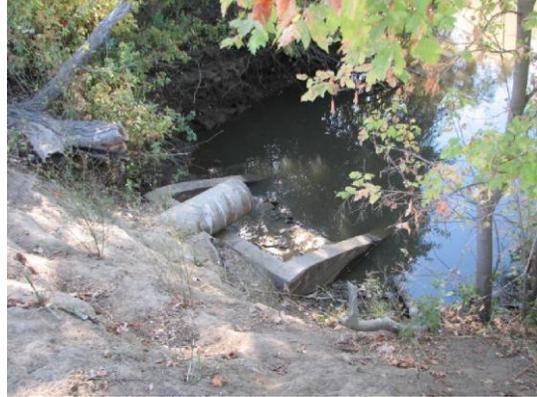
Photo 2 of 3 : UCIP\_FA\_2015\_5301.jpg

Pipe at outlet on WS toe

Action/Comments					
Inspector Comments: FS_ID:45164 DS_ID:17091 EP_NO: 13624 FS_HLM: 0.804 Repair Type: Urgent Crossing Status: Found UCIP Comments: 5/12/2015 Watelevel high in WS ditch so could not see WS end of crossing. Do not believe that repairs have been made yet.5/21/2013 SBFCA project recommends replacing in accordance with title 23.5/21/2013 Hole in slope along outside of standpipe thats about 1 foot deep with moisture in the bottom. Dirt inside standpipe around siphon breaker also wet indicating there may be a leak. Need to investigate source or moisture.10/30/2013 Same as last inspection.5/14/2014 Pipe section that was suspected of leaking was dug up and deemed to be in good condition. No signs of leaks were found.11/17/2014 Same as last inspection. FIELD_STRUCT_DESC: 20-inch pipe through the levee 3 feet below the crown. Siphon breaker on the waterward shoulder. Open on waterward end. Pump in ditch on landward side. (Permit No. 13624-D & D, Inc.) FS Date: 05/14/2015

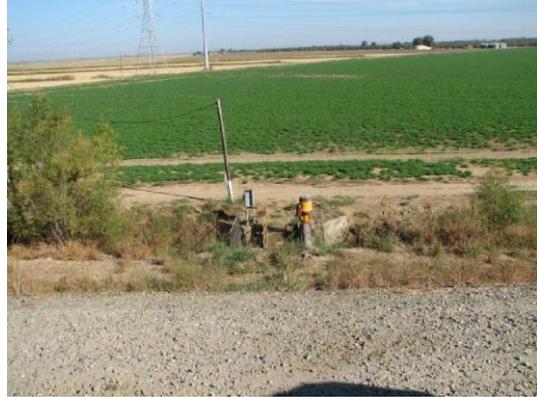
Photo 3 of 3 : UCIP\_FA\_2015\_5302.jpg

Item	DWR UCIP Field Study			38.903264 °	38.903264 °
				-121.605698 °	-121.605698 °
DWR ID					
<b>Action/Comments</b>					
Inspector Comments: FS_ID:45164 DS_ID:17091 EP_NO: 13624 FS_HLM: 0.804 Repair Type: Urgent Crossing Status: Found UCIP Comments: 5/12/2015 Watelevel high in WS ditch so could not see WS end of crossing. Do not believe that repairs have been made yet.5/21/2013 SBFCA project recommends replacing in accordance with title 23.5/21/2013 Hole in slope along outside of standpipe thats about 1 foot deep with moisture in the bottom. Dirt inside standpipe around siphon breaker also wet indicating there may be a leak. Need to investigate source or moisture.10/30/2013 Same as last inspection.5/14/2014 Pipe section that was suspected of leaking was dug up and deemed to be in good condition. No signs of leaks were found.11/17/2014 Same as last inspection. FIELD_STRUCT_DESC: 20-inch pipe through the levee 3 feet below the crown. Siphon breaker on the waterward shoulder. Open on waterward end. Pump in ditch on landward side. (Permit No. 13624-D & D, Inc.) FS Date: 05/14/2015

Pump on concrete headwall at LS toe.

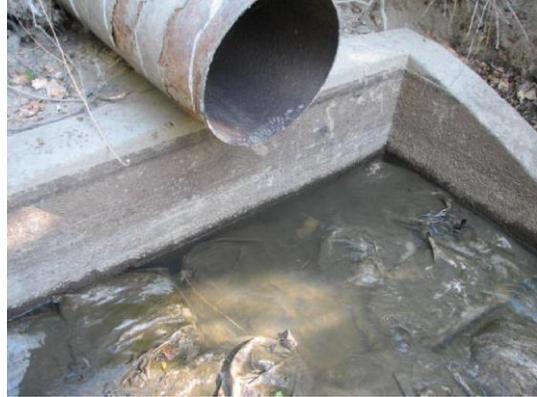
Photo 1 of 3 : UCIP\_FA\_2015\_5297.jpg

Inspector Comments: FS\_ID:45163  
 DS\_ID:17092  
 EP\_NO: N/A  
 FS\_HLM: 0.804  
 Repair Type: Urgent  
 Crossing Status: Found  
 UCIP Comments: 5/12/2015 Watelevel high in WS ditch so could not see WS end of crossing. Do not believe that repairs have been made yet. Flap gates not visible on waterward headwall and it appears as though they have been replaced by sandbags. Slide gates on LS appear to be closed yet water leaks excessively from the WS at the sandbagged headwall. 5/21/2013 SBFCA project recommends replacing in accordance with title 23.5/21/2013 High water levels in WS ditch have pipe ends underwater but repairs have not yet been completed but are planned for when water levels drop. 10/30/2013 Same as last inspection. 5/14/2014 Same as last inspection. 11/17/2014 Same as last inspection.  
 FIELD\_STRUCT\_DESC: 1 of 2. 18-inch pipe through the levee, 32.0 feet below the crown. Flap gate on the waterward end. Slide gate on the landward end at concrete headwall. Concrete "U" shaped headwall at the waterward toe. Originally included in O+M manual (1955).

Concrete U shaped headwall filled in with sandbags on WS toe. Flap gates appear to be missing and water readily flows through the sandbags fro landside.

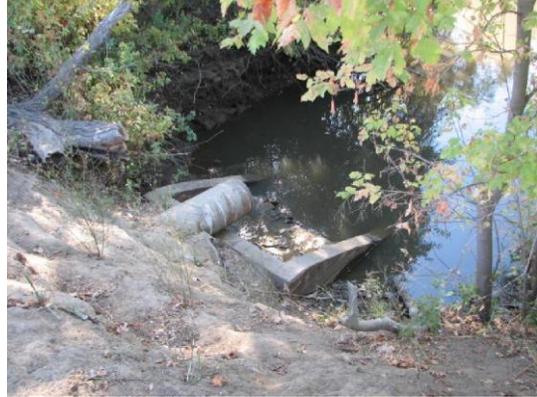
Photo 2 of 3 : UCIP\_FA\_2015\_5298.jpg

Inspector Comments: FS\_ID:45163  
 DS\_ID:17092  
 EP\_NO: N/A  
 FS\_HLM: 0.804  
 Repair Type: Urgent  
 Crossing Status: Found  
 UCIP Comments: 5/12/2015 Watelevel high in WS ditch so could not see WS end of crossing. Do not believe that repairs have been made yet. Flap gates not visible on waterward headwall and it appears as though they have been replaced by sandbags. Slide gates on LS appear to be closed yet water leaks excessively from the WS at the sandbagged headwall. 5/21/2013 SBFCA project recommends replacing in accordance with title 23.5/21/2013 High water levels in WS ditch have pipe ends underwater but repairs have not yet been completed but are planned for when water levels drop. 10/30/2013 Same as last inspection. 5/14/2014 Same as last inspection. 11/17/2014 Same as last inspection.  
 FIELD\_STRUCT\_DESC: 1 of 2. 18-inch pipe through the levee, 32.0 feet below the crown. Flap gate on the waterward end. Slide gate on the landward end at concrete headwall. Concrete "U" shaped headwall at the waterward toe. Originally included in O+M manual (1955).

Concrete U shaped headwall on WS toe filled in with Sandbags. 16-inch pipe shown over top of headwall.

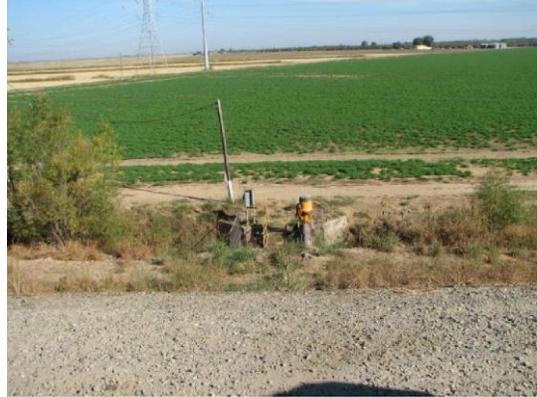
Photo 3 of 3 : UCIP\_FA\_2015\_5299.jpg

Item	DWR UCIP Field Study			38.903264 °	38.903264 °
				-121.605698 °	-121.605698 °
DWR ID					
Action/Comments					
Inspector Comments: FS_ID:45163 DS_ID:17092 EP_NO: N/A FS_HLM: 0.804 Repair Type: Urgent Crossing Status: Found UCIP Comments: 5/12/2015 Watelevel high in WS ditch so could not see WS end of crossing. Do not believe that repairs have been made yet. Flap gates not visible on waterward headwall and it appears as though they have been replaced by sandbags. Slide gates on LS appear to be closed yet water leaks excessively from the WS at the sandbagged headwall. 5/21/2013 SBFCA project recommends replacing in accordance with title 23.5/21/2013 High water levels in WS ditch have pipe ends underwater but repairs have not yet been completed but are planned for when water levels drop. 10/30/2013 Same as last inspection. 5/14/2014 Same as last inspection. 11/17/2014 Same as last inspection. FIELD_STRUCT_DESC: 1 of 2. 18-inch pipe through the levee, 32.0 feet below the crown. Flap gate on the waterward end. Slide gate on the landward end at concrete headwall. Concrete "U" shaped headwall at the waterward toe. Originally included in O+M manual (1955). FS Date: 05/14/2015

Concrete headwall with walkway and slide gates at LS toe.

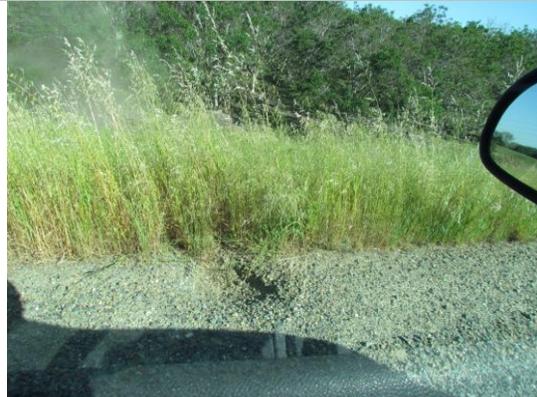
Photo 1 of 1 : FA\_2015\_MA0003\_195\_13\_20151106\_00006.jpg

LM Start	<b>1.51</b>	Rating **	M	Issue No.	<b>13</b>
LM End	<b>1.51</b>	Issue Type +	Ma	Location *	CR
Category	Earthen Levee			GPS Latitude/Longitude	
				Start	End
Item	Crown Surface / Depressions / Rutting			38.904680 °	38.904680 °
				-121.594229 °	-121.594229 °
DWR ID	DWR_MA0003_01_s_2015_13				
Action/Comments					
Repair depressions or ruts in the crown or slope.

Photo of a depression in the crown, taken looking at the landside.

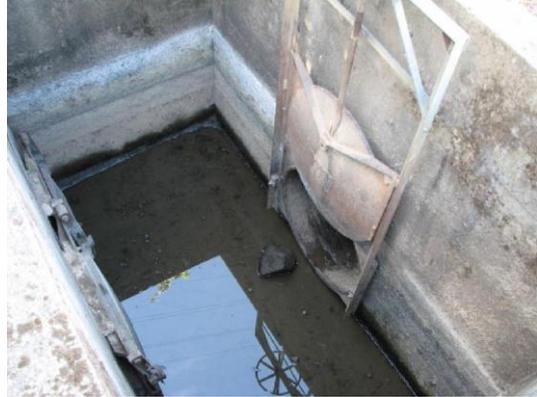
Photo 2 of 3 : UCIP\_FA\_2015\_5340.jpg

Inspector Comments: FS\_ID:45168  
 DS\_ID:17088  
 EP\_NO: 3284  
 FS\_HLM: 2.191  
 Repair Type: Non-Urgent  
 Crossing Status: Found  
 UCIP Comments: 5/12/2015 Only the right flapgate appeared to be abandoned. The left and middle flap gates were flowing water during the last inspection. Pumping plant has been disconnected from levee. Need to determine if abandonment is appropriate or if this is now a gravity drain with flap gate. 5/21/2013 Pumping plant was running and filling concrete vault on WS toe through the left flap gate and then flowing through levee pipe and filling irrigation ditch on LS. Left and middle flap gates appear to be connected to pumps and right gate appears abandoned. Recommend contacting owner to get more details. 10/30/2013 Same as last inspection. 5/14/2014 Same as last inspection. 11/17/2014 Same as last inspection.  
 FIELD\_STRUCT\_DESC: 32-inch by 32-inch concrete box culvert through the levee approximately 28 feet below the crown. Transition between vault on RS and box culvert within levee section is made with a 41-inch CMP. Slide gate on LS at concrete headwall. Flap Gate in concrete vault on RS at terminal of pipes from pump structure in floodway. Pipes from pump station in creek be no longer connected. (Permit No. 3284)

8-foot X 14-foot concrete box on WS toe with slide gate and 3 abandoned flap gates.

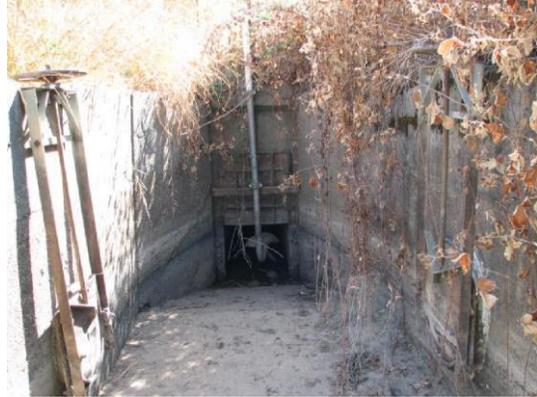
Photo 3 of 3 : UCIP\_FA\_2015\_5341.jpg

Inspector Comments: FS\_ID:45168  
 DS\_ID:17088  
 EP\_NO: 3284  
 FS\_HLM: 2.191  
 Repair Type: Non-Urgent  
 Crossing Status: Found  
 UCIP Comments: 5/12/2015 Only the right flapgate appeared to be abandoned. The left and middle flap gates were flowing water during the last inspection. Pumping plant has been disconnected from levee. Need to determine if abandonment is appropriate or if this is now a gravity drain with flap gate. 5/21/2013 Pumping plant was running and filling concrete vault on WS toe through the left flap gate and then flowing through levee pipe and filling irrigation ditch on LS. Left and middle flap gates appear to be connected to pumps and right gate appears abandoned. Recommend contacting owner to get more details. 10/30/2013 Same as last inspection. 5/14/2014 Same as last inspection. 11/17/2014 Same as last inspection.  
 FIELD\_STRUCT\_DESC: 32-inch by 32-inch concrete box culvert through the levee approximately 28 feet below the crown. Transition between vault on RS and box culvert within levee section is made with a 41-inch CMP. Slide gate on LS at concrete headwall. Flap Gate in concrete vault on RS at terminal of pipes from pump structure in floodway. Pipes from pump station in creek be no longer connected. (Permit No. 3284)

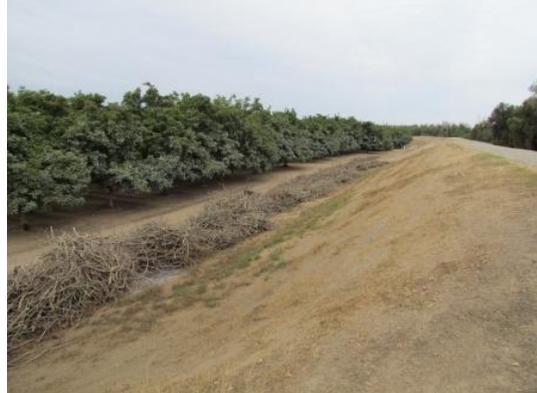
Photo 1 of 1 : FA\_2015\_MA0003\_195\_141\_20151106\_00012.jpg

LM Start	<b>2.19</b>	Rating **	U	Issue No.	<b>141</b>
LM End	<b>2.19</b>	Issue Type +	En	Location *	LS
Category	Earthen Levee			GPS Latitude/Longitude	
				Start	End
Item	Encroachments			38.912027 °	38.912027 °
				-121.585941 °	-121.585941 °
DWR ID	DWR_MA0003_01_f_2014_141				
Action/Comments					
Prunings

This photo was taken from the crown facing north looking down the landward levee slope at pruning piles located at the levee toe that need to be removed. Fall 2014.

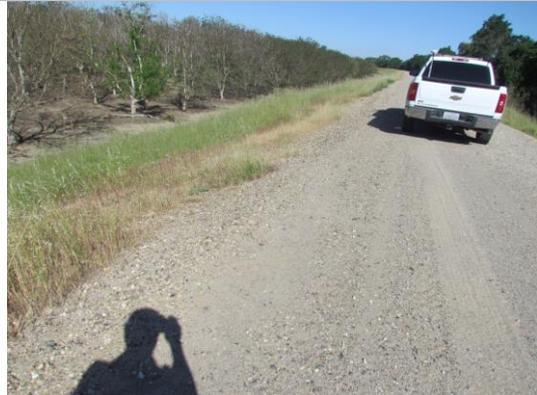
Photo 1 of 1 : FA\_2015\_MA0003\_195\_20\_20151106\_00009.jpg

LM Start	<b>3.20</b>	Rating **	M	Issue No.	<b>20</b>
LM End	<b>3.20</b>	Issue Type +	Ma	Location *	LS
Category	Earthen Levee			GPS Latitude/Longitude	
				Start	End
Item	Slope Stability			38.925909 °	38.925909 °
				-121.585401 °	-121.585401 °
DWR ID	DWR_MA0003_01_s_2015_20				
Action/Comments					
Repair slope instability.

Photo of slope on the landside facing upstream, areas with little vegetation appear to have eroded leaving the crown smaller.

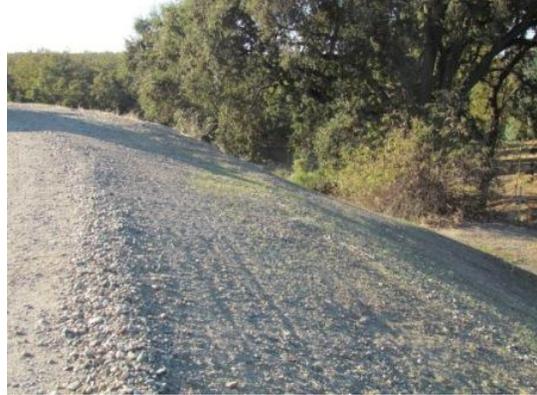
Photo 1 of 1 : FA\_2015\_MA0003\_195\_19\_20151106\_00008.jpg

LM Start	<b>3.59</b>	Rating **	M	Issue No.	<b>19</b>
LM End	<b>3.59</b>	Issue Type +	Ma	Location *	LS
Category	Earthen Levee		GPS Latitude/Longitude		
			Start	End	
Item	Vegetation		38.930063 °	38.930063 °	
			-121.590211 °	-121.590211 °	
DWR ID	DWR_MA0003_01_f_2013_19				
Action/Comments					
Elderberries are blocking visibility and flood fight capability. Inspector Comments: Elderberries on the landward levee toe.

This photo was taken from the levee crown facing south looking down the landward levee slope at a group of Elderberries. Fall 2013.

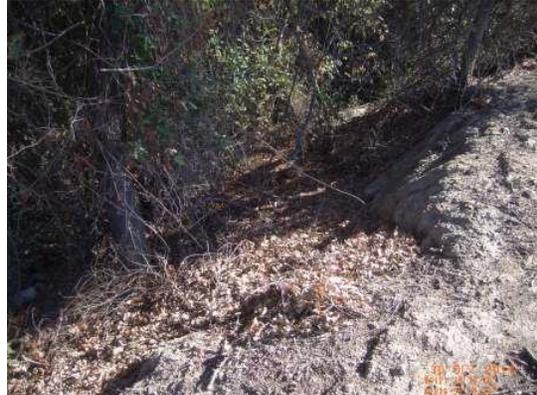
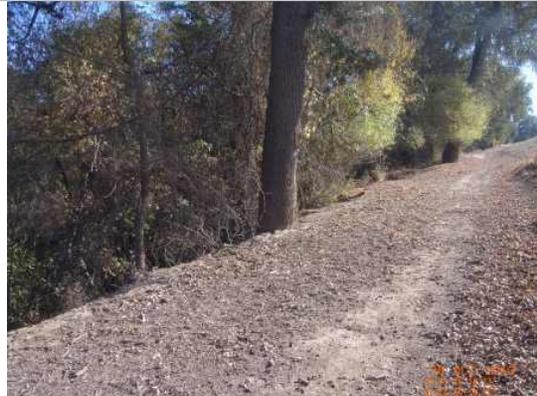
LM Start	<b>4.15</b>	Rating **	M	Issue No.	<b>1</b>
LM End	<b>4.18</b>	Issue Type +	Ma	Location *	WS
Category	Supplemental		GPS Latitude/Longitude		
			Start	End	
Item	2015 USACE Erosion Survey, DRAFT		38.937451 °	38.937937 °	
			-121.588512 °	-121.588471 °	
DWR ID					
Action/Comments					
Inspector Comments: 2013 - Minor toe scour causing gradual erosion of bank slope. Site is within ecological reserve. 2015: Last observed in 2013. [2015 Site ID: FHR_12-3_R]

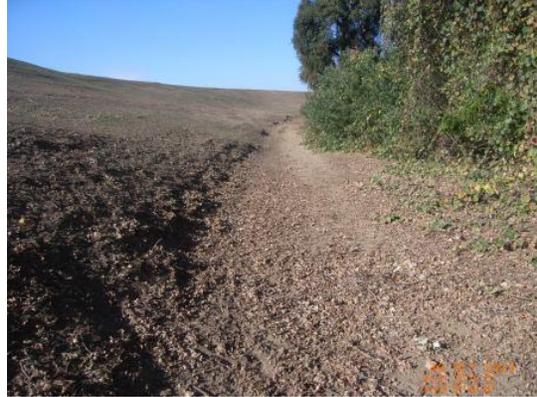
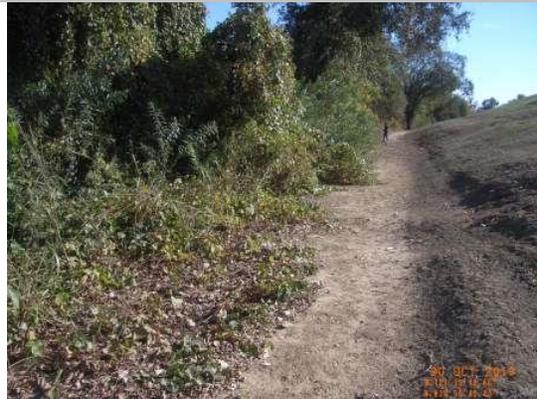
LM Start	<b>4.71</b>	Rating **	M	Issue No.	<b>2</b>
LM End	<b>4.76</b>	Issue Type +	Ma	Location *	WS
Category	Supplemental			GPS Latitude/Longitude	
				Start	End
Item	2015 USACE Erosion Survey, DRAFT			38.945188 °	38.945958 °
				-121.586096 °	-121.586394 °
DWR ID					
Action/Comments					
Inspector Comments: 2013 - Minor toe scour causing gradual erosion into the bank slope. 2015: Last observed in 2013. [2015 Site ID: FHR_12-8_R]
