**Flood Control Project Maintenance
Levee Inspections**

**Fall 2015 Levee Maintenance Deficiency Summary Report
Overall LMA & Unit Ratings, including USACE Erosion Survey**

Sacramento River Basin

Sacramento Maintenance Yard Maintenance Area 0004

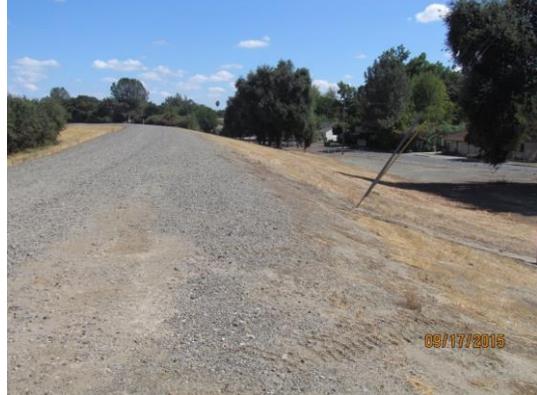
Photo 1 of 1 : FA_2015_MA0004_298_6_20150921_00019.jpg

LM Start	0.00	Rating **	A	Issue No.	6
LM End	3.03	Issue Type +	Ma	Location *	LS
Category	Earthen Levee		GPS Latitude/Longitude		
			Start	End	
Item	Vegetation		38.596817 °	38.587186 °	
			-121.547525 °	-121.508022 °	
DWR ID	DWR_MA0004_01_f_2015_6				
Action/Comments					
Control annual grass and weeds on the levee slopes and easements. Inspector Comments: Vegetation on the slope has been mowed and there is no visibility obstruction.

View of the vegetation on the landward side of the levee looking downstream. Fall 2015.

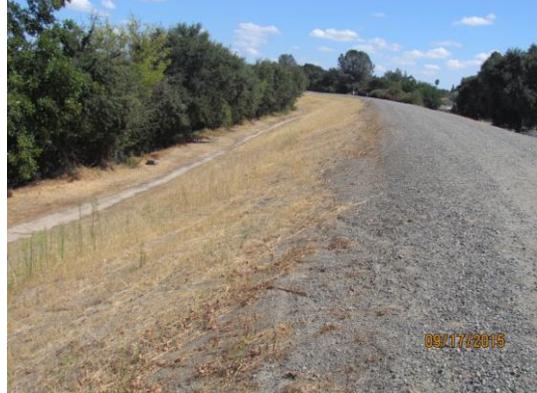
Photo 1 of 1 : FA_2015_MA0004_298_1_20150921_00018.jpg

LM Start	0.00	Rating **	A	Issue No.	1
LM End	3.03	Issue Type +	Ma	Location *	WS
Category	Earthen Levee		GPS Latitude/Longitude		
			Start	End	
Item	Vegetation		38.596817 °	38.587185 °	
			-121.547524 °	-121.508022 °	
DWR ID	DWR_MA0004_01_f_2015_1				
Action/Comments					
Control annual grass and weeds on the levee slopes and easements. Inspector Comments: Vegetation on the slope has been mowed and there is no visibility obstruction.

View of the vegetation on the waterward side of the levee looking downstream. Fall 2015.

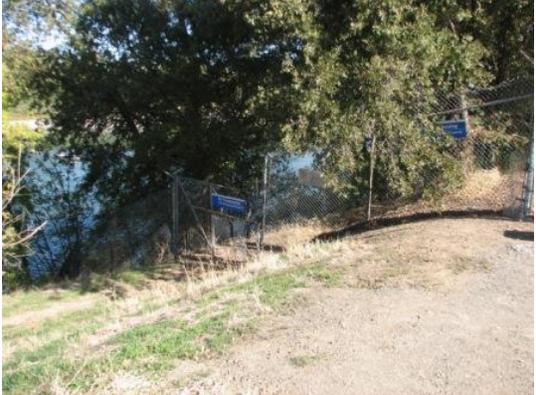
Photo 1 of 3 : FA_2015_MA0004_298_2_20150914_00001.jpg

LM Start	0.24	Rating **	U	Issue No.	2
LM End	0.24	Issue Type +	En	Location *	CR
Category	Earthen Levee			GPS Latitude/Longitude	
				Start	End
Item	Encroachments			38.597193 °	38.597193 °
				-121.543421 °	-121.543421 °
DWR ID	DWR_MA0004_01_s_2012_2				
Action/Comments					
Fence Inspector Comments: This is the USACE yard and the chain link fence crosses the levee. The fence runs the length of the yard on the crown.

The fence blocks access to the waterside levee slope. Fall 2013

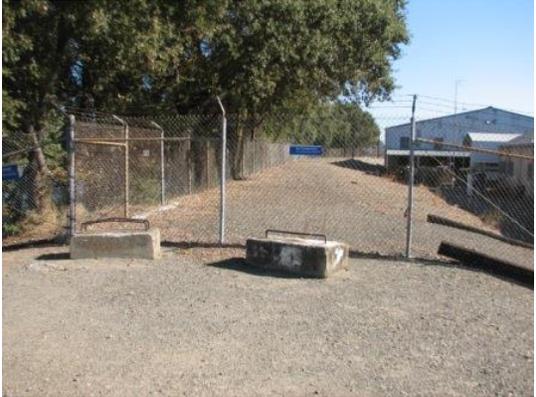
Photo 2 of 3 : FA_2015_MA0004_298_2_20150914_00002.jpg

The fence blocks the crown of the levee. Fall 2013

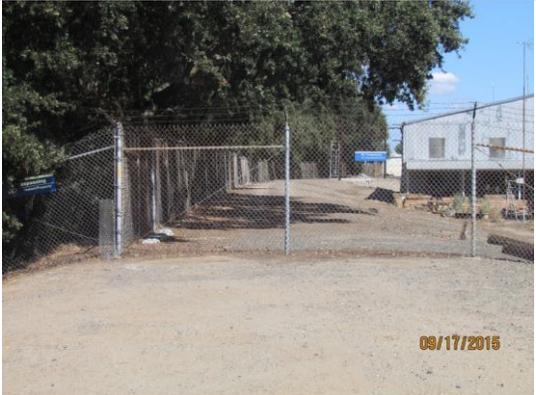
Photo 3 of 3 : FA_2015_MA0004_298_2_20150921_00020.jpg

View of the fence blocking access on the crown of the levee looking downstream. Fall 2015.

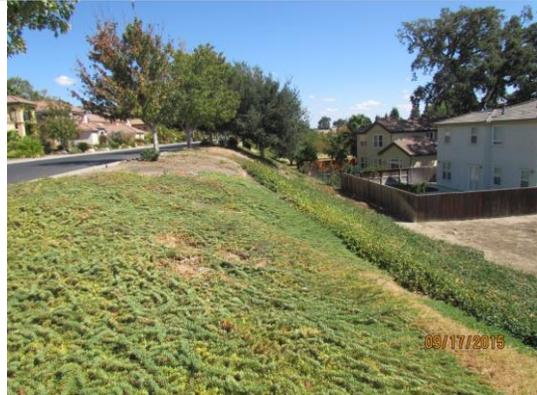
Photo 1 of 1 : FA_2015_MA0004_298_7_20150921_00021.jpg

LM Start	1.34	Rating **	A/W	Issue No.	7
LM End	1.97	Issue Type +	Ma	Location *	LS
Category	Earthen Levee			GPS Latitude/Longitude	
				Start	End
Item	Vegetation			38.602756 °	38.600449 °
				-121.525618 °	-121.514459 °
DWR ID	DWR_MA0004_01_s_2012_7				
Action/Comments					
Landscaping Inspector Comments: The Rivers housing development

View of the landscaping on the landward side of the levee looking downstream. Fall 2015.

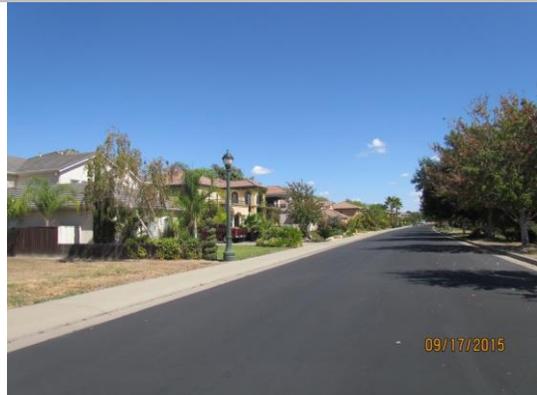
Photo 1 of 1 : FA_2015_MA0004_298_8_20150921_00022.jpg

LM Start	1.35	Rating **	A/W	Issue No.	8
LM End	1.51	Issue Type +	Ma	Location *	CR
Category	Earthen Levee			GPS Latitude/Longitude	
				Start	End
Item	Encroachments			38.602764 °	38.602596 °
				-121.525319 °	-121.522439 °
DWR ID	DWR_MA0004_01_s_2012_8				
Action/Comments					
Building Inspector Comments: The Rivers housing development houses on crown of levee waterside

View of the houses on the crown of the levee looking downstream. Fall 2015.

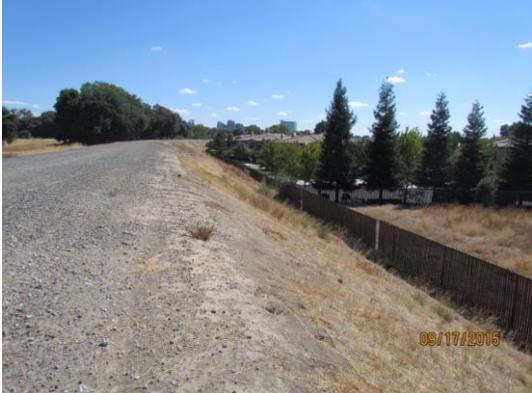
Photo 1 of 1 : FA_2015_MA0004_298_14_20150921_00023.jpg

LM Start	2.02	Rating **	M	Issue No.	14
LM End	2.21	Issue Type +	En	Location *	LS
Category	Earthen Levee			GPS Latitude/Longitude	
				Start	End
Item	Encroachments			38.599834 °	38.597531 °
				-121.513994 °	-121.513147 °
DWR ID	DWR_MA0004_01_s_2012_14				
Action/Comments					
Fence Inspector Comments: A fence runs along the toe of the landside levee

View of the fence running along the toe of the landward side of the levee looking downstream. Fall 2015.

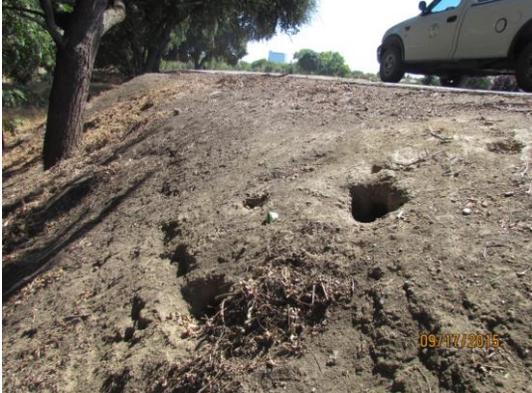
Photo 1 of 1 : FA_2015_MA0004_298_18_20150921_00024.jpg

LM Start	2.12	Rating **	M	Issue No.	18
LM End	2.12	Issue Type +	Ma	Location *	WS
Category	Earthen Levee			GPS Latitude/Longitude	
				Start	End
Item	Animal Control			38.598613 °	38.598613 °
				-121.513012 °	-121.513012 °
DWR ID	DWR_MA0004_01_f_2015_18				
Action/Comments					
No rodents visible, but rodent burrows visible; need to backfill and compact or grout burrows.

View of the animal holes on the waterward side of the levee looking downstream. Fall 2015.

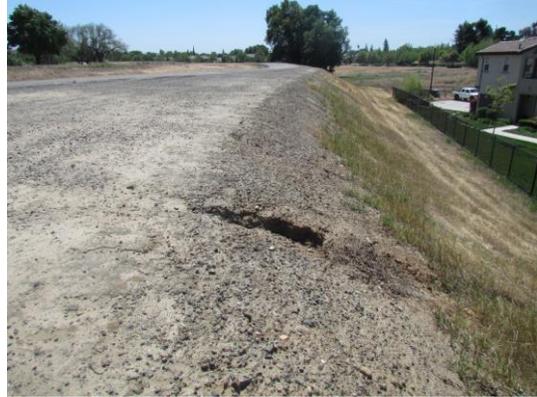
Photo 1 of 1 : FA_2015_MA0004_298_13_20150914_00012.jpg

LM Start	2.18	Rating **	M	Issue No.	13
LM End	2.18	Issue Type +	Ma	Location *	LS
Category	Earthen Levee		GPS Latitude/Longitude		
			Start	End	
Item	Erosion / Bank Caving		38.597967 °	38.597967 °	
			-121.512892 °	-121.512892 °	
DWR ID	DWR_MA0004_01_s_2015_13				
Action/Comments					
Schedule repair of erosion site prior to the next inspection.

View of the erosion on the landward side of the levee looking downstream. Spring 2015.

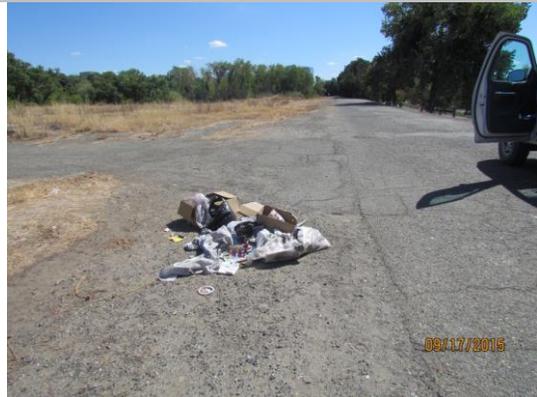
Photo 1 of 1 : FA_2015_MA0004_298_20_20150921_00025.jpg

LM Start	2.41	Rating **	M	Issue No.	20
LM End	2.41	Issue Type +	En	Location *	CR
Category	Earthen Levee		GPS Latitude/Longitude		
			Start	End	
Item	Encroachments		38.594767 °	38.594767 °	
			-121.512318 °	-121.512318 °	
DWR ID	DWR_MA0004_01_f_2015_20				
Action/Comments					
Garbage

View of the trash on the crown of the levee looking downstream. Fall 2015.

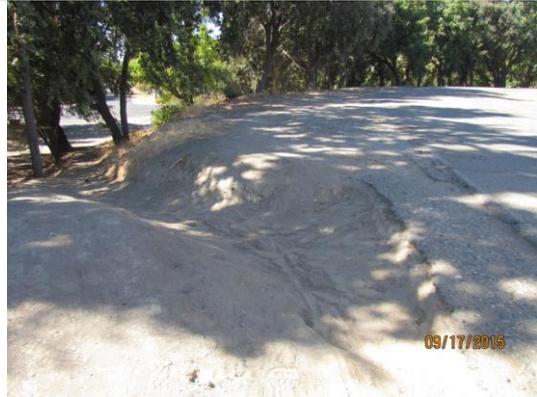
Photo 1 of 1 : FA_2015_MA0004_298_22_20150921_00026.jpg

LM Start	2.65	Rating **	M	Issue No.	22
LM End	2.65	Issue Type +	Ma	Location *	LS
Category	Earthen Levee			GPS Latitude/Longitude	
				Start	End
Item	Slope Stability			38.591380 °	38.591380 °
				-121.511345 °	-121.511345 °
DWR ID	DWR_MA0004_01_f_2015_22				
Action/Comments					
Repair the levee slope damaged by foot traffic and prevent access where possible.

View of the depression on the landward side of the levee due to foot traffic looking upstream. Fall 2015.

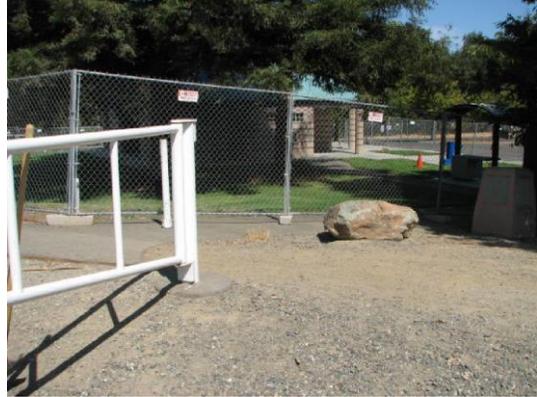
Photo 1 of 2 : UCIP_FA_2015_0165.jpg

LM Start	2.69	Rating **	M	Issue No.	28
LM End	2.69	Issue Type +	En	Location *	LS
Category	Supplemental			GPS Latitude/Longitude	
				Start	End
Item	DWR UCIP Field Study			38.590910 °	38.590910 °
				-121.510830 °	-121.510830 °
DWR ID					
Action/Comments					
Inspector Comments: FS_ID:41443 DS_ID:19405 EP_NO: N/A FS_HLM: 2.666 Repair Type: Non-Urgent Crossing Status: Found UCIP Comments: Found during the field survey, not listed in the desk study. FIELD_STRUCT_DESC: A 6-inch sewer line from the public facility of boat launching area. No other details available. FS Date: 09/12/2012

Waterside view- public facility in the background.

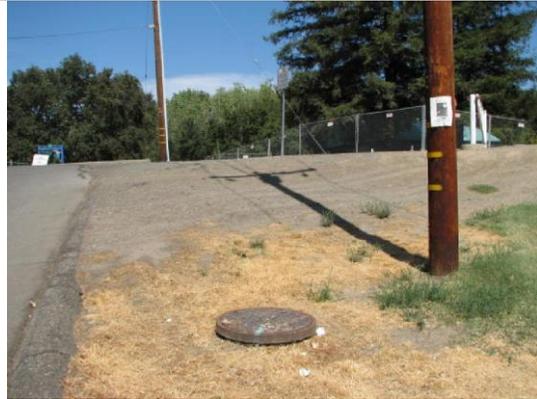
Photo 2 of 2 : UCIP_FA_2015_0166.jpg

Landside view- manhole on the side of the levee and a road.

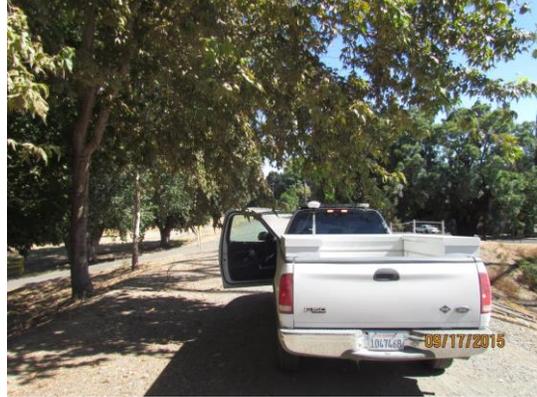
Photo 1 of 1 : FA_2015_MA0004_298_23_20150921_00027.jpg

LM Start	2.76	Rating **	M	Issue No.	23
LM End	2.76	Issue Type +	Ma	Location *	CR
Category	Earthen Levee			GPS Latitude/Longitude	
				Start	End
Item	Trim / Thin Trees			38.590248 °	38.590248 °
				-121.509940 °	-121.509940 °
DWR ID	DWR_MA0004_01_f_2015_23				
Action/Comments					
Trim trees over roadway to at least 12 feet above ground level.

View of the tree branches on top of the crown of the levee looking downstream. Fall 2015.

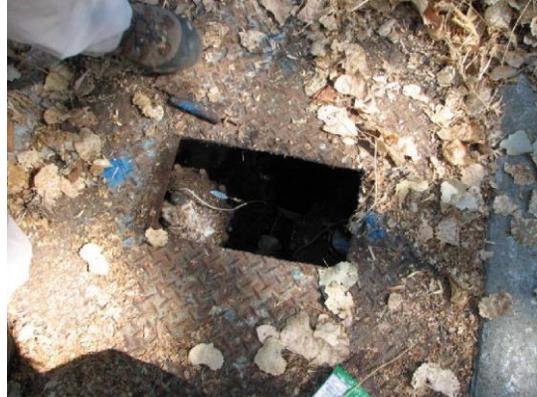
Photo 1 of 3 : UCIP_FA_2015_0160.jpg

LM Start	2.77	Rating **	M	Issue No.	29
LM End	2.77	Issue Type +	En	Location *	CR
Category	Supplemental			GPS Latitude/Longitude	
				Start	End
Item	DWR UCIP Field Study			38.590140 °	38.590140 °
				-121.509750 °	-121.509750 °
DWR ID					
Action/Comments					
Inspector Comments: FS_ID:41485 DS_ID:19406 EP_NO: N/A FS_HLM: 2.745 Repair Type: Non-Urgent Crossing Status: Found UCIP Comments: Found during field survey. Not listed in the desk study. FIELD_STRUCT_DESC: 1 of 2. A 3-inch wrapped GI water pipe(of 3-inch and 5-inch water pipe) daylight in a metal cage box. A valve box for the pipe is also found. FS Date: 09/12/2012

Waterside view- a manhole/control valve box.

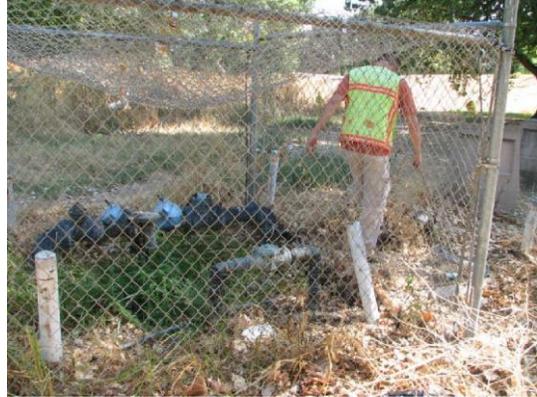
Photo 2 of 3 : UCIP_FA_2015_0161.jpg

Action/Comments
 Inspector Comments: FS_ID:41485
 DS_ID:19406
 EP_NO: N/A
 FS_HLM: 2.745
 Repair Type: Non-Urgent
 Crossing Status: Found
 UCIP Comments: Found during field survey. Not listed in the desk study.
 FIELD_STRUCT_DESC: 1 of 2. A 3-inch wrapped GI water pipe(of 3-inch and 5-inch water pipe) daylight in a metal cage box. A valve box for the pipe is also found.
 FS Date: 09/12/2012

Waterside view- pipe daylight in a metal cage.

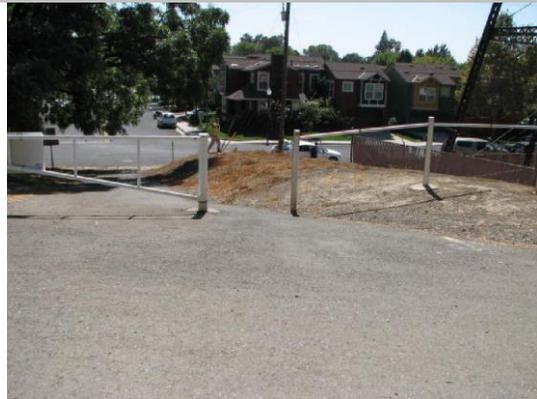
Photo 3 of 3 : UCIP_FA_2015_0162.jpg

Landside overview

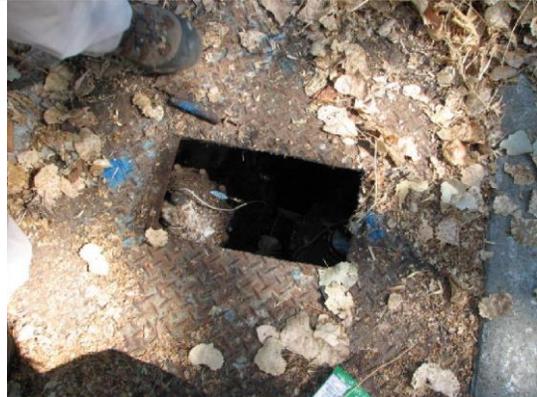
Photo 1 of 2 : UCIP_FA_2015_0163.jpg

LM Start	2.82	Rating **	M	Issue No.	30
LM End	2.82	Issue Type +	En	Location *	CR
Category	Supplemental			GPS Latitude/Longitude	
				Start	End
Item	DWR UCIP Field Study			38.590130 °	38.590130 °
				-121.508740 °	-121.508740 °
DWR ID					
Action/Comments					
Inspector Comments: FS_ID:41486 DS_ID:19407 EP_NO: N/A FS_HLM: 2.745 Repair Type: Non-Urgent Crossing Status: Found

Waterside view- manhole/control valve.

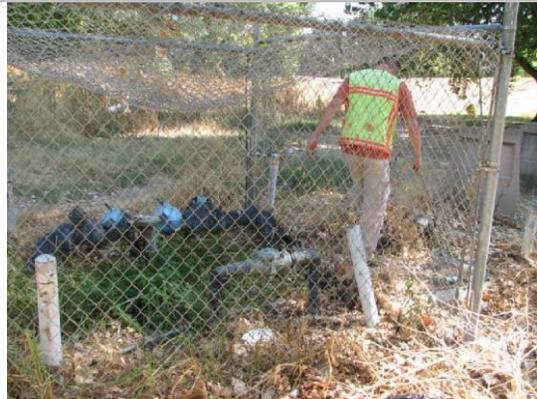
Photo 2 of 2 : UCIP_FA_2015_0164.jpg

Waterside view- pipe daylight in a cage.

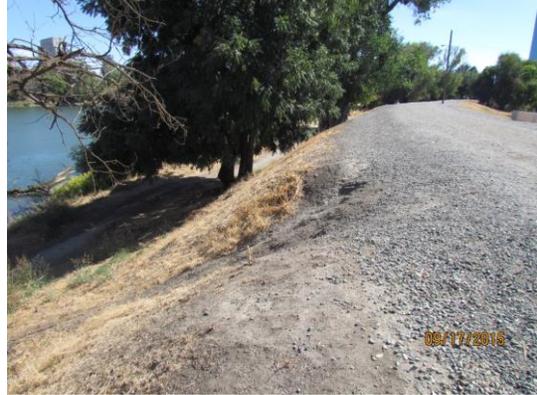
Photo 1 of 1 : FA_2015_MA0004_298_24_20150921_00028.jpg

LM Start	2.91	Rating **	M	Issue No.	24
LM End	2.91	Issue Type +	Ma	Location *	WS
Category	Earthen Levee		GPS Latitude/Longitude		
			Start	End	
Item	Slope Stability		38.588937 °	38.588937 °	
			-121.507920 °	-121.507920 °	
DWR ID	DWR_MA0004_01_f_2015_24				
Action/Comments					
Repair the levee slope damaged by foot traffic and prevent access where possible.

View of the slope stability due to foot traffic on the waterward side of the levee looking downstream. Fall 2015.

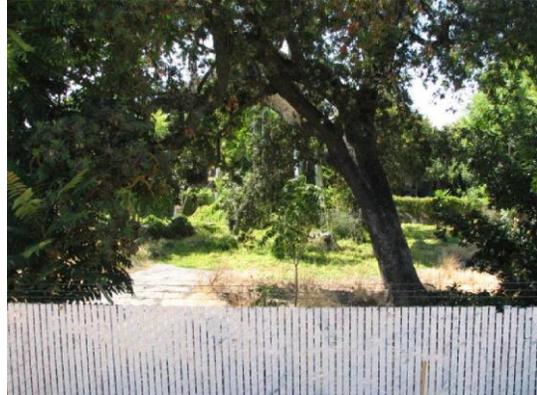
Photo 1 of 1 : UCIP_FA_2015_0147.jpg

LM Start	2.92	Rating **	M	Issue No.	31
LM End	2.92	Issue Type +	En	Location *	WS
Category	Supplemental		GPS Latitude/Longitude		
			Start	End	
Item	DWR UCIP Field Study		38.588688 °	38.588688 °	
			-121.507910 °	-121.507910 °	
DWR ID					
Action/Comments					
Inspector Comments: FS_ID:41557 DS_ID:18883 EP_NO: N/A FS_HLM: 2.896 Repair Type: Non-Urgent Crossing Status: Found UCIP Comments: Abandoned 7-inch pipe found. Needs to be abandoned properly. FIELD_STRUCT_DESC: 2 of 4. An abandoned 7-inch pipe of one 3-inch, two 7-inch and one 10-inch pipes through the levee 18.6 feet below the crown. Unable to locate. Pipes exposed and extend 10 feet from bank. O&M Manual Sac 116, August 1955, Revision Year 2011. FS Date: 09/12/2012

Land side view- Water tower area.

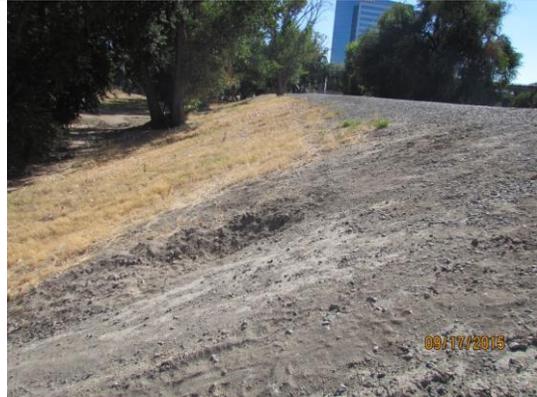
Photo 1 of 1 : FA_2015_MA0004_298_25_20150921_00029.jpg

LM Start	2.97	Rating **	M	Issue No.	25
LM End	2.97	Issue Type +	Ma	Location *	WS
Category	Earthen Levee			GPS Latitude/Longitude	
				Start	End
Item	Slope Stability			38.587998 °	38.587998 °
				-121.507896 °	-121.507896 °
DWR ID	DWR_MA0004_01_f_2015_25				
Action/Comments					
Repair slope instability.

View of the depression on the waterward side of the levee looking downstream. Fall 2015.

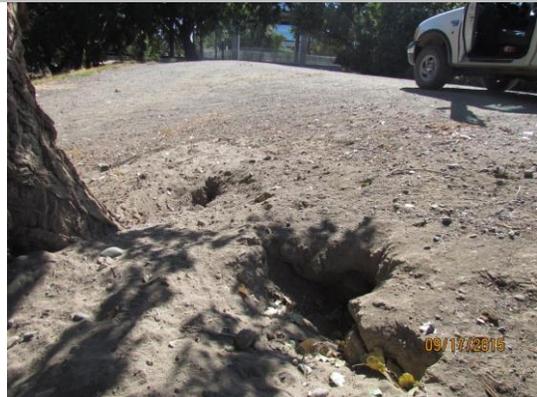
Photo 1 of 1 : FA_2015_MA0004_298_26_20150921_00030.jpg

LM Start	3.01	Rating **	M	Issue No.	26
LM End	3.01	Issue Type +	Ma	Location *	WS
Category	Earthen Levee			GPS Latitude/Longitude	
				Start	End
Item	Animal Control			38.587406 °	38.587406 °
				-121.507991 °	-121.507991 °
DWR ID	DWR_MA0004_01_f_2015_26				
Action/Comments					
No rodents visible, but rodent burrows visible; need to backfill and compact or grout burrows.

View of the animal hole on the waterward side of the levee looking downstream. Fall 2015.

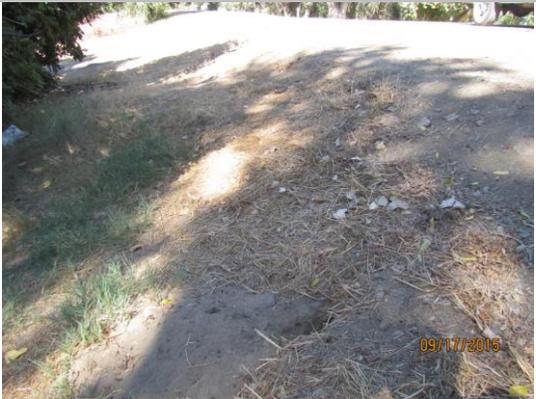
Photo 1 of 1 : FA_2015_MA0004_298_3_20150921_00031.jpg

LM Start	3.03	Rating **	M	Issue No.	3
LM End	3.03	Issue Type +	Ma	Location *	LS
Category	Earthen Levee			GPS Latitude/Longitude	
				Start	End
Item	Animal Control			38.587135 °	38.587135 °
				-121.508093 °	-121.508093 °
DWR ID	DWR_MA0004_01_f_2015_3				
Action/Comments					
No rodents visible, but rodent burrows visible; need to backfill and compact or grout burrows. Inspector Comments: There are holes in the surrounding area that are hidden by vegetation.

Rodent holes are still visible on the landward side of the levee. Photo taken looking upstream. Fall 2015.

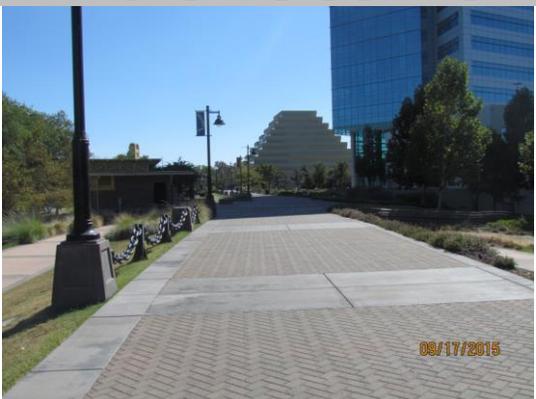
Photo 1 of 2 : FA_2015_MA0004_298_12_20150921_00033.jpg

LM Start	3.14	Rating **	A/W	Issue No.	12
LM End	3.40	Issue Type +	En	Location *	WS
Category	Earthen Levee			GPS Latitude/Longitude	
				Start	End
Item	Vegetation			38.585642 °	38.534710 °
				-121.508385 °	-121.517390 °
DWR ID	DWR_MA0004_01_s_2012_12				
Action/Comments					
Landscaping Inspector Comments: West Sacramento's River walk runs from Tower Bridge to the I Street bridge.

The Riverwalk is part of the landscape on the levee. Fall 2015.

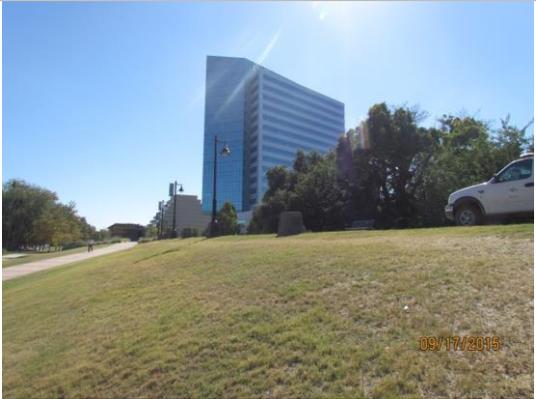
Photo 2 of 2 : FA_2015_MA0004_298_12_20150921_00032.jpg

Landscaping and buildings are on the crown and waterward side of the levee. Fall 2015.

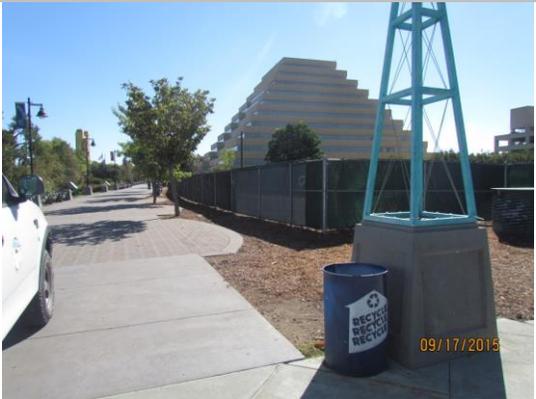
Photo 1 of 2 : FA_2015_MA0004_298_27_20150921_00034.jpg

View of the fence on the crown of the levee looking downstream. Fall 2015.

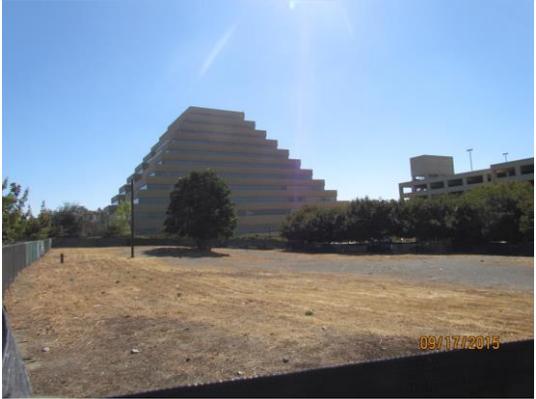
Photo 2 of 2 : FA_2015_MA0004_298_27_20150921_00035.jpg

View of the inside of the fence looking downstream. Fall 2015.
