**Flood Control Project Maintenance
Levee Inspections**
LMA District Cover Sheet
Spring 2016 Levee Inspection Results

Sutter Maintenance Yard Maintenance Area 0007

Spring 2016 Levee Inspection Results

Waterway		Bank	Unit Miles
Unit No. 01 Feather River		Right	11.90

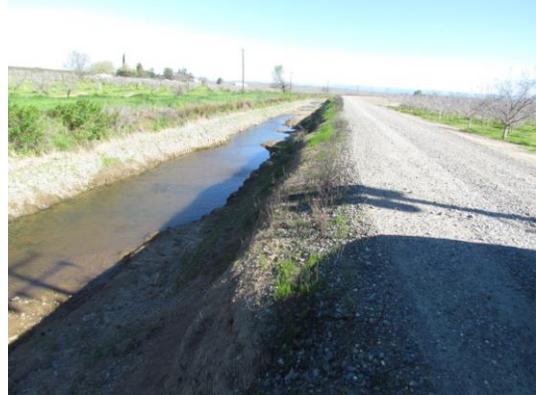
Photo 1 of 2 : SP_2016_MA0007_200_42_20160307_00007.jpg

This photo was taken from the levee crown facing north looking at the erosion along the landward levee slope due to an agricultural ditch. Spring 2014.

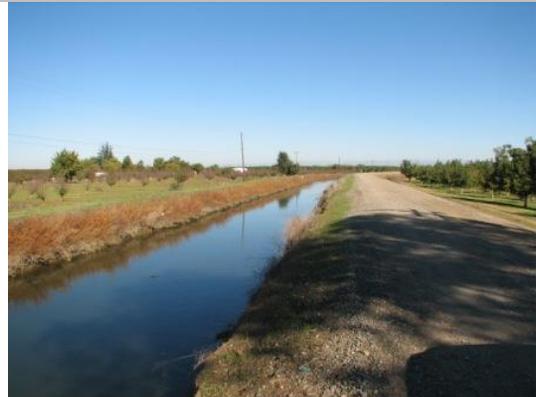
Photo 2 of 2 : SP_2016_MA0007_200_42_20160307_00008.jpg

Agricultural ditch landside slope and toe.

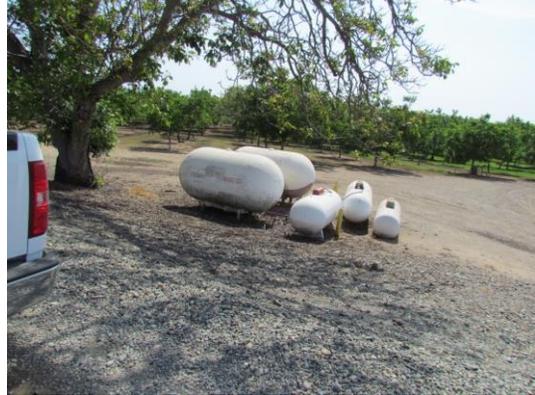
Photo 1 of 1 : SP_2016_MA0007_200_48_20160307_00011.jpg

This view of the tanks was taken looking at the waterside of the levee facing upstream.

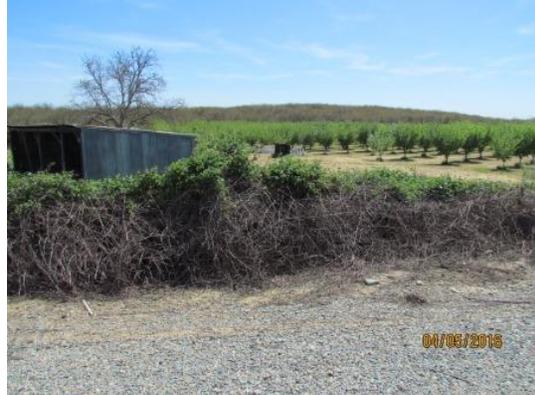
Photo 1 of 1 : SP_2016_MA0007_200_67_20160418_00117.jpg

View of landside toe vegetation looking downstream.

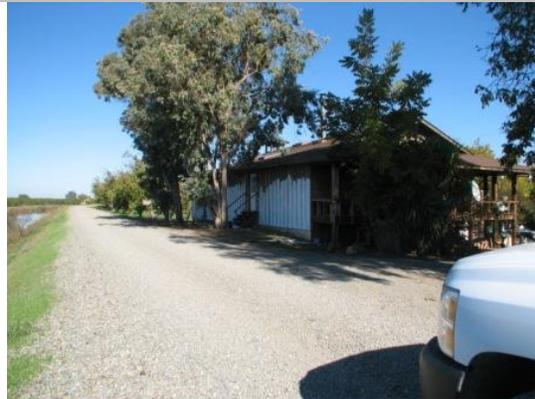
Photo 1 of 1 : SP_2016_MA0007_200_33_20160307_00003.jpg

LM Start	1.21	Rating **	U	Issue No.	33
LM End	1.21	Issue Type +	En	Location *	WS
Category	Earthen Levee		GPS Latitude/Longitude		
			Start	End	
Item	Encroachments		39.327187 °	39.327187 °	
			-121.632395 °	-121.632395 °	
DWR ID	DWR_MA0007_01_s_2012_33				
Comment Code					
BU : Building					
Inspector Comment

Levee mile 1.21. This is a photo of the building on the waterside slope.

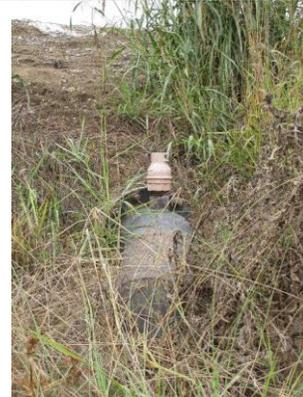
Photo 2 of 2 : UCIP_SP_2016_47834_65805.jpg

Exposed section of the pipe located on WS slope.

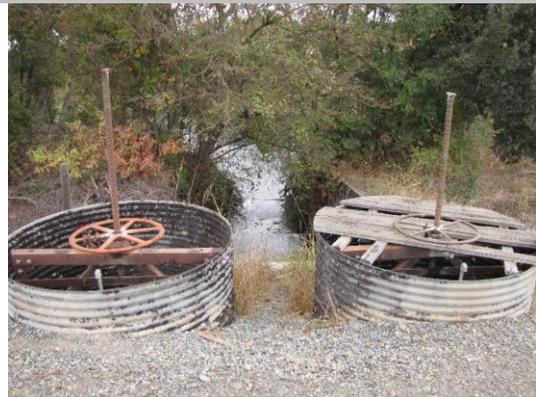
Photo 2 of 2 : UCIP_SP_2016_47836_65813.jpg

78-inch CMP risers located on WS slope. Upstream riser (far left) missing riser cover. Reinforced concrete spillway also located on WS end.

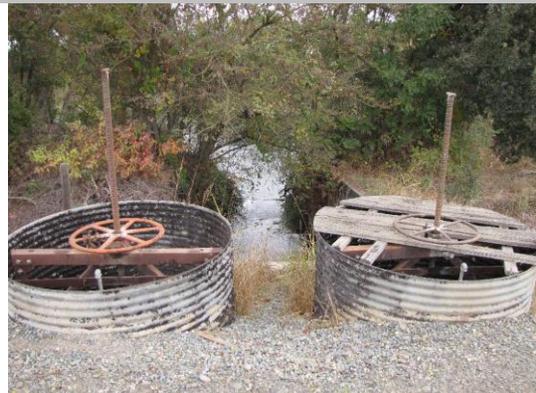
Photo 2 of 2 : UCIP_SP_2016_47837_65819.jpg

78-inch CMP risers located on WS slope. Upstream riser (far left) missing riser cover. Reinforced concrete spillway also located on WS end.

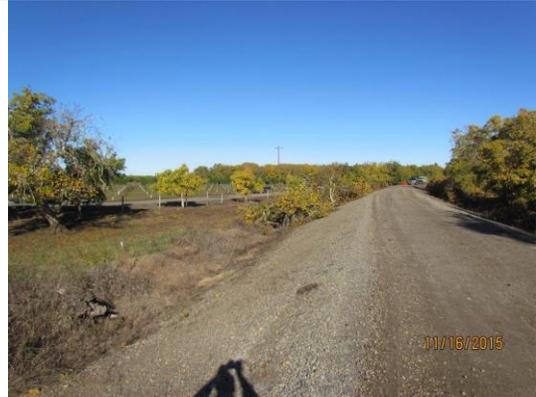
Photo 1 of 1 : SP_2016_MA0007_200_41_20160307_00006.jpg

View of the down trees along the landside slope and toe.

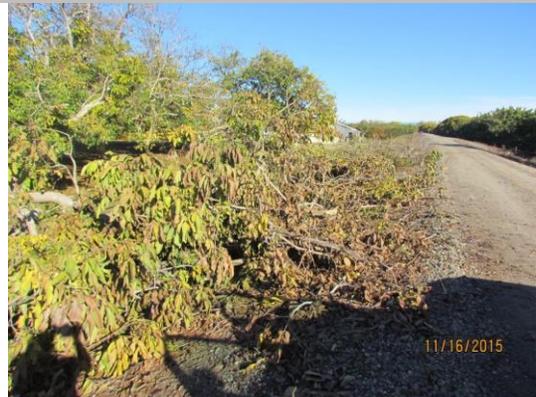
Photo 1 of 1 : SP_2016_MA0007_200_52_20160307_00014.jpg

LM Start	1.93	Rating **	M	Issue No.	52
LM End	1.93	Issue Type +	En	Location *	LS
Category	Earthen Levee		GPS Latitude/Longitude		
			Start	End	
Item	Encroachments		39.337336 °	39.337336 °	
			-121.633536 °	-121.633536 °	
DWR ID	DWR_MA0007_01_s_2015_52				
Comment Code					
PR : Prunings					
Inspector Comment					
SBFCA Is removing trees as part of their ongoing construction project.

View of the down trees along the landside slope and toe.

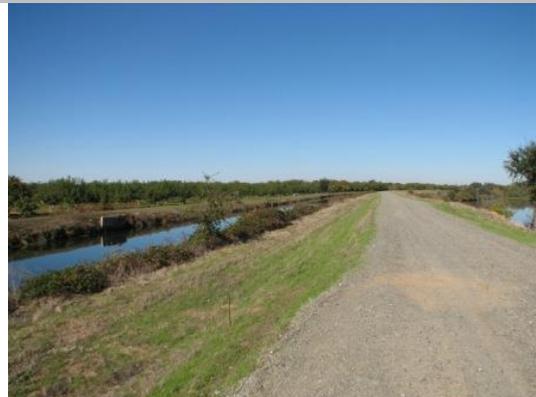
Photo 1 of 2 : SP_2016_MA0007_200_39_20160307_00004.jpg

Ag ditch landside slope and toe.

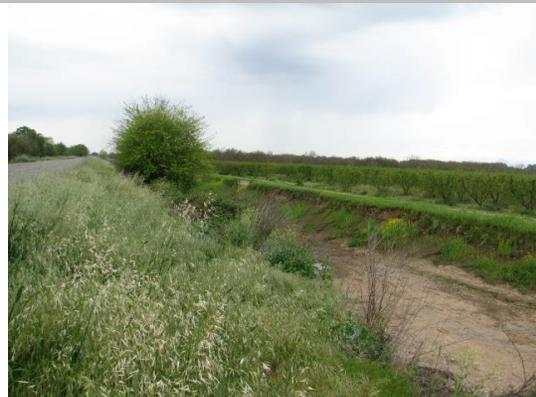
Photo 2 of 2 : SP_2016_MA0007_200_39_20160307_00005.jpg

This is a photo of the Ag ditch on the landside slope and toe.

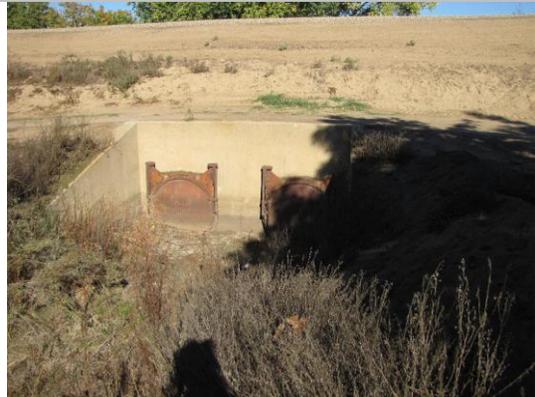
Photo 2 of 2 : UCIP_SP_2016_48005_65905.jpg

View of headwall structure on WS. Sediment built up

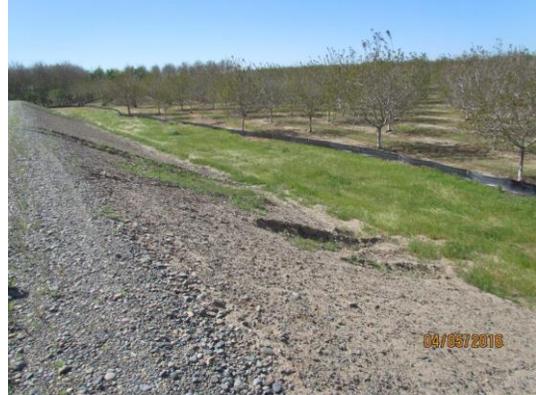
Photo 1 of 1 : SP_2016_MA0007_200_58_20160418_00111.jpg

Ruts in landside slope from equipment looking downstream.

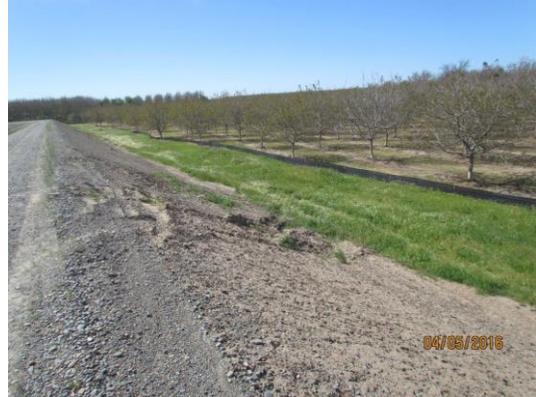
Photo 1 of 1 : SP_2016_MA0007_200_57_20160418_00110.jpg

Ruts in landside slope from equipment.

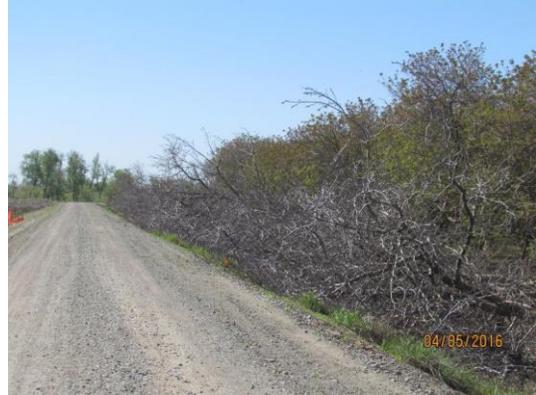
Photo 1 of 1 : SP_2016_MA0007_200_55_20160418_00109.jpg

Pruning's from trees that are being removed from right-of-way, Spring 2016.

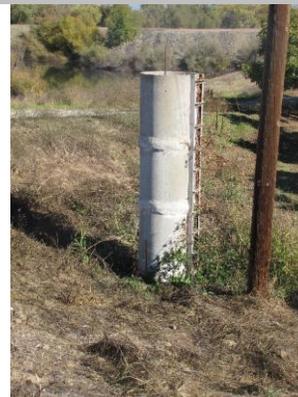
Photo 1 of 2 : UCIP_SP_2016_47989_65939.jpg

WS view of concrete standpipe with blackberry shrubs preventing access to latter.

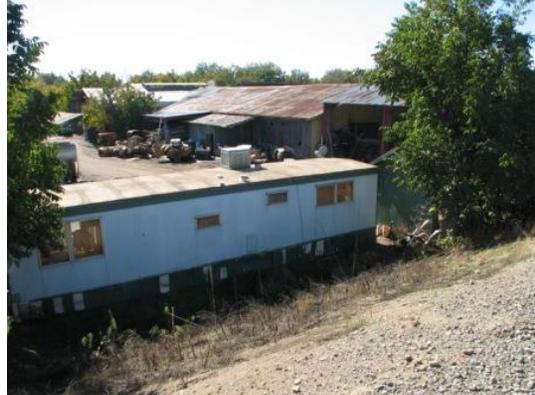
Photo 1 of 1 : SP_2016_MA0007_200_45_20160307_00010.jpg

This photo shows a building at the landside toe.

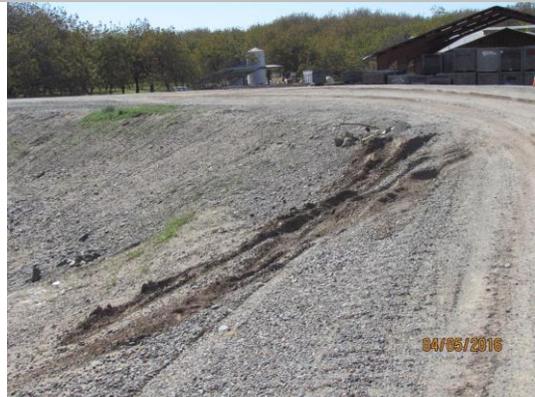
Photo 1 of 1 : SP_2016_MA0007_200_53_20160418_00108.jpg

Ruts on waterside slope caused by equipment, Spring 2016.

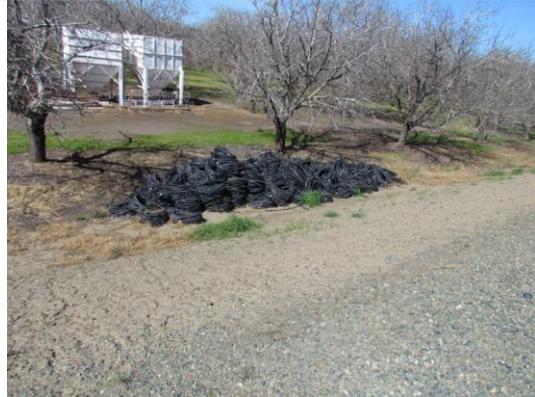
Photo 1 of 1 : SP_2016_MA0007_200_51_20160307_00013.jpg

This photo was taken from the levee crown facing north looking at irrigation pipe placed on the levee slope near the landward toe. Spring 2014.

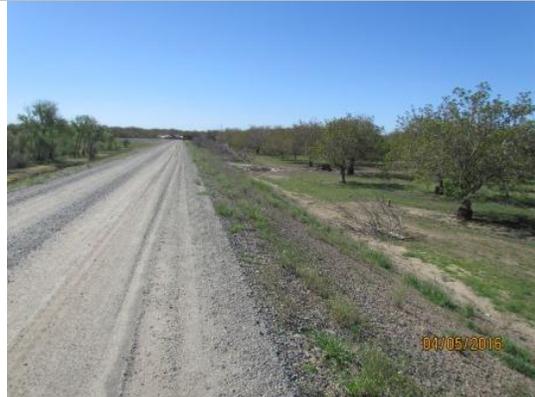
Photo 1 of 1 : SP_2016_MA0007_200_49_20160418_00107.jpg

View looking downstream of pruning's at landside toe.

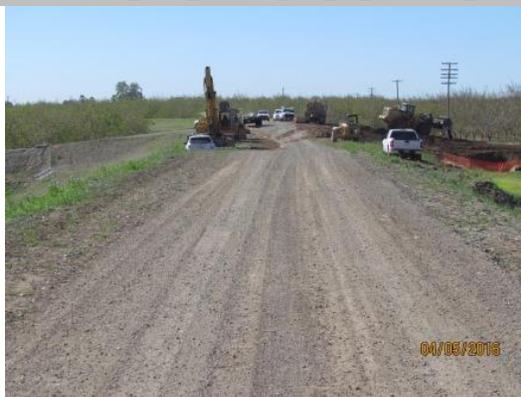
Photo 1 of 1 : SP_2016_MA0007_200_46_20160418_00105.jpg

Depression in the levee is being filled as part of the reconstruction.
