**Flood Control Project Maintenance
Levee Inspections**

Maintenance Issue Types Only, Levee Inspection Report By Mile - Fall 2015

Sutter Maintenance Yard Maintenance Area 0007

Waterway	Bank	Unit Miles	Inspection Start/End	Inspector
Unit No. 01 Feather River	Right	11.90	11/16/2015 11/16/2015	Bob Duffey

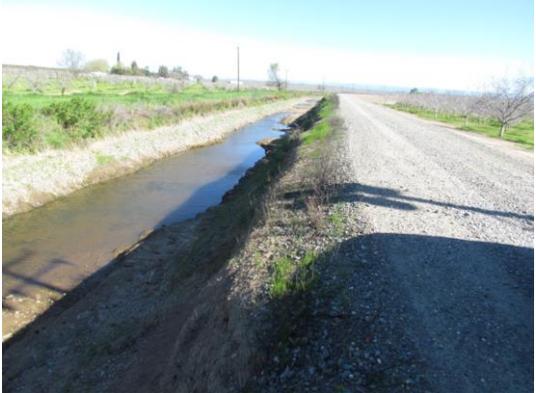
Photo 1 of 2 : FA_2015_MA0007_200_42_20151109_00006.jpg

LM Start	0.03	Rating **	M	Issue No.	42
LM End	1.72	Issue Type +	Ma	Location *	LS
Category	Earthen Levee		GPS Latitude/Longitude		
			Start	End	
Item	Erosion / Bank Caving		39.311297 °	39.334365 °	
			-121.637490 °	-121.633975 °	
DWR ID	DWR_MA0007_01_s_2012_42				
Action/Comments					
Note and monitor erosion site. Inspector Comments: Erosion along landward levee slope due to agricultural ditch.

This photo was taken from the levee crown facing north looking at the erosion along the landward levee slope due to an agricultural ditch. Spring 2014.

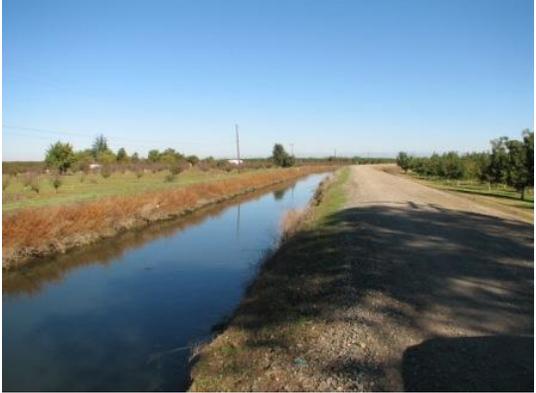
Photo 2 of 2 : FA_2015_MA0007_200_42_20151109_00007.jpg

Agricultural ditch landside slope and toe.

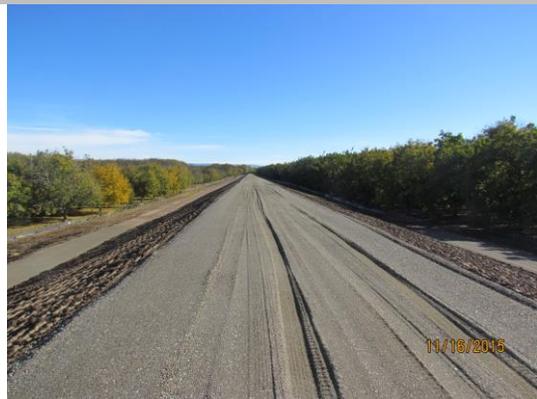
Photo 1 of 1 : FA_2015_MA0007_200_49_20151118_00019.jpg

LM Start	3.25	Rating **	A	Issue No.	49
LM End	11.89	Issue Type +	Ma	Location *	CR
Category	Earthen Levee			GPS Latitude/Longitude	
				Start	End
Item	Crown Surface / Depressions / Rutting			39.354193 °	39.439672 °
				-121.634230 °	-121.641448 °
DWR ID	DWR_MA0007_01_f_2015_49				
Action/Comments					
Add appropriate material and re-grade the levee to bring the crown above the design elevation. Inspector Comments: The SBFCA levee project is still in construction phase so I was unable to inspect the levee from levee mile 3.25 to 11.89.

View of the new gravel on the Crown roadway where the ongoing SBFCA construction project.
