**Flood Control Project Maintenance
Levee Inspections**

**Fall 2015 Levee Maintenance Deficiency Summary Report
Overall LMA & Unit Ratings, including USACE Erosion Survey**

Sutter Maintenance Yard Maintenance Area 0017

Levee Inspection Report By Mile - Fall 2015

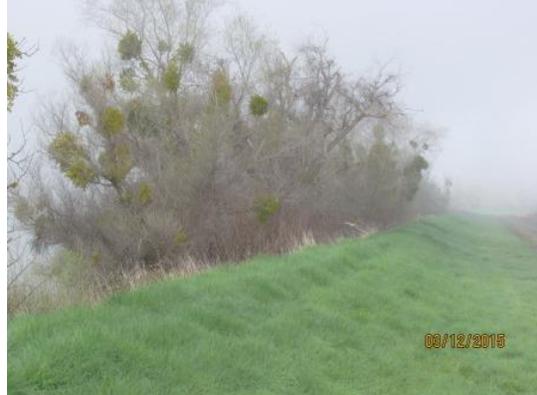
Photo 1 of 1 : FA_2015_MA0017_339_2_20150910_00002.jpg

LM Start	4.09	Rating **	U	Issue No.	2
LM End	7.23	Issue Type +	Ma	Location *	WS
Category	Earthen Levee		GPS Latitude/Longitude		
			Start	End	
Item	Trim / Thin Trees		39.142155 °	39.118735 °	
			-122.902343 °	-122.884892 °	
DWR ID	DWR_MA0017_01_s_2012_2				
Action/Comments					
Thin trees to allow visibility of the ground and room to flood fight. Inspector Comments: Trees and limbs are completely obstructing the visibility.

View of the trees along the waterside slope and toe.

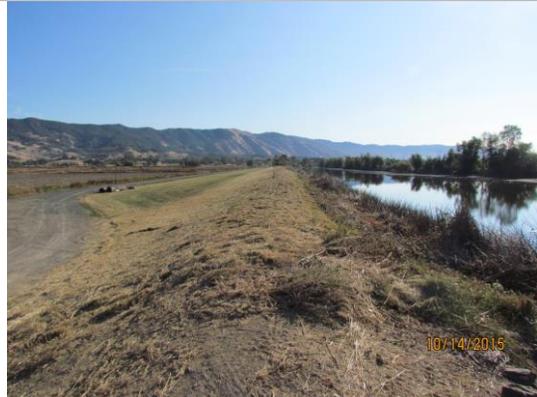
Photo 1 of 1 : FA_2015_MA0017_339_1_20151016_00007.jpg

LM Start	4.09	Rating **	A	Issue No.	1
LM End	7.11	Issue Type +	Ma	Location *	CR
Category	Earthen Levee		GPS Latitude/Longitude		
			Start	End	
Item	Vegetation		39.120513 °	39.120513 °	
			-122.887085 °	-122.887085 °	
DWR ID	DWR_MA0017_01_s_2015_1				
Action/Comments					
Control annual grass and weeds on the levee slopes and easements. Inspector Comments: Sutter Yard mowed the levee crown.

View of the mowed levee crown.

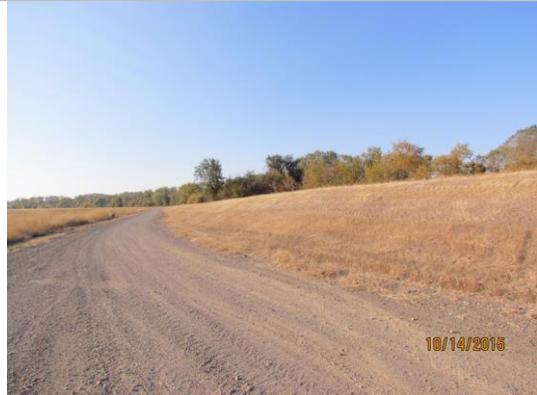
Photo 1 of 1 : FA_2015_MA0017_339_16_20151016_00005.jpg

LM Start	4.09	Rating **	A	Issue No.	16
LM End	7.28	Issue Type +	Ma	Location *	LS
Category	Earthen Levee		GPS Latitude/Longitude		
			Start	End	
Item	Vegetation		39.141417 °	39.118730 °	
			-122.901922 °	-122.884908 °	
DWR ID	DWR_MA0017_01_f_2015_16				
Action/Comments					
Control annual grass and weeds on the levee slopes and easements. Inspector Comments: Sutter Yard mowed the landside slope.

View of no vegetation on the landside slope.

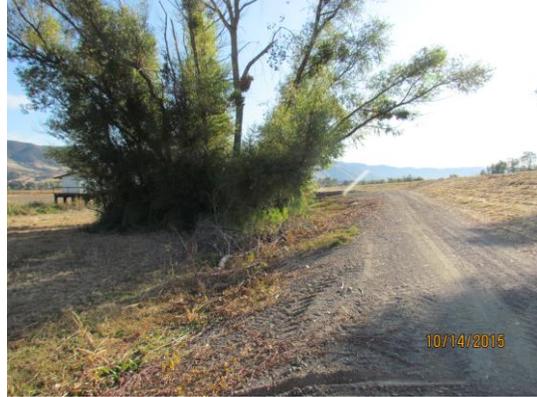
Photo 1 of 1 : FA_2015_MA0017_339_18_20151016_00008.jpg

LM Start	5.27	Rating **	A	Issue No.	18
LM End	5.27	Issue Type +	En	Location *	LS
Category	Earthen Levee		GPS Latitude/Longitude		
			Start	End	
Item	Encroachments		39.127544 °	39.127544 °	
			-122.893763 °	-122.893763 °	
DWR ID	DWR_MA0017_01_s_2014_18				
Action/Comments					
Tree or limb Inspector Comments: Sutter Yard remove the tree limbs from the landside toe.

View of the removed tree limbs.

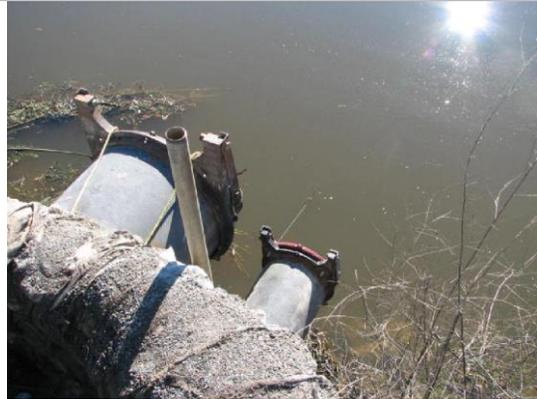
Photo 1 of 2 : UCIP_FA_2015_2786.jpg

LM Start	5.34	Rating **	M	Issue No.	20
LM End	5.34	Issue Type +	En	Location *	LS
Category	Supplemental		GPS Latitude/Longitude		
			Start	End	
Item	DWR UCIP Field Study		39.127449 °	39.127449 °	
			-122.893460 °	-122.893460 °	
DWR ID					
Action/Comments					
Inspector Comments: FS_ID:44730 DS_ID:847 EP_NO: 11469 FS_HLM: 5.375 Repair Type: Non-Urgent Crossing Status: Found UCIP Comments: 4/23/2015 Sack ring is still built up underneath the pipes.flood fight materials-ring levees around both LS and WS slopes at pipe crossing. This may or may not be an issue.8/2/2013 Same as last inspection.12/23/2013 Same as last inspection.7/3/2014 Same as last inspection. FIELD_STRUCT_DESC: 1 of 2: 16 inch steel drainpipe through the levee 5-feet below the crown. Drainage pumping plant on the landward side. Flap gate on the waterward end. (ABO No.11469-R.D.# 2070). This entry matches the Drainage/Irrigation Structure referenced in O&M manual (Levee Mile 5.43). Permit document and O&M referred As-built drawings are available. O&M manual Vol. 5, Revision Year 2010. FS Date: 04/24/2015

16-inch pipe, flap gate, air vent, and ring levee on WS slope.

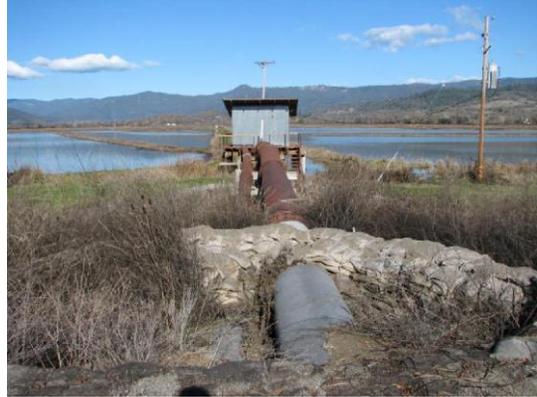
Photo 2 of 2 : UCIP_FA_2015_2787.jpg

LM Start	5.34	Rating **	M	Issue No.	20 (cont)
LM End	5.34	Issue Type +	En	Location *	LS
Category	Supplemental			GPS Latitude/Longitude	
			Start	End	
Item	DWR UCIP Field Study			39.127449 °	39.127449 °
DWR ID				-122.893460 °	-122.893460 °
Action/Comments					
Inspector Comments: FS_ID:44730 DS_ID:847 EP_NO: 11469 FS_HLM: 5.375 Repair Type: Non-Urgent Crossing Status: Found UCIP Comments: 4/23/2015 Sack ring is still built up underneath the pipes.flood fight materials-ring levees around both LS and WS slopes at pipe crossing. This may or may not be an issue.8/2/2013 Same as last inspection.12/23/2013 Same as last inspection.7/3/2014 Same as last inspection. FIELD_STRUCT_DESC: 1 of 2: 16 inch steel drainpipe through the levee 5-feet below the crown. Drainage pumping plant on the landward side. Flap gate on the waterward end. (ABO No.11469-R.D.# 2070). This entry matches the Drainage/Irrigation Structure referenced in O&M manual (Levee Mile 5.43). Permit document and O&M referred As-built drawings are available. O&M manual Vol. 5, Revision Year 2010. FS Date: 04/24/2015

Pumping plant, pipes, and ring levees on LS toe.

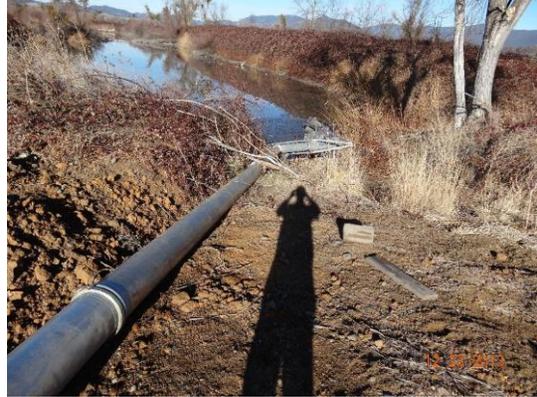
Photo 1 of 1 : UCIP_FA_2015_2655.jpg

LM Start	5.99	Rating **	M	Issue No.	23
LM End	5.99	Issue Type +	En	Location *	LS
Category	Supplemental			GPS Latitude/Longitude	
				Start	End
Item	DWR UCIP Field Study			39.126057 °	39.126057 °
				-122.883096 °	-122.883096 °
DWR ID					
Action/Comments					
Inspector Comments: FS_ID:44735 DS_ID:20589 EP_NO: N/A FS_HLM: 6.018 Repair Type: Non-Urgent Crossing Status: Found

Portable pump on WS and temporary piping over roadway

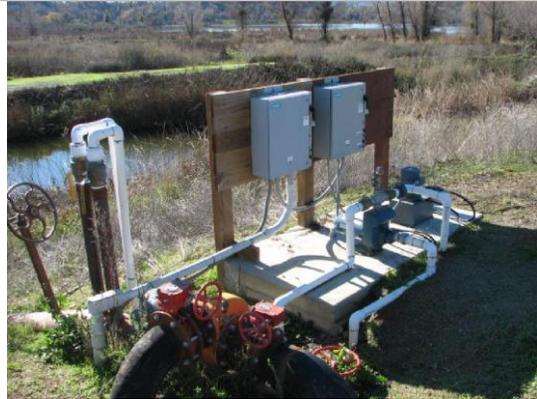
Photo 1 of 3 : UCIP_FA_2015_2792.jpg

LM Start	6.00	Rating **	U	Issue No.	24
LM End	6.00	Issue Type +	En	Location *	LS
Category	Supplemental			GPS Latitude/Longitude	
				Start	End
Item	DWR UCIP Field Study			39.126038 °	39.126038 °
				-122.883351 °	-122.883351 °
DWR ID					
Action/Comments					
Inspector Comments: FS_ID:44737 DS_ID:20588 EP_NO: N/A FS_HLM: 6.032 Repair Type: Urgent Crossing Status: Found UCIP Comments: 4/23/2015 Erosion still present on WS shoulder.No permit for this crossing. It is unclear what these hydraulic lines are for, but it is probably the works for a hydraulic butterfly valve at the outlet.8/2/2013 Erosion on WS shoulder above pipes.12/23/2013 Same as last inspection.7/3/2014 Same as last inspection. FIELD_STRUCT_DESC: 4-inch PVC conduit through the levee 2-feet below the crown with hydraulic lines running through it to pump on LS shoulder. FS Date: 04/24/2015

Pump station on LS shoulder, see hydraulic pump at right.

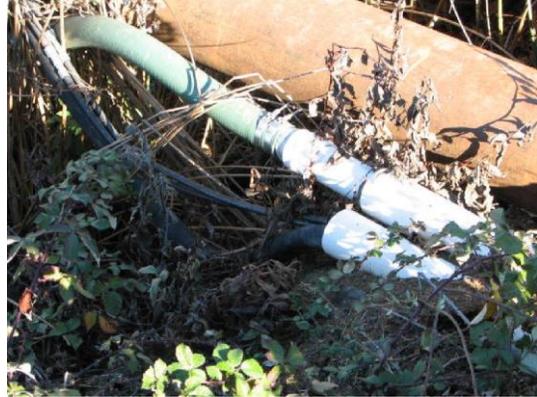
Photo 2 of 3 : UCIP_FA_2015_2793.jpg

LM Start	6.00	Rating **	U	Issue No.	24 (cont)
LM End	6.00	Issue Type +	En	Location *	LS
Category	Supplemental			GPS Latitude/Longitude	
				Start	End
Item	DWR UCIP Field Study			39.126038 °	39.126038 °
				-122.883351 °	-122.883351 °
DWR ID					
Action/Comments					
Inspector Comments: FS_ID:44737 DS_ID:20588 EP_NO: N/A FS_HLM: 6.032 Repair Type: Urgent Crossing Status: Found UCIP Comments: 4/23/2015 Erosion still present on WS shoulder.No permit for this crossing. It is unclear what these hydraulic lines are for, but it is probably the works for a hydraulic butterfly valve at the outlet.8/2/2013 Erosion on WS shoulder above pipes.12/23/2013 Same as last inspection.7/3/2014 Same as last inspection. FIELD_STRUCT_DESC: 4-inch PVC conduit through the levee 2-feet below the crown with hydraulic lines running through it to pump on LS shoulder. FS Date: 04/24/2015

Pipe and hydraulic lines on WS shoulder.

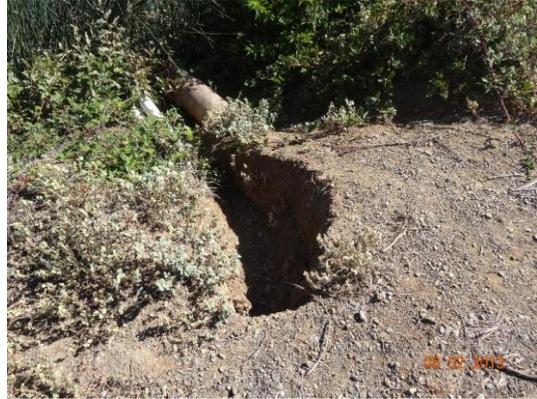
Photo 3 of 3 : UCIP_FA_2015_2794.jpg

Erosion on WS shoulder

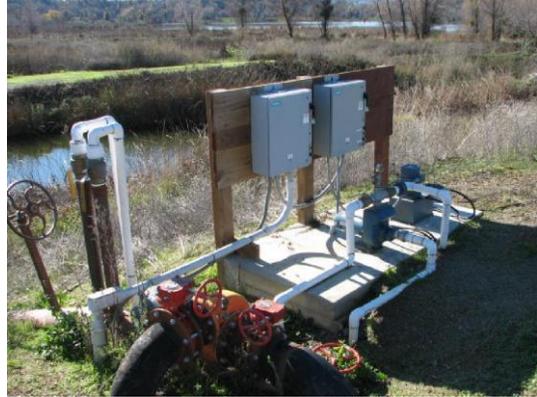
Photo 1 of 3 : UCIP_FA_2015_2795.jpg

LM Start	6.00	Rating **	U	Issue No.	25
LM End	6.00	Issue Type +	En	Location *	LS
Category	Supplemental			GPS Latitude/Longitude	
				Start	End
Item	DWR UCIP Field Study			39.126038 °	39.126038 °
				-122.883351 °	-122.883351 °
DWR ID					
Action/Comments					
Inspector Comments: FS_ID:44736 DS_ID:20587 EP_NO: N/A FS_HLM: 6.032 Repair Type: Urgent Crossing Status: Found

LS pump station on shoulder.

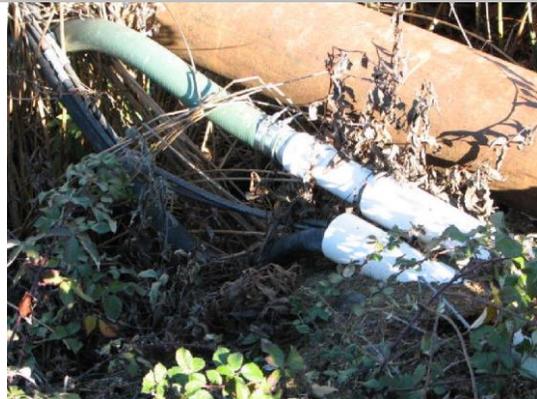
Photo 2 of 3 : UCIP_FA_2015_2796.jpg

4-inch pvc pipe with green flexible pipe running through it on WS shoulder.

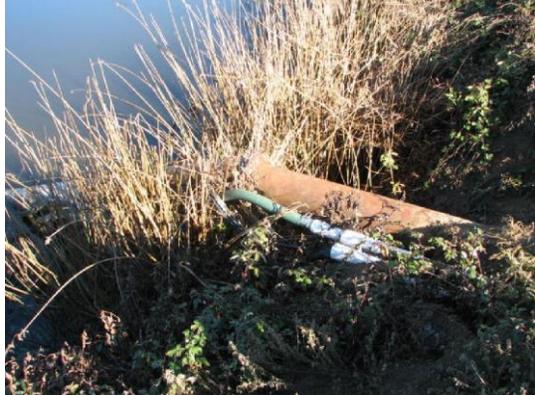
Photo 3 of 3 : UCIP_FA_2015_2797.jpg

LM Start	6.00	Rating **	U	Issue No.	25 (cont)
LM End	6.00	Issue Type +	En	Location *	LS
Category	Supplemental			GPS Latitude/Longitude	
				Start	End
Item	DWR UCIP Field Study			39.126038 °	39.126038 °
				-122.883351 °	-122.883351 °
DWR ID					
Action/Comments					
Inspector Comments: FS_ID:44736 DS_ID:20587 EP_NO: N/A FS_HLM: 6.032 Repair Type: Urgent Crossing Status: Found

4-inch pvc pipe with green flexible pipe running through it on WS shoulder.

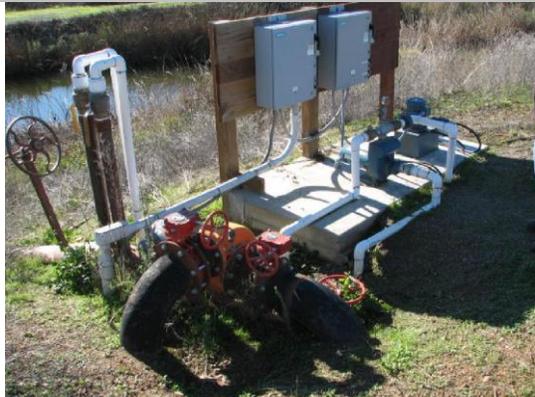
Photo 1 of 3 : UCIP_FA_2015_2806.jpg

LM Start	6.00	Rating **	M	Issue No.	26
LM End	6.00	Issue Type +	En	Location *	LS
Category	Supplemental			GPS Latitude/Longitude	
				Start	End
Item	DWR UCIP Field Study			39.126027 °	39.126027 °
				-122.883371 °	-122.883371 °
DWR ID					
Action/Comments					
Inspector Comments: FS_ID:44738 DS_ID:850 EP_NO: 11467 FS_HLM: 6.033 Repair Type: Non-Urgent Crossing Status: Found UCIP Comments: 4/23/2015 Same as last inspection.This pipe and appurtances do not match what was described in the permit (PN: 11467). Does not appear to be in compliance with board regulations.8/2/2013 Same as last inspection.12/23/2013 Same as last inspection.7/3/2014 Same as last inspection. FIELD_STRUCT_DESC: 12-inch drainpipe through the levee, 2-feet below the crown. Butterfly Valve on the landward shoulder. Pump and electric panel along with multiple valves and appurtances on LS shoulder. (ABO No.11467-Modglin)O&M manual Vol. 5, Revision Year 2010. FS Date: 04/24/2015

Pumping plant and appurtances on LS shoulder.

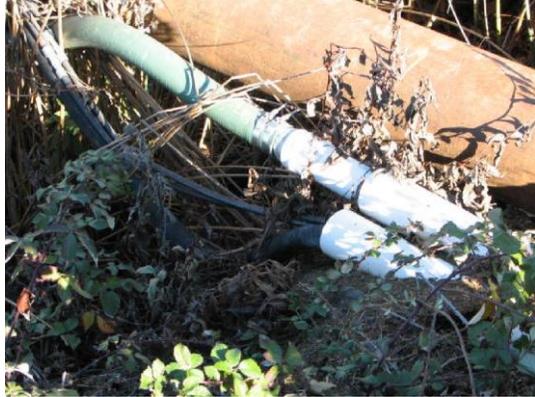
Photo 2 of 3 : UCIP_FA_2015_2807.jpg

LM Start	6.00	Rating **	M	Issue No.	26 (cont)
LM End	6.00	Issue Type +	En	Location *	LS
Category	Supplemental			GPS Latitude/Longitude	
				Start	End
Item	DWR UCIP Field Study			39.126027 °	39.126027 °
				-122.883371 °	-122.883371 °
DWR ID					
Action/Comments					
Inspector Comments: FS_ID:44738 DS_ID:850 EP_NO: 11467 FS_HLM: 6.033 Repair Type: Non-Urgent Crossing Status: Found UCIP Comments: 4/23/2015 Same as last inspection.This pipe and appurtances do not match what was described in the permit (PN: 11467). Does not appear to be in compliance with board regulations.8/2/2013 Same as last inspection.12/23/2013 Same as last inspection.7/3/2014 Same as last inspection. FIELD_STRUCT_DESC: 12-inch drainpipe through the levee, 2-feet below the crown. Butterfly Valve on the landward shoulder. Pump and electric panel along with multiple valves and appurtances on LS shoulder. (ABO No.11467-Modglin)O&M manual Vol. 5, Revision Year 2010. FS Date: 04/24/2015

12-inch pipe and appurtances on WS shoulder.

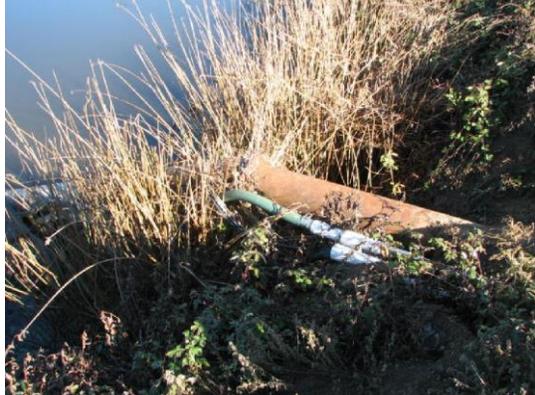
Photo 3 of 3 : UCIP_FA_2015_2808.jpg

12-inch pipe and appurtances on WS shoulder.

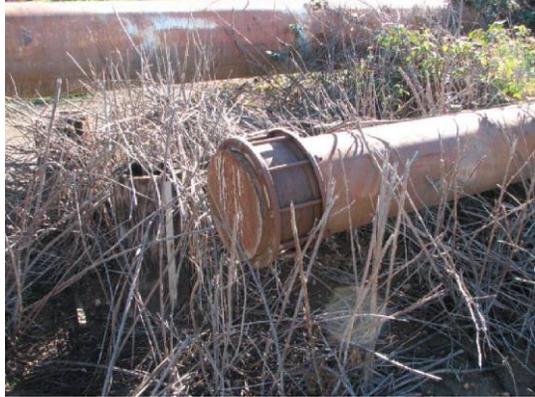
Photo 1 of 2 : UCIP_FA_2015_2809.jpg

LM Start	7.15	Rating **	M	Issue No.	27
LM End	7.15	Issue Type +	En	Location *	LS
Category	Supplemental			GPS Latitude/Longitude	
				Start	End
Item	DWR UCIP Field Study			39.120083 °	39.120083 °
				-122.886502 °	-122.886502 °
DWR ID					
Action/Comments					
Inspector Comments: FS_ID:44739 DS_ID:851 EP_NO: 11467 FS_HLM: 7.185 Repair Type: Non-Urgent Crossing Status: Found

Steel plate welded over end of pipe at LS toe.

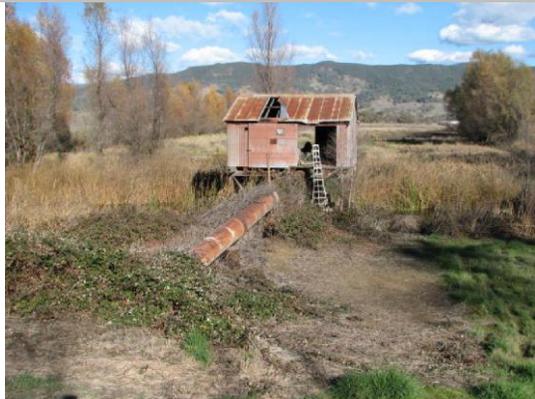
Photo 2 of 2 : UCIP_FA_2015_2810.jpg

Pumping plant in shed on LS at drainage ditch.
