**Flood Control Project Maintenance  
Levee Inspections**

**Fall 2015 Levee Maintenance Deficiency Summary Report**

**Sacramento River Basin**

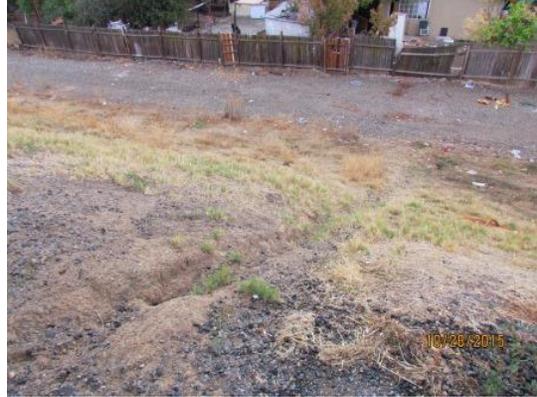
Photo 1 of 1 : FA\_2015\_NA0001\_51\_81\_20151112\_00063.jpg

LM Start	<b>0.46</b>	Rating **	M	Issue No.	<b>81</b>
LM End	<b>0.46</b>	Issue Type +	Ma	Location *	LS
Category	Earthen Levee		GPS Latitude/Longitude		
			Start	End	
Item	Slope Stability		38.623101 °	38.623101 °	
			-121.460573 °	-121.460573 °	
DWR ID	DWR_NA0001_01_f_2015_81				
Action/Comments					
Repair the levee slope damaged by foot traffic and prevent access where possible.

View of the landside levee slope damaged by foot traffic.

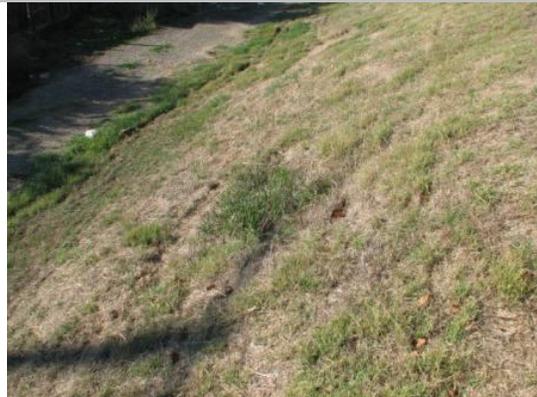
Photo 2 of 2 : FA\_2015\_NA0001\_51\_164\_20150910\_00035.jpg

LM Start	<b>0.48</b>	Rating **	A/W	Issue No.	<b>164</b>
LM End	<b>0.48</b>	Issue Type +	Ma	Location *	LS
Category	Earthen Levee		GPS Latitude/Longitude		
			Start	End	
Item	Erosion / Bank Caving		38.623227 °	38.623227 °	
			-121.460399 °	-121.460399 °	
DWR ID	DWR_NA0001_01_s_2012_164				
Action/Comments					
Note and monitor erosion site. Inspector Comments: 4'-5' diameter by 1' deep hole mid-slope on the landside.

11/17/2011 Hole/depression approximately mid-slope.

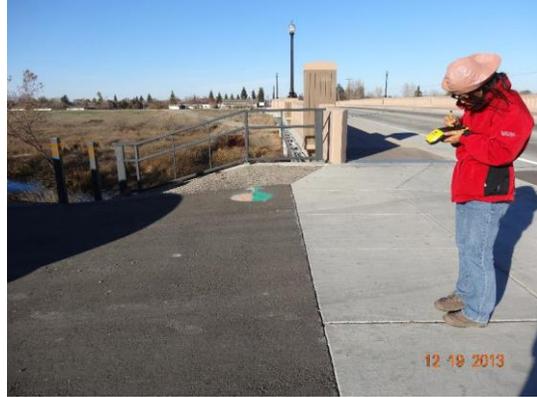
Photo 2 of 3 : UCIP\_FA\_2015\_4474.jpg

LM Start	<b>0.66</b>	Rating **	U	Issue No.	<b>186 (cont)</b>
LM End	<b>0.66</b>	Issue Type +	En	Location *	LS
Category	Supplemental			GPS Latitude/Longitude	
				Start	End
Item	DWR UCIP Field Study			38.623667 °	38.623667 °
				-121.457134 °	-121.457134 °
DWR ID					
Action/Comments					
Inspector Comments: FS_ID:31167 DS_ID:24266 EP_NO: 3417 FS_HLM: 0.662 Repair Type: Urgent Crossing Status: Found UCIP Comments: no markers visible on waterward or landward side indicating this is a gas line--need to contact owner to determine if this crossing is gas line. FIELD_STRUCT_DESC: 4-inch steel gas line through the levee, 1.5 feet below the crown. CM cutoff wall around pipe at center of levee. Pump hung on bridge for channel crossing. (Permit No. 3417-1961) FS Date: 12/19/2013

Paint on paved levee indicates crossing could be a storm drain.

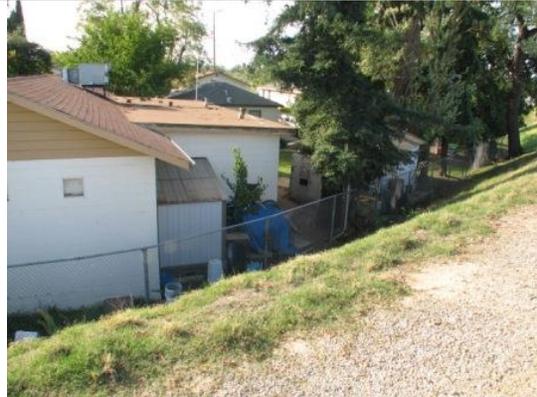
Photo 1 of 1 : FA\_2015\_NA0001\_51\_18\_20150910\_00016.jpg

Fall 2009 photo: Buildings and fence near levee toe.

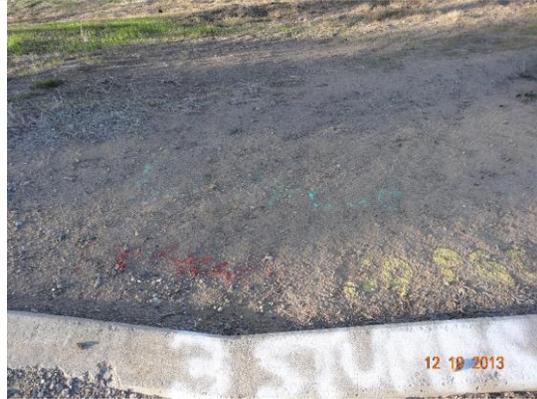
Photo 1 of 3 : UCIP\_FA\_2015\_3021.jpg

LM Start	<b>1.28</b>	Rating **	M	Issue No.	<b>188</b>
LM End	<b>1.28</b>	Issue Type +	En	Location *	LS
Category	Supplemental			GPS Latitude/Longitude	
				Start	End
Item	DWR UCIP Field Study			38.625500 °	38.625500 °
				-121.446390 °	-121.446390 °
DWR ID					
Action/Comments					
Inspector Comments: FS_ID:29732 DS_ID:24577 EP_NO: N/A FS_HLM: 1.272 Repair Type: Non-Urgent Crossing Status: Indicator Found UCIP Comments: Unable to confirm location--will need to coordinate with owner to determine if crossing is still active and determine location. FIELD_STRUCT_DESC: 2 of 3: 6-inch pipe through the levee, 8.0 feet below the crown. Flap gate on the waterward end. Floodgates within the levee across the channel, installed under Permit No. 14480 (1986). FS Date: 12/19/2013

Underground service alert (USA) paint markers visible on waterward shoulder--unable to confirm type of crossings.

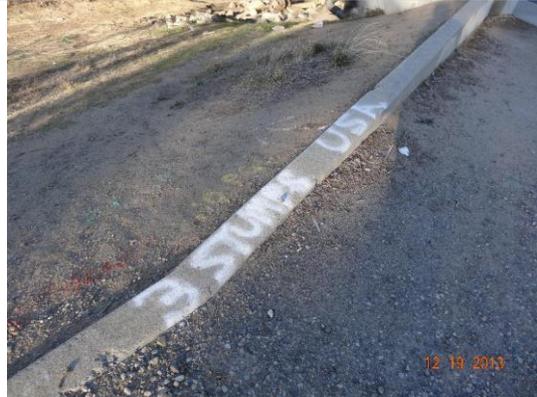
Photo 3 of 3 : UCIP\_FA\_2015\_3023.jpg

Floodwall visible along waterward shoulder.

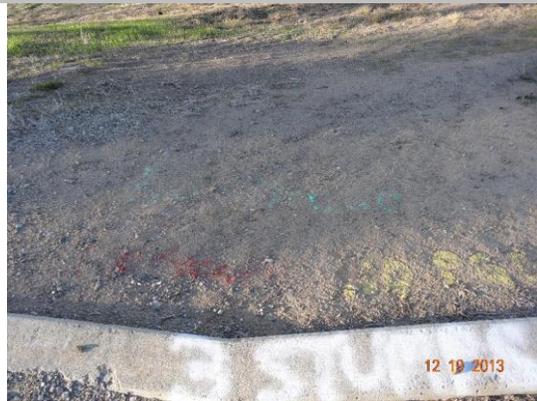
Photo 1 of 3 : UCIP\_FA\_2015\_4590.jpg

LM Start	<b>1.28</b>	Rating **	M	Issue No.	<b>189</b>
LM End	<b>1.28</b>	Issue Type +	En	Location *	LS
Category	Supplemental			GPS Latitude/Longitude	
				Start	End
Item	DWR UCIP Field Study			38.625500 °	38.625500 °
				-121.446390 °	-121.446390 °
DWR ID					
Action/Comments					
Inspector Comments: FS_ID:30085 DS_ID:24576 EP_NO: N/A FS_HLM: 1.271 Repair Type: Non-Urgent Crossing Status: Indicator Found UCIP Comments: Unable to confirm location--will need to coordinate with owner to determine if crossing is still active and determine location. FIELD_STRUCT_DESC: 1 of 3: 16-inch pipe through the levee, 8.0 feet below the crown. Floodgates within the levee across the channel, installed under Permit No. 14480 (1986). FS Date: 12/19/2013

Underground service alert (USA) paint markings visible on waterward slope.

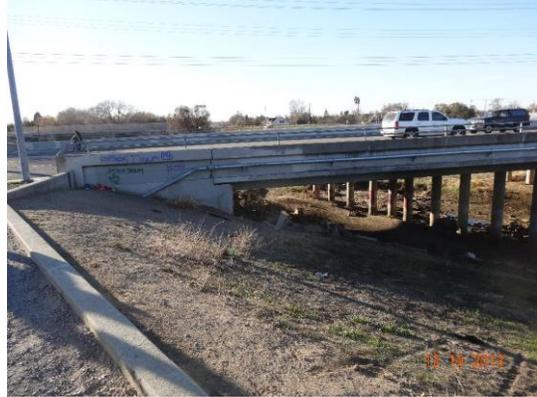
Photo 1 of 3 : UCIP\_FA\_2015\_3024.jpg

LM Start	<b>1.30</b>	Rating **	U	Issue No.	<b>190</b>
LM End	<b>1.30</b>	Issue Type +	En	Location *	LS
Category	Supplemental			GPS Latitude/Longitude	
				Start	End
Item	DWR UCIP Field Study			38.625603 °	38.625603 °
				-121.446035 °	-121.446035 °
DWR ID					
Action/Comments					
Inspector Comments: FS_ID:29734 DS_ID:24252 EP_NO: 15152 FS_HLM: 1.297 Repair Type: Urgent Crossing Status: Indicator Found

View of pipe across channel on the upstream face of bridge.

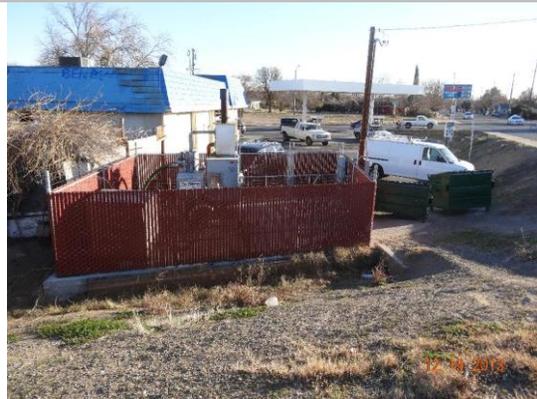
Photo 2 of 3 : UCIP\_FA\_2015\_3025.jpg

View of landward side. Unable to confirm if features shown in this photo are associated with gas line.

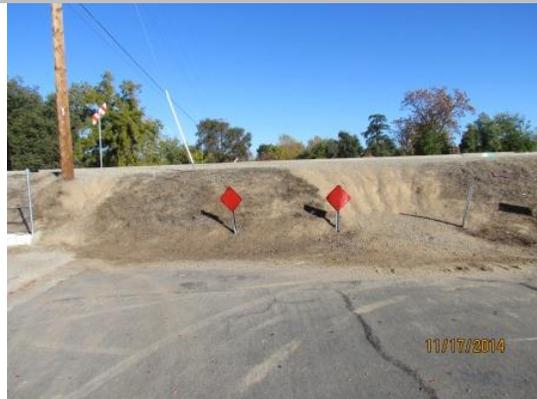
Photo 1 of 1 : FA\_2015\_NA0001\_51\_54\_20150910\_00031.jpg

Slope stability due to foot traffic needs to be monitored.

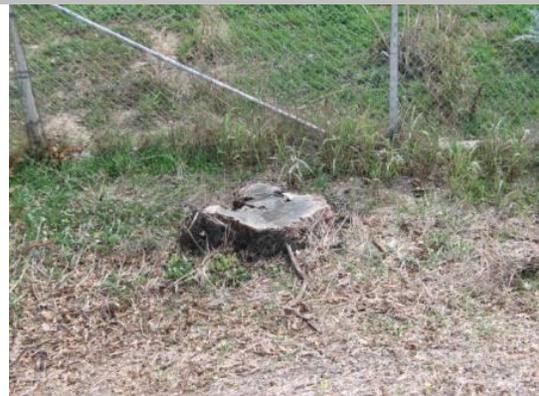
Photo 1 of 1 : FA\_2015\_NA0001\_51\_173\_20150910\_00040.jpg

11/17/2011 Stump at levee toe.

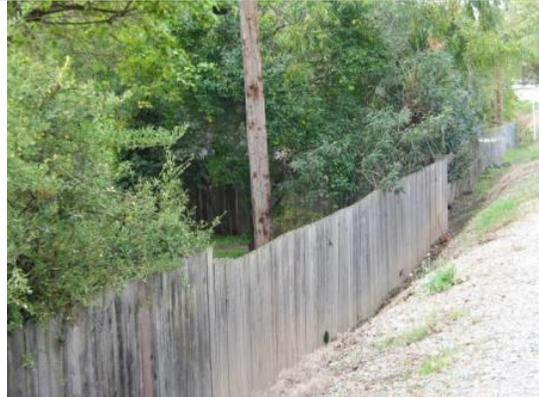
Photo 1 of 1 : FA\_2015\_NA0001\_51\_5\_20150910\_00004.jpg

11/17/2011 Wooden privacy fence built at the levee toe.

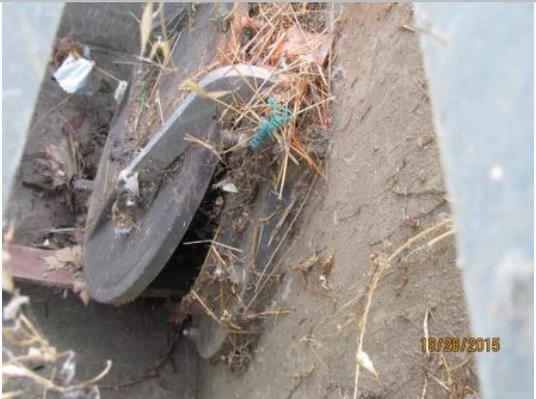
Photo 2 of 2 : FA\_2015\_NA0001\_51\_168\_20151112\_00055.jpg

View of the flap gate propped open by debris.

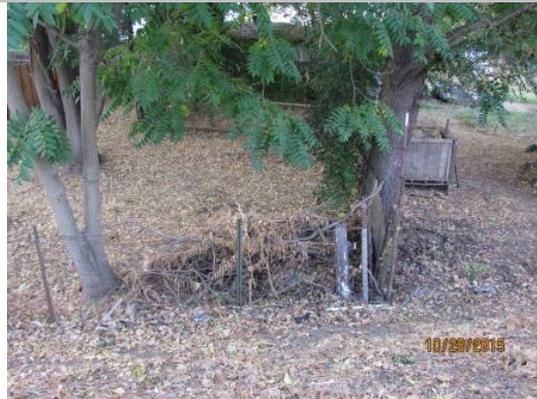
Photo 1 of 1 : FA\_2015\_NA0001\_51\_47\_20151112\_00054.jpg

View of the prunings at the landside levee toe.

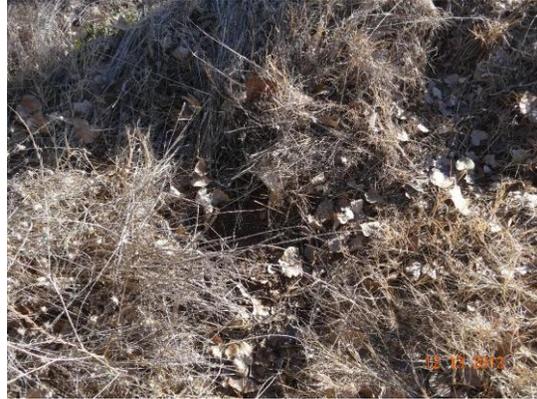
Photo 2 of 3 : UCIP\_FA\_2015\_3248.jpg

Pipe buried by vegetation--unable to determine if pipe goes through levee.

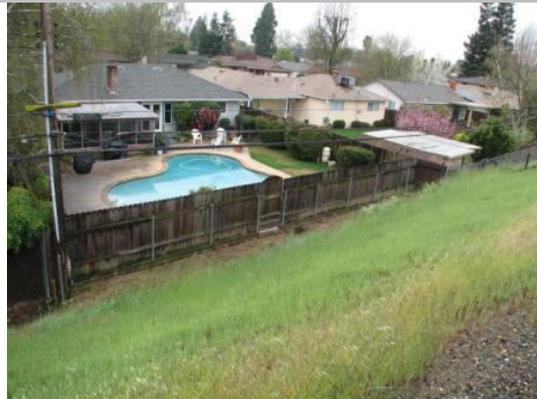
Photo 1 of 1 : FA\_2015\_NA0001\_55\_190\_20150910\_00161.jpg

03/16/2012 Wood privacy fence completely obstructs access and visibility.

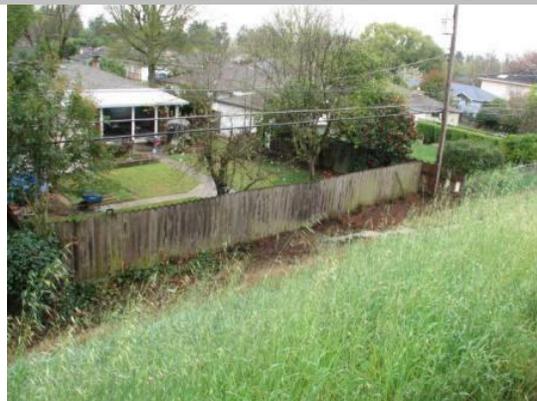
Photo 1 of 1 : FA\_2015\_NA0001\_55\_35\_20150910\_00031.jpg

03/16/2012 Wood privacy fence completely obstructs access and visibility.

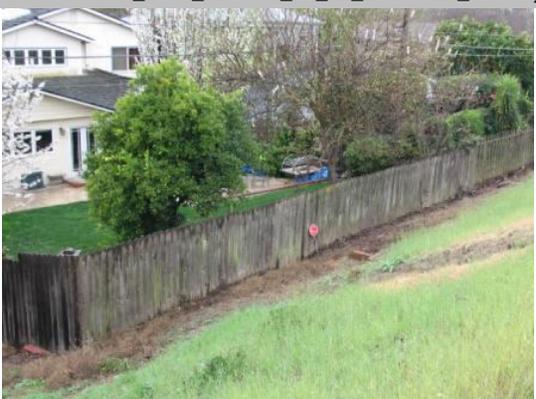
Photo 1 of 1 : FA\_2015\_NA0001\_55\_42\_20150910\_00033.jpg

03/16/2012 Wood privacy fence completely obstructs access and visibility.

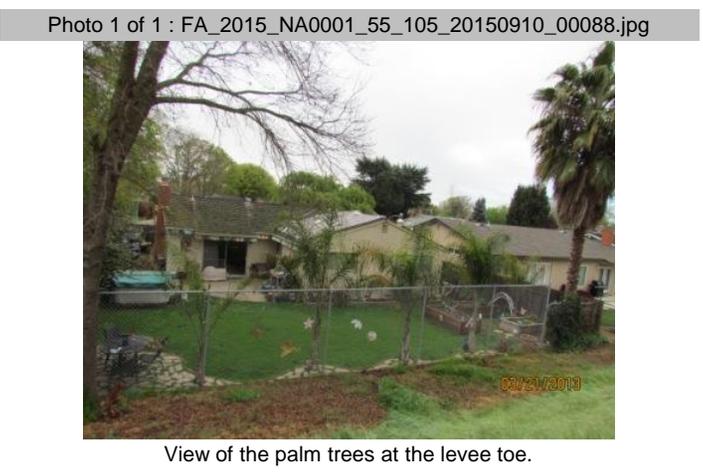
LM Start	<b>8.44</b>	Rating **	M	Issue No.	<b>105</b>
LM End	<b>8.44</b>	Issue Type +	En	Location *	LS
Category	Earthen Levee		GPS Latitude/Longitude		
			Start	End	
Item	Vegetation		38.563238 °	38.563238 °	
			-121.390073 °	-121.390073 °	
DWR ID	DWR_NA0001_04_s_2012_105				
Action/Comments					
Landscaping Inspector Comments: Palms planted within 10-ft of the levee toe.

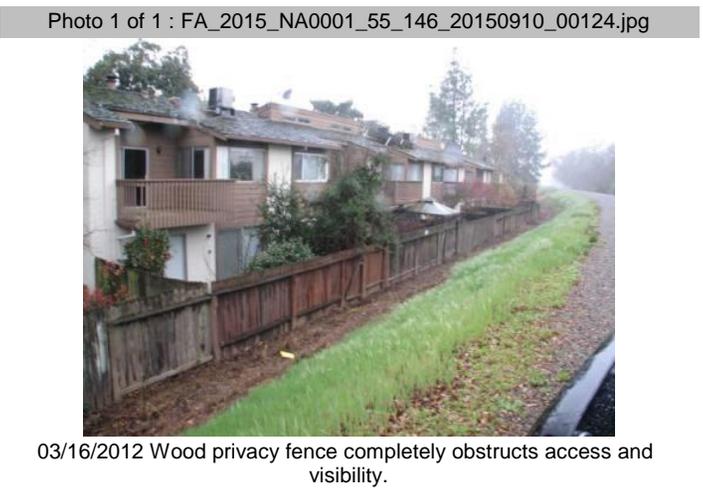
LM Start	<b>10.30</b>	Rating **	U	Issue No.	<b>146</b>
LM End	<b>10.32</b>	Issue Type +	En	Location *	LS
Category	Earthen Levee		GPS Latitude/Longitude		
			Start	End	
Item	Encroachments		38.570225 °	38.570245 °	
			-121.357014 °	-121.356791 °	
DWR ID	DWR_NA0001_04_s_2012_146				
Action/Comments					
Fence Inspector Comments: Wooden fence behind 6 apartments.

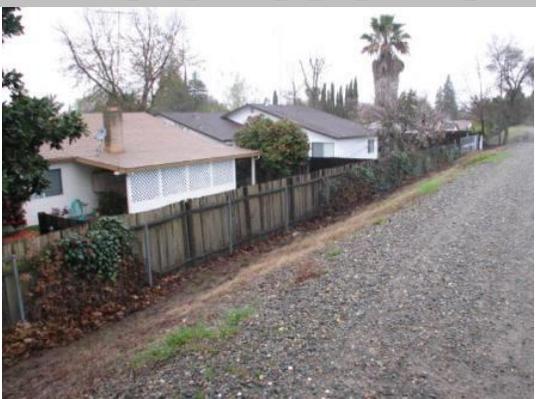
Photo 1 of 1 : FA\_2015\_NA0001\_55\_162\_20150910\_00140.jpg

03/16/2012 Wood privacy fence completely obstructs access and visibility.

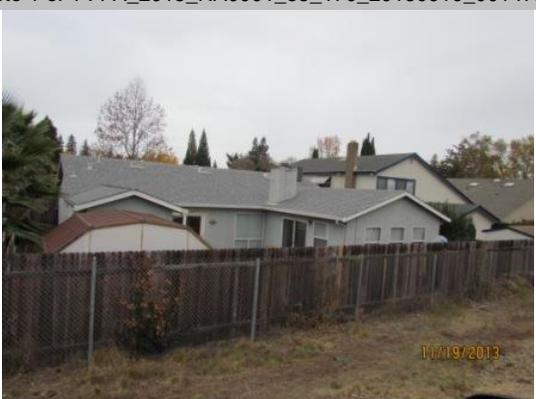
Photo 1 of 1 : FA\_2015\_NA0001\_55\_170\_20150910\_00147.jpg

View of the fence obstructing visibility and access.

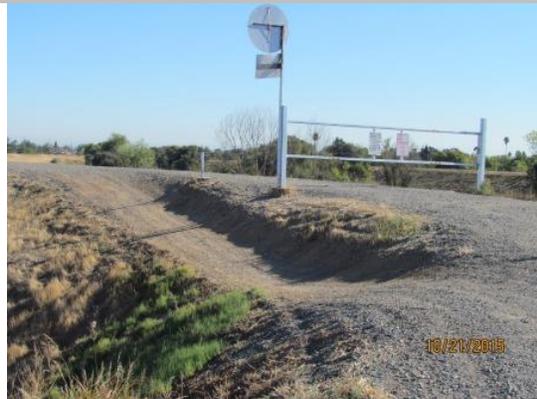
Photo 1 of 1 : FA\_2015\_NA0001\_58\_38\_20151112\_00034.jpg

View of the landside levee slope damaged by motorized traffic.

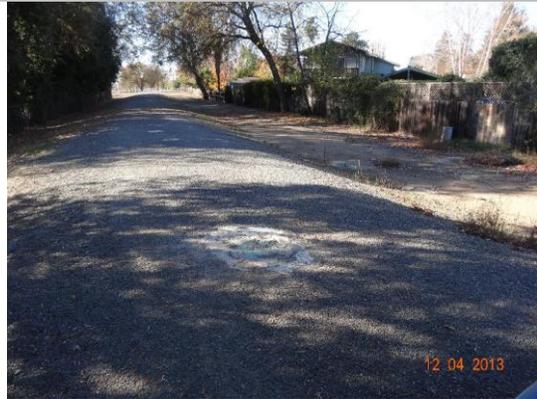
Photo 1 of 3 : UCIP\_FA\_2015\_2582.jpg

Overview of levee crown with grout holes visible at the crown along pipe alignment.

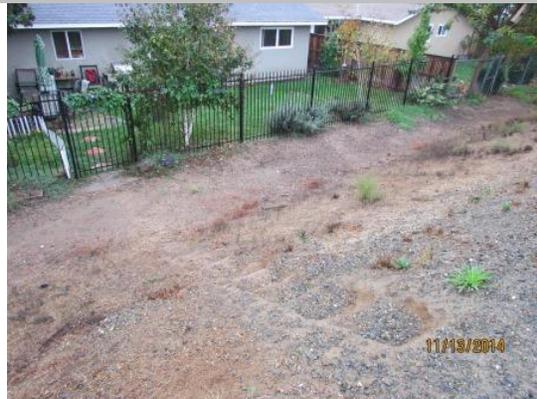
Photo 1 of 1 : FA\_2015\_NA0001\_438\_1\_20150910\_00001.jpg

View of the stairs on the landside levee slope.
