**Flood Control Project Maintenance
Levee Inspections**
LMA District Cover Sheet
Spring 2016 Levee Inspection Results

Lake County Watershed Protection District

Spring 2016 Levee Inspection Results

Waterway		Bank	Unit Miles
Unit No. 01 Middle Creek		Left	3.35

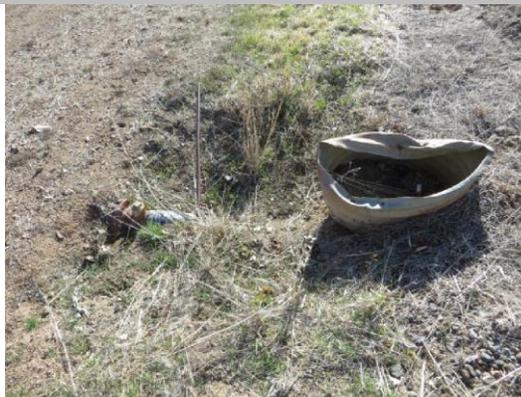
Photo 1 of 2 : UCIP_SP_2016_26943_49782.jpg

Comment Code					
Inspector Comment					
FS_ID:26943 DS_ID:21193 EP_NO: 5237 Repair Type: Non-Urgent Crossing Status: Found UCIP Comments: Pipe appears abandoned and should be done so properly. FIELD_STRUCT_DESC: 6-inch steel pipe possibly sleeved through an 8-inch steel pipe, 3.0-feet below the crown. Siphon breaker in 24-inch CMP riser on the landward slope. Reinforced concrete cutoff wall at center of levee. Butterfly valve on the waterward side at pump on concrete base on the waterward bank, installed under Permit No. 5237 (1971). Pole on the waterward berm, with overhead power line supplying electricity to pump. Originally included in the 1961 O+M manual. FS Date: 1/9/2014

Pipe and siphon breaker visible on LS slope.

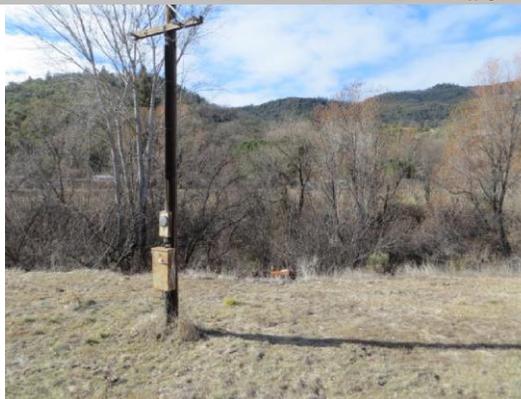
Photo 2 of 2 : UCIP_SP_2016_26943_49781.jpg

Power pole, meter, and pump visible on WS berm.

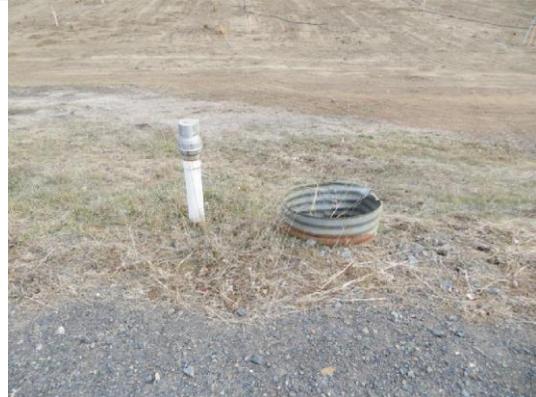
Photo 1 of 2 : UCIP_SP_2016_26946_49789.jpg

LM Start	0.84	Rating **	M	Issue No.	536
LM End	0.84	Issue Type +	En	Location *	LS
Category	Supplemental			GPS Latitude/Longitude	
				Start	End
Item	DWR UCIP Field Study			39.179534 °	39.179534 °
				-122.912512 °	-122.912512 °
DWR ID					
Comment Code					
Inspector Comment					
FS_ID:26946 DS_ID:21196 EP_NO: N/A Repair Type: Non-Urgent Crossing Status: Found UCIP Comments: Pump and pipe appear abandoned and should be done so properly. FIELD_STRUCT_DESC: 8-inch steel irrigation pipe through the levee, 3.0 feet below the crown. Siphon breaker in 24-inch CMP riser on landward slope. Pump on the waterward bank with a butterfly valve. Service pole on the waterward berm. (USACE-1961). This entry matches the Drainage or Irrigation Structure referenced in O&M manual (HLM 0.83). FS Date: 1/9/2014

Siphon breaker in 24-inch cmp riser with vent on LS shoulder.

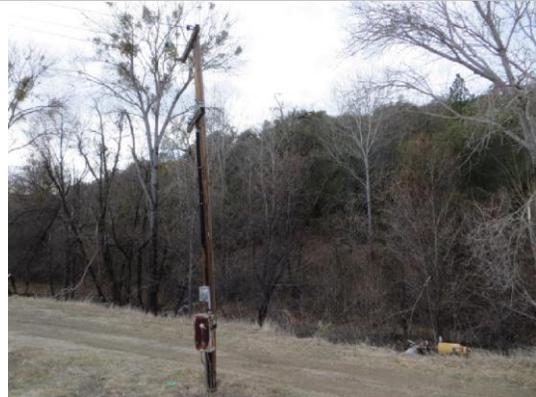
Photo 2 of 2 : UCIP_SP_2016_26946_49788.jpg

Pump, pole, and meter on WS berm.

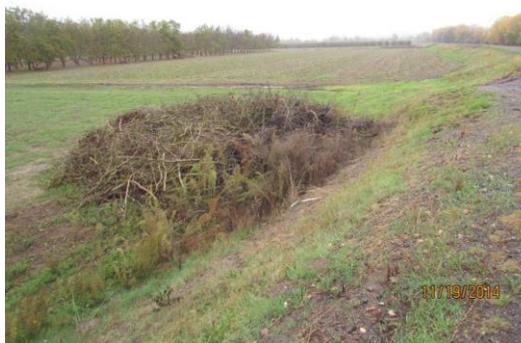
Photo 1 of 1 : SP_2016_NA0009_3_290_20160321_00016.jpg

View of the prunings along the landside toe.

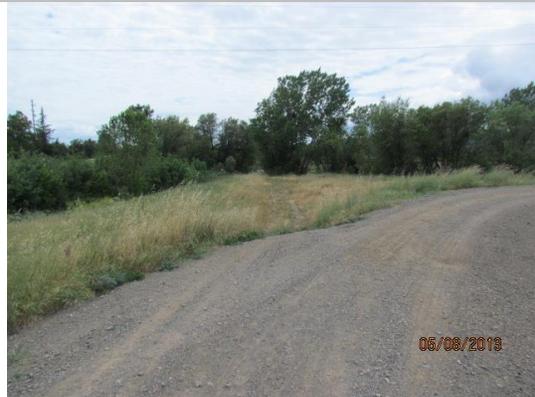
Photo 1 of 1 : SP_2016_NA0009_3_13_20160321_00008.jpg

LM Start	2.29	Rating **	M	Issue No.	13
LM End	2.29	Issue Type +	Ma	Location *	WS
Category	Earthen Levee			GPS Latitude/Longitude	
				Start	End
Item	Slope Stability			39.160285 °	39.160285 °
				-122.913481 °	-122.913481 °
DWR ID	DWR_NA0009_01_s_2013_13				
Comment Code					
S3 : Repair the levee slope damaged by vehicle traffic and prevent access where possible.					
Inspector Comment					
Unchanged from 2013 photo.

View of the vehicle erosion along the waterside slope.

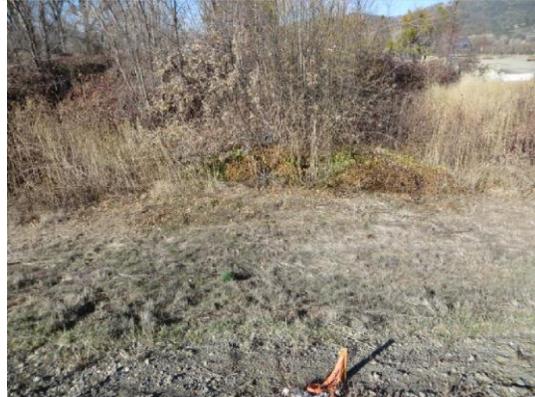
Photo 1 of 2 : UCIP_SP_2016_27004_49862.jpg

LM Start	2.35	Rating **	M	Issue No.	537
LM End	2.35	Issue Type +	En	Location *	WS
Category	Supplemental			GPS Latitude/Longitude	
				Start	End
Item	DWR UCIP Field Study			39.161002 °	39.161002 °
				-122.912843 °	-122.912843 °
DWR ID					
Comment Code					
Inspector Comment					
FS_ID:27004 DS_ID:21199 EP_NO: 11460 Repair Type: Non-Urgent Crossing Status: Found UCIP Comments: Heavy vegetation on LS at inlet should be removed. FIELD_STRUCT_DESC: 42-inch CM drainpipe through the levee, 10.0 feet below the crown. Flap gate on waterward end. Concrete headwall on both ends. Originally included in 1961 O+M manual. Pipe retained under ABO No. 11460 (1975). FS Date: 1/14/2014

Heavy vegetation at inlet on LS toe.

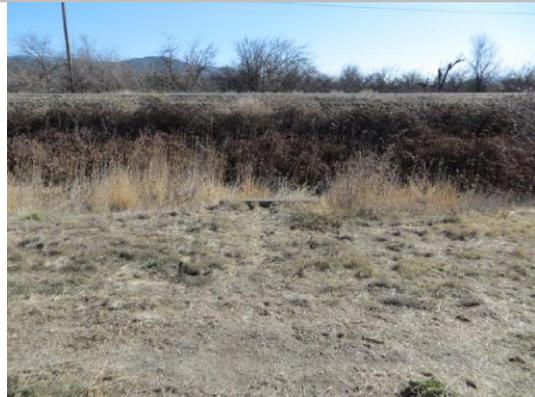
Photo 2 of 2 : UCIP_SP_2016_27004_49861.jpg

Concrete U-shaped headwall on WS berm.

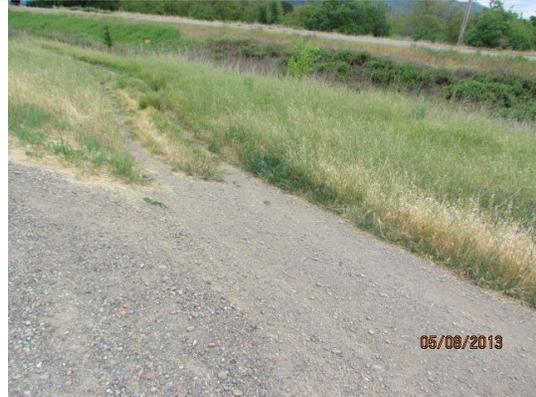
Photo 1 of 1 : SP_2016_NA0009_3_14_20160321_00009.jpg

LM Start	2.36	Rating **	M	Issue No.	14
LM End	2.36	Issue Type +	Ma	Location *	WS
Category	Earthen Levee		GPS Latitude/Longitude		
			Start	End	
Item	Slope Stability		39.161153 °	39.161153 °	
			-122.912740 °	-122.912740 °	
DWR ID	DWR_NA0009_01_s_2013_14				
Comment Code					
S3 : Repair the levee slope damaged by vehicle traffic and prevent access where possible.					
Inspector Comment					
Unchanged from 2013 photo.

View of the vehicle erosion along the waterside slope.

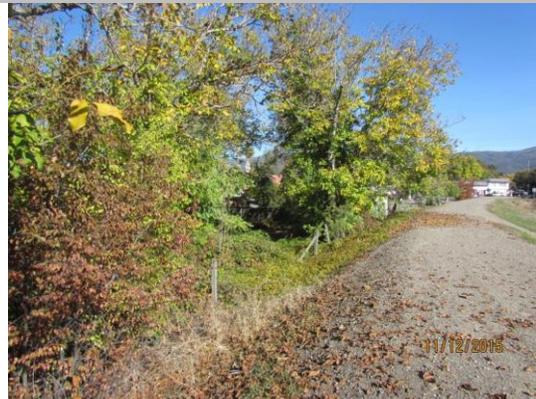
Photo 1 of 1 : SP_2016_NA0009_3_23_20160321_00014.jpg

View of the vegetation along the landside slope & toe.

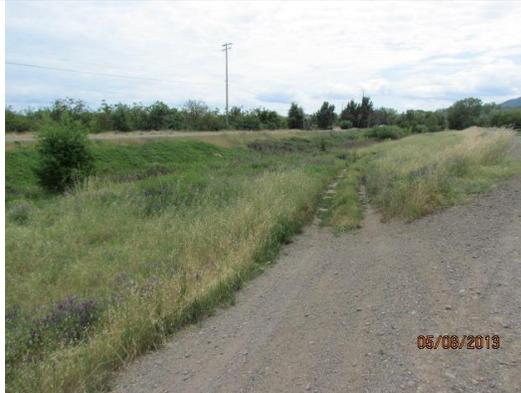
Photo 1 of 1 : SP_2016_NA0009_3_16_20160321_00011.jpg

LM Start	2.40	Rating **	M	Issue No.	16
LM End	2.40	Issue Type +	Ma	Location *	WS
Category	Earthen Levee		GPS Latitude/Longitude		
			Start	End	
Item	Slope Stability		39.161601 °	39.161601 °	
			-122.912303 °	-122.912303 °	
DWR ID	DWR_NA0009_01_s_2013_16				
Comment Code					
S3 : Repair the levee slope damaged by vehicle traffic and prevent access where possible.					
Inspector Comment					
unchanged from 2013 photo.

View of the vehicle erosion along the waterside slope.

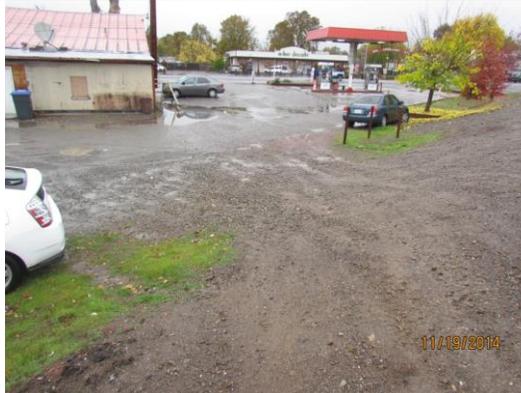
Photo 1 of 1 : SP_2016_NA0009_3_17_20160321_00012.jpg

LM Start	2.42	Rating **	M	Issue No.	17
LM End	2.42	Issue Type +	Ma	Location *	LS
Category	Earthen Levee		GPS Latitude/Longitude		
			Start	End	
Item	Slope Stability		39.161802 °	39.161802 °	
			-122.912020 °	-122.912020 °	
DWR ID	DWR_NA0009_01_s_2013_17				
Comment Code					
S3 : Repair the levee slope damaged by vehicle traffic and prevent access where possible.					
Inspector Comment					
unchanged from 2013 photo

View of the erosion caused by vehicle along the landside slope.

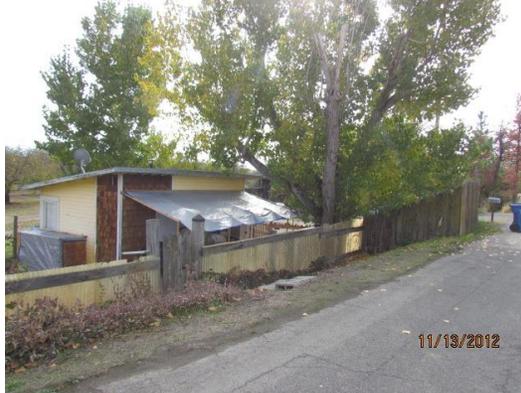
Photo 1 of 1 : SP_2016_NA0009_3_7_20160321_00004.jpg

LM Start	2.47	Rating **	M	Issue No.	7
LM End	2.59	Issue Type +	En	Location *	LS
Category	Earthen Levee		GPS Latitude/Longitude		
			Start	End	
Item	Encroachments		39.161692 °	39.160217 °	
			-122.911748 °	-122.912957 °	
DWR ID	DWR_NA0009_01_s_2012_7				
Comment Code					
BU : Building					
Inspector Comment

View of a building & fence along the toe of the levee.

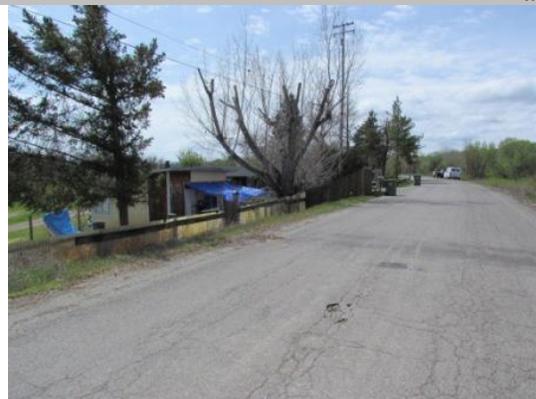
Photo 1 of 1 : SP_2016_NA0009_3_4_20160321_00002.jpg

View of the fences at the Landside toe.

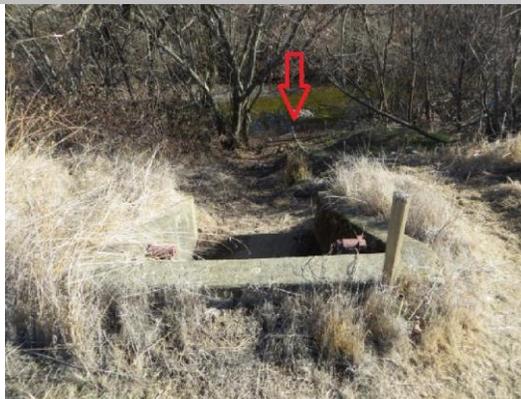
Photo 1 of 2 : UCIP_SP_2016_27563_51182.jpg

LM Start	0.48	Rating **	M	Issue No.	23
LM End	0.48	Issue Type +	En	Location *	LS
Category	Supplemental		GPS Latitude/Longitude		
			Start	End	
Item	DWR UCIP Field Study		39.184080 °	39.184080 °	
			-122.912130 °	-122.912130 °	
DWR ID					
Comment Code					
Inspector Comment					
FS_ID:27563 DS_ID:24761 EP_NO: N/A Repair Type: Non-Urgent Crossing Status: Found UCIP Comments: No Permit identified for crossing. FIELD_STRUCT_DESC: 1.5-inch HDPE irrigation pipe through the levee at unknown depth below the crown. Pipe visible on WS berm slope. Pumphouse on LS toe. FS Date: 1/14/2014 7:19:18 AM

Pipe visible just downstream from stormdrain.

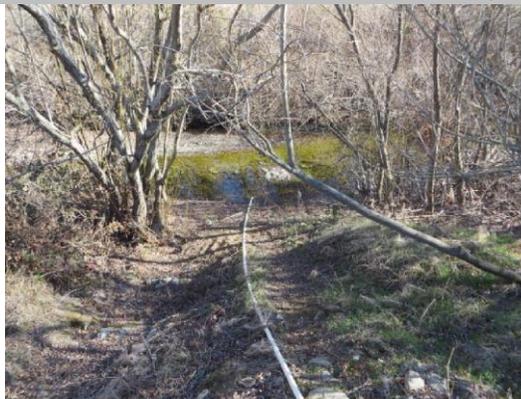
Photo 2 of 2 : UCIP_SP_2016_27563_51181.jpg

Pipe visible just downstream from storm drain.

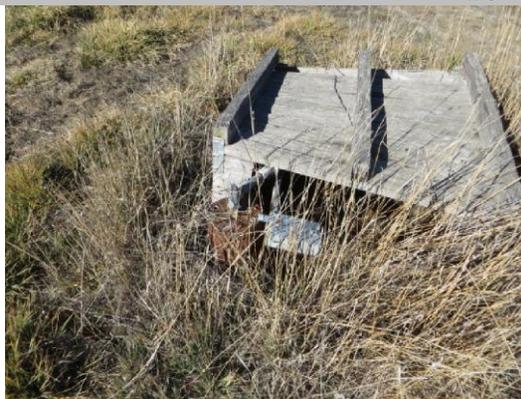
Photo 1 of 2 : UCIP_SP_2016_43053_50393.jpg

LM Start	0.50	Rating **	U	Issue No.	30
LM End	0.50	Issue Type +	En	Location *	LS
Category	Supplemental			GPS Latitude/Longitude	
				Start	End
Item	DWR UCIP Field Study			39.183775 °	39.183775 °
				-122.912187 °	-122.912187 °
DWR ID					
Comment Code					
Inspector Comment					
FS_ID:43053 DS_ID:21209 EP_NO: 8513 Repair Type: Urgent Crossing Status: Found UCIP Comments: Appears pipe is leaking on WS toe of Levee at mud pit FIELD_STRUCT_DESC: 1 of 2: 1.25-inch steel pipe through the levee, 2.0 feet below the levee. Steel cutoff wall around pipe at center of levee. Well with 8-inch casing on waterward slope. (Permit No. 8513-1974) FS Date: 1/14/2014

Pump and pipe visible at wooden box on WS berm.

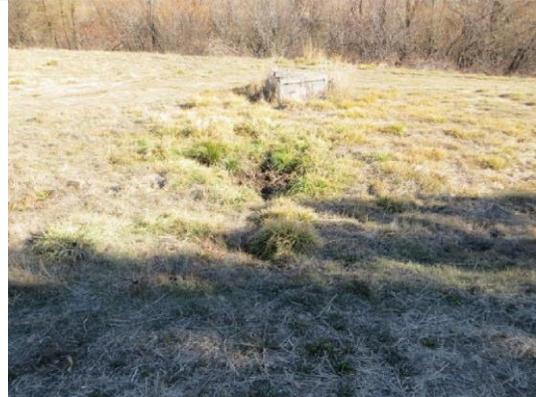
Photo 2 of 2 : UCIP_SP_2016_43053_50392.jpg

Mudpit at WS berm were pipe may be leaking.

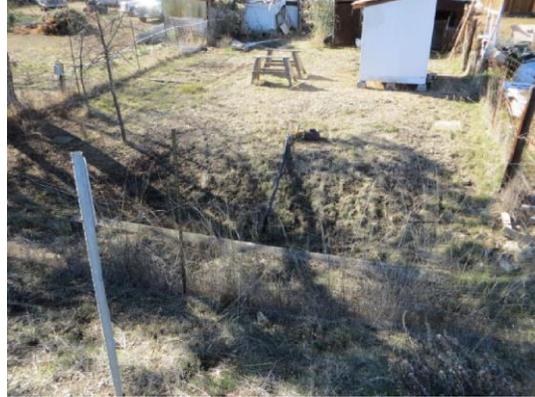
Photo 1 of 2 : UCIP_SP_2016_27208_50411.jpg

LM Start	0.55	Rating **	M	Issue No.	29
LM End	0.55	Issue Type +	En	Location *	LS
Category	Supplemental		GPS Latitude/Longitude		
			Start	End	
Item	DWR UCIP Field Study		39.183130 °	39.183130 °	
			-122.912198 °	-122.912198 °	
DWR ID					
Comment Code					
Inspector Comment					
FS_ID:27208 DS_ID:21210 EP_NO: 11482 Repair Type: Non-Urgent Crossing Status: Found UCIP Comments: Fence on LS slope creates access issue. FIELD_STRUCT_DESC: 36-inch CM drainpipe through the levee, 9.0 feet below the crown. Flap gate on the waterward end. Concrete headwalls on both ends. (USACE-1961). This entry matches the Drainage or Irrigation Structure referenced in O&M manual (HLM 0.54). This pipe was retained under ABO No. 11482 (1975). FS Date: 1/14/2014

Concrete headwall on LS toe.

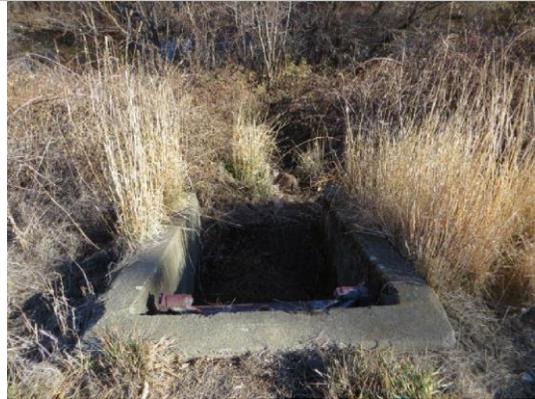
Photo 2 of 2 : UCIP_SP_2016_27208_50410.jpg

Flapgate and concrete headwall on WS berm.

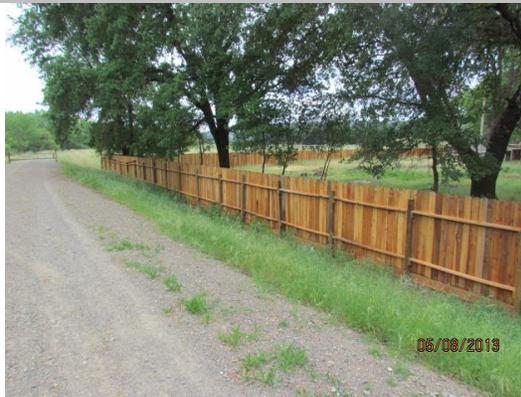
Photo 1 of 1 : SP_2016_NA0009_4_10_20160321_00009.jpg

View of the unauthorized fence along the landside toe.

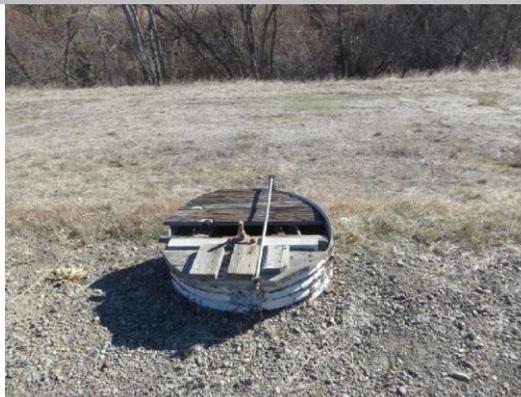
Photo 1 of 2 : UCIP_SP_2016_42994_51214.jpg

LM Start	1.16	Rating **	M	Issue No.	31
LM End	1.16	Issue Type +	En	Location *	LS
Category	Supplemental			GPS Latitude/Longitude	
				Start	End
Item	DWR UCIP Field Study			39.174370 °	39.174370 °
				-122.913543 °	-122.913543 °
DWR ID					
Comment Code					
Inspector Comment					
FS_ID:42994 DS_ID:21212 EP_NO: 11483 Repair Type: Non-Urgent Crossing Status: Found UCIP Comments: Pipe appears abandoned and if so, should be done so properly. Debris blocking flaggate at outlet. FIELD_STRUCT_DESC: 30-inch CM drainpipe through the levee, 17.8 feet below the crown. Slide gate in 44-inch diameter CMP riser waterward slope. Flap gate on the waterward end at concrete headwall. 6'X8' concrete sump at landward toe. (USACE-1961). Originally included in O&M manual (HLM 1.22). This pipe was retained under ABO No. 11483 (1975). FS Date: 1/22/2014

Slide gate in 44-inch CMP riser on WS shoulder.

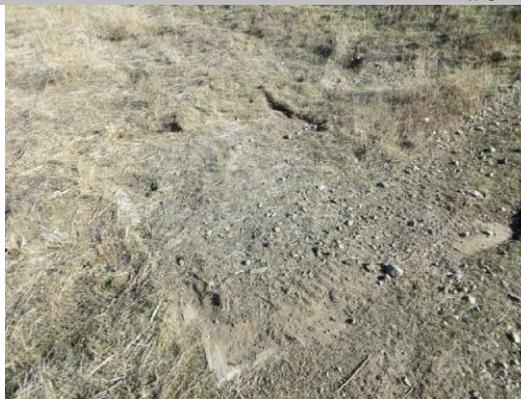
Photo 2 of 2 : UCIP_SP_2016_42994_51213.jpg

6'X8' concrete sump filled in with soil, visible at LS toe.

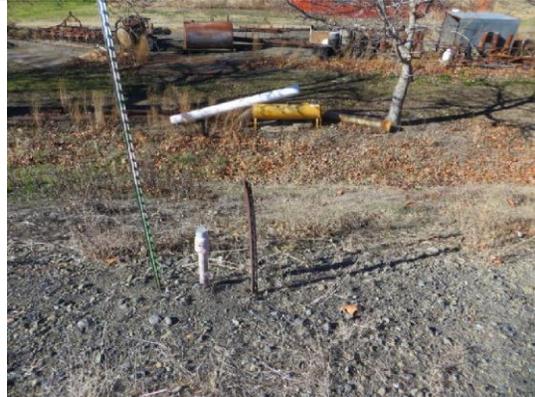
Photo 1 of 2 : UCIP_SP_2016_27606_51250.jpg

LM Start	1.70	Rating **	M	Issue No.	24
LM End	1.70	Issue Type +	En	Location *	LS
Category	Supplemental			GPS Latitude/Longitude	
				Start	End
Item	DWR UCIP Field Study			39.167156 °	39.167156 °
				-122.916610 °	-122.916610 °
DWR ID					
Comment Code					
Inspector Comment					
FS_ID:27606 DS_ID:21214 EP_NO: 15825 Repair Type: Non-Urgent Crossing Status: Found UCIP Comments: Pipe with closure device not visible on WS toe. Clear soil from pipe and cover for better verification of closure. FIELD_STRUCT_DESC: 8-inch steel pipe through the levee, 2.0 feet below the crown. Siphon breaker on apex of pipe at landward shoulder. Exposed filter at landward slope. Seasonal pump on waterward slope. (Permit No. 15825-1992) FS Date: 1/22/2014

Vent on LS shoulder with filter visible on LS toe.

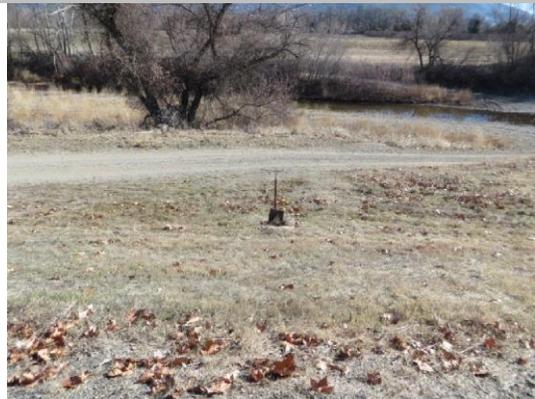
Photo 2 of 2 : UCIP_SP_2016_27606_51249.jpg

T-post at WS toe may indicate location of pipe end. Covered with soil.

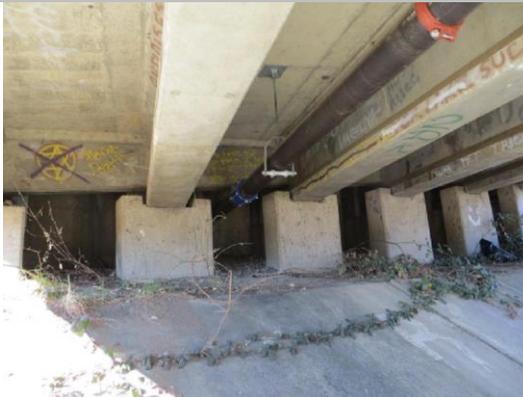
Photo 1 of 2 : UCIP_SP_2016_27624_51263.jpg

Pipe visible under bridge.

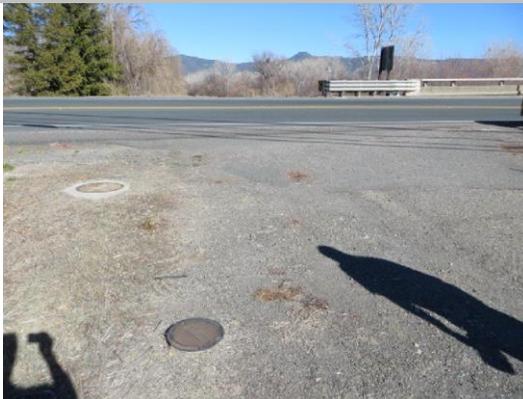
Photo 2 of 2 : UCIP_SP_2016_27624_51262.jpg

Manhole and vent lids visible on LS shoulder.

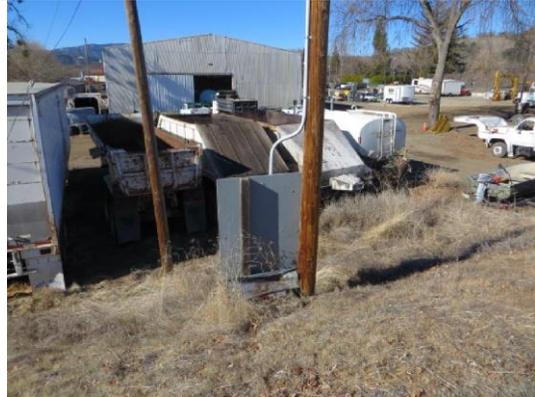
Photo 1 of 2 : UCIP_SP_2016_27629_51280.jpg

Meter and control on LS slope next to pole.

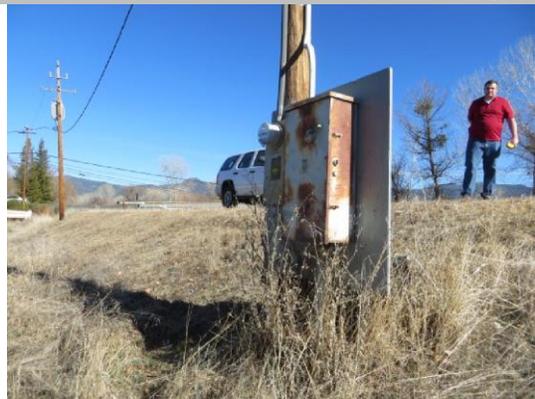
Photo 2 of 2 : UCIP_SP_2016_27629_51279.jpg

Meter and control on LS slope next to pole.

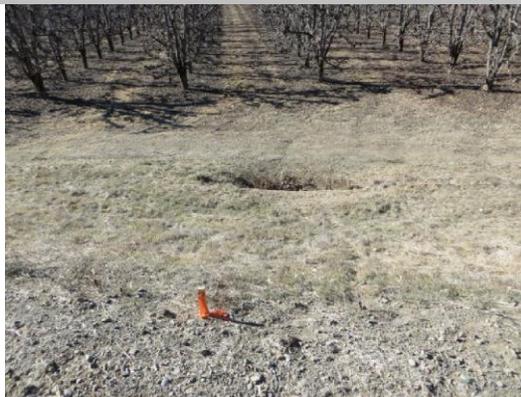
Photo 1 of 2 : UCIP_SP_2016_27630_51283.jpg

Concrete headwall and pipe visible at LS toe.

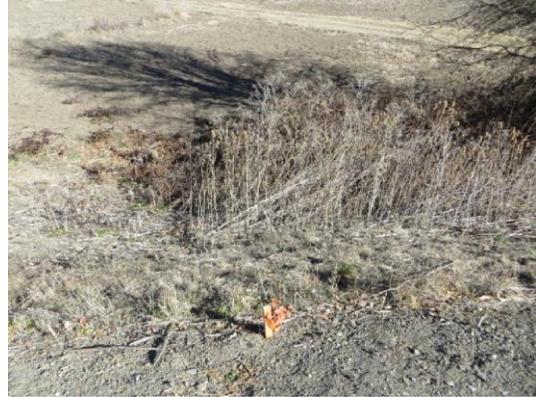
Photo 1 of 2 : UCIP_SP_2016_27863_51542.jpg

Pipe visible at LS toe covered with vegetation.

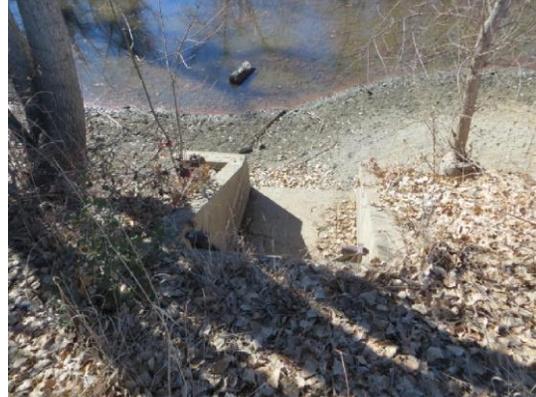
Photo 2 of 2 : UCIP_SP_2016_27863_51541.jpg

Concrete headwall and flapgate visible at WS berm.

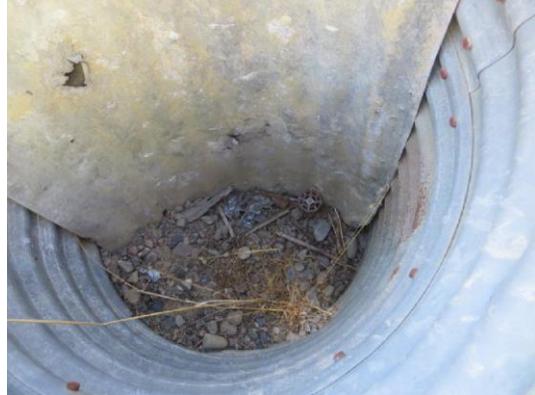
Photo 1 of 2 : UCIP_SP_2016_27891_51587.jpg

Valve visible at bottom of CMP riser on LS shoulder.

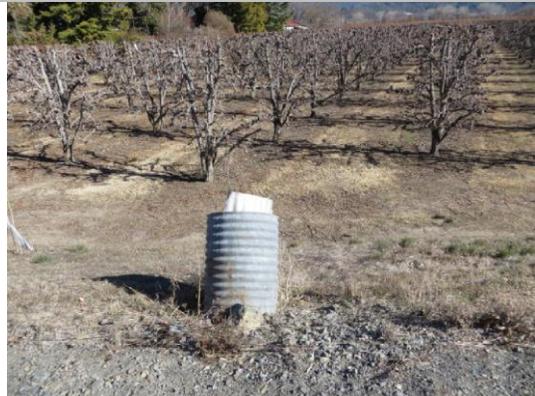
Photo 2 of 2 : UCIP_SP_2016_27891_51586.jpg

Siphon at LS shoulder inside 24-inch CMP riser.

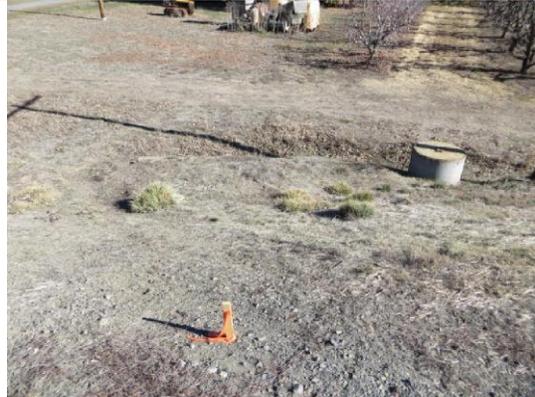
Photo 1 of 2 : UCIP_SP_2016_27892_51591.jpg

Concrete headwall visible next to concrete standpipe on LS toe.

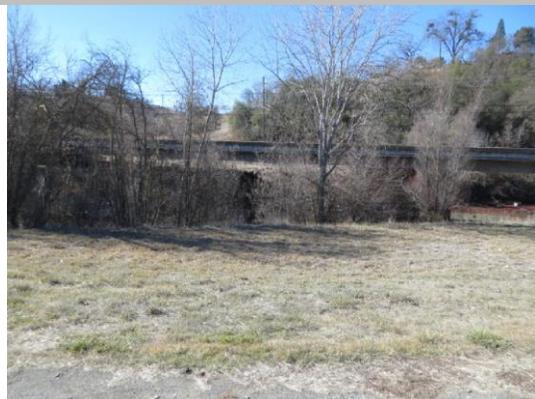
Photo 2 of 2 : UCIP_SP_2016_27892_51590.jpg

Concrete outfall visible off WS berm.

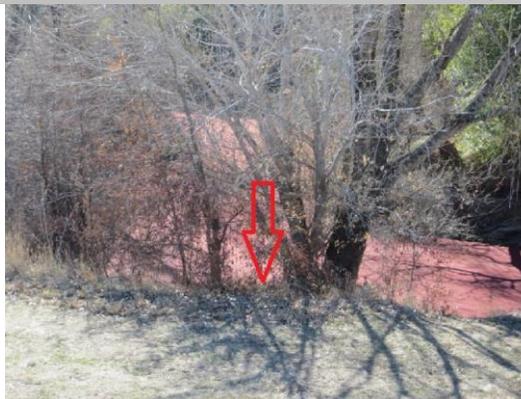
Photo 1 of 2 : UCIP_SP_2016_27894_51599.jpg

Flapgate and headwall off WS toe.

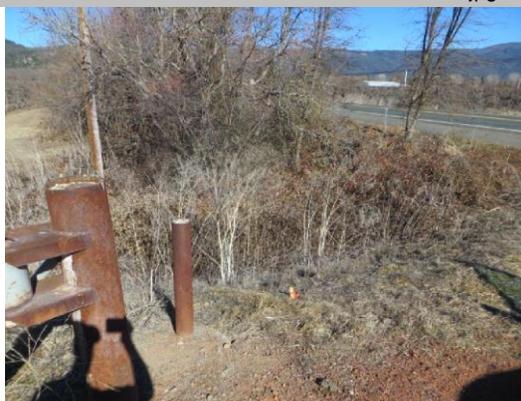
Photo 2 of 2 : UCIP_SP_2016_27894_51598.jpg

Concrete headwall on LS toe.

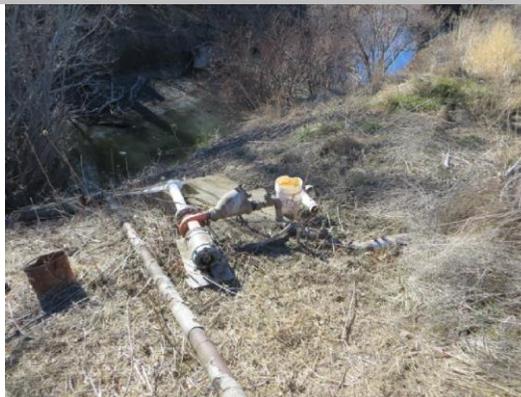
Photo 1 of 2 : UCIP_SP_2016_27903_51622.jpg

Pump at concrete pad on WS berm.

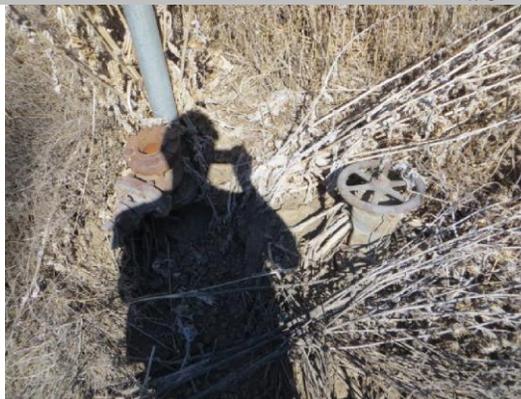
Photo 2 of 2 : UCIP_SP_2016_27903_51621.jpg

Gate valves at tank appear to be in disrepair.

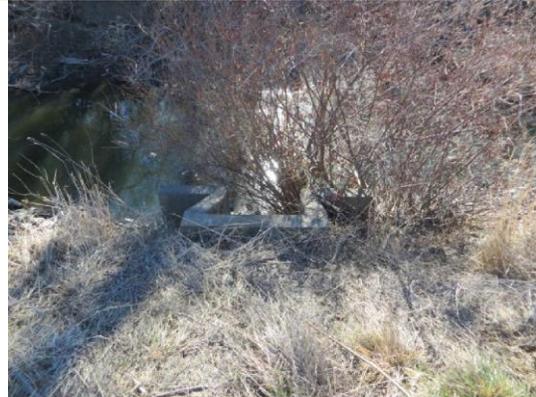
Photo 1 of 2 : UCIP_SP_2016_27943_51642.jpg

Concrete Headwall on WS berm.

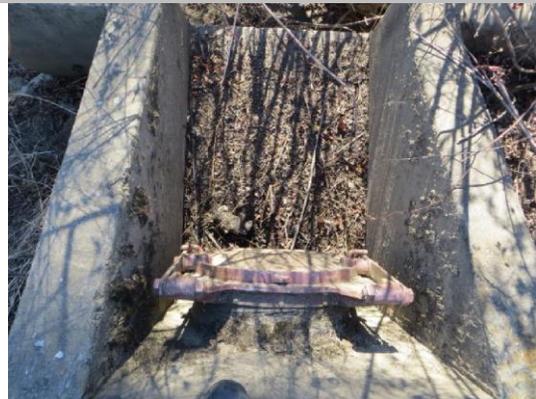
Photo 2 of 2 : UCIP_SP_2016_27943_51641.jpg

Headwall and flapgate on WS berm.

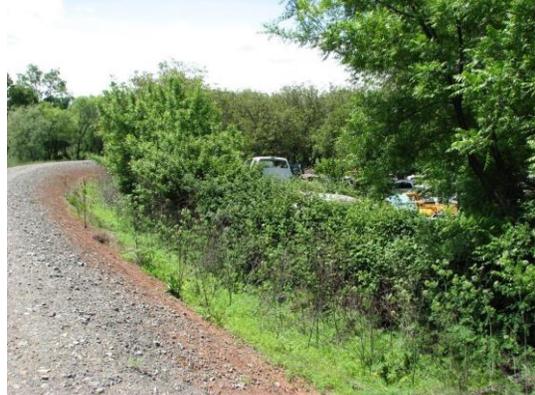
Photo 1 of 1 : SP_2016_NA0009_5_12_20160513_00025.jpg

5/2/2016: Dense bushes and vines covering fence along vehicle junk yard.

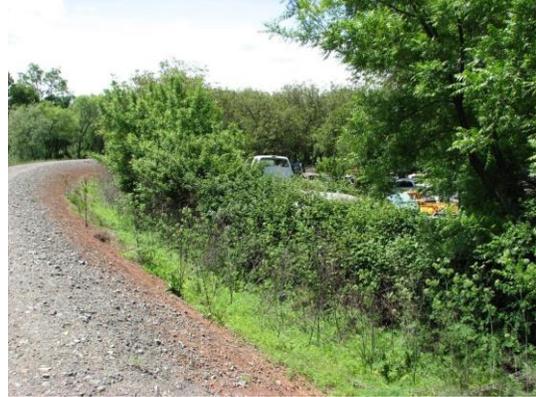
Photo 1 of 1 : SP_2016_NA0009_5_11_20160513_00024.jpg

5/2/2016: Fence along vehicle junk yard is covered in dense growth of bushes and vines.

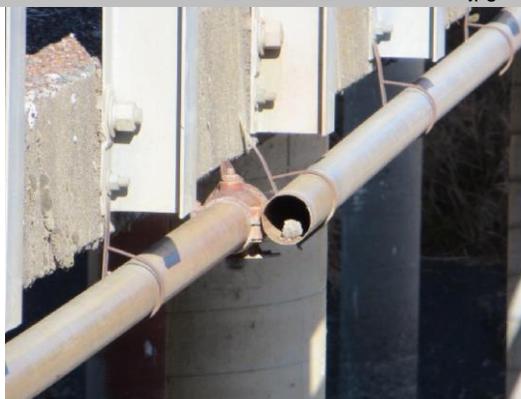
Photo 1 of 2 : UCIP_SP_2016_26907_49751.jpg

Pipe open on waterward end.

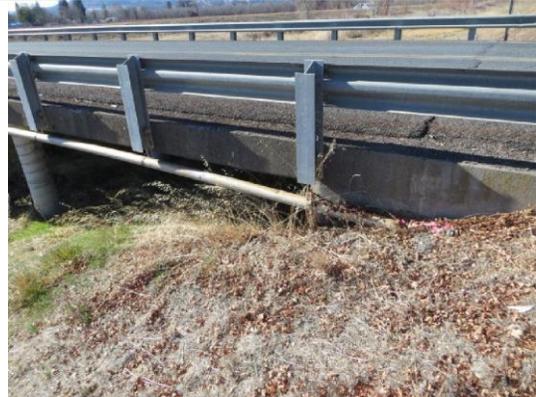
Photo 2 of 2 : UCIP_SP_2016_26907_49750.jpg

Pipe visible on upstream side of bridge.

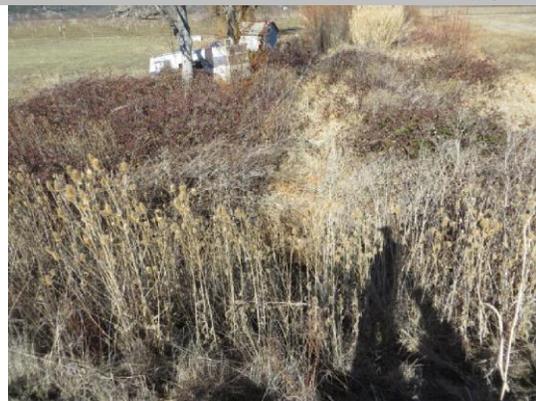
Photo 1 of 2 : UCIP_SP_2016_43043_49754.jpg

Drainage canal at inlet on LS toe.

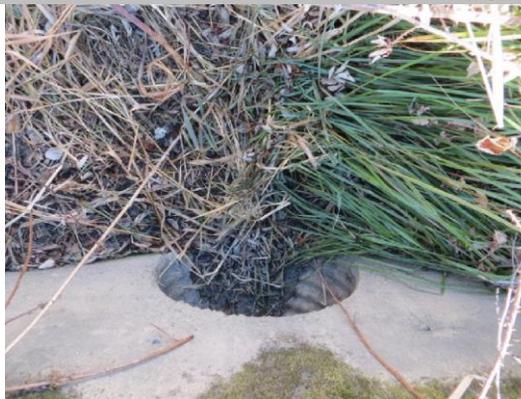
Photo 2 of 2 : UCIP_SP_2016_43043_49753.jpg

Pipe and concrete headwall visible in drainage channel on LS toe.

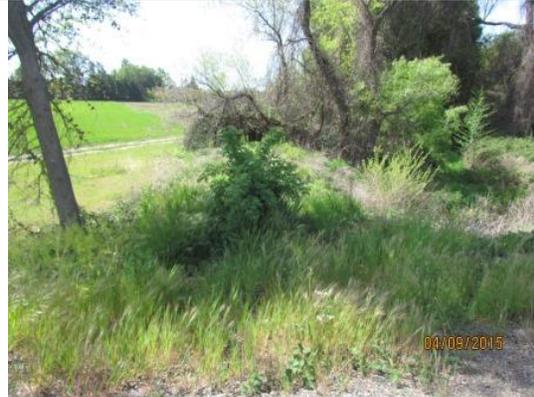
Photo 1 of 1 : SP_2016_NA0009_7_3_20160321_00001.jpg

View of the elderberry along the landside toe.

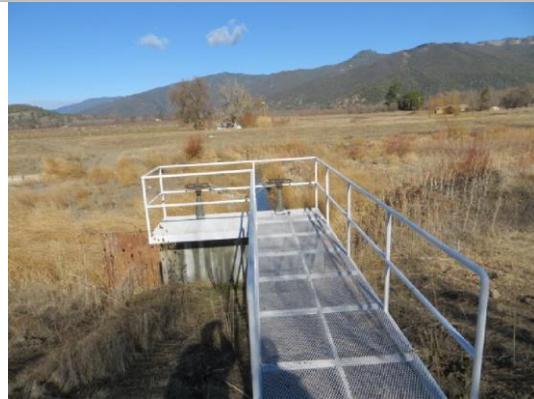
Photo 1 of 2 : UCIP_SP_2016_26897_49712.jpg

Slide gate at steel walkway on WS toe.

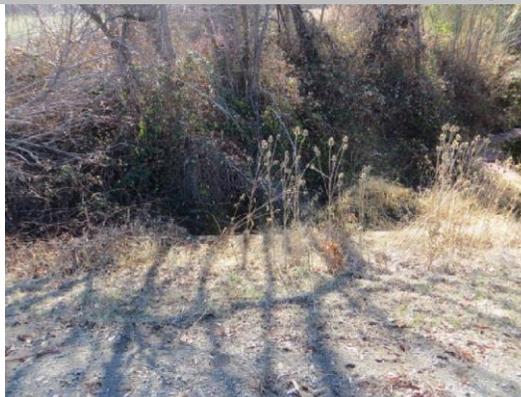
Photo 2 of 2 : UCIP_SP_2016_26897_49711.jpg

Outlet visible at concrete headwall on LS toe.

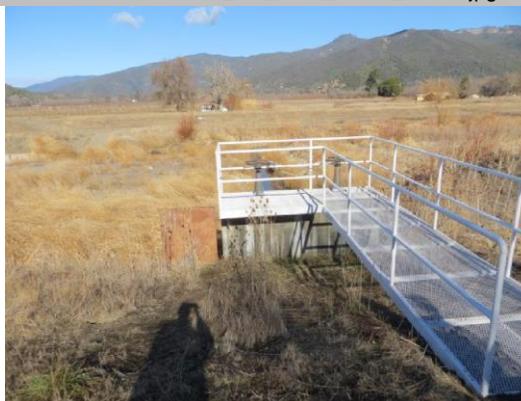
Photo 1 of 2 : UCIP_SP_2016_26891_49682.jpg

Slide gate on steel walkway at WS toe.

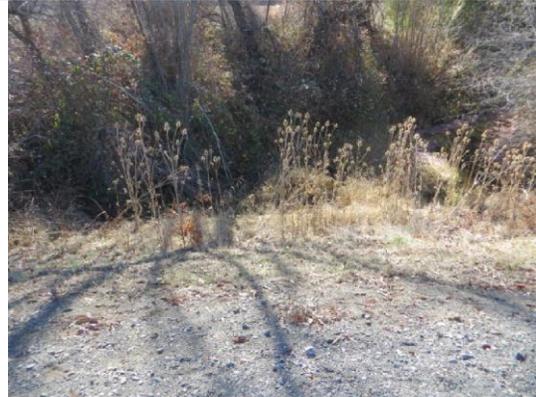
Photo 2 of 2 : UCIP_SP_2016_26891_49681.jpg

Outlet visible at concrete headwall on LS toe.

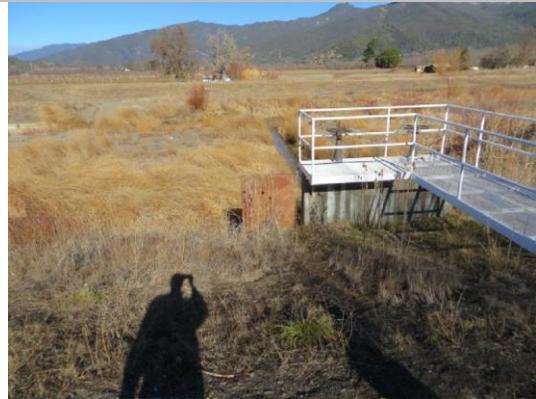
Photo 1 of 2 : UCIP_SP_2016_26888_49666.jpg

Steel slide gate visible at concrete headwall on WS toe.

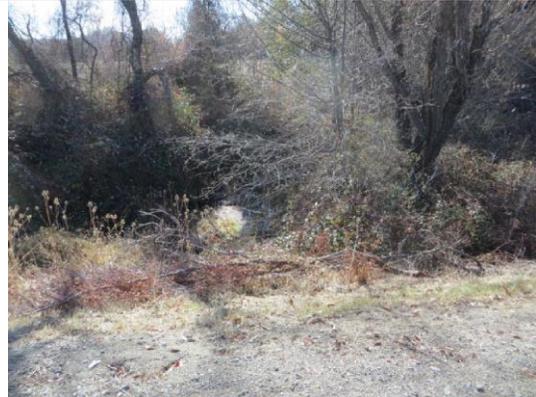
Photo 2 of 2 : UCIP_SP_2016_26877_49609.jpg

Concrete headwall on LS toe.
