**Flood Control Project Maintenance
Levee Inspections**
LMA District Cover Sheet
Spring 2016 Levee Inspection Results

Solano County Public Works Mellin Levee

Spring 2016 Levee Inspection Results

Waterway		Bank	Unit Miles
Unit No. 01 Mellin Levee		Right	0.59

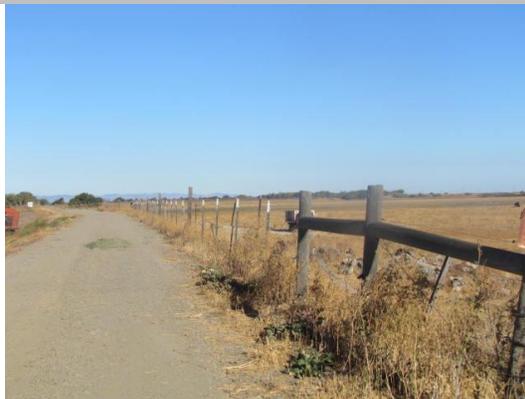
Photo 1 of 1 : SP_2016_NA0012_258_3_20160308_00003.jpg

LM Start	0.01	Rating **	M	Issue No.	3
LM End	0.49	Issue Type +	En	Location *	WS
Category	Earthen Levee		GPS Latitude/Longitude		
			Start	End	
Item	Encroachments		38.174167 °	38.178960 °	
			-121.674312 °	-121.680600 °	
DWR ID	DWR_NA0012_01_s_2012_3				
Comment Code					
FE : Fence					
Inspector Comment

Looking west at fence on waterside shoulder.

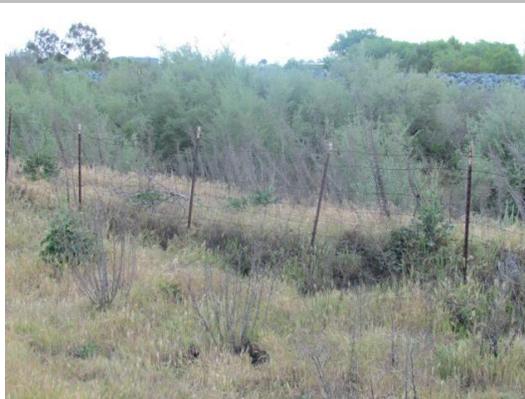
Photo 1 of 1 : SP_2016_NA0012_258_4_20160308_00004.jpg

LM Start	0.10	Rating **	M	Issue No.	4
LM End	0.28	Issue Type +	En	Location *	LS
Category	Earthen Levee		GPS Latitude/Longitude		
			Start	End	
Item	Encroachments		38.175115 °	38.176805 °	
			-121.675463 °	-121.677893 °	
DWR ID	DWR_NA0012_01_s_2012_4				
Comment Code					
FE : Fence					
Inspector Comment

Looking southeast at fence on landward slope.

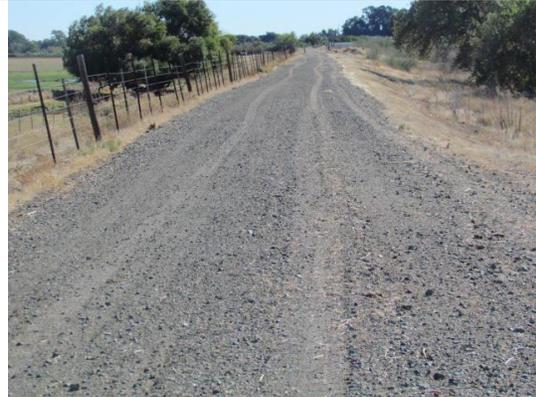
Photo 1 of 3 : SP_2016_NA0012_258_10_20160308_00007.jpg

LM Start	0.15	Rating **	M	Issue No.	10
LM End	0.59	Issue Type +	Ma	Location *	CR
Category	Earthen Levee			GPS Latitude/Longitude	
				Start	End
Item	Crown Surface / Depressions / Rutting			38.175627 °	38.180044 °
				-121.676185 °	-121.681978 °
DWR ID	DWR_NA0012_01_s_2015_10				
Comment Code					
C1 : Add appropriate material and re-grade the levee to bring the crown above the design elevation.					
Inspector Comment					
Add appropriate gravel or road base.

Looking east at levee crown fall 2015.

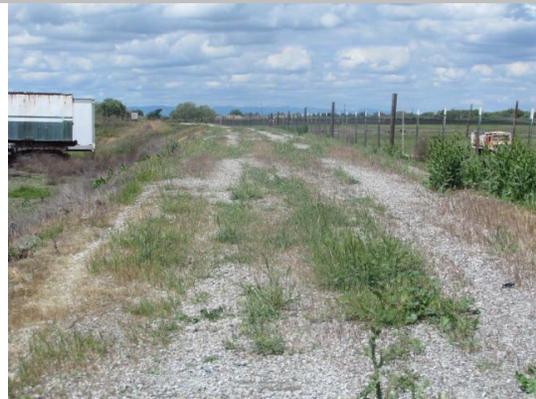
Photo 2 of 3 : SP_2016_NA0012_258_10_20160308_00008.jpg

Looking west at vegetation on levee crown at LM 0.00 to 0.10

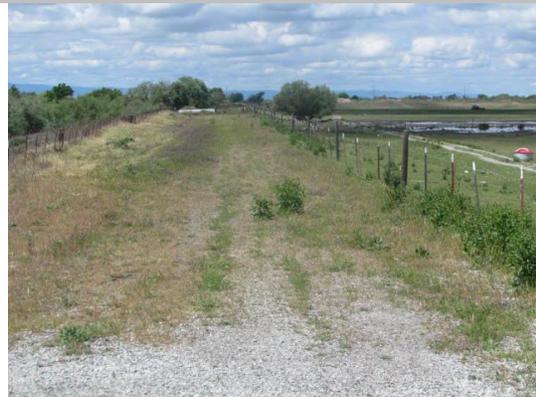
Photo 3 of 3 : SP_2016_NA0012_258_10_20160308_00009.jpg

Looking west at vegetation on levee crown at LM 0.28 to 0.59

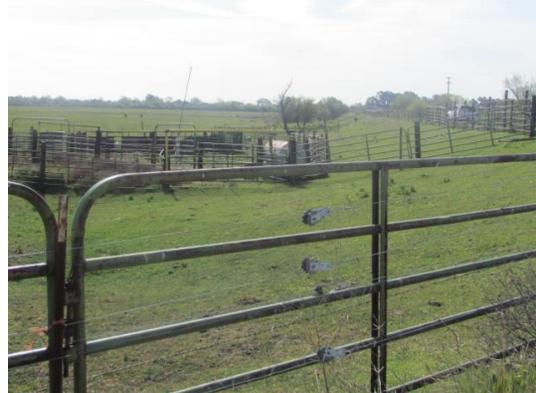
Photo 1 of 2 : SP_2016_NA0012_258_5_20160308_00005.jpg

LM Start	0.57	Rating **	M	Issue No.	5
LM End	0.59	Issue Type +	En	Location *	WS
Category	Earthen Levee			GPS Latitude/Longitude	
				Start	End
Item	Encroachments			38.179783 °	38.180027 °
				-121.681648 °	-121.681978 °
DWR ID	DWR_NA0012_01_s_2012_5				
Comment Code					
FE : Fence					
Inspector Comment					
Animal corral.

Looking east at animal corral on waterside toe.

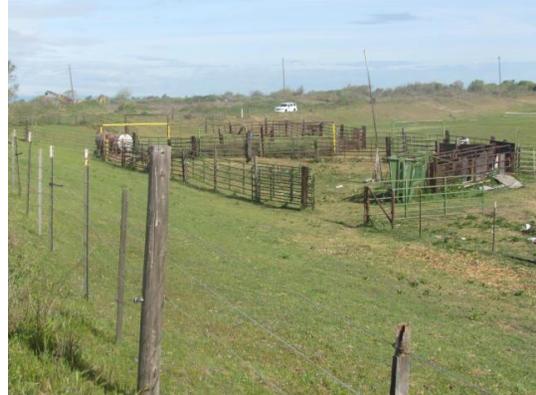
Photo 2 of 2 : SP_2016_NA0012_258_5_20160308_00006.jpg

Looking west at animal corral on waterside toe.

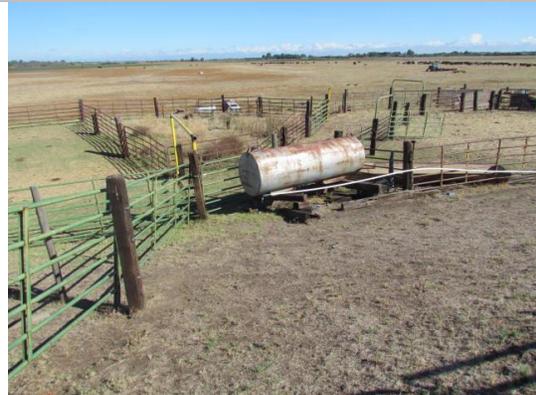
Photo 1 of 1 : SP_2016_NA0012_258_2_20160308_00002.jpg

LM Start	0.58	Rating **	M	Issue No.	2
LM End	0.58	Issue Type +	En	Location *	WS
Category	Earthen Levee			GPS Latitude/Longitude	
				Start	End
Item	Encroachments			38.179951 °	38.179951 °
				-121.681854 °	-121.681854 °
DWR ID	DWR_NA0012_01_f_2015_2				
Comment Code					
TA : Tank					
Inspector Comment					
Water tank for watering cattle stored at waterward toe.

Looking north at water tank stored at waterward toe.

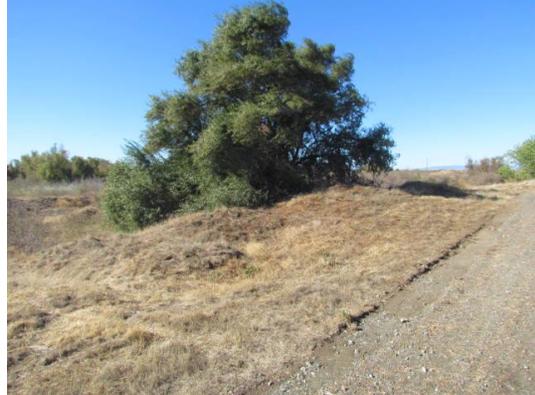
Photo 1 of 2 : SP_2016_NA0012_258_12_20160308_00010.jpg

LM Start	0.58	Rating **	U	Issue No.	12
LM End	0.58	Issue Type +	Ma	Location *	LS
Category	Earthen Levee			GPS Latitude/Longitude	
				Start	End
Item	Trim / Thin Trees			38.179966 °	38.179966 °
				-121.681872 °	-121.681872 °
DWR ID	DWR_NA0012_01_s_2015_12				
Comment Code					
T1 : Trim trees to at least five feet above ground level.					
Inspector Comment

Looking at untrimmed tree on landward slope fall 2015.

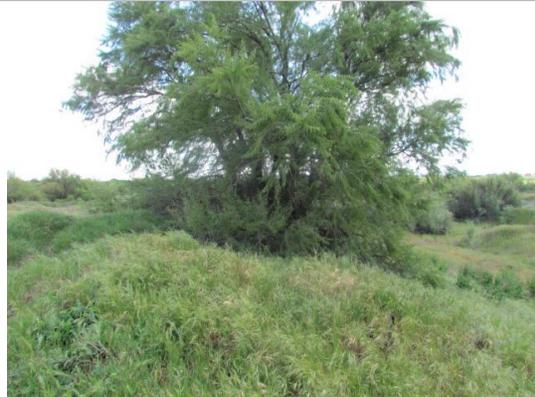
Photo 2 of 2 : SP_2016_NA0012_258_12_20160308_00011.jpg

Looking east at untrimmed tree on landward slope spring 2015
