**Flood Control Project Maintenance
Levee Inspections**

Fall 2015 Levee Maintenance Deficiency Summary Report

Sacramento River Basin

Sacramento River West Side Levee District

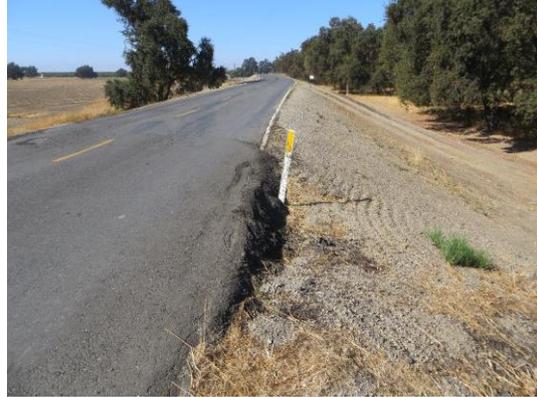
Photo 1 of 3 : UCIP_FA_2015_6066.jpg

LM Start		Rating **	U	Issue No.	1552
LM End		Issue Type +	En	Location *	N/A
Category	Supplemental			GPS Latitude/Longitude	
				Start	End
Item	DWR UCIP Field Study			39.186111 °	39.186111 °
				-121.968069 °	-121.968069 °
DWR ID					
Action/Comments					
Inspector Comments: FS_ID:46773 DS_ID:20296 EP_NO: 5551 FS_HLM: 46.898 Repair Type: Urgent Crossing Status: Found UCIP Comments: Possible sink hole along alignment 10-feet LS of siphon breaker on LS slope. Recent road repair along the approximate pipe alignment suggests that levee slumping is related to pipe. It is recommended that further investigation e.g. video inspection or other internal method may help determine if the issue is due to pipe or due to levee settlement in vicinity of the pipe. FIELD_STRUCT_DESC: 18-inch steel pipe through levee 3.0 feet below crown. Pump mounted on piling structure on the waterward bank. Switch box on the waterward shoulder and siphon breaker in 30-inch CMP riser on LS shoulder. Discharges into concrete box at toe of the landward slope (ABO No. 9349, 1974). Design drawings available in Permit No. 5551, 1968. Fish screen installed under permit No. 17222. FS Date: 03/22/2013

Recent pavement repair showing levee slumping. Photo taken from WS looking upstream along Moon Bend Rd

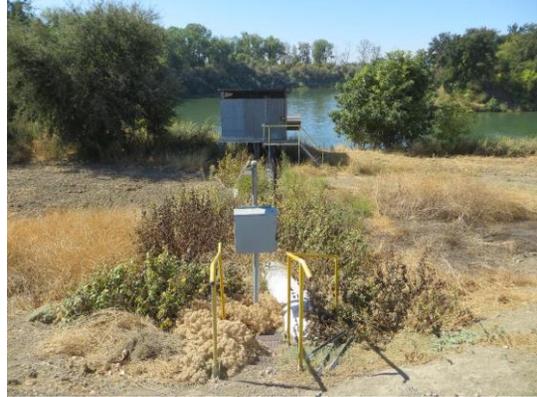
Photo 1 of 3 : UCIP_FA_2015_6063.jpg

LM Start		Rating **	M	Issue No.	1553
LM End		Issue Type +	En	Location *	N/A
Category	Supplemental			GPS Latitude/Longitude	
				Start	End
Item	DWR UCIP Field Study			38.864844 °	38.864844 °
				-121.757540 °	-121.757540 °
DWR ID					
Action/Comments					
Inspector Comments: FS_ID:46766 DS_ID:25126 EP_NO: 8501 FS_HLM: 6.89 Repair Type: Non-Urgent Crossing Status: Found UCIP Comments: a few actions are recommended based on field inspection: 1. clear out metal fence posts near daylight of pipe on water side levee. 2. clear vegetation around pipes on water side of levee to aid in inspection. 3. monitor burrowing activities on water side of levee. FIELD_STRUCT_DESC: A 20 inch steel pipe and a 16 inch steel pipe are located at levee mile 6.889 and 6.89, respectively. Both pipes have a protective paint coating. The pipes are used to supply irrigation water to the adjacent fields. On the water side of the levee, the pipes are above ground and follow the slope of the bank into the river. A metal pumphouse, supported on a steel frame is located on a bench on the waterside of the levee. When the pumps are operational a drum fish screen is lowered over the pipe intakes on a track. Both irrigation pipes travel through the levee and have siphon breakers in CMP risers on the land side crest of the levee. The pipes discharge under submerged conditions to a 9.5 ft x 12 ft concrete distribution box. There are two gated outlets on the distribution box that lead to distribution canals. FS Date: 10/09/2015

view from levee crest along pipe looking towards water side. shows pipe daylight and pump house

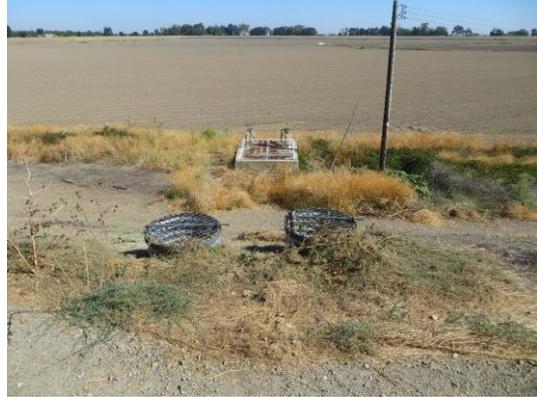
Photo 2 of 3 : UCIP_FA_2015_6064.jpg

view from levee crest along pipe looking towards land side. shows siphon breaker standpipes and distribution box.

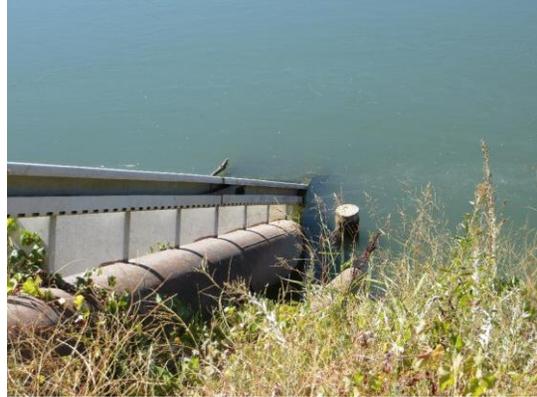
Photo 3 of 3 : UCIP_FA_2015_6065.jpg

Inspector Comments: FS_ID:46766
 DS_ID:25126
 EP_NO: 8501
 FS_HLM: 6.89
 Repair Type: Non-Urgent
 Crossing Status: Found
 UCIP Comments: a few actions are recommended based on field inspection: 1. clear out metal fence posts near daylight of pipe on water side levee. 2. clear vegetation around pipes on water side of levee to aid in inspection. 3. monitor burrowing activities on water side of levee.
 FIELD_STRUCT_DESC: A 20 inch steel pipe and a 16 inch steel pipe are located at levee mile 6.889 and 6.89, respectively. Both pipes have a protective paint coating. The pipes are used to supply irrigation water to the adjacent fields. On the water side of the levee, the pipes are above ground and follow the slope of the bank into the river. A metal pumphouse, supported on a steel frame is located on a bench on the waterside of the levee. When the pumps are operational a drum fish screen is lowered over the pipe intakes on a track. Both irrigation pipes travel through the levee and have siphon breakers in CMP risers on the land side crest of the levee. The pipes discharge under submerged conditions to a 9.5 ft x 12 ft concrete distribution box. There are two gated outlets on the distribution box that lead to distribution canals.

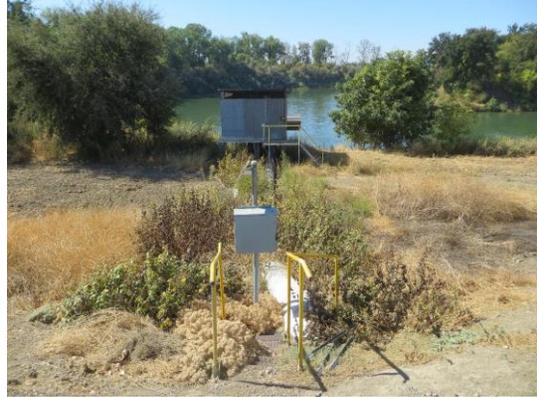
Photo 1 of 3 : UCIP_FA_2015_6043.jpg

Inspector Comments: FS_ID:46765
 DS_ID:25125
 EP_NO: 8501
 FS_HLM: 6.889
 Repair Type: Non-Urgent
 Crossing Status: Found
 UCIP Comments: field inspection of the site revealed a few minor actions: 1. there are metal fence posts located near the pipe that should be cleared out for safety, 2. vegetation around the pipes should be cleared as it limits inspection, 3. some burrowing activity was noticed nearby the pipes.
 FIELD_STRUCT_DESC: A 20 inch steel pipe and a 16 inch steel pipe are located at levee mile 6.889 and 6.89, respectively. Both pipes have a protective paint coating. The pipes are used to supply irrigation water to the adjacent fields. On the water side of the levee, the pipes are above ground and follow the slope of the bank into the river. A metal pumphouse, supported on a steel frame is located on a bench on the waterside of the levee. When the pumps are operational a drum fish screen is lowered over the pipe intakes on a track. Both irrigation pipes travel through the levee and have siphon breakers in CMP risers on the land side crest of the levee. The pipes discharge under submerged conditions to a 9.5 ft x 12 ft concrete distribution box. There are two gated outlets on the distribution box that lead to distribution canals.

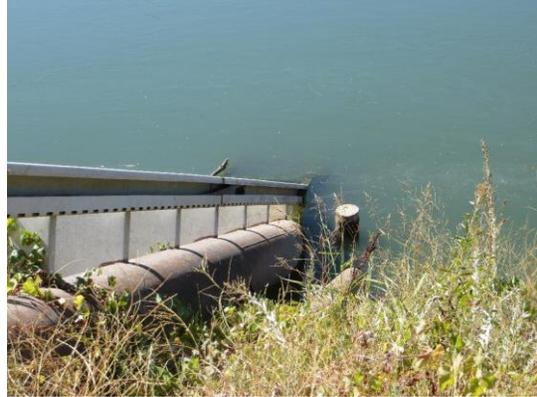
Photo 3 of 3 : UCIP_FA_2015_6045.jpg

Inspector Comments: FS_ID:46765
 DS_ID:25125
 EP_NO: 8501
 FS_HLM: 6.889
 Repair Type: Non-Urgent
 Crossing Status: Found
 UCIP Comments: field inspection of the site revealed a few minor actions: 1. there are metal fence posts located near the pipe that should be cleared out for safety, 2. vegetation around the pipes should be cleared as it limits inspection, 3. some burrowing activity was noticed nearby the pipes.
 FIELD_STRUCT_DESC: A 20 inch steel pipe and a 16 inch steel pipe are located at levee mile 6.889 and 6.89, respectively. Both pipes have a protective paint coating. The pipes are used to supply irrigation water to the adjacent fields. On the water side of the levee, the pipes are above ground and follow the slope of the bank into the river. A metal pumphouse, supported on a steel frame is located on a bench on the waterside of the levee. When the pumps are operational a drum fish screen is lowered over the pipe intakes on a track. Both irrigation pipes travel through the levee and have siphon breakers in CMP risers on the land side crest of the levee. The pipes discharge under submerged conditions to a 9.5 ft x 12 ft concrete distribution box. There are two gated outlets on the distribution box that lead to distribution canals.

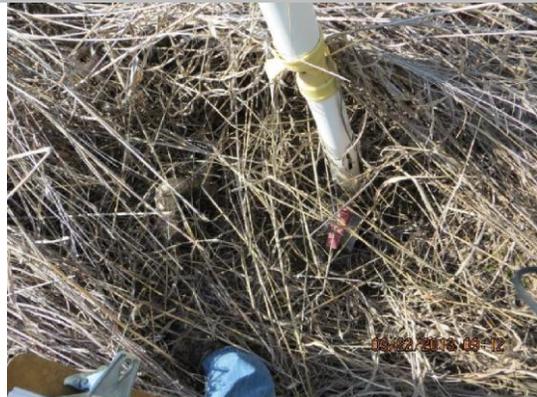
Photo 2 of 3 : UCIP_FA_2015_0203.jpg

Pipe connection at WS toe.

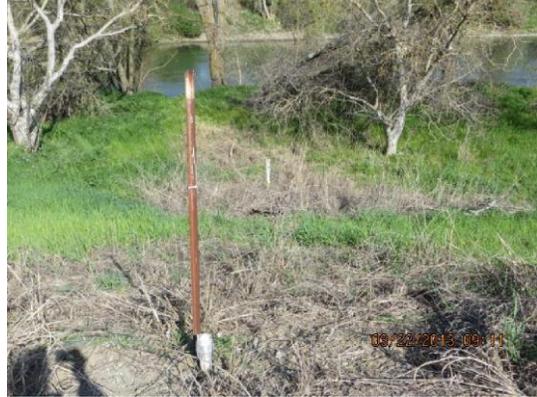
Photo 3 of 3 : UCIP_FA_2015_0204.jpg

Broken fresno valve on WS shoulder

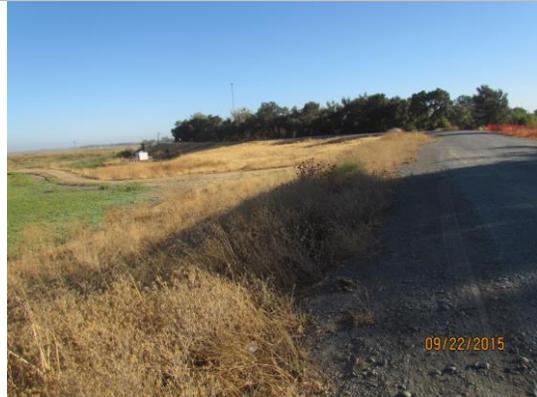
Photo 1 of 1 : FA_2015_NA0016_435_78_20151001_00093.jpg

LM Start	0.00	Rating **	M	Issue No.	78
LM End	0.25	Issue Type +	Ma	Location *	LS
Category	Earthen Levee		GPS Latitude/Longitude		
			Start	End	
Item	Vegetation		38.799633 °	38.802426 °	
			-121.725410 °	-121.724274 °	
DWR ID	DWR_NA0016_01_f_2015_78				
Action/Comments					
Control annual grass and weeds on the levee slopes and easements.

View of the vegetation on the landward side of the levee looking upstream. Fall 2015.

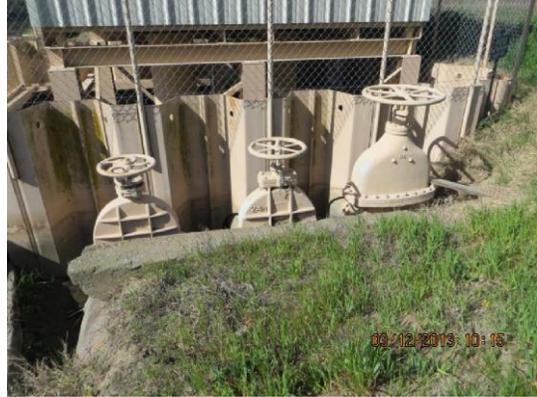
Photo 1 of 3 : UCIP_FA_2015_0337.jpg

Slide gates at pumphouse on LS toe.

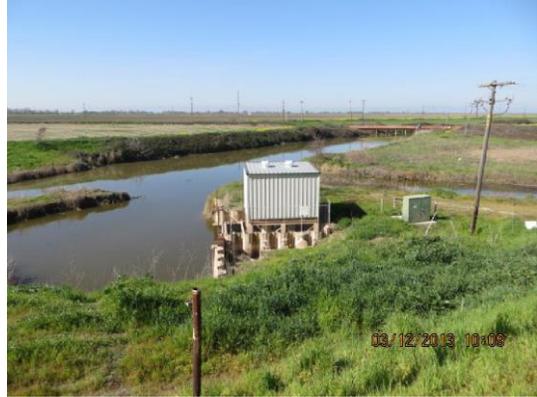
Photo 3 of 3 : UCIP_FA_2015_0339.jpg

Pumphouse at LS toe.

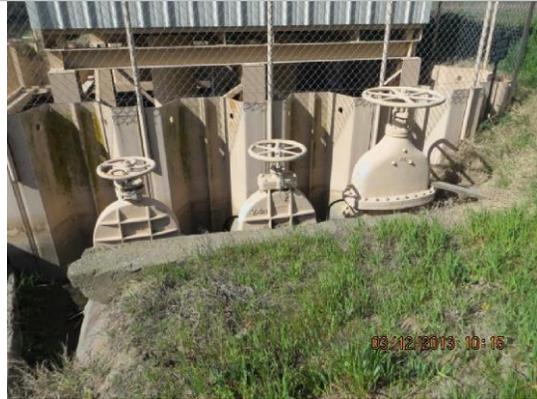
Photo 1 of 3 : UCIP_FA_2015_0307.jpg

Slide gates at pumphouse on LS toe.

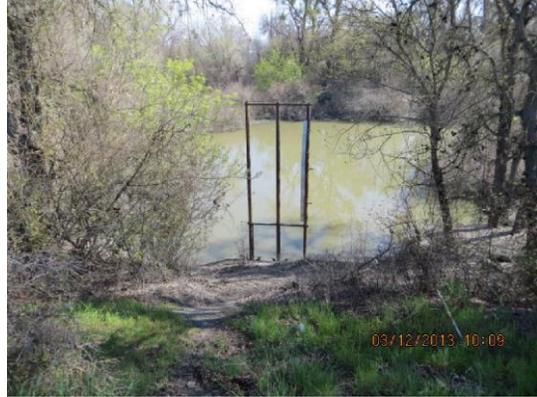
Photo 2 of 3 : UCIP_FA_2015_0308.jpg

Air vents on pipes at WS toe.

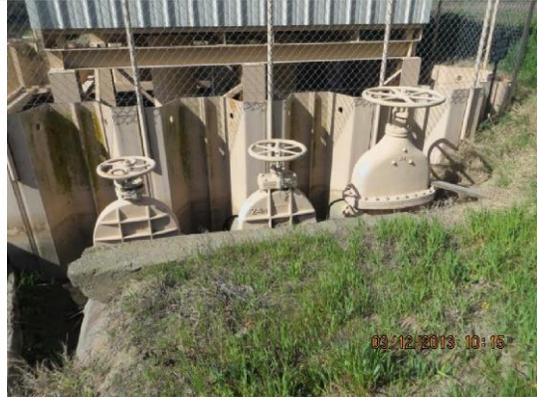
Photo 1 of 3 : UCIP_FA_2015_0374.jpg

Slide gates at pumphouse on LS toe.

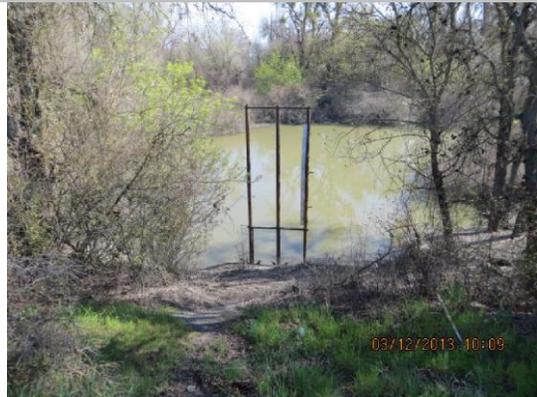
Photo 2 of 3 : UCIP_FA_2015_0375.jpg

Air vents on pipes at WS toe.

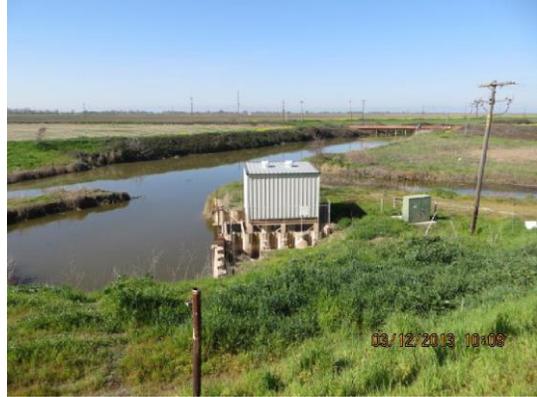
Photo 3 of 3 : UCIP_FA_2015_0376.jpg

Pumphouse on LS toe.

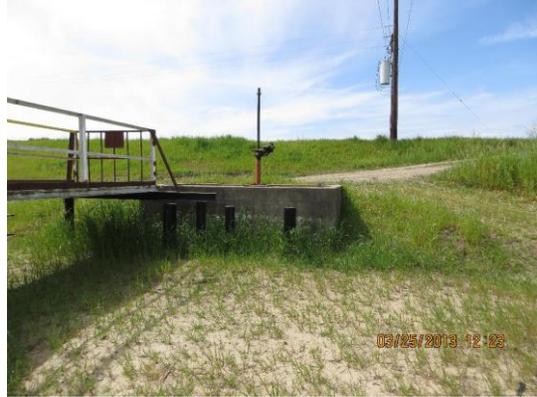
Photo 1 of 3 : UCIP_FA_2015_0390.jpg

Vents for 3 pipes entering surge box on WS toe.

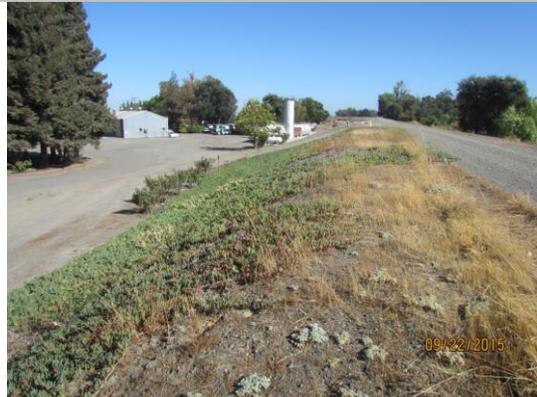
Photo 1 of 1 : FA_2015_NA0016_435_6_20151001_00100.jpg

View of the landscaping along the landward slope at River Gardens Farms looking upstream. Fall 2015.

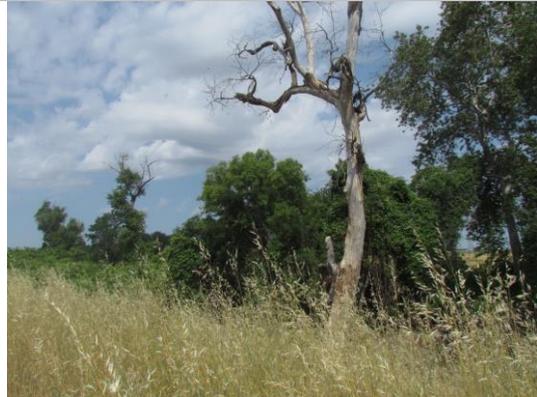
Photo 1 of 1 : FA_2015_NA0016_435_91_20150914_00041.jpg

View of the dying tree on the waterward side of the levee. Spring 2015.

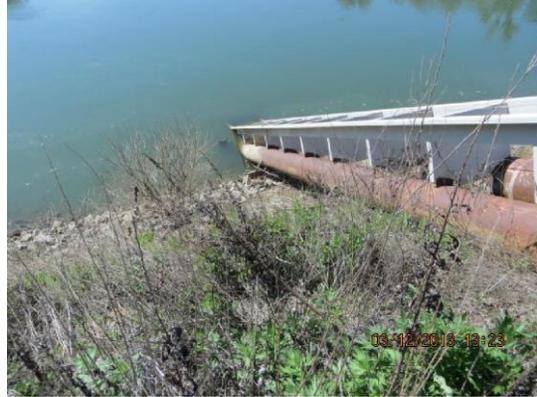
Photo 1 of 3 : UCIP_FA_2015_0413.jpg

Pipe and fish screen ramp on WS.

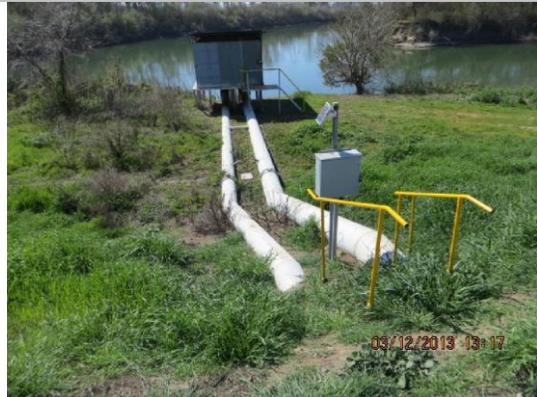
Photo 2 of 3 : UCIP_FA_2015_0414.jpg

Pumphouse and steps on WS.

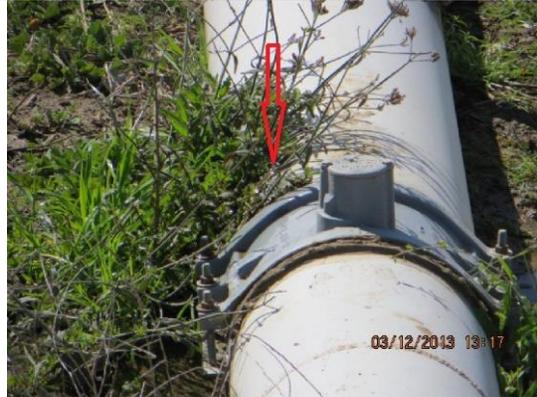
Photo 3 of 3 : UCIP_FA_2015_0415.jpg

Minor leak at flowmeter on WS berm.

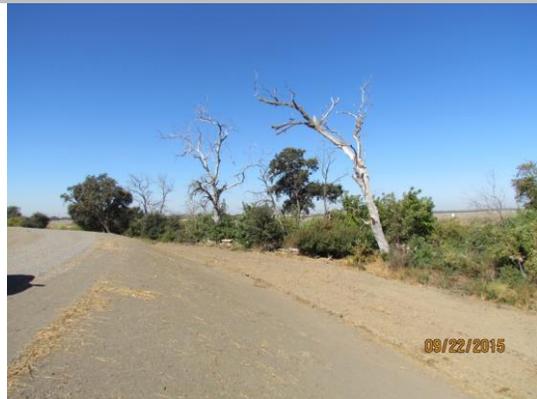
Photo 1 of 1 : FA_2015_NA0016_435_114_20151001_00107.jpg

View of the dying tree on the waterward side of the levee looking upstream. Fall 2015.

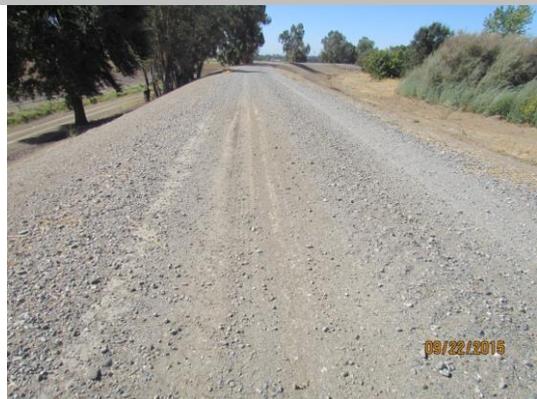
Photo 1 of 1 : FA_2015_NA0016_435_115_20151001_00108.jpg

View of the depression caused by vehicles on the crown of the levee looking upstream. Fall 2015.

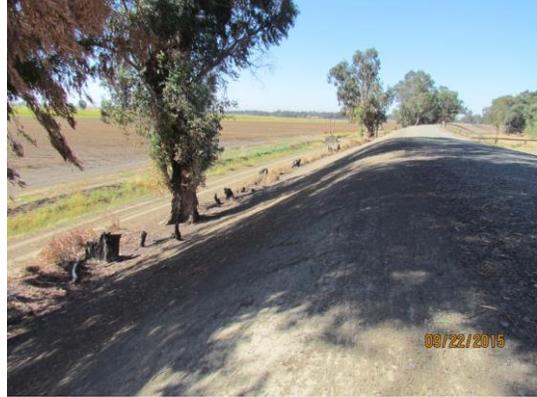
Photo 1 of 1 : FA_2015_NA0016_435_116_20151001_00109.jpg

View of the tree stumps along the landward levee toe looking upstream. Fall 2015.

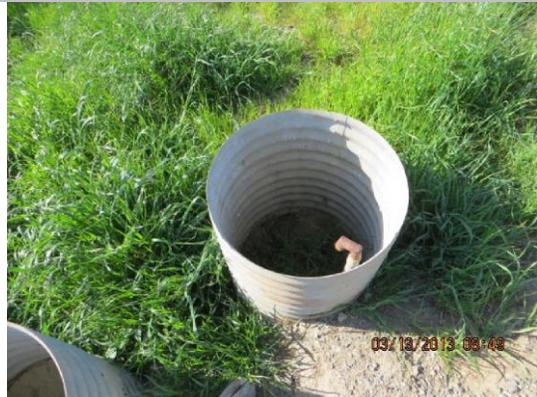
Photo 1 of 3 : UCIP_FA_2015_0419.jpg

Air vent in CMP riser on LS shoulder.

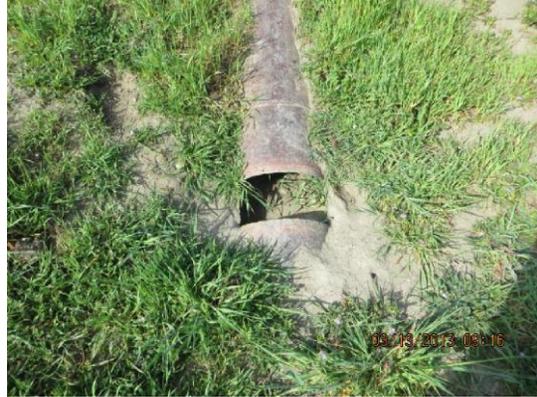
Photo 1 of 3 : UCIP_FA_2015_0497.jpg

Pipe open where watermeter was removed.

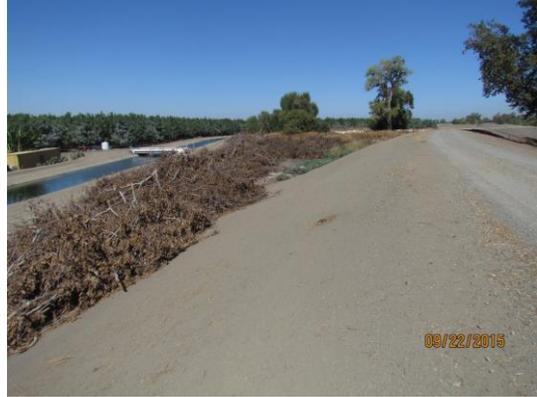
Photo 1 of 1 : FA_2015_NA0016_435_126_20151001_00115.jpg

View of the prunings on the landward side of the levee looking upstream. Fall 2015.

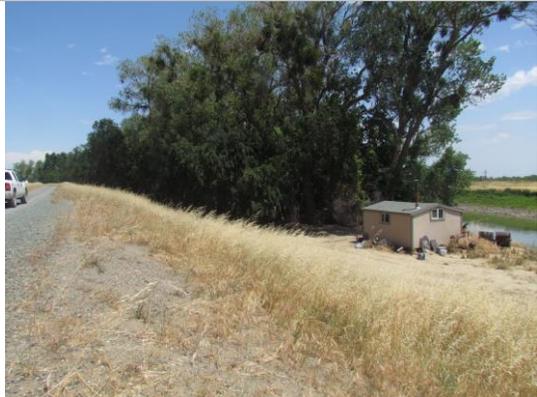
Photo 1 of 1 : FA_2015_NA0016_435_96_20150914_00044.jpg

View of the building on the waterward side of the levee looking upstream. Spring 2015.

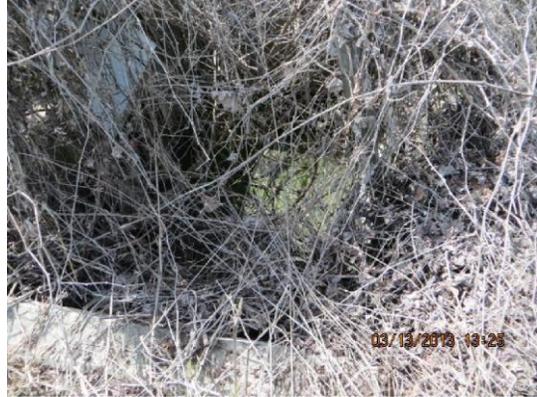
Photo 1 of 2 : UCIP_FA_2015_0356.jpg

Concrete distribution box under heavy blackberry cover at LS toe.

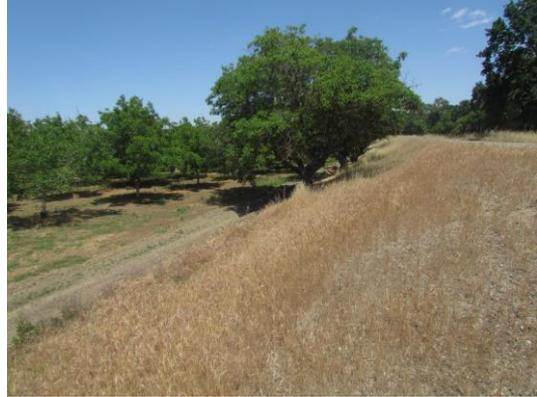
Photo 1 of 1 : FA_2015_NA0016_435_97_20150914_00045.jpg

View of the ditch at the toe of the landward side of the levee looking upstream. Spring 2015.

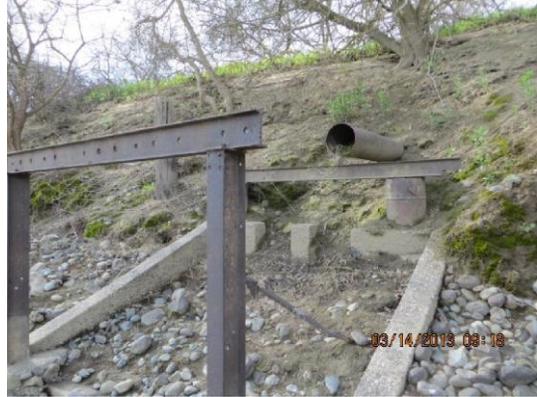
Photo 1 of 3 : UCIP_FA_2015_0257.jpg

abandoned pump platform on Rivers edge.

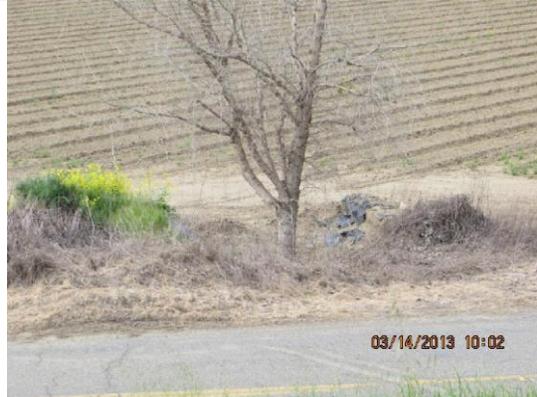
Photo 3 of 3 : UCIP_FA_2015_0266.jpg

Pipe located at base of tree off LS toe.

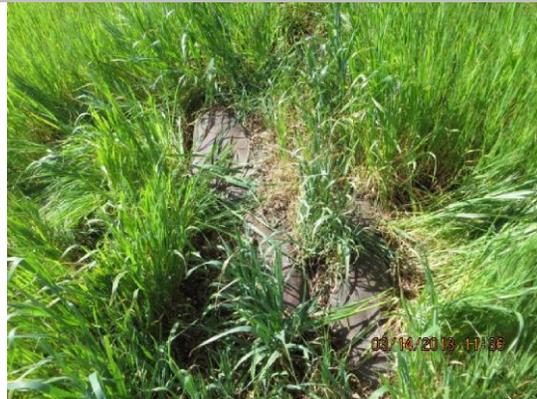
Photo 2 of 2 : UCIP_FA_2015_0364.jpg

Pipe debris on WS slope.

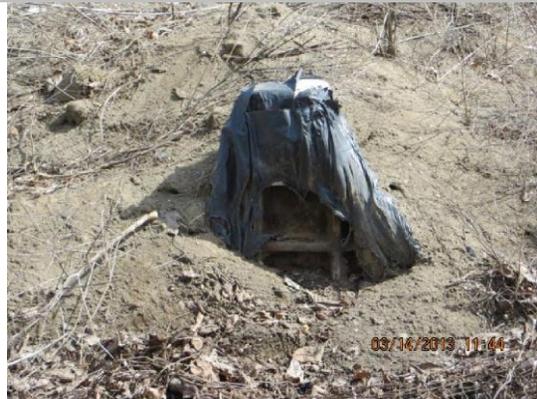
Photo 2 of 3 : UCIP_FA_2015_0366.jpg

Gate valve buried on LS toe.

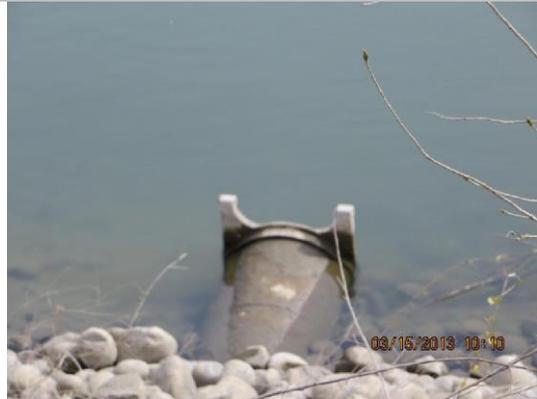
Photo 1 of 3 : UCIP_FA_2015_0384.jpg

Pipe missing flap gate at waters edge.

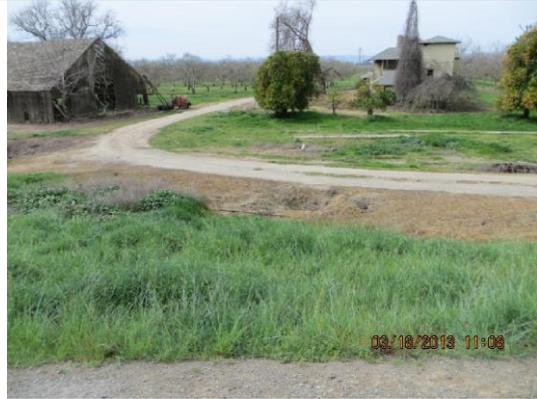
Photo 2 of 3 : UCIP_FA_2015_0335.jpg

Headwall and gate valve on LS toe burried but partially exposed.

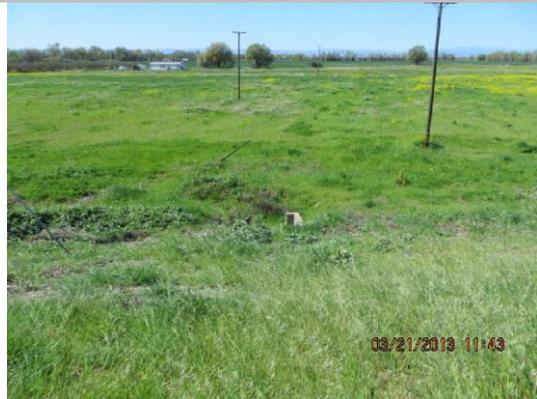
Photo 3 of 3 : UCIP_FA_2015_0302.jpg

Demolished concrete distribution box at LS toe.

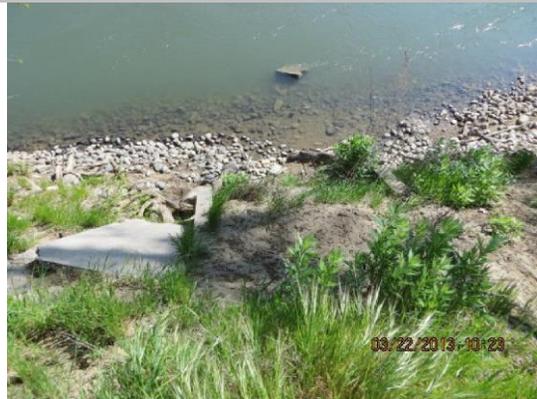
Photo 2 of 2 : UCIP_FA_2015_0233.jpg

Concrete pumphouse debris on WS berm.
