**Flood Control Project Maintenance  
Levee Inspections**

**Fall 2015 Levee Maintenance Deficiency Summary Report  
Overall LMA & Unit Ratings, including USACE Erosion Survey**

**Yolo County Service Area 6**

Waterway		Bank	Unit Miles	
Unit No. 01 Right Bank of Sacramento River at Knights Landing		Right	5.87	
	Spring (March - May)	Summer (June - August)	(September - November) Fall	Winter (December - February)
Unit Maintenance Rating (Fall Only)			U	
Date of Inspection	05/26/2015 - 05/26/2015		10/02/2015 - 10/02/2015	
DWR Inspector	Jai Lor		Jai Lor	
Accompanied By	Chris Starke Yolo County

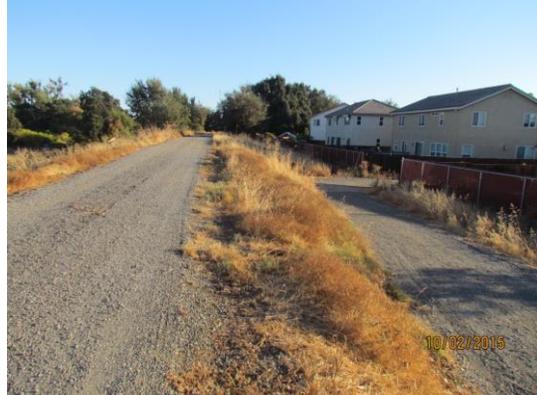
Photo 1 of 1 : FA\_2015\_NA0022\_350\_67\_20151005\_00064.jpg

View of the vegetation on the landward side of the levee looking downstream. Fall 2015.

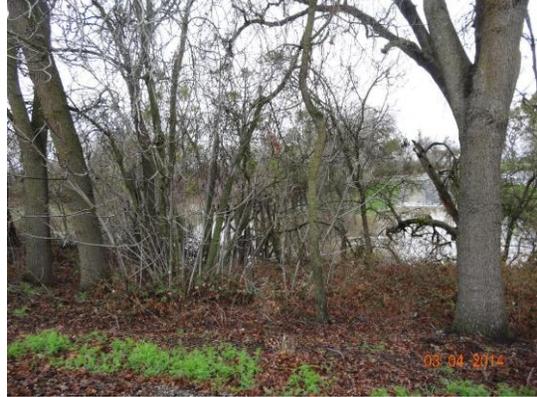
Photo 1 of 3 : UCIP\_FA\_2015\_3821.jpg

LM Start	<b>0.13</b>	Rating **	M	Issue No.	<b>402</b>
LM End	<b>0.13</b>	Issue Type +	En	Location *	LS
Category	Supplemental			GPS Latitude/Longitude	
				Start	End
Item	DWR UCIP Field Study			38.800647 °	38.800647 °
				-121.723212 °	-121.723212 °
DWR ID					
Action/Comments					
Inspector Comments: FS_ID:31903 DS_ID:19515 EP_NO: 9425 FS_HLM: 0.13 Repair Type: Non-Urgent Crossing Status: Found UCIP Comments: Need to properly abandon crossing per Title 23-- pipe has been disconnected. No signs of pipe visible on waterward and landward sides. Need to contact owner to determine additional information about pipe section through levee. FIELD_STRUCT_DESC: Abandoned 8-inch steel pipe through the levee, 3.0-feet below the crown. Pump structure in channel. (ABO Permit No. 9425-1974). FS Date: 03/04/2014

View of waterward side.

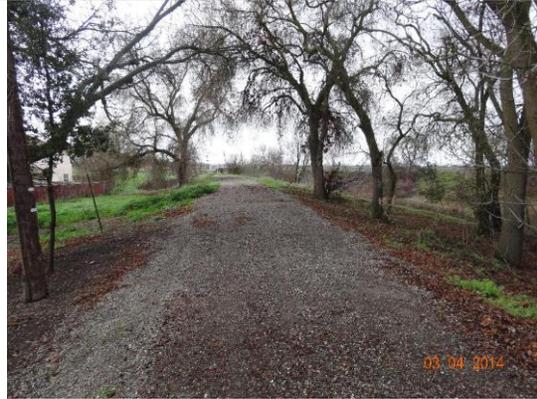
Photo 2 of 3 : UCIP\_FA\_2015\_3822.jpg

Overview of levee crown looking at crossing.

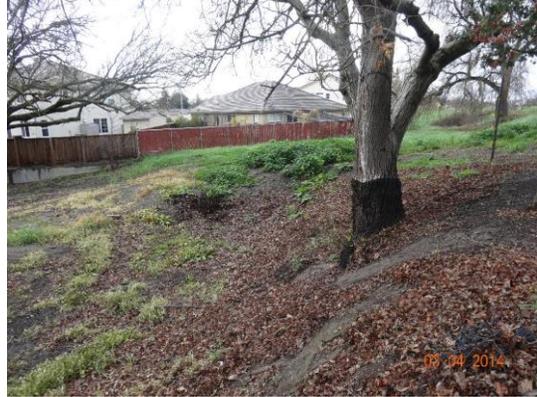
Photo 3 of 3 : UCIP\_FA\_2015\_3823.jpg

LM Start	<b>0.13</b>	Rating **	M	Issue No.	<b>402 (cont)</b>
LM End	<b>0.13</b>	Issue Type +	En	Location *	LS
Category	Supplemental			GPS Latitude/Longitude	
				Start	End
Item	DWR UCIP Field Study			38.800647 °	38.800647 °
				-121.723212 °	-121.723212 °
DWR ID					
Action/Comments					
Inspector Comments: FS_ID:31903 DS_ID:19515 EP_NO: 9425 FS_HLM: 0.13 Repair Type: Non-Urgent Crossing Status: Found

View of landward side.

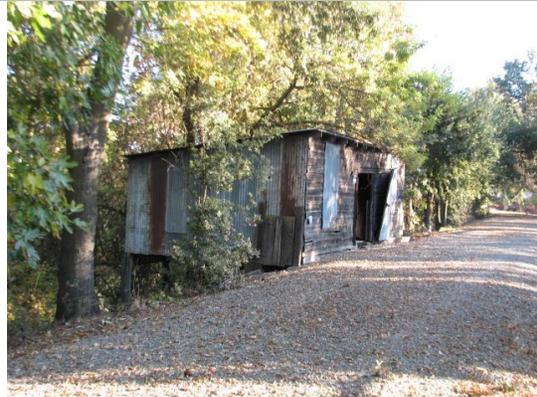
Photo 1 of 1 : FA\_2015\_NA0022\_350\_29\_20150914\_00029.jpg

The old barn is on the waterside of the levee. Fall 2013

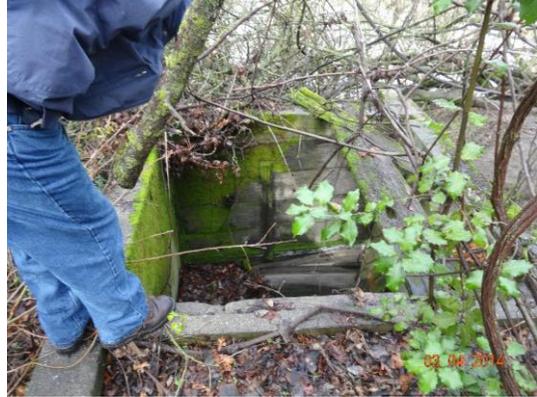
Photo 1 of 3 : UCIP\_FA\_2015\_3824.jpg

LM Start	<b>0.21</b>	Rating **	M	Issue No.	<b>403</b>
LM End	<b>0.21</b>	Issue Type +	En	Location *	WS
Category	Supplemental			GPS Latitude/Longitude	
				Start	End
Item	DWR UCIP Field Study			38.801280 °	38.801280 °
				-121.722000 °	-121.722000 °
DWR ID					
Action/Comments					
Inspector Comments: FS_ID:31904 DS_ID:19516 EP_NO: N/A FS_HLM: 0.195 Repair Type: Non-Urgent Crossing Status: Indicator Found UCIP Comments: Need to properly abandon per Title 23 if crossing is no longer used--debris inside concrete box and near site. Need to contact owner. FIELD_STRUCT_DESC: 48-inch CM pipe through the levee, 14.5-feet below the crown. Slide gate in concrete box on the waterward bank. (ABO Permit - 1976). FS Date: 03/04/2014

Concrete box located on waterward side.

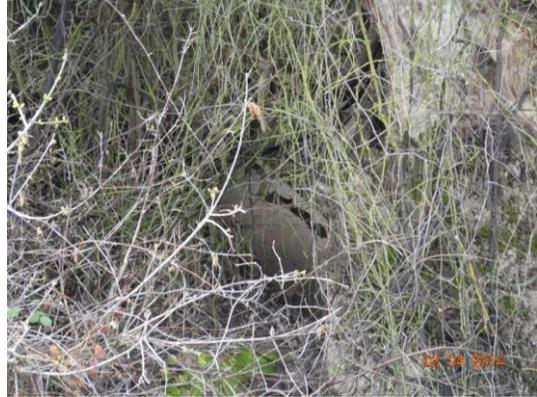
Photo 3 of 3 : UCIP\_FA\_2015\_3826.jpg

LM Start	<b>0.21</b>	Rating **	M	Issue No.	<b>403 (cont)</b>
LM End	<b>0.21</b>	Issue Type +	En	Location *	WS
Category	Supplemental			GPS Latitude/Longitude	
				Start	End
Item	DWR UCIP Field Study			38.801280 °	38.801280 °
				-121.722000 °	-121.722000 °
DWR ID					
Action/Comments					
Inspector Comments: FS_ID:31904 DS_ID:19516 EP_NO: N/A FS_HLM: 0.195 Repair Type: Non-Urgent Crossing Status: Indicator Found

Pipe section with holes abandoned on waterward side.

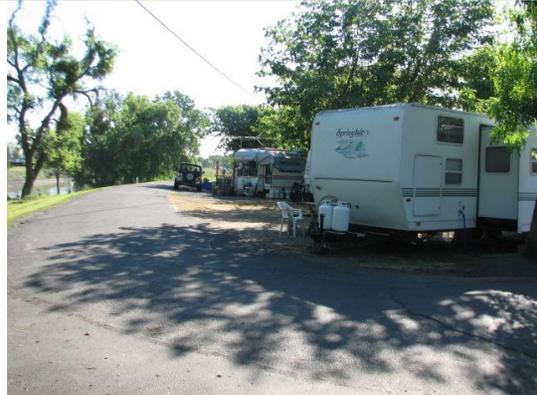
Photo 2 of 2 : FA\_2015\_NA0022\_350\_28\_20150914\_00028.jpg

LM Start	<b>0.22</b>	Rating **	M	Issue No.	<b>28</b>
LM End	<b>0.25</b>	Issue Type +	En	Location *	LS
Category	Earthen Levee			GPS Latitude/Longitude	
				Start	End
Item	Encroachments			38.801500 °	38.801613 °
				-121.721878 °	-121.721328 °
DWR ID	DWR_NA0022_01_s_2012_28				
Action/Comments					
Building Inspector Comments: RV park runs on and along levee to bridge

Trailers on the crown of the levee. Spring 2014

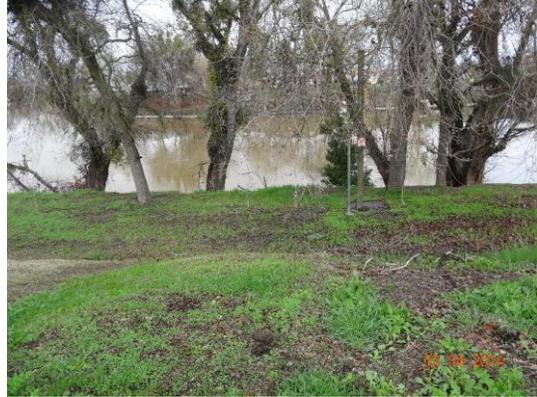
Photo 1 of 3 : UCIP\_FA\_2015\_3662.jpg

LM Start	<b>0.26</b>	Rating **	M	Issue No.	<b>404</b>
LM End	<b>0.26</b>	Issue Type +	En	Location *	LS
Category	Supplemental			GPS Latitude/Longitude	
				Start	End
Item	DWR UCIP Field Study			38.801597 °	38.801597 °
				-121.721226 °	-121.721226 °
DWR ID					
Action/Comments					
Inspector Comments: FS_ID:45403 DS_ID:19513 EP_NO: 9424 FS_HLM: 0.26 Repair Type: Non-Urgent Crossing Status: Indicator Found

View of waterward side.

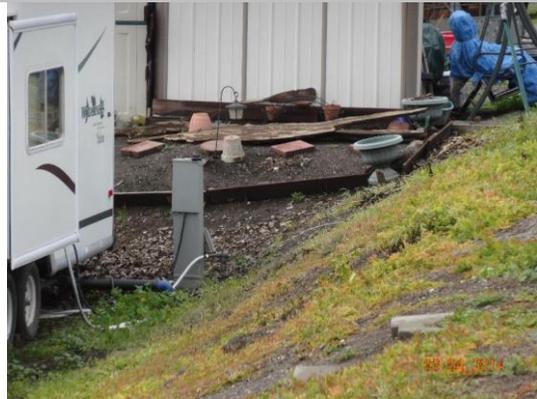
Photo 2 of 3 : UCIP\_FA\_2015\_3663.jpg

Spigot located on landward toe.

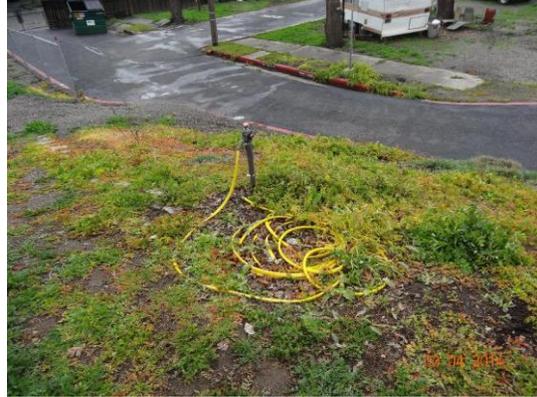
Photo 3 of 3 : UCIP\_FA\_2015\_3664.jpg

Spigot located on landward side.

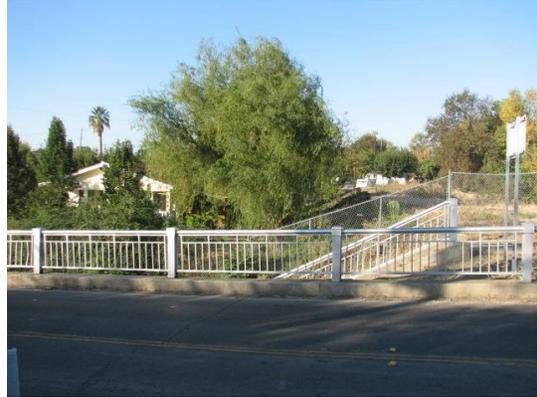
Photo 1 of 1 : FA\_2015\_NA0022\_350\_27\_20150914\_00026.jpg

LM Start	<b>0.30</b>	Rating **	U	Issue No.	<b>27</b>
LM End	<b>0.32</b>	Issue Type +	En	Location *	LS
Category	Earthen Levee			GPS Latitude/Longitude	
				Start	End
Item	Vegetation			38.801720 °	38.801840 °
				-121.720447 °	-121.720030 °
DWR ID	DWR_NA0022_01_s_2012_27				
Action/Comments					
Landscaping Inspector Comments: I have talked to the owner about a permit and he continues to landscape the landside slope with no permit. Owner has added fence across levee. I gave her an application and did a field investigation report.

Landscaping is encroaching onto the levee easement. Fall 2013

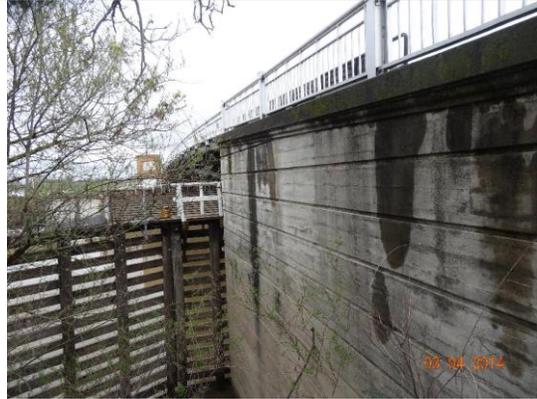
Photo 1 of 2 : UCIP\_FA\_2015\_3851.jpg

Item	DWR UCIP Field Study			38.801867 °	38.801867 °
				-121.719923 °	-121.719923 °
DWR ID					
Action/Comments					
Inspector Comments: FS_ID:31906 DS_ID:19534 EP_NO: 17016 FS_HLM: 0.334 Repair Type: Non-Urgent Crossing Status: Indicator Found UCIP Comments: Unable to confirm crossing alignment--steel pipe visible on waterward side however, unable to confirm if crossing is the same one found during field confirmation. Need to contact owner to verify alignment and status of crossing. Slope was too steep to verify and obtain additional information about pipe. FIELD_STRUCT_DESC: Three 2-inch diameter and three 1.5-inch diameter fiber optic conduits through the levee, encased in a single HDPE conduit, 30-feet below the levee crown. Concrete caps on both ends of the casing, on the landward and waterward sides. Voids in the HDPE conduit grouted. (Permit No. 17016-2000). FS Date: 03/04/2014

No pipe attached along bridge.

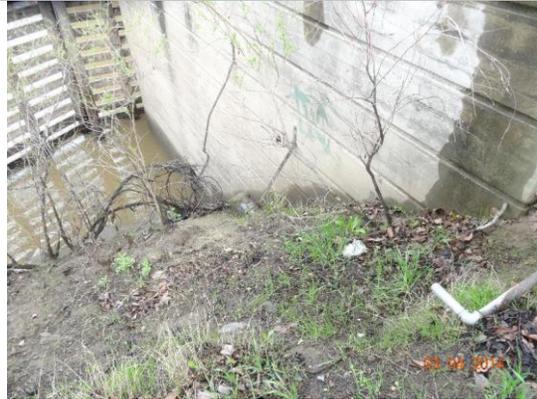
Photo 2 of 2 : UCIP\_FA\_2015\_3852.jpg

Steel pipe located on waterward side--pipe disconnected.

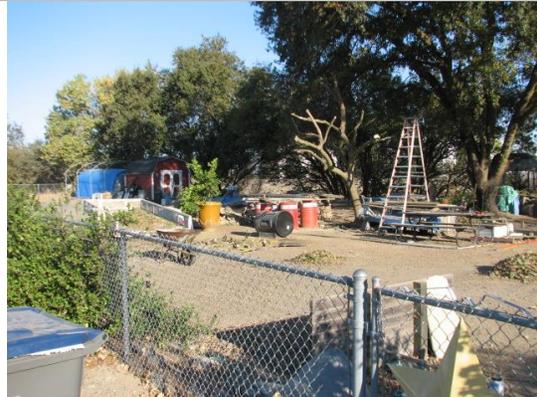
Photo 1 of 1 : FA\_2015\_NA0022\_350\_395\_20150914\_00061.jpg

Material blocking visibility on the waterside of the levee. Fall 2013

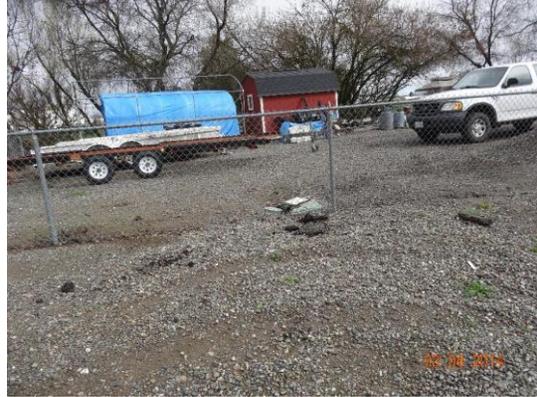
Photo 1 of 3 : UCIP\_FA\_2015\_2950.jpg

LM Start	<b>0.51</b>	Rating **	M	Issue No.	<b>406</b>
LM End	<b>0.51</b>	Issue Type +	En	Location *	WS
Category	Supplemental			GPS Latitude/Longitude	
				Start	End
Item	DWR UCIP Field Study			38.802062 °	38.802062 °
				-121.716740 °	-121.716740 °
DWR ID					
Action/Comments					
Inspector Comments: FS_ID:31627 DS_ID:19544 EP_NO: N/A FS_HLM: 0.51 Repair Type: Non-Urgent Crossing Status: Indicator Found UCIP Comments: Unable to confirm if signs of crossing are for the same crossing listed here. Need to contact owner and determine additional information about crossing. Also found is service box for water line--need permit and alignment confirmation. FIELD_STRUCT_DESC: 10-inch steel pipe through the levee. (USACE-1953). This entry matches the Drainage or Irrigation Structure referenced in O&M manual (Station 285+27). FS Date: 03/04/2014

Service box located on waterward side near fence post.

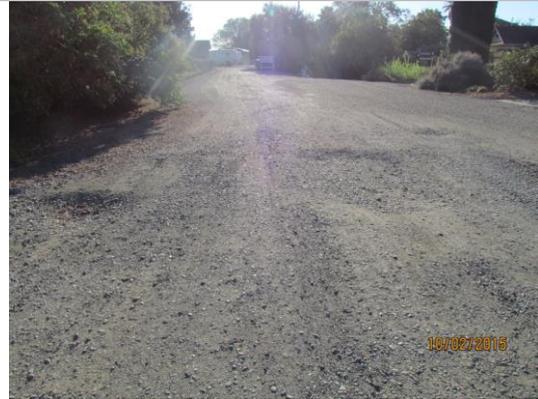
Photo 1 of 1 : FA\_2015\_NA0022\_350\_69\_20151005\_00067.jpg

LM Start	<b>0.53</b>	Rating **	M	Issue No.	<b>69</b>
LM End	<b>0.53</b>	Issue Type +	Ma	Location *	CR
Category	Earthen Levee			GPS Latitude/Longitude	
				Start	End
Item	Crown Surface / Depressions / Rutting			38.801950 °	38.801950 °
				-121.716299 °	-121.716299 °
DWR ID	DWR_NA0022_01_f_2015_69				
Action/Comments					
Repair depressions or ruts in the crown or slope.

View of the depression on the crown of the levee looking downstream. Fall 2015.

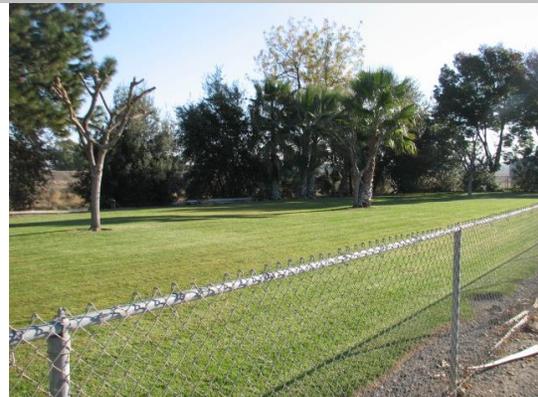
Photo 1 of 1 : FA\_2015\_NA0022\_350\_24\_20150914\_00023.jpg

LM Start	<b>0.54</b>	Rating **	A/W	Issue No.	<b>24</b>
LM End	<b>0.57</b>	Issue Type +	En	Location *	WS
Category	Earthen Levee			GPS Latitude/Longitude	
				Start	End
Item	Vegetation			38.801910 °	38.801823 °
				-121.716170 °	-121.715683 °
DWR ID	DWR_NA0022_01_s_2012_24				
Action/Comments					
Landscaping

The lawn area is on the levee waterside and crown. Fall 2013

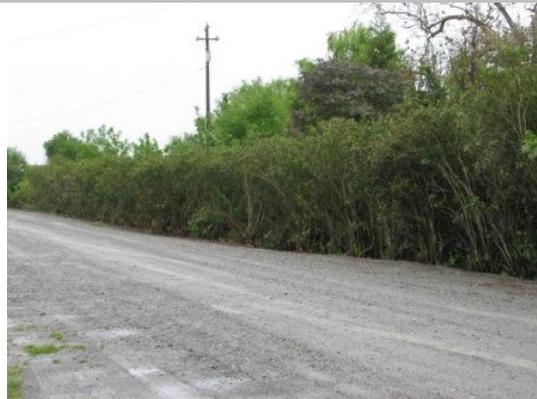
Photo 1 of 1 : FA\_2015\_NA0022\_350\_22\_20150914\_00021.jpg

Oleanders along the shoulder.

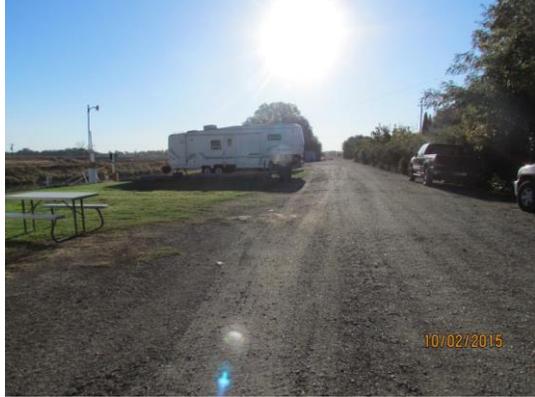
Photo 1 of 1 : FA\_2015\_NA0022\_350\_23\_20151005\_00068.jpg

View of the Yacht club on the crown of the levee looking downstream. Fall 2015.

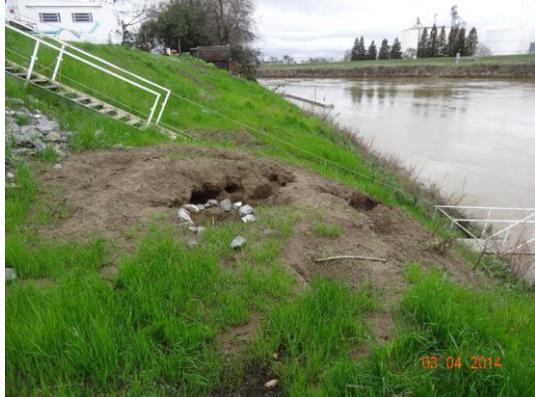
Photo 1 of 3 : UCIP\_FA\_2015\_4841.jpg

LM Start	<b>0.57</b>	Rating **	M	Issue No.	<b>408</b>
LM End	<b>0.57</b>	Issue Type +	En	Location *	WS
Category	Supplemental		GPS Latitude/Longitude		
			Start	End	
Item	DWR UCIP Field Study		38.801798 °	38.801798 °	
			-121.715584 °	-121.715584 °	
DWR ID					
Action/Comments					
Inspector Comments: FS_ID:38188 DS_ID:19519 EP_NO: N/A FS_HLM: 0.581 Repair Type: Non-Urgent Crossing Status: Indicator Found UCIP Comments: Unable to find any signs of crossing on waterward side. Signs of concrete riser visible on landward side. If crossing is abandoned owner will need to coordinate with the Central Valley Flood Protection Board (CVFPB) for Title 23 requirements. FIELD_STRUCT_DESC: 10-inch pipe through the levee, 3.3 feet below the crown. Plate welded on waterward end (1975). 24-inch concrete riser on the landward side. FS Date: 03/04/2014

View of waterward slope. Large hole visible on waterward side.

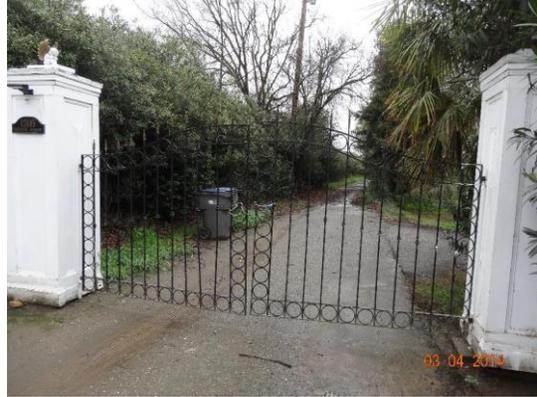
Photo 2 of 3 : UCIP\_FA\_2015\_4842.jpg

Inspector Comments: FS\_ID:38188  
 DS\_ID:19519  
 EP\_NO: N/A  
 FS\_HLM: 0.581  
 Repair Type: Non-Urgent  
 Crossing Status: Indicator Found  
 UCIP Comments: Unable to find any signs of crossing on waterward side. Signs of concrete riser visible on landward side. If crossing is abandoned owner will need to coordinate with the Central Valley Flood Protection Board (CVFPB) for Title 23 requirements.  
 FIELD\_STRUCT\_DESC: 10-inch pipe through the levee, 3.3 feet below the crown. Plate welded on waterward end (1975). 24-inch concrete riser on the landward side.  
 FS Date: 03/04/2014

Residential property standpipe located behind fence.

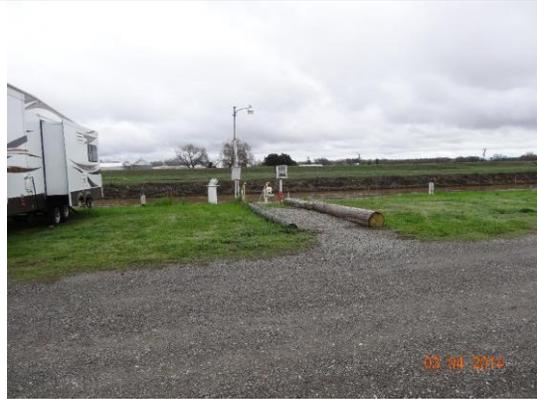
Photo 3 of 3 : UCIP\_FA\_2015\_4843.jpg

View of waterward side.

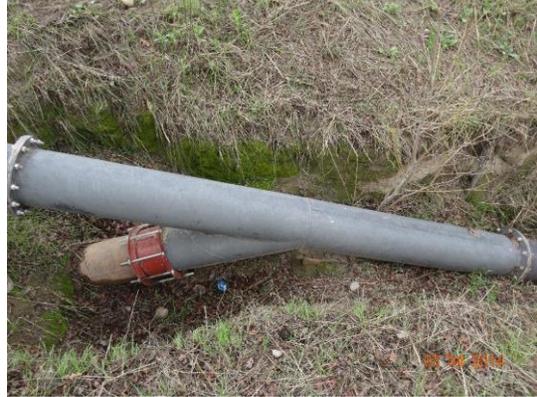
Photo 1 of 3 : UCIP\_FA\_2015\_4162.jpg

LM Start	<b>0.93</b>	Rating **	M	Issue No.	<b>409</b>
LM End	<b>0.93</b>	Issue Type +	En	Location *	LS
Category	Supplemental			GPS Latitude/Longitude	
				Start	End
Item	DWR UCIP Field Study			38.800200 °	38.800200 °
				-121.709258 °	-121.709258 °
DWR ID					
Action/Comments					
Inspector Comments: FS_ID:31969 DS_ID:19540 EP_NO: N/A FS_HLM: 0.95 Repair Type: Non-Urgent Crossing Status: Found UCIP Comments: Pipe section on waterward side appears to have been removed and reinstalled--Need to contact owner to obtain additional information regarding work completed. FIELD_STRUCT_DESC: 14-inch steel drain pipe through the levee. Pump and valve on waterside bank. (USACE-1953). This entry matches the Drainage or Irrigation Structure referenced in O&M manual (Station 266+72.2). Pipe and pump completely replaced under Permit No. 3798 (1962). FS Date: 03/04/2014

Pipe junction exposed on waterward side.

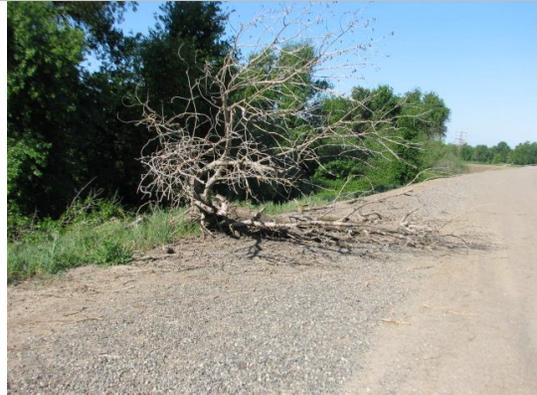
Photo 1 of 1 : FA\_2015\_NA0022\_350\_17\_20150914\_00017.jpg

A tree has fallen on the crown and blocks visibility. Spring 2014

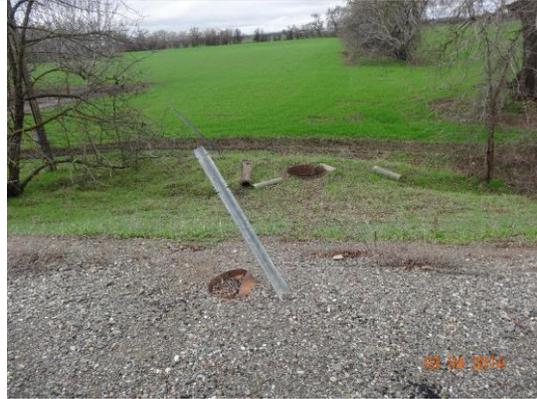
Photo 3 of 3 : UCIP\_FA\_2015\_3855.jpg

View of landward side.

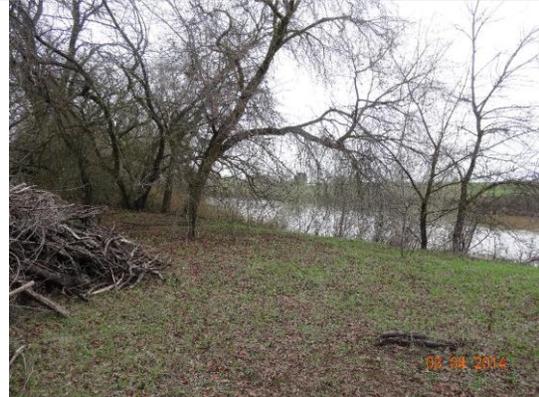
Photo 3 of 3 : UCIP\_FA\_2015\_4846.jpg

View of waterward side.

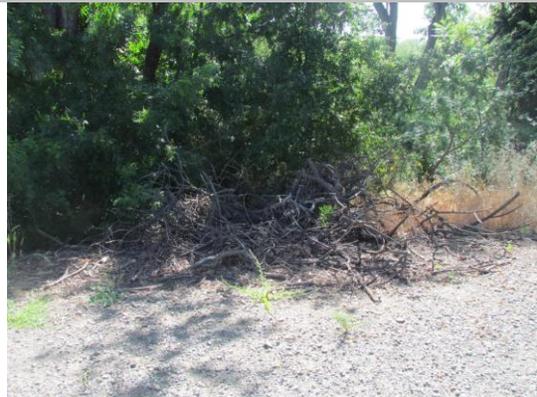
Photo 1 of 1 : FA\_2015\_NA0022\_350\_44\_20150914\_00044.jpg

View of the prunings on the waterward side of the levee. Spring 2015.

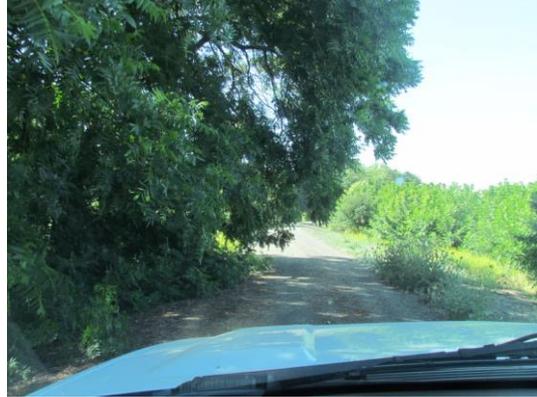
Photo 1 of 1 : FA\_2015\_NA0022\_350\_74\_20150914\_00050.jpg

View of the trees on the crown of the levee looking downstream. Spring 2015.

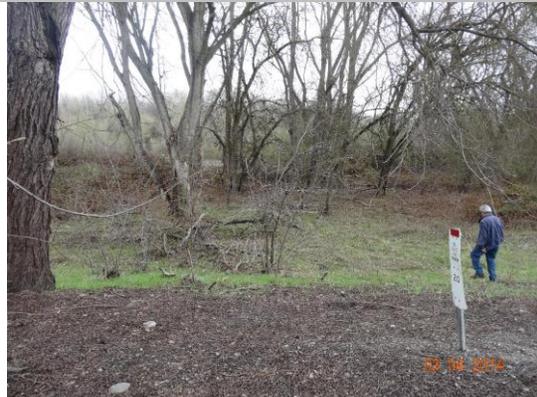
Photo 1 of 3 : UCIP\_FA\_2015\_3956.jpg

View of waterward side.

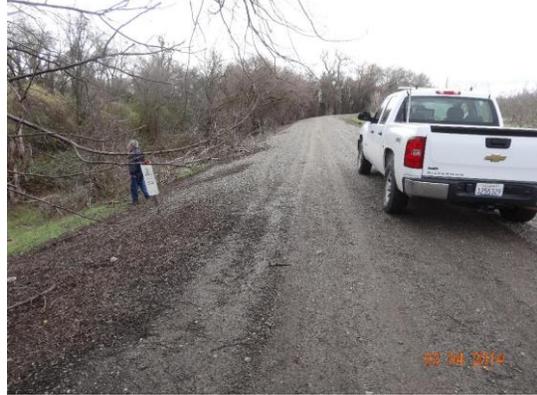
Photo 2 of 3 : UCIP\_FA\_2015\_3957.jpg

View of levee crown at crossing.

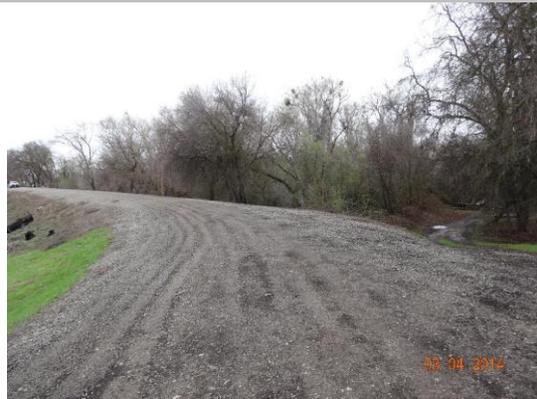
Photo 1 of 3 : UCIP\_FA\_2015\_3035.jpg

Overview of levee crown at crossing.

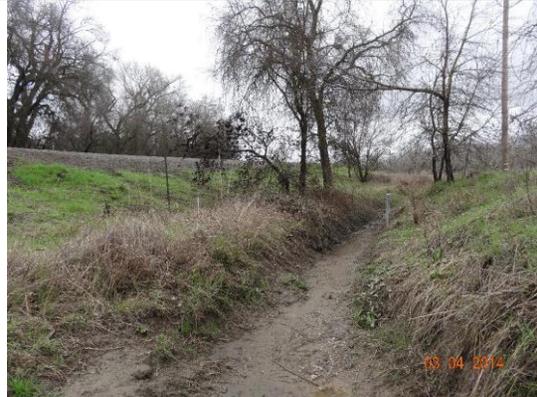
Photo 1 of 2 : UCIP\_FA\_2015\_3959.jpg

View of canal runs parallel on landward toe.

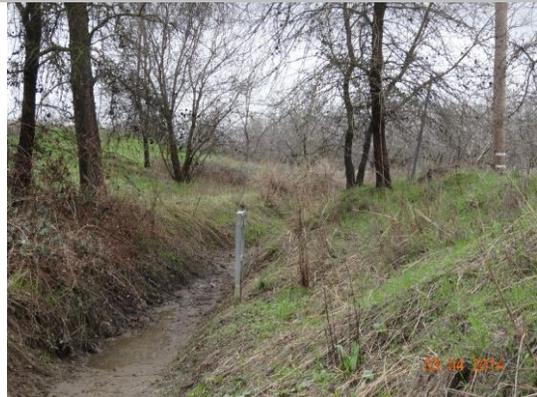
Photo 2 of 2 : UCIP\_FA\_2015\_3960.jpg

Slide gate inside canal.

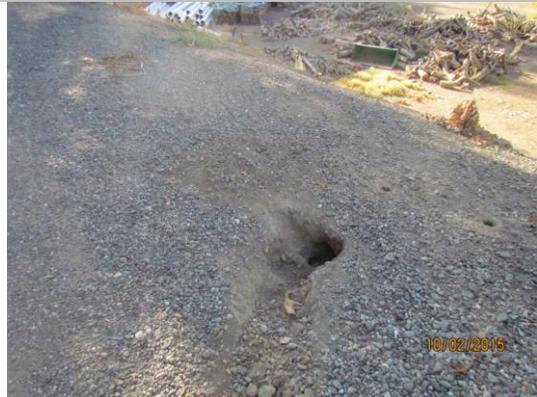
Photo 1 of 2 : FA\_2015\_NA0022\_350\_92\_20151005\_00078.jpg

There is a hole on the crown of the levee. Fall 2015.

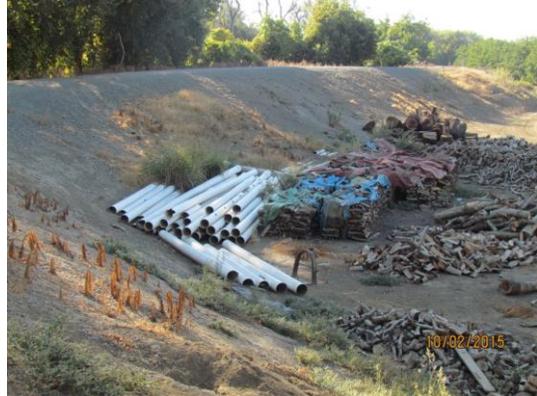
Photo 1 of 1 : FA\_2015\_NA0022\_350\_40\_20151005\_00080.jpg

View of equipment on the landward side of the levee looking downstream. Fall 2015.

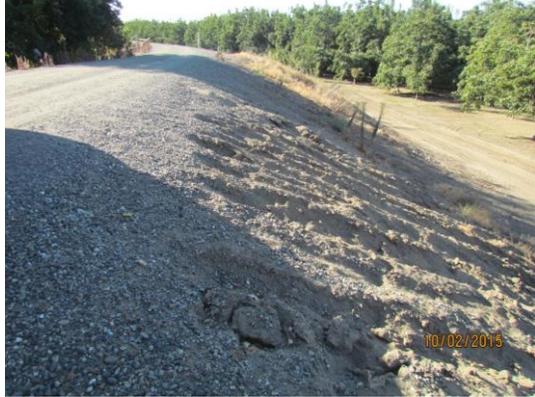
Photo 1 of 1 : FA\_2015\_NA0022\_350\_93\_20151005\_00082.jpg

View of the slope stability on the landward side of the levee looking downstream. Fall 2015.

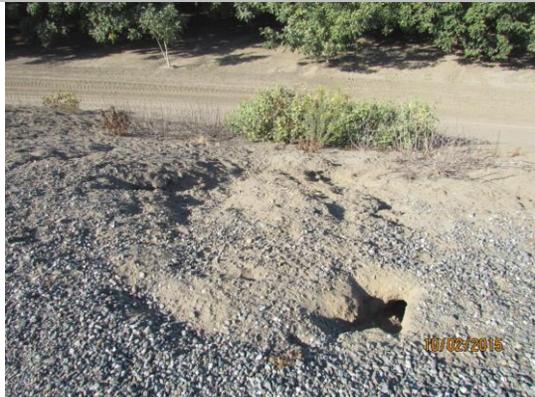
Photo 2 of 2 : FA\_2015\_NA0022\_350\_94\_20151005\_00085.jpg

Looking down on the erosion sight from the crown of the levee. Fall 2015.

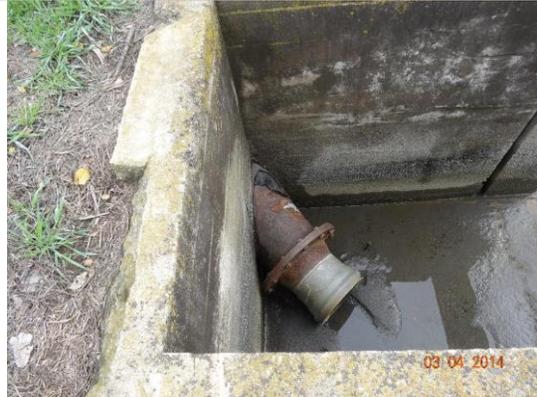
Photo 1 of 3 : UCIP\_FA\_2015\_3038.jpg

Outlet located on landward side.

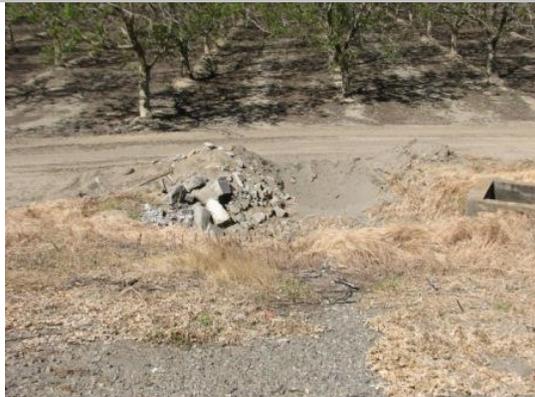
Photo 1 of 1 : FA\_2015\_NA0022\_350\_45\_20150914\_00045.jpg

Concrete debris is at the toe of the levee. Spring 2013

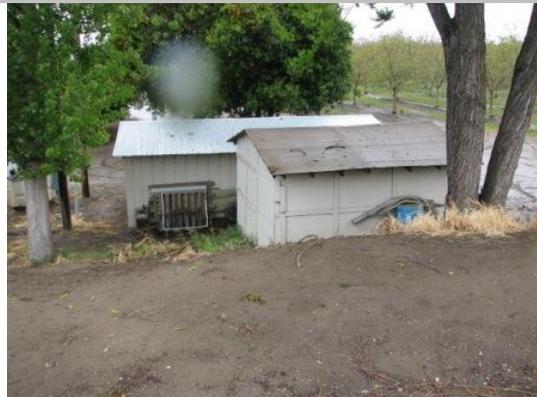
Photo 1 of 1 : FA\_2015\_NA0022\_350\_11\_20150914\_00012.jpg

Garage at toe.

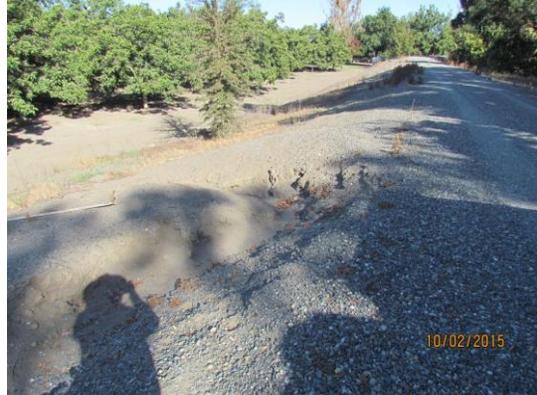
Photo 1 of 2 : FA\_2015\_NA0022\_350\_87\_20151005\_00093.jpg

Perspective view of the erosion on the landward side of the levee looking upstream. Fall 2015.

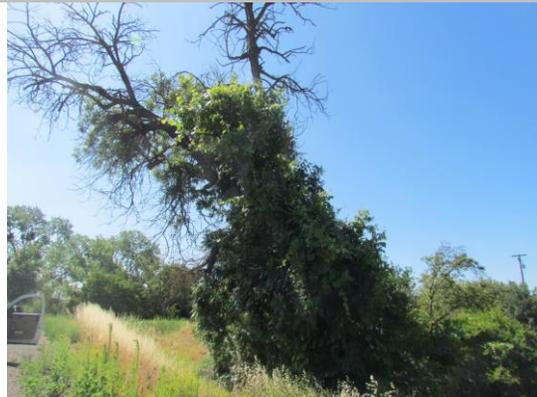
Photo 1 of 1 : FA\_2015\_NA0022\_350\_77\_20150914\_00051.jpg

View of the dying tree on the landward side of the levee looking downstream. Spring 2015.

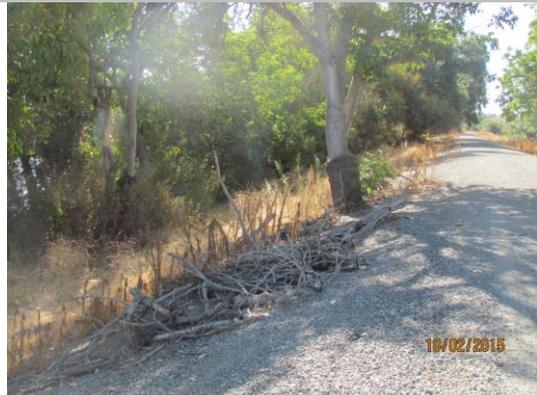
Photo 1 of 1 : FA\_2015\_NA0022\_350\_30\_20151005\_00099.jpg

View of the pruning pile on the waterward side of the levee looking downstream. Fall 2015.

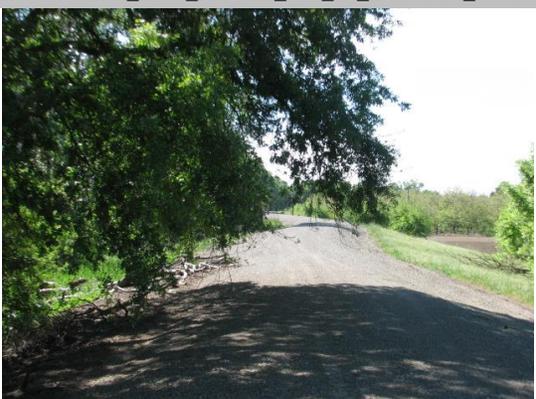
Photo 1 of 1 : FA\_2015\_NA0022\_350\_46\_20150914\_00046.jpg

Trees need to be trimmed up to at least 12 feet above the crown. Spring 2014

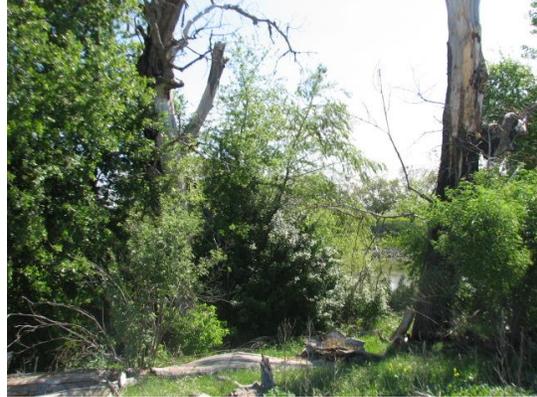
Photo 1 of 1 : FA\_2015\_NA0022\_350\_15\_20150914\_00016.jpg

Monitor dying trees they may pose to be a threat to the levee. Spring 2014

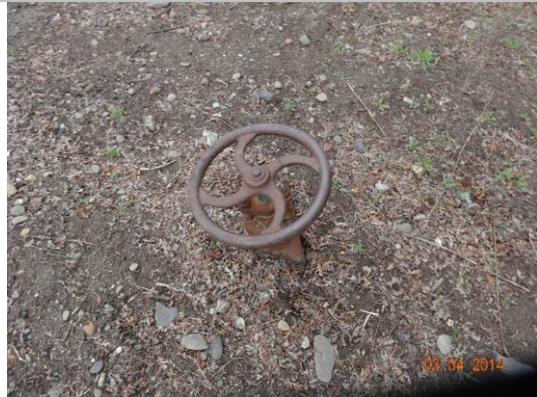
Photo 1 of 3 : UCIP\_FA\_2015\_6528.jpg

Positive closure device is buried on waterward side.

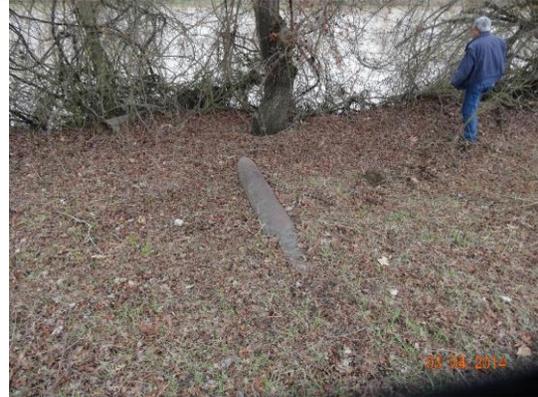
Photo 3 of 3 : UCIP\_FA\_2015\_6530.jpg

Pipe section visible on waterward side.

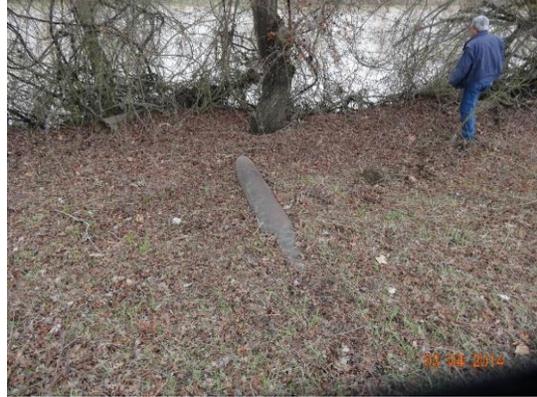
Photo 1 of 3 : UCIP\_FA\_2015\_3986.jpg

Pipe section visible on waterward side.

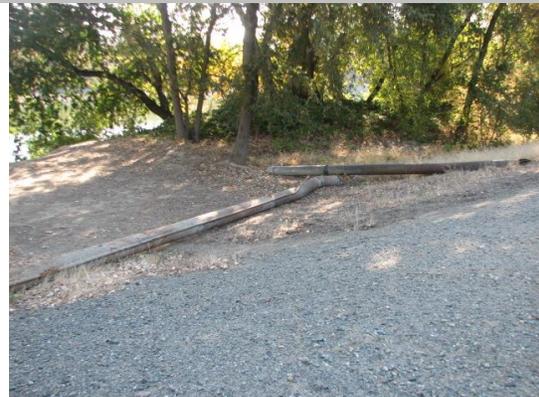
Photo 1 of 1 : FA\_2015\_NA0022\_350\_401\_20150914\_00062.jpg

Pipe has been laid on the waterside berm. Fall 2013

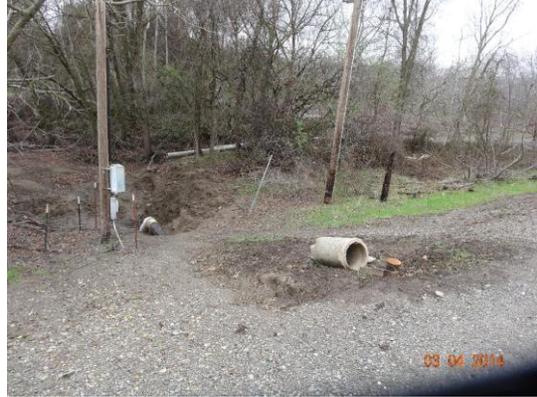
Photo 1 of 3 : UCIP\_FA\_2015\_3989.jpg

View of landward side, photo 1 of 2.

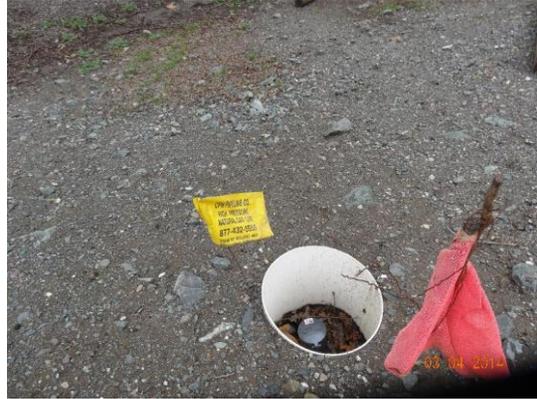
Photo 2 of 3 : UCIP\_FA\_2015\_3990.jpg

Flow meter located on waterward shoulder.

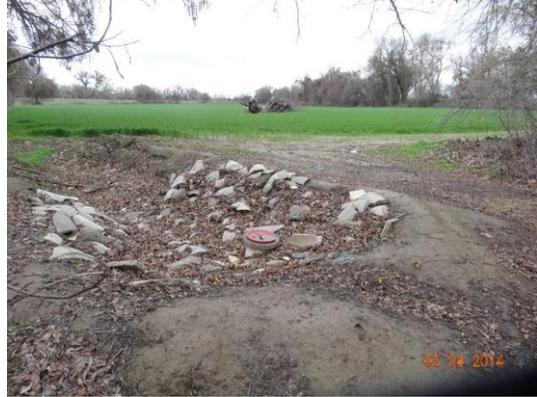
Photo 3 of 3 : UCIP\_FA\_2015\_3991.jpg

View of landward side, photo 2 of 2.

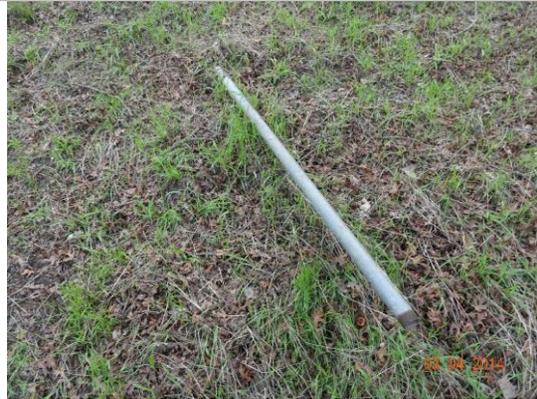
Photo 1 of 3 : UCIP\_FA\_2015\_4847.jpg

Abandoned conduit line through levee.

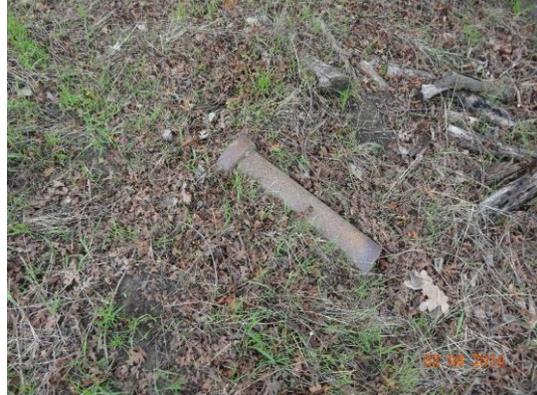
Photo 2 of 3 : UCIP\_FA\_2015\_4848.jpg

Debris scattered on landward side.

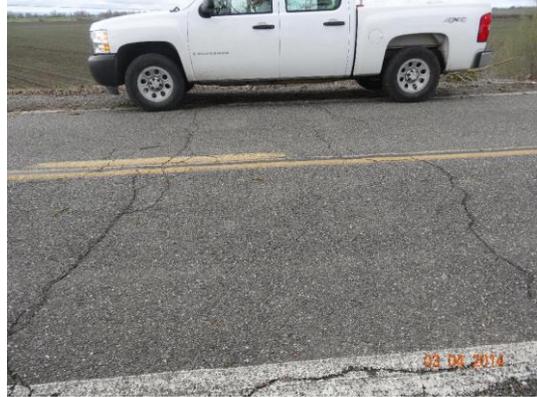
Photo 1 of 3 : UCIP\_FA\_2015\_3107.jpg

View of levee crown at crossing.

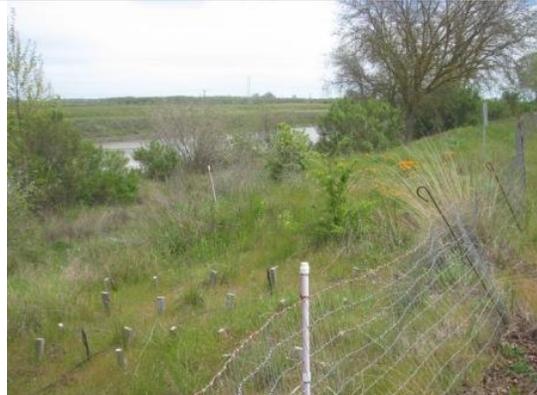
Photo 2 of 2 : FA\_2015\_NA0022\_350\_36\_20150914\_00036.jpg

Fence, irrigation and stakes in the revegetation site.

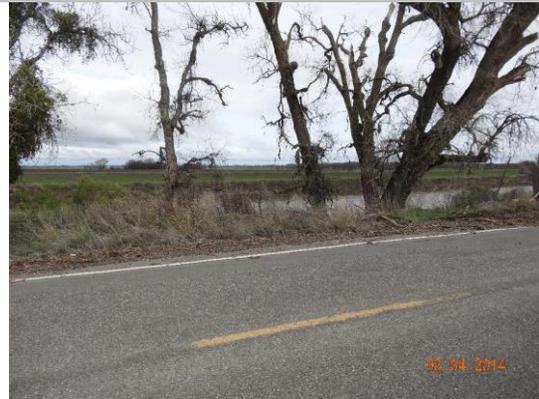
Photo 2 of 3 : UCIP\_FA\_2015\_4193.jpg

View of waterward side.

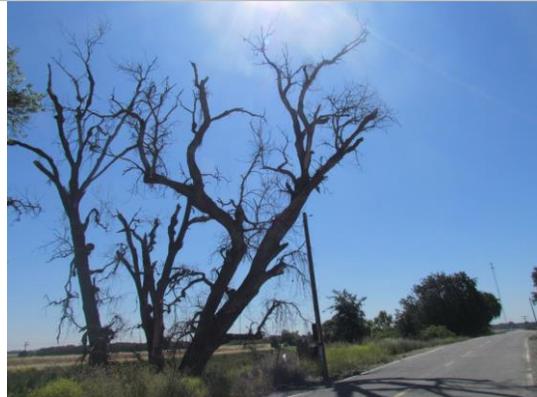
Photo 1 of 1 : FA\_2015\_NA0022\_350\_81\_20150914\_00053.jpg

View of the dying tree on the waterward side of the levee looking downstream. Spring 2015.

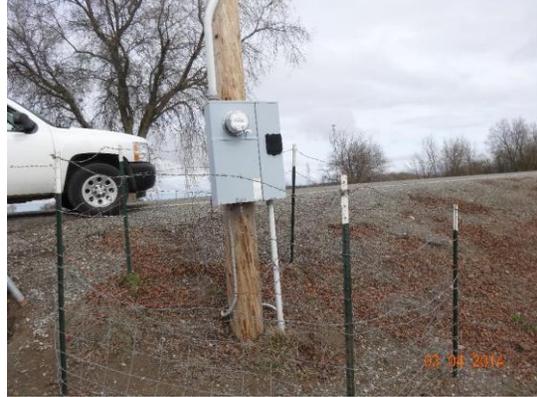
Photo 1 of 2 : UCIP\_FA\_2015\_4850.jpg

Power pole with conduit line through levee.

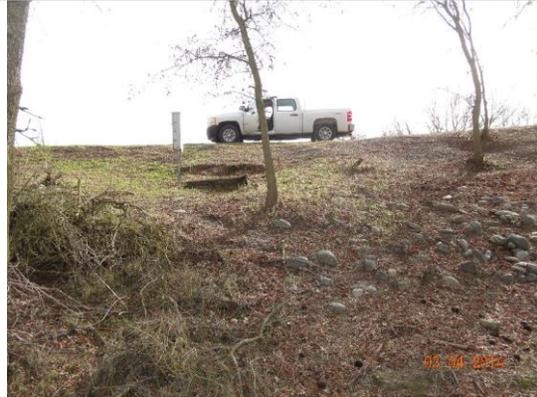
Photo 1 of 2 : UCIP\_FA\_2015\_4117.jpg

Rip rap along waterward slope.

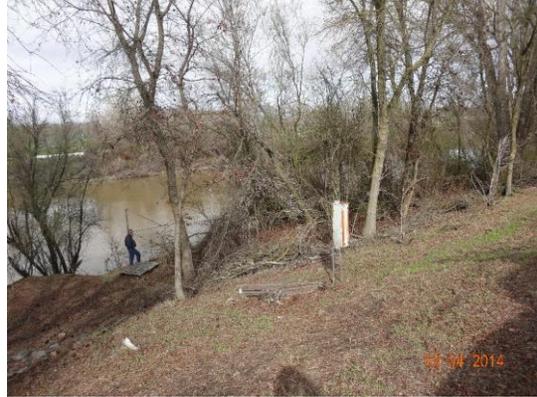
Photo 2 of 2 : UCIP\_FA\_2015\_4118.jpg

View of waterward side.

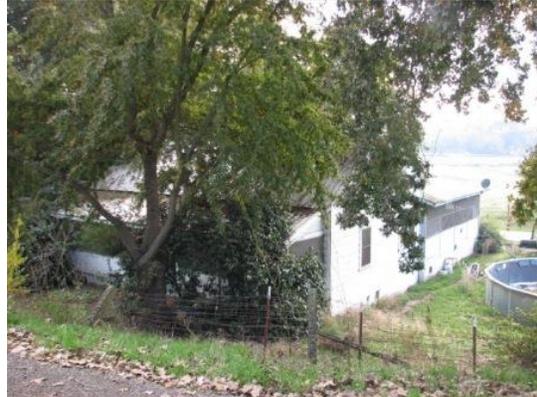
Photo 1 of 1 : FA\_2015\_NA0022\_350\_1\_20150914\_00001.jpg

The house and landscape are in the easment of the levee. Fall 2011

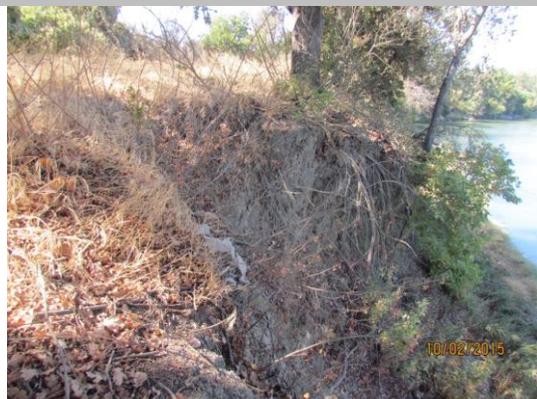
Photo 1 of 2 : FA\_2015\_NA0022\_350\_84\_20151005\_00103.jpg

View of the erosion on the waterward side of the levee looking upstream. Fall 2015.

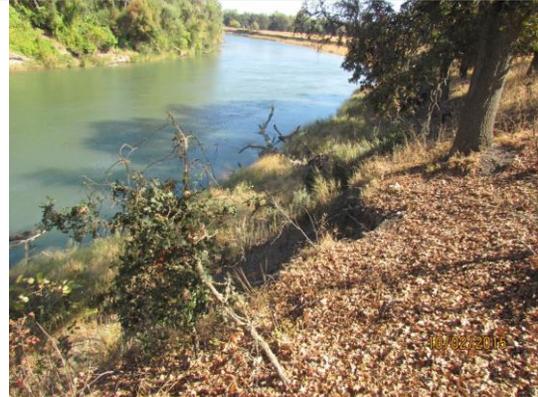
Photo 2 of 2 : FA\_2015\_NA0022\_350\_84\_20151005\_00104.jpg

View of the erosion on the waterward side of the levee looking downstream. Fall 2015.
