Flood Control Project Maintenance
2016 Structure Summary Report
Overall Unit and Item Ratings

DWR Sacramento Maintenance Yard

Flood Control Project Maintenance

2016 Structure Inspection Results

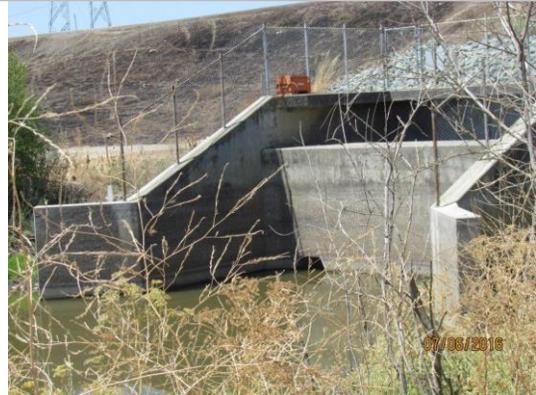
Photo 1 of 2 : ST_2016_NA0055_12_24_20160719_00033.jpg

View of the outlet structure at the south end of the weir. Summer 2016.

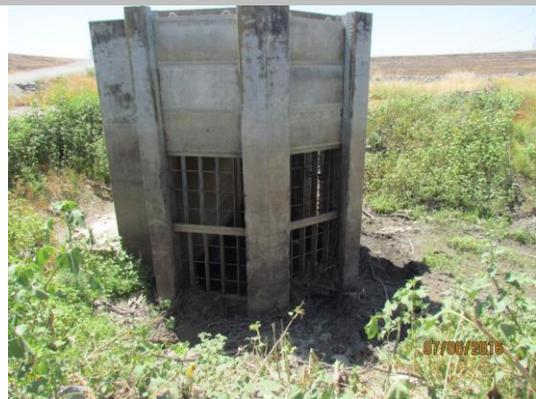
Photo 2 of 2 : ST_2016_NA0055_12_24_20160719_00034.jpg

View of the inlet structure at the south end of the weir. Summer 2016.

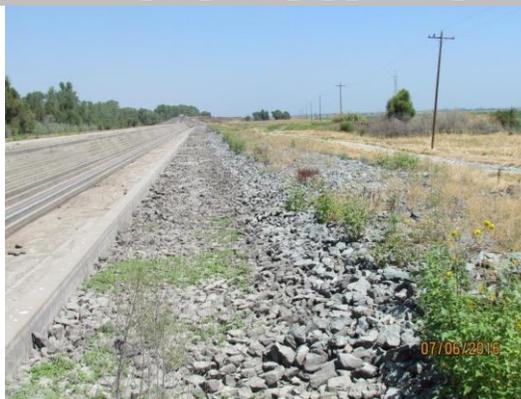
Photo 1 of 2 : ST_2016_NA0055_12_5_20160719_00026.jpg

View of the revetments of the weir on the south end looking north. Summer 2016.

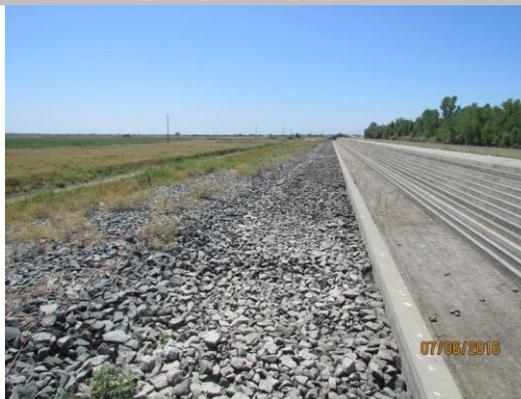
Photo 2 of 2 : ST_2016_NA0055_12_5_20160719_00027.jpg

View of the revetments of the weir on the north end looking south. Summer 2016.

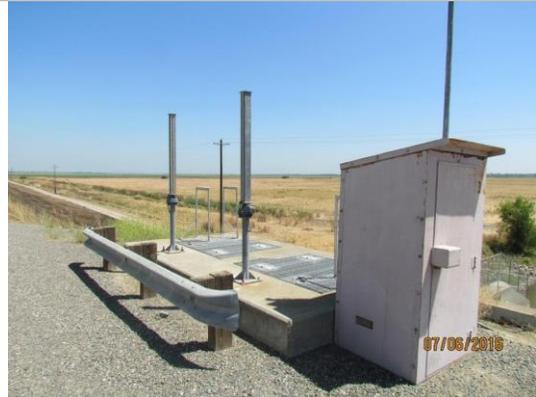
Photo 1 of 1 : ST_2016_NA0055_12_14_20160719_00028.jpg

View of the gate operators to the drainage structure. Summer 2016.

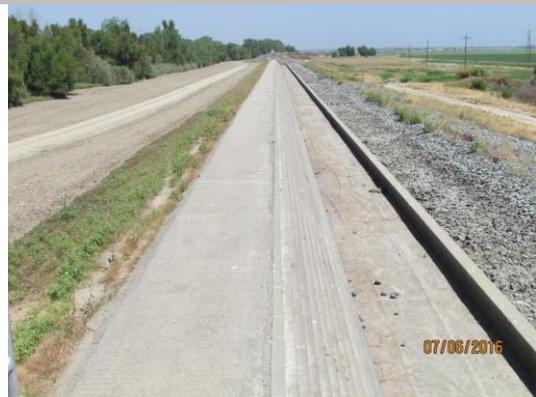
Photo 1 of 4 : ST_2016_NA0055_12_15_20160719_00029.jpg

LM Start	0.00	Rating **	A	Issue No.	15
LM End	0.00	Issue Type +	Ma	Location *	CR
Category	Structures & Concrete Lined Channels		GPS Latitude/Longitude		
			Start	End	
Item	Concrete Surfaces		38.682460 °	38.687350 °	
			-121.672930 °	-121.673740 °	
DWR ID	DWR_NA0055_12_t_2012_15				
Action/Comments					
Inspector Comments: Negligible spalling, scaling or cracking. Cracks should be sealed to prevent freeze/thaw damage.

View of the weir on the south end looking north. Summer 2016.

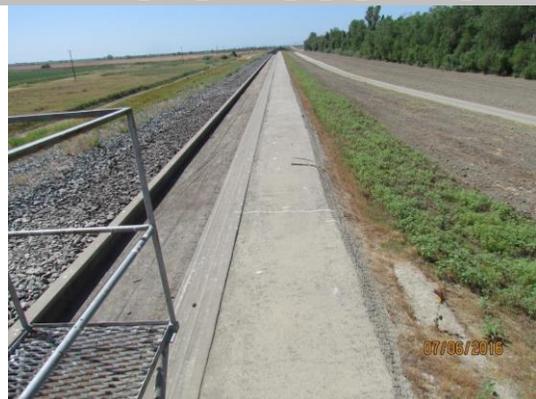
Photo 2 of 4 : ST_2016_NA0055_12_15_20160719_00030.jpg

View of the weir on the north end looking south. Summer 2016.

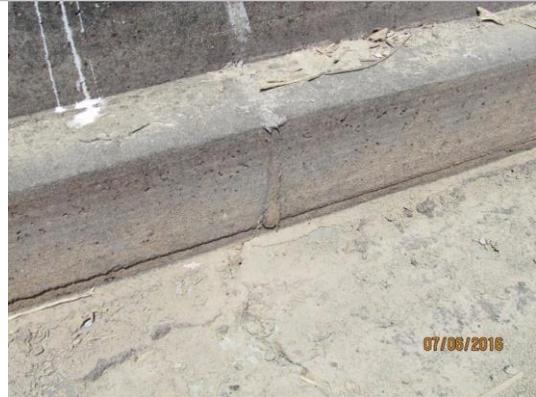
Photo 3 of 4 : ST_2016_NA0055_12_15_20160719_00031.jpg

LM Start	0.00	Rating **	A	Issue No.	15 (cont)
LM End	0.00	Issue Type +	Ma	Location *	CR
Category	Structures & Concrete Lined Channels			GPS Latitude/Longitude	
				Start	End
Item	Concrete Surfaces			38.682460 °	38.687350 °
				-121.672930 °	-121.673740 °
DWR ID	DWR_NA0055_12_t_2012_15				
Action/Comments					
Inspector Comments: Negligible spalling, scaling or cracking. Cracks should be sealed to prevent freeze/thaw damage.

Crack seems to be connected to previous crack from the steps. Summer 2016.

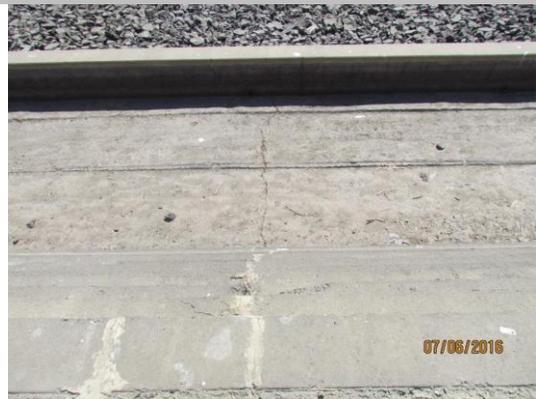
Photo 4 of 4 : ST_2016_NA0055_12_15_20160719_00032.jpg

Crack is at the toe but does not seem to impede the function of the weir. Summer 2016.

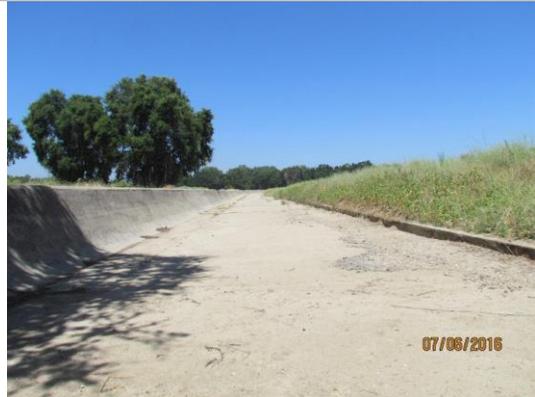
Photo 1 of 5 : ST_2016_NA0055_2_24_20160719_00015.jpg

View of the weir looking northeast from (38.759090, -121.665400). Summer 2016.

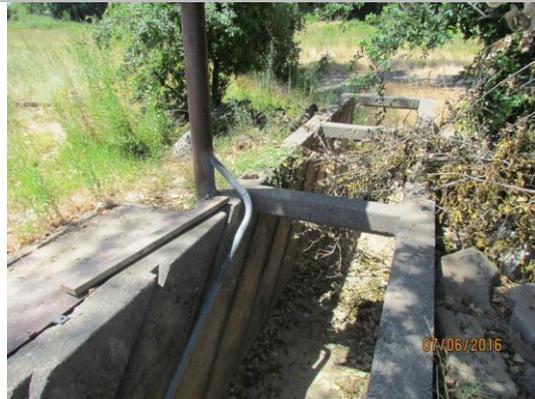
Photo 2 of 5 : ST_2016_NA0055_2_24_20160719_00017.jpg

View of the fish ladder at (38.764355, -121.646851). Summer 2016.

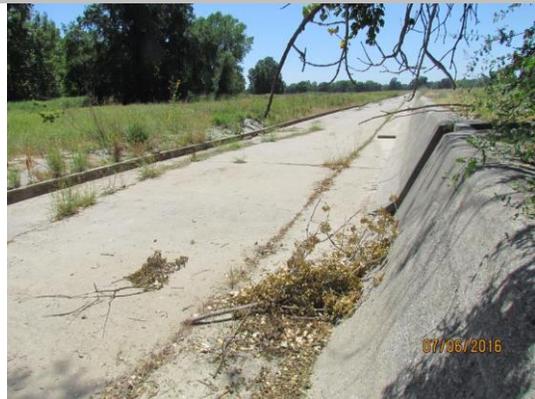
Photo 3 of 5 : ST_2016_NA0055_2_24_20160719_00019.jpg

Looking southwest from the fish ladder along the Fremont Weir. Summer 2016.

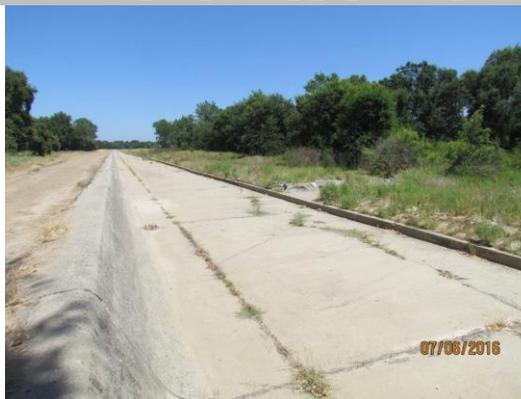
Photo 4 of 5 : ST_2016_NA0055_2_24_20160719_00018.jpg

Looking northeast from the fish ladder along the Fremont Weir. Summer 2016.

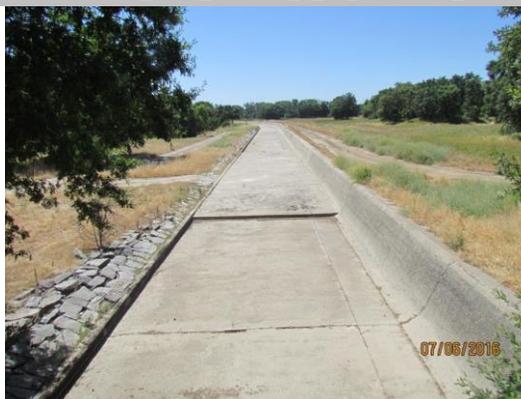
Photo 5 of 5 : ST_2016_NA0055_2_24_20160719_00020.jpg

View of the weir looking northwest along the weir from (38.764660, -121.635572). Summer 2016.

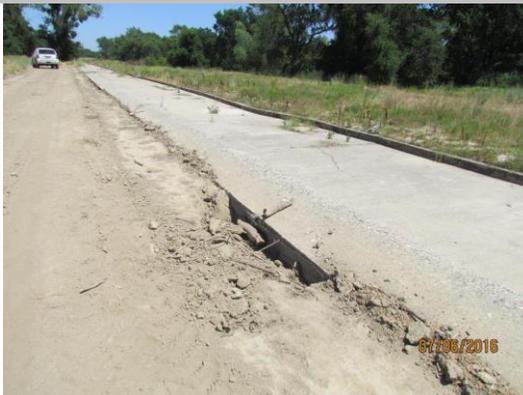
Photo 1 of 2 : ST_2016_NA0055_2_4_20160719_00011.jpg

Erosion may have been created from the last high water along the Fremont weir. Summer 2016.

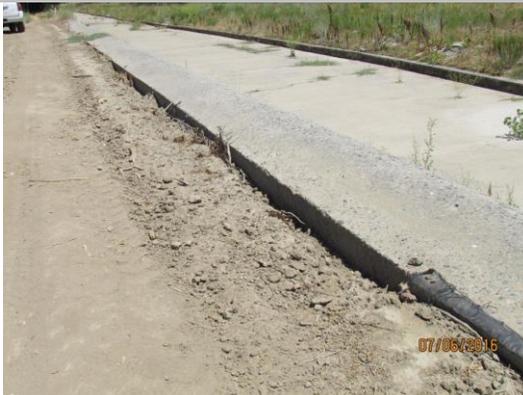
Photo 2 of 2 : ST_2016_NA0055_2_4_20160719_00012.jpg

More erosion near the concrete of the weir. Summer 2016.

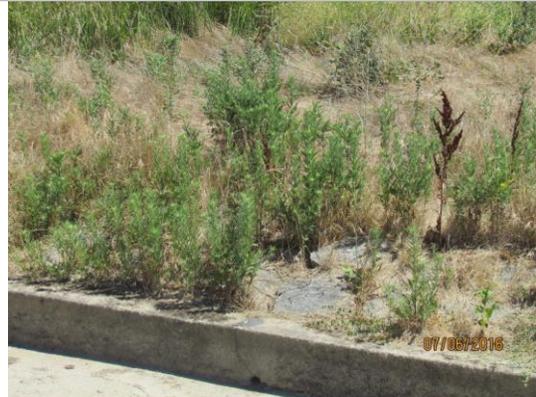
Photo 1 of 1 : ST_2016_NA0055_2_5_20160719_00010.jpg

View of the revetment covered in vegetation. Summer 2016.

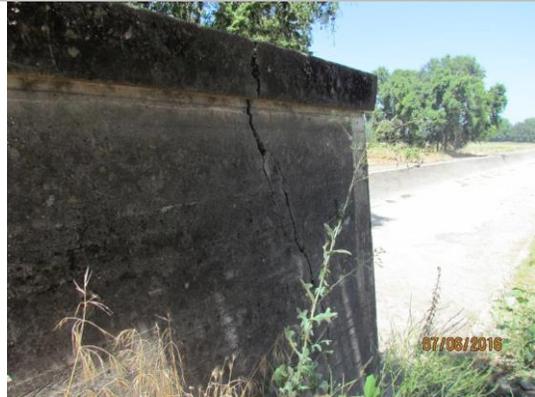
Photo 1 of 2 : ST_2016_NA0055_2_15_20160719_00013.jpg

LM Start	0.00	Rating **	A	Issue No.	15
LM End	0.00	Issue Type +	Ma	Location *	CR
Category	Structures & Concrete Lined Channels		GPS Latitude/Longitude		
			Start	End	
Item	Concrete Surfaces		38.758880 °	38.764680 °	
			-121.665380 °	-121.635430 °	
DWR ID	DWR_NA0055_2_t_2012_15				
Action/Comments					
Inspector Comments: Crack runs from the top to the bottom on the downstream side at the West end of the weir. The crack appears to be about 1" at the top of the wall and about 1/2" near the bottom. This does not affect the function of the weir. It is minor but needs to be repaired.

View of the crack at location (38.758996, -121.665420).

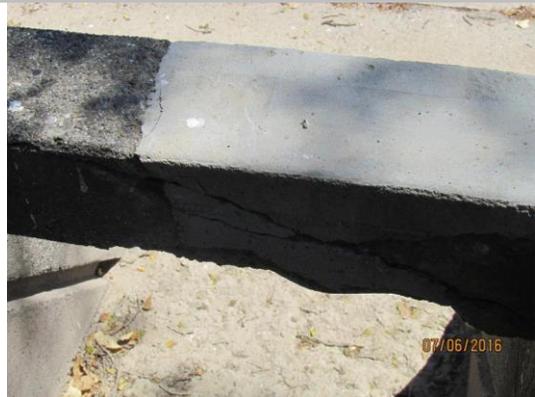
Photo 2 of 2 : ST_2016_NA0055_2_15_20160719_00014.jpg

Cracks on the fish ladder bar towards the Fremont Weir. Summer 2016.

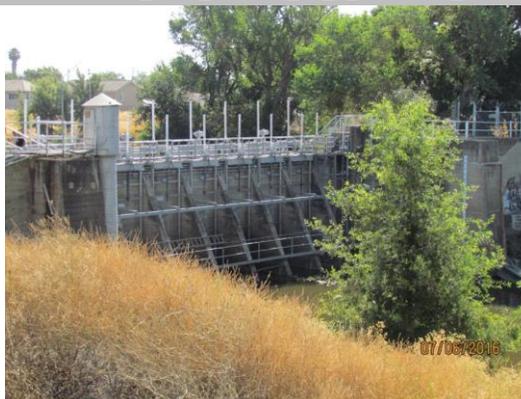
Photo 1 of 2 : ST_2016_NA0055_41_1_20160719_00009.jpg

View of the inlet side of the structure. Summer 2016.

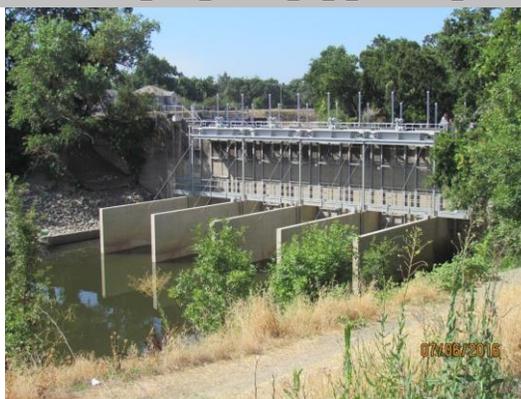
Photo 2 of 2 : ST_2016_NA0055_41_1_20160719_00010.jpg

View of the outlet side of the structure. Summer 2016.

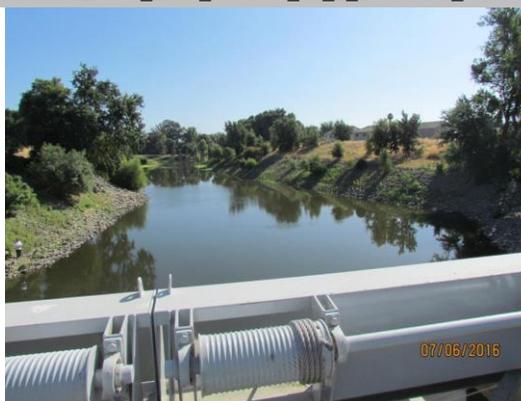
Photo 1 of 2 : ST_2016_NA0055_41_2_20160802_00013.jpg

LM Start	0.00	Rating **	A	Issue No.	2
LM End	0.00	Issue Type +	Ma	Location *	
Category	Structures & Concrete Lined Channels		GPS Latitude/Longitude		
			Start	End	
Item	Vegetation & Obstructions		38.799560 °	38.799320 °	
			-121.725530 °	-121.724850 °	
DWR ID	DWR_NA0055_41_t_2012_2				
Action/Comments					
Inspector Comments: Minimal, scattered obstructions or vegetation. The flow is not impeded. Aquatic weeds are increasing on the stop logs and upstream of the structure.

View of the channel looking downstream from the structure. Summer 2016.

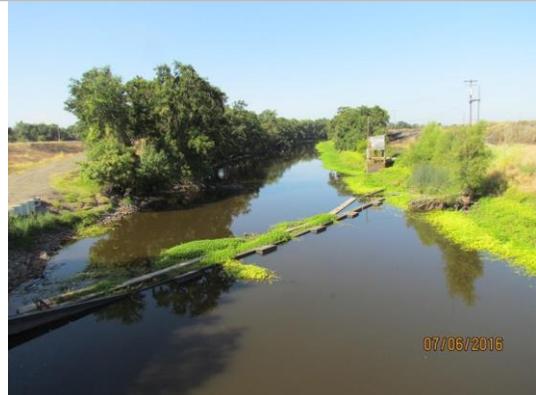
Photo 2 of 2 : ST_2016_NA0055_41_2_20160802_00014.jpg

View of the stop log and channel looking upstream. Summer 2016.

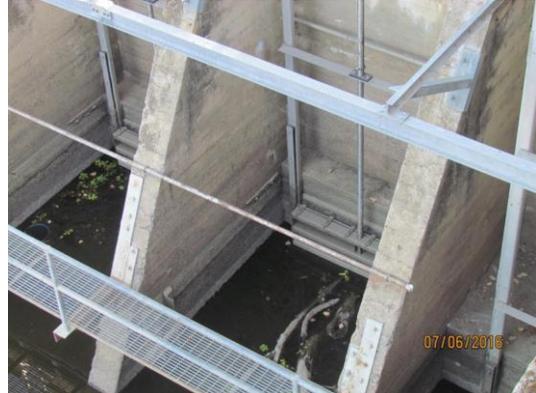
Photo 1 of 1 : ST_2016_NA0055_41_12_20160719_00008.jpg

View of the unopened slide gate on the inlet side of the structure. Summer 2016.

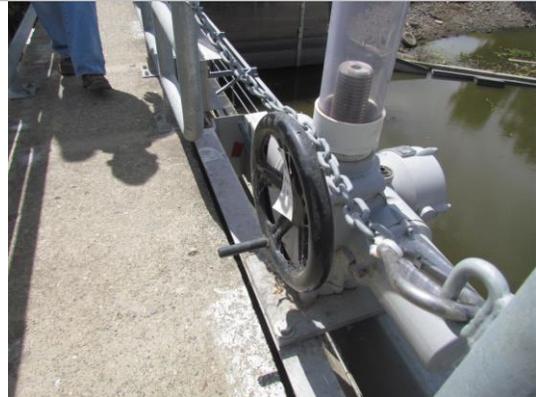
Photo 1 of 2 : ST_2016_NA0055_41_14_20160620_00006.jpg

Close-up view of the wheel for the flap gate. Summer 2015.

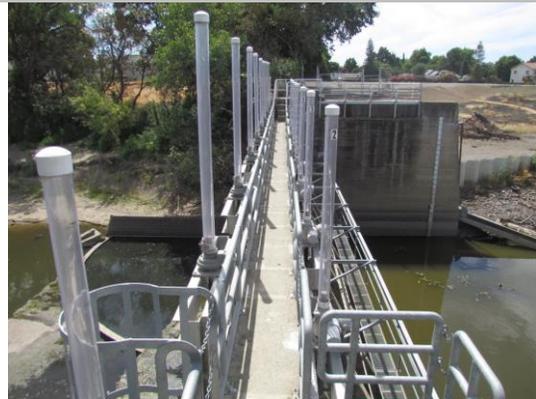
Photo 2 of 2 : ST_2016_NA0055_41_14_20160620_00007.jpg

View of the control structure to manually close the flap gates. Summer 2015.

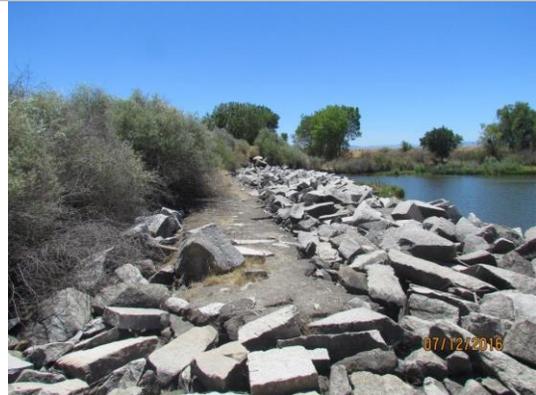
Photo 1 of 5 : ST_2016_NA0055_52_24_20160719_00013.jpg

View of the structure looking south from the north end. Summer 2016.

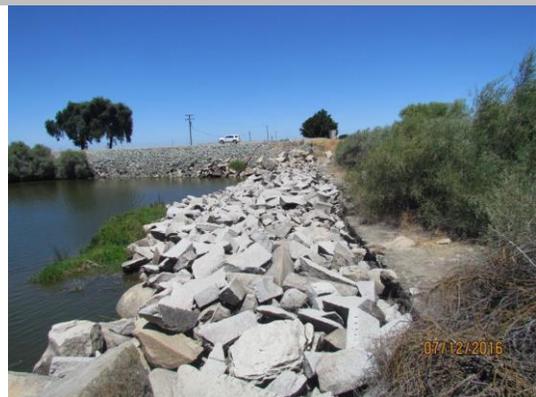
Photo 2 of 5 : ST_2016_NA0055_52_24_20160719_00014.jpg

View of the structure looking to the north from the south end. Summer 2016.

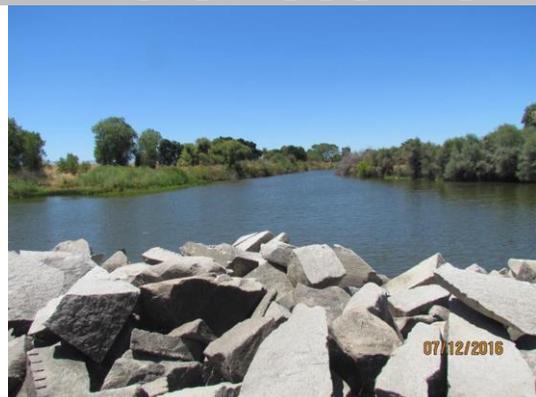
Photo 3 of 5 : ST_2016_NA0055_52_24_20160719_00015.jpg

Looking downstream to the west from the structure. Summer 2016.

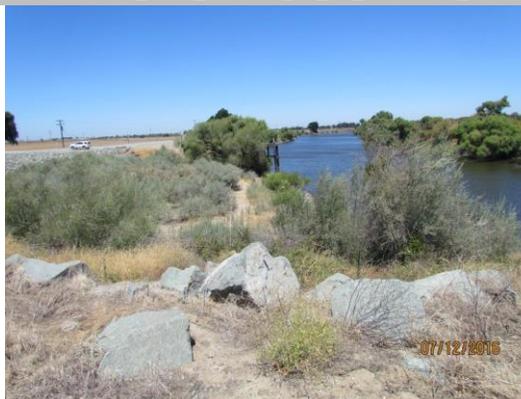
Photo 4 of 5 : ST_2016_NA0055_52_24_20160719_00016.jpg

View of the inlet of the structure and channel looking north from the south end. Summer 2016.

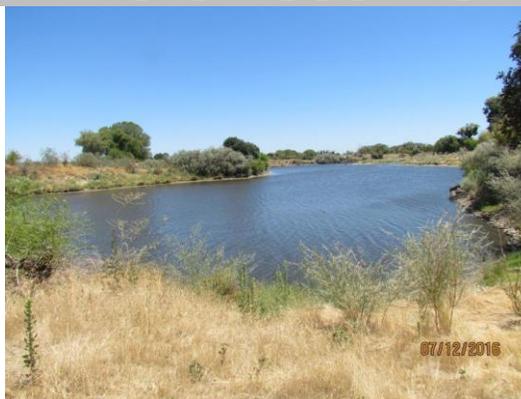
Photo 5 of 5 : ST_2016_NA0055_52_24_20160719_00017.jpg

Looking upstream towards the San Joaquin River from the inlet side of the structure. Summer 2016.

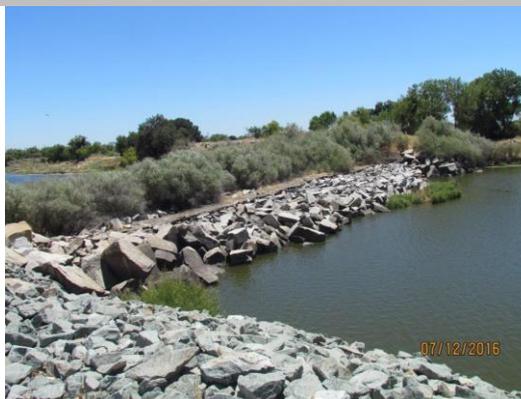
Photo 1 of 2 : ST_2016_NA0055_52_2_20160719_00011.jpg

View of the willows and dam looking upstreamstream towards the San Joaquin River. Summer 2016.

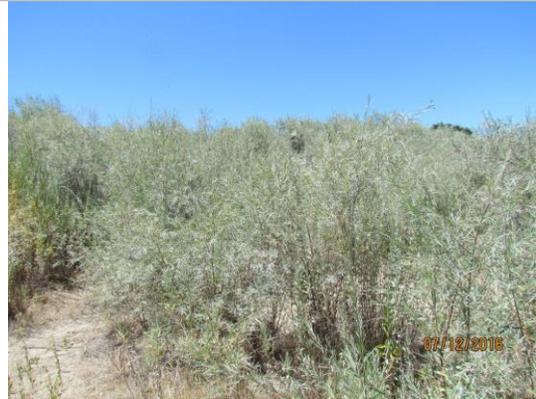
Photo 2 of 2 : ST_2016_NA0055_52_2_20160719_00009.jpg

View of the vegetation looking downstream from the inlet side of the dam. Summer 2016.

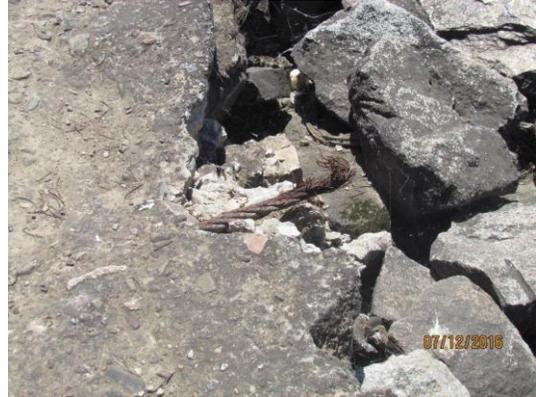
Photo 1 of 1 : ST_2016_NA0055_52_23_20160719_00012.jpg

Exposed cables are on the dam near the revetments. Summer 2016.

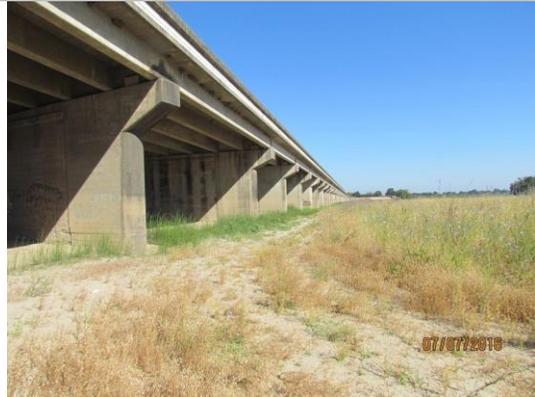
Photo 1 of 4 : ST_2016_NA0055_1_24_20160719_00012.jpg

View of the inlet of the weir looking northeast along the structure. Summer 2016.

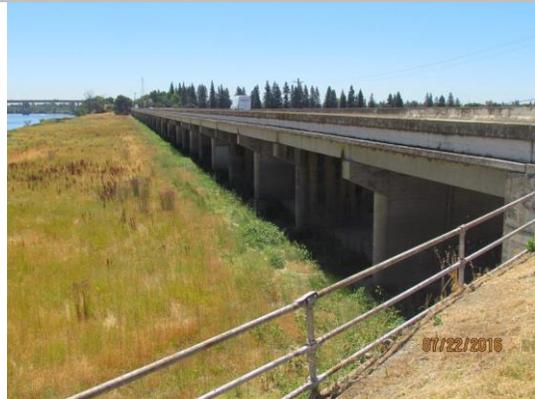
Photo 2 of 4 : ST_2016_NA0055_1_24_20160722_00023.jpg

View of the inlet of the weir looking southwest along the structure. Summer 2016.

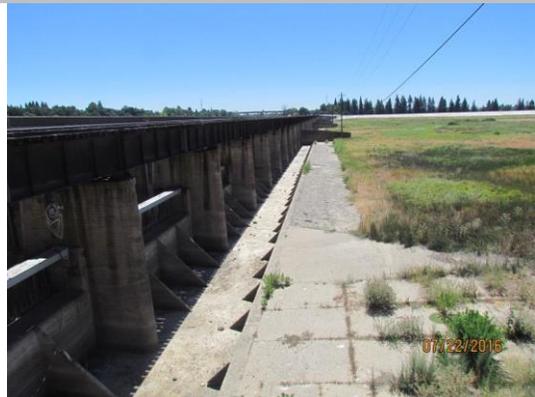
Photo 3 of 4 : ST_2016_NA0055_1_24_20160722_00024.jpg

View of the outlet side of the structure looking to the southeast. Summer 2016.

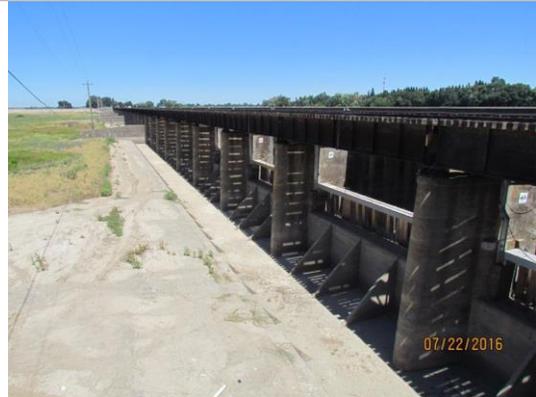
Photo 4 of 4 : ST_2016_NA0055_1_24_20160722_00025.jpg

View of the outlet side of the structure looking to the northwest. Summer 2016.

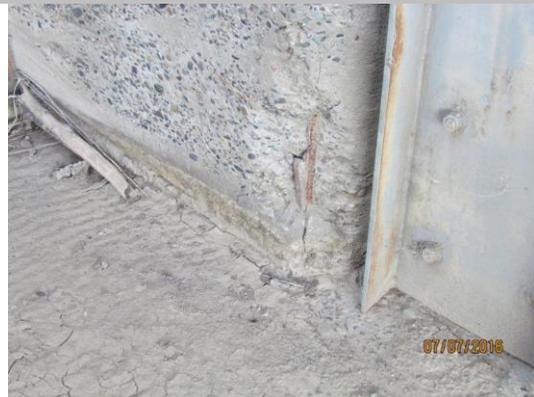
Photo 1 of 4 : ST_2016_NA0055_1_15_20160720_00013.jpg

Rebar is exposed in Bay 31 on the inlet side of the weir. Some rebar exposure are also present in Bay 29 on the same side of the wall. Summer 2016.

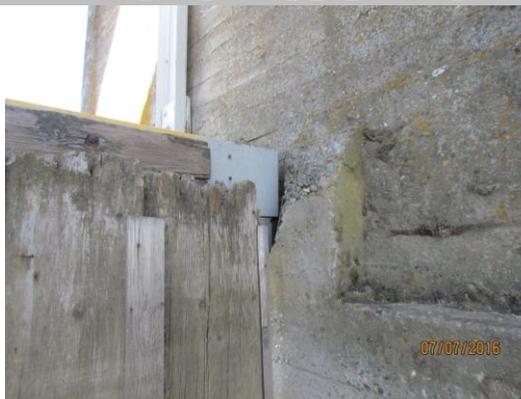
Photo 2 of 4 : ST_2016_NA0055_1_15_20160720_00014.jpg

Scouring can be seen near the end of the beam in Bay 7. Bays 31, 10, 7, 4, 3, and 1 also has scourings in the same beam areas. Summer 2016.

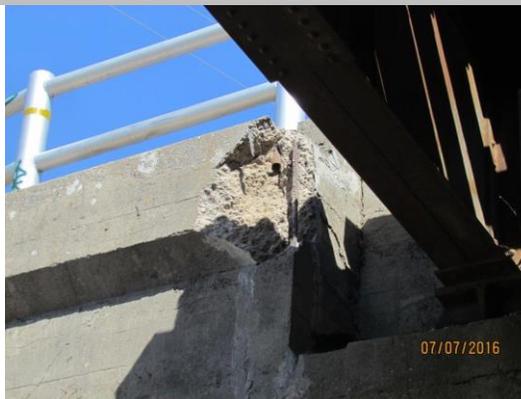
Photo 3 of 4 : ST_2016_NA0055_1_15_20160720_00015.jpg

View of the top corner of the weir on the north end of the weir on the outlet side. Summer 2016.

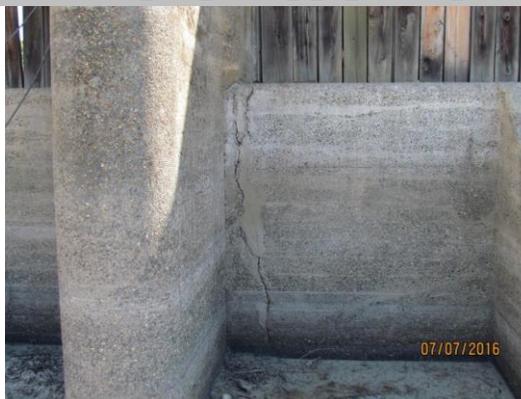
Photo 4 of 4 : ST_2016_NA0055_1_15_20160720_00016.jpg

View of the crack in Bay 2. Other cracking can be seen in Bays 1, 2, and 23 as well. Summer 2016.

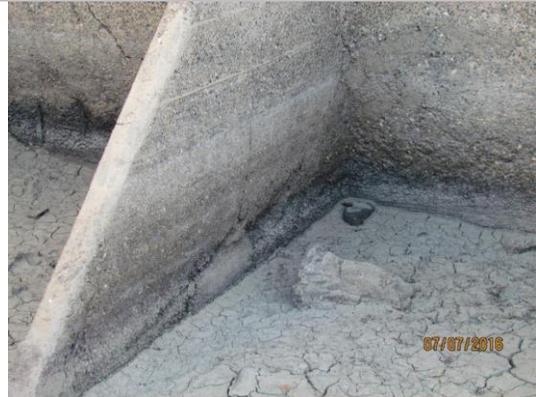
Photo 1 of 4 : ST_2016_NA0055_1_17_20160720_00017.jpg

View of the base of the wing walls in Bay 1. Summer 2016.

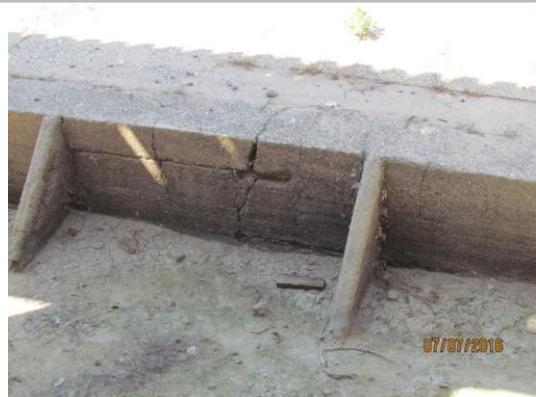
Photo 2 of 4 : ST_2016_NA0055_1_17_20160720_00019.jpg

Cracks are found on the base of the weir towards the Sacramento Bypass in Bay 1. Summer 2016.

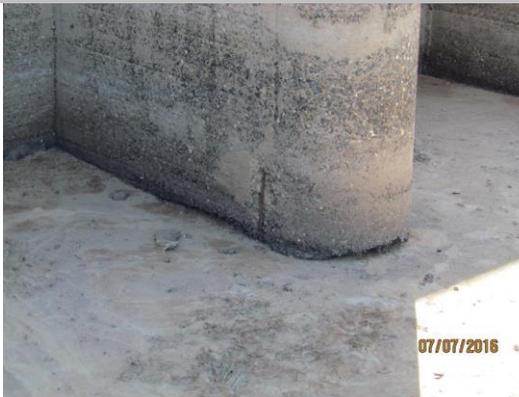
Photo 3 of 4 : ST_2016_NA0055_1_17_20160720_00022.jpg

The rebar at the base of the weir in Bay 8 is exposed and scalding can be seen where the structure is connected to the ground. Summer 2016.

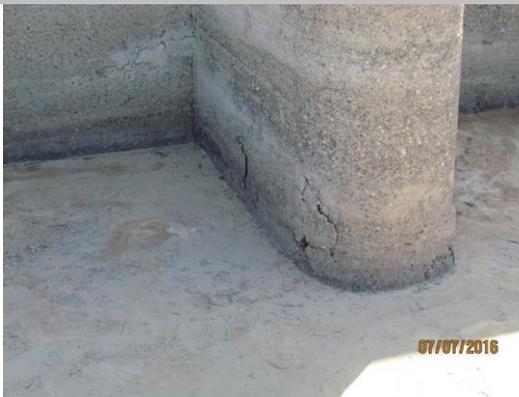
Photo 4 of 4 : ST_2016_NA0055_1_17_20160720_00020.jpg

Cracks are at the base of the structure in Bay 6. Summer 2016.
