**Flood Control Project Maintenance
Levee Inspections**

Fall 2015 Levee Maintenance Deficiency Summary Report

Reclamation District No. 0001 Union Island

Waterway		Bank	Unit Miles	
Unit No. 01 Old River		Right	1.14	
	Spring (March - May)	Summer (June - August)	(September - November) Fall	Winter (December - February)
Unit Maintenance Rating (Fall Only)			M	
Date of Inspection	05/14/2015 - 05/14/2015		09/29/2015 - 09/29/2015	
DWR Inspector	Maksim Khashchuk		Maksim Khashchuk	
Accompanied By

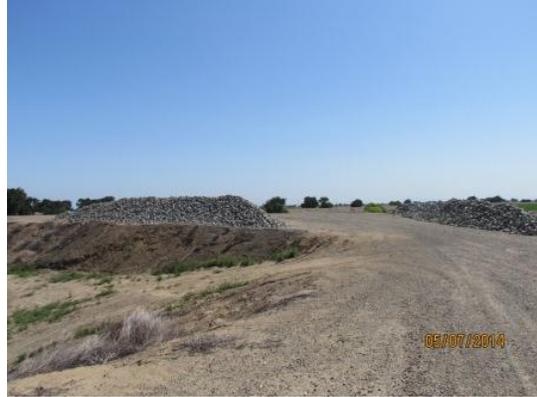
Photo 1 of 1 : FA_2015_RD0001_23_11_20150910_00006.jpg

LM Start	0.24	Rating **	A/W	Issue No.	11
LM End	0.24	Issue Type +	Ma	Location *	CR
Category	Earthen Levee		GPS Latitude/Longitude		
			Start	End	
Item	Encroachments		37.820362 °	37.820362 °	
			-121.378359 °	-121.378359 °	
DWR ID	DWR_RD0001_01_s_2014_11				
Action/Comments					
Material Inspector Comments: Stockpiled riprap on levee crown. Keep the stockpile so that a vehicle could maneuver around the pile to facilitate visibility and access of the levee.

View of the riprap stockpiled on the levee crown.

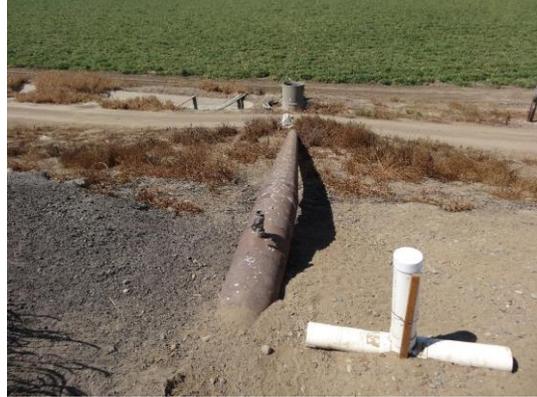
Photo 1 of 3 : UCIP_FA_2015_1529.jpg

LM Start	0.85	Rating **	M	Issue No.	17
LM End	0.85	Issue Type +	En	Location *	LS
Category	Supplemental			GPS Latitude/Longitude	
				Start	End
Item	DWR UCIP Field Study			37.814601 °	37.814601 °
				-121.382509 °	-121.382509 °
DWR ID					
Action/Comments					
Inspector Comments: FS_ID:41600 DS_ID:22691 EP_NO: N/A FS_HLM: 0.853 Repair Type: Non-Urgent Crossing Status: Found UCIP Comments: - 2" electric conduit on WS- pipe exposed on both sides.- power pole on LS. - erosion on WS hinge near walkway. FIELD_STRUCT_DESC: 14-inch pipe and 2-inch electric conduit through the levee, 6.0 feet below the crown, pump on pile structure in the stream, air valve on the landward shoulder, 30-inch concrete standpipe on the landward toe. O&M Manual LSJR 8, 1968 FS Date: 09/12/2013

LS view: exposed steel pipe on levee slope and concrete standpipe on levee toe.

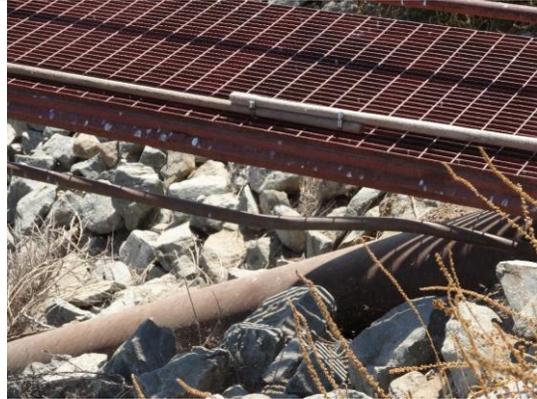
Photo 2 of 3 : UCIP_FA_2015_1530.jpg

WS view: exposed pipe, walkway, and electric conduit under walkway. Rock revetment on lower levee slope.

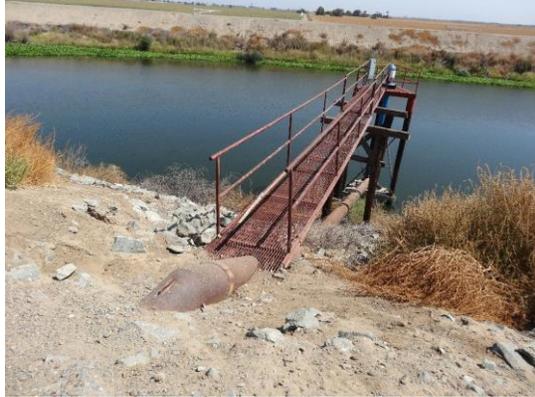
Photo 3 of 3 : UCIP_FA_2015_1531.jpg

LM Start	0.85	Rating **	M	Issue No.	17 (cont)
LM End	0.85	Issue Type +	En	Location *	LS
Category	Supplemental			GPS Latitude/Longitude	
				Start	End
Item	DWR UCIP Field Study			37.814601 °	37.814601 °
				-121.382509 °	-121.382509 °
DWR ID					
Action/Comments					
Inspector Comments: FS_ID:41600 DS_ID:22691 EP_NO: N/A FS_HLM: 0.853 Repair Type: Non-Urgent Crossing Status: Found

WS view: exposed pipe, walkway, and pump on pile structure. Soil erosion on levee hinge near walkway.

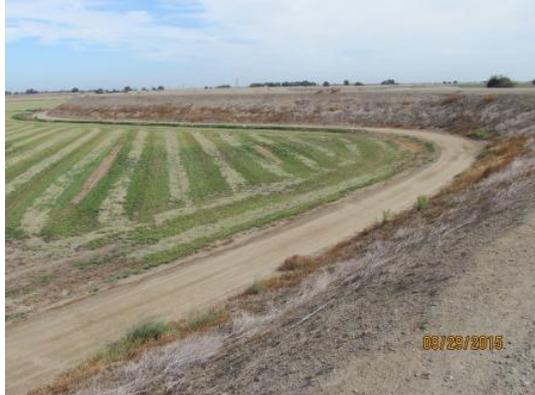
Photo 1 of 1 : FA_2015_RD0001_23_3_20151005_00009.jpg

LM Start	1.11	Rating **	A	Issue No.	3
LM End	1.11	Issue Type +	Ma	Location *	LS
Category	Earthen Levee			GPS Latitude/Longitude	
				Start	End
Item	Vegetation			37.811839 °	37.811839 °
				-121.384527 °	-121.384527 °
DWR ID	DWR_RD0001_01_f_2015_3				
Action/Comments					
Control annual grass and weeds on the levee slopes and easements.

View of the acceptable vegetation control on the landside levee slope.
