**Flood Control Project Maintenance
Levee Inspections**
LMA District Cover Sheet
Spring 2016 Levee Inspection Results

Reclamation District No. 0341 Sherman Island

Spring 2016 Levee Inspection Results

Waterway	Bank	Unit Miles
Unit No. 01 Threemile Slough	Right	3.36

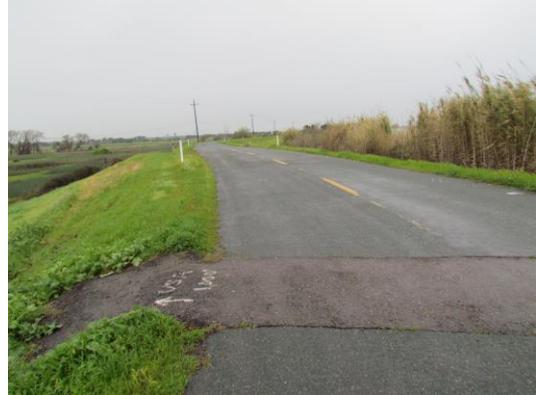
Photo 1 of 1 : SP_2016_RD0341_167_20_20160316_00045.jpg

Looking upstream from levee mile 0.00 landside unit 1 RD 341.

LM Start	0.00	Rating **	A	Issue No.	21
LM End	3.35	Issue Type +	Ma	Location *	LS
Category	Earthen Levee		GPS Latitude/Longitude		
			Start	End	
Item	Vegetation		38.085535 °	38.105238 °	
			-121.686463 °	-121.702391 °	
DWR ID	DWR_RD0341_01_s_2016_21				
Comment Code					
V1 : Control annual grass and weeds on the levee slopes and easements.					
Inspector Comment					
District has mowed the landside shoulder and slope.

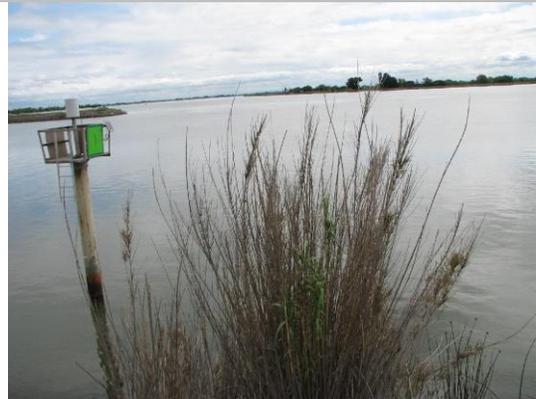
Photo 1 of 2 : UCIP_SP_2016_22063_37640.jpg

Comment Code					
Inspector Comment					
FS_ID:22063 DS_ID:24215 EP_NO: N/A Repair Type: Non-Urgent Crossing Status: Found UCIP Comments: Dense vegetation limits the inspector's visibility to identify signs of pipe failure (leaks) along the slopes. Recommend removing vegetation along pipe alignment to conduct proper inspection of structure and appurtenances. FIELD_STRUCT_DESC: 30-inch steel drainage pipe through the levee, 11.1 feet below the crown. CM cutoff wall around pipe at center of levee. Siphon breaker on both sides. Pump on landward side approximately 300 feet from landward toe. Pipe exposed on both levee slopes. Rock revetment on waterward slope. (USACE-1962). This entry matches the Drainage or Irrigation Structure referenced in O&M manual (HLM 0.0). Marine Station number 1 located on waterward side with attached small solar panel on top. FS Date: 5/5/2009

Marine station posts in river identified as Station 1 near crossing.

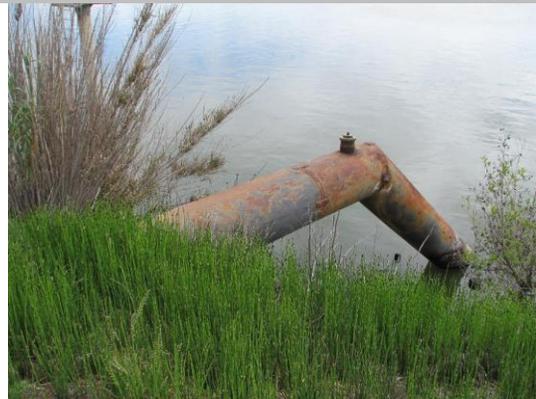
Photo 2 of 2 : UCIP_SP_2016_22063_37644.jpg

View of pipe and siphon breaker located on waterward side--dense vegetation on slope.

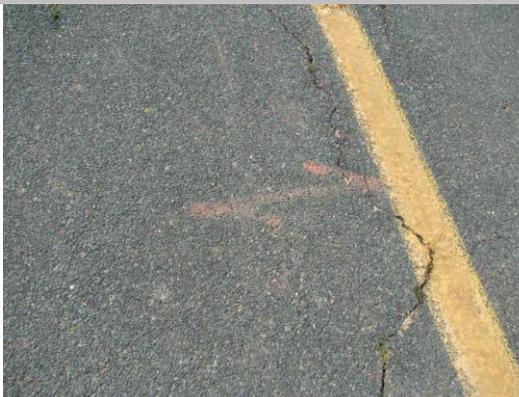
Photo 1 of 2 : UCIP_SP_2016_22064_37647.jpg

LM Start	0.48	Rating **	M	Issue No.	23
LM End	0.48	Issue Type +	En	Location *	LS
Category	Supplemental			GPS Latitude/Longitude	
				Start	End
Item	DWR UCIP Field Study			38.092464 °	38.092464 °
				-121.686962 °	-121.686962 °
DWR ID					
Comment Code					
Inspector Comment					
FS_ID:22064 DS_ID:24110 EP_NO: 6297 Repair Type: Non-Urgent Crossing Status: Found UCIP Comments: Markers Missing. No markers found to confirm crossing is still in use--need to contact owner to determine status of crossing. FIELD_STRUCT_DESC: 3-inch electrical conduit through the levee, 3.5 feet below the crown. Location marker on waterward shoulder--no marker found. Pole on landward side. Rock revetment on waterward slope. (Permit No. 6297-1969) FS Date: 5/5/2009

Underground Service Alert (USA) markings on road surface indicating line is still present.

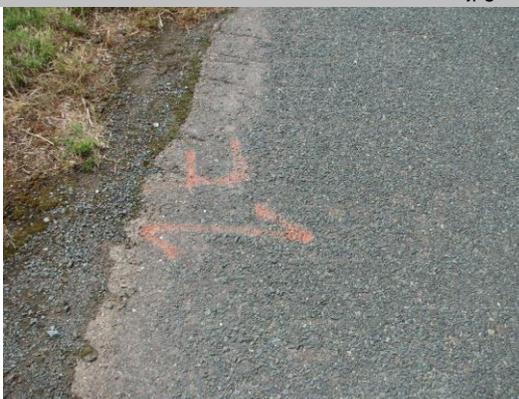
Photo 2 of 2 : UCIP_SP_2016_22064_37646.jpg

Underground Service Alert (USA) markings on road shoulder.

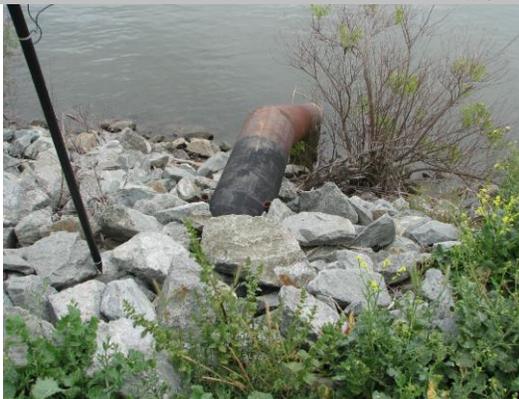
Photo 1 of 2 : UCIP_SP_2016_22070_37664.jpg

LM Start	1.07	Rating **	M	Issue No.	25
LM End	1.07	Issue Type +	En	Location *	LS
Category	Supplemental			GPS Latitude/Longitude	
				Start	End
Item	DWR UCIP Field Study			38.100972 °	38.100972 °
				-121.686813 °	-121.686813 °
DWR ID					
Comment Code					
Inspector Comment					
FS_ID:22070 DS_ID:24113 EP_NO: 11095 Repair Type: Non-Urgent Crossing Status: Found UCIP Comments: Dense vegetation limits the inspector's visibility to identify signs of pipe failure (leaks) along the slope. Recommend removing vegetation along pipe alignment to conduct proper inspection of structure and appurtenances. FIELD_STRUCT_DESC: 18-inch pipe sleeved through 24-inch pipe through the levee, 4.0 feet below the crown. Air vent and monitoring well on landward side. Pipe exposed on the waterward slope. This pipe was retained under ABO No. 11095 (1975). FS Date: 5/5/2009

View of pipe located on waterward side.

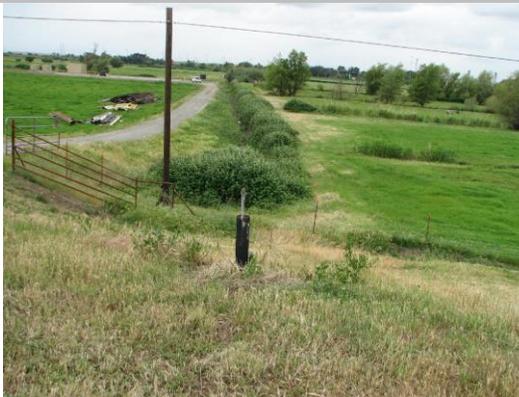
Photo 2 of 2 : UCIP_SP_2016_22070_37663.jpg

View of landward side--visible standup pipe on slope.

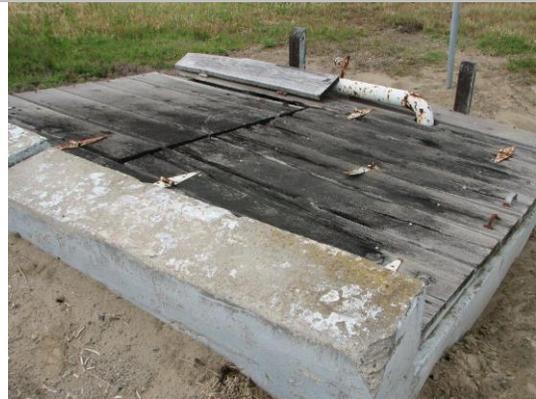
Photo 1 of 2 : UCIP_SP_2016_22074_37675.jpg

LM Start	1.44	Rating **	M	Issue No.	26
LM End	1.44	Issue Type +	En	Location *	LS
Category	Supplemental			GPS Latitude/Longitude	
				Start	End
Item	DWR UCIP Field Study			38.106183 °	38.106183 °
				-121.685541 °	-121.685541 °
DWR ID					
Comment Code					
Inspector Comment					
FS_ID:22074 DS_ID:24115 EP_NO: N/A Repair Type: Non-Urgent Crossing Status: Found UCIP Comments: Need to contact owner to determine if crossing is still active and to determine last inspection date. Will need copy of letter showing crossings passed inspection. NEED photo of emergency contact information from marker. FIELD_STRUCT_DESC: 10-inch steel gas line through the levee. Valve in concrete box on the landward side. (USACE-1962). This entry matches the Drainage or Irrigation Structure referenced in O&M manual (HLM 1.42). FS Date: 5/5/2009

Concrete box located on landward side.

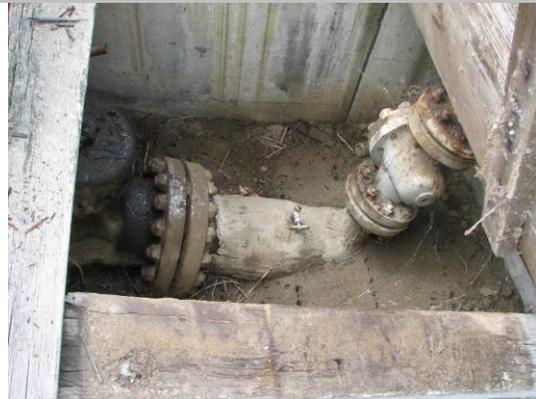
Photo 2 of 2 : UCIP_SP_2016_22074_37672.jpg

Inside view of vault located on the landward side.

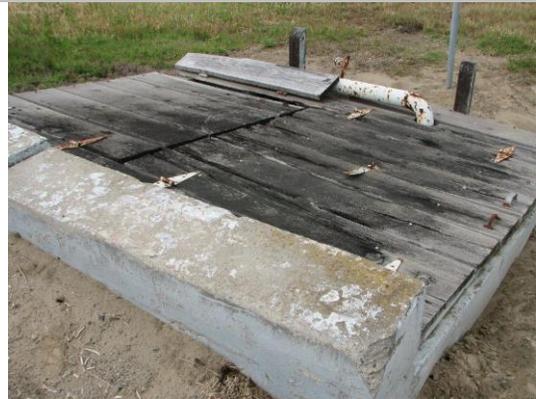
Photo 1 of 2 : UCIP_SP_2016_22076_37680.jpg

LM Start	1.45	Rating **	M	Issue No.	27
LM End	1.45	Issue Type +	En	Location *	LS
Category	Supplemental			GPS Latitude/Longitude	
				Start	End
Item	DWR UCIP Field Study			38.106323 °	38.106323 °
				-121.685493 °	-121.685493 °
DWR ID					
Comment Code					
Inspector Comment					
FS_ID:22076 DS_ID:24217 EP_NO: N/A Repair Type: Non-Urgent Crossing Status: Found UCIP Comments: Unknown detail of the size of crossing. Need to contact owner to determine if crossing is still active and to determine last inspection date. Will need copy of letter showing crossings passed inspection. NEED photo of emergency contact information from marker. FIELD_STRUCT_DESC: Gas line through the levee. (USACE-1962). This entry matches the Drainage or Irrigation Structure referenced in O&M manual (HLM 1.44). FS Date: 5/5/2009

Concrete box located on landward side.

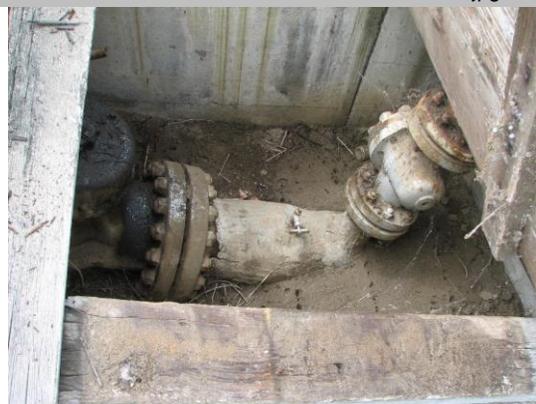
Photo 2 of 2 : UCIP_SP_2016_22076_37677.jpg

Inside view of vault located on the landward side.

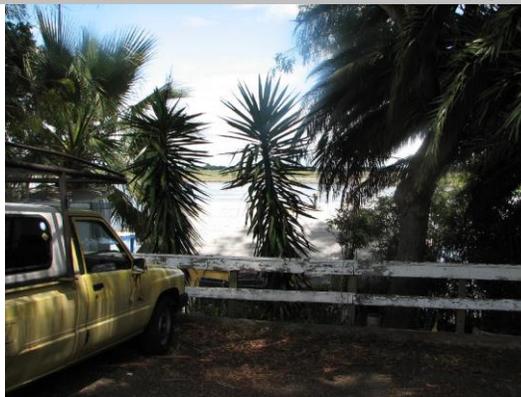
Photo 1 of 2 : UCIP_SP_2016_22086_37706.jpg

LM Start	1.96	Rating **	M	Issue No.	30
LM End	1.96	Issue Type +	En	Location *	LS
Category	Supplemental			GPS Latitude/Longitude	
				Start	End
Item	DWR UCIP Field Study			38.113641 °	38.113641 °
				-121.684112 °	-121.684112 °
DWR ID					
Comment Code					
Inspector Comment					
FS_ID:22086 DS_ID:24116 EP_NO: 11103 Repair Type: Non-Urgent Crossing Status: Found UCIP Comments: Unable to determine if crossing is the same as permitted under permit no. 11103. Need to contact owner and determine status of crossing under permit no. 11103. Believe steel conduit is exposed on landward side. FIELD_STRUCT_DESC: 1.5-inch iron water pipe and 3.5-inch electrical steel conduit through the levee, both 3.0 feet below the crown. Pressure system and service pole on landward slope. Fishing resort on waterward side. This pipe was retained under ABO No. 11103 (1975). FS Date: 5/5/2009

View of waterward side.

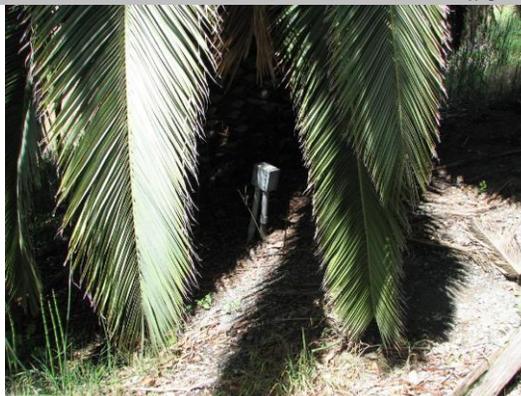
Photo 2 of 2 : UCIP_SP_2016_22086_37704.jpg

Power connection on waterward side no other appurtenances found.

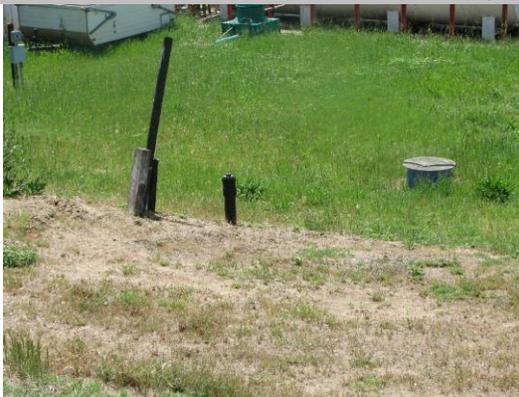
Photo 1 of 2 : UCIP_SP_2016_22091_37712.jpg

LM Start	2.00	Rating **	M	Issue No.	35
LM End	2.00	Issue Type +	En	Location *	LS
Category	Supplemental			GPS Latitude/Longitude	
				Start	End
Item	DWR UCIP Field Study			38.114092 °	38.114092 °
				-121.684524 °	-121.684524 °
DWR ID					
Comment Code					
Inspector Comment					
FS_ID:22091 DS_ID:24117 EP_NO: 5427 Repair Type: Non-Urgent Crossing Status: Indicator Found UCIP Comments: Unable to find pipe or sump pump. Indicators found on landward side include potential septic tank and observation well. Need to contact owner of crossing to determine status of crossing. FIELD_STRUCT_DESC: 1 of 2: 4-inch diameter pipe sleeved through 6-inch pipe through the levee, 3.7 feet below the crown. Sump pump on waterward slope. Septic tank and observation well on the landward side. (Permit No. 5427-1966) FS Date: 5/5/2009

View of potential observation well on landward side.

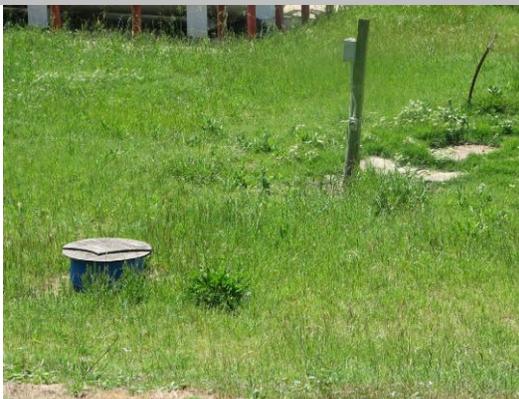
Photo 2 of 2 : UCIP_SP_2016_22091_37711.jpg

Stand pipe (potential observation well) and concrete pad located on landward side.

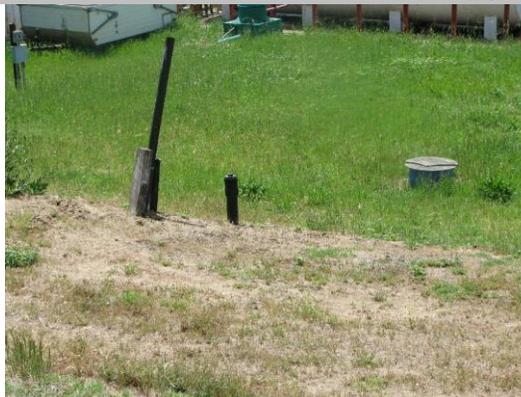
Photo 1 of 2 : UCIP_SP_2016_22093_37717.jpg

LM Start	2.00	Rating **	M	Issue No.	36
LM End	2.00	Issue Type +	En	Location *	LS
Category	Supplemental			GPS Latitude/Longitude	
				Start	End
Item	DWR UCIP Field Study			38.114092 °	38.114092 °
				-121.684524 °	-121.684524 °
DWR ID					
Comment Code					
Inspector Comment					
FS_ID:22093 DS_ID:24237 EP_NO: 5427 Repair Type: Non-Urgent Crossing Status: Indicator Found UCIP Comments: Signs of electrical connection boxes. Unable to determine if these boxes are associated to crossing. Need to contact owner to determine status of crossing. FIELD_STRUCT_DESC: 2 of 2: Five 1 to 1.5-inch pipes through the levee, 3.7 feet below the crown. Pump on waterward slope. Septic tank and observation well on the landward side. (Permit No. 5427-1966) FS Date: 5/5/2009

Electrical conduit and box located on left corner of picture.

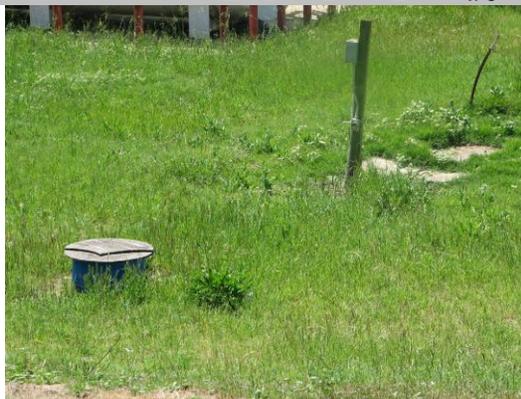
Photo 2 of 2 : UCIP_SP_2016_22093_37716.jpg

Electrical connection visible next to concrete pad--right corner.

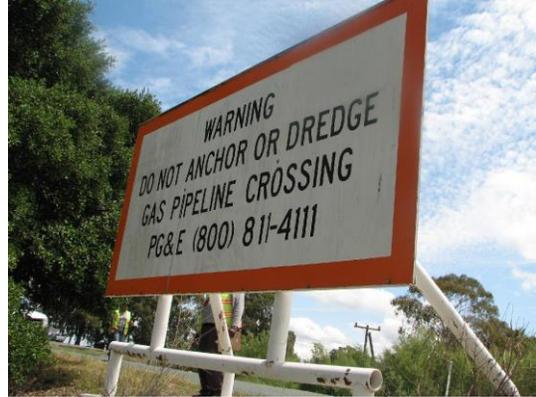
Photo 1 of 2 : UCIP_SP_2016_39860_71847.jpg

LM Start	2.11	Rating **	M	Issue No.	37
LM End	2.11	Issue Type +	En	Location *	LS
Category	Supplemental			GPS Latitude/Longitude	
				Start	End
Item	DWR UCIP Field Study			38.113753 °	38.113753 °
				-121.686298 °	-121.686298 °
DWR ID					
Comment Code					
Inspector Comment					
FS_ID:39860 DS_ID:24756 EP_NO: 17251 Repair Type: Non-Urgent Crossing Status: Indicator Found UCIP Comments: Need to contact owner to determine status of crossing. Need date of last inspection and confirmation that crossing is still in operable condition. FIELD_STRUCT_DESC: 24-inch steel natural gas pipeline through the levee 125-feet below the crown (Permit No. 17251, 2002). FS Date: 3/4/2014

View of sign located on waterward side.

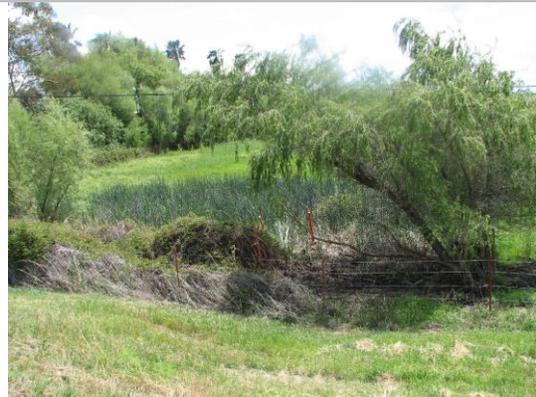
Photo 2 of 2 : UCIP_SP_2016_39860_71846.jpg

Markers visible on landward toe.

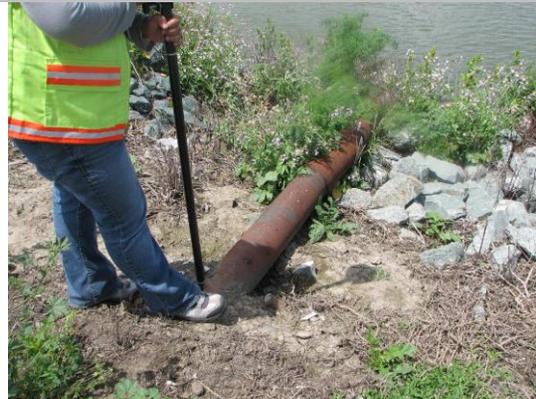
Photo 1 of 2 : UCIP_SP_2016_22112_37750.jpg

FS_ID:22112
 DS_ID:24121
 EP_NO: N/A
 Repair Type: Non-Urgent
 Crossing Status: Found
 UCIP Comments: Pipe side does not match found 10 inch instead of 8 inch. Pipe (1 of 2) was supposed to be removed and replaced with 12-inch steel irrigation pipes under Permit No. 5629 (1966). Historical Levee Logs from 1992 do not reflect that the replacement was completed, verify diameter of pipes and status with applicant. Dense vegetation limits the inspector's visibility to identify signs of pipe failure (leaks) along the slope. Recommend removing vegetation along pipe alignment to conduct proper inspection of structure and appurtenances.
 FIELD_STRUCT_DESC: 1 of 2: 10-inch (not 8-inch as originally noted in records) steel irrigation pipe through the levee, 1.4 feet below the crown. Siphon breaker on landward side. Irrigation ditch with distribution box at landward toe. Pipe exposed on both slopes. Rock revetment on waterward slope. (USACE-1962). This entry matches the Drainage or Irrigation Structure referenced in O&M manual (HLM 2.93).

View of pipe and rip rap located on waterward side.

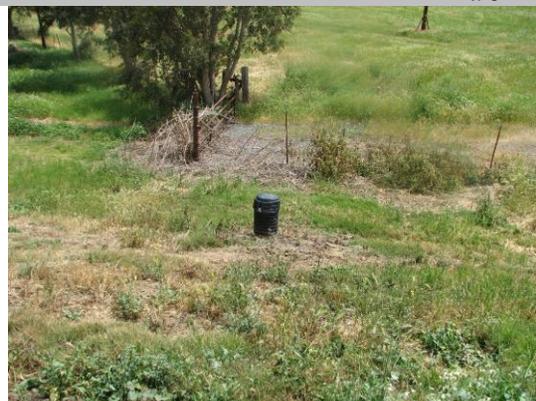
Photo 2 of 2 : UCIP_SP_2016_22112_37748.jpg

Stand pipe located near levee toe on landward side.

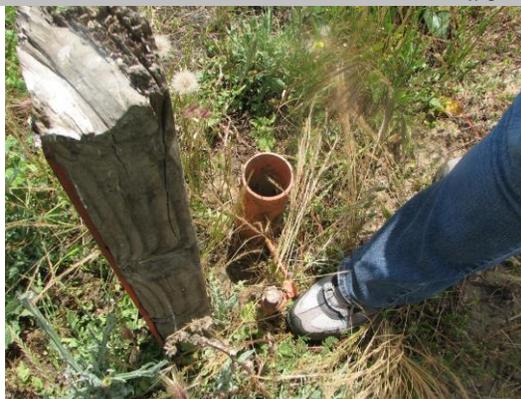
Photo 2 of 2 : UCIP_SP_2016_22116_37755.jpg

FS_ID:22116
 DS_ID:24238
 EP_NO: N/A
 Repair Type: Non-Urgent
 Crossing Status: Indicator Found
 UCIP Comments: Pipe side does not match--found 10 inch instead of 8 inch. Pipe (2 of 2) was supposed to be removed and replaced with 12-inch steel irrigation pipes under Permit No. 5629 (1966). Historical Levee Logs from 1992 do not reflect that the replacement was completed, verify diameter of pipes and status with applicant. Dense vegetation limits the inspector's visibility to identify signs of pipe failure (leaks) along the slope. Recommend removing vegetation along pipe alignment to conduct proper inspection of structure and appurtenances.
 FIELD_STRUCT_DESC: 2 of 2: 10-inch (not 8-inch as originally mentioned in desk study) steel irrigation pipe through the levee, 1.6 feet below the crown. Siphon breaker on landward side. Irrigation ditch with distribution box at landward toe. Pipe exposed on both slopes. Rock revetment on waterward slope. (USACE-1962). This entry matches the Drainage or Irrigation Structure referenced in O&M manual (HLM 2.93).

Small stand pipe located on waterward side--unknown purpose of stand pipe.

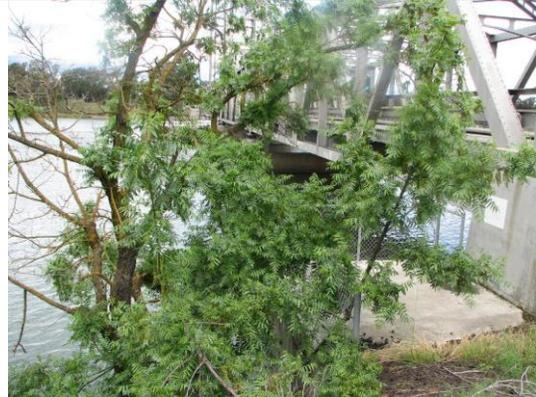
Photo 1 of 2 : UCIP_SP_2016_22183_37780.jpg

LM Start	3.33	Rating **	M	Issue No.	31
LM End	3.33	Issue Type +	En	Location *	LS
Category	Supplemental			GPS Latitude/Longitude	
				Start	End
Item	DWR UCIP Field Study			38.105183 °	38.105183 °
				-121.702026 °	-121.702026 °
DWR ID					
Comment Code					
Inspector Comment					
FS_ID:22183 DS_ID:24245 EP_NO: N/A Repair Type: Non-Urgent Crossing Status: Found UCIP Comments: New crossing found in field--need to find owner and determine permit authorizing work. FIELD_STRUCT_DESC: 10-inch corrugated metal pipe extruding from the waterward slope. FS Date: 5/5/2009

View of waterward side.

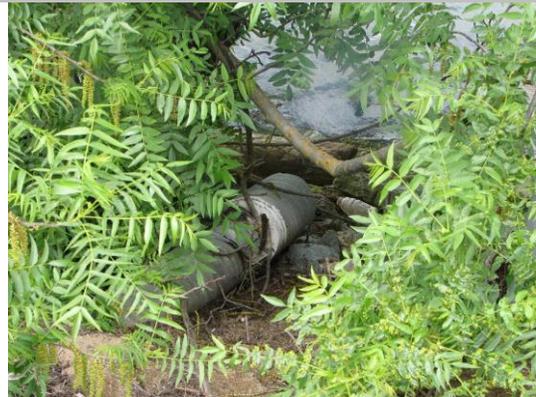
Photo 2 of 2 : UCIP_SP_2016_22183_37783.jpg

Pipe on waterward side.

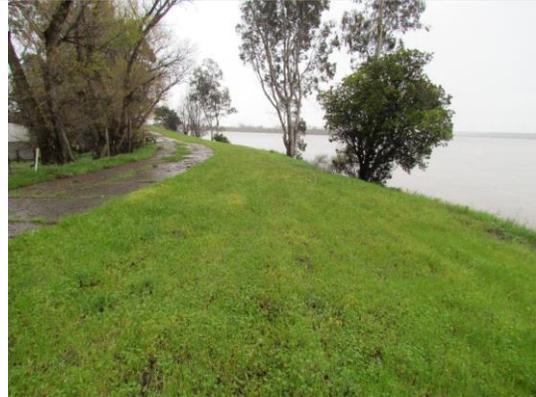
Photo 1 of 1 : SP_2016_RD0341_168_38_20160316_00079.jpg

Looking downstream of Sacramento River Levee mile 3.40 Unit 2 RD 341.

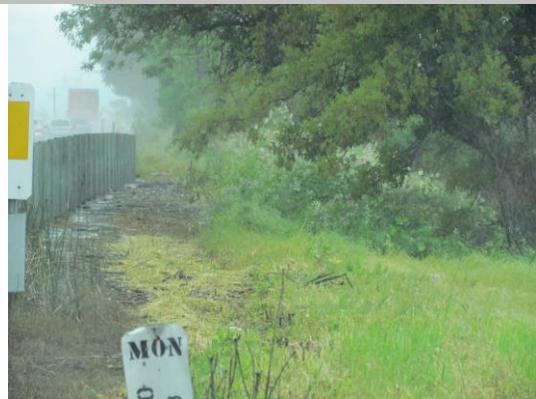
Photo 1 of 1 : SP_2016_RD0341_168_45_20160316_00080.jpg

Looking downstream from the waterside levee mile 3.97 to levee mile 6.19 unwanted vegetation on the slope and shoulder.

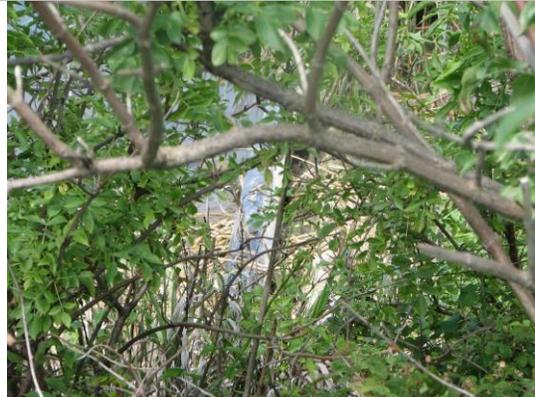
Photo 1 of 2 : UCIP_SP_2016_22203_37833.jpg

Comment Code					
Inspector Comment					
FS_ID:22203 DS_ID:24135 EP_NO: 11110 Repair Type: Non-Urgent Crossing Status: Found UCIP Comments: Need to determine status of crossing--need to contact owner. Dense vegetation limits the inspector's visibility to identify signs of pipe failure (leaks) along the slope. Recommend removing vegetation along pipe alignment to conduct proper inspection of structure and appurtenances. FIELD_STRUCT_DESC: 10-inch pipe sleeved through 12-inch pipe through the levee, 3.8 feet below the crown. Pump on concrete well on landward slope. (USACE-1962). This entry matches the Drainage or Irrigation Structure referenced in O&M manual (HLM 4.03). 10-inch pipe was retained under ABO No. 11110 (1975). FS Date: 5/6/2009

Limited access to waterward side--pipe visible through brush.

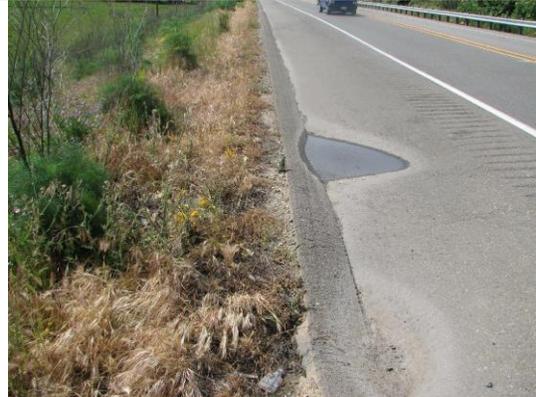
Photo 2 of 2 : UCIP_SP_2016_22203_37832.jpg

Comment Code					
Inspector Comment					
FS_ID:22203 DS_ID:24135 EP_NO: 11110 Repair Type: Non-Urgent Crossing Status: Found UCIP Comments: Need to determine status of crossing--need to contact owner. Dense vegetation limits the inspector's visibility to identify signs of pipe failure (leaks) along the slope. Recommend removing vegetation along pipe alignment to conduct proper inspection of structure and appurtenances. FIELD_STRUCT_DESC: 10-inch pipe sleeved through 12-inch pipe through the levee, 3.8 feet below the crown. Pump on concrete well on landward slope. (USACE-1962). This entry matches the Drainage or Irrigation Structure referenced in O&M manual (HLM 4.03). 10-inch pipe was retained under ABO No. 11110 (1975). FS Date: 5/6/2009

View of landward shoulder and low spots on highway.

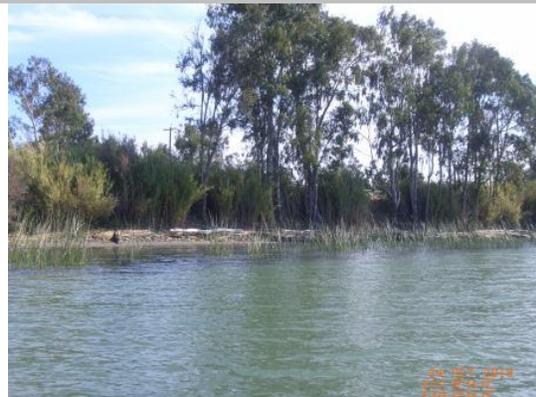
Photo 1 of 1 : SP_2016_RD0341_168_7_20160223_00005.jpg

LM Start	4.15	Rating **	M	Issue No.	7
LM End	4.19	Issue Type +	Ma	Location *	WS
Category	Supplemental			GPS Latitude/Longitude	
				Start	End
Item	2015 USACE Erosion Survey, DRAFT			38.095148 °	38.094590 °
				-121.706367 °	-121.706393 °
DWR ID	DWR_RD0341_02_s_2016_7				
Comment Code					
Inspector Comment					
2011 - Large new erosion pocket probably hidden by vegetation in the past. 2015: No observed changes. [2015 Site ID: SAC_8-2_L]

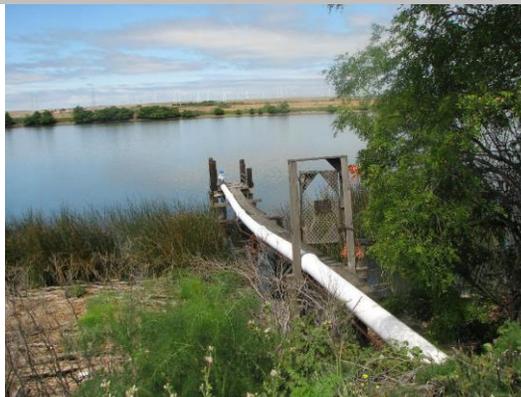
Photo 1 of 1 : UCIP_SP_2016_22223_37840.jpg

Comment Code					
Inspector Comment					
FS_ID:22223 DS_ID:24122 EP_NO: 11106 Repair Type: Non-Urgent Crossing Status: Found UCIP Comments: Need to contact owner to determine status of crossing. Dense vegetation limits the inspector's visibility to identify signs of pipe failure (leaks) along the slope. Recommend removing vegetation along pipe alignment to conduct proper inspection of structure and appurtenances. FIELD_STRUCT_DESC: 12-inch pipe through the levee, 4.0 feet below the crown. Pump on pile structure in stream. (USACE-1962). This entry matches the Drainage or Irrigation Structure referenced in O&M manual (HLM 4.29). 12-inch pipe was retained under ABO No. 11106 (1975). FS Date: 5/6/2009

View of waterward side--pipe and pump visible.

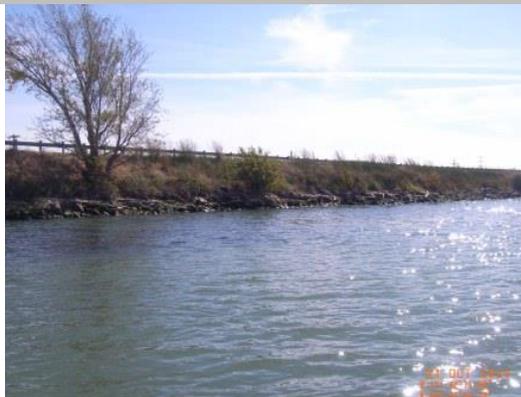
Photo 1 of 1 : SP_2016_RD0341_168_4_20160223_00004.jpg

LM Start	4.76	Rating **	U	Issue No.	4
LM End	4.85	Issue Type +	Ma	Location *	WS
Category	Supplemental			GPS Latitude/Longitude	
				Start	End
Item	2015 USACE Erosion Survey, DRAFT			38.086603 °	38.085459 °
				-121.707786 °	-121.708607 °
DWR ID	DWR_RD0341_02_s_2016_4				
Comment Code					
Inspector Comment					
2011 - Large slump section. 2012 - Site extended downstream, upgraded to critical, severe windwave. Slope is very steep and may be effecting the highway on top of the levee. 2015: No observed changes. [2015 Site ID: SAC_7-9_L]

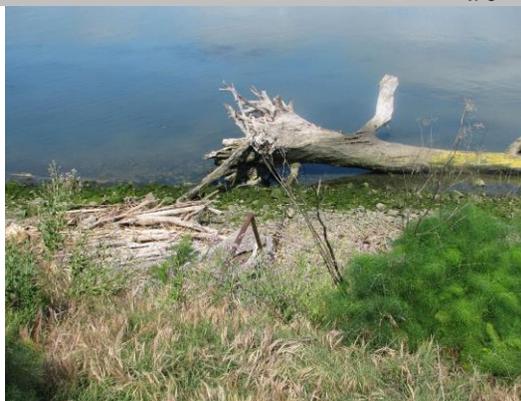
Photo 1 of 2 : UCIP_SP_2016_22186_37787.jpg

LM Start	4.79	Rating **	M	Issue No.	63
LM End	4.79	Issue Type +	En	Location *	WS
Category	Supplemental			GPS Latitude/Longitude	
				Start	End
Item	DWR UCIP Field Study			38.086119 °	38.086119 °
				-121.707912 °	-121.707912 °
DWR ID					
Comment Code					
Inspector Comment					
FS_ID:22186 DS_ID:24123 EP_NO: 4855 Repair Type: Non-Urgent Crossing Status: Found UCIP Comments: Dense vegetation limits the inspector's visibility to identify signs of pipe failure (leaks) along the slope. Recommend removing vegetation along pipe alignment to conduct proper inspection of structure and appurtenances. FIELD_STRUCT_DESC: 2-inch steel irrigation pipe through the levee, 3.0 feet below the crown. Valve and pump on landward side. Rock revetment on waterward slope. (Permit No. 4855-1965) FS Date: 5/6/2009

View of crossing on waterward side--dense vegetation on slopes.

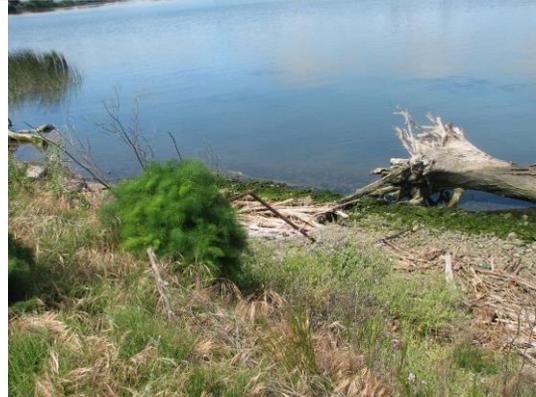
Photo 2 of 2 : UCIP_SP_2016_22186_37786.jpg

View of waterward toe.

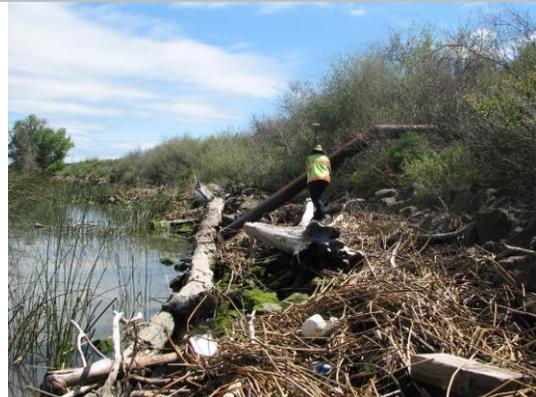
Photo 1 of 2 : UCIP_SP_2016_39862_37842.jpg

View of crossing on waterward side. Dense vegetation limits inspection of crossing.

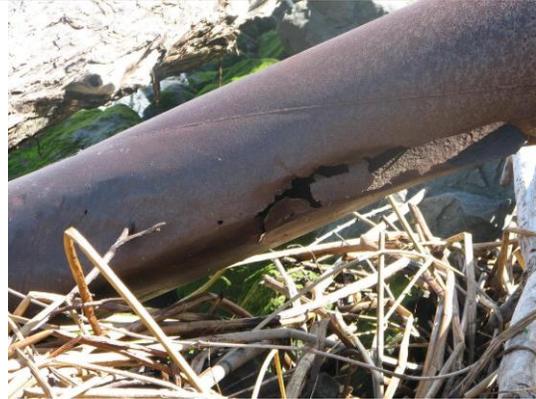
Photo 2 of 2 : UCIP_SP_2016_39862_37841.jpg

Holes present on waterward side.

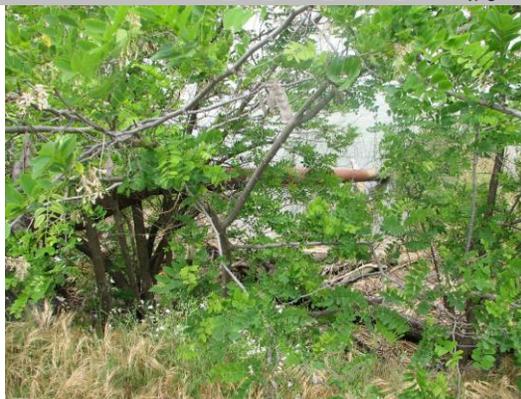
Photo 2 of 2 : UCIP_SP_2016_22256_37914.jpg

View of pipe through brush on waterward side.

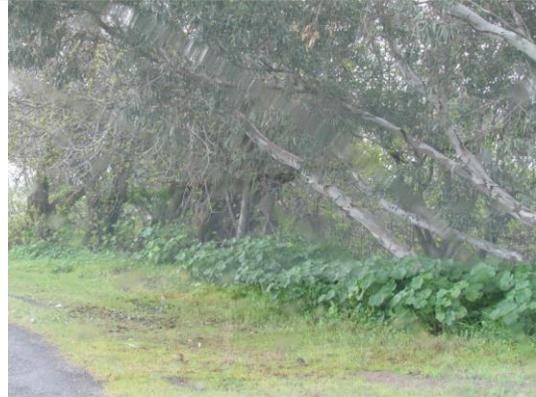
Photo 1 of 1 : SP_2016_RD0341_168_47_20160316_00078.jpg

Landside slope blocked by woody growth of fig trees.

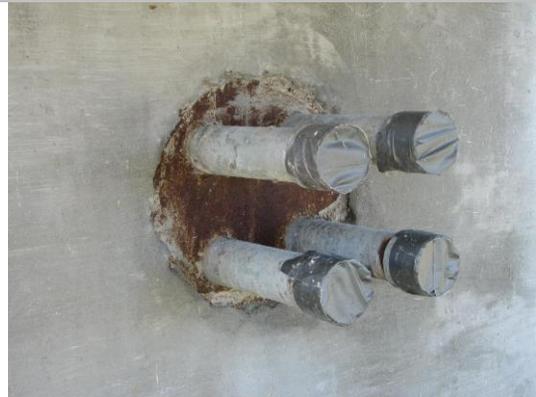
Photo 2 of 2 : UCIP_SP_2016_22303_38061.jpg

Conduits exposed on waterward side.

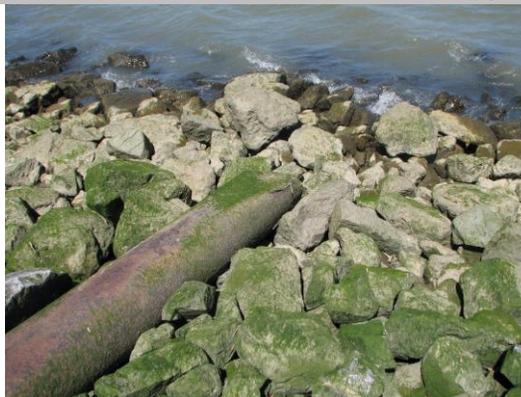
Photo 2 of 2 : UCIP_SP_2016_22323_38090.jpg

Deformed pipe end located on waterward side.

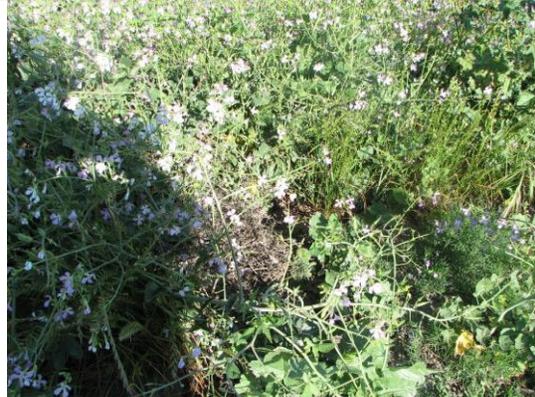
Photo 2 of 2 : UCIP_SP_2016_22324_38095.jpg

Potential subsidence in slope however difficult to determine due to dense vegetation.
