**Flood Control Project Maintenance
Levee Inspections**
LMA District Cover Sheet
Spring 2016 Levee Inspection Results

Reclamation District No. 0369 Libby McNeil

Waterway	Bank	Unit Miles
Unit No. 01 Sacramento River	Left	0.78

Levee Inspection Report By Mile - Spring 2016

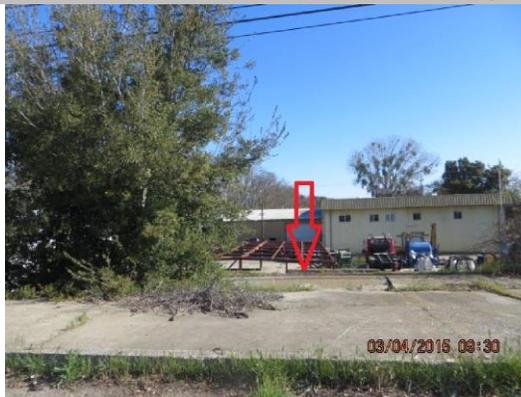
Photo 2 of 2 : UCIP_SP_2016_43625_73164.jpg

LM Start	0.04	Rating **	M	Issue No.	36 (cont)
LM End	0.04	Issue Type +	En	Location *	WS
Category	Supplemental			GPS Latitude/Longitude	
				Start	End
Item	DWR UCIP Field Study			38.258434 °	38.258434 °
				-121.517283 °	-121.517283 °
DWR ID					
Comment Code					
Inspector Comment					
FS_ID:43625 DS_ID:18971 EP_NO: 8555 Repair Type: Non-Urgent Crossing Status: Found UCIP Comments: Pipe corroded through on LS at retaining wall. May not go all the way through the levee. Appears abandoned and if so should be done so properly. FIELD_STRUCT_DESC: 2 of 2: 4-inch steel pipe through the levee, 4-feet below the crown. Pipe visible on LS at retaining wall (Permit No. 8555 - Jordan Investment Co.) FS Date: 3/4/2015 4:11:00 PM

Pipe visible on retaining wall at LS toe.

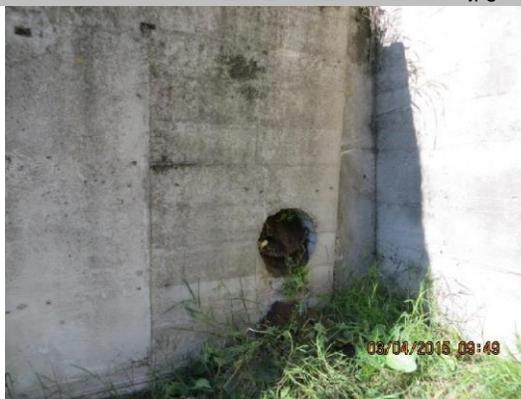
Photo 1 of 2 : UCIP_SP_2016_43811_73162.jpg

LM Start	0.05	Rating **	M	Issue No.	30
LM End	0.05	Issue Type +	En	Location *	WS
Category	Supplemental			GPS Latitude/Longitude	
				Start	End
Item	DWR UCIP Field Study			38.258347 °	38.258347 °
				-121.517169 °	-121.517169 °
DWR ID					
Comment Code					
Inspector Comment					
FS_ID:43811 DS_ID:18970 EP_NO: N/A Repair Type: Non-Urgent Crossing Status: Found UCIP Comments: Pipe appears abandoned and is filled with soil. Appears abandoned and if so should be done so properly. FIELD_STRUCT_DESC: 8-inch steel drainpipe through the levee, 8-feet below the crown. Hole in concrete retaining wall on LS slope measures 10-inches in diameter. FS Date: 3/4/2015 4:41:00 PM

10-inch hole in concrete retaining wall likely for this pipe. Visible on LS toe. Portion of pipe visible.

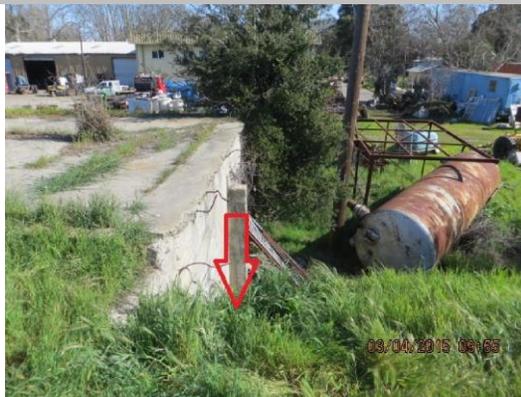
Photo 2 of 2 : UCIP_SP_2016_43811_73161.jpg

LM Start	0.05	Rating **	M	Issue No.	30 (cont)
LM End	0.05	Issue Type +	En	Location *	WS
Category	Supplemental			GPS Latitude/Longitude	
				Start	End
Item	DWR UCIP Field Study			38.258347 °	38.258347 °
				-121.517169 °	-121.517169 °
DWR ID					
Comment Code					
Inspector Comment					
FS_ID:43811 DS_ID:18970 EP_NO: N/A Repair Type: Non-Urgent Crossing Status: Found UCIP Comments: Pipe appears abandoned and is filled with soil. Appears abandoned and if so should be done so properly. FIELD_STRUCT_DESC: 8-inch steel drainpipe through the levee, 8-foot below the crown. Hole in concrete retaining wall on LS slope measures 10-inches in diameter. FS Date: 3/4/2015 4:41:00 PM

10-inch hole in concrete retaining wall likely for this pipe. Visible on LS toe.

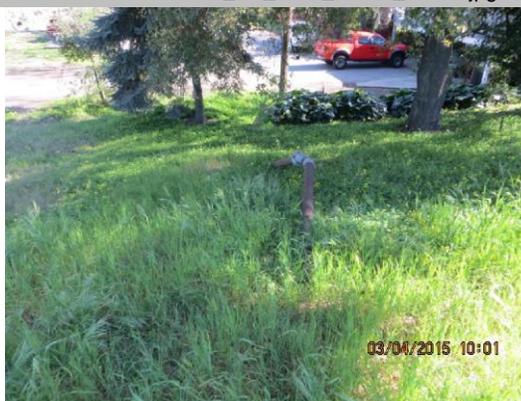
Photo 1 of 2 : UCIP_SP_2016_43812_73331.jpg

LM Start	0.09	Rating **	U	Issue No.	31
LM End	0.09	Issue Type +	En	Location *	WS
Category	Supplemental			GPS Latitude/Longitude	
				Start	End
Item	DWR UCIP Field Study			38.257953 °	38.257953 °
				-121.516613 °	-121.516613 °
DWR ID					
Comment Code					
Inspector Comment					
FS_ID:43812 DS_ID:25084 EP_NO: N/A Repair Type: Urgent Crossing Status: Found UCIP Comments: Severe corrosion and holes visible in pipe on LS shoulder. Pipe appears abandoned and should be done so properly. FIELD_STRUCT_DESC: 4-inch steel pipe through the levee, 1-foot below the crown. Pipe visible on LS slope just in-front of gate on LS shoulder. Listed in O+M manual at RM 27.87, 1959. FS Date: 3/4/2015

Pipe visible on LS slope.

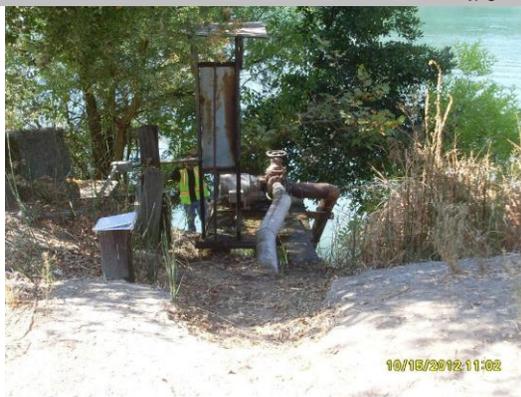
Photo 1 of 2 : UCIP_SP_2016_43814_10460.jpg

LM Start	0.35	Rating **	M	Issue No.	32
LM End	0.35	Issue Type +	En	Location *	LS
Category	Supplemental		GPS Latitude/Longitude		
			Start	End	
Item	DWR UCIP Field Study		38.255250°	38.255250°	
			-121.513210°	-121.513210°	
DWR ID					
Comment Code					
Inspector Comment					
FS_ID:43814 DS_ID:18972 EP_NO: 11117 Repair Type: Non-Urgent Crossing Status: Found UCIP Comments: Siphon breaker on LS slope needs protection. Water is leaking from pump station. Abandoned concrete structure found on WS. 10-inch abandoned pipe found on WS. Should be removed 6-inch abandoned pipe found on WS. Should be removed. FIELD_STRUCT_DESC: 10-inch steel irrigation pipe through the levee 4.5-feet below the crown. Pump and Gate valve on WS shoulder. Siphon breaker on LS slope. O&M Manual Sac 111, May 1959, Revision Year 2011 RM 27.63 FS Date: 10/15/2012 4:11:00 PM

Waterside view: overview of pipe & pump and abandoned concrete structure (left). Shutoff Valve.

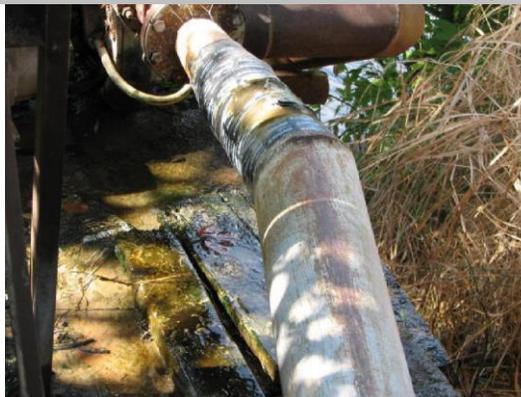
Photo 2 of 2 : UCIP_SP_2016_43814_10456.jpg

LM Start	0.35	Rating **	M	Issue No.	32 (cont)
LM End	0.35	Issue Type +	En	Location *	LS
Category	Supplemental			GPS Latitude/Longitude	
				Start	End
Item	DWR UCIP Field Study			38.255250 °	38.255250 °
				-121.513210 °	-121.513210 °
DWR ID					
Comment Code					
Inspector Comment					
FS_ID:43814 DS_ID:18972 EP_NO: 11117 Repair Type: Non-Urgent Crossing Status: Found UCIP Comments: Siphon breaker on LS slope needs protection. Water is leaking from pump station. Abandoned concrete structure found on WS. 10-inch abandoned pipe found on WS. Should be removed. 6-inch abandoned pipe found on WS. Should be removed. FIELD_STRUCT_DESC: 10-inch steel irrigation pipe through the levee 4.5-feet below the crown. Pump and Gate valve on WS shoulder. Siphon breaker on LS slope. O&M Manual Sac 111, May 1959, Revision Year 2011 RM 27.63 FS Date: 10/15/2012 4:11:00 PM

Waterside view: water leaking pump station.

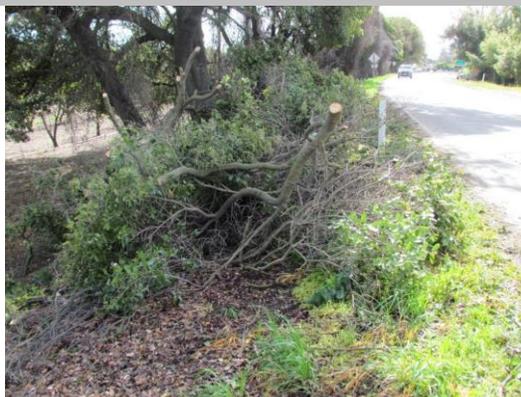
Photo 1 of 1 : SP_2016_RD0369_207_14_20160308_00023.jpg

LM Start	0.50	Rating **	U	Issue No.	14
LM End	0.50	Issue Type +	Ma	Location *	LS
Category	Earthen Levee			GPS Latitude/Longitude	
				Start	End
Item	Encroachments			38.253468 °	38.253468 °
				-121.511692 °	-121.511692 °
DWR ID	DWR_RD0369_01_s_2016_14				
Comment Code					
TR : Tree or limb					
Inspector Comment					
These tree limbs were placed here by the County Fire Department. The storm caused the limbs to break and block traffic. This brush was causing a safety hazard to highway traffic. The County Fire Dept. cut the limbs up and drug them off the HWY.

Cut up tree limbs placed on the shoulder and landside slope.

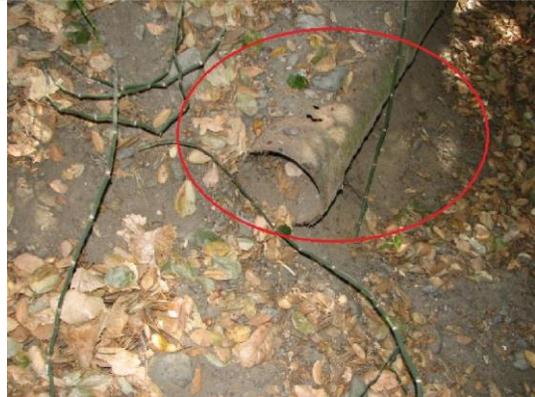
Photo 1 of 2 : UCIP_SP_2016_43815_73301.jpg

LM Start	0.50	Rating **	M	Issue No.	33
LM End	0.50	Issue Type +	En	Location *	LS
Category	Supplemental			GPS Latitude/Longitude	
				Start	End
Item	DWR UCIP Field Study			38.253468 °	38.253468 °
				-121.511654 °	-121.511654 °
DWR ID					
Comment Code					
Inspector Comment					
FS_ID:43815 DS_ID:18981 EP_NO: N/A Repair Type: Non-Urgent Crossing Status: Indicator Found UCIP Comments: Found abandoned pipe laying on WS levee slope. Pipe purpose and status should be determined. further investigation required. FIELD_STRUCT_DESC: 8-inch steel pipe running parallel with levee crown on WS slope. FS Date: 3/4/2015

Pipe visible on WS slope running parallel to crown.

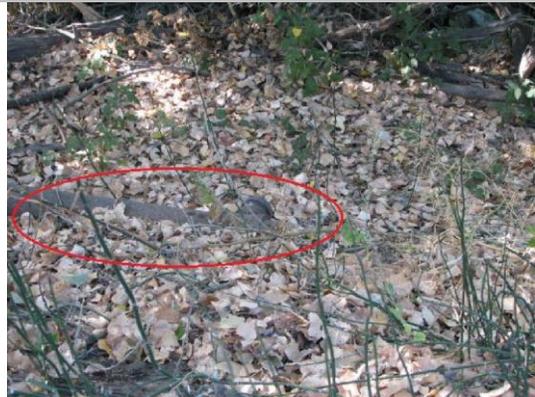
Photo 2 of 2 : UCIP_SP_2016_43815_73300.jpg

Pipe on WS slope running parallel to leveel crown.

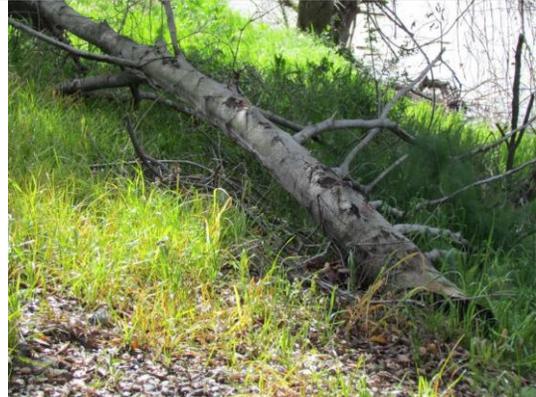
Photo 1 of 1 : SP_2016_RD0369_207_16_20160314_00024.jpg

LM Start	0.53	Rating **	M	Issue No.	16
LM End	0.53	Issue Type +	Ma	Location *	WS
Category	Earthen Levee			GPS Latitude/Longitude	
				Start	End
Item	Encroachments			38.253095 °	38.253095 °
				-121.511387 °	-121.511387 °
DWR ID	DWR_RD0369_01_s_2016_16				
Comment Code					
TR : Tree or limb					
Inspector Comment					
Cut up and remove the dead tree from the waterside slope.

Dead tree on water side slope.

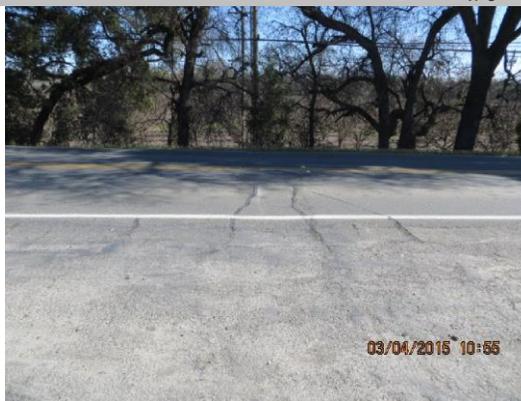
Photo 1 of 2 : UCIP_SP_2016_43816_73166.jpg

LM Start	0.61	Rating **	U	Issue No.	34
LM End	0.61	Issue Type +	En	Location *	WS
Category	Supplemental			GPS Latitude/Longitude	
				Start	End
Item	DWR UCIP Field Study			38.252176 °	38.252176 °
				-121.510833 °	-121.510833 °
DWR ID					
Comment Code					
Inspector Comment					
FS_ID:43816 DS_ID:18977 EP_NO: 14313 Repair Type: Urgent Crossing Status: Indicator Found UCIP Comments: Septic line appears to be leaking at LS toe. Erosion of soil and wet soil visible at LS toe. No septic smell accompanied other evidence at site. FIELD_STRUCT_DESC: 1 of 3: 2-inch-diameter galvanized steel sewer line through the left bank levee of the Sacramento River. A metal cutoff placed around the pipeline near the centerline of the levee. 4' x 6' CC box at LS toe (Permit No. 14313). FS Date: 3/4/2015 4:48:00 PM

View at crossing through crown on LS shoulder from WS shoulder. Evidence of trench visible at cut in pavement.

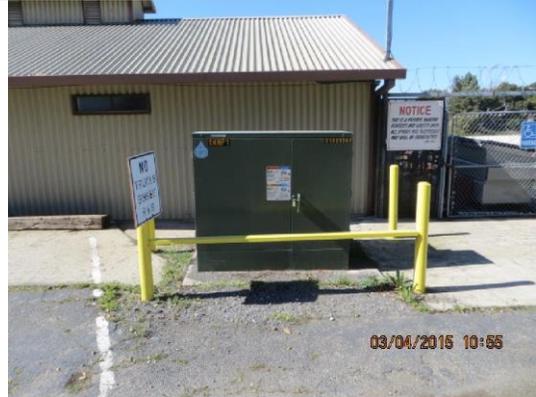
Photo 2 of 2 : UCIP_SP_2016_43816_73167.jpg

LM Start	0.61	Rating **	U	Issue No.	34 (cont)
LM End	0.61	Issue Type +	En	Location *	WS
Category	Supplemental			GPS Latitude/Longitude	
				Start	End
Item	DWR UCIP Field Study			38.252176°	38.252176°
				-121.510833°	-121.510833°
DWR ID					
Comment Code					
Inspector Comment					
FS_ID:43816 DS_ID:18977 EP_NO: 14313 Repair Type: Urgent Crossing Status: Indicator Found UCIP Comments: Septic line appears to be leaking at LS toe. Erosion of soil and wet soil visible at LS toe. No septic smell accompanied other evidence at site. FIELD_STRUCT_DESC: 1 of 3: 2-inch-diameter galvanized steel sewer line through the left bank levee of the Sacramento River. A metal cutoff placed around the pipeline near the centerline of the levee. 4' x 6' CC box at LS toe (Permit No. 14313). FS Date: 3/4/2015 4:48:00 PM

Waterside view. Unclear if there is a sewer cleanout or other evidence of pipe location on WS shoulder.

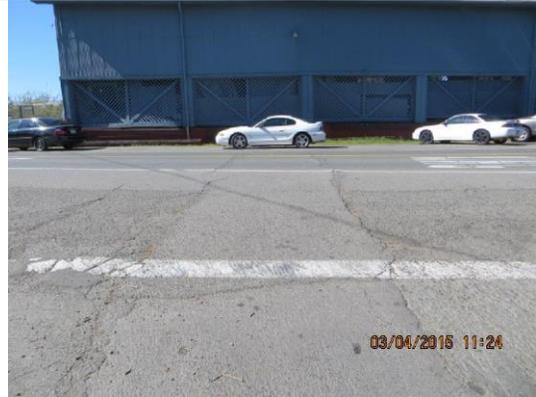
Photo 2 of 2 : UCIP_SP_2016_43756_73293.jpg

Comment Code					
Inspector Comment					
FS_ID:43756 DS_ID:18984 EP_NO: 12944 Repair Type: Urgent Crossing Status: Indicator Found UCIP Comments: WS shoulder is saturated do to a water leak either at this backflow preventer or due to another waterline in the area. Leak needs to be repaired. FIELD_STRUCT_DESC: 1 of 2: 4-inch Galvanized steel domestic water line through the levee 1.5-feet below the crown. Provides service to town of lock down center of Levee Street. Concrete Block pumphouse on WS at south end of boathouse. Gate valves and Backflow device visible at south side of Boathouse (Permit No. 12944, 1982). FS Date: 10/15/2012 4:56:00 PM

Cut in pavement still visible at crossing near centerline of Levee Street.
