**Flood Control Project Maintenance  
Levee Inspections**

**Maintenance Issue Types Only, Levee Inspection Report By Mile - Spring 2016**

**Reclamation District No. 0524 Middle Roberts Island**

Waterway	Bank	Unit Miles	Inspection Start/End	Inspector
Unit No. 01 San Joaquin River	Left	6.20	04/12/2016 04/13/2016	Richard Willoughby

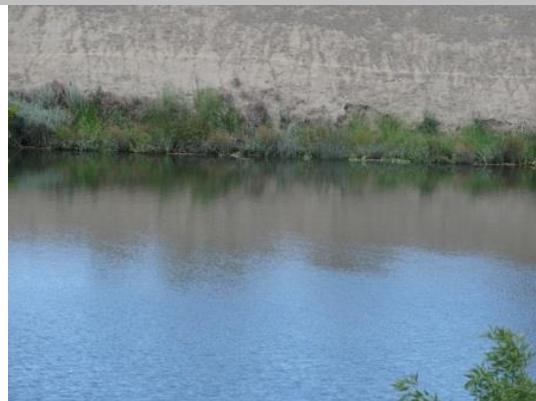
Photo 1 of 2 : SP\_2016\_RD0524\_107\_129\_20160404\_00169.jpg

LM Start	<b>0.19</b>	Rating **	U	Issue No.	<b>129</b>
LM End	<b>0.19</b>	Issue Type +	Ma	Location *	WS
Category	Supplemental		GPS Latitude/Longitude		
			Start	End	
Item	DWR Erosion Survey		37.939085 °	37.939085 °	
			-121.343917 °	-121.343917 °	
DWR ID	DWR_RD0524_01_s_2016_129				
Comment Code					
Inspector Comment					
06/24/2015: No significant change observed. 6/19/2014: No significant change observed. 08/13/2013: The erosion was discovered during 2013 spring levee inspection. Inspector comment: Erosion is located along the lower level of water-ward slope. [2015 Site ID:RD0524U01RM40.85]

Front view of the erosion.

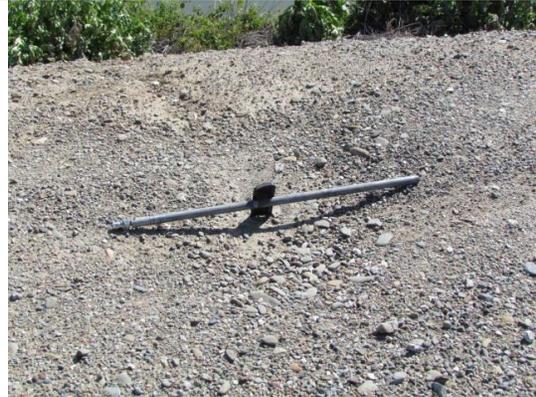
Photo 3 of 3 : SP\_2016\_RD0524\_107\_3\_20160404\_00008.jpg

LM Start	<b>0.21</b>	Rating **	M	Issue No.	<b>3 (cont)</b>
LM End	<b>0.21</b>	Issue Type +	Ma	Location *	CR
Category	Earthen Levee		GPS Latitude/Longitude		
			Start	End	
Item	Crown Surface / Depressions / Rutting		37.938890 °	37.938890 °	
			-121.343657 °	-121.343657 °	
DWR ID	DWR_RD0524_01_s_2016_3				
Comment Code					
C2 : Repair depressions or ruts in the crown or slope.					
Inspector Comment					
No change in status.

Looking east at 3" depression on levee crown. (Spring 2012)

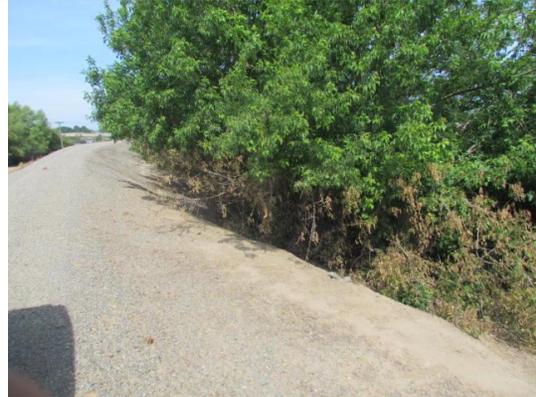
Photo 2 of 3 : SP\_2016\_RD0524\_107\_179\_20160404\_00201.jpg

Looking north at untrimmed tree on waterward slope. (Spring 2015)

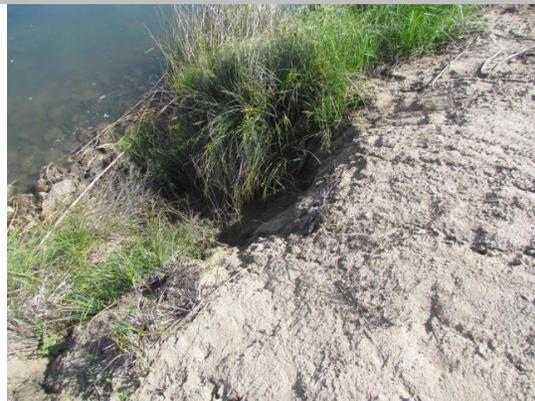
Photo 1 of 2 : SP\_2016\_RD0524\_107\_180\_20160404\_00203.jpg

LM Start	<b>0.34</b>	Rating **	M	Issue No.	<b>180</b>
LM End	<b>0.34</b>	Issue Type +	Ma	Location *	WS
Category	Earthen Levee			GPS Latitude/Longitude	
				Start	End
Item	Erosion / Bank Caving			37.938461 °	37.938461 °
				-121.341626 °	-121.341626 °
DWR ID	DWR_RD0524_01_s_2014_180				
Comment Code					
E2 : Schedule repair of erosion site prior to the next inspection.					
Inspector Comment					
Erosion is located along the lower level of waterward slope.

Looking southeast at erosion on waterward toe.

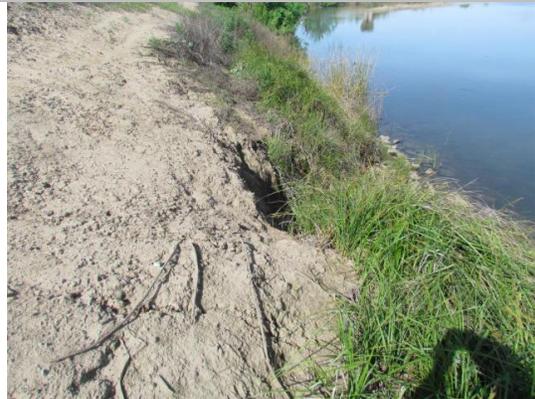
Photo 2 of 2 : SP\_2016\_RD0524\_107\_180\_20160404\_00204.jpg

Looking northeast at erosion on waterward toe.

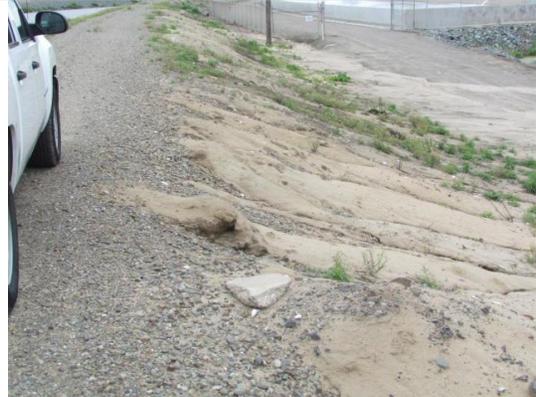
Photo 2 of 2 : SP\_2016\_RD0524\_107\_205\_20160414\_00343.jpg

LM Start	<b>0.40</b>	Rating **	U	Issue No.	<b>205 (cont)</b>
LM End	<b>0.46</b>	Issue Type +	Ma	Location *	LS
Category	Earthen Levee			GPS Latitude/Longitude	
				Start	End
Item	Slope Stability			37.938625 °	37.938695 °
				-121.340479 °	-121.339420 °
DWR ID	DWR_RD0524_01_s_2016_205				
Comment Code					
S1 : Repair slope instability.					
Inspector Comment					
Several damage site within this reach.

Looking south at slope damage on landward slope.

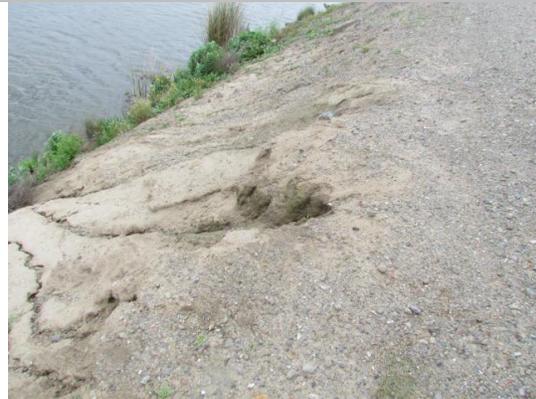
Photo 1 of 3 : SP\_2016\_RD0524\_107\_170\_20160414\_00344.jpg

LM Start	<b>0.41</b>	Rating **	U	Issue No.	<b>170</b>
LM End	<b>0.45</b>	Issue Type +	Ma	Location *	WS
Category	Earthen Levee			GPS Latitude/Longitude	
				Start	End
Item	Slope Stability			37.938628 °	37.938688 °
				-121.340385 °	-121.339627 °
DWR ID	DWR_RD0524_01_s_2015_170				
Comment Code					
S1 : Repair slope instability.					
Inspector Comment					
Several slope instabilites within this reach.

Looking east at slope damage on waterward shoulder (Spring 2016)

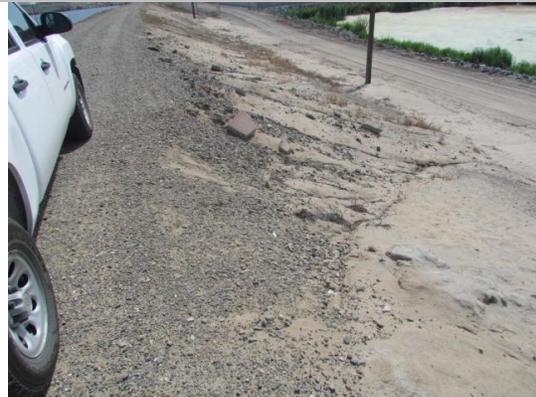
Photo 2 of 3 : SP\_2016\_RD0524\_107\_170\_20160404\_00188.jpg

Looking south at slope damage on waterward shoulder.

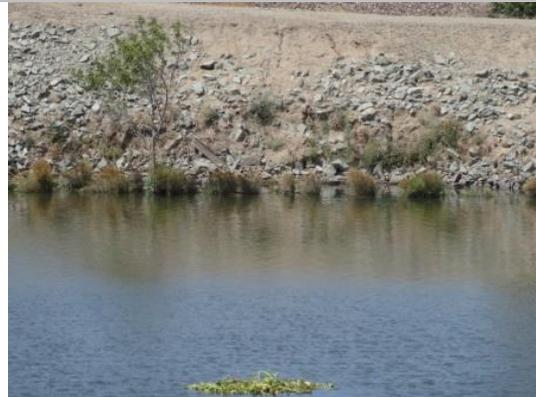
Photo 2 of 2 : SP\_2016\_RD0524\_107\_132\_20160404\_00174.jpg

Front view of the erosion.

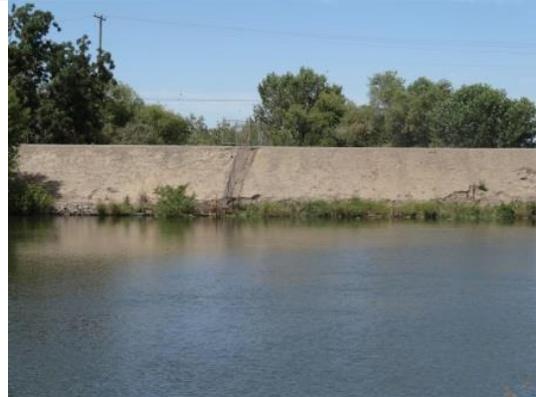
Photo 1 of 2 : SP\_2016\_RD0524\_107\_133\_20160404\_00175.jpg

LM Start	<b>0.76</b>	Rating **	U	Issue No.	<b>133</b>
LM End	<b>0.77</b>	Issue Type +	Ma	Location *	WS
Category	Supplemental			GPS Latitude/Longitude	
				Start	End
Item	DWR Erosion Survey			37.936821 °	37.936821 °
				-121.334582 °	-121.334582 °
DWR ID	DWR_RD0524_01_s_2016_133				
Comment Code					
Inspector Comment					
06/24/2015: No significant change observed. 06/19/2014: No significant change observed. 08/13/2013: No significant change at this site. 08/07/2012: The site has been visited by boat survey. No significant change observed. 08/23/2011: The site is located immediately upstream of a Railroad bridge. Dense vegetation at the water line blocks the view of erosion. [2015 Site ID:RD0524U01RM41.39]

Front view of the erosion site.

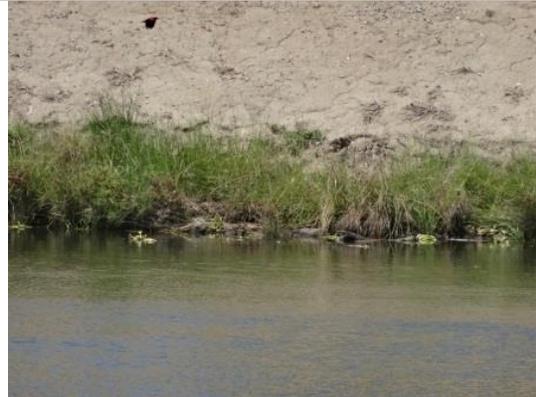
Photo 2 of 2 : SP\_2016\_RD0524\_107\_133\_20160404\_00176.jpg

Front view of the erosion site. Vegetation is visible.

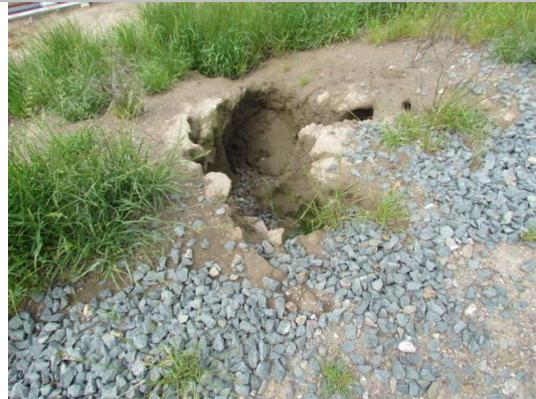
Photo 1 of 6 : SP\_2016\_RD0524\_107\_2\_20160414\_00348.jpg

Looking west at large hole on landward shoulder (Spring 2016)

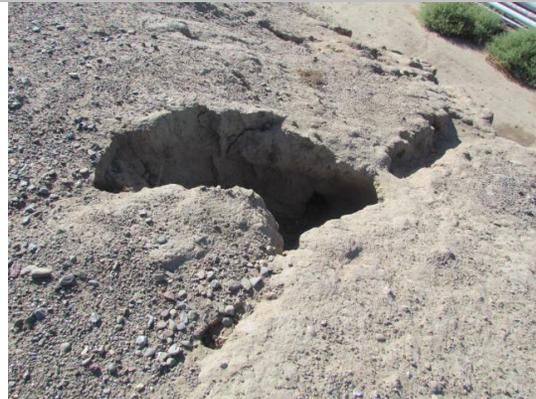
Photo 2 of 6 : SP\_2016\_RD0524\_107\_2\_20160404\_00001.jpg

Looking southwest at hole on landward shoulder.

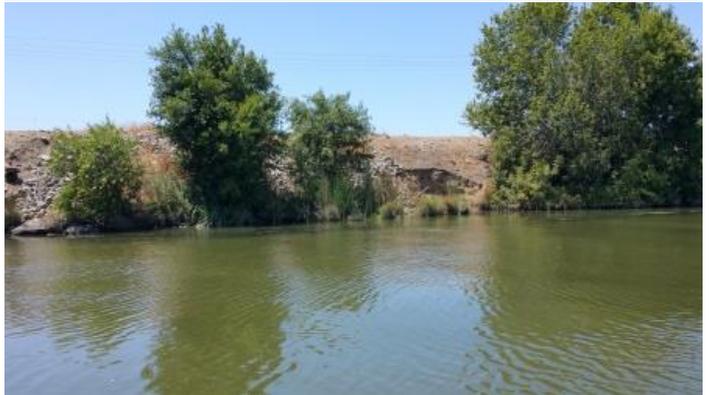
Photo 1 of 2 : SP\_2016\_RD0524\_107\_135\_20160404\_00179.jpg

Front view of the erosion. Note the riprap protection near the site.

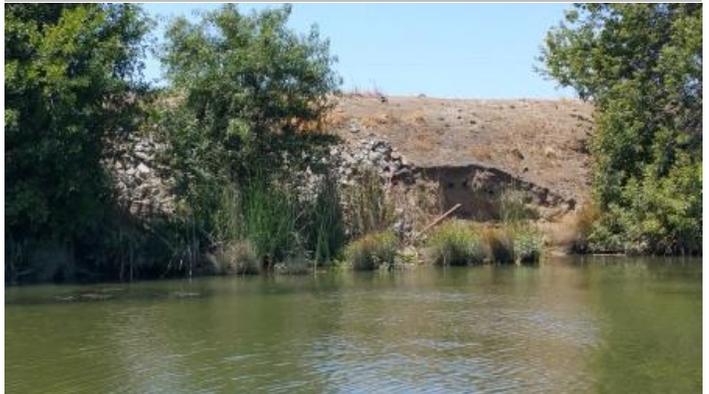
Photo 2 of 2 : SP\_2016\_RD0524\_107\_135\_20160404\_00180.jpg

A close view of the erosion.

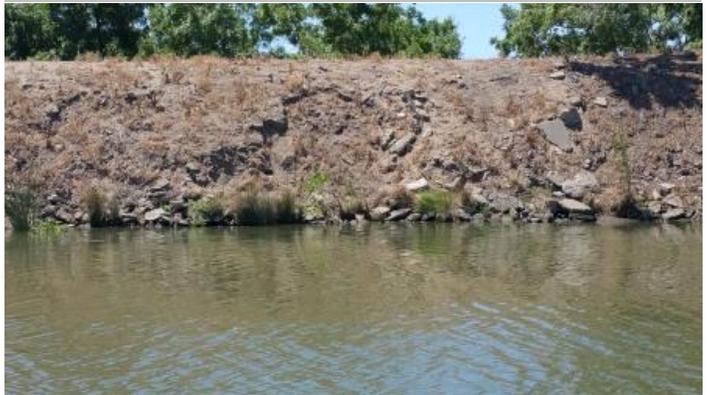
Photo 1 of 2 : SP\_2016\_RD0524\_107\_137\_20160404\_00182.jpg

Close view of the erosion.

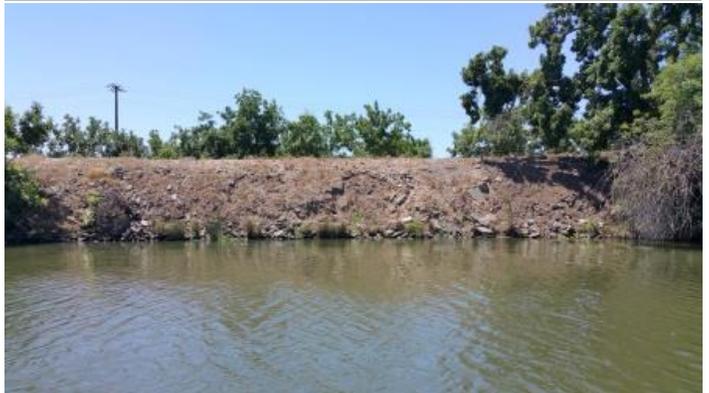
Photo 2 of 2 : SP\_2016\_RD0524\_107\_137\_20160404\_00183.jpg

Front view of the erosion.

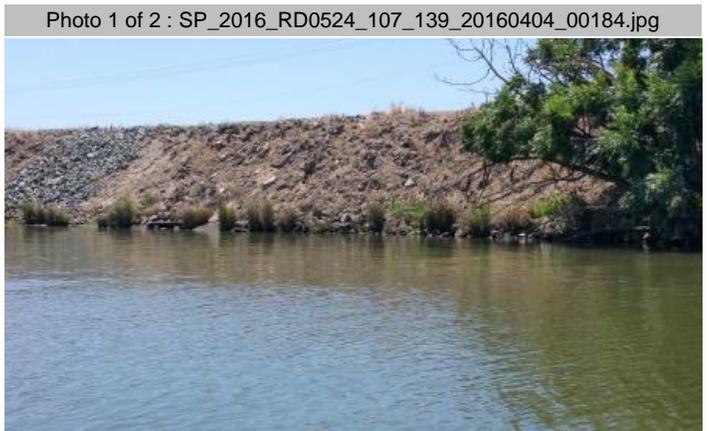
LM Start	<b>1.02</b>	Rating **	U	Issue No.	<b>139</b>
LM End	<b>1.02</b>	Issue Type +	Ma	Location *	WS
Category	Supplemental			GPS Latitude/Longitude	
				Start	End
Item	DWR Erosion Survey			37.935078 °	37.935078 °
				-121.331134 °	-121.331134 °
DWR ID	DWR_RD0524_01_s_2016_139				
Comment Code					
Inspector Comment					
06/24/2015: No significant change observed. 6/19/2014: No significant change observed. 08/13/2013: No significant change at this site. 08/07/2012: The site has been visited by boat survey. Site has been repaired, but new erosion occurred at the levee slope and immediately upstream of the repaired site. 08/23/2011: The site is about 500 ft downstream of bridge. The levee toe seems to be protected, but the protection is being washed away. [2015 Site ID:RD0524U01RM41.59]

Front view of the site.

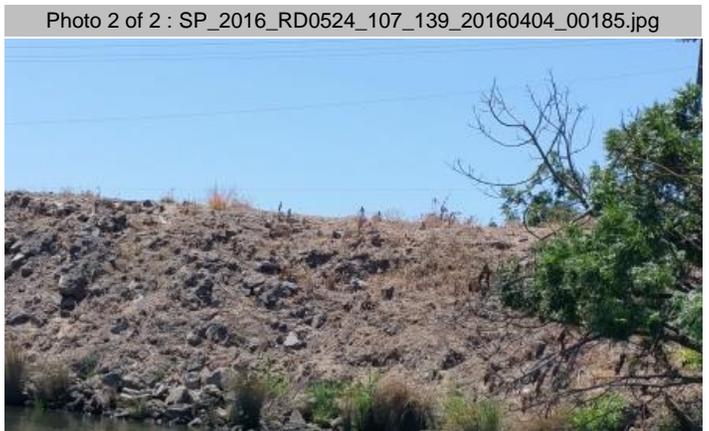
LM Start	<b>1.02</b>	Rating **	U	Issue No.	<b>139 (cont)</b>
LM End	<b>1.02</b>	Issue Type +	Ma	Location *	WS

Close view of the erosion.

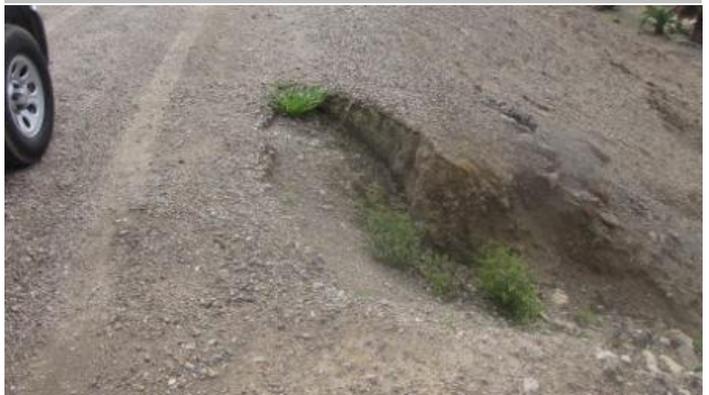
Photo 6 of 7 : SP\_2016\_RD0524\_107\_18\_20160404\_00036.jpg

Looking at updated slope stability as of Fall 2013.

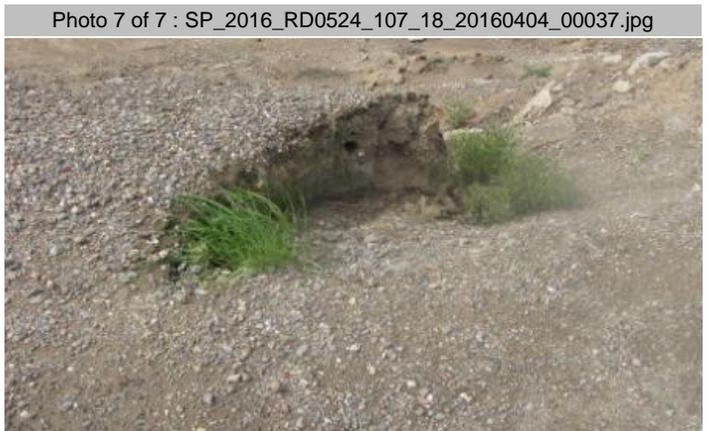
LM Start	<b>1.08</b>	Rating **	U	Issue No.	<b>18 (cont)</b>
LM End	<b>1.08</b>	Issue Type +	Ma	Location *	LS
Category	Earthen Levee			GPS Latitude/Longitude	
				Start	End
Item	Slope Stability			37.934645 °	37.934645 °
				-121.330310 °	-121.330310 °
DWR ID	DWR_RD0524_01_s_2012_18				
Comment Code					
S1 : Repair slope instability.					
Inspector Comment					
Slope damage extend from shoulder to middle of slope.

Updated view from above the slope stability.

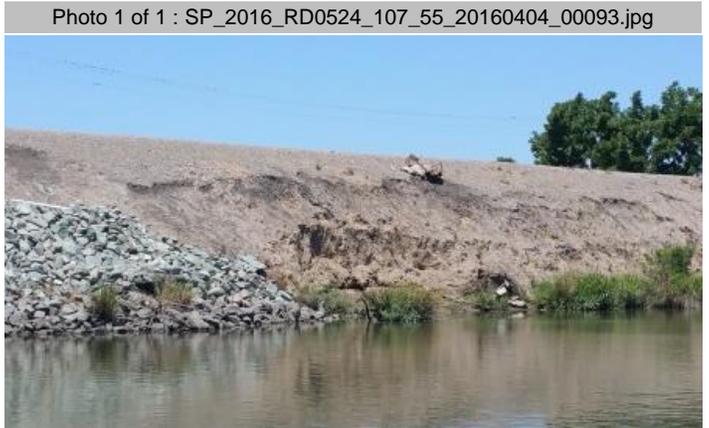
LM Start	<b>1.29</b>	Rating **	U	Issue No.	<b>55</b>
LM End	<b>1.32</b>	Issue Type +	Ma	Location *	WS
Category	Supplemental			GPS Latitude/Longitude	
				Start	End
Item	DWR Erosion Survey			37.931858 °	37.931858 °
				-121.328300 °	-121.328300 °
DWR ID	DWR_RD0524_01_s_2016_55				
Comment Code					
Inspector Comment					
06/24/2015: No significant change observed. 6/19/2014: No significant change observed. 08/13/2013: New signs of animal activity were found. 08/07/2012: The site was first reported in 2012 spring levee inspection report. [2015 Site ID:RD0524U01RM41.92]

Front view of the erosion.

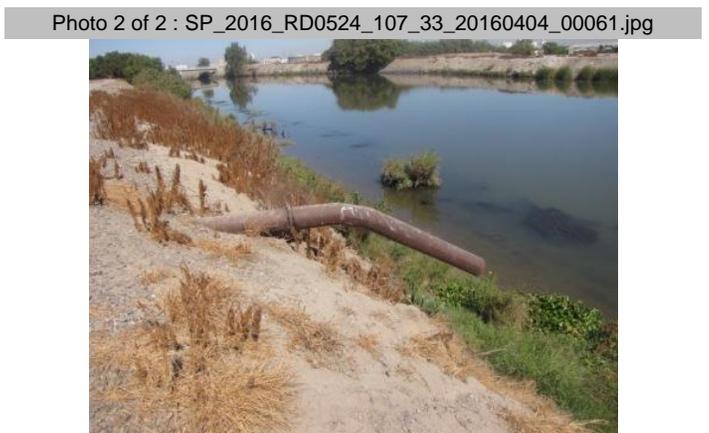
LM Start	<b>1.30</b>	Rating **	U	Issue No.	<b>33 (cont)</b>
LM End	<b>1.30</b>	Issue Type +	Ma	Location *	WS

Looking north at broken pipe.

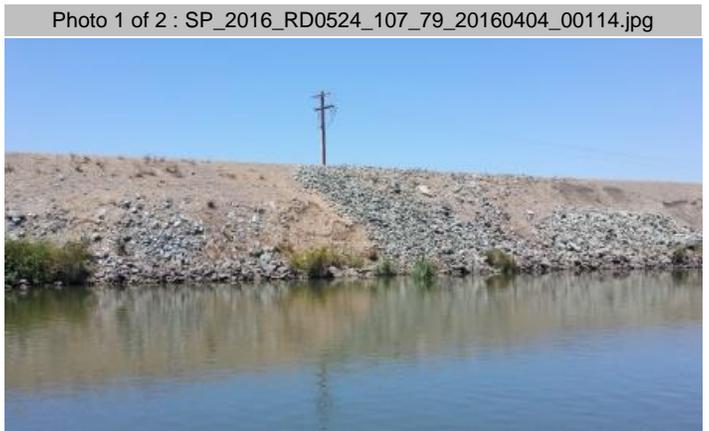
LM Start	<b>1.39</b>	Rating **	U	Issue No.	<b>79</b>
LM End	<b>1.39</b>	Issue Type +	Ma	Location *	WS
Category	Supplemental			GPS Latitude/Longitude	
				Start	End
Item	DWR Erosion Survey			37.930575 °	37.930575 °
				-121.328090 °	-121.328090 °
DWR ID	DWR_RD0524_01_s_2016_79				
Comment Code					
Inspector Comment					
06/24/2015: No significant change observed. 6/19/2014: No significant change observed. 08/13/2013: No significant change observed. 08/07/2012: The site was first reported in 2012 spring levee inspection report. The site is located about 750 ft downstream of SR 4 Bridge. [2015 Site ID:RD0524U01RM42.03]

Front view of the erosion.

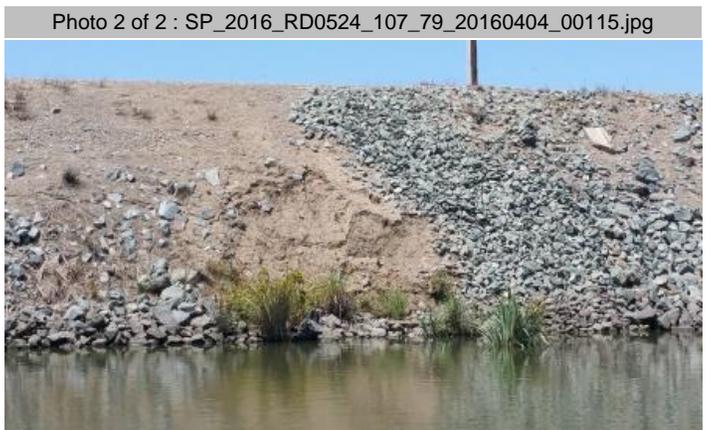
LM Start	<b>1.39</b>	Rating **	U	Issue No.	<b>79 (cont)</b>
LM End	<b>1.39</b>	Issue Type +	Ma	Location *	WS

Close view of the erosion.

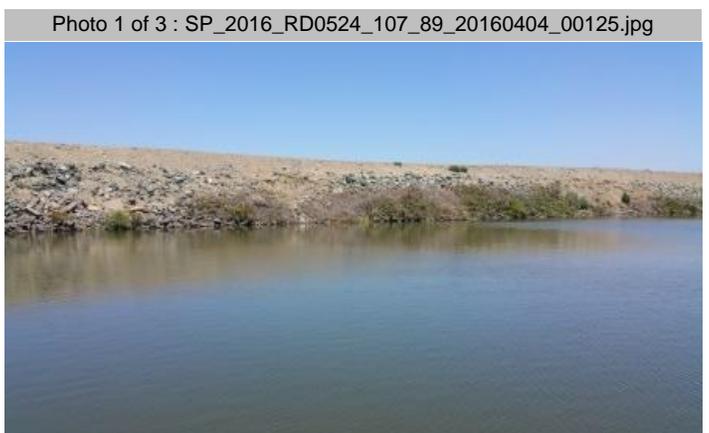
LM Start	<b>1.45</b>	Rating **	U	Issue No.	<b>89</b>
LM End	<b>1.47</b>	Issue Type +	Ma	Location *	WS
Category	Supplemental			GPS Latitude/Longitude	
				Start	End
Item	DWR Erosion Survey			37.929650 °	37.929650 °
				-121.328110 °	-121.328110 °
DWR ID	DWR_RD0524_01_s_2016_89				
Comment Code					
Inspector Comment					
06/24/2015: No significant change observed. 6/19/2014: No significant change observed. 08/13/2013: The site is located approximately 400 ft. downstream SR 4 Bridge. Dense vegetation is visible at the toe. [2015 Site ID:RD0524U01RM42.09]

Front view of the erosion site.

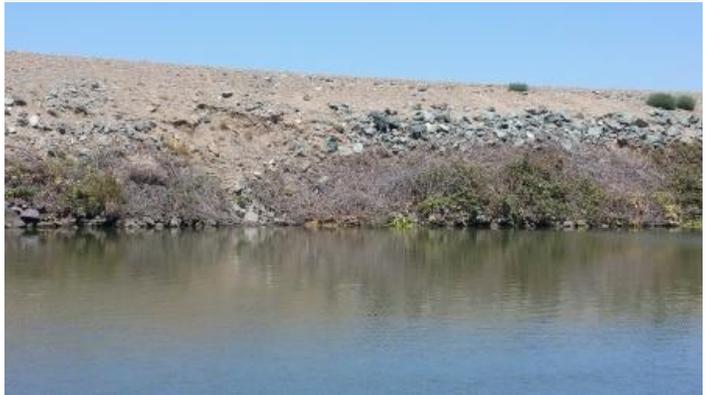
Photo 2 of 3 : SP\_2016\_RD0524\_107\_89\_20160404\_00126.jpg

Close view of the erosion.

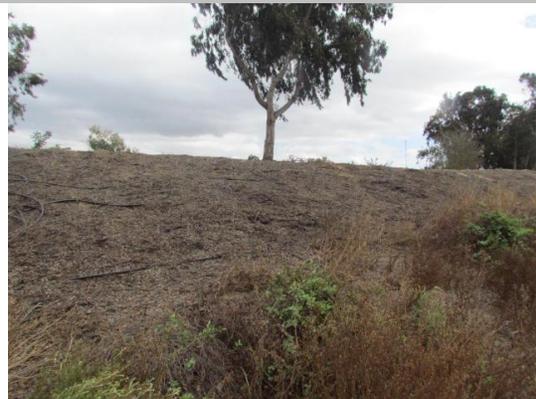
Photo 3 of 5 : SP\_2016\_RD0524\_107\_23\_20160404\_00045.jpg

Looking east from landward berm at corrected site.

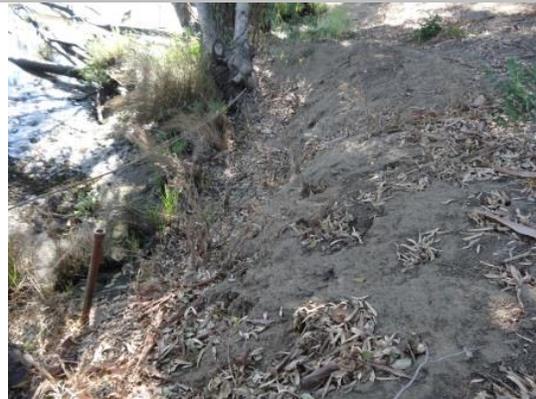
Photo 2 of 2 : SP\_2016\_RD0524\_107\_90\_20160404\_00129.jpg

Close view of the erosion at the levee toe.

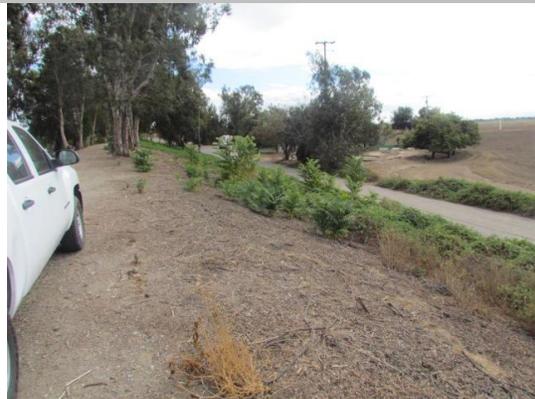
Photo 4 of 4 : SP\_2016\_RD0524\_107\_24\_20160404\_00049.jpg

Looking south at vegetation blocking view of landward toe. (Spring 2014)

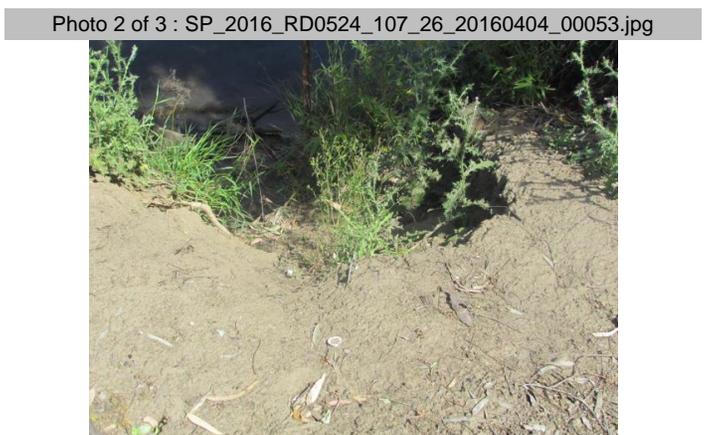
LM Start	<b>1.62</b>	Rating **	M	Issue No.	<b>26 (cont)</b>
LM End	<b>1.64</b>	Issue Type +	Ma	Location *	WS

Looking east at waterward erosion.

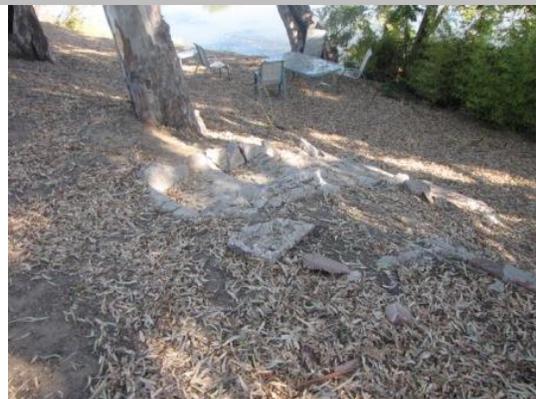
Photo 1 of 3 : SP\_2016\_RD0524\_107\_45\_20160404\_00077.jpg

Looking northeast at non-permitted concrete stairs on waterside slope.

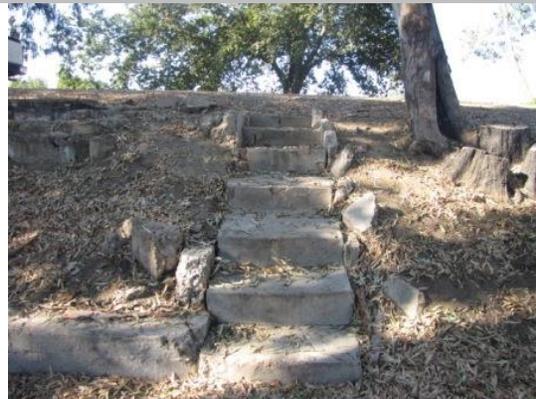
Photo 3 of 3 : SP\_2016\_RD0524\_107\_45\_20160404\_00079.jpg

Looking west at concrete stairs on waterside slope.

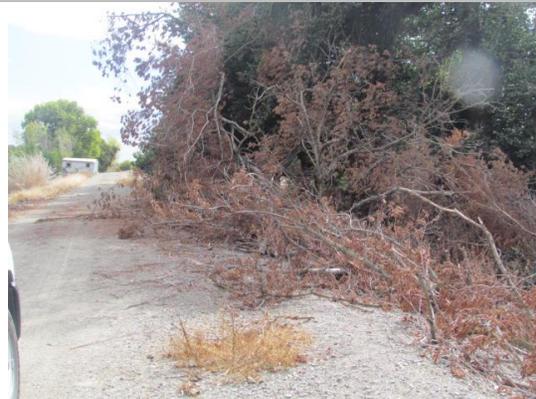
Photo 1 of 4 : SP\_2016\_RD0524\_107\_46\_20160404\_00080.jpg

Looking south at tree limbs on landward slope.

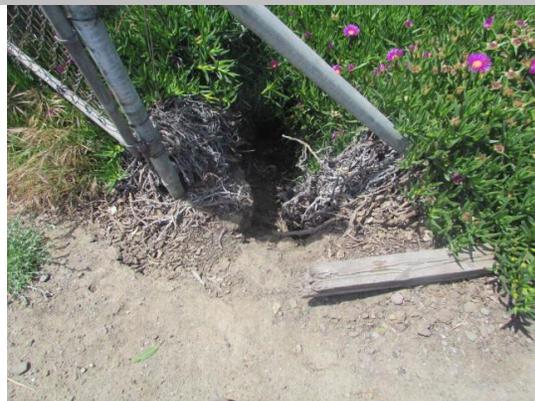
Photo 1 of 2 : SP\_2016\_RD0524\_107\_176\_20160404\_00197.jpg

Looking west at erosion within landscaping on landward shoulder and slope.

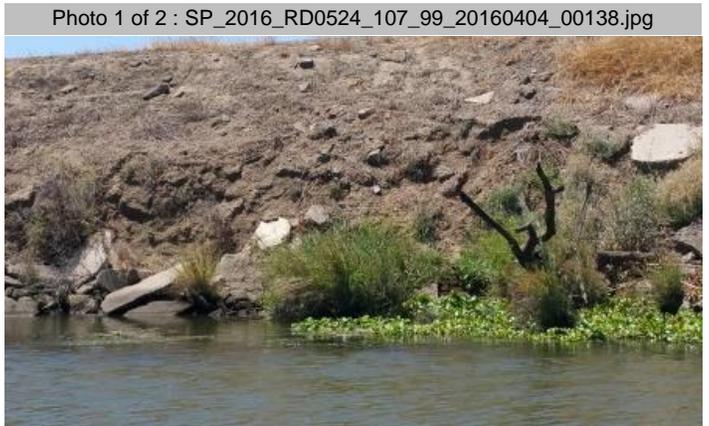
LM Start	<b>2.19</b>	Rating **	U	Issue No.	<b>99</b>
LM End	<b>2.19</b>	Issue Type +	Ma	Location *	WS
Category	Supplemental			GPS Latitude/Longitude	
				Start	End
Item	DWR Erosion Survey			37.920992 °	37.920992 °
				-121.321370 °	-121.321370 °
DWR ID	DWR_RD0524_01_s_2016_99				
Comment Code					
Inspector Comment					
06/24/2015: No significant change observed. 7/22/2014: The erosion has increased in size. 08/13/2013: No significant change observed. Slightly more vegetation was visible. 08/07/2012: The site was first reported in 2012 spring levee inspection report. [2015 Site ID:RD0524U01RM42.79]

Close view of the pocket erosion.

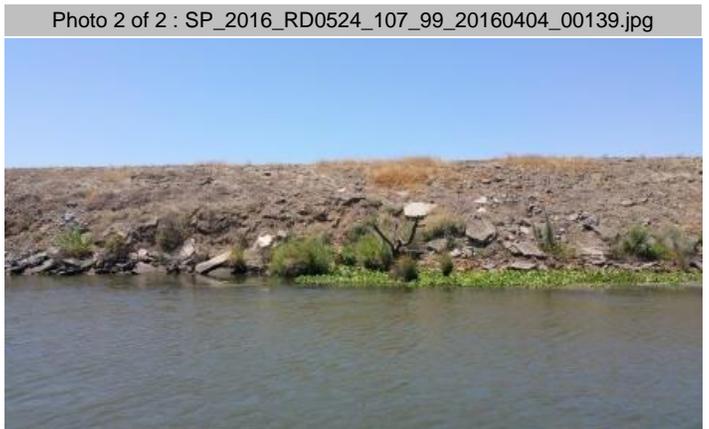
LM Start	<b>2.19</b>	Rating **	U	Issue No.	<b>99 (cont)</b>
LM End	<b>2.19</b>	Issue Type +	Ma	Location *	WS
Category	Supplemental			GPS Latitude/Longitude	
				Start	End
Item	DWR Erosion Survey			37.920992 °	37.920992 °
				-121.321370 °	-121.321370 °
DWR ID	DWR_RD0524_01_s_2016_99				
Comment Code					
Inspector Comment					
06/24/2015: No significant change observed. 7/22/2014: The erosion has increased in size. 08/13/2013: No significant change observed. Slightly more vegetation was visible. 08/07/2012: The site was first reported in 2012 spring levee inspection report. [2015 Site ID:RD0524U01RM42.79]

Front view of the erosion.

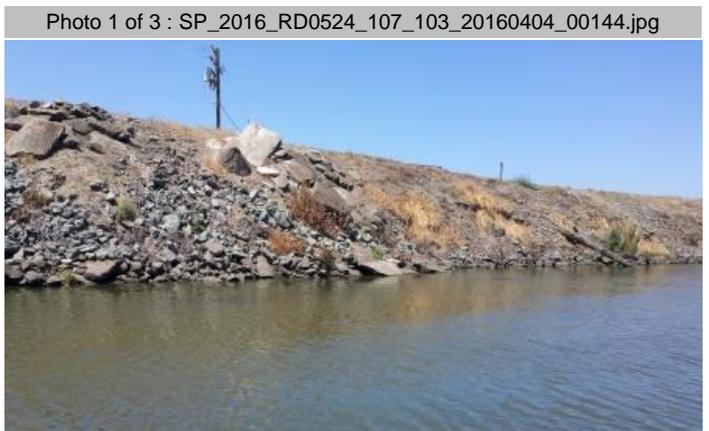
LM Start	<b>2.24</b>	Rating **	U	Issue No.	<b>103</b>
LM End	<b>2.27</b>	Issue Type +	Ma	Location *	WS
Category	Supplemental			GPS Latitude/Longitude	
				Start	End
Item	DWR Erosion Survey			37.920650 °	37.920650 °
				-121.320370 °	-121.320370 °
DWR ID	DWR_RD0524_01_s_2016_103				
Comment Code					
Inspector Comment					
06/24/2015: No significant change observed. 6/19/2014: No significant change observed. 08/13/2013: An irrigation pipe is on site. [2015 Site ID:RD0524U01RM42.84]

View from upstream.

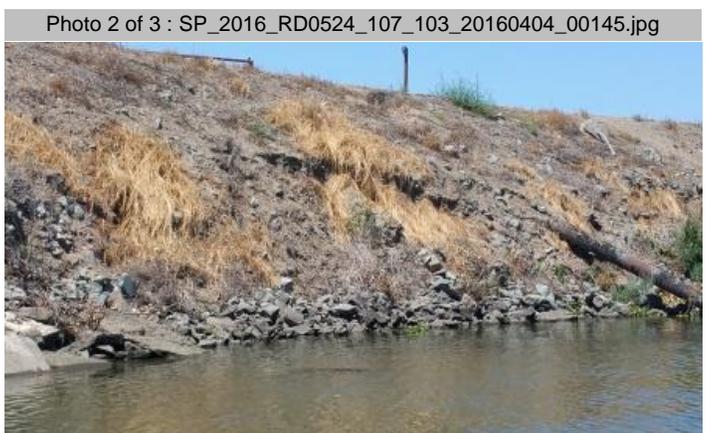
LM Start	<b>2.24</b>	Rating **	U	Issue No.	<b>103 (cont)</b>
LM End	<b>2.27</b>	Issue Type +	Ma	Location *	WS

Close view of the erosion. Note the irrigation pipe.

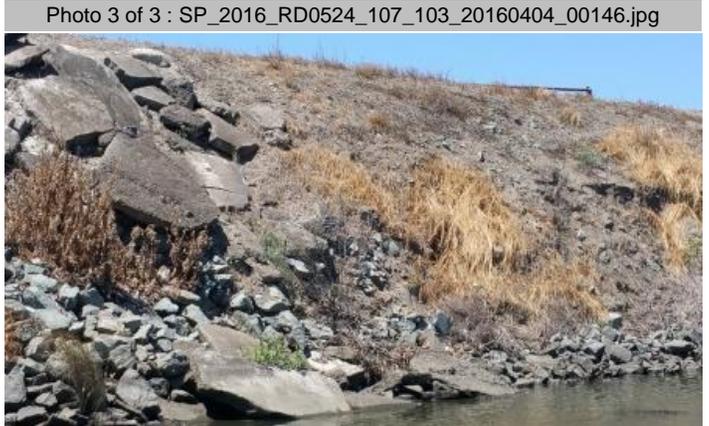
LM Start	<b>2.24</b>	Rating **	U	Issue No.	<b>103 (cont)</b>
LM End	<b>2.27</b>	Issue Type +	Ma	Location *	WS
Category	Supplemental			GPS Latitude/Longitude	
				Start	End
Item	DWR Erosion Survey			37.920650 °	37.920650 °
				-121.320370 °	-121.320370 °
DWR ID	DWR_RD0524_01_s_2016_103				
Comment Code					
Inspector Comment					
06/24/2015: No significant change observed. 6/19/2014: No significant change observed. 08/13/2013: An irrigation pipe is on site. [2015 Site ID:RD0524U01RM42.84]

Close view of the erosion.

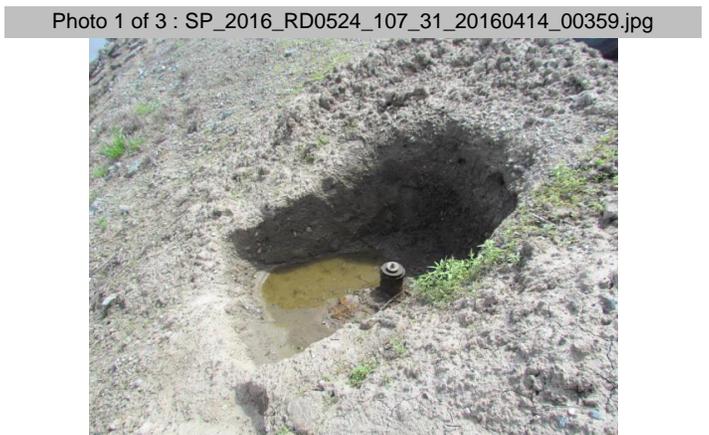
LM Start	<b>2.25</b>	Rating **	U	Issue No.	<b>31</b>
LM End	<b>2.25</b>	Issue Type +	Ma	Location *	WS
Category	Earthen Levee			GPS Latitude/Longitude	
				Start	End
Item	Slope Stability			37.920493 °	37.920493 °
				-121.320565 °	-121.320565 °
DWR ID	DWR_RD0524_01_s_2012_31				
Comment Code					
S1 : Repair slope instability.					
Inspector Comment					
Slope instability probably cause by leak in irrigation pipe. Pipe should be inspected internally.

Looking south at siphon on waterward slope.

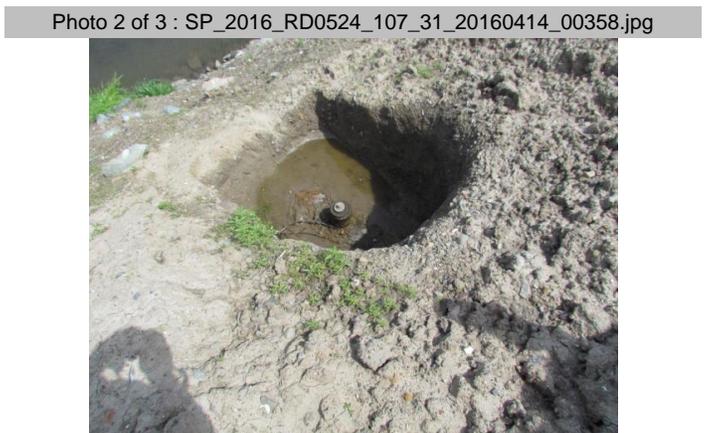
LM Start	<b>2.25</b>	Rating **	U	Issue No.	<b>31 (cont)</b>
LM End	<b>2.25</b>	Issue Type +	Ma	Location *	WS

Looking east at siphon on waterward slope.

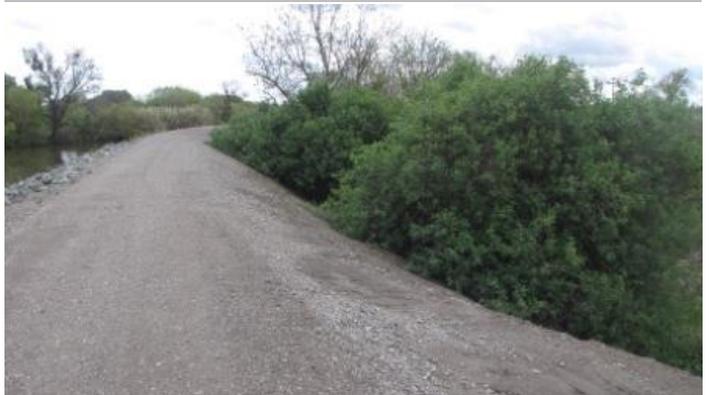
Photo 2 of 2 : SP\_2016\_RD0524\_107\_32\_20160404\_00059.jpg

Looking south at dense veg on landside slope and toe.

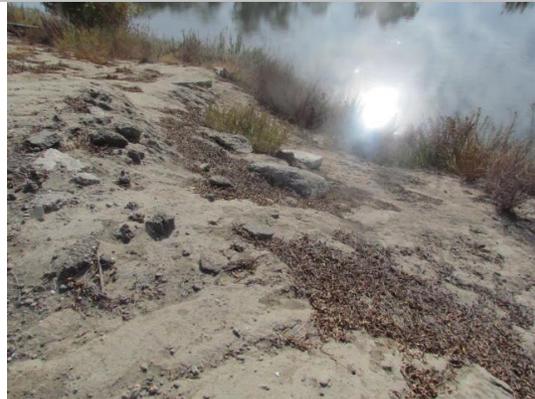
Photo 1 of 1 : SP\_2016\_RD0524\_107\_36\_20160404\_00064.jpg

Looking east at erosion on waterside slope.

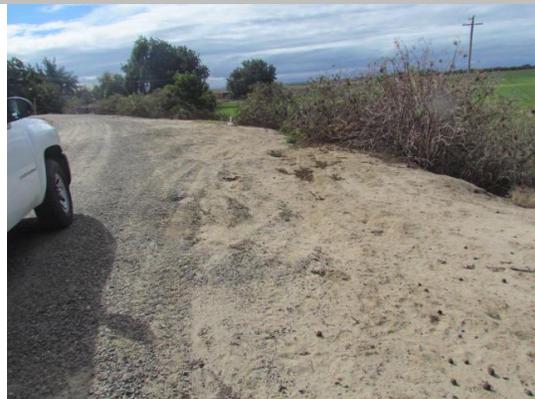
Photo 1 of 1 : SP\_2016\_RD0524\_107\_82\_20160404\_00120.jpg

Looking southwest at damaged landward slope.

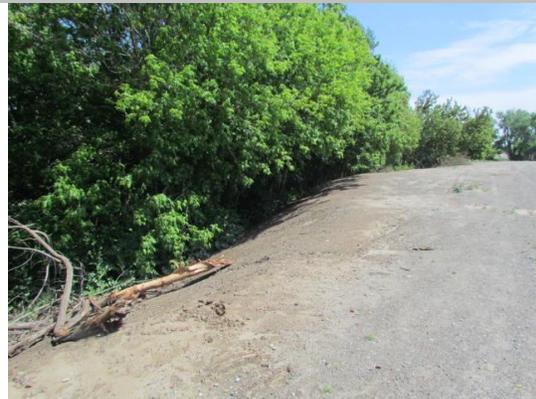
Photo 1 of 1 : SP\_2016\_RD0524\_107\_185\_20160414\_00365.jpg

Looking northwest at untrimmed trees on landward slope and toe.

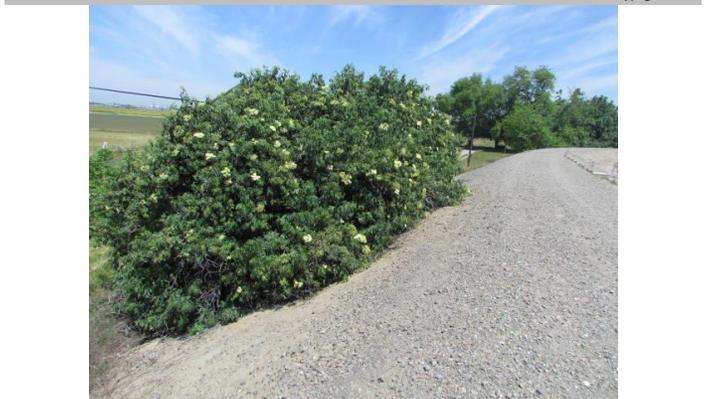
Photo 1 of 1 : SP\_2016\_RD0524\_107\_49\_20160404\_00088.jpg

Looking northwest at elderberry on landside slope.

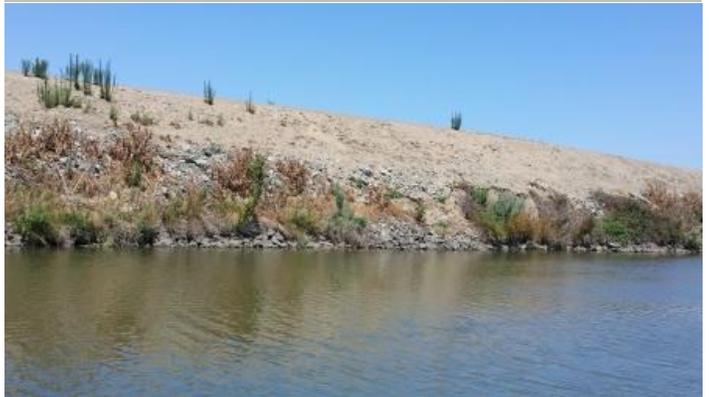
Photo 1 of 1 : SP\_2016\_RD0524\_107\_126\_20160404\_00166.jpg

Front view of the erosion.

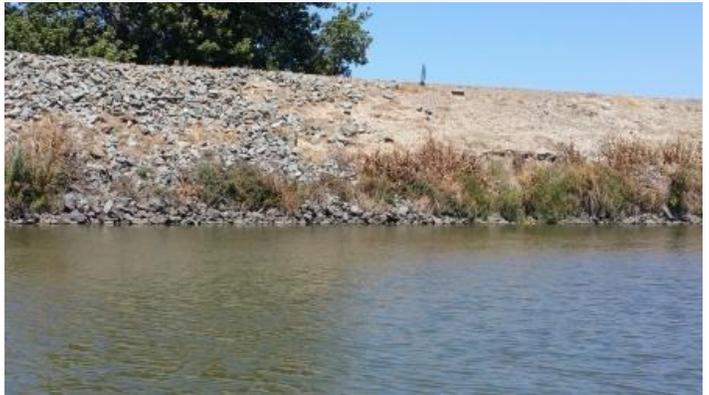
Photo 1 of 2 : SP\_2016\_RD0524\_107\_128\_20160404\_00167.jpg

Front view of the erosion.

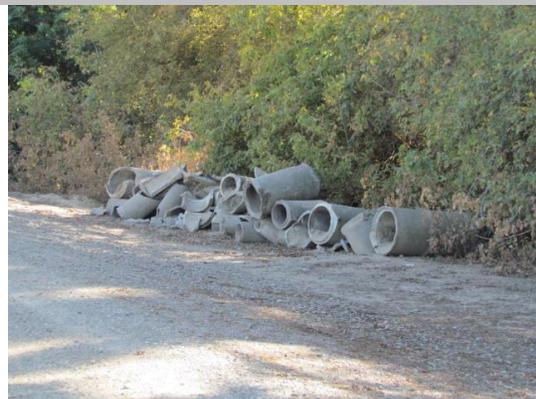
Photo 1 of 1 : SP\_2016\_RD0524\_107\_56\_20160404\_00094.jpg

Looking southwest at concrete pipes on landside toe.

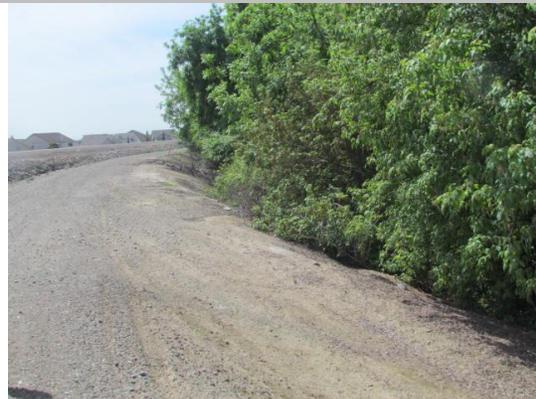
Photo 1 of 1 : SP\_2016\_RD0524\_107\_57\_20160404\_00095.jpg

Looking south at dense trees on landward slope.

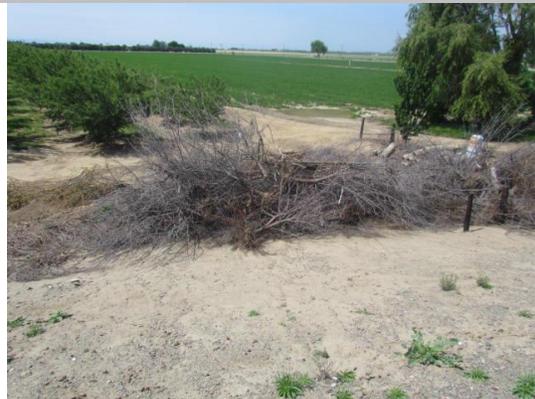
Photo 1 of 1 : SP\_2016\_RD0524\_107\_192\_20160404\_00211.jpg

Looking east at pruning pile at landward toe.

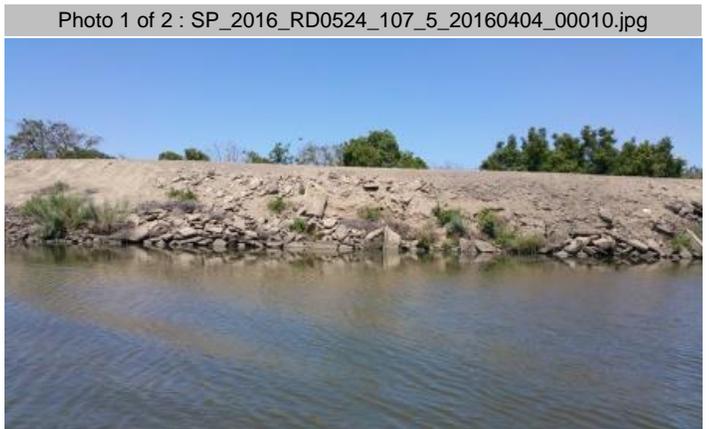
LM Start	<b>4.53</b>	Rating **	U	Issue No.	<b>5</b>
LM End	<b>4.54</b>	Issue Type +	Ma	Location *	WS
Category	Supplemental			GPS Latitude/Longitude	
				Start	End
Item	DWR Erosion Survey			37.892230 °	37.892230 °
				-121.327930 °	-121.327930 °
DWR ID	DWR_RD0524_01_s_2016_5				
Comment Code					
Inspector Comment					
06/24/2015: No significant change observed. 6/19/2014: No significant change observed. 08/13/2013: No significant change observed. 08/07/2012: The erosion is located at the inside of a river bend. Site is covered with broken concrete blocks and other debris. [2015 Site ID:RD0524U01RM45.07]

Front view of the erosion site.

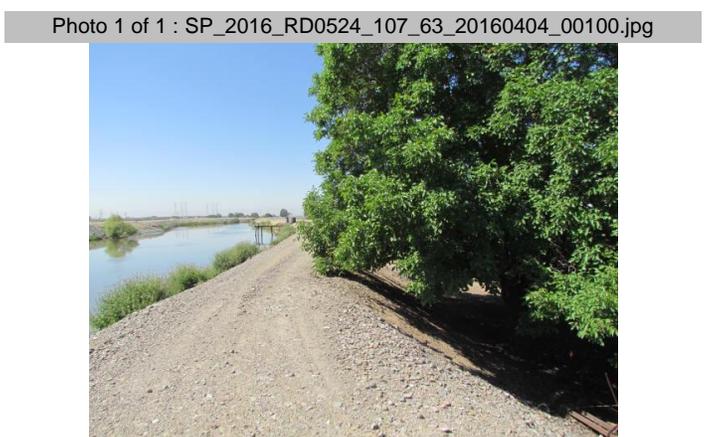
LM Start	<b>4.61</b>	Rating **	U	Issue No.	<b>63</b>
LM End	<b>4.61</b>	Issue Type +	Ma	Location *	LS
Category	Earthen Levee			GPS Latitude/Longitude	
				Start	End
Item	Trim / Thin Trees			37.891285 °	37.891285 °
				-121.328728 °	-121.328728 °
DWR ID	DWR_RD0524_01_s_2012_63				
Comment Code					
T1 : Trim trees to at least five feet above ground level.					
Inspector Comment

Looking south at dense trees on landside slope.

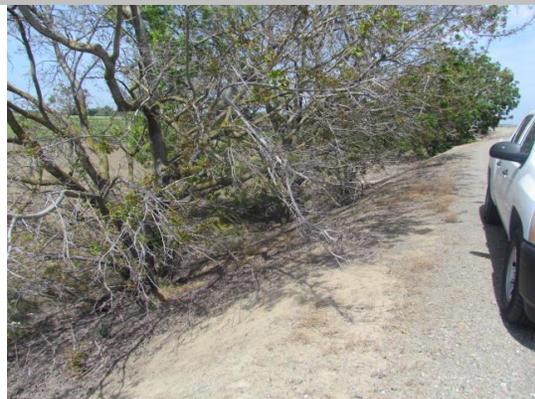
Photo 1 of 1 : SP\_2016\_RD0524\_107\_84\_20160404\_00122.jpg

Looking northeast at untrimmed trees on landward slope.

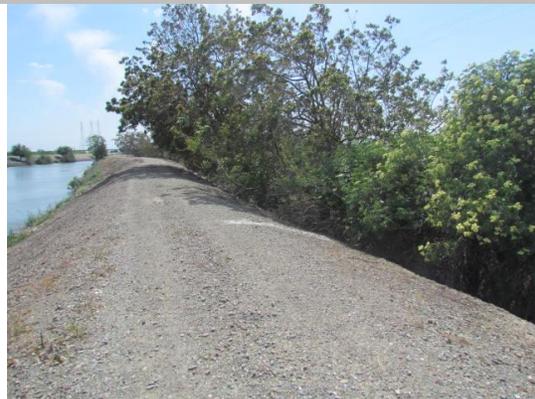
Photo 1 of 1 : SP\_2016\_RD0524\_107\_71\_20160404\_00104.jpg

Looking south at untrimmed trees on landward slope.

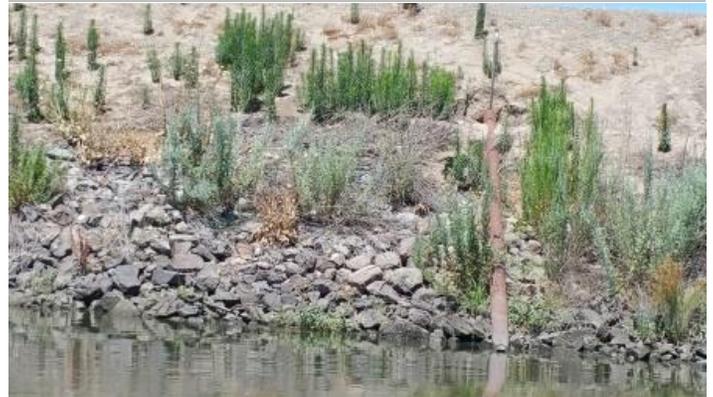
Photo 1 of 2 : SP\_2016\_RD0524\_107\_16\_20160404\_00026.jpg

Close view of the erosion and the pipe.

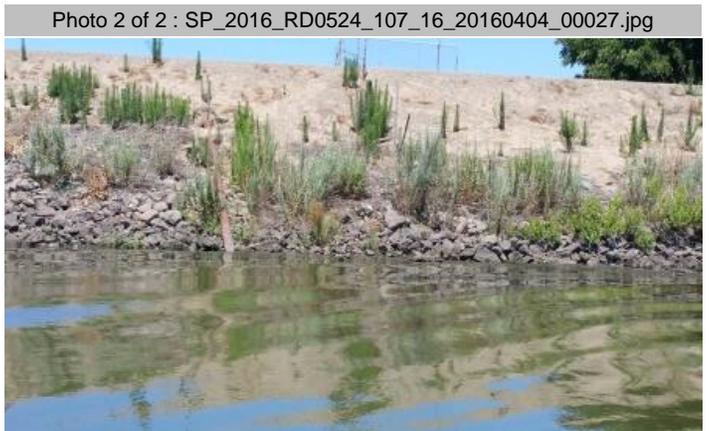
LM Start	<b>5.43</b>	Rating **	U	Issue No.	<b>16 (cont)</b>
LM End	<b>5.43</b>	Issue Type +	Ma	Location *	WS
Category	Supplemental			GPS Latitude/Longitude	
				Start	End
Item	DWR Erosion Survey			37.880320 °	37.880320 °
				-121.333266 °	-121.333266 °
DWR ID	DWR_RD0524_01_s_2016_16				
Comment Code					
Inspector Comment					
06/24/2015: No significant change observed. 6/19/2014: No significant change observed. 08/13/2013: The erosion seems to be getting worse. More material sloughing visible. 08/07/2012: The erosion is underneath an irrigation pipe. The likely cause of the erosion is the pipe leakage. [2015 Site ID:RD0524U01RM45.97]

Front view of the site.

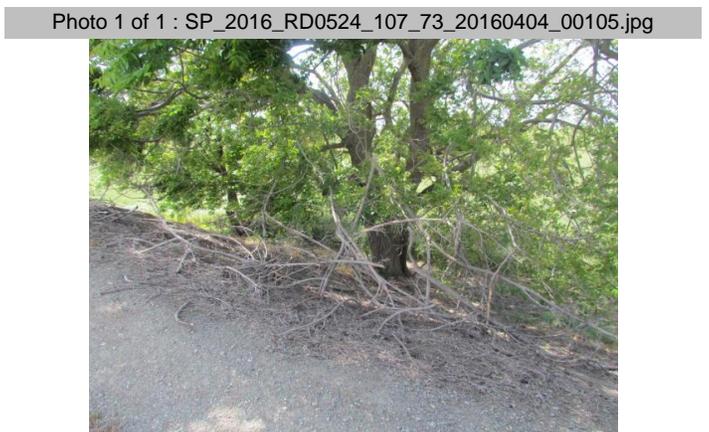
LM Start	<b>5.44</b>	Rating **	U	Issue No.	<b>73</b>
LM End	<b>5.44</b>	Issue Type +	Ma	Location *	LS
Category	Earthen Levee			GPS Latitude/Longitude	
				Start	End
Item	Trim / Thin Trees			37.880085 °	37.880085 °
				-121.333045 °	-121.333045 °
DWR ID	DWR_RD0524_01_s_2012_73				
Comment Code					
T1 : Trim trees to at least five feet above ground level.					
Inspector Comment

Looking east at untrimmed trees on landward slope.

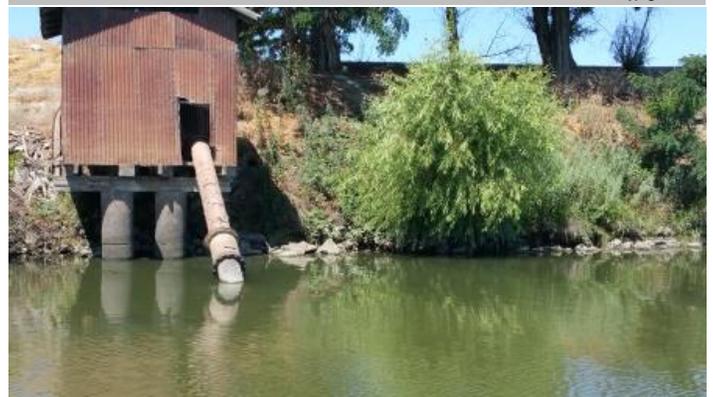
Photo 1 of 2 : SP\_2016\_RD0524\_107\_22\_20160404\_00041.jpg

Front view of the erosion.

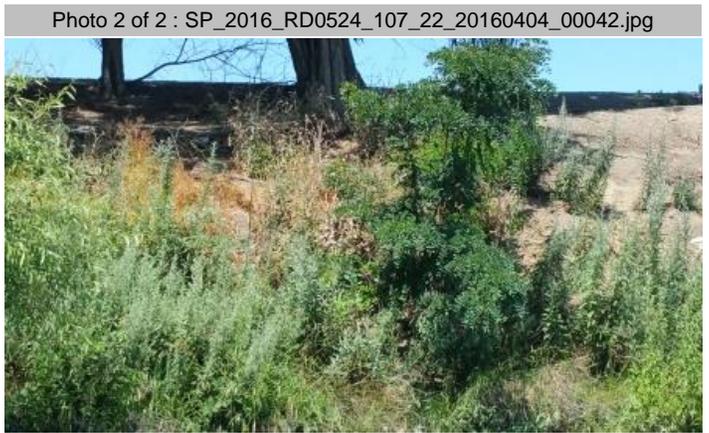
LM Start	<b>5.53</b>	Rating **	M	Issue No.	<b>22 (cont)</b>
LM End	<b>5.53</b>	Issue Type +	Ma	Location *	WS
Category	Supplemental			GPS Latitude/Longitude	
				Start	End
Item	DWR Erosion Survey			37.878920 °	37.878920 °
				-121.332670 °	-121.332670 °
DWR ID	DWR_RD0524_01_s_2016_22				
Comment Code					
Inspector Comment					
06/24/2015: No significant change observed. 6/19/2014: No significant change observed. 08/13/2013: Larger trees are at the levee shoulder, and an irrigation pump station is next to the erosion site. [2015 Site ID:RD0524U01RM46.06]

Close view of the site. Note large trees at the levee shoulder.

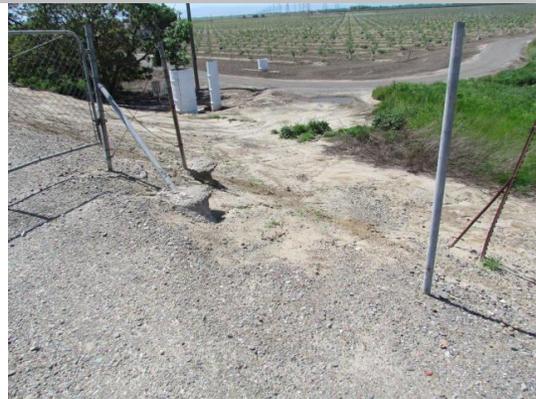
Photo 2 of 3 : SP\_2016\_RD0524\_107\_215\_20160414\_00388.jpg

Looking north at slope damage (ramp) on landward slope.

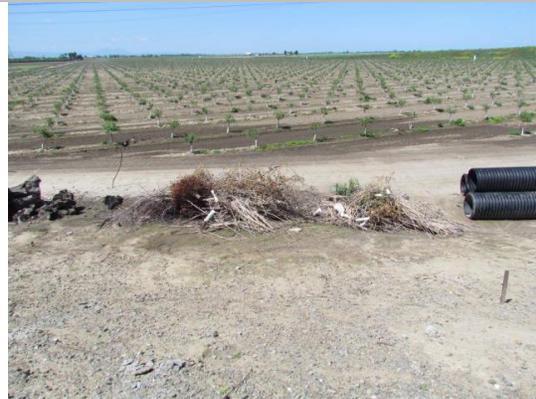
Photo 1 of 1 : SP\_2016\_RD0524\_107\_267\_20160414\_00394.jpg

Looking west at prunings at landward toe.

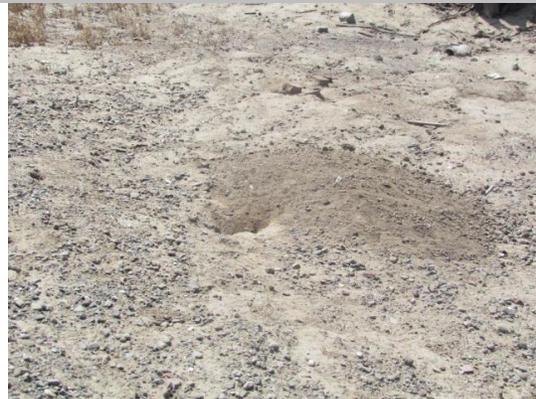
Photo 1 of 2 : SP\_2016\_RD0524\_107\_197\_20160404\_00216.jpg

Looking north at typical view of rodent holes on landward slope.

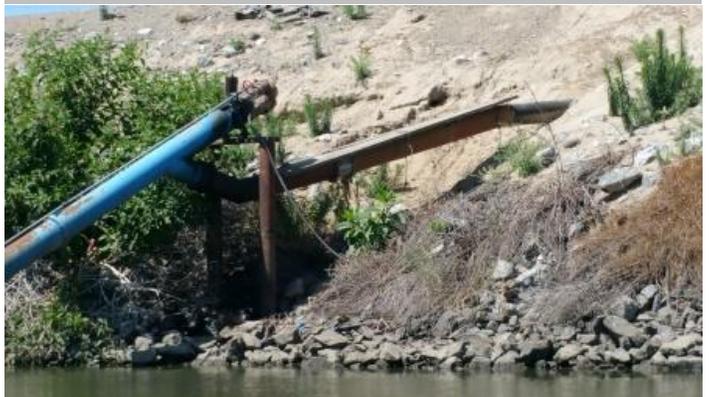
Photo 1 of 2 : SP\_2016\_RD0524\_107\_47\_20160404\_00084.jpg

Close view of the erosion and the pipe.

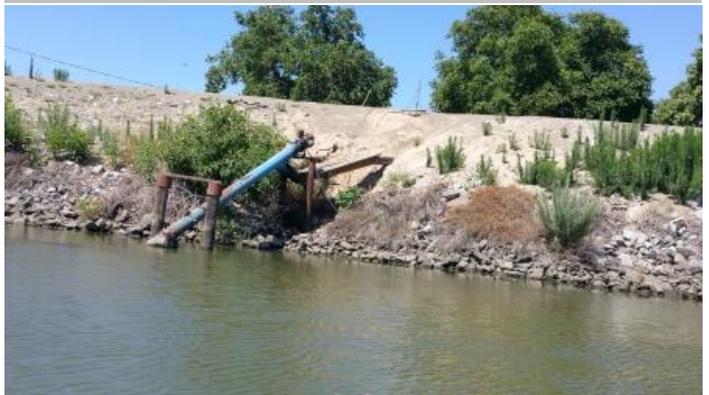
Photo 2 of 2 : SP\_2016\_RD0524\_107\_47\_20160404\_00085.jpg

Front view of the site.

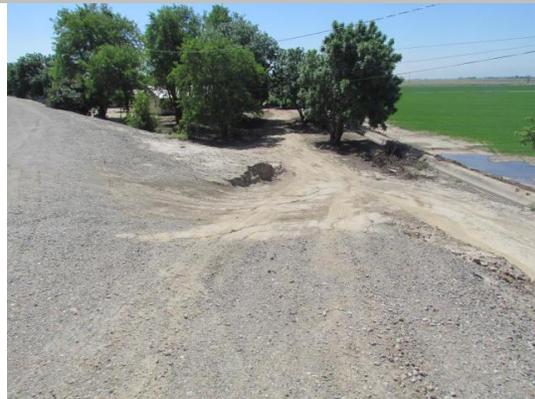
Photo 2 of 2 : SP\_2016\_RD0524\_107\_119\_20160404\_00162.jpg

Looking southwest at damaged slope and ramp on landside slope.

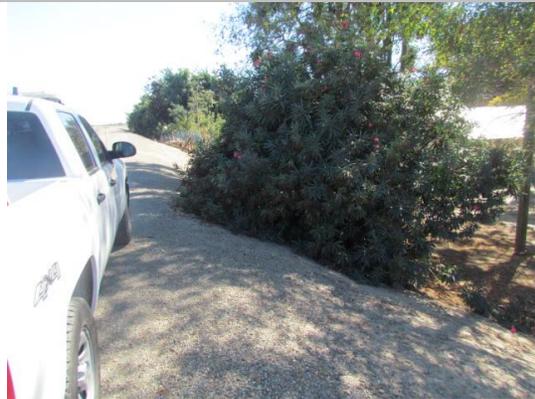
Photo 1 of 1 : SP\_2016\_RD0524\_107\_200\_20160404\_00222.jpg

Looking south at oleander on landward slope fall 2015.

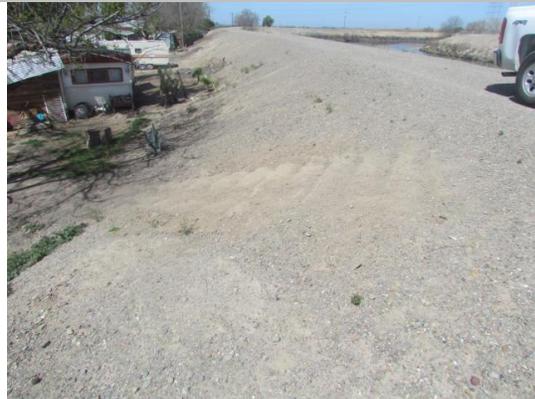
Looking north at steps cut into landward slope.
