**Flood Control Project Maintenance
Levee Inspections**
LMA District Cover Sheet
Spring 2016 Levee Inspection Results

Reclamation District No. 0537 Lovdal

Spring 2016 Levee Inspection Results

Waterway		Bank	Unit Miles
Unit No. 01 Sacramento River		Right	4.74

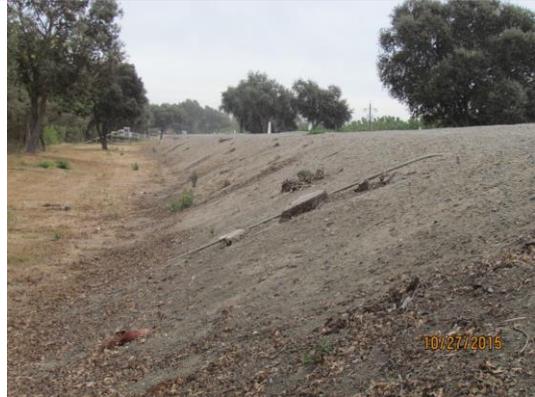
Photo 1 of 1 : SP_2016_RD0537_173_22_20160304_00019.jpg

View of the tree stumps on the waterward side of the levee looking downstream. Fall 2015.

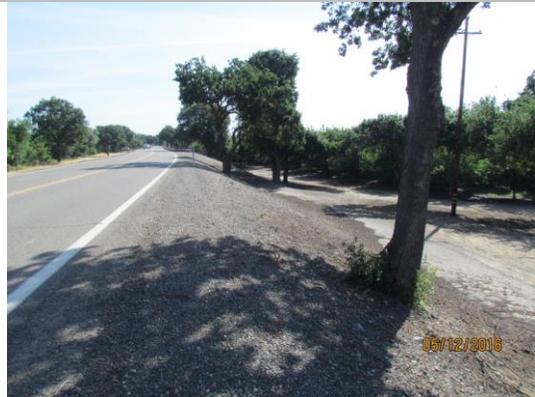
Photo 1 of 1 : SP_2016_RD0537_173_26_20160516_00061.jpg

LM Start	0.03	Rating **	A	Issue No.	26
LM End	0.60	Issue Type +	Ma	Location *	LS
Category	Earthen Levee		GPS Latitude/Longitude		
			Start	End	
Item	Vegetation		38.643246 °	38.647431 °	
			-121.583684 °	-121.575255 °	
DWR ID	DWR_RD0537_01_s_2016_26				
Comment Code					
V1 : Control annual grass and weeds on the levee slopes and easements.					
Inspector Comment					
LMA has maintained levee slopes.

View of the vegetation on the landward side of the levee looking downstream. Spring 2016.

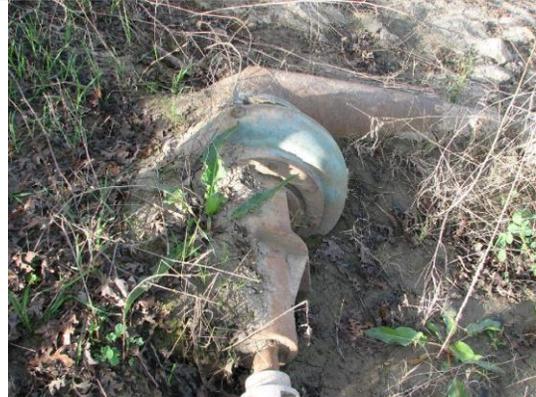
Photo 1 of 2 : UCIP_SP_2016_46165_17140.jpg

Comment Code					
Inspector Comment					
FS_ID:46165 DS_ID:169 EP_NO: N/A Repair Type: Urgent Crossing Status: Found UCIP Comments: Crossing appears abandoned; if so, must be done so properly. Cracking on pavement along pipe alignment. Holes visible on pipe along WS slope. FIELD_STRUCT_DESC: 10-inch steel irrigation pipe thru levee, 18 ft below crown (not 6.7 ft per permit drawing). Pump on WS found. Concrete collar on WS per permit drawing not found. PVC standpipe and valve enclosed by concrete standpipe off LS toe. 1-inch electric conduit thru levee, 3.8 ft below crown (not 2-inch as per LL). Permit No. 558, 1932. FPIIB 2004 Levee Log (at LM 0.04). FS Date: 3/18/2013

WS- an abandoned pump.

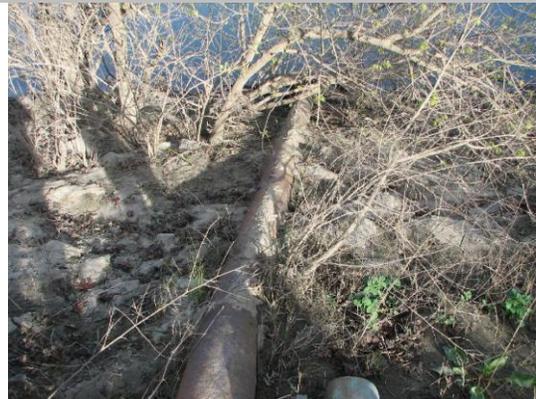
Photo 2 of 2 : UCIP_SP_2016_46165_17141.jpg

WS- abandoned steel pipe.

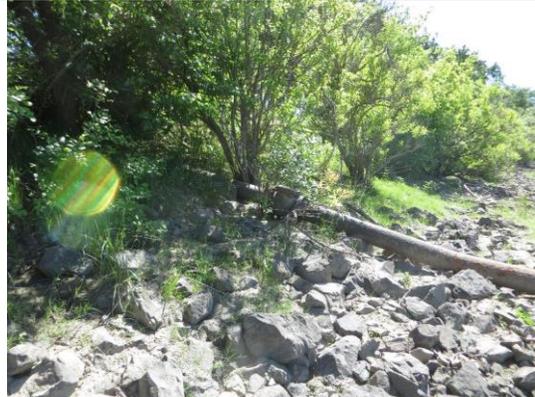
Photo 1 of 2 : UCIP_SP_2016_46803_74402.jpg

LM Start	0.07	Rating **	M	Issue No.	478
LM End	0.07	Issue Type +	En	Location *	LS
Category	Supplemental			GPS Latitude/Longitude	
				Start	End
Item	DWR UCIP Field Study			38.643528 °	38.643528 °
				-121.583193 °	-121.583193 °
DWR ID					
Comment Code					
Inspector Comment					
FS_ID:46803 DS_ID:168 EP_NO: N/A Repair Type: Non-Urgent Crossing Status: Found UCIP Comments: Crossing appears abandoned; if so, must be done so properly. FIELD_STRUCT_DESC: 10-inch steel irrigation pipe, 3.8 FBC. Pump gone. Concrete pump pad on WS bank not found. 36-inch concrete standpipe off LS toe. 2-inch electric conduit not found (1-inch electric line found for 10-inch pipe located 50 ft upstream). Plate bolted on WW end of pipe. FPIIB 2004 Levee Logs. FS Date: 4/29/2015

Pipe visible along WS slope.

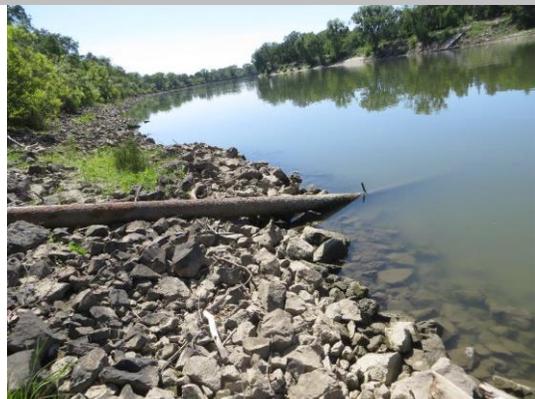
Photo 2 of 2 : UCIP_SP_2016_46803_74403.jpg

View of pipe into water.

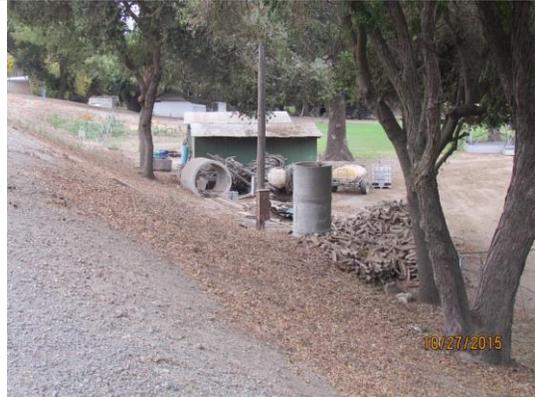
Photo 1 of 2 : SP_2016_RD0537_173_47_20160304_00022.jpg

Perspective view of more firewood at the toe of the levee on the landward side looking downstream. Fall 2015.

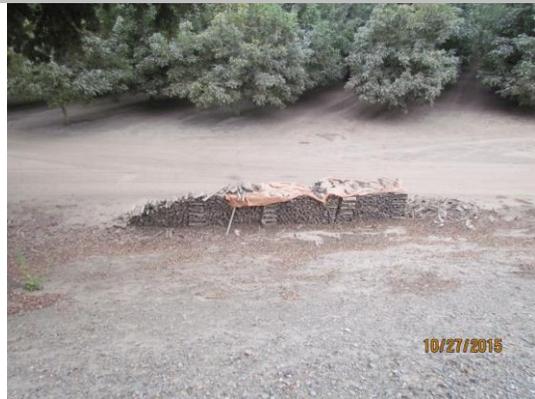
Photo 2 of 2 : SP_2016_RD0537_173_47_20160304_00023.jpg

View of the firewood pile at the toe of the levee on the landward side. Fall 2015.

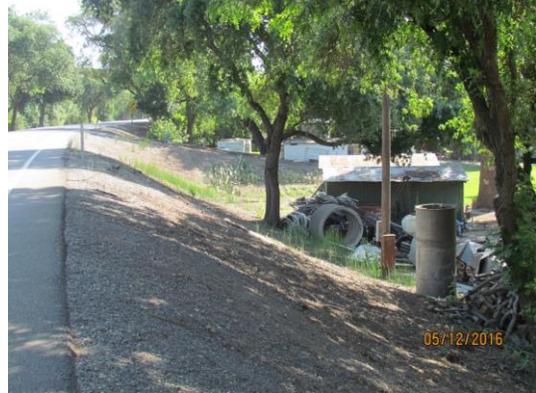
Photo 1 of 1 : SP_2016_RD0537_173_6_20160516_00062.jpg

View of the equipment at the toe of the levee looking downstream. Spring 2016.

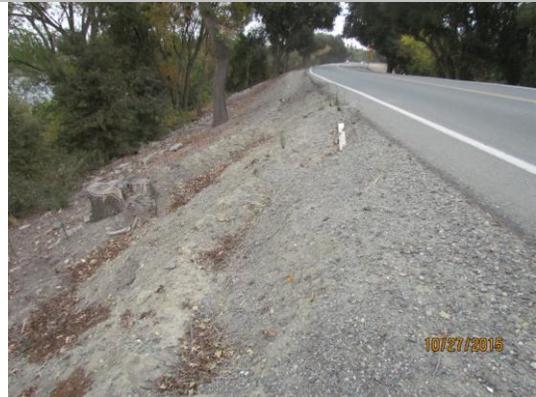
Photo 1 of 1 : SP_2016_RD0537_173_21_20160304_00018.jpg

LM Start	0.40	Rating **	M	Issue No.	21
LM End	0.40	Issue Type +	Ma	Location *	WS
Category	Earthen Levee		GPS Latitude/Longitude		
			Start	End	
Item	Slope Stability		38.646696 °	38.646696 °	
			-121.578418 °	-121.578418 °	
DWR ID	DWR_RD0537_01_f_2015_21				
Comment Code					
S3 : Repair the levee slope damaged by vehicle traffic and prevent access where possible.					
Inspector Comment

View of the slope stability on the waterward side of the levee looking downstream. Fall 2015.

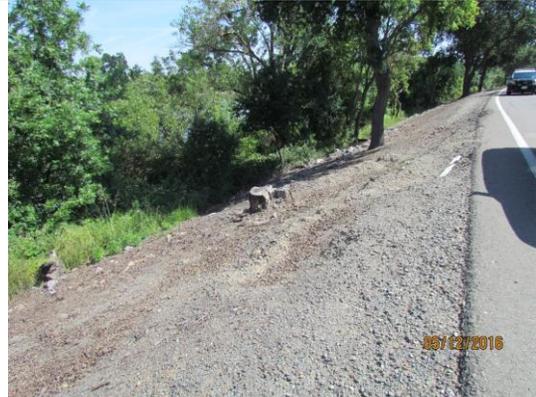
Photo 1 of 1 : SP_2016_RD0537_173_31_20160516_00076.jpg

LM Start	0.42	Rating **	M	Issue No.	31
LM End	0.42	Issue Type +	Ma	Location *	WS
Category	Earthen Levee		GPS Latitude/Longitude		
			Start	End	
Item	Slope Stability		38.646811 °	38.646811 °	
			-121.578241 °	-121.578241 °	
DWR ID	DWR_RD0537_01_s_2016_31				
Comment Code					
S3 : Repair the levee slope damaged by vehicle traffic and prevent access where possible.					
Inspector Comment

View of the slope stability near the shoulder of the waterward side of the levee looking downstream. Spring 2016.

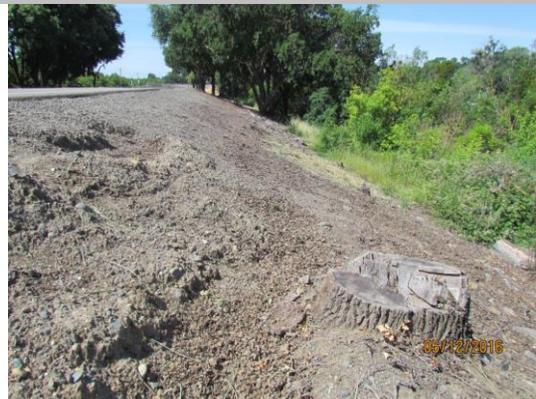
Photo 1 of 1 : SP_2016_RD0537_173_32_20160516_00077.jpg

LM Start	0.42	Rating **	N	Issue No.	32
LM End	0.42	Issue Type +	Ma	Location *	WS
Category	Earthen Levee		GPS Latitude/Longitude		
			Start	End	
Item	Trim / Thin Trees		38.646811 °	38.646811 °	
			-121.578241 °	-121.578241 °	
DWR ID	DWR_RD0537_01_s_2016_32				
Comment Code					
T5 : Tree stumps.					
Inspector Comment

View of the tree stump on the waterward side of the levee looking downstream. Spring 2016.

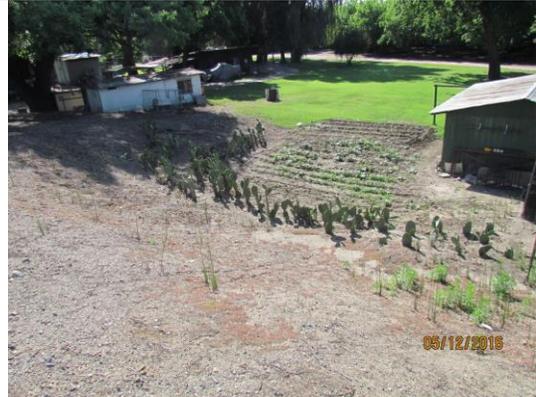
Photo 1 of 2 : SP_2016_RD0537_173_18_20160516_00063.jpg

View of the cactus at the toe of the levee. Spring 2016.

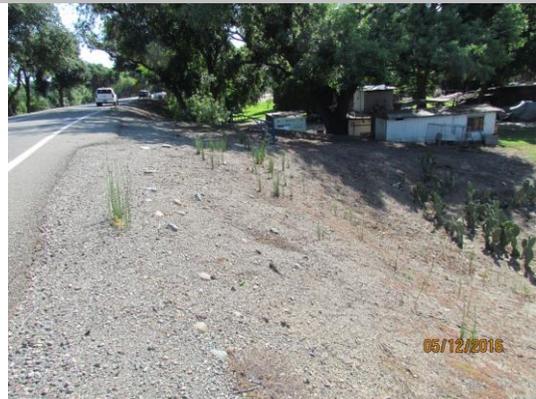
Photo 2 of 2 : SP_2016_RD0537_173_18_20160516_00064.jpg

Perspective view of the landscaping on the landward side of the levee looking downstream. Spring 2016.

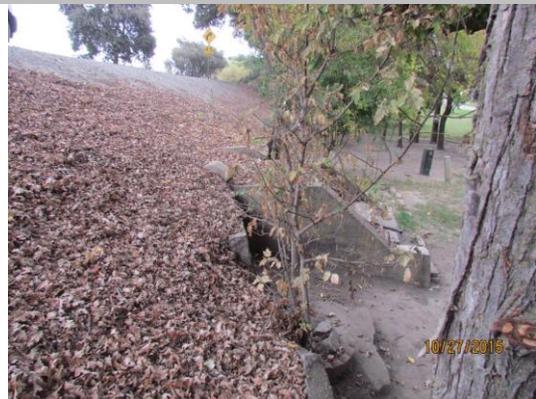
Photo 1 of 2 : SP_2016_RD0537_173_50_20160304_00026.jpg

LM Start	0.44	Rating **	M	Issue No.	50
LM End	0.44	Issue Type +	Ma	Location *	LS
Category	Earthen Levee		GPS Latitude/Longitude		
			Start	End	
Item	Slope Stability		38.647005 °	38.647005 °	
			-121.577813 °	-121.577813 °	
DWR ID	DWR_RD0537_01_s_2012_50				
Comment Code					
S1 : Repair slope instability.					
Inspector Comment

View of the retaining wall at the levee toe on the landward side of the levee looking downstream. The wall is partially broken. Fall 2015.

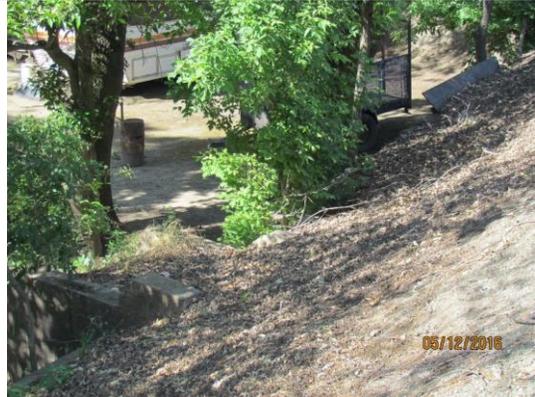
Photo 2 of 2 : SP_2016_RD0537_173_50_20160516_00065.jpg

LM Start	0.44	Rating **	M	Issue No.	50 (cont)
LM End	0.44	Issue Type +	Ma	Location *	LS
Category	Earthen Levee			GPS Latitude/Longitude	
				Start	End
Item	Slope Stability			38.647005 °	38.647005 °
				-121.577813 °	-121.577813 °
DWR ID	DWR_RD0537_01_s_2012_50				
Comment Code					
S1 : Repair slope instability.					
Inspector Comment

View of the retaining wall at the toe of the levee on the landward side. Spring 2016.

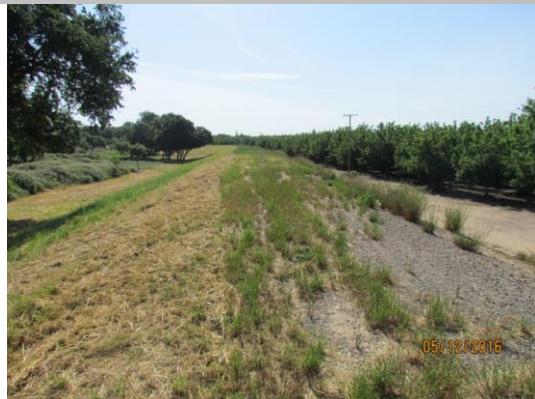
Photo 1 of 1 : SP_2016_RD0537_173_471_20160516_00066.jpg

LM Start	0.56	Rating **	M	Issue No.	471
LM End	0.59	Issue Type +	Ma	Location *	CR
Category	Earthen Levee			GPS Latitude/Longitude	
				Start	End
Item	Crown Surface / Depressions / Rutting			38.647589 °	38.647462 °
				-121.575844 °	-121.575348 °
DWR ID	DWR_RD0537_01_s_2015_471				
Comment Code					
C3 : Add appropriate gravel or road base. Grade and compact.					
Inspector Comment

View of the crown of the levee looking downstream. Spring 2016.

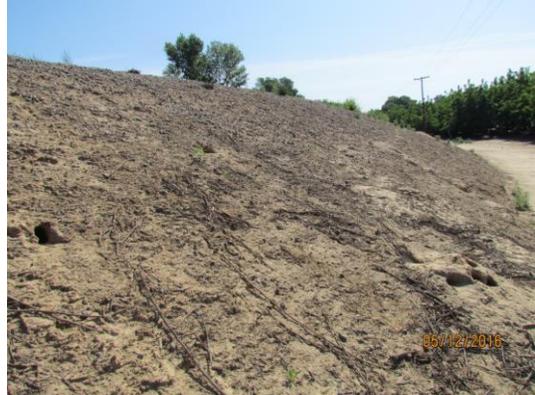
Photo 1 of 1 : SP_2016_RD0537_173_27_20160516_00067.jpg

View of the rodent holes on the landward side of the levee looking downstream. Spring 2016.

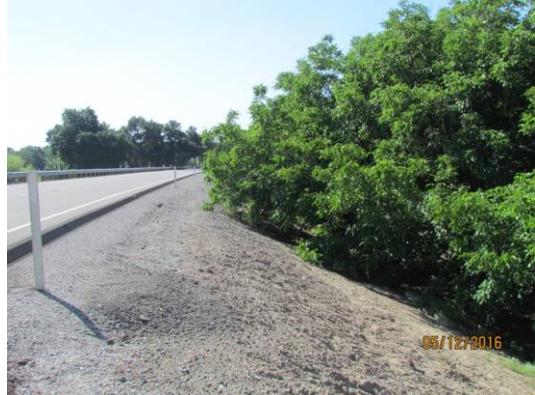
Photo 1 of 1 : SP_2016_RD0537_173_28_20160516_00072.jpg

LM Start	1.05	Rating **	M	Issue No.	28
LM End	1.08	Issue Type +	Ma	Location *	LS
Category	Earthen Levee		GPS Latitude/Longitude		
			Start	End	
Item	Trim / Thin Trees		38.644973 °	38.644686 °	
			-121.568153 °	-121.567903 °	
DWR ID	DWR_RD0537_01_s_2016_28				
Comment Code					
T1 : Trim trees to at least five feet above ground level.					
Inspector Comment

View of the trees on the landward side of the levee looking downstream. Spring 2016.

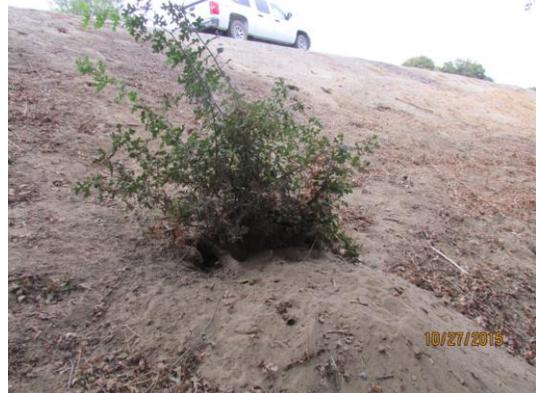
Photo 1 of 2 : SP_2016_RD0537_173_40_20160304_00020.jpg

View of the rodent holes on the landward side of the levee looking down. Fall 2015.

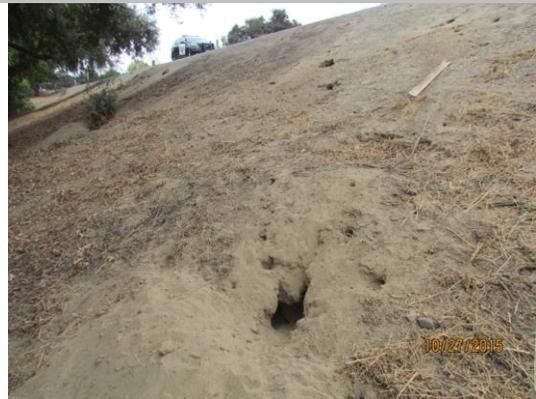
Photo 2 of 2 : SP_2016_RD0537_173_40_20160304_00021.jpg

View of the rodent holes on the landward side of the levee looking upstream. There are more than 2 cubic feet of material from the hole. Fall 2015.

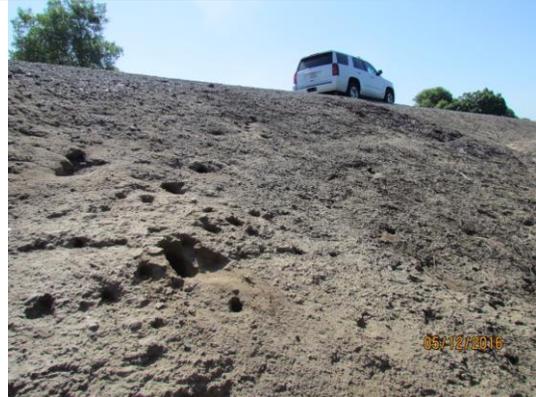
Photo 1 of 1 : SP_2016_RD0537_173_29_20160516_00073.jpg

View of the rodent holes on the landward side of the levee looking downstream. Spring 2016.

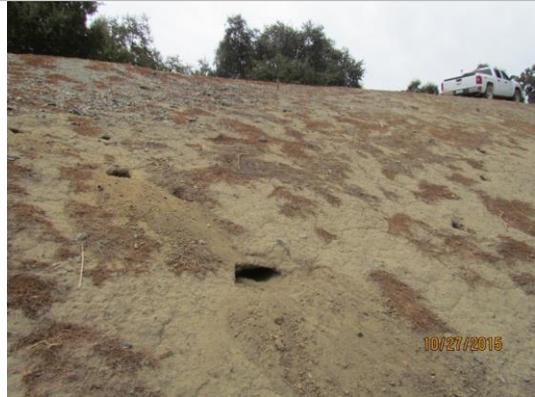
Photo 1 of 1 : SP_2016_RD0537_173_7_20160304_00006.jpg

View of the rodent hole on the landward side of the levee. Fall 2015.

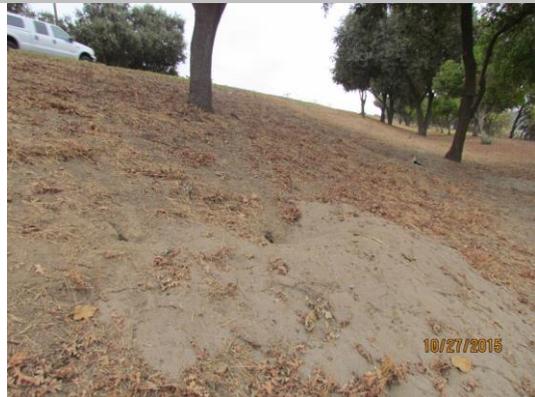
Photo 1 of 1 : SP_2016_RD0537_173_17_20160304_00015.jpg

View of the rodent hole on the waterward side of the levee looking upstream. There are more than 2 cubic feet of material next to the hole. Fall 2015.

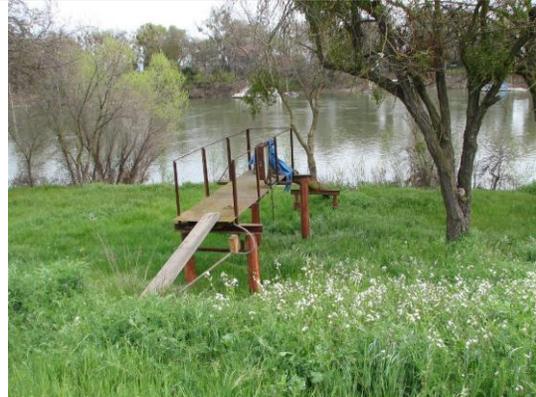
Photo 1 of 2 : UCIP_SP_2016_46035_17008.jpg

LM Start	2.72	Rating **	M	Issue No.	480
LM End	2.72	Issue Type +	En	Location *	WS
Category	Supplemental			GPS Latitude/Longitude	
				Start	End
Item	DWR UCIP Field Study			38.621437 °	38.621437 °
				-121.563373 °	-121.563373 °
DWR ID					
Comment Code					
Inspector Comment					
FS_ID:46035 DS_ID:178 EP_NO: N/A Repair Type: Non-Urgent Crossing Status: Found UCIP Comments: Wasted pipe and valve not visible due to vegetation. FIELD_STRUCT_DESC: 12-inch pipe through the levee, 4.5 feet below the crown. Slant pump column on the waterward bank. Timber walkway (not found) mounted on pile structure across the berm. Siphon breaker in CM pipe riser on the landward slope. Concrete standpipe on the landward side. 6-inch wasted pipe down bank, gate valve on waste line. A 2" electrical conduit through the levee. FS Date: 3/18/2013

WS- overview of pump, pipe and steel structure structure.

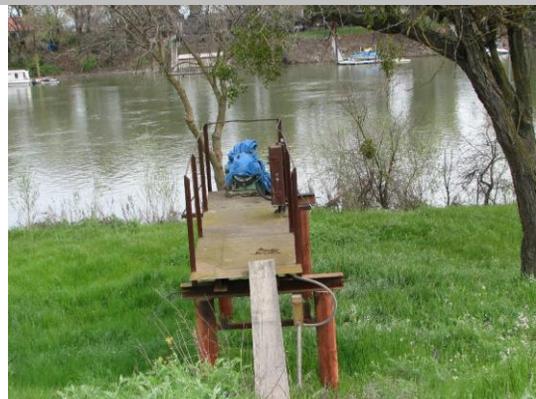
Photo 2 of 2 : UCIP_SP_2016_46035_17007.jpg

WS- closer view of pump, pipe and steel structure.

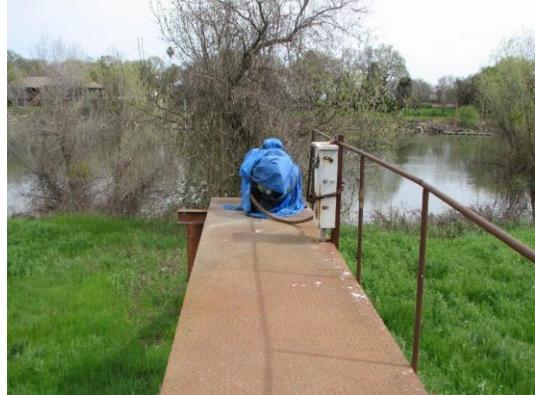
Photo 1 of 2 : UCIP_SP_2016_46037_17027.jpg

LM Start	2.84	Rating **	M	Issue No.	481
LM End	2.84	Issue Type +	En	Location *	WS
Category	Supplemental			GPS Latitude/Longitude	
				Start	End
Item	DWR UCIP Field Study			38.619674 °	38.619674 °
				-121.563330 °	-121.563330 °
DWR ID					
Comment Code					
Inspector Comment					
FS_ID:46037 DS_ID:179 EP_NO: N/A Repair Type: Non-Urgent Crossing Status: Found UCIP Comments: A 6-inch wasted pipe down bank, gate valve on waste line- not visible due to the vegetation. FIELD_STRUCT_DESC: 12-inch pipe through the levee, 7.0 feet below the crown. Slant pump column on the bank. Steel walkway mounted on pile structure across the berm to pump. Burried siphon breaker in CM pipe riser on the landward slope. Concrete standpipe not found on LS but a shallow CM standpipe found on cultivated field. FS Date: 3/18/2013

WS- overview of slanted pump on steel structure.

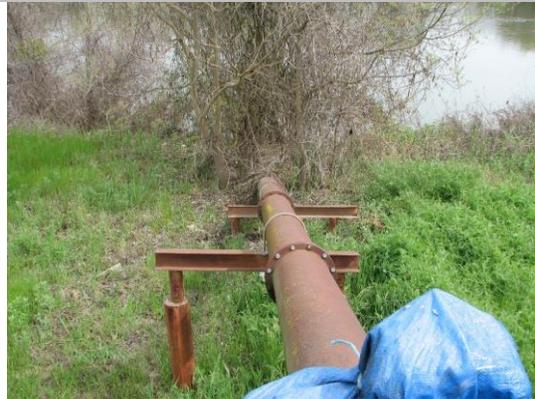
Photo 2 of 2 : UCIP_SP_2016_46037_17026.jpg

WS- slanted pump and pipe on steel structure.

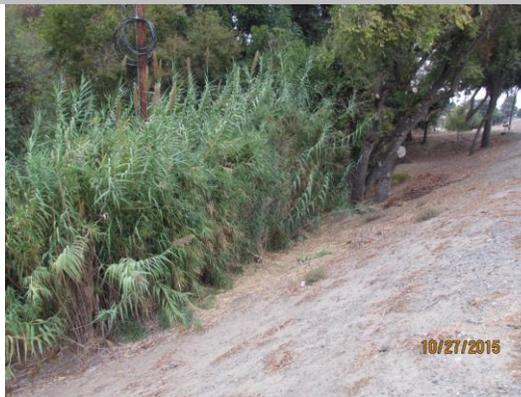
Photo 1 of 1 : SP_2016_RD0537_173_3_20160304_00002.jpg

View of the arundo at the levee toe on the landward side of the levee looking upstream. Fall 2015.

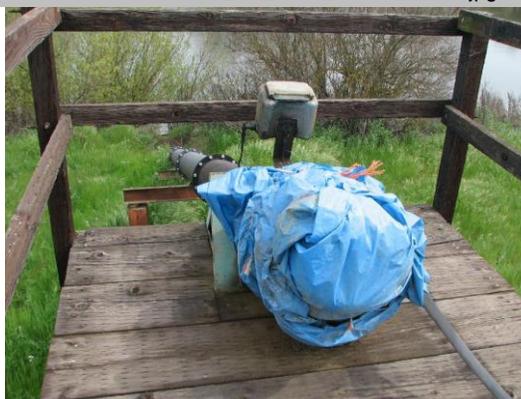
Photo 1 of 2 : UCIP_SP_2016_46806_17038.jpg

LM Start	2.93	Rating **	M	Issue No.	479
LM End	2.93	Issue Type +	En	Location *	LS
Category	Supplemental			GPS Latitude/Longitude	
				Start	End
Item	DWR UCIP Field Study			38.618334 °	38.618334 °
				-121.563318 °	-121.563318 °
DWR ID					
Comment Code					
Inspector Comment					
FS_ID:46806 DS_ID:180 EP_NO: 4656 Repair Type: Non-Urgent Crossing Status: Found UCIP Comments: Broken gate valve handle on waste pipe. FIELD_STRUCT_DESC: 12-inch irrigation pipe through the levee, 7.0 feet below the crown. Slant pump column on the bank. Timber walkway mounted on pile structure across the berm to pump. Siphon breaker on CM pipe riser on the landward slope. Concrete pipe riser on the landward side. A waste pipe down bank. Gate valve on waste line. (Permit No. 4656) FS Date: 3/18/2013

WS- slanted pipe and pump on timber structure.

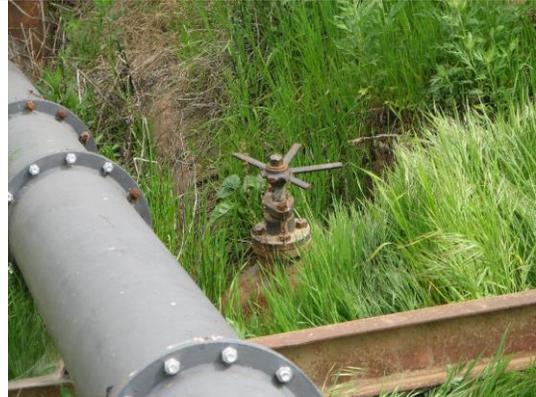
Photo 2 of 2 : UCIP_SP_2016_46806_17037.jpg

WS- main pipe and waste pipe with gate valve

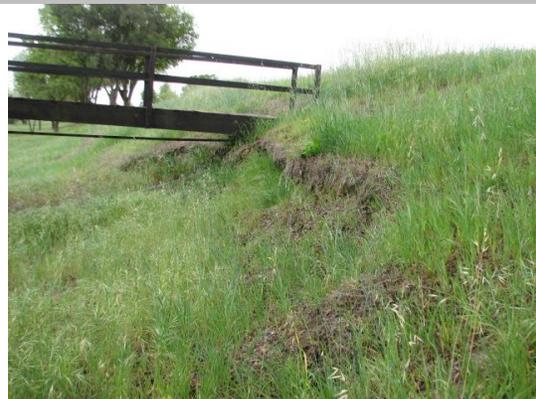
Photo 1 of 3 : SP_2016_RD0537_173_264_20160304_00028.jpg

LM Start	3.06	Rating **	M	Issue No.	264
LM End	3.06	Issue Type +	Ma	Location *	WS
Category	Earthen Levee			GPS Latitude/Longitude	
				Start	End
Item	Erosion / Bank Caving			38.616504 °	38.616504 °
				-121.563270 °	-121.563270 °
DWR ID	DWR_RD0537_01_s_2014_264				
Comment Code					
E2 : Schedule repair of erosion site prior to the next inspection.					
Inspector Comment					
The previous erosions from Spring 2014 are corrected, however, there is erosion under the gangway.

Erosion cut 20 feet from the other one. Erosion 2-3 feet deep. Spring 2014

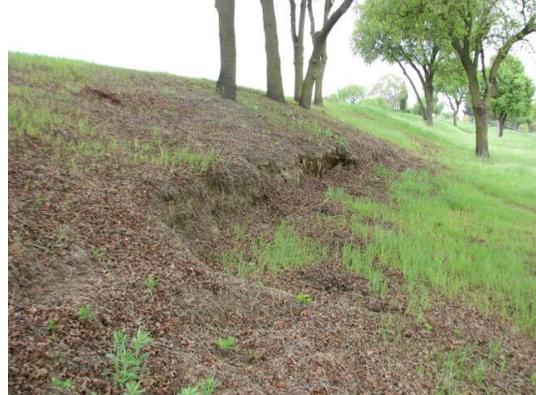
Photo 2 of 3 : SP_2016_RD0537_173_264_20160304_00029.jpg

Erosion cut in levee slope 2-3 feet deep. Spring 2014

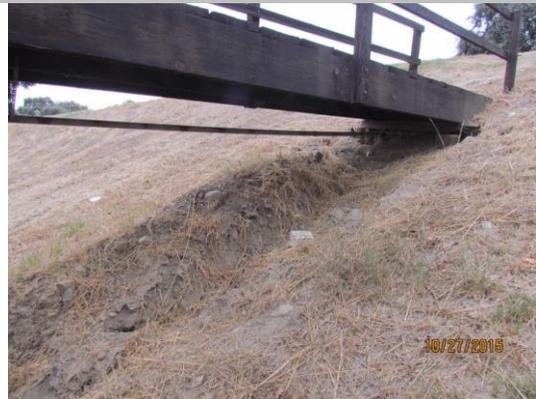
Photo 3 of 3 : SP_2016_RD0537_173_264_20160304_00030.jpg

There is erosion under the gangway on the waterward side of the levee looking downstream. Fall 2015.

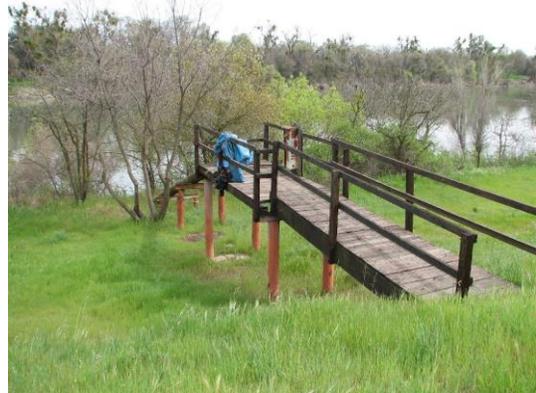
Photo 1 of 2 : UCIP_SP_2016_46041_17171.jpg

LM Start	3.06	Rating **	M	Issue No.	477
LM End	3.06	Issue Type +	En	Location *	WS
Category	Supplemental			GPS Latitude/Longitude	
				Start	End
Item	DWR UCIP Field Study			38.616413 °	38.616413 °
				-121.563205 °	-121.563205 °
DWR ID					
Comment Code					
Inspector Comment					
FS_ID:46041 DS_ID:181 EP_NO: N/A Repair Type: Non-Urgent Crossing Status: Found UCIP Comments: Obstructed siphon breaker. FIELD_STRUCT_DESC: 12-inch steel irrigation pipe through the levee, 7.0 feet below the crown. Slant pump column on the bank. Timber walkway mounted on pile structure across the berm to pump. Siphon breaker in CM pipe riser on the landward slope. Concrete standpipe on the landward side. 6-inch waste pipe down bank, gate valve on waste line. FS Date: 3/18/2013

WS- overview of slanted pipe and pump on steel pile structure

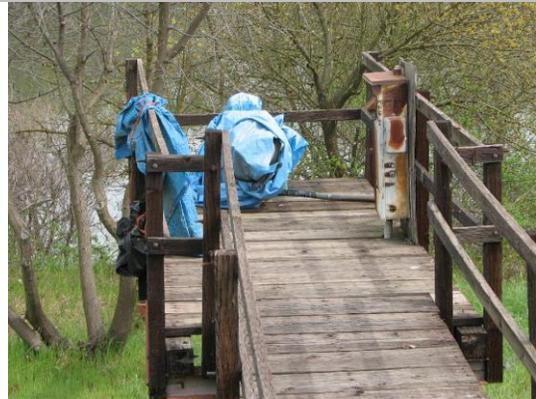
Photo 2 of 2 : UCIP_SP_2016_46041_17170.jpg

WS- covered slanted pump on timber platform.

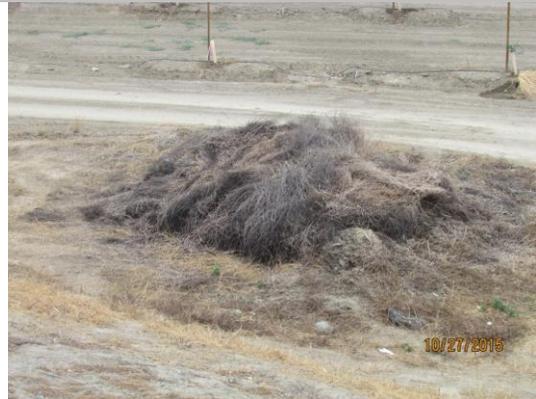
Photo 1 of 1 : SP_2016_RD0537_173_9_20160304_00009.jpg

View of the prunings at the levee toe on the landward side of the levee. Fall 2015.

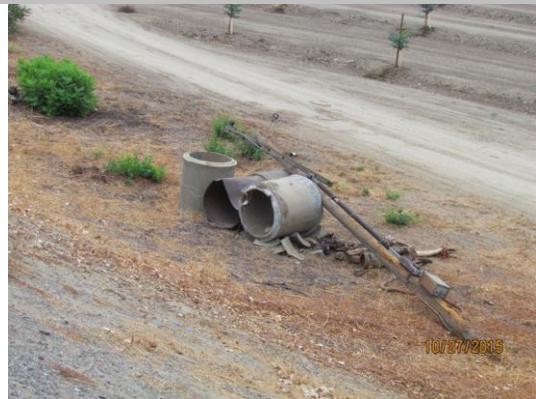
Photo 1 of 1 : SP_2016_RD0537_173_14_20160304_00010.jpg

View of concrete debris and a utility pole on the landward side of the levee. Fall 2015.

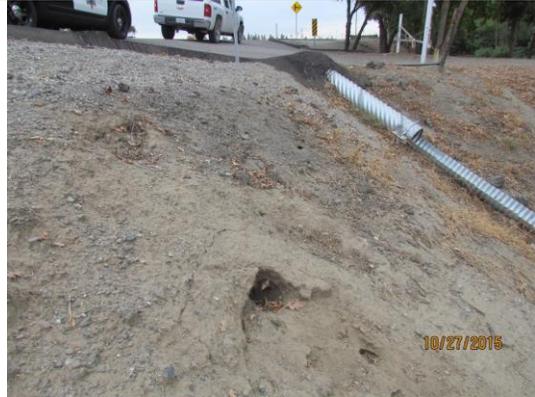
Photo 1 of 3 : SP_2016_RD0537_173_15_20160304_00011.jpg

View of the rodent hole on the landward side of the levee looking downstream. Fall 2015.

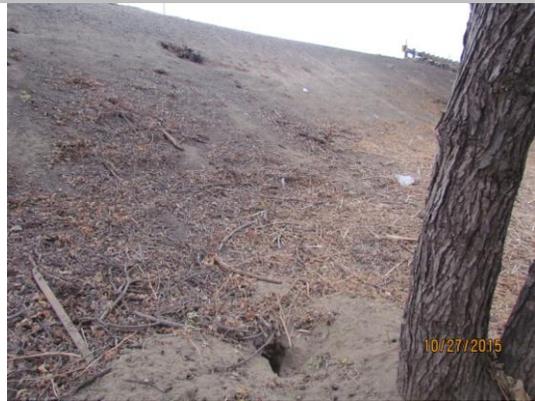
Photo 2 of 3 : SP_2016_RD0537_173_15_20160304_00012.jpg

More rodent holes a little further upstream. Fall 2015.

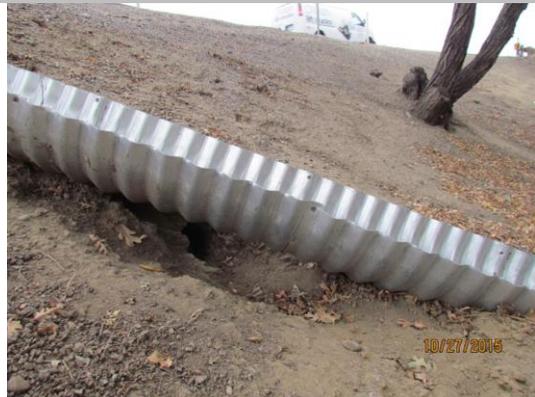
Photo 3 of 3 : SP_2016_RD0537_173_15_20160304_00013.jpg

There is a rodent hole under the pipe spill way. Fall 2015.

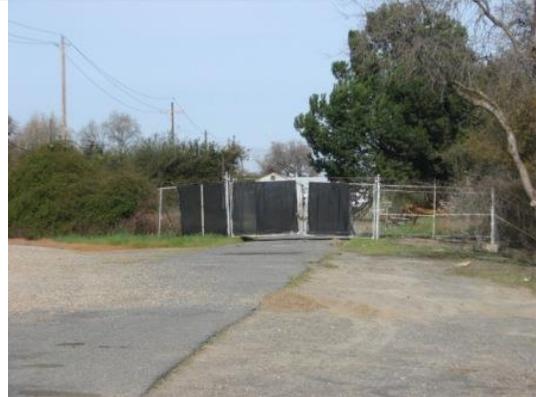
Photo 1 of 2 : SP_2016_RD0537_173_8_20160304_00007.jpg

Abandoned building and fence on the levee crown. Spring 2013

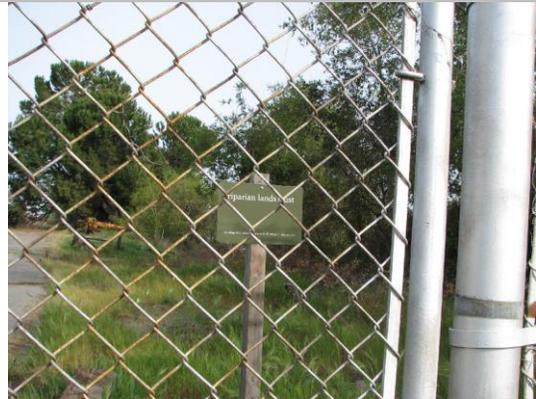
Photo 1 of 2 : UCIP_SP_2016_45026_17073.jpg

LM Start	4.24	Rating **	M	Issue No.	483
LM End	4.24	Issue Type +	En	Location *	WS
Category	Supplemental			GPS Latitude/Longitude	
				Start	End
Item	DWR UCIP Field Study			38.601384 °	38.601384 °
				-121.554099 °	-121.554099 °
DWR ID					
Comment Code					
Inspector Comment					
FS_ID:45026 DS_ID:171 EP_NO: N/A Repair Type: Non-Urgent Crossing Status: Indicator Found UCIP Comments: Appears abandoned and if so should be done so properly. FIELD_STRUCT_DESC: 12-inch pipe off WS slope on concrete platform. FS Date: 4/28/2015

Riparian Lands Trust- no access through gate.

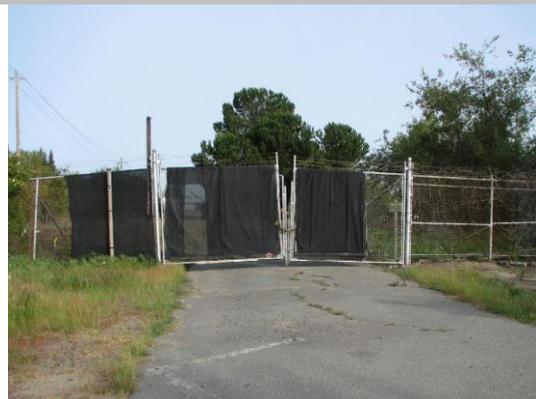
Photo 2 of 2 : UCIP_SP_2016_45026_17072.jpg

No access through gate. Area behind gated area along WS slope accessible.

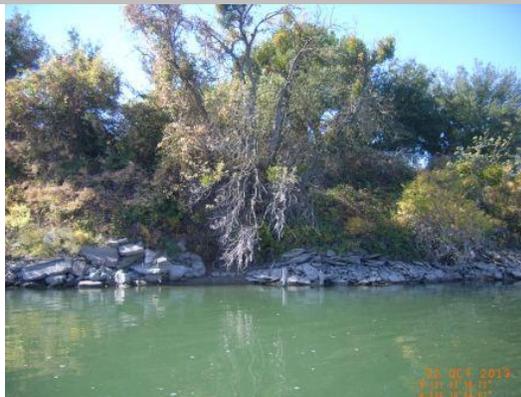
Photo 1 of 1 : SP_2016_RD0537_173_1_20160304_00001.jpg

LM Start	4.27	Rating **	M	Issue No.	1
LM End	4.32	Issue Type +	Ma	Location *	WS
Category	Supplemental			GPS Latitude/Longitude	
				Start	End
Item	2015 USACE Erosion Survey, DRAFT			38.601388 °	38.600907 °
				-121.553250 °	-121.552815 °
DWR ID	DWR_RD0537_01_s_2016_1				
Comment Code					
Inspector Comment					
1997 - This may have been a cobble rehabilitation site to the 1957 cobble that was place all the way to the I-80 Bridge. 2000 - Local damage induced by human use. 2003 - Site is still very close to the levee and into the levee toe. 2011 - One new tree has fallen. 2015: 62.9 and 63.0 have been combined into one site. [2015 Site ID: SAC_62-9_R]

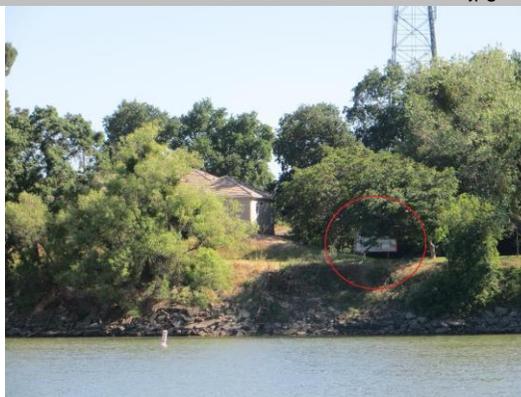
Photo 1 of 2 : UCIP_SP_2016_45024_74020.jpg

LM Start	4.35	Rating **	M	Issue No.	476
LM End	4.35	Issue Type +	En	Location *	WS
Category	Supplemental			GPS Latitude/Longitude	
				Start	End
Item	DWR UCIP Field Study			38.600310 °	38.600310 °
				-121.552816 °	-121.552816 °
DWR ID					
Comment Code					
Inspector Comment					
FS_ID:45024 DS_ID:235 EP_NO: 17993 Repair Type: Non-Urgent Crossing Status: Indicator Found UCIP Comments: Need signs on WS slope for all gas lines in area. FIELD_STRUCT_DESC: To install a 20-inch-diameter natural gas pipeline (bored) under the channel and levees of the Sacramento River. Sign on opposite bank. Sign off LS toe on other side of railroad tracks at base of tower. Application No. 17993, 2006. FS Date: 4/28/2015

Red circle shows location of sign on opposite bank.

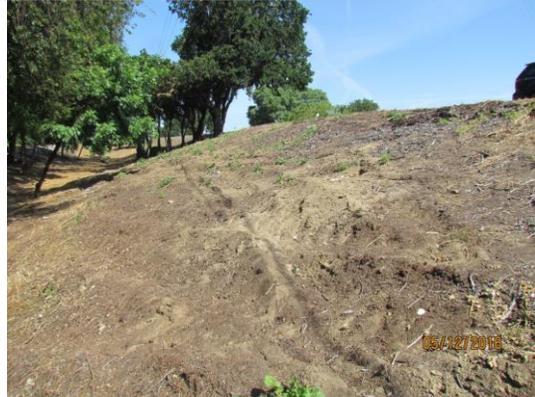
Photo 1 of 1 : SP_2016_RD0537_173_30_20160516_00074.jpg

View of the slope stability caused by vehicles on the waterward side of the levee looking downstream. Spring 2016.

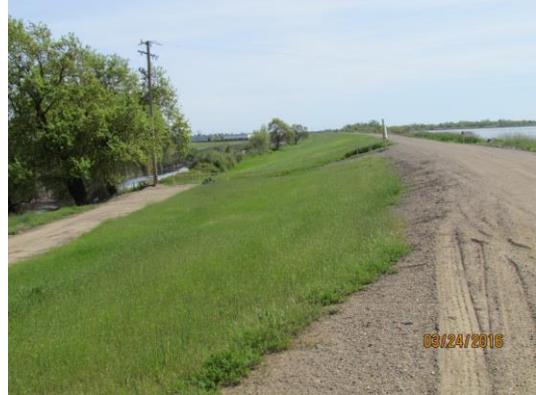
Photo 1 of 1 : SP_2016_RD0537_174_2_20160407_00006.jpg

View of the vegetation on the landward side of the levee looking upstream. Spring 2016.

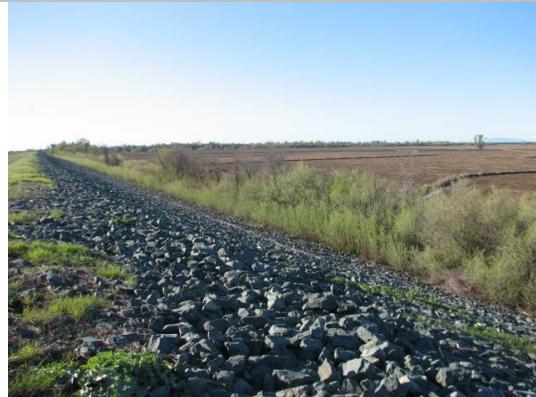
Photo 1 of 2 : SP_2016_RD0537_174_4_20160304_00004.jpg

Photo of the willows at the toe of the rip rap and levee. No other trees in the rip rap. Spring 2014

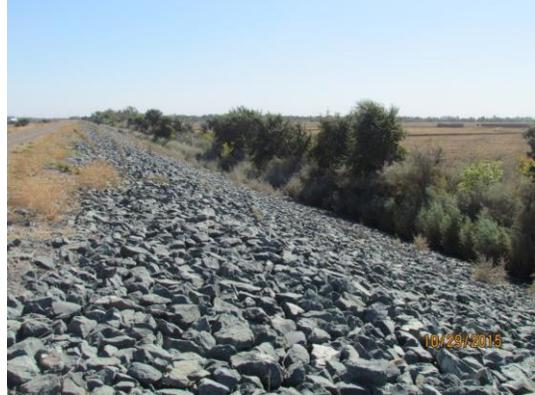
Photo 2 of 2 : SP_2016_RD0537_174_4_20160304_00005.jpg

View of the willows at the toe of the waterward side of the levee looking upstream. Fall 2015.
