**Flood Control Project Maintenance
Levee Inspections**
LMA District Cover Sheet
Spring 2016 Levee Inspection Results

Reclamation District No. 0784 Plumas Lake

Spring 2016 Levee Inspection Results

Waterway	Bank	Unit Miles
Unit No. 01 Yuba River	Left	2.21

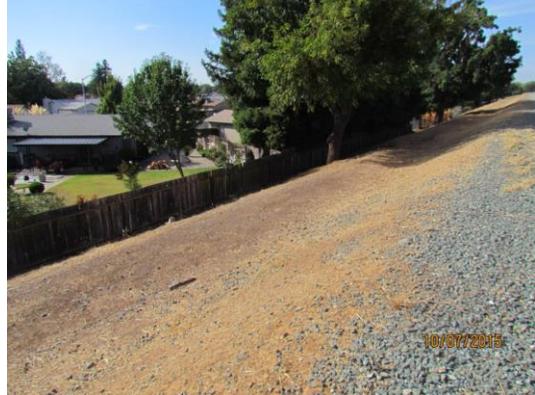
Photo 1 of 1 : SP_2016_RD0784_178_12_20160307_00003.jpg

LM Start	0.51	Rating **	M	Issue No.	12
LM End	1.00	Issue Type +	En	Location *	LS
Category	Earthen Levee		GPS Latitude/Longitude		
			Start	End	
Item	Encroachments		39.131558 °	39.129475 °	
			-121.560668 °	-121.569209 °	
DWR ID	DWR_RD0784_01_f_2012_12				
Comment Code					
FE : Fence					
Inspector Comment					
Fences are found within the 10 feet of levee easement .

Fences were found on the landside toe of the levee looking downstream.

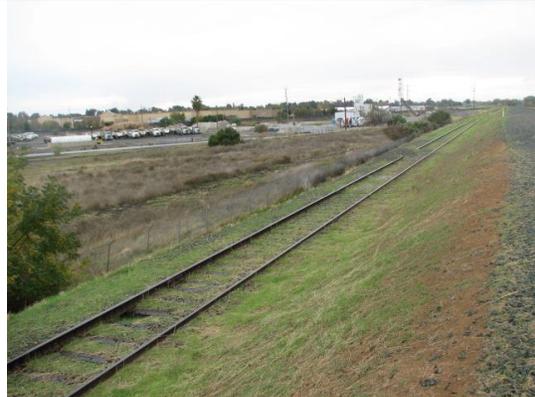
Photo 1 of 1 : SP_2016_RD0784_178_13_20160307_00004.jpg

LM Start	1.00	Rating **	M	Issue No.	13
LM End	1.12	Issue Type +	En	Location *	LS
Category	Earthen Levee		GPS Latitude/Longitude		
			Start	End	
Item	Encroachments		39.129475 °	39.129615 °	
			-121.569210 °	-121.571371 °	
DWR ID	DWR_RD0784_01_f_2012_13				
Comment Code					
FE : Fence					
Inspector Comment

Levee mile 1.00-1.12, this photo shows a fence near the levee toe on the landside.

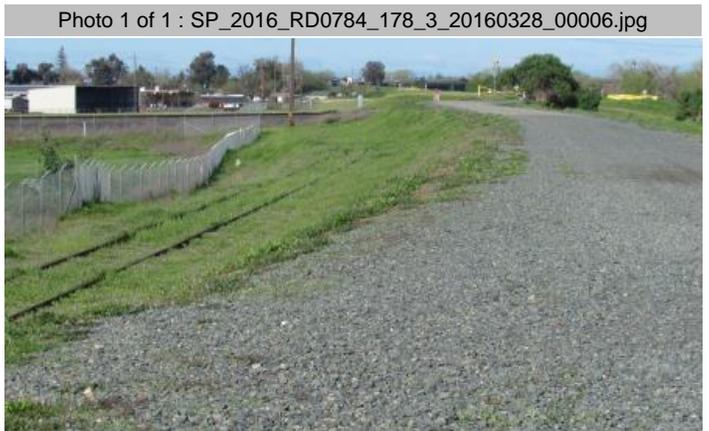
LM Start	1.15	Rating **	A	Issue No.	3
LM End	1.15	Issue Type +	Ma	Location *	LS
Category	Earthen Levee		GPS Latitude/Longitude		
			Start	End	
Item	Vegetation		39.129622 °	39.129622 °	
			-121.571981 °	-121.571981 °	
DWR ID	DWR_RD0784_01_s_2016_3				
Comment Code					
V1 : Control annual grass and weeds on the levee slopes and easements.					
Inspector Comment

View of acceptable landside vegetation looking downstream. Spring 2016.

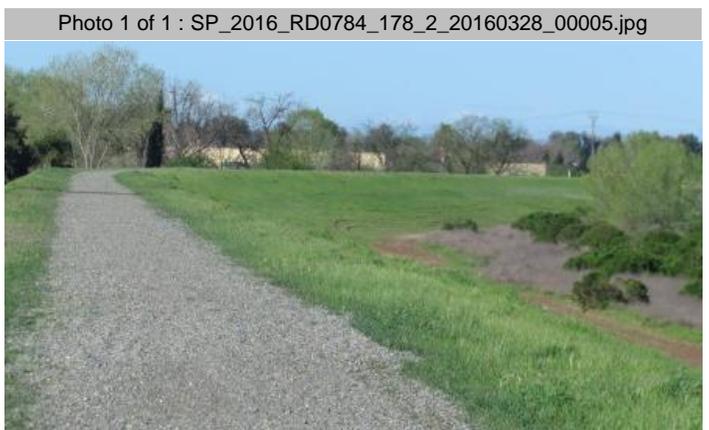
LM Start	1.28	Rating **	A	Issue No.	2
LM End	1.28	Issue Type +	Ma	Location *	WS
Category	Earthen Levee		GPS Latitude/Longitude		
			Start	End	
Item	Vegetation		39.129783 °	39.129783 °	
			-121.574384 °	-121.574384 °	
DWR ID	DWR_RD0784_01_s_2012_2				
Comment Code					
V1 : Control annual grass and weeds on the levee slopes and easements.					
Inspector Comment

View of acceptable waterside vegetation looking downstream. Spring 2016.

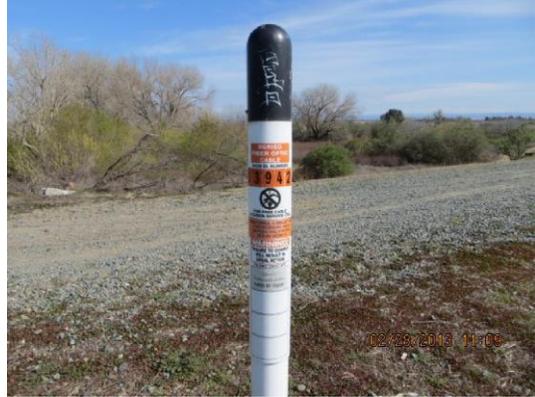
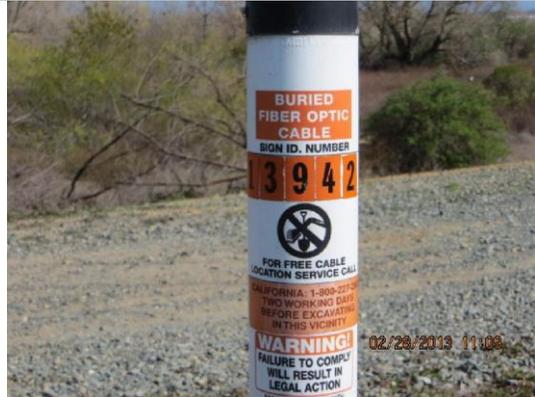
Comment Code					
Inspector Comment					
FS_ID:46778 DS_ID:18552 EP_NO: N/A Repair Type: Non-Urgent Crossing Status: Indicator Found UCIP Comments: 11-1-2015 - Letter requesting permit or to provide permit sent to owner Century Link, 700 W. Mineral Avenue, Rm D 27.34, Littleton, CO 80120 on 2/18/2014. Pending CVFPB enforcement on utility crossing owner. Requesting DWR inspector to change the status of this issue to "No Action Needed" (P. Meagher - RD784) No permit identified for this crossing. Need to determine if owner has permit. (W.Wylie UCIP Inspector). FIELD_STRUCT_DESC: Fiber Optic Communication lines cross levee. Diameter unknown. FS Date: 9/11/2015 9:08:00 AM

Marker on east side of Rail/WS of Levee.

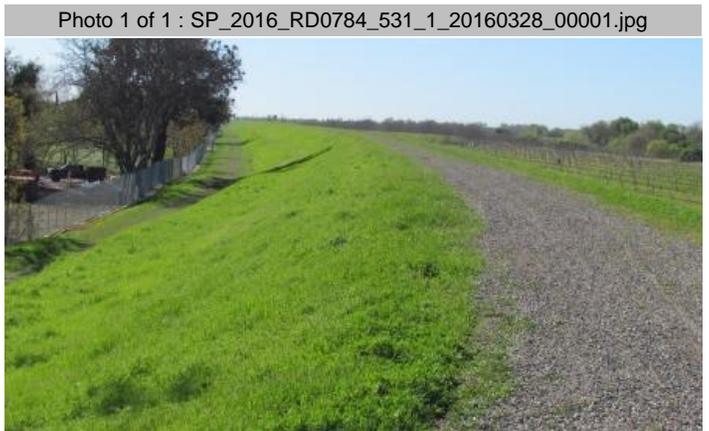
LM Start	0.01	Rating **	A	Issue No.	1
LM End	0.01	Issue Type +	Ma	Location *	LS
Category	Earthen Levee		GPS Latitude/Longitude		
			Start	End	
Item	Vegetation		39.125724 °	39.125724 °	
			-121.588665 °	-121.588665 °	
DWR ID	DWR_RD0784_02A_s_2016_1				
Comment Code					
V1 : Control annual grass and weeds on the levee slopes and easements.					
Inspector Comment

View of acceptable landside vegetation looking downstream. Spring 2016.

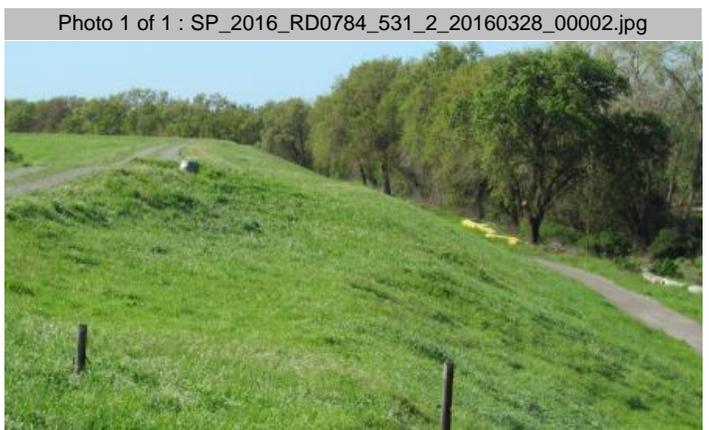
LM Start	0.97	Rating **	A	Issue No.	2
LM End	0.97	Issue Type +	Ma	Location *	WS
Category	Earthen Levee		GPS Latitude/Longitude		
			Start	End	
Item	Vegetation		39.112386 °	39.112386 °	
			-121.583602 °	-121.583602 °	
DWR ID	DWR_RD0784_02A_s_2016_2				
Comment Code					
V1 : Control annual grass and weeds on the levee slopes and easements.					
Inspector Comment

View of acceptable waterside vegetation looking downstream. Spring 2016.

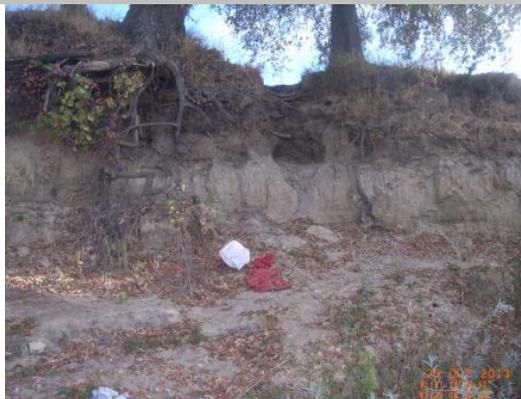
Photo 1 of 1 : SP_2016_RD0784_532_1_20160307_00001.jpg

Comment Code					
Inspector Comment					
2003 - Bank is near vertical. Identified as a Potentially Critical site. 2004 - Eddy flow off downstream end of Modesto formation eroding the fluvial sediments. 2005 - Some new slumping. Actively eroding but berm width is greater than 50 ft. 2006 - Downgraded to regular erosion site. Still actively eroding. Large old rotational failures in high bank on the downstream end. 2008 - Removed from inventory due to wide berm width does not meet criteria for an erosion site. 2010 - Added back to the inventory after 10 ft of bank erosion in the winter 2009 storm. Steep vertical face. 2011 - Bank has retreated an additional 2.5 ft from last year. New tree popouts and erosion throughout the site. 2012 - Site continues to worsen with new tree popouts and many sections of new erosion. 2015: Last observed in 2013. [2015 Site ID: FHR_17-8_L]

USACE 2013 Photo #1

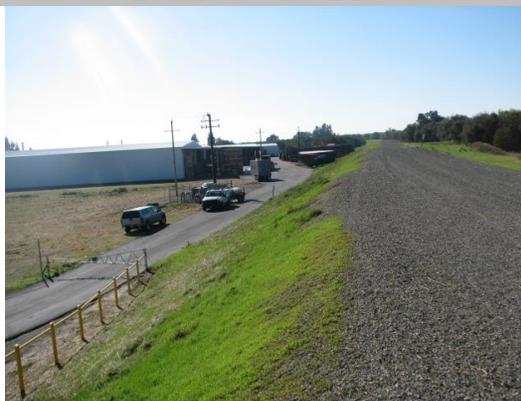
Photo 1 of 1 : SP_2016_RD0784_532_6_20160307_00002.jpg

Levee mile 9.21, new paving near the levee toe, no permit found for this work.

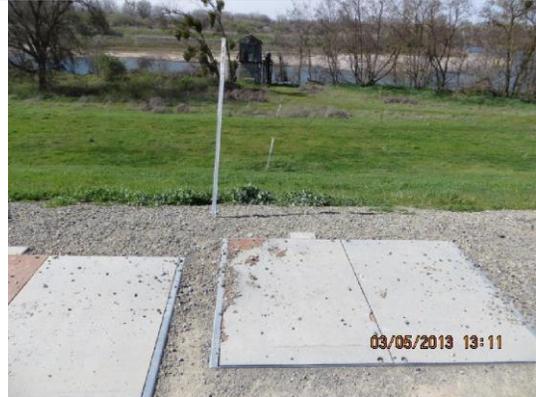
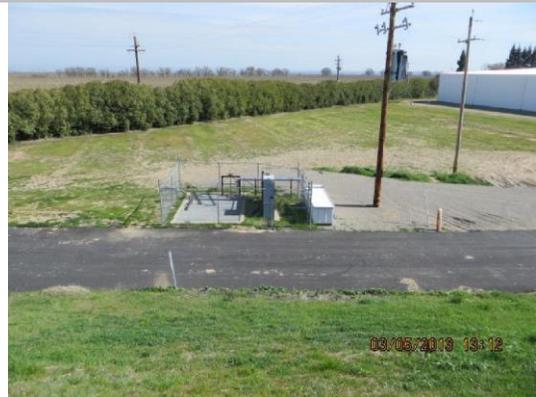
Comment Code					
Inspector Comment					
FS_ID:46784 DS_ID:18716 EP_NO: 18227 Repair Type: Non-Urgent Crossing Status: Indicator Found UCIP Comments: 11-1-2015 - Gate is locked (By owner) as of 9/11/2015 (P. Meagher - RD784) Gate on enclosure at LS toe is not locked. Vaults on WS toe are open and need to be secured. (W. Wylie - UCIP Inspector). FIELD_STRUCT_DESC: 1 of 3: 30-inch HDPE irrigation pipe through the levee 3-feet below the crown. Siphon breaker and air relief valve in vault on waterside shoulder. Pumps in pump house on the bank. Gate valves in concrete distribution box. Chain link enclosure at the landside toe. Discharges into concrete box on the landward side. (Permit No. 18227, 2007) FS Date: 8/1/2014 2:19:00 PM

Vault on WS shoulder.

Concrete distribution box with chain link enclosure on LS toe.

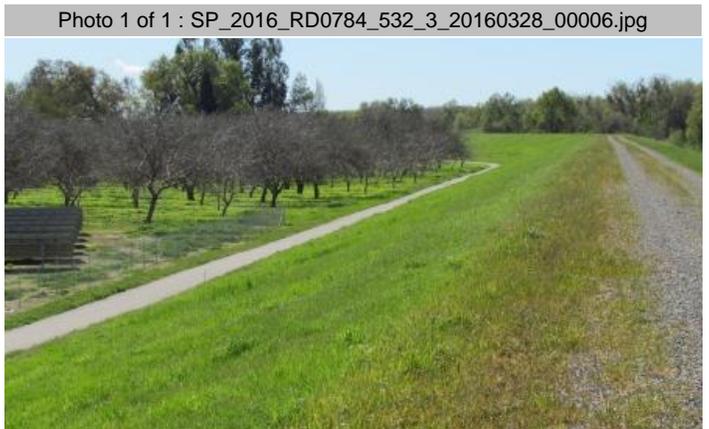
LM Start	9.50	Rating **	A	Issue No.	3
LM End	9.50	Issue Type +	Ma	Location *	LS
Category	Earthen Levee			GPS Latitude/Longitude	
				Start	End
Item	Vegetation			39.002566 °	39.002566 °
				-121.579263 °	-121.579263 °
DWR ID	DWR_RD0784_02B_s_2016_3				
Comment Code					
V1 : Control annual grass and weeds on the levee slopes and easements.					
Inspector Comment

View of acceptable landside vegetation looking downstream. Spring 2016.

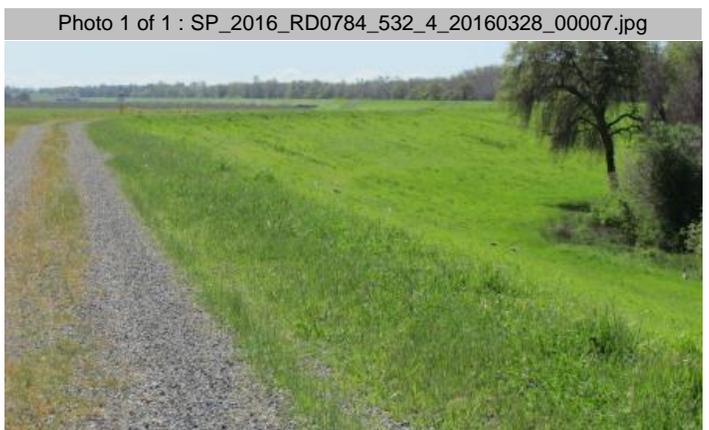
LM Start	9.92	Rating **	A	Issue No.	4
LM End	9.92	Issue Type +	Ma	Location *	WS
Category	Earthen Levee			GPS Latitude/Longitude	
				Start	End
Item	Vegetation			38.996544 °	38.996544 °
				-121.580271 °	-121.580271 °
DWR ID	DWR_RD0784_02B_s_2016_4				
Comment Code					
V1 : Control annual grass and weeds on the levee slopes and easements.					
Inspector Comment

View of acceptable waterside vegetation looking downstream. Spring 2016.

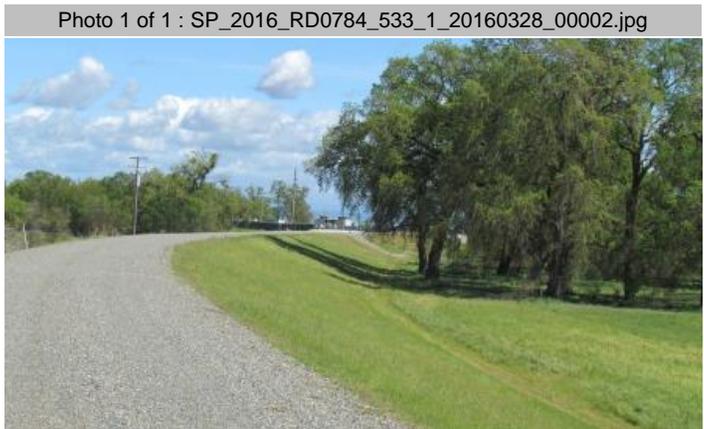
LM Start	2.45	Rating **	A	Issue No.	1
LM End	2.45	Issue Type +	Ma	Location *	WS
Category	Earthen Levee		GPS Latitude/Longitude		
			Start	End	
Item	Vegetation		38.970899 °	38.970899 °	
			-121.547358 °	-121.547358 °	
DWR ID	DWR_RD0784_03A_s_2016_1				
Comment Code					
V1 : Control annual grass and weeds on the levee slopes and easements.					
Inspector Comment

View of acceptable waterside vegetation looking upstream. Spring 2016.

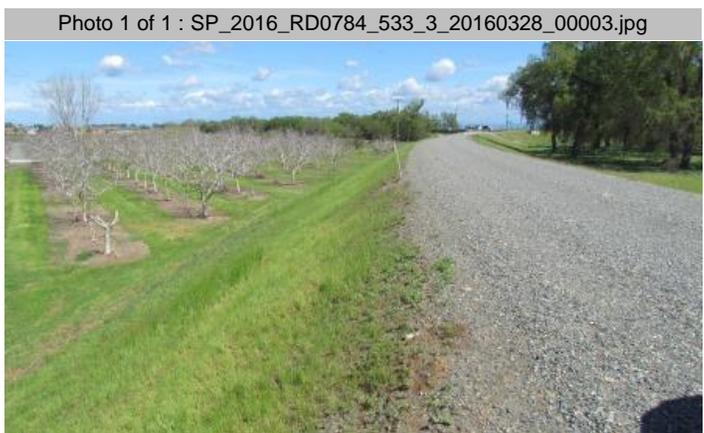
LM Start	2.49	Rating **	A	Issue No.	3
LM End	2.49	Issue Type +	Ma	Location *	LS
Category	Earthen Levee		GPS Latitude/Longitude		
			Start	End	
Item	Vegetation		38.971308 °	38.971308 °	
			-121.547059 °	-121.547059 °	
DWR ID	DWR_RD0784_03A_s_2016_3				
Comment Code					
V1 : Control annual grass and weeds on the levee slopes and easements.					
Inspector Comment

View of acceptable vegetation on the landside looking upstream. Spring 2016.

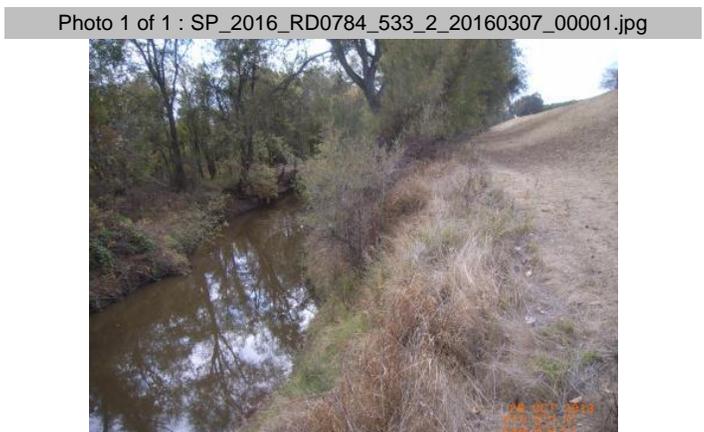
LM Start	10.36	Rating **	M	Issue No.	2
LM End	10.40	Issue Type +	Ma	Location *	WS
Category	Supplemental		GPS Latitude/Longitude		
			Start	End	
Item	2015 USACE Erosion Survey, DRAFT		38.981400 °	38.981271 °	
			-121.515848 °	-121.515999 °	
DWR ID	DWR_RD0784_03A_s_2016_2				
Comment Code					
Inspector Comment					
2009 - Small site which could be repaired with maintenance. Erosion into the levee toe, rock has started to fail. 2015: Last observed in 2013. [2015 Site ID: BER_4-9_R]

USACE 2013 Photo #1

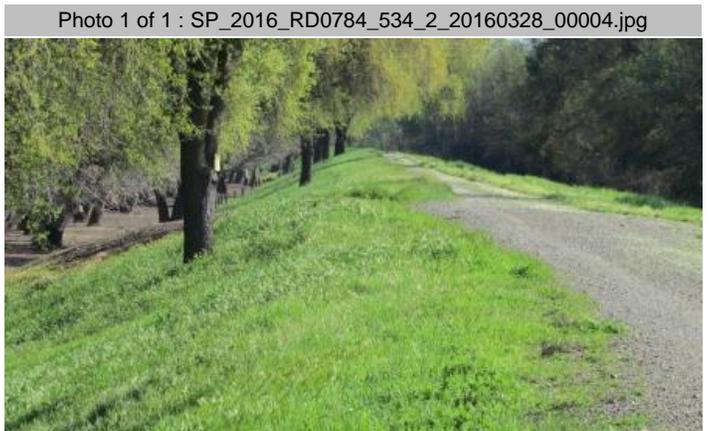
LM Start	3.58	Rating **	A	Issue No.	2
LM End	3.58	Issue Type +	Ma	Location *	LS
Category	Earthen Levee		GPS Latitude/Longitude		
			Start	End	
Item	Vegetation		38.974674 °	38.974674 °	
			-121.525965 °	-121.525965 °	
DWR ID	DWR_RD0784_03B_s_2016_2				
Comment Code					
V1 : Control annual grass and weeds on the levee slopes and easements.					
Inspector Comment

View of acceptable landside vegetation looking upstream. Spring 2016.

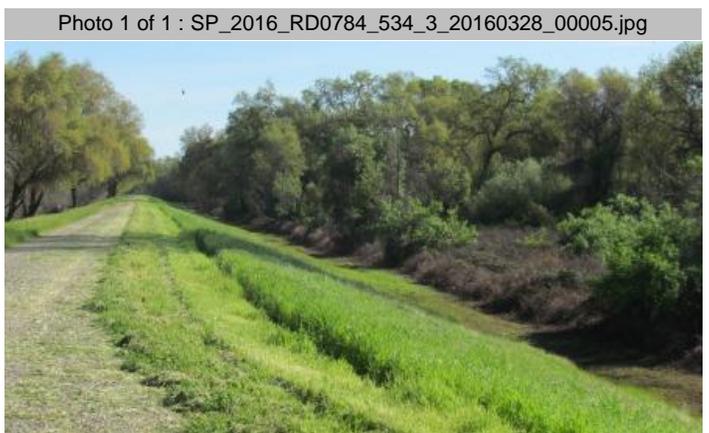
LM Start	3.65	Rating **	A	Issue No.	3
LM End	3.65	Issue Type +	Ma	Location *	WS
Category	Earthen Levee		GPS Latitude/Longitude		
			Start	End	
Item	Vegetation		38.975295 °	38.975295 °	
			-121.524920 °	-121.524920 °	
DWR ID	DWR_RD0784_03B_s_2016_3				
Comment Code					
V1 : Control annual grass and weeds on the levee slopes and easements.					
Inspector Comment

View of acceptable waterside vegetation looking upstream. Spring 2016.

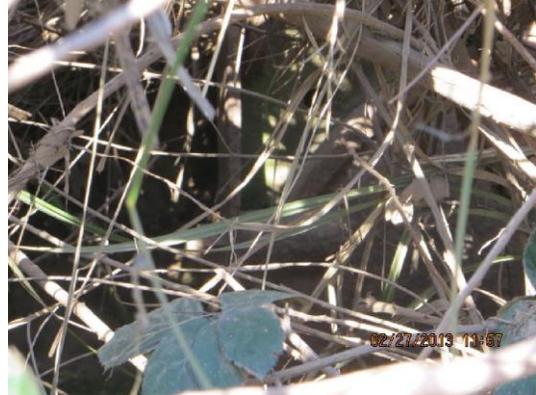
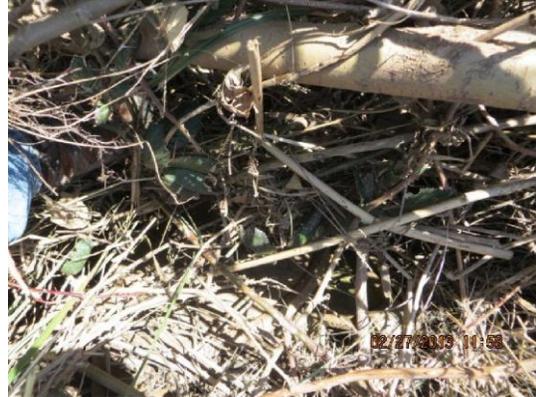
LM Start	4.66	Rating **	U	Issue No.	4
LM End	4.66	Issue Type +	En	Location *	WS
Category	Supplemental		GPS Latitude/Longitude		
			Start	End	
Item	DWR UCIP Field Study		38.985247 °	38.985247 °	
			-121.511075 °	-121.511075 °	
DWR ID					
Comment Code					
Inspector Comment					
FS_ID:46782 DS_ID:18627 EP_NO: N/A Repair Type: Urgent Crossing Status: Found UCIP Comments: 11-1-2015 - Flap Gate has been cleared as of 12/9/2014 and again during summer of 2015 - (P.Meagher-RD784)Flap gate blocked by vegetation on WS toe. Unable to locate inlet.(W. Wylie - UCIP Inspector) FIELD_STRUCT_DESC: 18-inch CM drain pipe through the levee 20-feet below the crown. Gate valve on waterward side. Originally included in O+M Manual (1955). FS Date: 9/11/2015 9:23:00 AM

Flap gate blocked by vegetation on WS Toe.

Flap gate blocked by vegetation on WS toe.

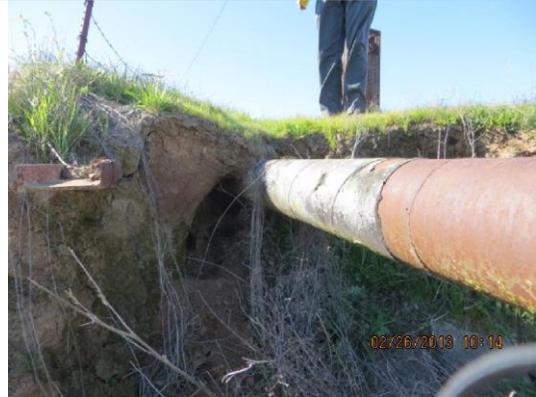
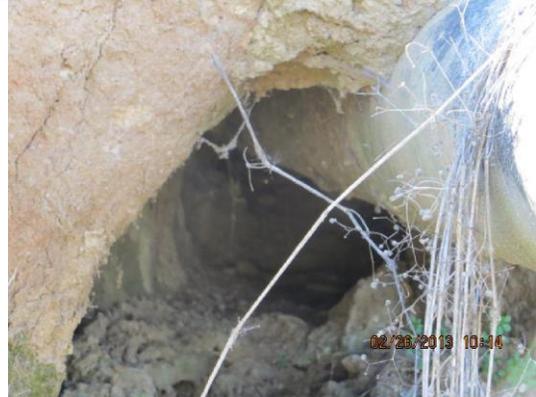
Comment Code					
Inspector Comment					
FS_ID:46783 DS_ID:18581 EP_NO: 5384 Repair Type: Urgent Crossing Status: Found UCIP Comments: 11-1-2015 - Notification Letter Dated 1/10/2014 to fix the problem sent to property owner Vera Lyn Herell at 18548 Ivan St., Rochester WA 98579. UPDATE: On June 11, 2014 the pipe owner accepted a blank CVFPB permit application to pursue repairs. Pending Correspondence. Requesting DWR to change the status of this issue to "No Further Action Needed by the LMA". Large animal burrough along pipe alignment on WS has undermined pipe for an unknown length. Pipe is corroded through on WS. Pipe should be properly abandoned. (W. Wylie - UCIP Inspector). FIELD_STRUCT_DESC: 8-inch pipe through the levee 2.6 feet below the crown. Vertical pump unit and service pole on the waterward side. Discharge into concrete riser on the landward side. (Permit No. 5384) 1966. FS Date: 9/11/2015 9:22:00 AM

Animal burrough under pipe on WS slope.

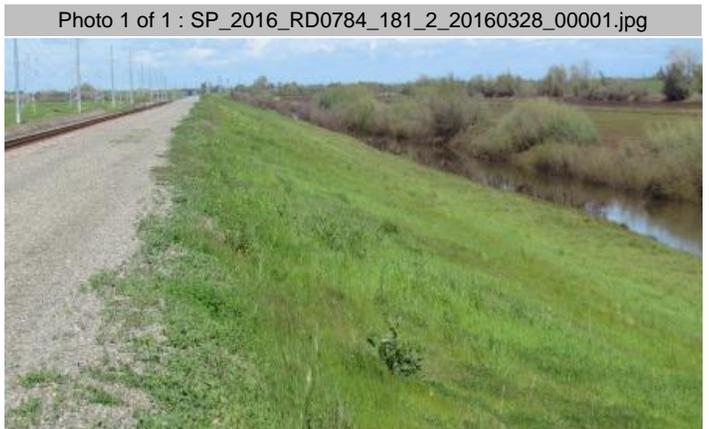
LM Start	1.08	Rating **	A	Issue No.	2
LM End	1.08	Issue Type +	Ma	Location *	WS
Category	Earthen Levee		GPS Latitude/Longitude		
			Start	End	
Item	Vegetation		38.990188 °	38.990188 °	
			-121.538020 °	-121.538020 °	
DWR ID	DWR_RD0784_04_s_2016_2				
Comment Code					
V1 : Control annual grass and weeds on the levee slopes and easements.					
Inspector Comment

View of acceptable waterside vegetation looking upstream. Spring 2016.

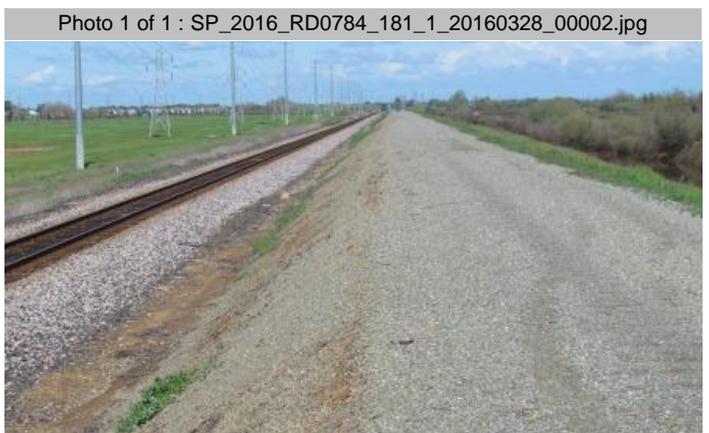
LM Start	1.08	Rating **	A	Issue No.	1
LM End	1.08	Issue Type +	Ma	Location *	LS
Category	Earthen Levee		GPS Latitude/Longitude		
			Start	End	
Item	Vegetation		38.990188 °	38.990188 °	
			-121.538021 °	-121.538021 °	
DWR ID	DWR_RD0784_04_s_2016_1				
Comment Code					
V1 : Control annual grass and weeds on the levee slopes and easements.					
Inspector Comment

View of acceptable vegetation on the landside looking upstream. Spring 2016.

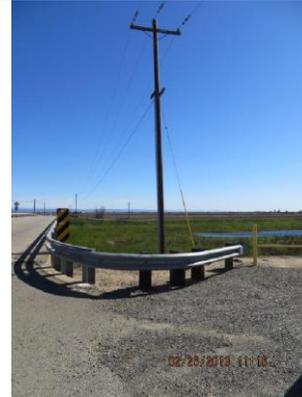
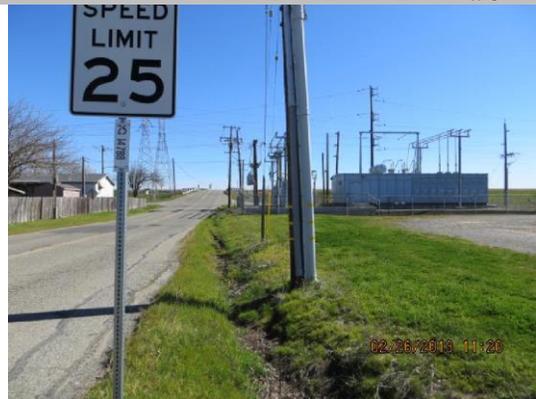
LM Start	3.59	Rating **	M	Issue No.	4
LM End	3.59	Issue Type +	En	Location *	LS
Category	Supplemental			GPS Latitude/Longitude	
				Start	End
Item	DWR UCIP Field Study			39.026347 °	39.026347 °
				-121.542343 °	-121.542343 °
DWR ID					
Comment Code					
Inspector Comment					
FS_ID:46600 DS_ID:22686 EP_NO: N/A Repair Type: Non-Urgent Crossing Status: Found UCIP Comments: No permit identified for crossing. FIELD_STRUCT_DESC: Communication line through the levee at unknown depth on downstream side of bridge. FS Date: 9/11/2015 9:25:57 AM

Communication line at base of JP on WS slope.

Communication line runs on south side of Plumas Arboga Road to JP approximately 400-feet West of levee crown.

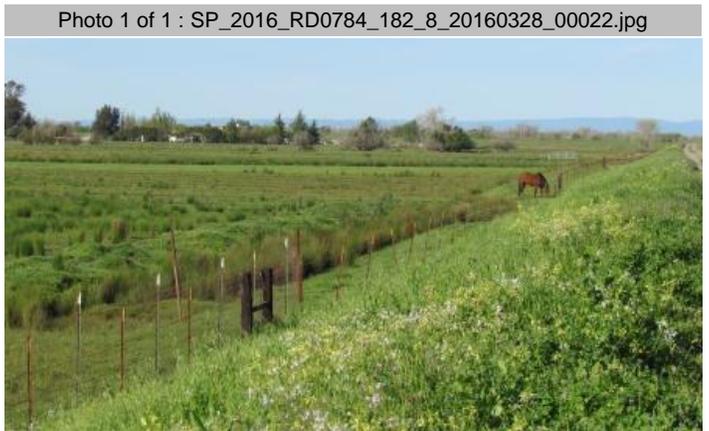
LM Start	0.02	Rating **	M	Issue No.	8
LM End	3.86	Issue Type +	Ma	Location *	LS
Category	Earthen Levee		GPS Latitude/Longitude		
			Start	End	
Item	Vegetation		38.974617 °	39.019460 °	
			-121.532619 °	-121.515089 °	
DWR ID	DWR_RD0784_05_s_2016_8				
Comment Code					
V1 : Control annual grass and weeds on the levee slopes and easements.					
Inspector Comment

View of landside vegetation looking downstream. Spring 2016.

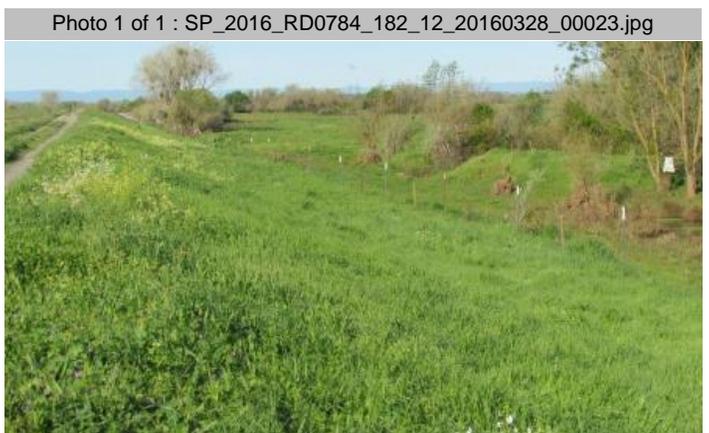
LM Start	0.02	Rating **	M	Issue No.	12
LM End	3.86	Issue Type +	Ma	Location *	WS
Category	Earthen Levee		GPS Latitude/Longitude		
			Start	End	
Item	Vegetation		38.974617 °	39.019460 °	
			-121.532620 °	-121.515088 °	
DWR ID	DWR_RD0784_05_s_2016_12				
Comment Code					
V1 : Control annual grass and weeds on the levee slopes and easements.					
Inspector Comment

View of waterside vegetation looking downstream. Spring 2016.

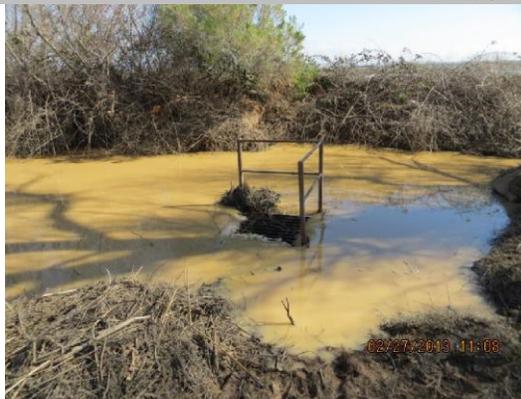
Photo 1 of 2 : UCIP_SP_2016_46592_54246.jpg

Concrete drop-inlet at LS toe.

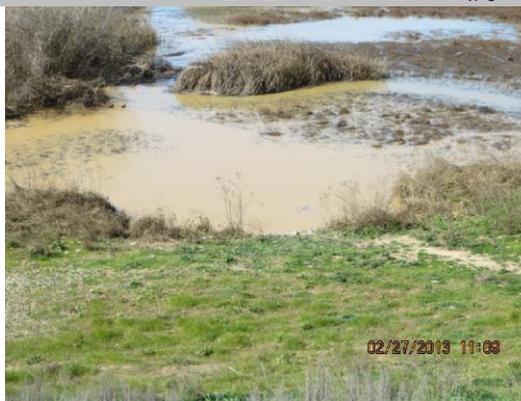
Photo 2 of 2 : UCIP_SP_2016_46592_54245.jpg

Outlet with riprap on WS toe.

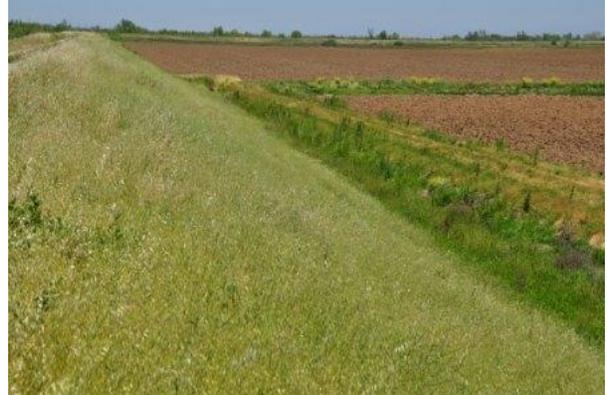
Photo 1 of 1 : SP_2016_RD0784_182_10_20160307_00002.jpg

Ditch at landside toe.

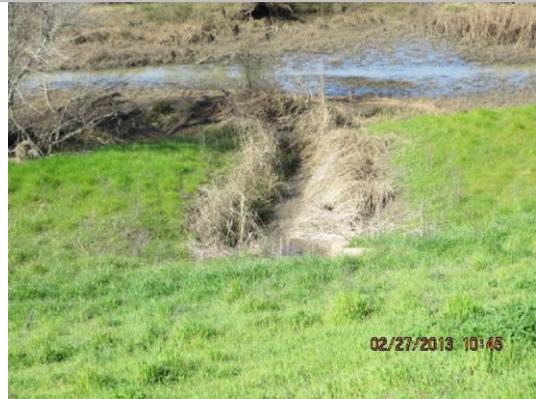
Photo 1 of 2 : UCIP_SP_2016_46604_54249.jpg

Drainage outlet on WS toe.

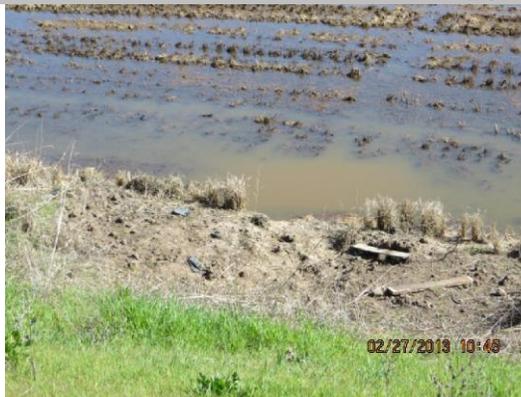
Photo 2 of 2 : UCIP_SP_2016_46604_54248.jpg

Debris covered inlet on LS toe.

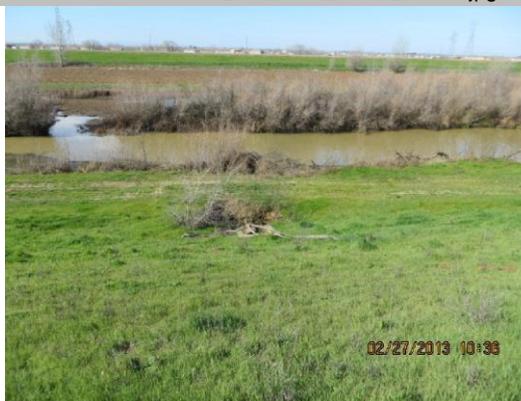
Photo 1 of 2 : UCIP_SP_2016_46603_54252.jpg

Concrete U-shaped outlet on WS toe.

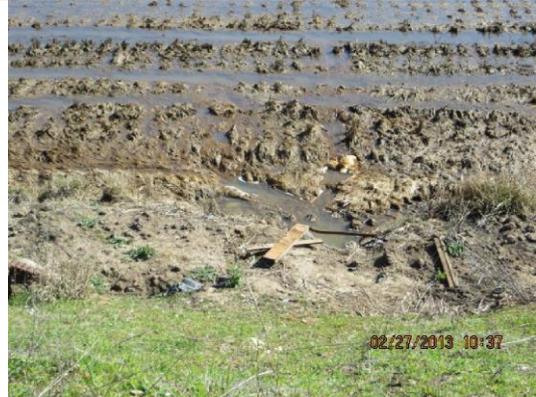
Photo 2 of 2 : UCIP_SP_2016_46603_54251.jpg

Inlet with PVC weir on LS toe.

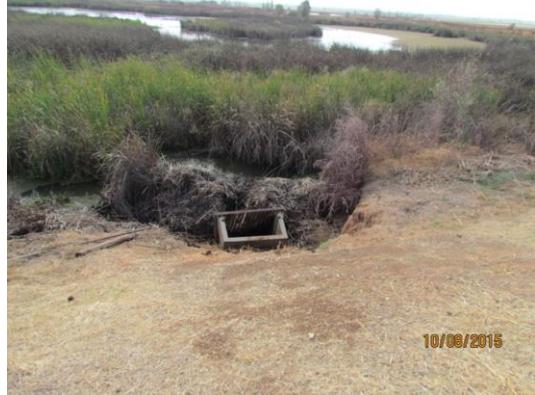
Photo 1 of 2 : SP_2016_RD0784_182_11_20160307_00003.jpg

View of the broken headwall on the landside of the levee.

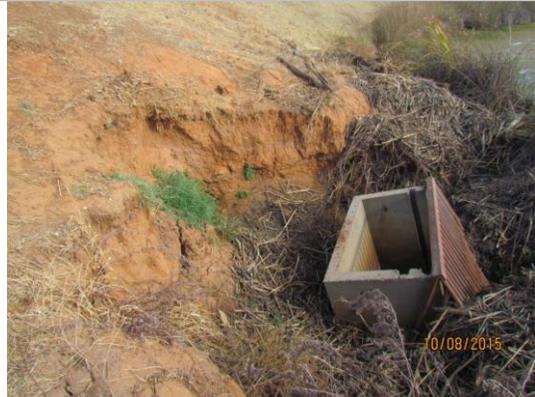
Photo 2 of 2 : SP_2016_RD0784_182_11_20160307_00004.jpg

View of the broken headwall and erosion on the landside toe of the levee looking upstream.

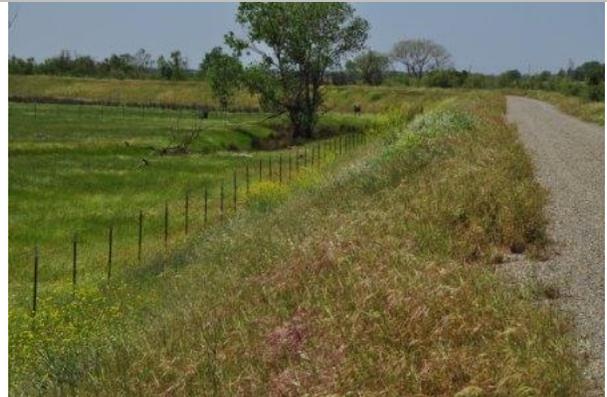
Photo 1 of 1 : SP_2016_RD0784_182_5_20160307_00001.jpg

Fence at Landside levee toe.

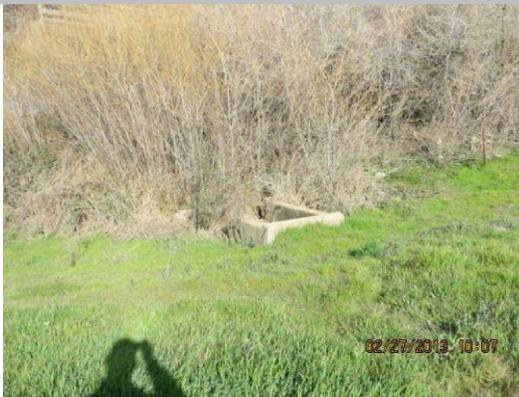
Photo 1 of 2 : UCIP_SP_2016_46601_54261.jpg

Concrete U-shaped headwall on WS toe.

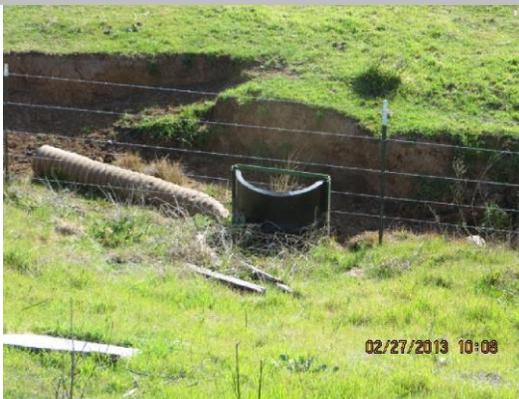
Photo 2 of 2 : UCIP_SP_2016_46601_54260.jpg

PVC weir on LS toe. Notice pipe debris from repair.

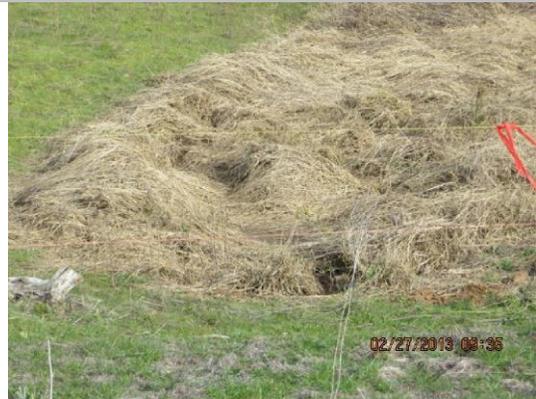
Photo 1 of 2 : UCIP_SP_2016_46781_56705.jpg

Outlet on WS toe .

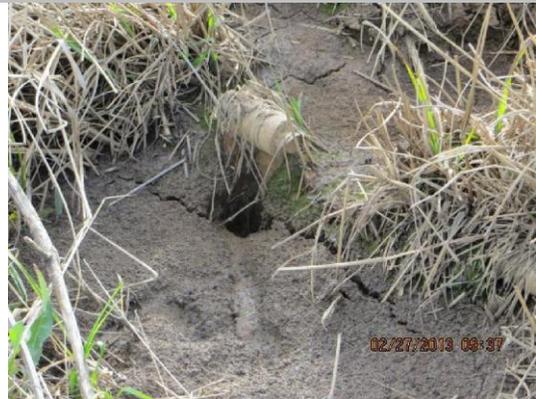
Photo 2 of 2 : UCIP_SP_2016_46781_56704.jpg

Flap gate burried in soil at outlet on WS toe.

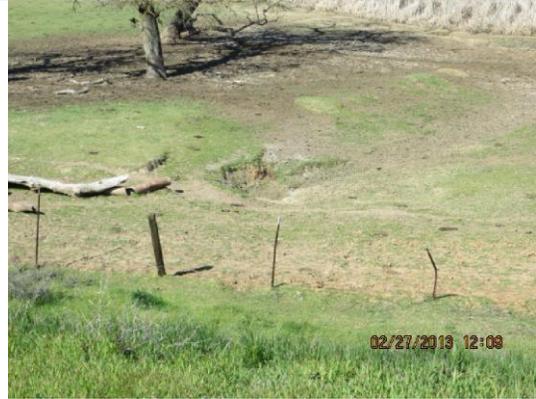
Photo 1 of 2 : UCIP_SP_2016_46776_54267.jpg

Inlet at LS toe.

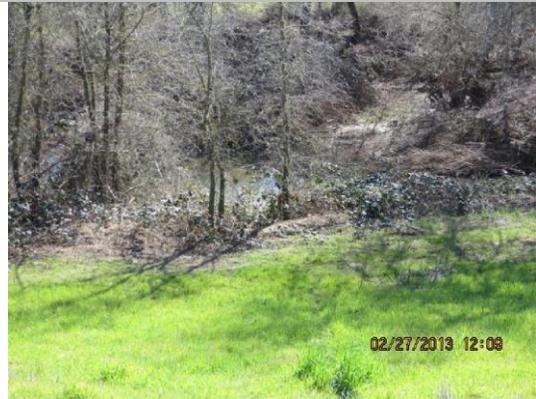
Photo 2 of 2 : UCIP_SP_2016_46776_54266.jpg

Outlet at WS stream bank.

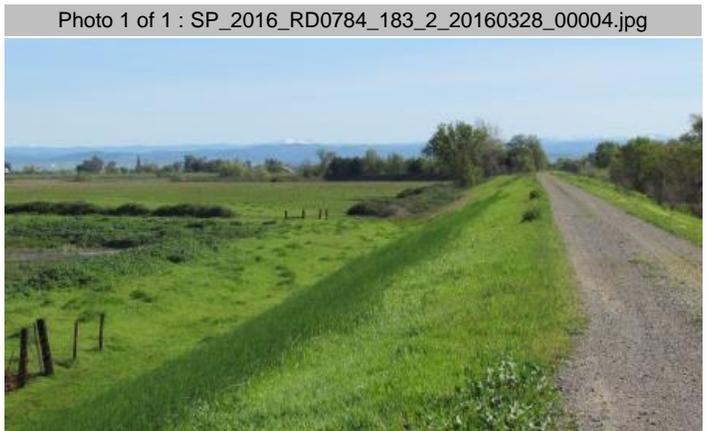
LM Start	0.14	Rating **	A	Issue No.	2
LM End	0.14	Issue Type +	Ma	Location *	LS
Category	Earthen Levee		GPS Latitude/Longitude		
			Start	End	
Item	Vegetation		38.986729 °	38.986729 °	
			-121.508283 °	-121.508283 °	
DWR ID	DWR_RD0784_06_s_2016_2				
Comment Code					
V1 : Control annual grass and weeds on the levee slopes and easements.					
Inspector Comment

View of acceptable landside vegetation looking upstream. Spring 2016.

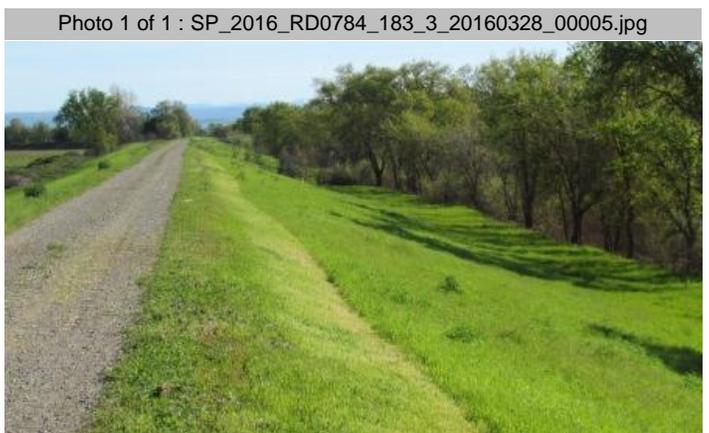
LM Start	0.14	Rating **	A	Issue No.	3
LM End	0.14	Issue Type +	Ma	Location *	WS
Category	Earthen Levee		GPS Latitude/Longitude		
			Start	End	
Item	Vegetation		38.986729 °	38.986729 °	
			-121.508283 °	-121.508283 °	
DWR ID	DWR_RD0784_06_s_2016_3				
Comment Code					
V1 : Control annual grass and weeds on the levee slopes and easements.					
Inspector Comment

View of acceptable waterside vegetation looking upstream. Spring 2016.

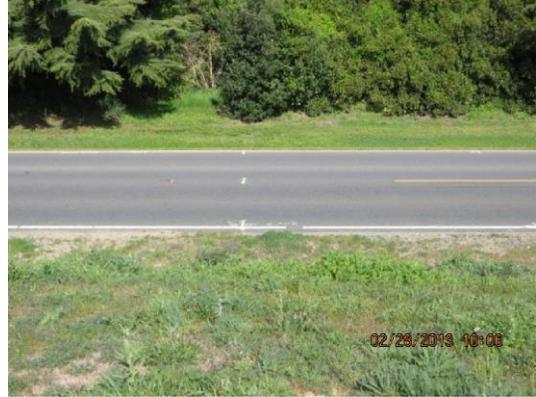
Photo 1 of 2 : UCIP_SP_2016_46590_54234.jpg

Paint alignment marks on pavement, LS toe.

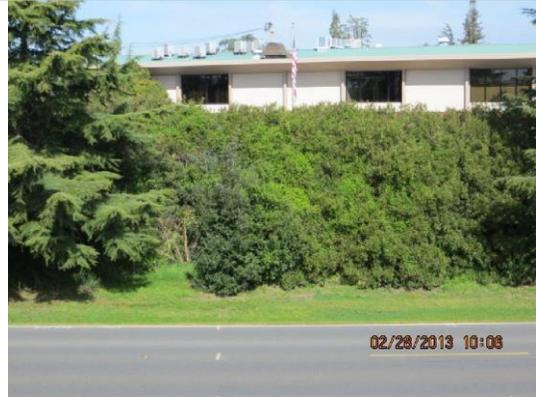
Photo 2 of 2 : UCIP_SP_2016_46590_54233.jpg

Alignment of pipe is approximately in-line with the flag pole on LS building.

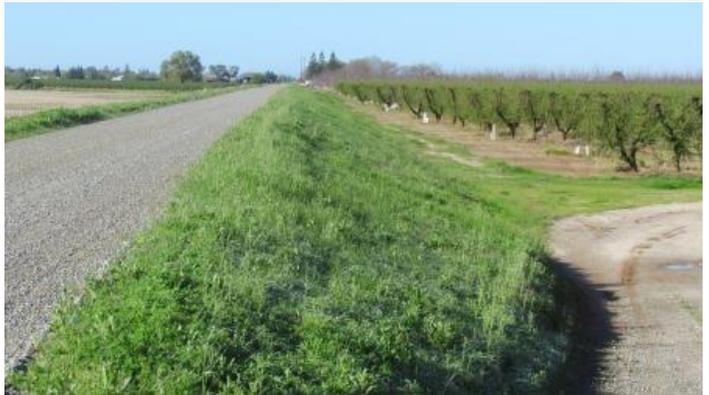
Photo 1 of 1 : SP_2016_RD0784_184_4_20160328_00006.jpg

View of waterside vegetation looking downstream. Spring 2016.

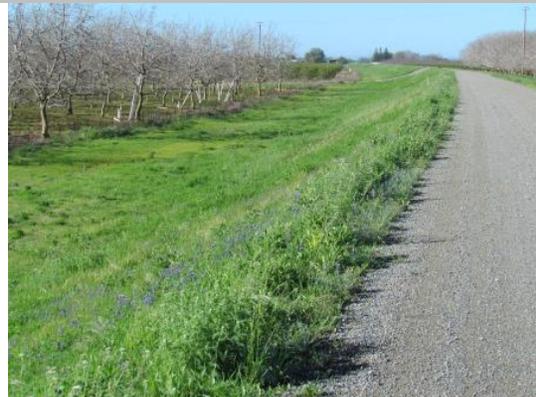
Photo 1 of 1 : SP_2016_RD0784_184_2_20160328_00004.jpg

View of landside vegetation looking downstream. Spring 2016.

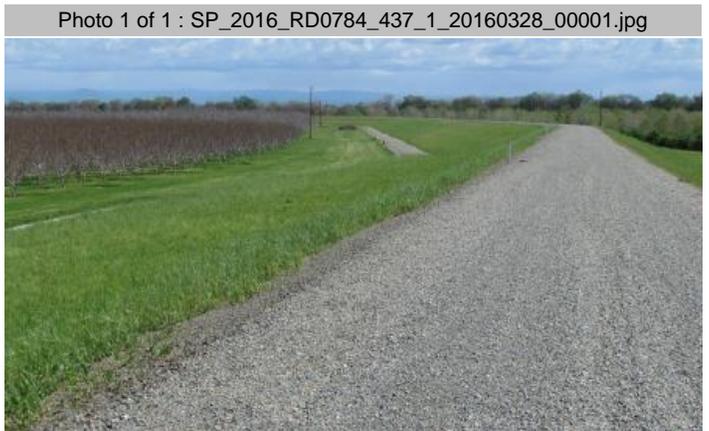
LM Start	0.39	Rating **	A	Issue No.	1
LM End	0.39	Issue Type +	Ma	Location *	LS
Category	Earthen Levee		GPS Latitude/Longitude		
			Start	End	
Item	Vegetation		38.956304 °	38.956304 °	
			-121.567820 °	-121.567820 °	
DWR ID	DWR_RD0784_08_s_2016_1				
Comment Code					
V1 : Control annual grass and weeds on the levee slopes and easements.					
Inspector Comment

View of acceptable landside vegetation looking upstream. Spring 2016.

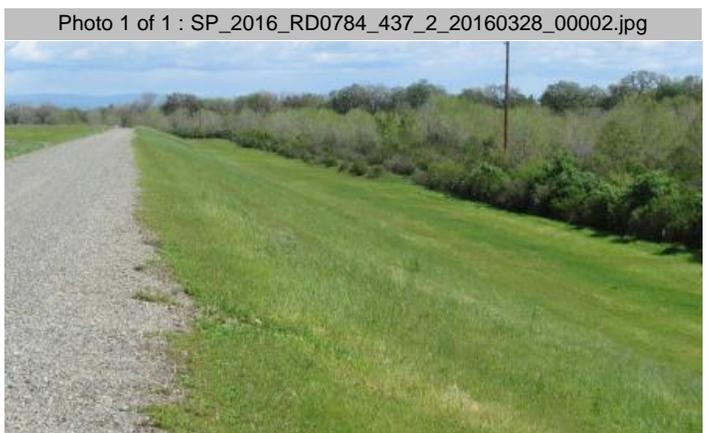
LM Start	0.61	Rating **	A	Issue No.	2
LM End	0.61	Issue Type +	Ma	Location *	WS
Category	Earthen Levee		GPS Latitude/Longitude		
			Start	End	
Item	Vegetation		38.957313 °	38.957313 °	
			-121.563988 °	-121.563988 °	
DWR ID	DWR_RD0784_08_s_2016_2				
Comment Code					
V1 : Control annual grass and weeds on the levee slopes and easements.					
Inspector Comment

View of acceptable vegetation on the waterside looking upstream. Spring 2016.

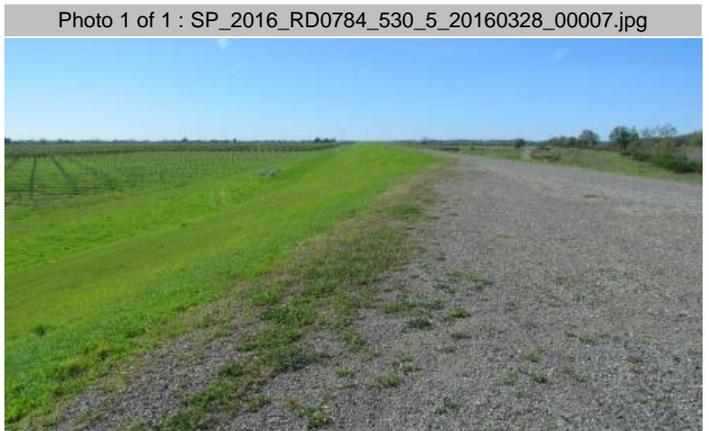
LM Start	0.01	Rating **	A	Issue No.	5
LM End	0.01	Issue Type +	Ma	Location *	LS
Category	Earthen Levee			GPS Latitude/Longitude	
				Start	End
Item	Vegetation			39.090153 °	39.090153 °
				-121.584764 °	-121.584764 °
DWR ID	DWR_RD0784_09_s_2016_5				
Comment Code					
V1 : Control annual grass and weeds on the levee slopes and easements.					
Inspector Comment

View of acceptable landside vegetation looking downstream. Spring 2016.

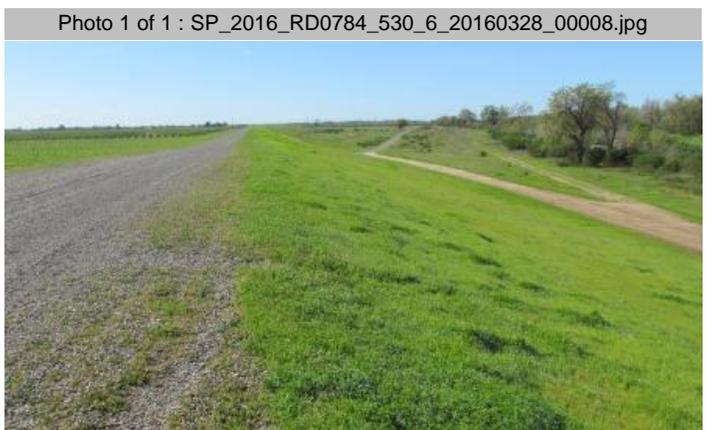
LM Start	0.01	Rating **	A	Issue No.	6
LM End	0.01	Issue Type +	Ma	Location *	WS
Category	Earthen Levee			GPS Latitude/Longitude	
				Start	End
Item	Vegetation			39.090153 °	39.090153 °
				-121.584764 °	-121.584764 °
DWR ID	DWR_RD0784_09_s_2016_6				
Comment Code					
V1 : Control annual grass and weeds on the levee slopes and easements.					
Inspector Comment

View of acceptable waterside vegetation looking downstream. Spring 2016.

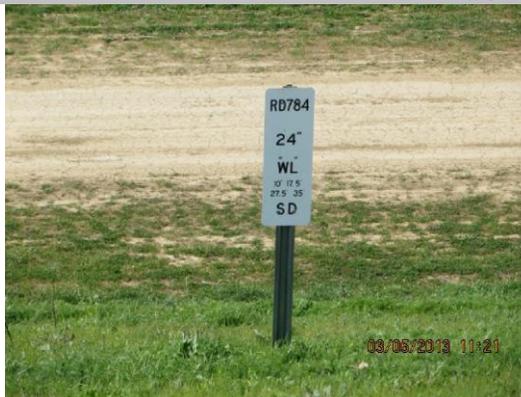
Photo 1 of 2 : UCIP_SP_2016_46591_27163.jpg

Paddle marker on WS toe.

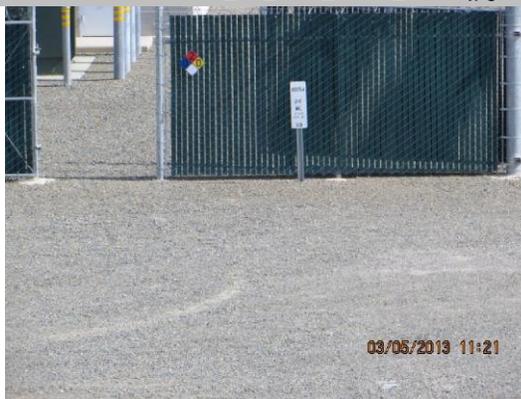
Photo 2 of 2 : UCIP_SP_2016_46591_27162.jpg

Paddle marker on LS toe at pumping plant fence.

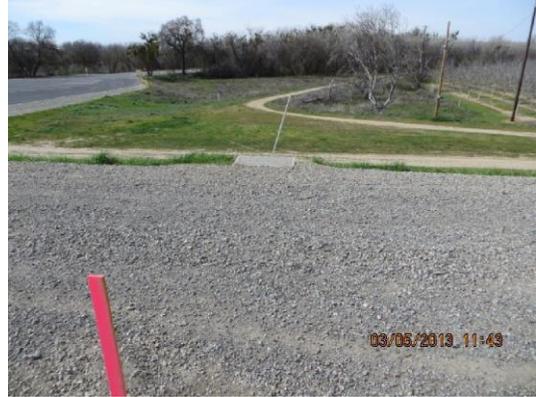
Photo 1 of 2 : UCIP_SP_2016_46586_27161.jpg

Christy box on WS shoulder.

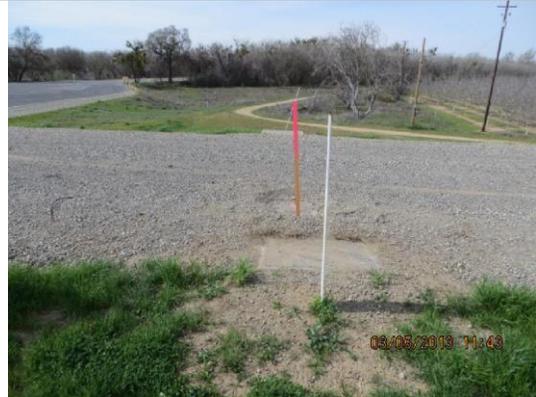
Photo 2 of 2 : UCIP_SP_2016_46586_27160.jpg

Christy box on LS shoulder.
