**Flood Control Project Maintenance  
Levee Inspections**  
**LMA District Cover Sheet**  
**Spring 2016 Levee Inspection Results**

**Reclamation District No. 0900 West Sacramento**

Waterway		Bank	Unit Miles
Unit No. 01 Sacramento River		Right	7.70

**Levee Inspection Report By Mile - Spring 2016**

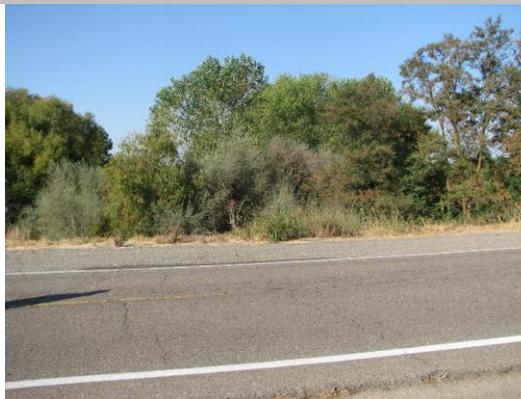
Photo 1 of 2 : UCIP\_SP\_2016\_37665\_68376.jpg

LM Start	<b>2.15</b>	Rating **	M	Issue No.	<b>971</b>
LM End	<b>2.15</b>	Issue Type +	En	Location *	CR
Category	Supplemental			GPS Latitude/Longitude	
				Start	End
Item	DWR UCIP Field Study			38.556994 °	38.556994 °
				-121.516843 °	-121.516843 °
DWR ID					
Comment Code					
Inspector Comment					
FS_ID:37665 DS_ID:17772 EP_NO: N/A Repair Type: Non-Urgent Crossing Status: Found UCIP Comments: Dense vegetation limits the inspector's visibility to identify signs of pipe failure (leaks) along the slope. Recommend removing vegetation along pipe alignment to conduct proper inspection of structure and appurtenances. FIELD_STRUCT_DESC: 42-inch pipeline through the levee 21.5 feet below the crown. Slide gate in concrete riser on the waterward slope. Flap gate on the waterward end. FS Date: 10/6/2009

View of levee crown at crossing.

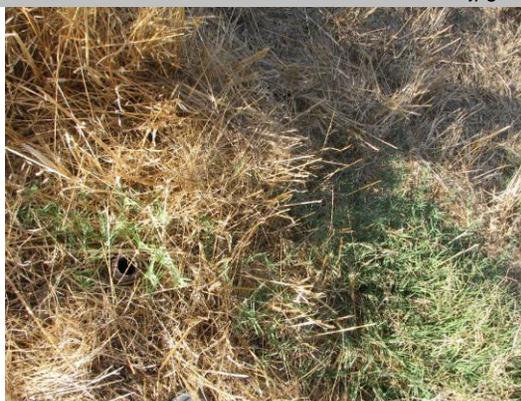
Photo 2 of 2 : UCIP\_SP\_2016\_37665\_68375.jpg

Air vent visible through dense vegetation.

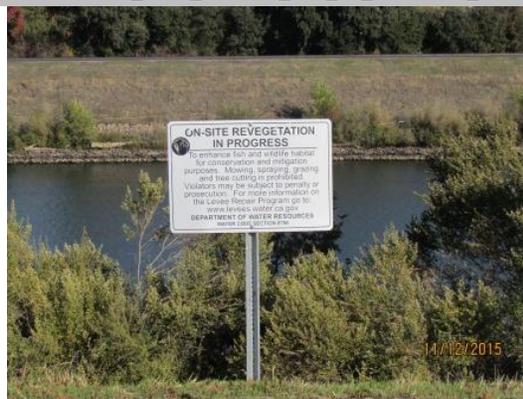
Photo 1 of 1 : SP\_2016\_RD0900\_230\_17\_20160219\_00010.jpg

View of the DWR environmental mitigation site.

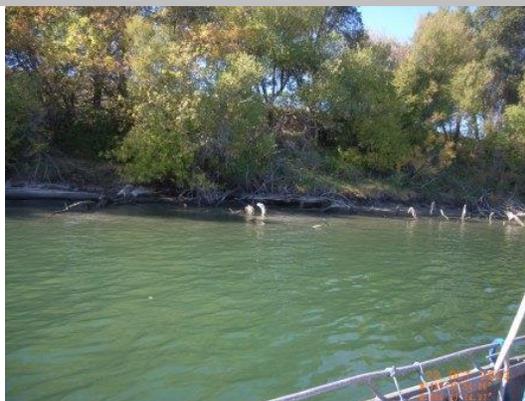
Photo 1 of 1 : SP\_2016\_RD0900\_230\_10\_20160219\_00008.jpg

LM Start	<b>2.35</b>	Rating **	M	Issue No.	<b>10</b>
LM End	<b>2.47</b>	Issue Type +	Ma	Location *	WS
Category	Supplemental		GPS Latitude/Longitude		
			Start	End	
Item	2015 USACE Erosion Survey, DRAFT		38.554277 °	38.552504 °	
			-121.515263 °	-121.514752 °	
DWR ID	DWR_RD0900_01_s_2016_10				
Comment Code					
Inspector Comment					
2007 - Have good berm width with minor toe erosion. Close to the levee toe protection, but levee slope is steep. 2011 - New large erosion pocket. 2012 - Minor new erosion at the toe. 2015: No observed changes. [2015 Site ID: SAC_56-7_R]

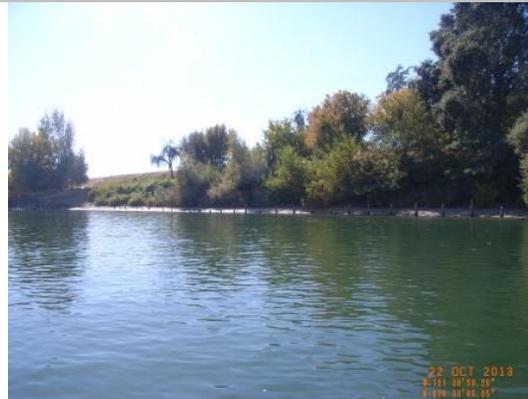
Photo 1 of 1 : SP\_2016\_RD0900\_230\_9\_20160219\_00007.jpg

LM Start	<b>2.55</b>	Rating **	M	Issue No.	<b>9</b>
LM End	<b>2.64</b>	Issue Type +	Ma	Location *	WS
Category	Supplemental			GPS Latitude/Longitude	
				Start	End
Item	2015 USACE Erosion Survey, DRAFT			38.551319 °	38.550090 °
				-121.514423 °	-121.513983 °
DWR ID	DWR_RD0900_01_s_2016_9				
Comment Code					
Inspector Comment					
1997 - Low berm is contributing to erosion. Old timber pile dikes above water parallel to bank. The upstream mitigation low berm causes a flow separation at the site. 1999 - Some new localized erosion with less than one foot of bank retreat. 2000 - Some new erosion at the upstream end. Fat toe deposits at toe. 2003 - Some new erosion upstream, but have a wide berm. 2011 - Minor new erosion at toe. 2015: No observed changes. [2015 Site ID: SAC_56-5_R]

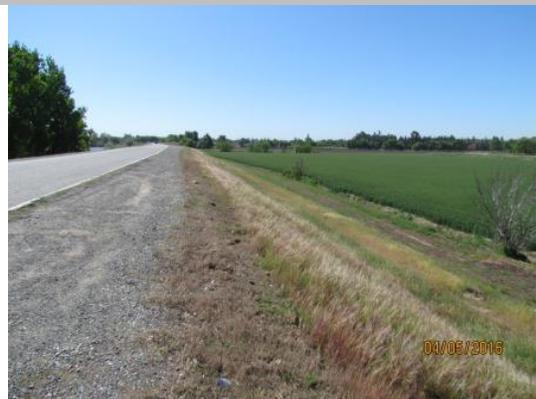
Photo 1 of 1 : SP\_2016\_RD0900\_230\_62\_20160406\_00029.jpg

View of the acceptable vegetation on the landside slope of the levee looking downstream.

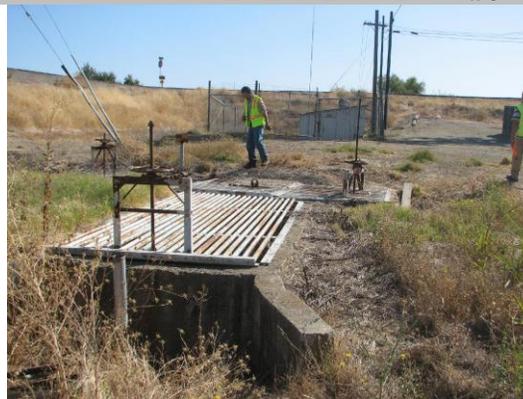
Photo 1 of 2 : UCIP\_SP\_2016\_37668\_68391.jpg

Item	DWR UCIP Field Study			38.540803°	38.540803°
				-121.514255°	-121.514255°
DWR ID					
Comment Code					
Inspector Comment					
FS_ID:37668 DS_ID:17769 EP_NO: N/A Repair Type: Non-Urgent Crossing Status: Found UCIP Comments: Dense vegetation limits the inspector's visibility to identify signs of pipe failure (leaks) along the slope. Recommend removing vegetation along pipe alignment to conduct proper inspection of structure and appurtenances. FIELD_STRUCT_DESC: 24-inch pipe through the levee, 22.0 feet below the crown. Pump house at the landward toe. Screw gate in landside of the levee. As-built drawing available/found. As-built drawing# 6-13-1100 page 3, January 1933 and USGS River Mile 55.65 &M Manual Sac 116, Revision Year 2011 FS Date: 10/6/2009

View of concrete structure located on landward side.

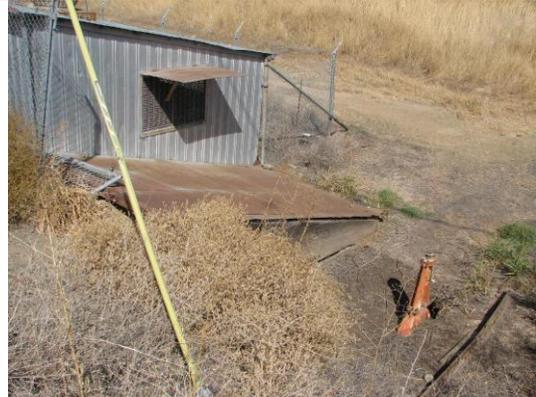
Photo 2 of 2 : UCIP\_SP\_2016\_37668\_68390.jpg

Pump house located on landward side.

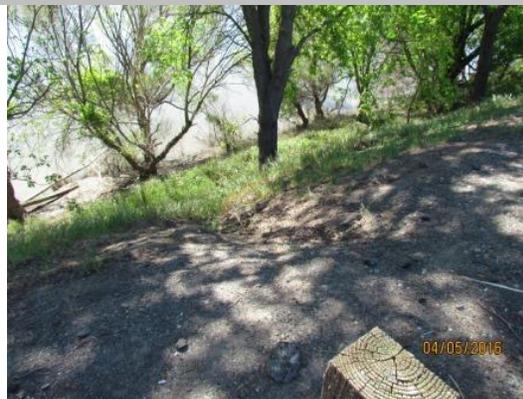
Photo 1 of 2 : SP\_2016\_RD0900\_230\_4\_20160406\_00030.jpg

LM Start	<b>3.41</b>	Rating **	M	Issue No.	<b>4</b>
LM End	<b>3.41</b>	Issue Type +	Ma	Location *	WS
Category	Earthen Levee		GPS Latitude/Longitude		
			Start	End	
Item	Slope Stability		38.539770 °	38.539770 °	
			-121.515276 °	-121.515276 °	
DWR ID	DWR_RD0900_01_s_2014_4				
Comment Code					
S2 : Repair the levee slope damaged by foot traffic and prevent access where possible.					
Inspector Comment

Updated picture of the slope instability on the waterside of the levee looking downstream during spring 2016 inspection.

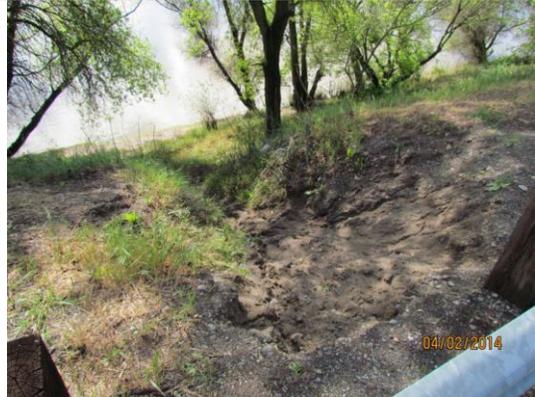
Photo 2 of 2 : SP\_2016\_RD0900\_230\_4\_20160219\_00004.jpg

A slope instability was found on the waterside slope of the levee looking downstream.

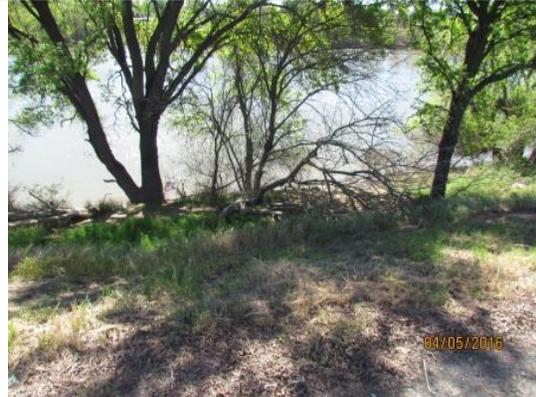
Photo 1 of 1 : SP\_2016\_RD0900\_230\_63\_20160406\_00031.jpg

View of broken tree branches on the waterside slope of the levee looking downstream.

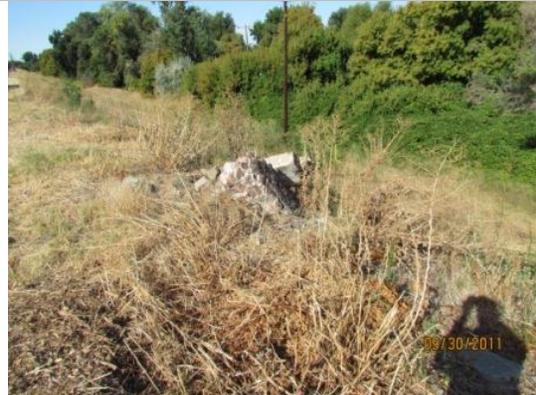
Photo 1 of 1 : SP\_2016\_RD0900\_230\_327\_20160219\_00017.jpg

Concrete debris were found on the landside of the levee looking upstream.

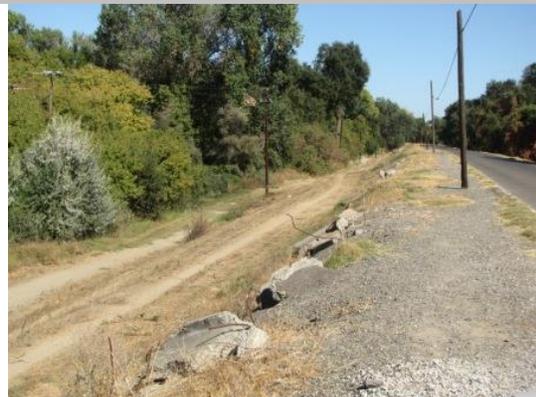
Photo 1 of 1 : SP\_2016\_RD0900\_230\_54\_20160219\_00014.jpg

LM Start	<b>4.10</b>	Rating **	M	Issue No.	<b>54</b>
LM End	<b>4.10</b>	Issue Type +	Ma	Location *	LS
Category	Earthen Levee			GPS Latitude/Longitude	
				Start	End
Item	Encroachments			38.534364 °	38.534364 °
				-121.526051 °	-121.526051 °
DWR ID	DWR_RD0900_01_s_2012_54				
Comment Code					
DE : Debris					
Inspector Comment					
Concrete debris with metal posing a safety risk.

View of concrete debris with metal looking upstream.

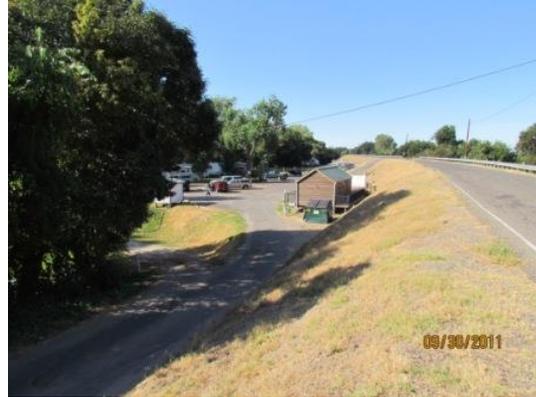
Photo 1 of 1 : SP\_2016\_RD0900\_230\_20\_20160219\_00012.jpg

View of Sherwood harbor's unpermitted properties on the waterside of the levee. The picture was taken from the crown looking upstream.

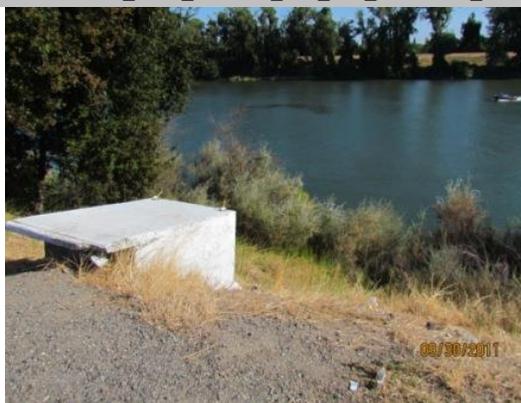
Photo 1 of 1 : SP\_2016\_RD0900\_230\_330\_20160219\_00018.jpg

Concrete anchor was found on the waterside slope of the levee looking upstream.

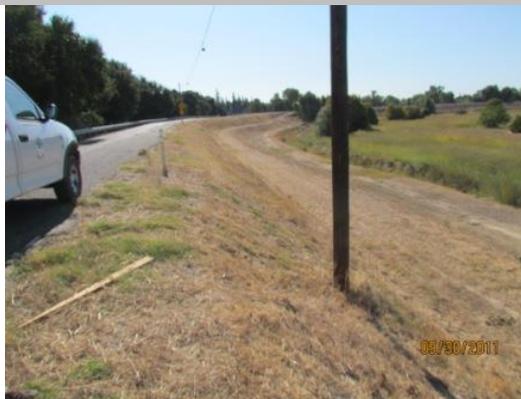
Photo 1 of 1 : SP\_2016\_RD0900\_230\_332\_20160219\_00019.jpg

View of the pole on the landside of the levee looking upstream.

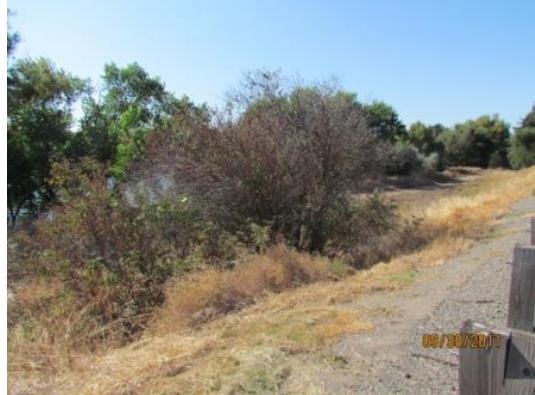
Photo 1 of 1 : SP\_2016\_RD0900\_230\_335\_20160219\_00020.jpg

View of elderberry bush on the waterside of the levee looking upstream.

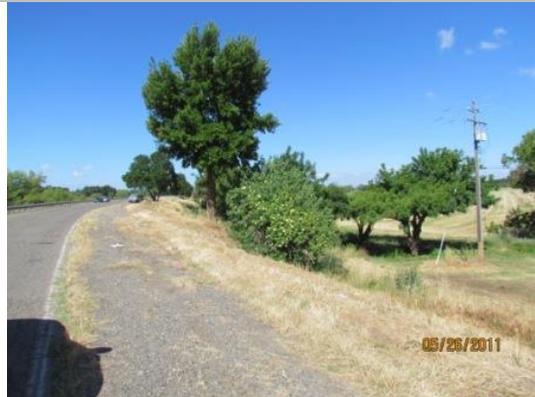
Photo 1 of 1 : SP\_2016\_RD0900\_230\_958\_20160219\_00022.jpg

Elderberry on the landside of the levee. The picture was taken from the crown looking downstream.

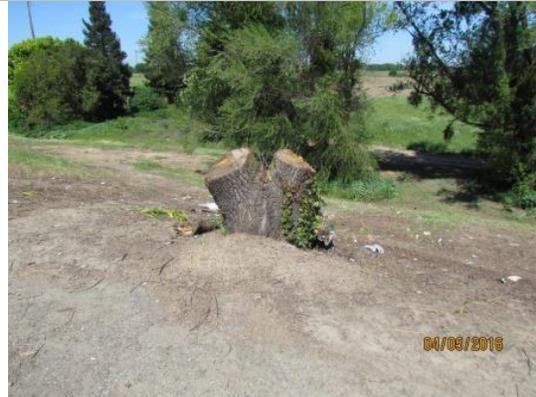
Photo 1 of 1 : SP\_2016\_RD0900\_230\_64\_20160406\_00032.jpg

View of a tree stump on the landside of the levee looking downstream.

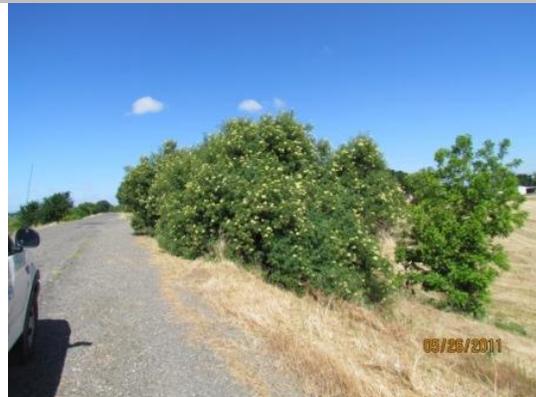
Photo 1 of 1 : SP\_2016\_RD0900\_230\_25\_20160219\_00013.jpg

Elderberry located on the landside of the levee obstructing the view. The picture was taken from the crown looking downstream.

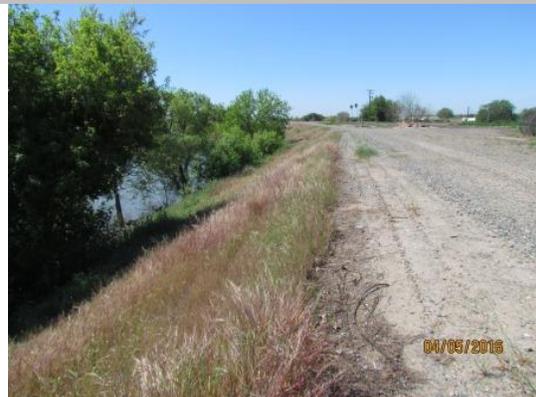
Photo 1 of 1 : SP\_2016\_RD0900\_230\_65\_20160406\_00033.jpg

View of vegetation on the waterside of the levee looking downstream.

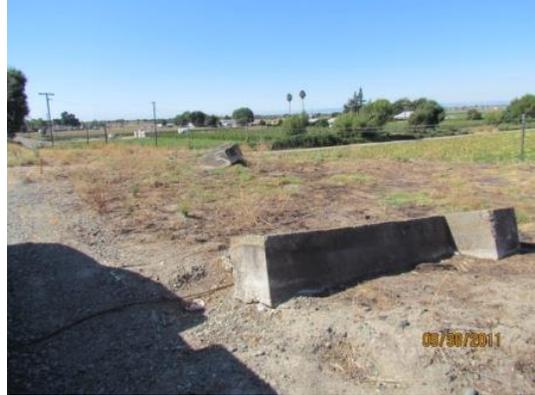
Photo 1 of 1 : SP\_2016\_RD0900\_230\_343\_20160219\_00021.jpg

Concrete debris from old rail road track was found on the landside of the levee looking upstream.

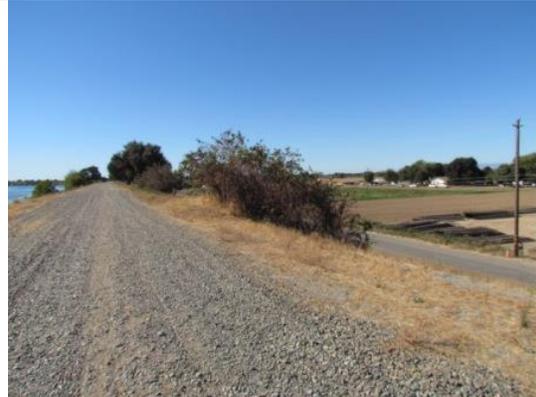
Photo 1 of 1 : SP\_2016\_RD0900\_230\_8\_20160219\_00006.jpg

An elderberry bush was found on the landside of the levee looking downstream.

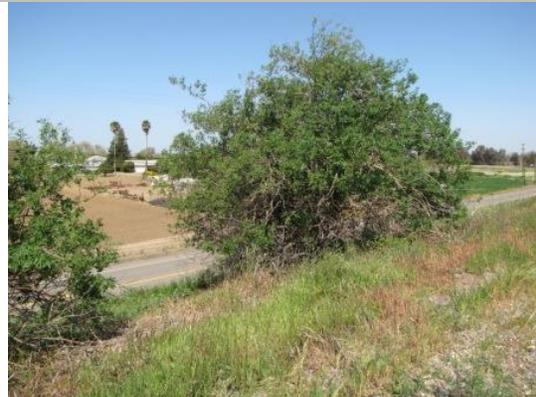
Photo 1 of 1 : SP\_2016\_RD0900\_230\_7\_20160219\_00005.jpg

View of elderberries on the landward slope looking upstream.

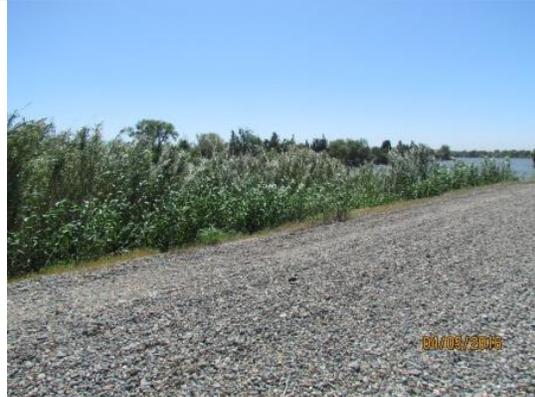
Photo 1 of 2 : SP\_2016\_RD0900\_230\_59\_20160406\_00034.jpg

Updated picture of the arundo on the waterside of the levee during spring 2016 inspection.

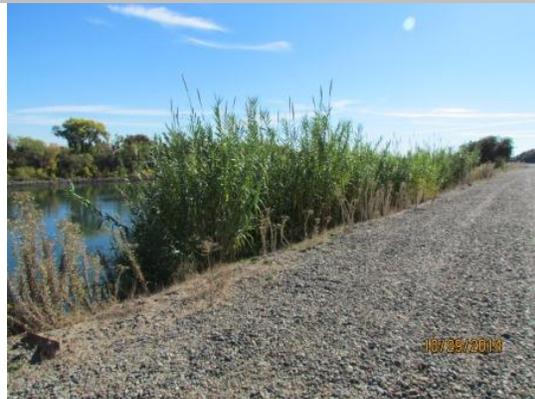
Photo 2 of 2 : SP\_2016\_RD0900\_230\_59\_20160219\_00016.jpg

View of arundo on the waterside of the levee during the fall 2014 inspection.

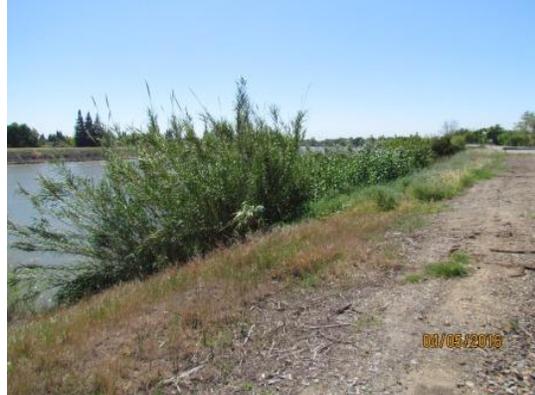
Photo 1 of 2 : SP\_2016\_RD0900\_230\_15\_20160406\_00035.jpg

Updated picture of the arundo on the waterside of the levee during spring 2016 inspection.

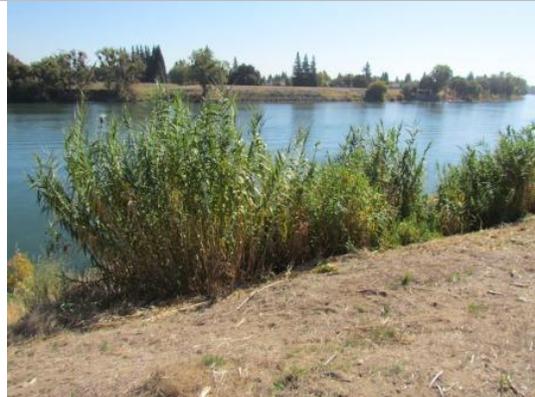
Photo 2 of 2 : SP\_2016\_RD0900\_230\_15\_20160219\_00009.jpg

View of arundo on the waterside of the levee looking downstream.

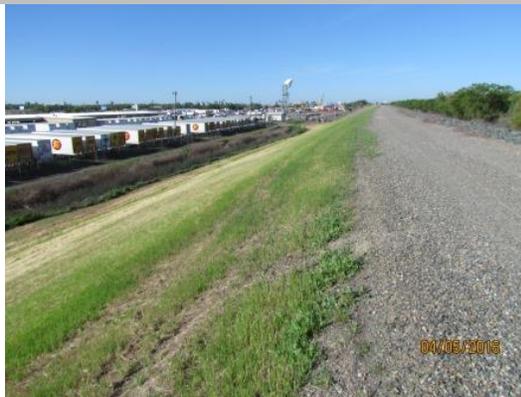
Photo 1 of 1 : SP\_2016\_RD0900\_231\_44\_20160406\_00044.jpg

View of the acceptable vegetation on the landside slope of the levee looking downstream.

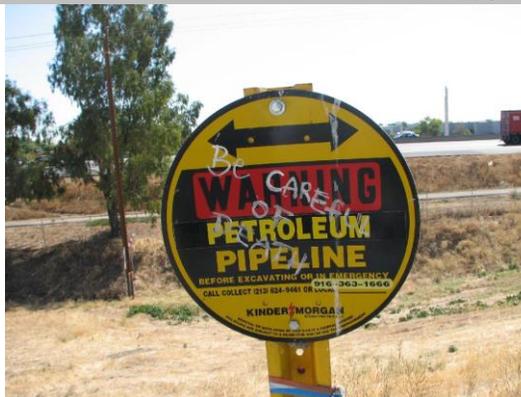
Photo 2 of 2 : UCIP\_SP\_2016\_41825\_72724.jpg

Marker of petroleum pipeline unable to confirm permit--there are 3 gas line in desk study records for gas line but none for Kinder Morgan.

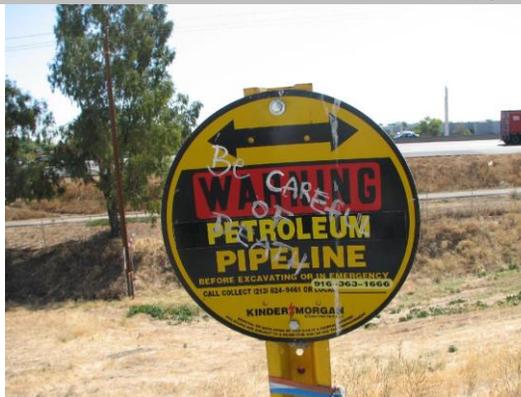
Photo 2 of 2 : UCIP\_SP\_2016\_41824\_72727.jpg

Marker of petroleum pipeline unable to confirm permit--there are 3 gas line in desk study records for gas line but none for Kinder Morgan.

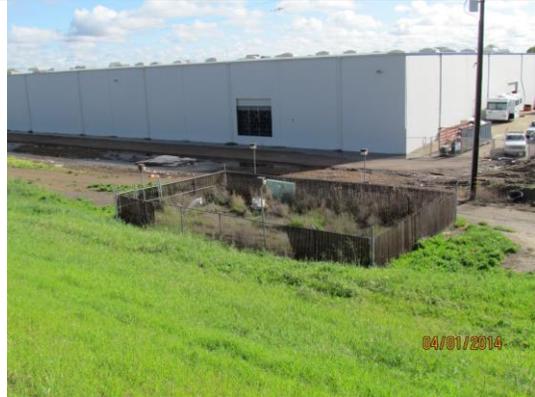
Photo 1 of 1 : SP\_2016\_RD0900\_231\_5\_20160219\_00001.jpg

View of the water well on the landside toe of the levee looking upstream.

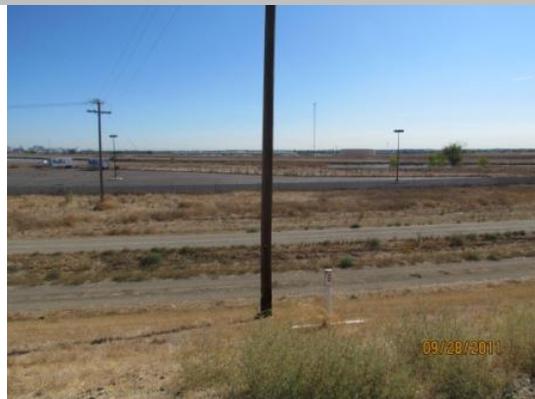
Photo 1 of 1 : SP\_2016\_RD0900\_231\_14\_20160219\_00002.jpg

Wood pole for electrical lines was located on the landside of the levee. The picture was taken from the crown looking upstream.

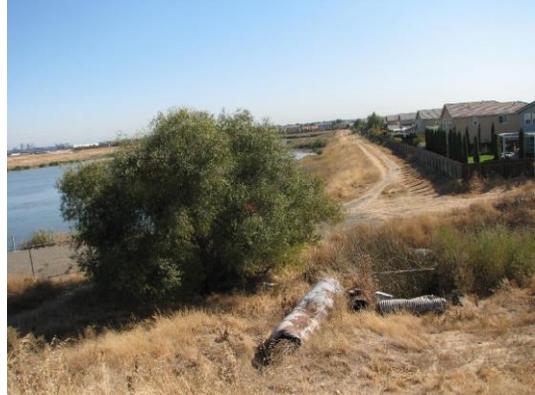
Photo 1 of 2 : UCIP\_SP\_2016\_37785\_68693.jpg

View of pipe sections visible on landward side.

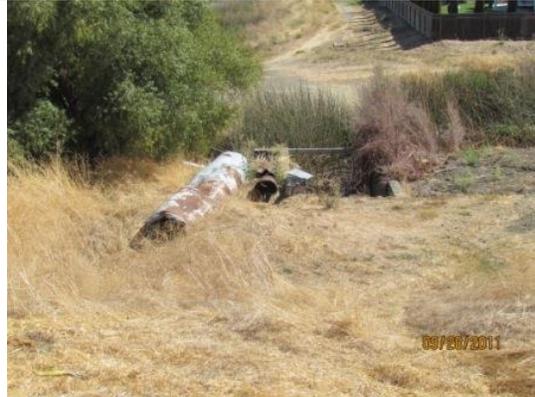
Photo 1 of 1 : SP\_2016\_RD0900\_231\_15\_20160219\_00003.jpg

Abandon pipes and debris was found on the landside of the levee looking upstream.

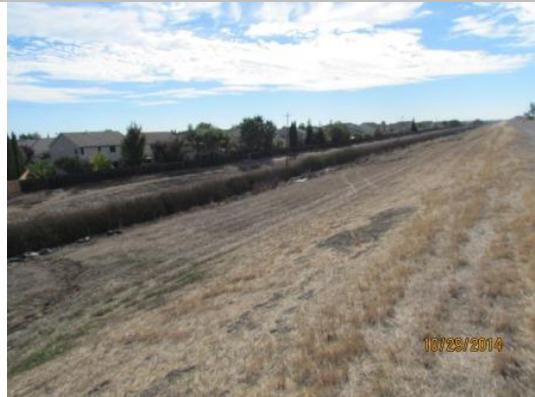
Photo 1 of 1 : SP\_2016\_RD0900\_231\_17\_20160219\_00004.jpg

View of the ditch on the landside toe of the levee looking downstream.
