**Flood Control Project Maintenance
Levee Inspections**
LMA District Cover Sheet
Spring 2016 Levee Inspection Results

Reclamation District No. 1001 Nicolaus

Spring 2016 Levee Inspection Results

Waterway		Bank	Unit Miles
Unit No. 01 Yankee Slough		Right	4.12

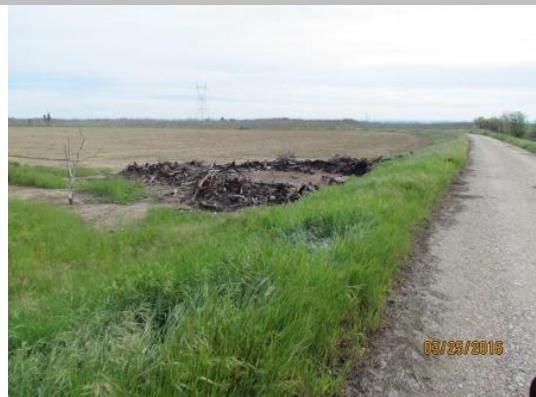
Photo 2 of 2 : SP_2016_RD1001_36_14_20160404_00013.jpg

View of pruning after burning Spring 2016.

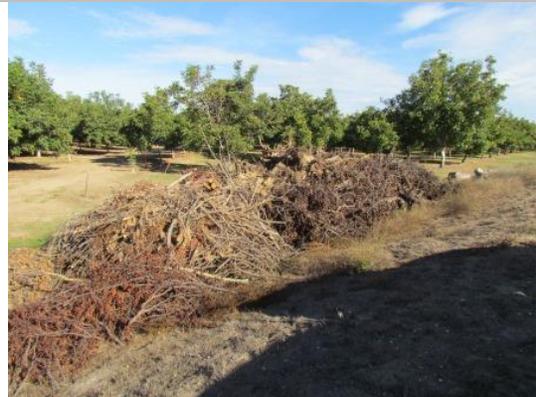
Photo 1 of 1 : SP_2016_RD1001_36_7_20160307_00005.jpg

This photo was taken from the levee crown facing east looking down the landward slope at prunings stacked up at the toe. Fall 2014.

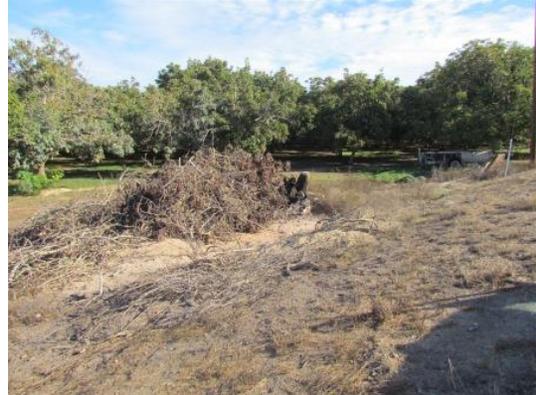
Photo 1 of 1 : SP_2016_RD1001_36_6_20160307_00004.jpg

This photo was taken from the levee crown facing east looking down the landward slope at prunings stacked up at the toe. Fall 2014.

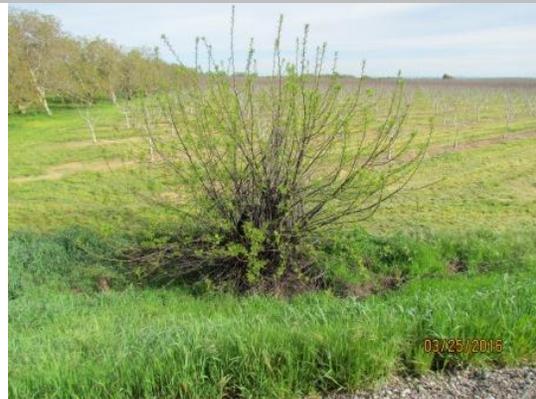
Photo 1 of 1 : SP_2016_RD1001_36_19_20160404_00012.jpg

View of tree that need limbs trimmed.

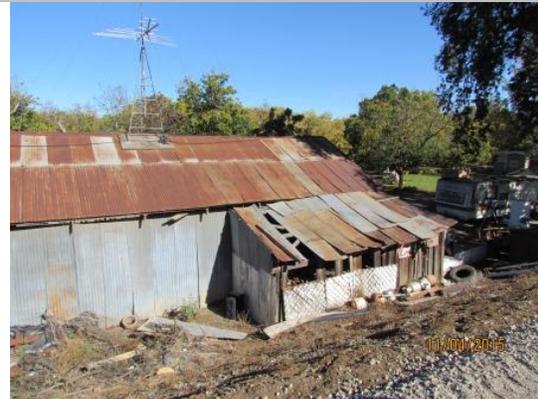
Photo 1 of 1 : SP_2016_RD1001_36_8_20160307_00006.jpg

View of the shed at the landside levee toe.

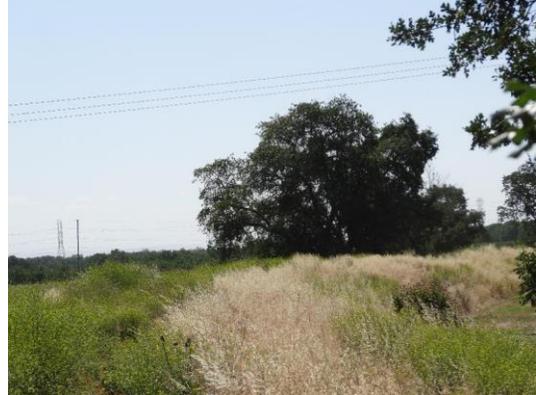
Photo 1 of 2 : UCIP_SP_2016_41673_22745.jpg

Comment Code					
Inspector Comment					
FS_ID:41673 DS_ID:22536 EP_NO: 5562 Repair Type: Non-Urgent Crossing Status: Found UCIP Comments: Pipe appears abandoned and if so should be done so properly. WS pipe plugged with stopper. Seems abandoned. Only abandoned pump base found. FIELD_STRUCT_DESC: 6-inch steel irrigation pipe through the levee, 3.5 feet below the crown, pump (removed) and pump base on the waterward berm, siphon breaker on the landward shoulder, pipe discharges into underground irrigation system on the landward side. Power pole and meter box 10 feet from the landward toe, 1-1/2-inch flexible conduit through levee, 3.5 feet below crown (Permit No. 5562, 1966) FS Date: 5/23/2013

Levee Crown: dense vegetation on levee crown and sides.

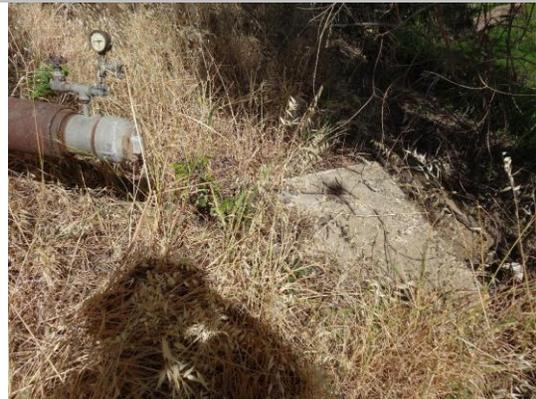
Photo 2 of 2 : UCIP_SP_2016_41673_22744.jpg

WS- plugged pipe and pump base.

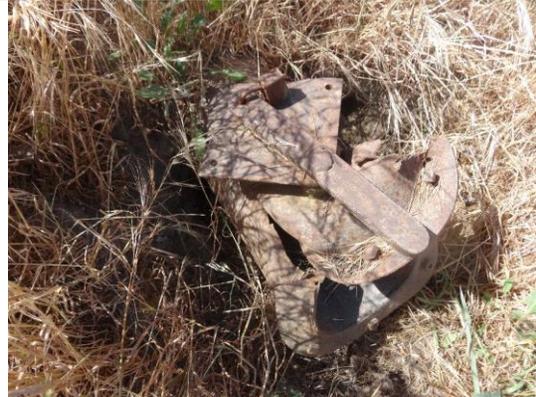
Photo 1 of 2 : UCIP_SP_2016_13847_22753.jpg

LM Start	0.47	Rating **	U	Issue No.	53
LM End	0.47	Issue Type +	En	Location *	WS
Category	Supplemental			GPS Latitude/Longitude	
				Start	End
Item	DWR UCIP Field Study			38.974329 °	38.974329 °
				-121.480043 °	-121.480043 °
DWR ID					
Comment Code					
Inspector Comment					
FS_ID:13847 DS_ID:22529 EP_NO: 2281 Repair Type: Urgent Crossing Status: Found UCIP Comments: - leaky pipe end and erosion on WS.- cracked dirt mound on LS - seems not been used for some time. FIELD_STRUCT_DESC: 8-inch steel pipe through the levee, 1.9 feet below the crown, portable pump mounted on the bank during the summer months, control valve on the waterward side, steel plate bolted on the waterward end during the winter months, the pipe discharges into a 30-inch concrete standpipe at the landward toe (Permit No. 2281, 1956) FS Date: 5/23/2013

WS- end of the pipe.

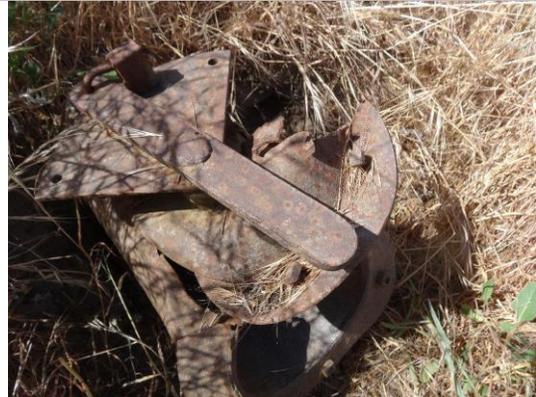
Photo 2 of 2 : UCIP_SP_2016_13847_22752.jpg

WS- seems abandoned or not been used for some time.

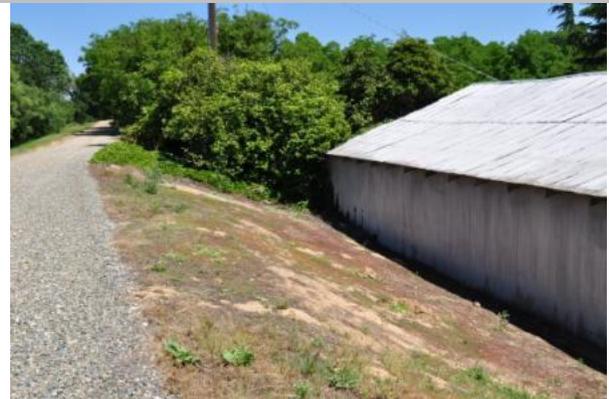
Photo 1 of 1 : SP_2016_RD1001_35_11_20160307_00006.jpg

RD 1001 Unit 2 - L/S -Building @ toe.

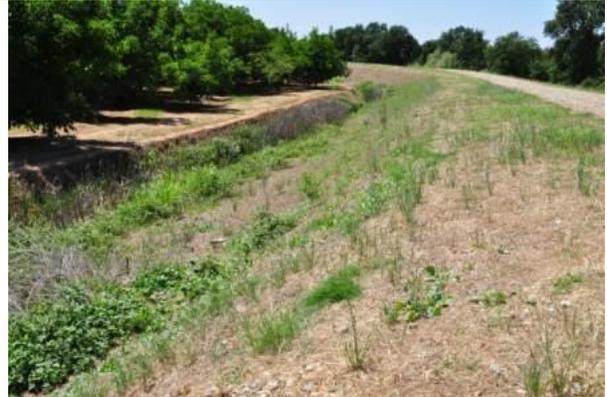
Photo 1 of 1 : SP_2016_RD1001_35_52_20160307_00009.jpg

RD 1001 Unit 2 - L/S - Drainage Ditch @ toe.

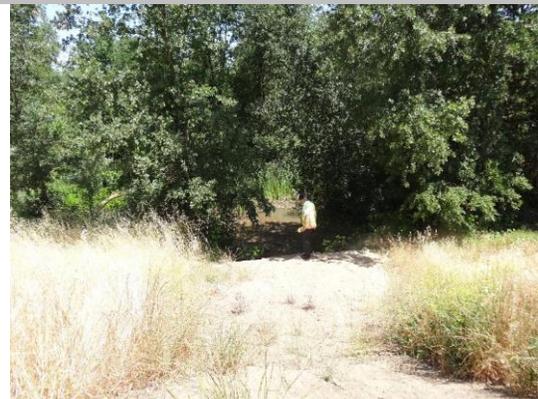
Photo 1 of 2 : UCIP_SP_2016_14008_23108.jpg

LM Start	2.28	Rating **	M	Issue No.	54
LM End	2.28	Issue Type +	En	Location *	LS
Category	Supplemental			GPS Latitude/Longitude	
				Start	End
Item	DWR UCIP Field Study			38.967403 °	38.967403 °
				-121.510953 °	-121.510953 °
DWR ID					
Comment Code					
Inspector Comment					
FS_ID:14008 DS_ID:22543 EP_NO: N/A Repair Type: Non-Urgent Crossing Status: Found UCIP Comments: - slide gate in inlet pipe on landside - pits on pipe due to corrosion FIELD_STRUCT_DESC: 36-inch corrugated-metal drainage pipe through the levee, 15.0 feet below the crown, concrete-U headwall and flap gate at outfall on the waterward end and slide gate on landside inlet (R.D. No. 1001). O&M Manual Sac 141, August 1955. FS Date: 5/23/2013

WS- overview of waterside of the levee.

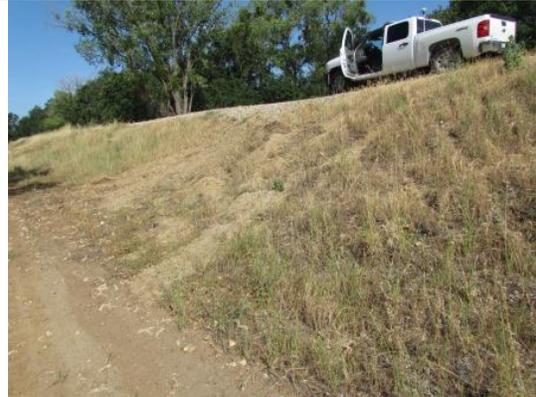
Photo 1 of 1 : SP_2016_RD1001_37_23_20160307_00011.jpg

LM Start	0.14	Rating **	M	Issue No.	23
LM End	0.14	Issue Type +	Ma	Location *	LS
Category	Earthen Levee			GPS Latitude/Longitude	
				Start	End
Item	Slope Stability			39.006351 °	39.006351 °
				-121.377313 °	-121.377313 °
DWR ID	DWR_RD1001_03_s_2015_23				
Comment Code					
S3 : Repair the levee slope damaged by vehicle traffic and prevent access where possible.					
Inspector Comment

View of the rutting on the landside of the levee from the toe facing downstream.

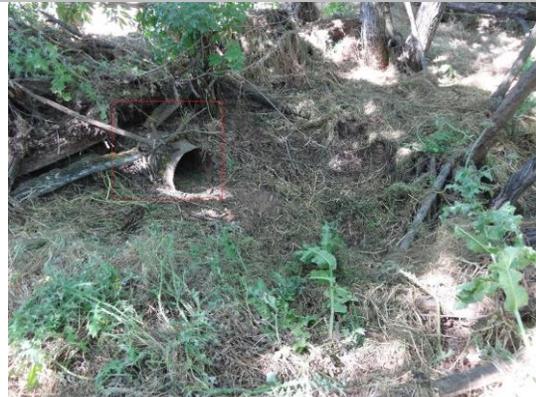
Photo 1 of 2 : UCIP_SP_2016_14128_23308.jpg

LM Start	0.88	Rating **	M	Issue No.	911
LM End	0.88	Issue Type +	En	Location *	LS
Category	Supplemental			GPS Latitude/Longitude	
				Start	End
Item	DWR UCIP Field Study			39.006508 °	39.006508 °
				-121.391086 °	-121.391086 °
DWR ID					
Comment Code					
Inspector Comment					
FS_ID:14128 DS_ID:22549 EP_NO: 958 Repair Type: Non-Urgent Crossing Status: Found UCIP Comments: - slide gate on WS not found- needs abandoned properly. FIELD_STRUCT_DESC: Abandoned 24-inch irrigation pipe through the levee.(Permit No. 958, 1944) FS Date: 5/21/2013

WS- abandoned CMP on berm of the levee.

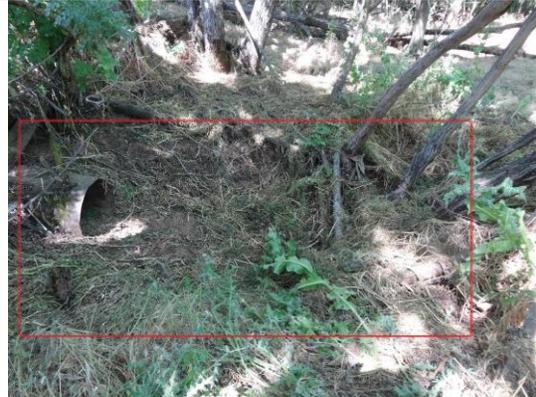
Photo 2 of 2 : UCIP_SP_2016_14128_23307.jpg

WS- abandoned CMP and depression around it.

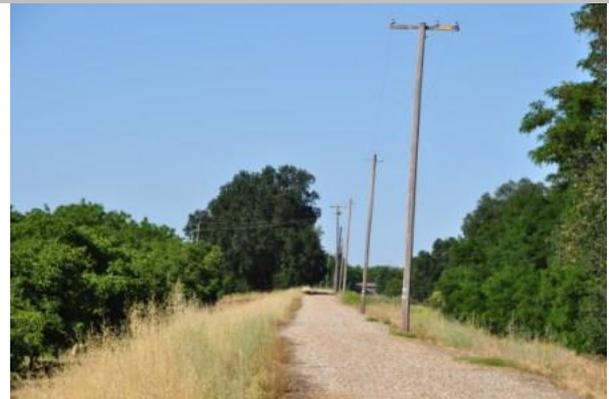
Photo 1 of 1 : SP_2016_RD1001_37_3_20160307_00004.jpg

LM Start	1.16	Rating **	M	Issue No.	3
LM End	1.78	Issue Type +	En	Location *	WS
Category	Earthen Levee			GPS Latitude/Longitude	
				Start	End
Item	Encroachments			39.005730 °	38.999534 °
				-121.396111 °	-121.404395 °
DWR ID	DWR_RD1001_03_s_2012_3				
Comment Code					
PO : Pole					
Inspector Comment

RD 1001 Unit 3 - Power Poles along W/S shoulder.

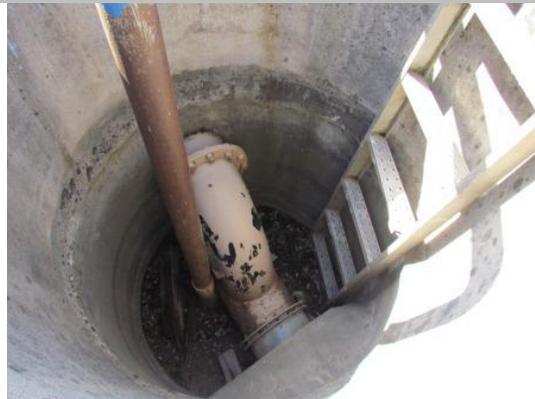
Photo 2 of 2 : SP_2016_RD1001_37_669_20160307_00022.jpg

This photo shows a pipe within a pipe on the on the landward side of the levee. Spring 2014.

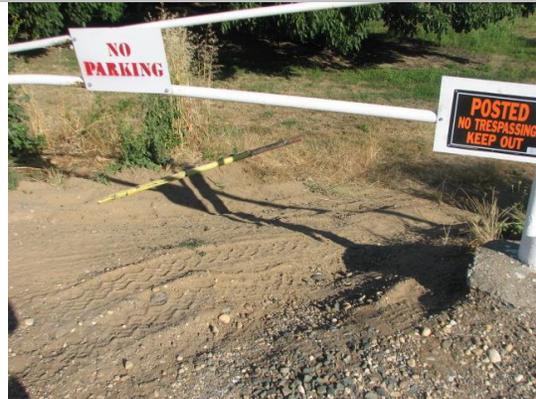
Photo 1 of 2 : SP_2016_RD1001_37_28_20160307_00013.jpg

LM Start	1.87	Rating **	A/W	Issue No.	28
LM End	1.87	Issue Type +	Ma	Location *	WS
Category	Earthen Levee			GPS Latitude/Longitude	
				Start	End
Item	Slope Stability			38.998608 °	38.998608 °
				-121.405570 °	-121.405570 °
DWR ID	DWR_RD1001_03_s_2013_28				
Comment Code					
S3 : Repair the levee slope damaged by vehicle traffic and prevent access where possible.					
Inspector Comment

Damage caused by vehicles Spring 2013

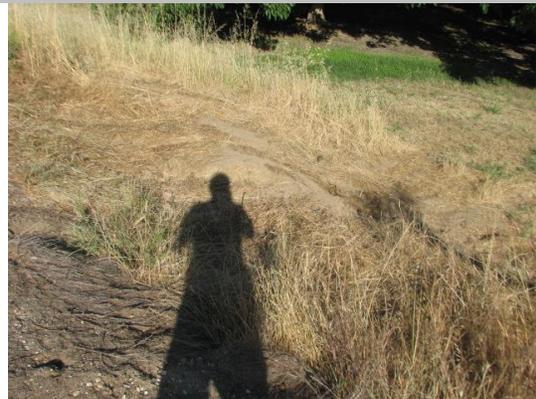
Photo 2 of 2 : SP_2016_RD1001_37_28_20160307_00014.jpg

Damage caused by vehicles. Spring 2013

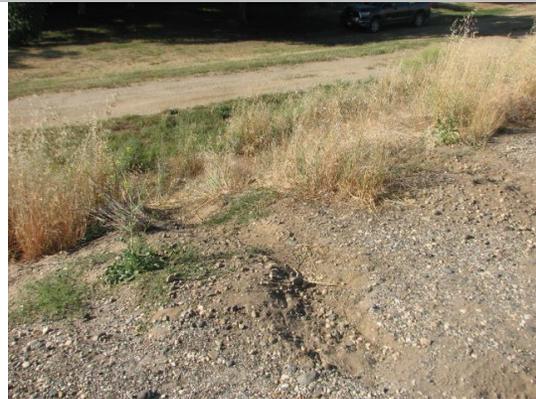
Photo 1 of 2 : SP_2016_RD1001_37_29_20160307_00015.jpg

Damage caused by vehicles going around the gate. Spring 2013

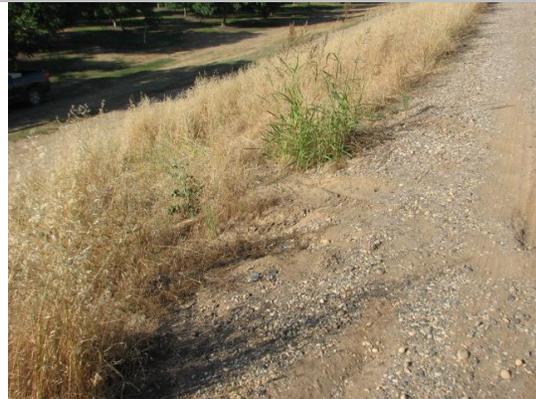
Photo 2 of 2 : SP_2016_RD1001_37_29_20160307_00016.jpg

Damage caused by vehicles. Spring 2013

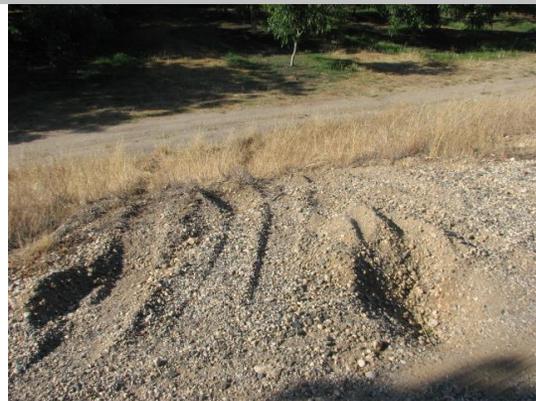
Photo 1 of 1 : SP_2016_RD1001_37_30_20160307_00017.jpg

Damage caused by vehicles. Spring 2013

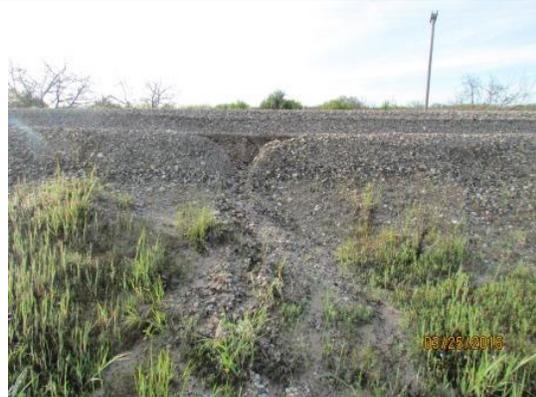
Photo 1 of 1 : SP_2016_RD1001_37_21_20160404_00033.jpg

Erosion on waterside slope.

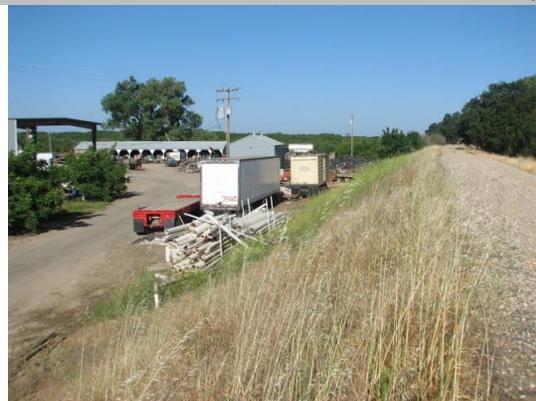
Photo 1 of 1 : SP_2016_RD1001_37_7_20160307_00007.jpg

Irrigation pipe equipment and plastic cans within the easement of the levee. Spring 2013

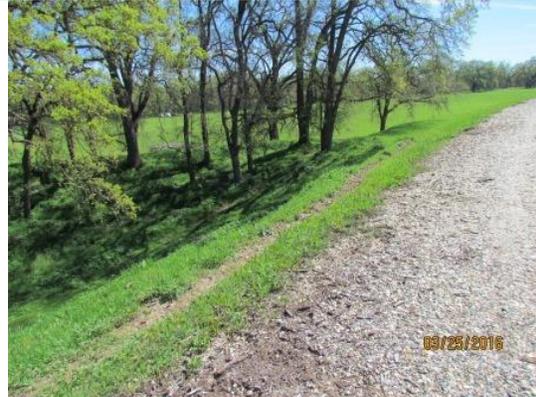
Photo 1 of 1 : SP_2016_RD1001_38_64_20160404_00044.jpg

Livestock trail cut into landside slope.

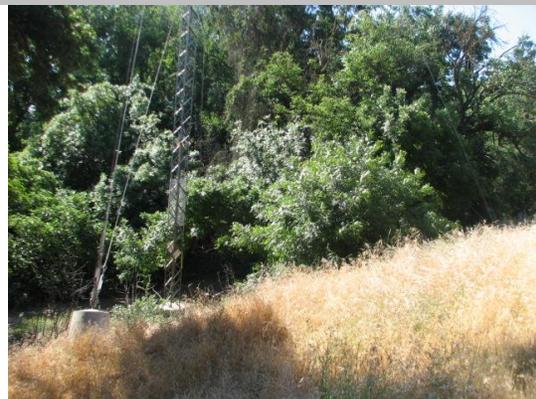
Photo 1 of 1 : SP_2016_RD1001_38_19_20160307_00011.jpg

Power pole and guy wire on the levee slope. Spring 2013

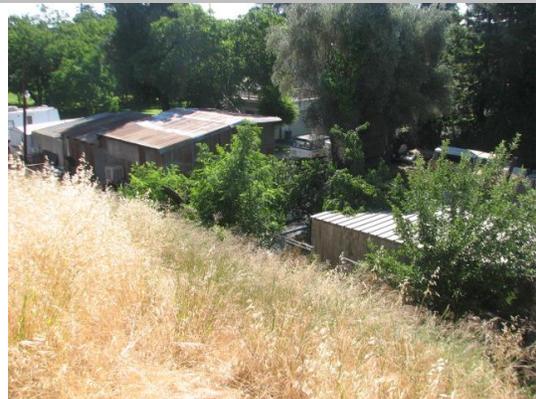
Photo 1 of 1 : SP_2016_RD1001_38_20_20160307_00012.jpg

Buildings along the toe within the easement of the levee. Spring 2013

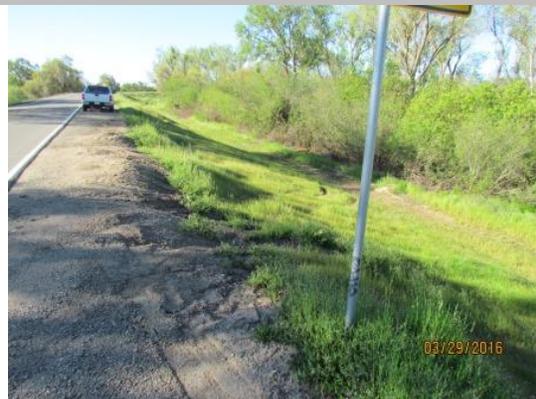
Photo 1 of 1 : SP_2016_RD1001_38_78_20160404_00046.jpg

Ruts on waterside slope due to vehicles.

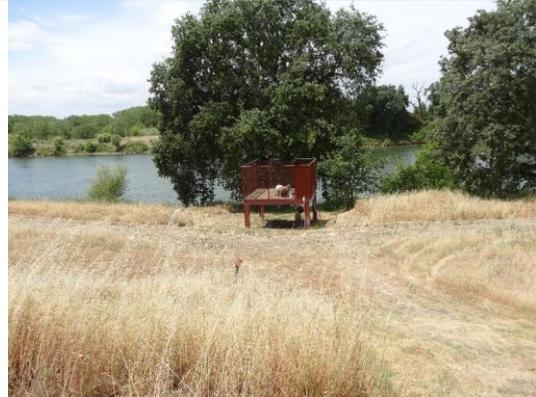
Photo 1 of 2 : UCIP_SP_2016_14604_24107.jpg

WS- slanted pump station on steel platform on levee berm.

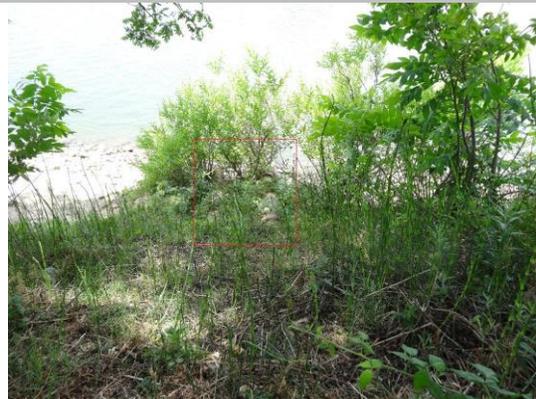
Photo 2 of 2 : UCIP_SP_2016_14604_24106.jpg

WS- inlet pipe on the river bank.

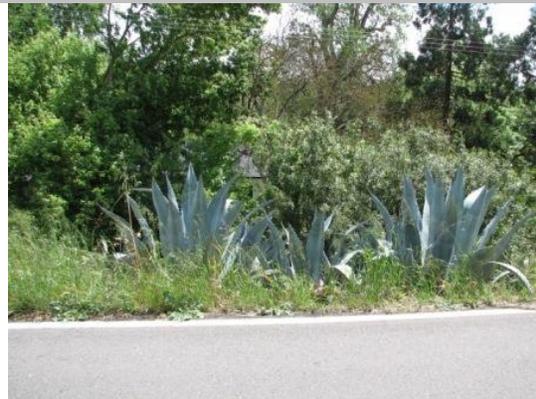
Photo 2 of 2 : SP_2016_RD1001_38_17_20160307_00010.jpg

Landscaping on the landside shoulder and slope.

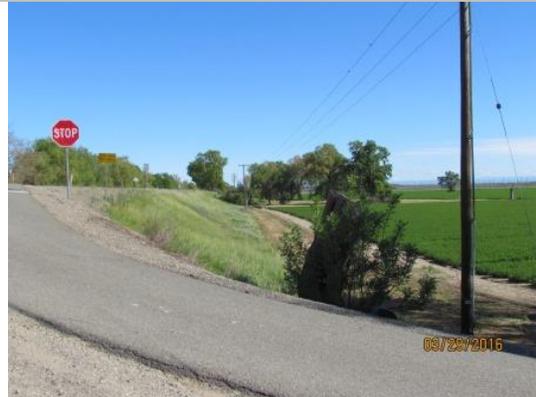
Photo 1 of 1 : SP_2016_RD1001_38_83_20160404_00049.jpg

View of tree stump on the landside toe.

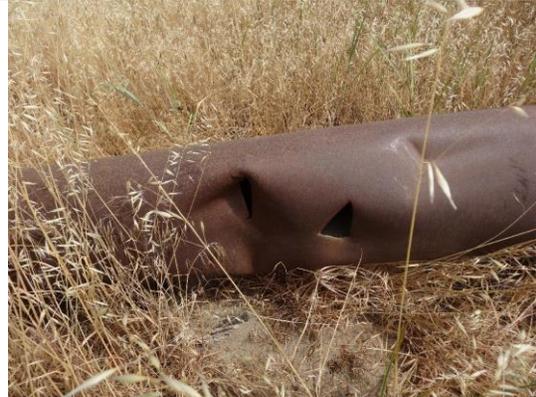
Photo 2 of 2 : UCIP_SP_2016_14544_23965.jpg

WS- abandoned damaged pipe with holes, cracks on levee slope.

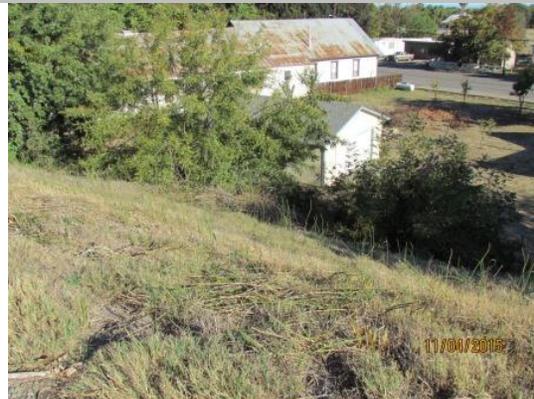
Photo 1 of 1 : SP_2016_RD1001_38_37_20160307_00020.jpg

View of the landscaping at the landside levee toe.

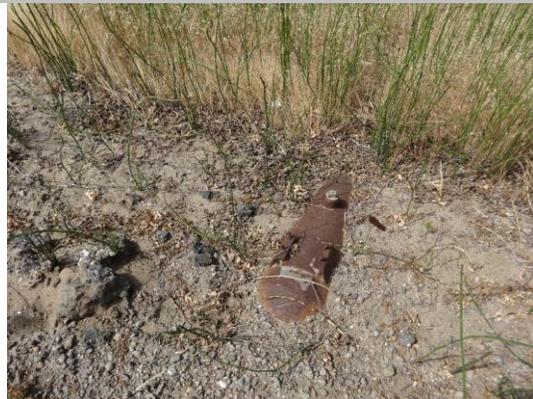
Photo 2 of 2 : UCIP_SP_2016_14627_24133.jpg

WS- exposed pipe on levee slope.

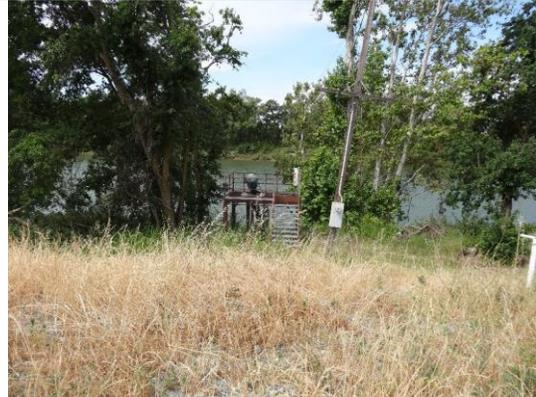
Photo 1 of 2 : UCIP_SP_2016_41723_23977.jpg

WS- slant pump on steel structure in river bank.

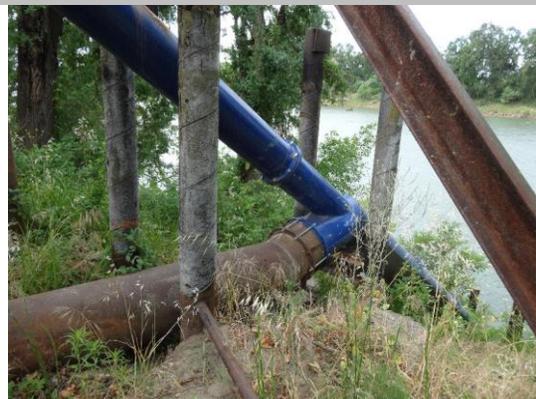
Photo 2 of 2 : UCIP_SP_2016_41723_23976.jpg

WS- main steel pipe on levee surface (without paint).

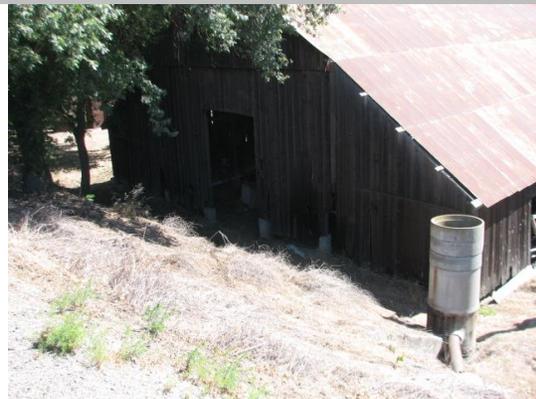
Photo 1 of 1 : SP_2016_RD1001_38_29_20160307_00016.jpg

The building is within the easement of the levee. Spring 2013

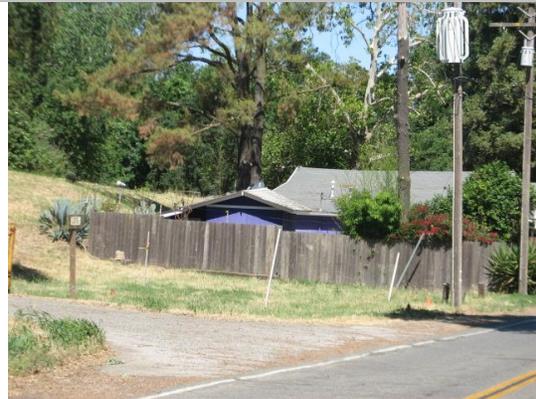
Photo 2 of 2 : SP_2016_RD1001_38_25_20160307_00014.jpg

A building is at the toe of the levee. Spring 2013

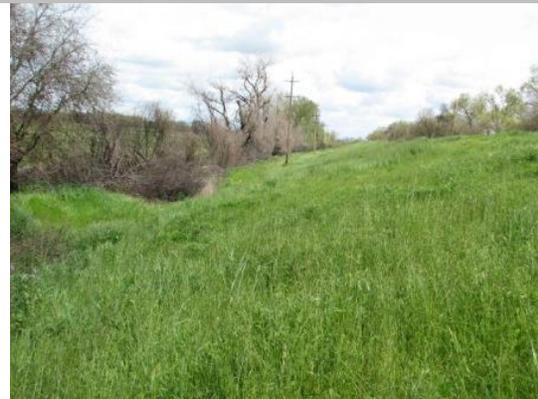
Photo 2 of 2 : SP_2016_RD1001_39_5_20160307_00006.jpg

Poles at the land side toe.

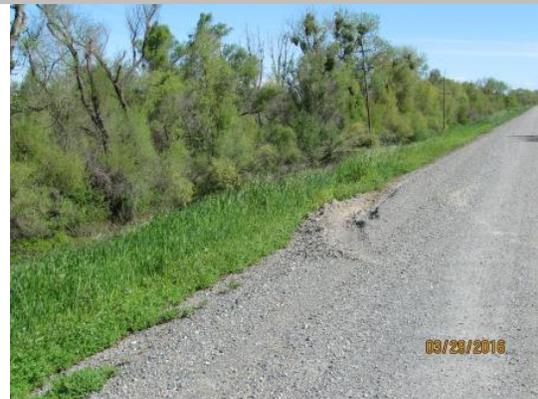
Photo 1 of 1 : SP_2016_RD1001_39_20_20160404_00031.jpg

Vehicle rut on landside crown.

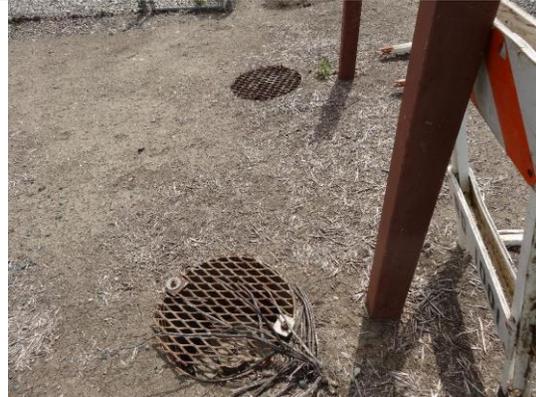
Photo 1 of 2 : UCIP_SP_2016_43047_23784.jpg

WS- two siphon breakers covered with steel screen.

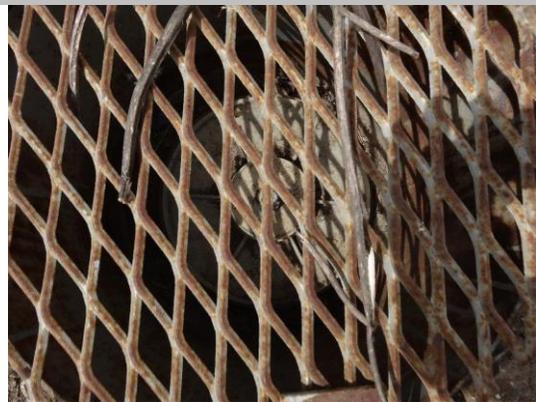
Photo 2 of 2 : UCIP_SP_2016_43047_23783.jpg

WS- siphon breaker covered with steel screen.

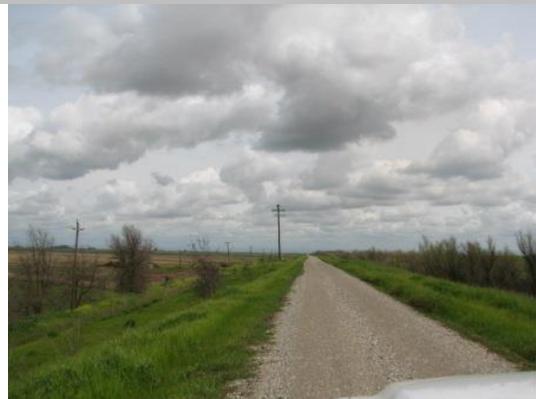
Photo 2 of 2 : SP_2016_RD1001_39_6_20160307_00008.jpg

Pole on land side shoulder.

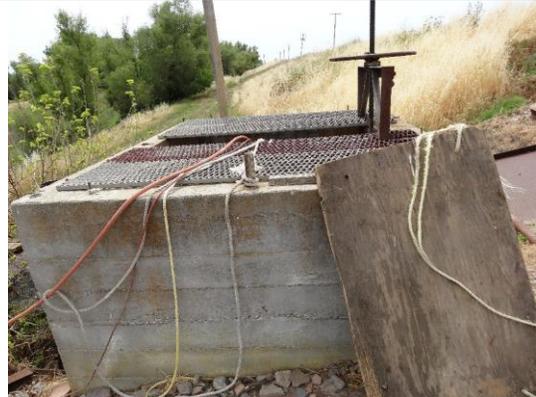
Photo 2 of 2 : UCIP_SP_2016_14484_23898.jpg

WS- slide gate in concrete box on levee toe.

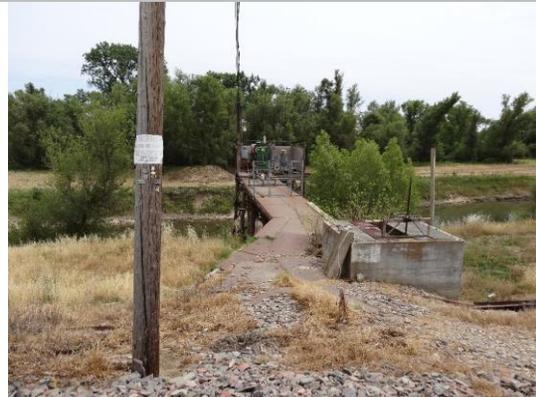
Photo 1 of 2 : UCIP_SP_2016_14472_23891.jpg

WS- pump station, walkway, and slide gate in concrete box on levee toe

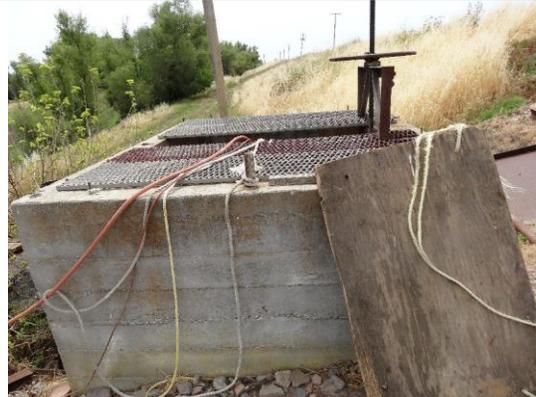
Photo 2 of 2 : UCIP_SP_2016_14472_23890.jpg

WS- slide gate in concrete box on levee toe

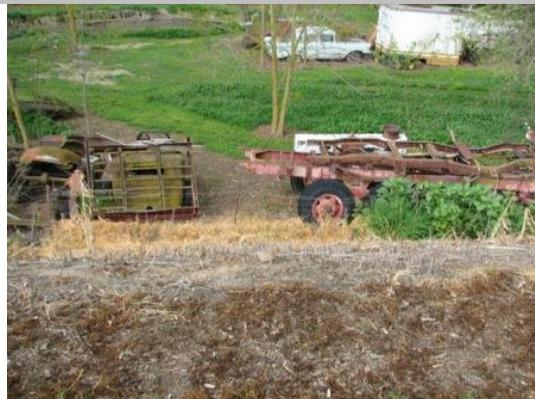
Photo 1 of 1 : SP_2016_RD1001_40_6_20160307_00003.jpg

Equipment at the landside toe LM 1.37.

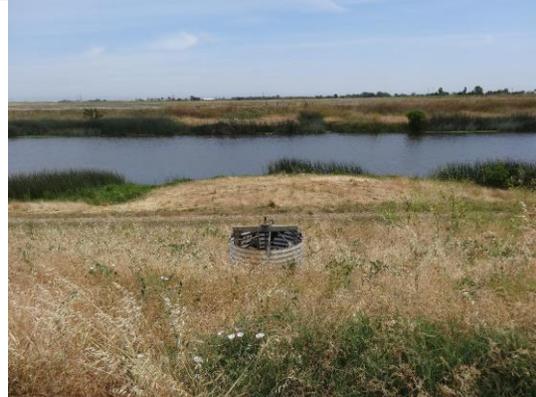
Photo 1 of 2 : UCIP_SP_2016_14244_23467.jpg

WS- slide gate in CMP riser on levee slope.

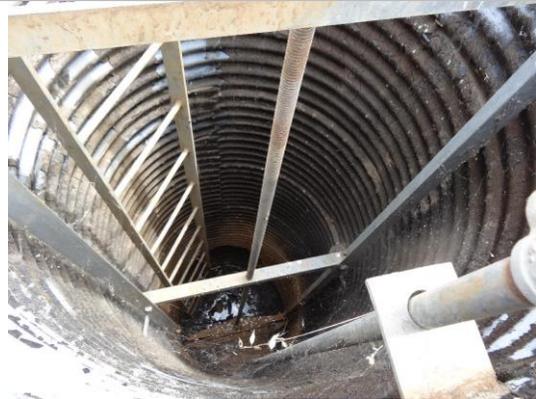
Photo 2 of 2 : UCIP_SP_2016_14244_23466.jpg

WS- slide gate, air vent pipe in CMP riser on levee slope.

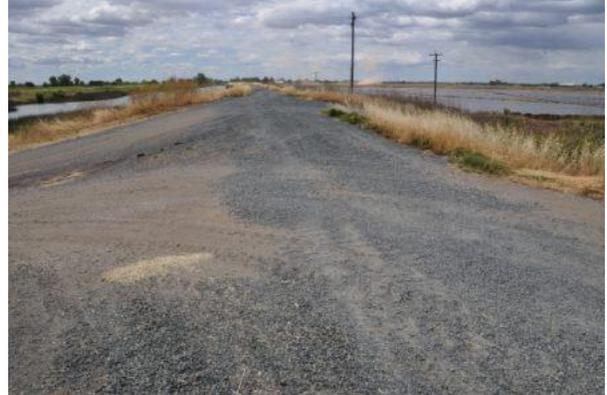
Photo 1 of 1 : SP_2016_RD1001_40_8_20160307_00005.jpg

RD 1001 Unit 6 - Levee Crown - Subsidence due to vehicle traffic.

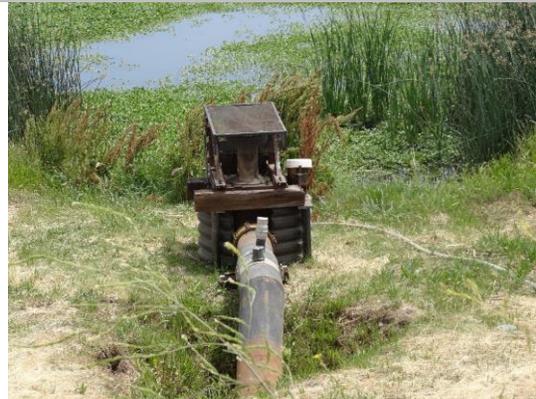
Photo 1 of 2 : UCIP_SP_2016_14204_23427.jpg

WS- pump and pipe on river bank

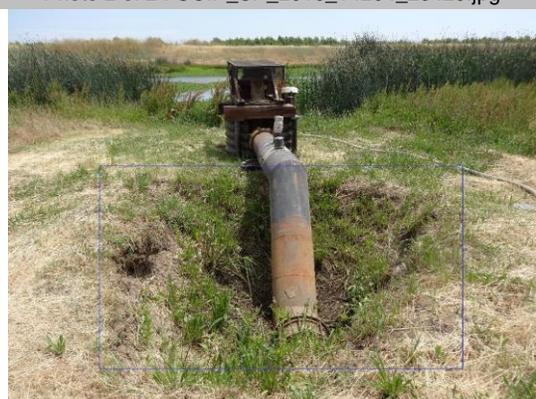
Photo 2 of 2 : UCIP_SP_2016_14204_23429.jpg

WS- large depression on levee berm

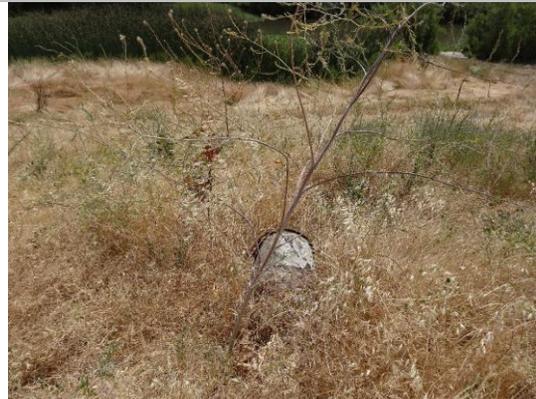
Photo 1 of 2 : UCIP_SP_2016_41674_23382.jpg

WS- an abandoned pipe on levee slope

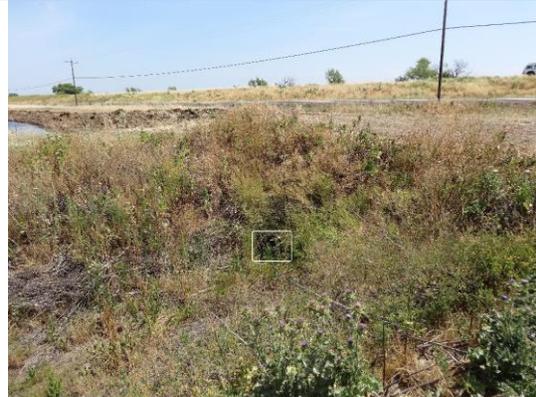
Photo 2 of 2 : UCIP_SP_2016_14167_23395.jpg

LS- CMP opens in irrigation ditch.

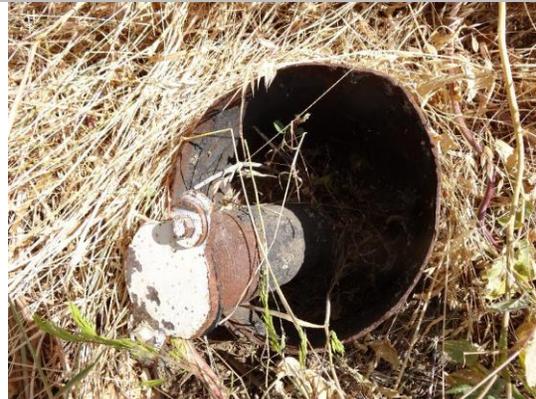
Photo 1 of 2 : UCIP_SP_2016_13523_22121.jpg

WS- a 4-inch steel pipe sleeved through 10-inch steel pipe.

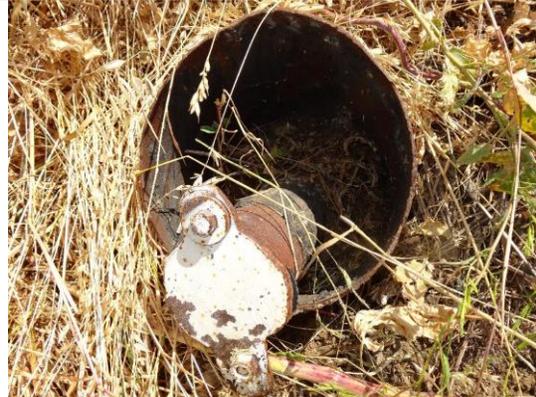
Photo 2 of 2 : UCIP_SP_2016_13523_22120.jpg

WS- gap between two pipes needs to be filled.

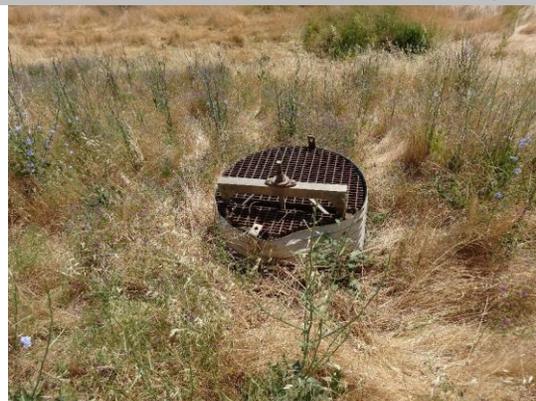
Photo 1 of 2 : UCIP_SP_2016_13509_22086.jpg

WS- fixed slide gate in CMP riser on levee slope.

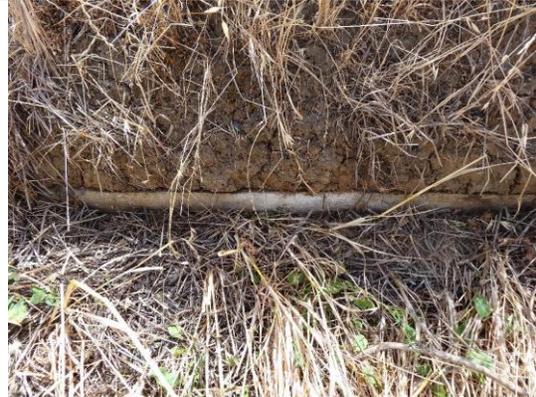
Photo 2 of 2 : UCIP_SP_2016_13509_22085.jpg

LS- almost buried concrete headwall. Only upper portion of the wall is visible.

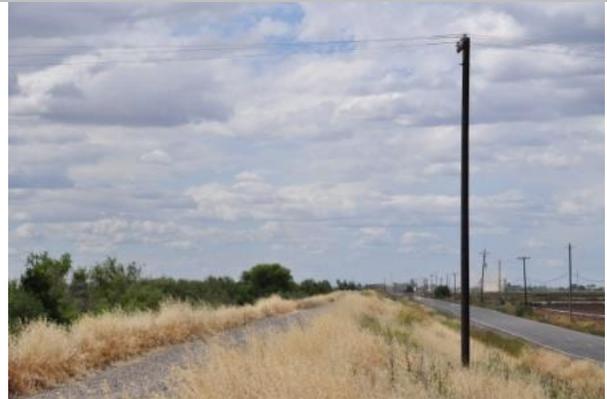
Photo 1 of 1 : SP_2016_RD1001_40_48_20160307_00008.jpg

RD 1001 Unit 6 - L/S Slope - Pole

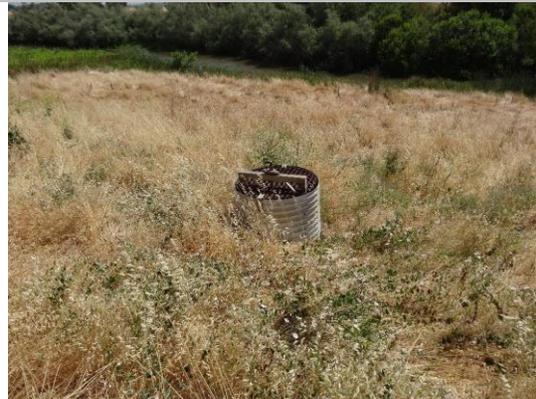
Photo 1 of 2 : UCIP_SP_2016_43048_22046.jpg

WS- slide gate, air vent in CMP riser on levee slope

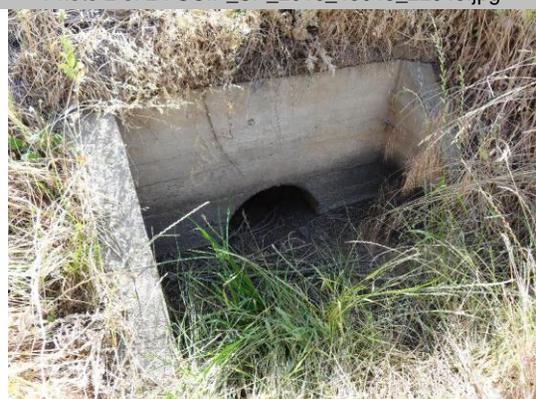
Photo 2 of 2 : UCIP_SP_2016_43048_22045.jpg

LS- CMP in concrete head/wing wall outlet

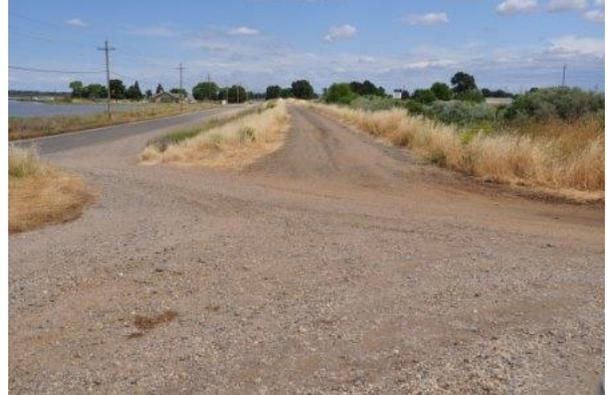
Photo 1 of 1 : SP_2016_RD1001_40_7_20160307_00004.jpg

RD 1001 Unit 6 - Levee Crown - Subsidence due to vehicle traffic.

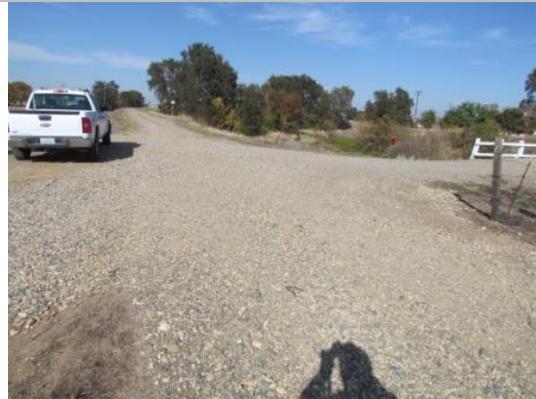
Photo 1 of 1 : SP_2016_RD1001_40_19_20160307_00006.jpg

This photo was taken from the levee crown facing north looking at subsidence due to vehicle traffic across crown. Fall 2013.
