**Flood Control Project Maintenance  
Levee Inspections**

**Fall 2015 Levee Maintenance Deficiency Summary Report**

**Reclamation District No. 2060 Hastings**

**Levee Inspection Report By Mile - Fall 2015**

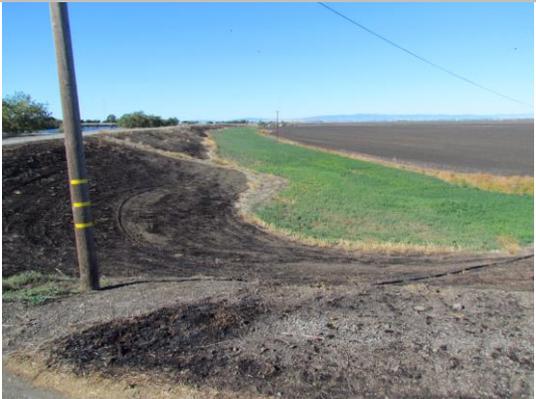
Photo 1 of 1 : FA\_2015\_RD2060\_241\_3\_20151103\_00002.jpg

LM Start	<b>0.00</b>	Rating **	A	Issue No.	<b>3</b>
LM End	<b>1.54</b>	Issue Type +	Ma	Location *	LS
Category	Earthen Levee		GPS Latitude/Longitude		
			Start	End	
Item	Vegetation		38.247345 °	38.252453 °	
			-121.696287 °	-121.722590 °	
DWR ID	DWR_RD2060_01_f_2015_3				
Action/Comments					
Control annual grass and weeds on the levee slopes and easements. Inspector Comments: The District has burned the landside levee slope where possible in this area.

RD 2060 Landside levee slope from levee mile 0.00 looking downstream.

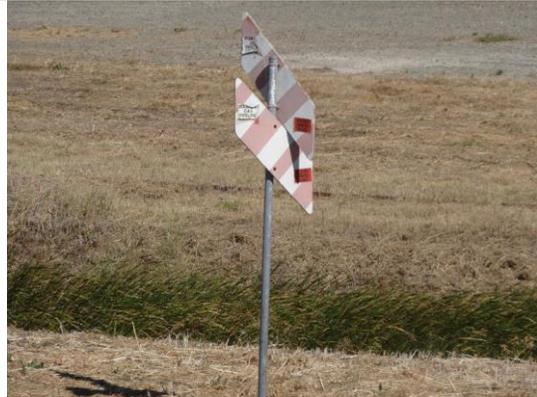
Photo 1 of 2 : UCIP\_FA\_2015\_1544.jpg

LM Start	<b>3.65</b>	Rating **	M	Issue No.	<b>18</b>
LM End	<b>3.65</b>	Issue Type +	En	Location *	LS
Category	Supplemental			GPS Latitude/Longitude	
				Start	End
Item	DWR UCIP Field Study			38.261314 °	38.261314 °
				-121.749191 °	-121.749191 °
DWR ID					
Action/Comments					
Inspector Comments: FS_ID:41908 DS_ID:22050 EP_NO: 10119 FS_HLM: 3.667 Repair Type: Non-Urgent Crossing Status: Indicator Found UCIP Comments: Need to contact owner and verify status of crossing. FIELD_STRUCT_DESC: 8-5/8-inch gas pipeline crosses Lindsey Slough to R.D. 536. Gasline marker on LS and sign board on WS. (Permit no. 10119) FS Date: 08/15/2013

LS view: gasline indicator across the road from levee toe.

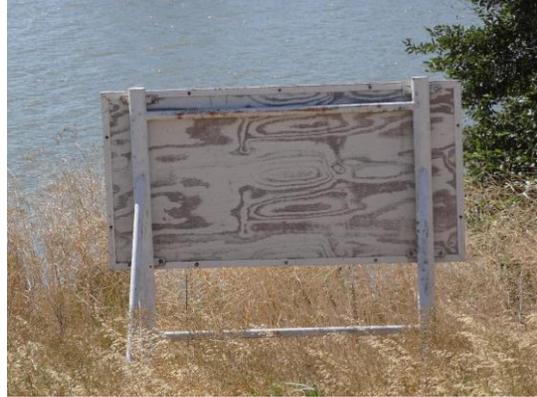
Photo 2 of 2 : UCIP\_FA\_2015\_1545.jpg

LM Start	3.65	Rating **	M	Issue No.	18 (cont)
LM End	3.65	Issue Type +	En	Location *	LS
Category	Supplemental			GPS Latitude/Longitude	
			Start	End	
Item	DWR UCIP Field Study			38.261314 °	38.261314 °
				-121.749191 °	-121.749191 °
DWR ID					
Action/Comments					
Inspector Comments: FS_ID:41908 DS_ID:22050 EP_NO: 10119 FS_HLM: 3.667 Repair Type: Non-Urgent Crossing Status: Indicator Found UCIP Comments: Need to contact owner and verify status of crossing. FIELD_STRUCT_DESC: 8-5/8-inch gas pipeline crosses Lindsey Slough to R.D. 536. Gasline marker on LS and sign board on WS. (Permit no. 10119) FS Date: 08/15/2013

WS view: gasline sign board on levee slope.

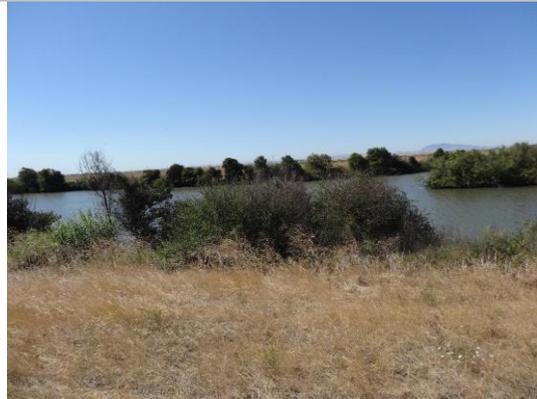
Photo 1 of 3 : UCIP\_FA\_2015\_1548.jpg

LM Start	3.76	Rating **	M	Issue No.	19
LM End	3.76	Issue Type +	En	Location *	LS
Category	Supplemental			GPS Latitude/Longitude	
			Start	End	
Item	DWR UCIP Field Study			38.261211 °	38.261211 °
				-121.751117 °	-121.751117 °
DWR ID					
Action/Comments					
Inspector Comments: FS_ID:41878 DS_ID:22045 EP_NO: 12784 FS_HLM: 3.747 Repair Type: Non-Urgent Crossing Status: Indicator Found UCIP Comments: Need to contact owner to determine status and install signs if appropriate. FIELD_STRUCT_DESC: 8.625-inch diameter natural gas pipeline across the channel and both levees of Lindsey Slough. 4 feet below the crown. Gasline marker found off LS (Permit No. 12784). FS Date: 08/15/2013

WS view: no indicators found on WS.

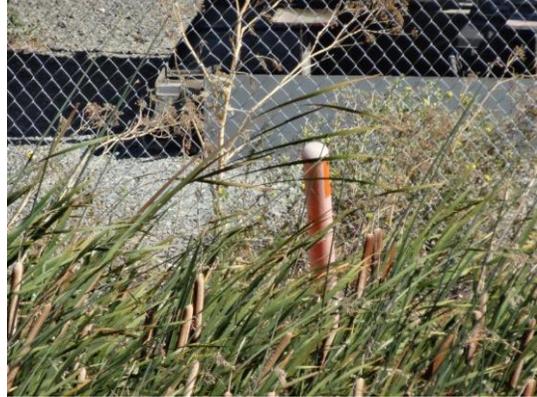
Photo 2 of 3 : UCIP\_FA\_2015\_1549.jpg

**Action/Comments**  
 Inspector Comments: FS\_ID:41878  
 DS\_ID:22045  
 EP\_NO: 12784  
 FS\_HLM: 3.747  
 Repair Type: Non-Urgent  
 Crossing Status: Indicator Found  
 UCIP Comments: Need to contact owner to determine status and install signs if appropriate.  
 FIELD\_STRUCT\_DESC: 8.625-inch diameter natural gas pipeline across the channel and both levees of Lindsey Slough. 4 feet below the crown. Gasline marker found off LS (Permit No. 12784).  
 FS Date: 08/15/2013

LS view: closer view of gasline indicator found on LS.

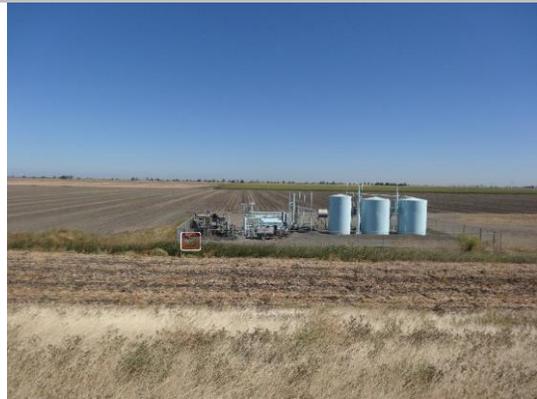
Photo 3 of 3 : UCIP\_FA\_2015\_1550.jpg

LS view: a gas plant and gasline indicator found on LS.

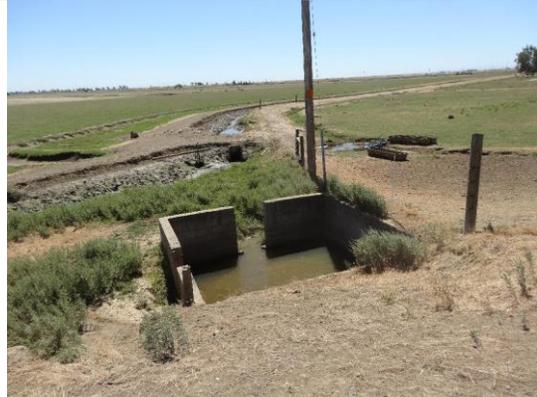
Photo 1 of 2 : UCIP\_FA\_2015\_1433.jpg

LM Start	Rating **	M	Issue No.	10
LM End	Issue Type +	En	Location *	LS
Category	Supplemental	GPS Latitude/Longitude		
		Start	End	
Item	DWR UCIP Field Study	38.289474 °	38.289474 °	
		-121.775914 °	-121.775914 °	
DWR ID				
Action/Comments				
Inspector Comments: FS_ID:46769 DS_ID:22059 EP_NO: N/A FS_HLM: 2.086 Repair Type: Non-Urgent Crossing Status: Indicator Found UCIP Comments: - Abandoned pump structure in stream needs proper abandonment- Not accessible due to wired fence FIELD_STRUCT_DESC: *ABANDONED* pump structure in stream and a concrete distribution on landside. Not accessible due to wired fence. FS Date: 08/15/2013

LS view: abandoned concrete distribution box. Not accessible due to wire fence.

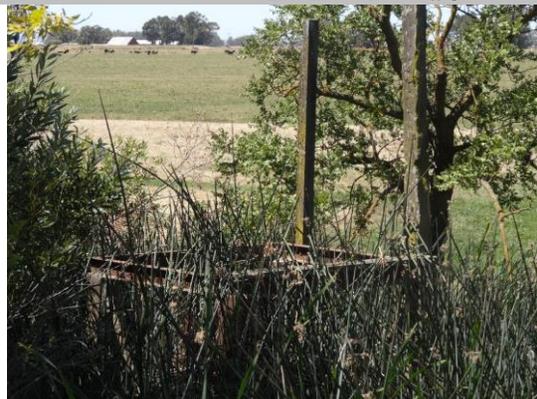
Photo 2 of 2 : UCIP\_FA\_2015\_1434.jpg

WS view: abandoned pump support in stream/channel. Not accessible due to vegetation.

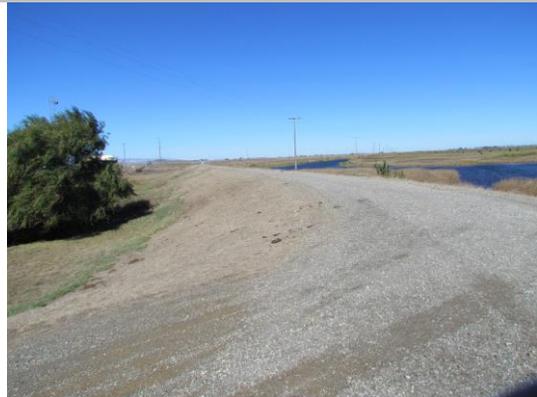
Photo 1 of 1 : FA\_2015\_RD2060\_242\_9\_20151103\_00006.jpg

LM Start	<b>0.07</b>	Rating **	A	Issue No.	<b>9</b>
LM End	<b>3.64</b>	Issue Type +	Ma	Location *	WS
Category	Earthen Levee		GPS Latitude/Longitude		
			Start	End	
Item	Vegetation		38.275780 °	38.296648 °	
			-121.795488 °	-121.748765 °	
DWR ID	DWR_RD2060_02_f_2015_9				
Action/Comments					
Control annual grass and weeds on the levee slopes and easements. Inspector Comments: No unwanted weeds present during this inspection.

RD 2060 Looking downstream from the waterside levee slope levee mile 0.07 Unit 2.

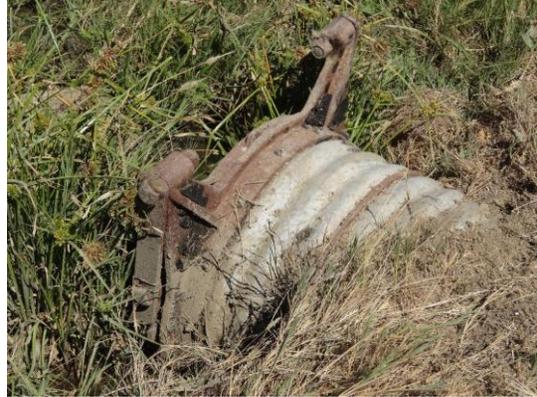
Photo 1 of 2 : UCIP\_FA\_2015\_1609.jpg

**Action/Comments**  
 Inspector Comments: FS\_ID:18386  
 DS\_ID:22056  
 EP\_NO: 10148  
 FS\_HLM: 1.766  
 Repair Type: Non-Urgent  
 Crossing Status: Found  
 UCIP Comments: U-type concrete headwall on LS. Not accessible due to fence. Vegetation is partially blocking inlet & outlet pipe.  
 FIELD\_STRUCT\_DESC: 24-inch CM drainpipe through levee, 16.0 feet below crown, flap gate on waterward end. U-type concrete headwall on LS. Not accessible due to fence. Vegetation is partially blocking inlet & outlet pipe.  
 FS Date: 08/15/2013

WS view: CM pipe with flap gate. Not accessible. Vegetation is partially blocking outlet pipe.

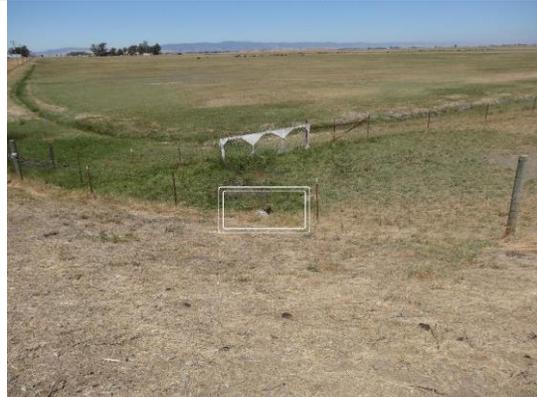
Photo 2 of 2 : UCIP\_FA\_2015\_1610.jpg

WS view: overview of CMP from levee.

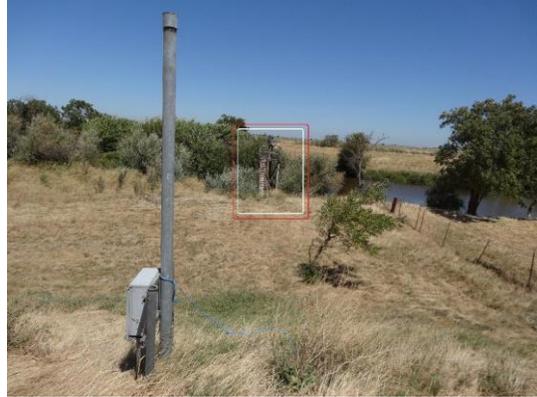
Photo 1 of 2 : UCIP\_FA\_2015\_1432.jpg

LM Start	<b>2.15</b>	Rating **	M	Issue No.	<b>12</b>
LM End	<b>2.15</b>	Issue Type +	En	Location *	LS
Category	Supplemental			GPS Latitude/Longitude	
				Start	End
Item	DWR UCIP Field Study			38.290440 °	38.290440 °
				-121.774808 °	-121.774808 °
DWR ID					
Action/Comments					
Inspector Comments: FS_ID:41668 DS_ID:22060 EP_NO: 5927 FS_HLM: 2.182 Repair Type: Non-Urgent Crossing Status: Found UCIP Comments: verify pipe has been abandoned properly. - abandoned pump and pipe.- electrical box on WS shoulder. FIELD_STRUCT_DESC: *Abandoned* 18-inch steel pipe through levee 4.0 feet below crown, siphon breaker on landward slope. Pump on piling on bank, distribution box at landward toe. (Permit No. 5927 - Cache Slough Pheasant Club). FS Date: 08/15/2013

WS view: electrical box on pole and pump structure in background.

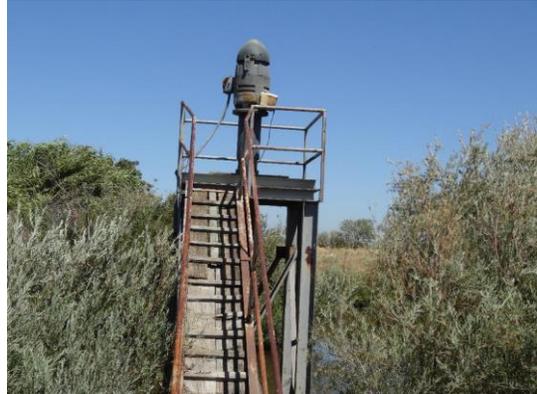
Photo 2 of 2 : UCIP\_FA\_2015\_1435.jpg

WS view: pump on pile structure with stairs on bank.

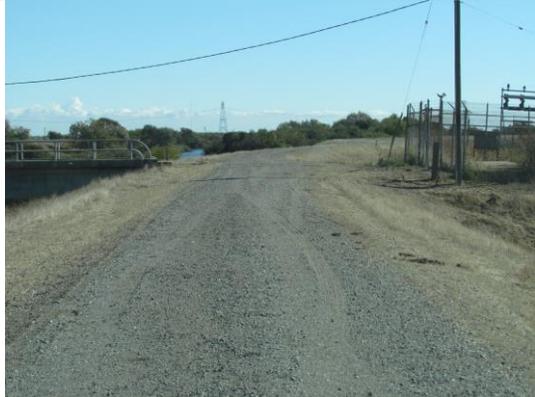
Photo 1 of 1 : FA\_2015\_RD2060\_243\_14\_20151103\_00011.jpg

LM Start	<b>0.00</b>	Rating **	A	Issue No.	<b>14</b>
LM End	<b>5.02</b>	Issue Type +	Ma	Location *	LS
Category	Earthen Levee		GPS Latitude/Longitude		
			Start	End	
Item	Vegetation		38.296648 °	38.247523 °	
			-121.748765 °	-121.696232 °	
DWR ID	DWR_RD2060_03_f_2015_14				
Action/Comments					
Control annual grass and weeds on the levee slopes and easements. Inspector Comments: No unwanted weeds present on the landside levee slope.

RD 2060 Unit 3 looking downstream from levee mile 0.00 landside.

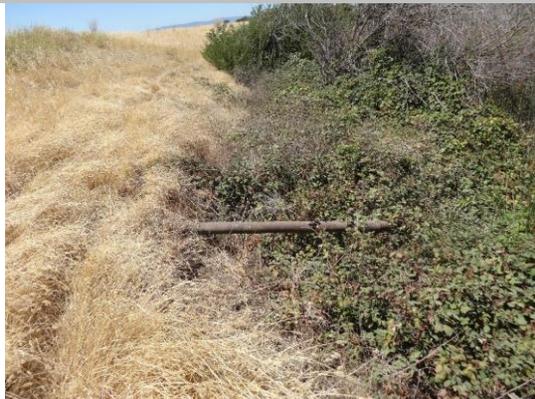
Photo 1 of 2 : UCIP\_FA\_2015\_1391.jpg

LM Start	<b>0.90</b>	Rating **	M	Issue No.	<b>16</b>
LM End	<b>0.90</b>	Issue Type +	En	Location *	LS
Category	Supplemental		GPS Latitude/Longitude		
			Start	End	
Item	DWR UCIP Field Study		38.290684 °	38.290684 °	
			-121.735668 °	-121.735668 °	
DWR ID					
Action/Comments					
Inspector Comments: FS_ID:18727 DS_ID:22067 EP_NO: N/A FS_HLM: 0.895 Repair Type: Non-Urgent Crossing Status: Found UCIP Comments: Seem abandoned. Not found- pump on LS. Needs more exploration. FIELD_STRUCT_DESC: 6-inch steel pipe through the levee, 2.8 feet below the crown. O&M Manual SAC 107, April 1959. FS Date: 08/15/2013

Waterside view: levee slope and a steel pipe.

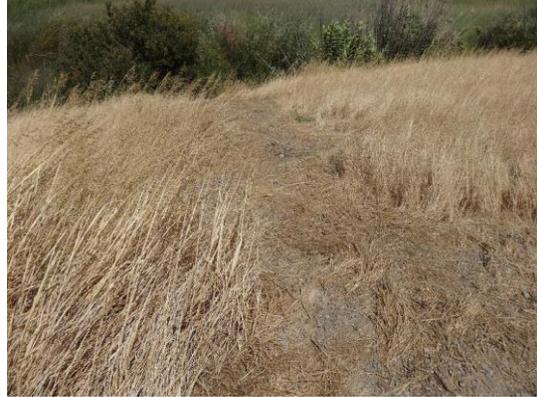
Photo 2 of 2 : UCIP\_FA\_2015\_1392.jpg

LM Start	0.90	Rating **	M	Issue No.	16 (cont)
LM End	0.90	Issue Type +	En	Location *	LS
Category	Supplemental			GPS Latitude/Longitude	
			Start	End	
Item	DWR UCIP Field Study			38.290684 °	38.290684 °
				-121.735668 °	-121.735668 °
DWR ID					
Action/Comments					
Inspector Comments: FS_ID:18727 DS_ID:22067 EP_NO: N/A FS_HLM: 0.895 Repair Type: Non-Urgent Crossing Status: Found UCIP Comments: Seem abandoned. Not found- pump on LS. Needs more exploration. FIELD_STRUCT_DESC: 6-inch steel pipe through the levee, 2.8 feet below the crown. O&M Manual SAC 107, April 1959. FS Date: 08/15/2013

Waterside view: levee slope.

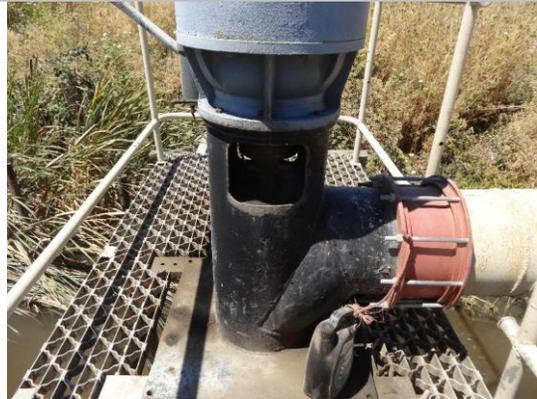
Photo 1 of 2 : UCIP\_FA\_2015\_1389.jpg

LM Start	0.90	Rating **	M	Issue No.	17
LM End	0.90	Issue Type +	En	Location *	LS
Category	Supplemental			GPS Latitude/Longitude	
			Start	End	
Item	DWR UCIP Field Study			38.290684 °	38.290684 °
				-121.735639 °	-121.735639 °
DWR ID					
Action/Comments					
Inspector Comments: FS_ID:18726 DS_ID:22063 EP_NO: 6342 FS_HLM: 0.897 Repair Type: Non-Urgent Crossing Status: Found UCIP Comments: Leaky siphon breaker may need to be repaired.  Dense vegetation on WS. Not found- gate valve on LS. FIELD_STRUCT_DESC: 16-inch steel pipe through levee 8.0 feet below crown, vertical pump in drain ditch on land-side. Siphon breaker on waterside. (App. No. 6342-A - Hastings Farms) FS Date: 08/15/2013

Landside view: pipe and pump on steel structure in drain ditch.

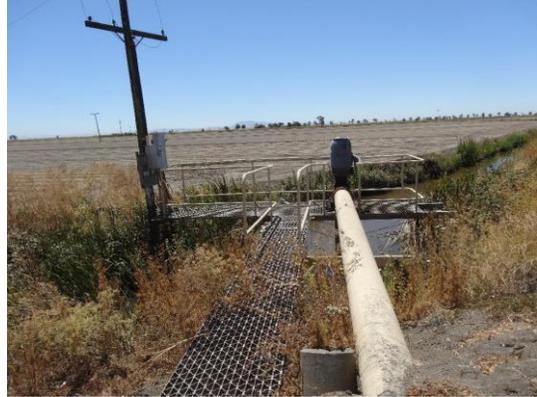
Photo 2 of 2 : UCIP\_FA\_2015\_1390.jpg

LM Start	0.90	Rating **	M	Issue No.	17 (cont)
LM End	0.90	Issue Type +	En	Location *	LS
Category	Supplemental			GPS Latitude/Longitude	
				Start	End
Item	DWR UCIP Field Study			38.290684 °	38.290684 °
				-121.735639 °	-121.735639 °
DWR ID					
Action/Comments					
Inspector Comments: FS_ID:18726 DS_ID:22063 EP_NO: 6342 FS_HLM: 0.897 Repair Type: Non-Urgent Crossing Status: Found UCIP Comments: Leaky siphon breaker may need to be repaired.					
Dense vegetation on WS.Not found- gate valve on LS. FIELD_STRUCT_DESC: 16-inch steel pipe through levee 8.0 feet below crown, vertical pump in drain ditch on land-side. Siphon breaker on waterside. (App. No. 6342-A - Hastings Farms) FS Date: 08/15/2013

Landside view: pump, service pole, steel support structure, walkway, and pipe.

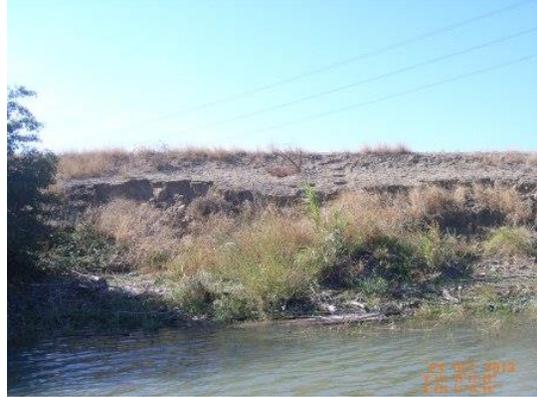
Photo 1 of 1 : USACE2013A\_CHS\_23-6\_R\_2.jpg

LM Start	<b>1.52</b>	Rating **	M	Issue No.	<b>8</b>
LM End	<b>1.74</b>	Issue Type +	Ma	Location *	WS
Category	Supplemental			GPS Latitude/Longitude	
				Start	End
Item	2015 USACE Erosion Survey, DRAFT			38.288598 °	38.286051 °
				-121.725184 °	-121.722818 °
DWR ID					
Action/Comments					
Inspector Comments: Site added in 1997 and removed in 2003. 2005 - Put back in the inventory. 2006 - Stone repair at the middle of the site. 2011 - Some rock place at toe in the past year. 2013 - Site extended both upstream and downstream to include new erosion pockets. 2015: No observed changes. [2015 Site ID: CHS_23-6_R]

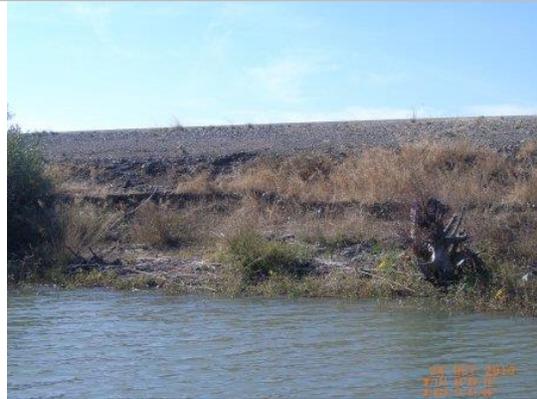
Photo 1 of 1 : USACE2013A\_CHS\_23-0\_R\_1.jpg

LM Start	<b>2.02</b>	Rating **	M	Issue No.	<b>1</b>
LM End	<b>2.08</b>	Issue Type +	Ma	Location *	WS
Category	Supplemental			GPS Latitude/Longitude	
				Start	End
Item	2015 USACE Erosion Survey, DRAFT			38.284105 °	38.283302 °
				-121.718471 °	-121.717814 °
DWR ID					
Action/Comments					
Inspector Comments: 2010 - Small maintenance site. 2015: No observed changes. [2015 Site ID: CHS_23-0_R]

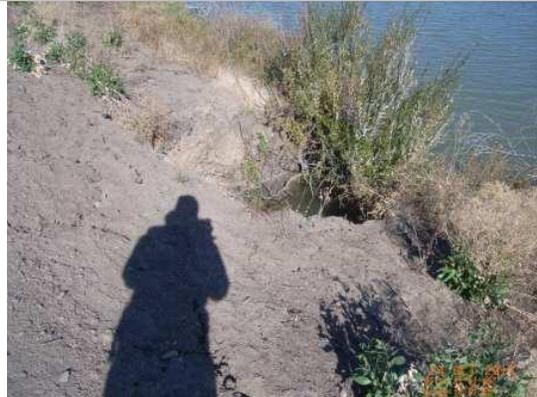
Photo 1 of 1 : USACE2013A\_CHS\_22-9\_R\_1.jpg

LM Start	<b>2.12</b>	Rating **	M	Issue No.	<b>6</b>
LM End	<b>2.17</b>	Issue Type +	Ma	Location *	WS
Category	Supplemental			GPS Latitude/Longitude	
				Start	End
Item	2015 USACE Erosion Survey, DRAFT			38.282880 °	38.282277 °
				-121.717487 °	-121.716996 °
DWR ID					
Action/Comments					
Inspector Comments: 2013 - Pockets of erosion behind willows. 2015: No observed changes. [2015 Site ID: CHS_22-9_R]

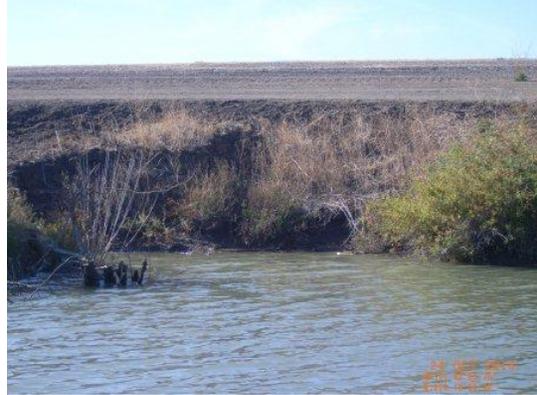
Photo 1 of 1 : USACE2013A\_CHS\_22-8\_R\_4.jpg

LM Start	<b>2.18</b>	Rating **	M	Issue No.	<b>7</b>
LM End	<b>2.23</b>	Issue Type +	Ma	Location *	WS
Category	Supplemental			GPS Latitude/Longitude	
				Start	End
Item	2015 USACE Erosion Survey, DRAFT			38.282100 °	38.281510 °
				-121.716817 °	-121.716319 °
DWR ID					
<b>Action/Comments</b>					
Inspector Comments: 2007 - Geotechnical failure of midside slope and wave wash/scalloping in toe area. Stone revetment upstream and downstream of site. Similar sites are present all along the right bank downstream of this site, most could be repaired with some maintenance. 2010 - Minor new erosion. 2015: No observed changes. [2015 Site ID: CHS_22-8_R]

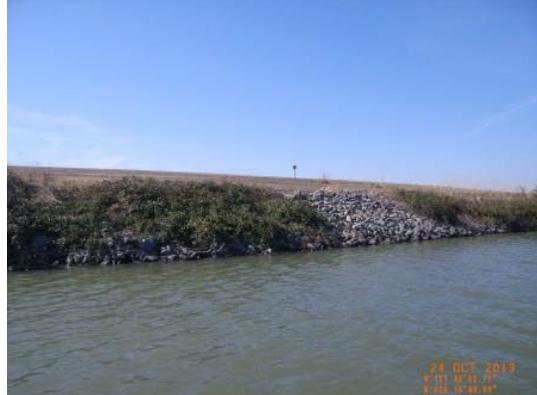
Photo 1 of 1 : USACE2013A\_CHS\_22-6\_R\_2.jpg

LM Start	<b>2.35</b>	Rating **	M	Issue No.	<b>4</b>
LM End	<b>2.53</b>	Issue Type +	Ma	Location *	WS
Category	Supplemental			GPS Latitude/Longitude	
				Start	End
Item	2015 USACE Erosion Survey, DRAFT			38.280377 °	38.278306 °
				-121.714633 °	-121.712722 °
DWR ID					
<b>Action/Comments</b>					
Inspector Comments: 2008 - Small scour pockets and mid-slope wave wash. 2010 - More vegetation growth, could be fixed through maintenance. 2011 - Site extended downstream and new erosion. 2015: No observed changes. [2015 Site ID: CHS_22-6_R]

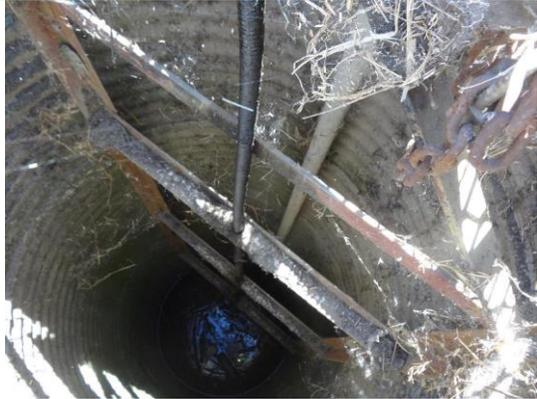
Photo 1 of 3 : UCIP\_FA\_2015\_1338.jpg

Inspector Comments: FS\_ID:18723  
 DS\_ID:22064  
 EP\_NO: N/A  
 FS\_HLM: 3.24  
 Repair Type: Non-Urgent  
 Crossing Status: Indicator Found  
 UCIP Comments: Only a CMP riser was found on WS.  
 FIELD\_STRUCT\_DESC: Only a CMP riser was found WS. All other features not found as described: 36-inch steel pipe through levee 15.0 feet below crown, slide gate in CM riser on waterward slope. (Asbestos bonded pipe.) Pump in pump house on pile structure in stream. Service pole and anchor on landward slope. Only a CMP riser was found WS.  
 FS Date: 08/15/2013

WS view: slide gate and air vent inside CMP riser.

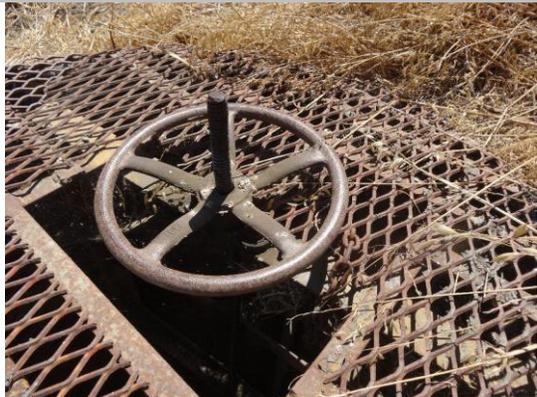
Photo 2 of 3 : UCIP\_FA\_2015\_1339.jpg

WS view: closer view of slide gate in CMP riser.

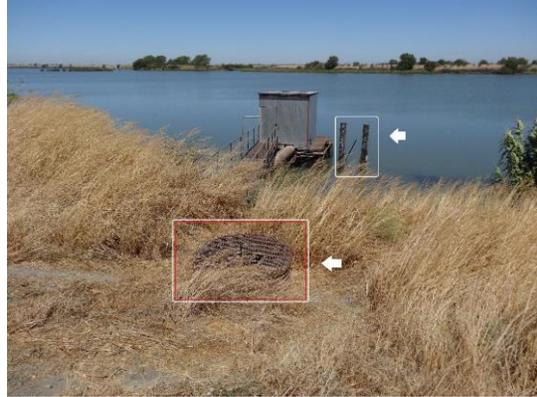
Photo 3 of 3 : UCIP\_FA\_2015\_1367.jpg

LM Start	<b>3.24</b>	Rating **	M	Issue No.	<b>18 (cont)</b>
LM End	<b>3.24</b>	Issue Type +	En	Location *	WS
Category	Supplemental			GPS Latitude/Longitude	
				Start	End
Item	DWR UCIP Field Study			38.270151 °	38.270151 °
				-121.705782 °	-121.705782 °
DWR ID					
Action/Comments					
Inspector Comments: FS_ID:18723 DS_ID:22064 EP_NO: N/A FS_HLM: 3.24 Repair Type: Non-Urgent Crossing Status: Indicator Found

WS view: slide gate in CMP riser (bottom- marked) and may be abandoned pile for pump support (marked- right).

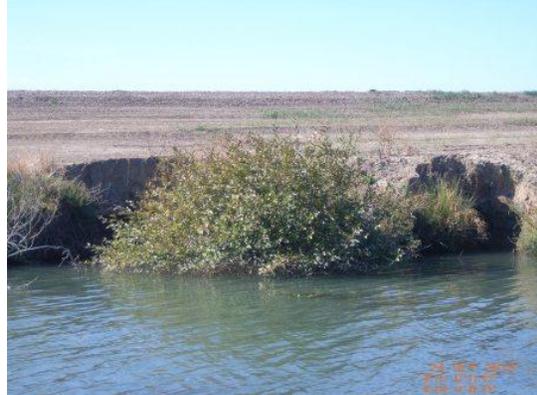
Photo 1 of 1 : USACE2013A\_CHS\_21-1\_R\_12.jpg

LM Start	<b>3.78</b>	Rating **	M	Issue No.	<b>2</b>
LM End	<b>4.09</b>	Issue Type +	Ma	Location *	WS
Category	Supplemental			GPS Latitude/Longitude	
				Start	End
Item	2015 USACE Erosion Survey, DRAFT			38.264585 °	38.260593 °
				-121.698868 °	-121.696403 °
DWR ID					
Action/Comments					
Inspector Comments: 2011 - Several pockets of erosion from rotational failure and slumping toe. 2013 - Site extended downstream to include new erosion pockets. 2015: No observed changes. [2015 Site ID: CHS_21-1_R]
