**Flood Control Project Maintenance
Levee Inspections**
LMA District Cover Sheet
Spring 2016 Levee Inspection Results

Reclamation District No. 2063 Crows Landing

Spring 2016 Levee Inspection Results

Waterway		Bank	Unit Miles
Unit No. 01 San Joaquin River		Right	10.44

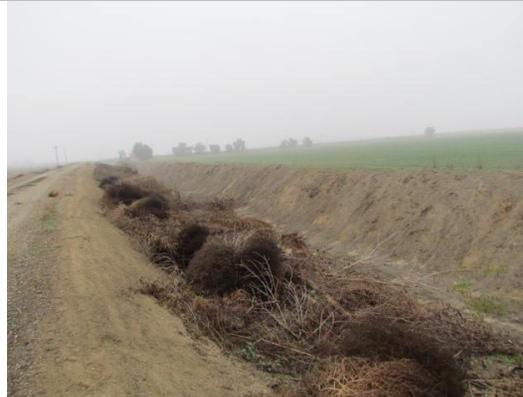
Photo 1 of 3 : SP_2016_RD2063_112_18_20160404_00005.jpg

Looking north at ditch on landside berm and toe.

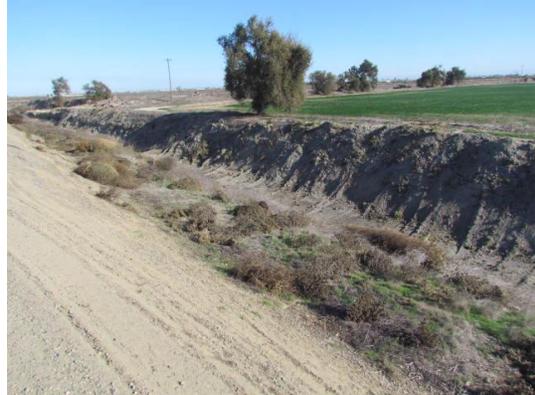
Photo 2 of 3 : SP_2016_RD2063_112_18_20160404_00006.jpg

Looking northeast at canal-ditch on landside berm.

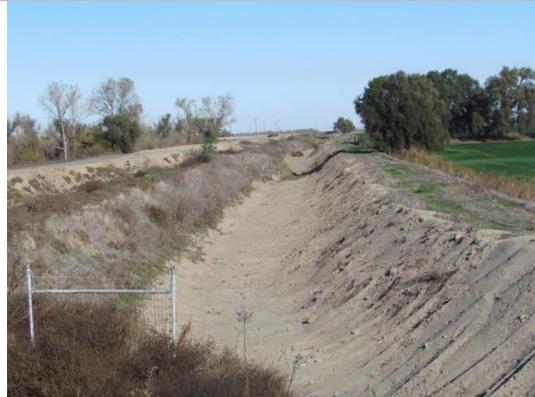
Photo 3 of 3 : SP_2016_RD2063_112_18_20160404_00007.jpg

Looking south at canal-ditch at landside berm and toe.

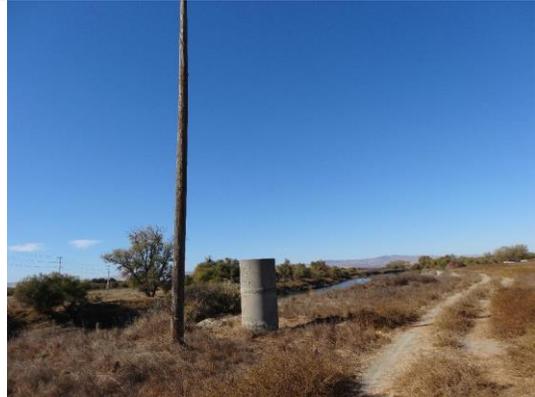
Photo 1 of 2 : UCIP_SP_2016_41588_43166.jpg

Comment Code					
Inspector Comment					
FS_ID:41588 DS_ID:22075 EP_NO: N/A Repair Type: Urgent Crossing Status: Found UCIP Comments: - Pipe has visible holes throughout both LS and WS along with pipe deformation. - looks abandoned. Needs proper abandonment.- alfalfa valve on concrete pipe riser on waterside toe.- no slide gate found on waterside. No pump and pile structure found in river. FIELD_STRUCT_DESC: 24-inch CM pipe through the levee, 10.0 feet below the crown. Pipe supported on two timber pile bents across drain ditch on the landward side. Two concrete standpipes on berm. Installed by USCE 1961. O&M Manual SJR 006, Sept. 1961. FS Date: 11/5/2013

WS view: abandoned concrete standpipe and abandoned power pole.

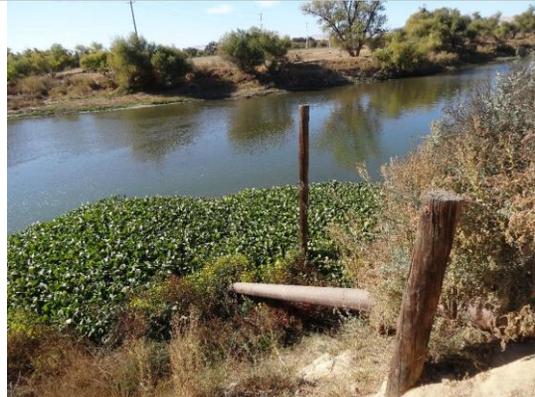
Photo 2 of 2 : UCIP_SP_2016_41588_43161.jpg

WS view: steel pipe immersed into the river. No pump found.

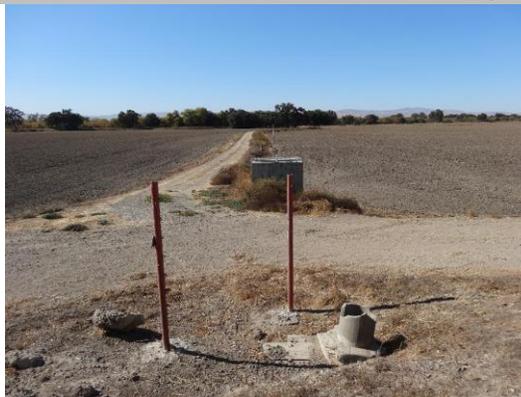
Photo 1 of 2 : UCIP_SP_2016_24404_43345.jpg

LM Start	2.09	Rating **	M	Issue No.	989
LM End	2.09	Issue Type +	En	Location *	LS
Category	Supplemental			GPS Latitude/Longitude	
				Start	End
Item	DWR UCIP Field Study			37.454125°	37.454125°
				-121.032240°	-121.032240°
DWR ID					
Comment Code					
Inspector Comment					
FS_ID:24404 DS_ID:22078 EP_NO: N/A Repair Type: Non-Urgent Crossing Status: Found UCIP Comments: Concrete distribution box with alfalfa valve not found at the waterward toe. Two steel standpipes and dismantled concrete standpipe on waterside levee toe. Concrete distribution box 50 ft off the levee center. FIELD_STRUCT_DESC: 30-inch CM pipe through the levee 16.5 feet below the crown. Slide gate in concrete distribution box 50 ft off the levee. Underground irrigation system. Installed by USCE 1961. O&M Manual SJR 006, Sept. 1961. FS Date: 11/5/2013

WS view: concrete box (top), and a dismantled concrete pipe on levee toe.

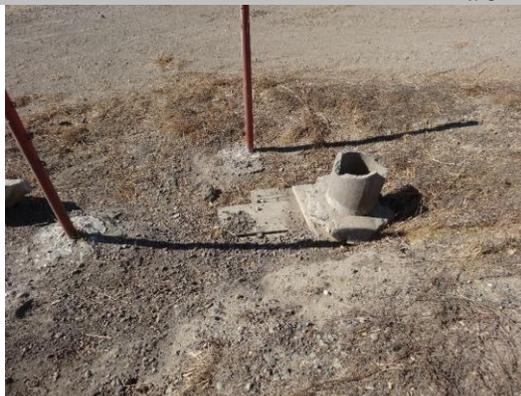
Photo 2 of 2 : UCIP_SP_2016_24404_43344.jpg

WS view: a dismantled concrete pipe on levee toe.

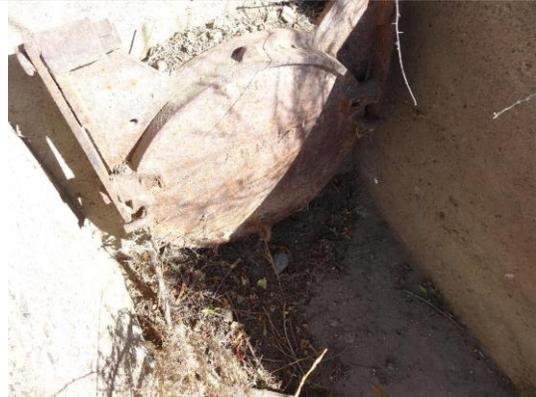
Photo 2 of 2 : UCIP_SP_2016_24435_43483.jpg

LM Start	2.62	Rating **	M	Issue No.	991 (cont)
LM End	2.62	Issue Type +	En	Location *	LS
Category	Supplemental			GPS Latitude/Longitude	
				Start	End
Item	DWR UCIP Field Study			37.448233 °	37.448233 °
				-121.026521 °	-121.026521 °
DWR ID					
Comment Code					
Inspector Comment					
FS_ID:24435 DS_ID:22086 EP_NO: N/A Repair Type: Non-Urgent Crossing Status: Found UCIP Comments: Both pipe ends 70 ft off the levee center. Clearing and cleaning of inlet/outlet pipe needed. FIELD_STRUCT_DESC: 24-inch CM pipe through the levee 12.0 feet below the crown. Flap gate on the waterward end. Concrete headwall on both ends. Installed by USCE 1961. O&M Manual SJR 006, Sept. 1961. FS Date: 11/5/2013

WS view: U shaped headwall outlet structure and pipe with flap gate.

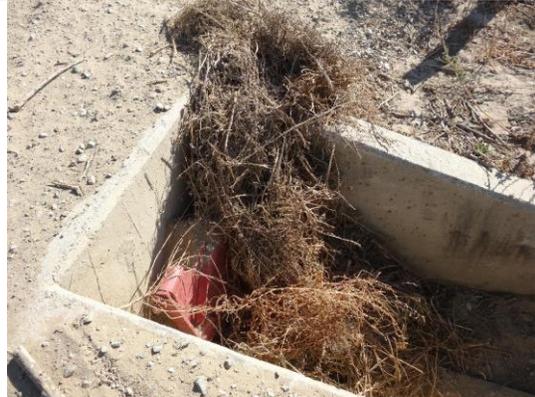
Photo 1 of 2 : UCIP_SP_2016_24443_43522.jpg

LM Start	2.93	Rating **	M	Issue No.	992
LM End	2.93	Issue Type +	En	Location *	LS
Category	Supplemental			GPS Latitude/Longitude	
				Start	End
Item	DWR UCIP Field Study			37.443871 °	37.443871 °
				-121.025775 °	-121.025775 °
DWR ID					
Comment Code					
Inspector Comment					
FS_ID:24443 DS_ID:22088 EP_NO: N/A Repair Type: Non-Urgent Crossing Status: Found UCIP Comments: - clear and clean debris FIELD_STRUCT_DESC: Abandoned 24-inch CM pipe through the levee 9.5 feet below the crown. Flap gate on the waterward end. Pipe open on landward end. Concrete headwall on both ends. O&M Manual SJR 006, Sept. 1961 FS Date: 11/5/2013

WS view: U typed concrete headwall on levee slope.

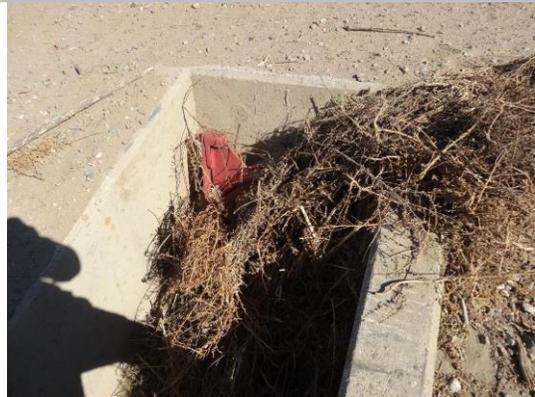
Photo 2 of 2 : UCIP_SP_2016_24443_43521.jpg

WS view: pipe, flap gate, and concrete headwall with debris blocking the outlet.

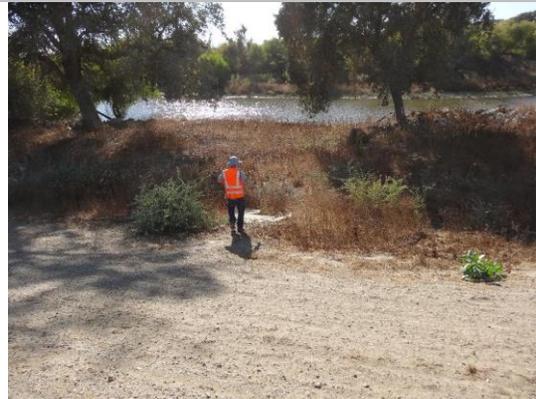
Photo 1 of 2 : UCIP_SP_2016_24469_43645.jpg

LM Start	3.29	Rating **	M	Issue No.	993
LM End	3.29	Issue Type +	En	Location *	WS
Category	Supplemental		GPS Latitude/Longitude		
			Start	End	
Item	DWR UCIP Field Study		37.441213 °	37.441213 °	
			-121.021130 °	-121.021130 °	
DWR ID					
Comment Code					
Inspector Comment					
FS_ID:24469 DS_ID:22089 EP_NO: N/A Repair Type: Non-Urgent Crossing Status: Found UCIP Comments: - cleaning required in inlet pipe.- new flap gate FIELD_STRUCT_DESC: 24-inch CM pipe through the levee 12.5 feet below the crown. Flap gate on the waterward end. Concrete headwall on both ends. O&M Manual SJR 006, Sept. 1961. FS Date: 11/5/2013

WS view: U typed concrete headwall on levee toe

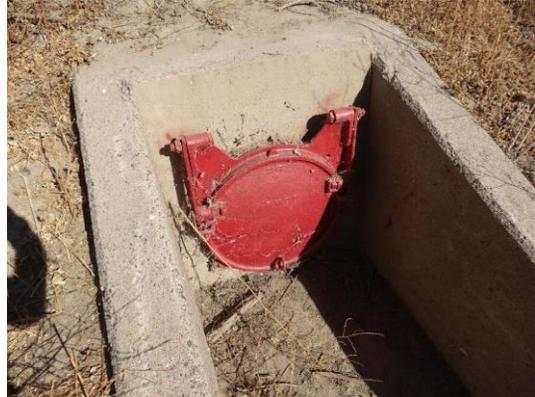
Photo 2 of 2 : UCIP_SP_2016_24469_43644.jpg

WS view: new flap gate, and U typed concrete headwall.

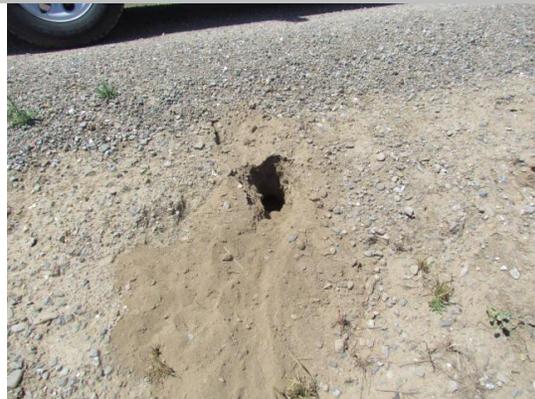
Photo 1 of 2 : SP_2016_RD2063_112_53_20160512_00073.jpg

LM Start	3.49	Rating **	M	Issue No.	53
LM End	3.49	Issue Type +	Ma	Location *	LS
Category	Earthen Levee			GPS Latitude/Longitude	
				Start	End
Item	Animal Control			37.438697 °	37.438697 °
				-121.019232 °	-121.019232 °
DWR ID	DWR_RD2063_01_f_2014_53				
Comment Code					
A1 : Exterminate rodents and backfill and compact or grout burrows.					
Inspector Comment					
Rodent hole notice on landward shoulder.

Looking east at typical rodent hole on landward shoulder.

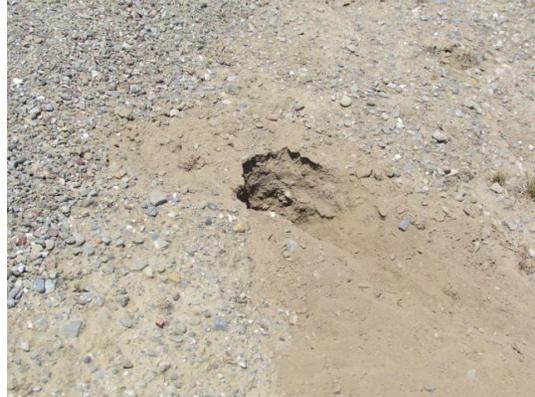
Photo 2 of 2 : SP_2016_RD2063_112_53_20160512_00074.jpg

Looking southeast at typical rodent hole on landward slope.

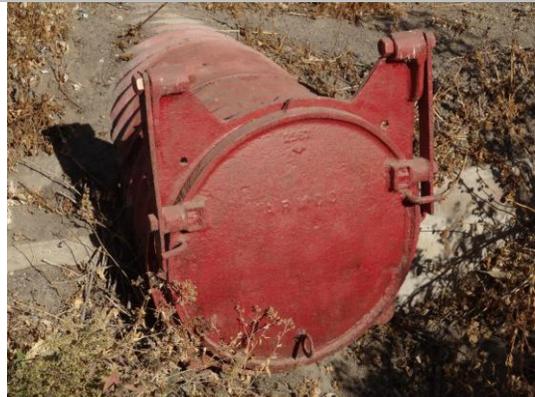
Photo 1 of 2 : UCIP_SP_2016_24485_43667.jpg

LM Start	3.64	Rating **	M	Issue No.	985
LM End	3.64	Issue Type +	En	Location *	LS
Category	Supplemental			GPS Latitude/Longitude	
				Start	End
Item	DWR UCIP Field Study			37.436845 °	37.436845 °
				-121.017826 °	-121.017826 °
DWR ID					
Comment Code					
Inspector Comment					
FS_ID:24485 DS_ID:22093 EP_NO: N/A Repair Type: Non-Urgent Crossing Status: Found UCIP Comments: - new flap gate on waterside.- cleaning and clearing of inlet box needed. FIELD_STRUCT_DESC: 24-inch CM pipe through the levee 12.0 feet below the crown. Flap gate and concrete saddle on the waterward end. Concrete drop inlet box on landward side. Installed by USCE 1961. O&M Manual SJR 006, Sept. 1961. FS Date: 11/5/2013

WS view: pipe, flap gate, and concrete saddle on levee slope

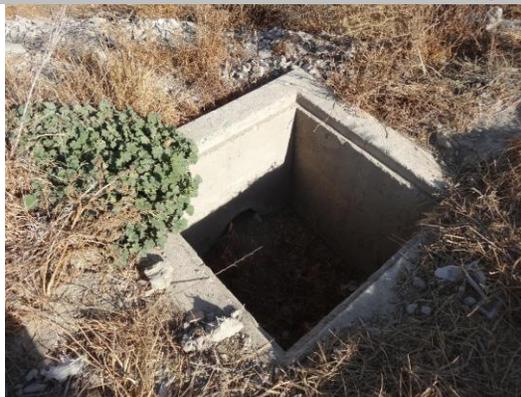
Photo 2 of 2 : UCIP_SP_2016_24485_43666.jpg

LS view: concrete drop inlet box on levee toe.

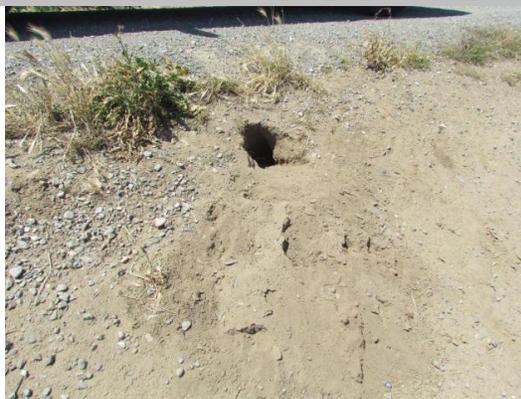
Photo 1 of 2 : SP_2016_RD2063_112_29_20160512_00075.jpg

LM Start	3.68	Rating **	M	Issue No.	29
LM End	3.76	Issue Type +	Ma	Location *	LS
Category	Earthen Levee			GPS Latitude/Longitude	
				Start	End
Item	Animal Control			37.436421 °	37.435767 °
				-121.017321 °	-121.016119 °
DWR ID	DWR_RD2063_01_s_2012_29				
Comment Code					
A3 : No rodents visible, but rodent burrows visible; need to backfill and compact or grout burrows.					
Inspector Comment					
Several rodent holes on landward shoulder and slope.

Looking east at typical rodent hole on landward shoulder.

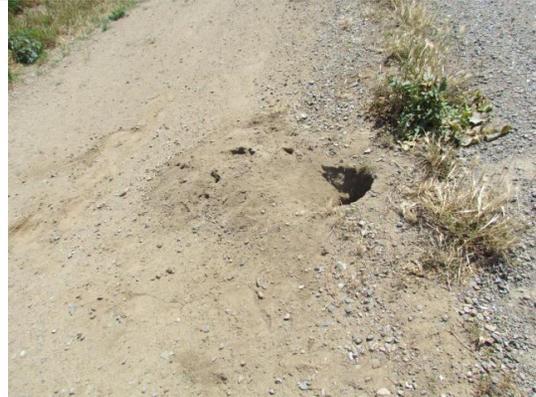
Photo 2 of 2 : SP_2016_RD2063_112_29_20160512_00076.jpg

Looking south at typical rodent hole on landward shoulder.

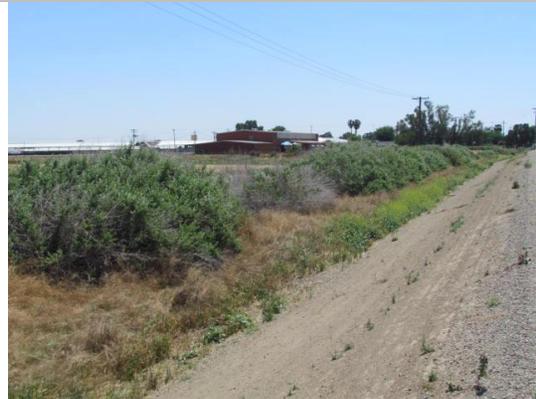
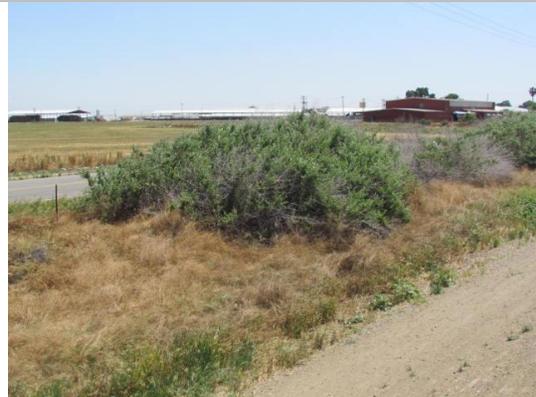
Photo 1 of 2 : SP_2016_RD2063_112_2_20160512_00077.jpg

LM Start	3.89	Rating **	U	Issue No.	2
LM End	3.97	Issue Type +	Ma	Location *	LS
Category	Earthen Levee		GPS Latitude/Longitude		
			Start	End	
Item	Vegetation		37.434506 °	37.433441 °	
			-121.014394 °	-121.013633 °	
DWR ID	DWR_RD2063_01_s_2016_2				
Comment Code					
V2 : Remove the wild growth other than native grasses from the levee slopes.					
Inspector Comment					
Remove dense veg on landward berm.

Looking at dense veg on landward berm.

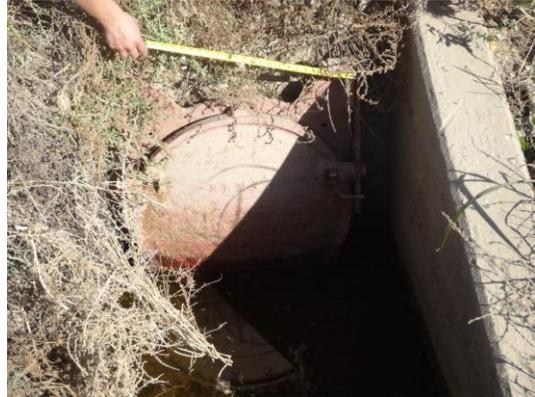
Photo 1 of 2 : UCIP_SP_2016_24583_43842.jpg

LM Start	4.02	Rating **	M	Issue No.	995
LM End	4.02	Issue Type +	En	Location *	LS
Category	Supplemental			GPS Latitude/Longitude	
				Start	End
Item	DWR UCIP Field Study			37.432813 °	37.432813 °
				-121.013419 °	-121.013419 °
DWR ID					
Comment Code					
Inspector Comment					
FS_ID:24583 DS_ID:22096 EP_NO: N/A Repair Type: Non-Urgent Crossing Status: Found UCIP Comments: - new flap gate on waterside.- cleaning of outlet and inlet pipes required. FIELD_STRUCT_DESC: 24-inch CM pipe through the levee 12.0 feet below the crown. Flap gate on the waterwad end. Concrete headwall on both ends. Installed by USCE 1961. O&M Manual SJR 006, Sept. 1961 FS Date: 11/5/2013

WS view: pipe, flap gate, and concrete headwall on drainage ditch.

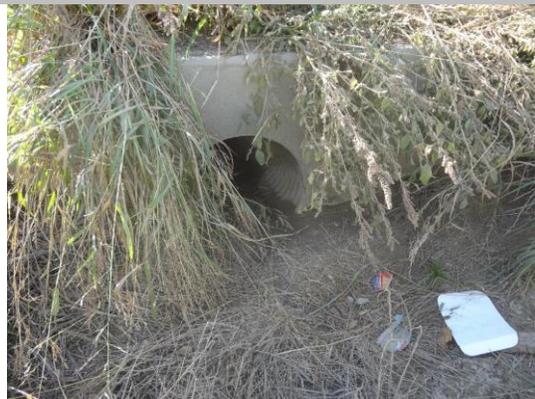
Photo 2 of 2 : UCIP_SP_2016_24583_43841.jpg

LS view: CM pipe and concrete headwall on levee toe.

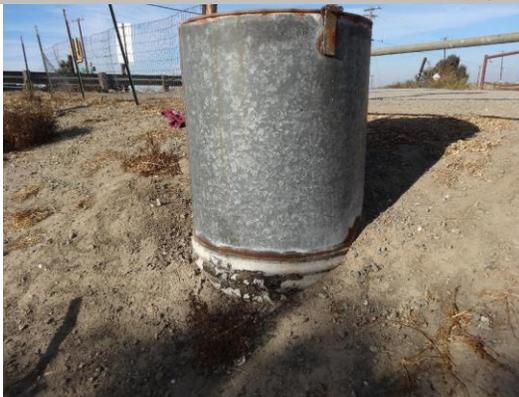
Photo 1 of 2 : UCIP_SP_2016_41746_43850.jpg

LM Start	4.10	Rating **	M	Issue No.	1001
LM End	4.10	Issue Type +	En	Location *	LS
Category	Supplemental			GPS Latitude/Longitude	
				Start	End
Item	DWR UCIP Field Study			37.431846 °	37.431846 °
				-121.012716 °	-121.012716 °
DWR ID					
Comment Code					
Inspector Comment					
FS_ID:41746 DS_ID:22099 EP_NO: N/A Repair Type: Non-Urgent Crossing Status: Found UCIP Comments: Need to determine if annular space has been grouted or if repair/sleeving was done in accordance with a permit or Title 23. Slide gate not found in CM pipe riser on the waterward slope. Dense vegetation on waterside. Pipe only visible in CMP riser on waterside slope. FIELD_STRUCT_DESC: A smaller pipe sleeved into 24-inch CM pipe. 24-inch pipe through the levee 10.0 feet below the crown. Connects to concrete pipe irrigation system. Installed by USCE 1961. O&M Manual SJR 006, Sept. 1961. FS Date: 11/5/2013

WS view: CMP riser on levee slope. Steel riser on top of CMP.

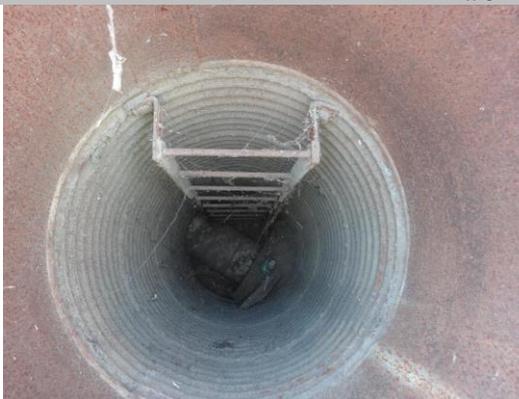
Photo 2 of 2 : UCIP_SP_2016_41746_43849.jpg

WS view: inside view of CMP riser on levee slope. Steel pipe and 24" CMP visible inside the riser.

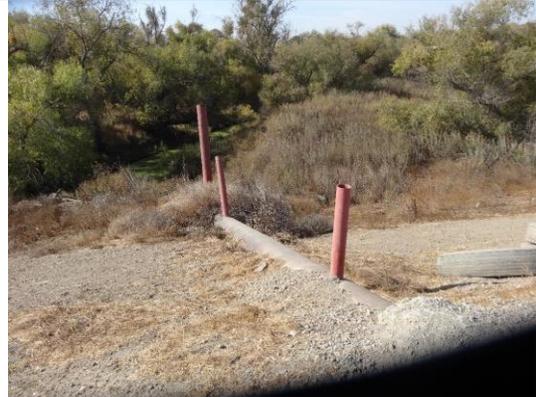
Photo 1 of 2 : UCIP_SP_2016_25025_45110.jpg

LM Start	4.17	Rating **	M	Issue No.	983
LM End	4.17	Issue Type +	En	Location *	LS
Category	Supplemental			GPS Latitude/Longitude	
				Start	End
Item	DWR UCIP Field Study			37.431029 °	37.431029 °
				-121.011865 °	-121.011865 °
DWR ID					
Comment Code					
Inspector Comment					
FS_ID:25025 DS_ID:24732 EP_NO: N/A Repair Type: Non-Urgent Crossing Status: Found UCIP Comments: - new pipe to pump.- overhead power line.- soil cover over the pipe seems not enough. FIELD_STRUCT_DESC: A 24-inch steel pipe through the levee at crown level. A thin layer of dirt acts as cover to the pipe. Pump house on steel structure in landside drainage ditch. Pump house and pipe on landside look new. Old wooden walkway to the pumphouse. Three new air vents on waterside pipe. Pipe opens on waterside. Exposed old pipe on waterside. FS Date: 11/6/2013

WS view: air vents (top- red) on exposed steel pipe.

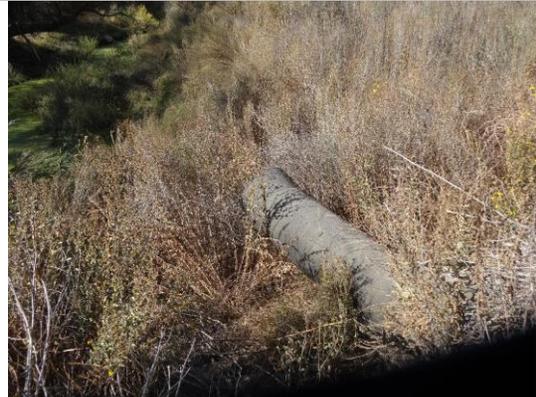
Photo 2 of 2 : UCIP_SP_2016_25025_45109.jpg

WS view: discharge pipe end on levee toe. No flap gate.

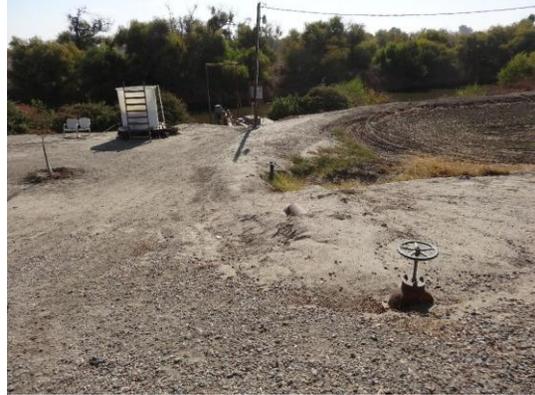
Photo 1 of 2 : UCIP_SP_2016_25028_45125.jpg

LM Start	4.58	Rating **	M	Issue No.	984
LM End	4.58	Issue Type +	En	Location *	LS
Category	Supplemental			GPS Latitude/Longitude	
				Start	End
Item	DWR UCIP Field Study			37.429501 °	37.429501 °
				-121.005667 °	-121.005667 °
DWR ID					
Comment Code					
Inspector Comment					
FS_ID:25028 DS_ID:22103 EP_NO: N/A Repair Type: Non-Urgent Crossing Status: Found UCIP Comments: Leaky pipe joint on landside where pipe daylights. Power pole on waterside. FIELD_STRUCT_DESC: 10-inch steel pipe through the levee 4.0 feet below the crown. Gate valve on waterside slope. Siphon breaker on landside slope. Pipe daylights halfway down landward slope and empties into a concrete standpipe at landward toe. Pump at top of the bank on waterside. Installed by USCE 1961. O&M Manual SJR 006, Sept. 1961. FS Date: 11/6/2013

WS view: overview of waterside- gate valve and power pole on levee slope.

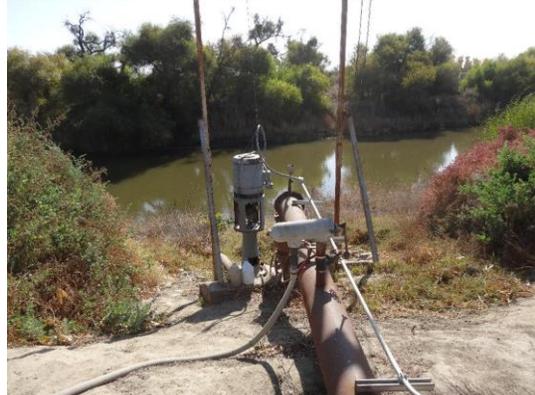
Photo 2 of 2 : UCIP_SP_2016_25028_45124.jpg

WS view: pump, pipe and other appurtenances on levee toe.

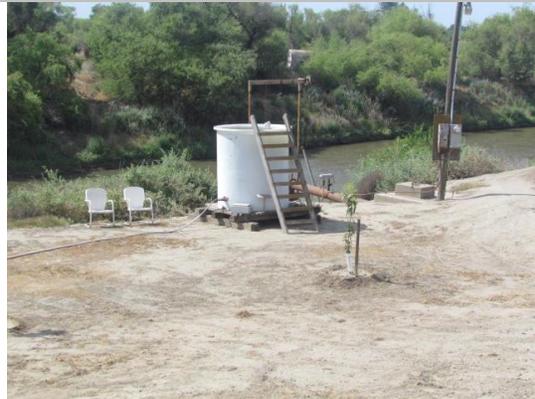
Photo 1 of 2 : SP_2016_RD2063_112_31_20160404_00009.jpg

Looking west at water tank on waterward berm.

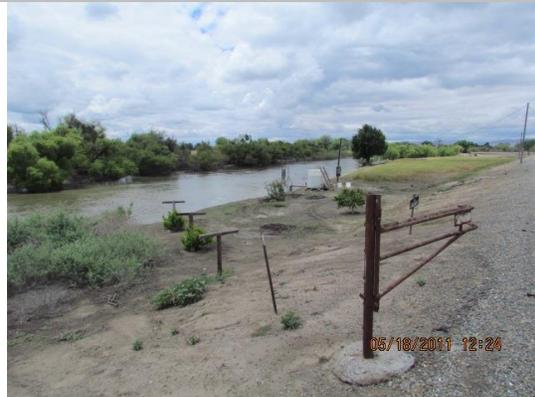
Photo 2 of 2 : SP_2016_RD2063_112_31_20160404_00010.jpg

Looking south at grapevines and fruit trees on waterside berm.

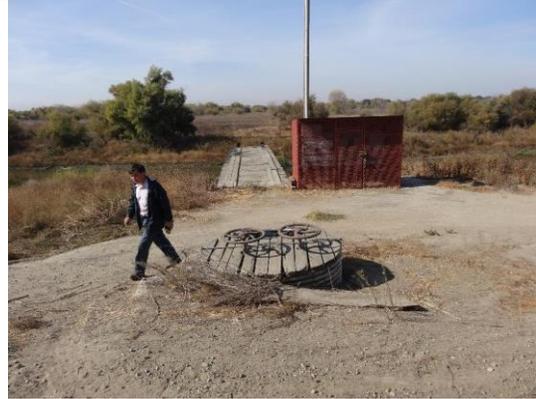
Photo 1 of 2 : UCIP_SP_2016_41669_45131.jpg

Comment Code					
Inspector Comment					
FS_ID:41669 DS_ID:22105 EP_NO: N/A Repair Type: Non-Urgent Crossing Status: Found UCIP Comments: Abandoned pipe should be done so properly.- rubber pipe attached to steel pipe on waterside.- a concrete standpipe on landside too.- overhead power line.- abandoned pipe and pile structure. Abandoned timber walkway on waterside. FIELD_STRUCT_DESC: 1 of 2: Two 12-inch steel pipes encased in reinforced concrete through levee 9.0 feet below crown. Two slide gates in 72-inch CM pipe riser on waterward slope. Two pumps on floating structure in river. Concrete distribution box on landward toe of the levee. Installed by USCE 1961. O&M Manual SJR 006, Sept. 1961. FS Date: 11/6/2013

WS view: CMP riser, abandoned walkway, power pole on levee slope.

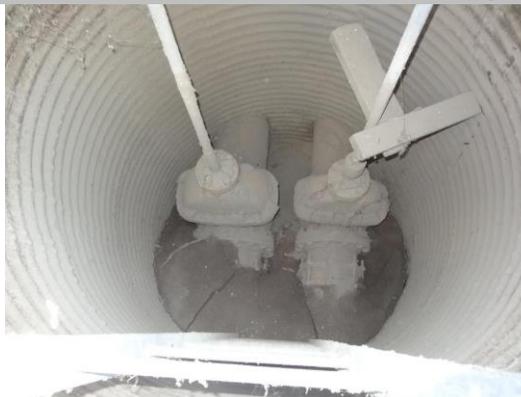
Photo 2 of 2 : UCIP_SP_2016_41670_43904.jpg

Comment Code					
Inspector Comment					
FS_ID:41670 DS_ID:22123 EP_NO: N/A Repair Type: Non-Urgent Crossing Status: Found UCIP Comments: Any abandoned pipes should be verified as having been abandoned properly. - abandoned walkway, pile structure and steel pipe.- concrete standpipe on landside toe.- overhead power line. FIELD_STRUCT_DESC: 2 of 2: Two 12-inch steel pipes encased in reinforced concrete through levee 9.0 feet below crown. Two slide gates in 72-inch CM pipe riser on waterward slope. Two pumps on floating structure in river. Concrete distribution box on landward toe of the levee. Installed by USCE 1961. O&M Manual SJR 006, Sept. 1961. FS Date: 11/6/2013

WS view: two gate valves inside CMP riser on levee slope.

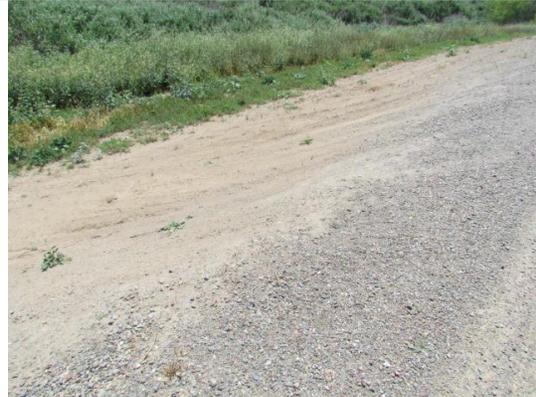
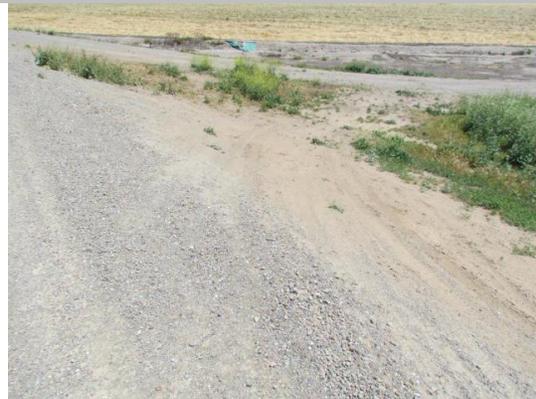
Photo 1 of 2 : SP_2016_RD2063_112_50_20160512_00079.jpg

LM Start	5.94	Rating **	M	Issue No.	50
LM End	5.94	Issue Type +	Ma	Location *	LS
Category	Earthen Levee		GPS Latitude/Longitude		
			Start	End	
Item	Slope Stability		37.416338 °	37.416338 °	
			-120.997517 °	-120.997517 °	
DWR ID	DWR_RD2063_01_s_2016_50				
Comment Code					
S3 : Repair the levee slope damaged by vehicle traffic and prevent access where possible.					
Inspector Comment					
Slope damage cause by vehicle traffic.

Looking northeast at slope damage on landward slope.

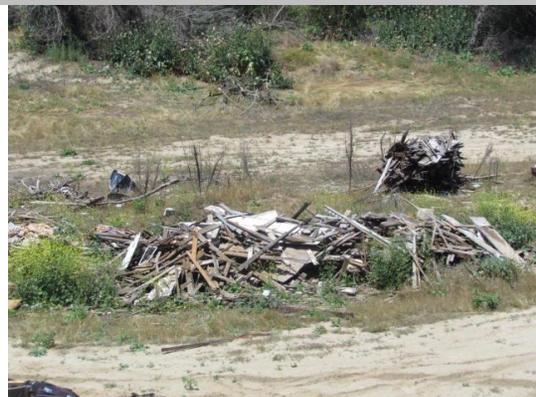
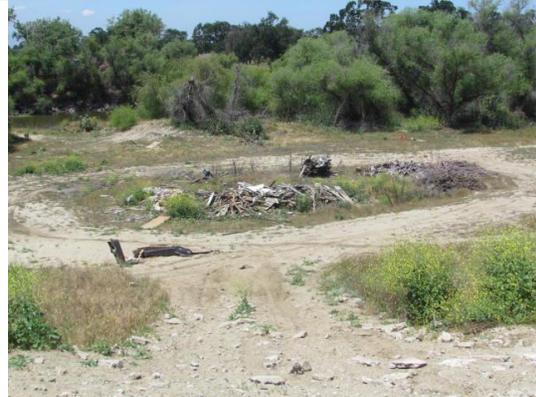
Photo 1 of 2 : SP_2016_RD2063_112_51_20160512_00081.jpg

Looking west at garbage pile in channel or waterward berm.

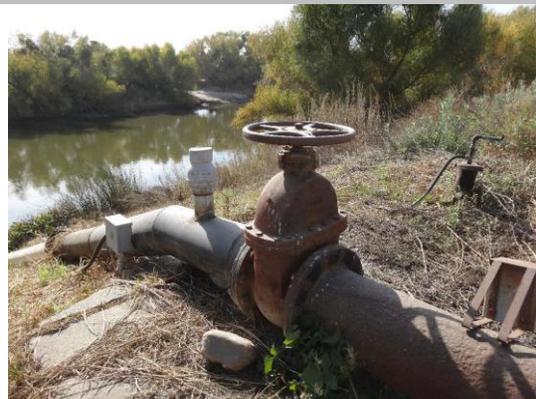
Photo 1 of 2 : UCIP_SP_2016_24628_43938.jpg

LM Start	6.53	Rating **	M	Issue No.	987
LM End	6.53	Issue Type +	En	Location *	WS
Category	Supplemental			GPS Latitude/Longitude	
				Start	End
Item	DWR UCIP Field Study			37.411347 °	37.411347 °
				-120.998063 °	-120.998063 °
DWR ID					
Comment Code					
Inspector Comment					
FS_ID:24628 DS_ID:22108 EP_NO: 4062 Repair Type: Non-Urgent Crossing Status: Found UCIP Comments: Abandoned pipe also found adjacent to this pipe. Needs proper abandonment. Soil erosion under pipe on waterside. No pipe visible on landside. Overhead powerline. FIELD_STRUCT_DESC: 12-inch pvc pipe through the levee 3.0 feet below the crown. Float pump in the river. Gate valve and air vent on waterside levee berm. Service pole with overhead line on the waterward shoulder. (App. No. 4062 - Greer) FS Date: 11/6/2013

WS view: steel pipe, gate valve, air vent on levee berm.

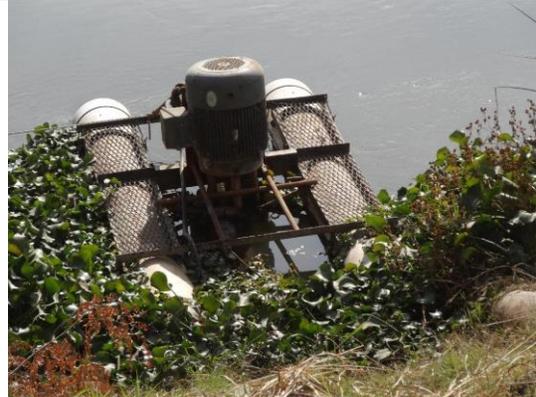
Photo 2 of 2 : UCIP_SP_2016_24628_43937.jpg

WS view: pump on floating structure in the stream.

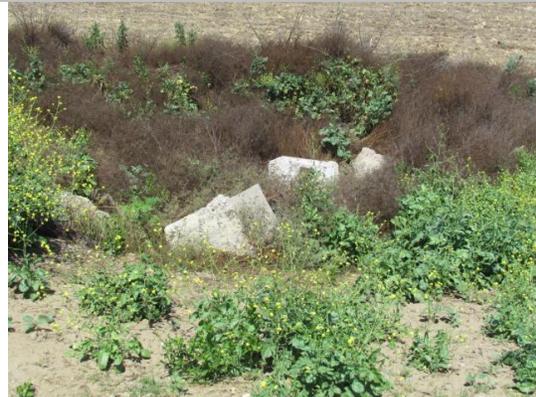
Photo 1 of 1 : SP_2016_RD2063_112_52_20160512_00083.jpg

Looking east at concrete rubble on landward slope.

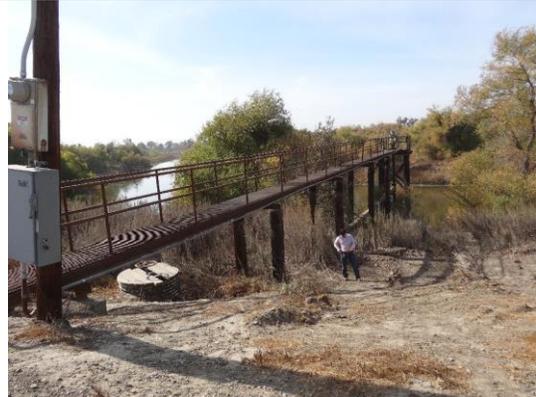
Photo 1 of 2 : UCIP_SP_2016_24629_43943.jpg

WS view: power pole, walkway to pump, CMP riser, and pipe on waterside slope.

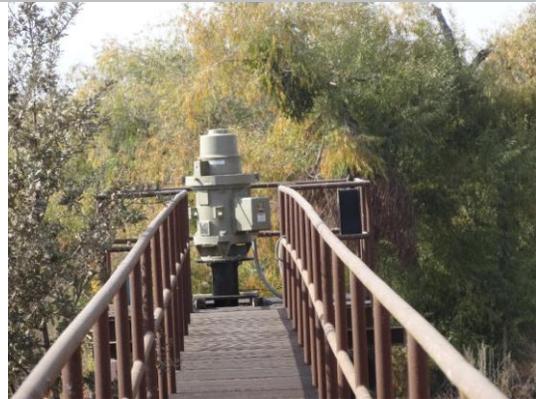
Photo 2 of 2 : UCIP_SP_2016_24629_43942.jpg

WS view: walkway to pump and pump on pile structure in the stream.

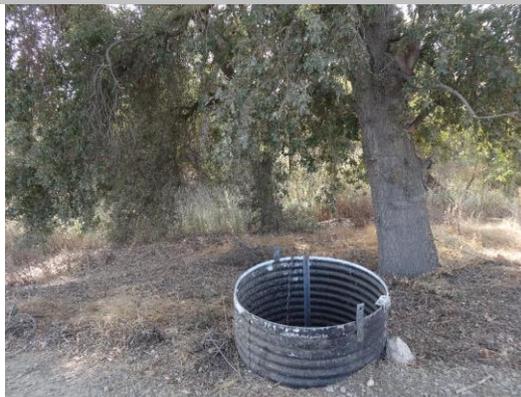
Photo 1 of 2 : UCIP_SP_2016_25031_45141.jpg

WS view: CMP riser with slide gate. Missing slide gate handwheel.

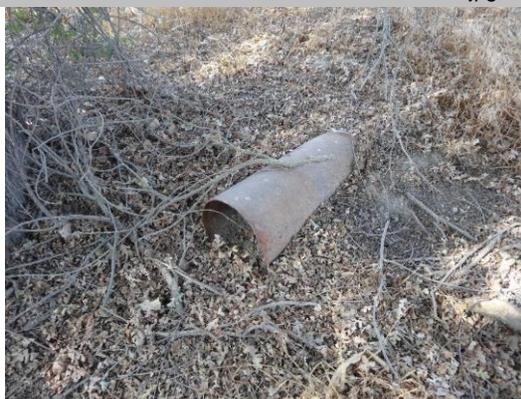
Photo 2 of 2 : UCIP_SP_2016_25031_45140.jpg

WS view: steel pipe with open-end on waterside slope.

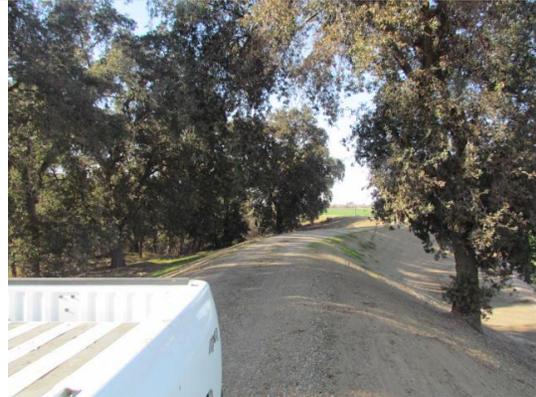
Photo 1 of 1 : SP_2016_RD2063_112_7_20160404_00004.jpg

Looking north at overhanging tree on landward slope.

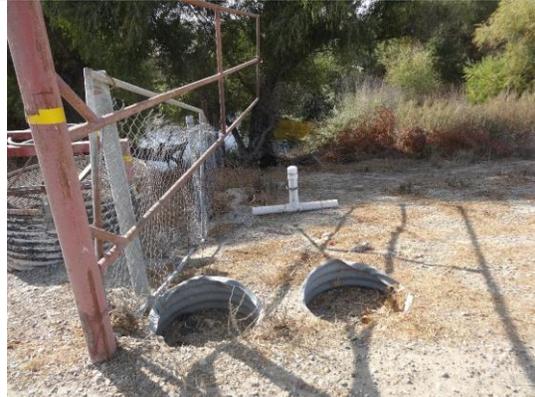
Photo 1 of 2 : UCIP_SP_2016_24651_44005.jpg

WS view: two siphon breakers in CMP risers on levee slope.

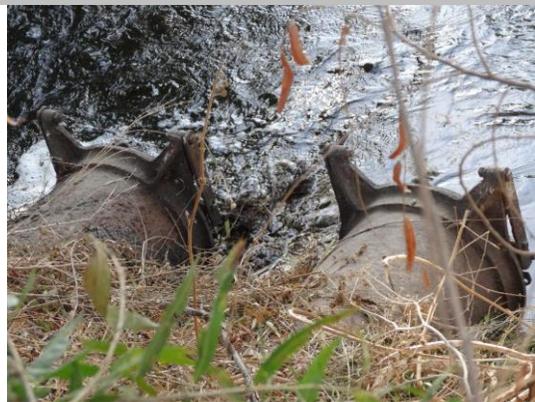
Photo 2 of 2 : UCIP_SP_2016_24651_44004.jpg

WS view: two flap gates on outfall pipe ends.

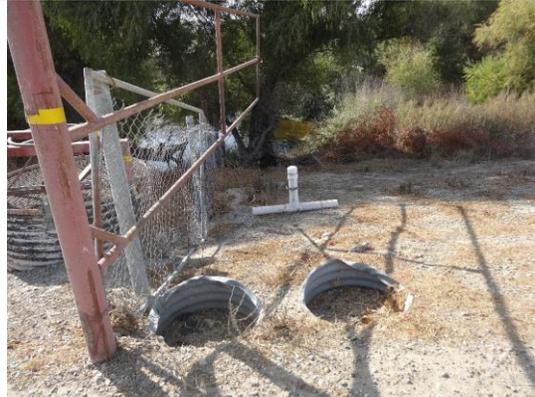
Photo 1 of 2 : UCIP_SP_2016_24652_44008.jpg

WS view: two siphon breakers in CMP risers on levee slope.

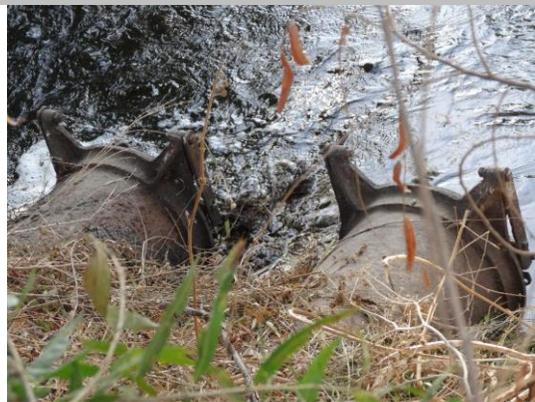
Photo 2 of 2 : UCIP_SP_2016_24652_44007.jpg

WS view: two flap gates on outfall pipe ends.

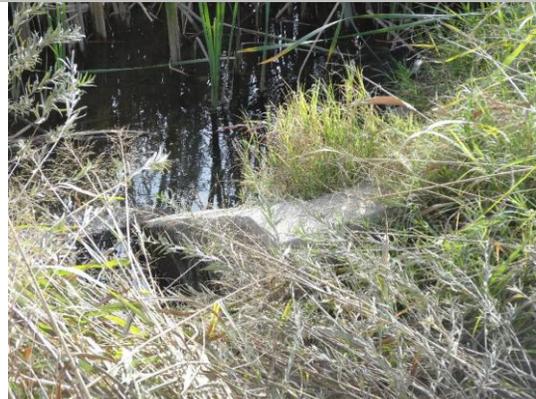
Photo 1 of 2 : UCIP_SP_2016_24645_43988.jpg

WS view: concrete U type headwall on channel bank. Not accessible.

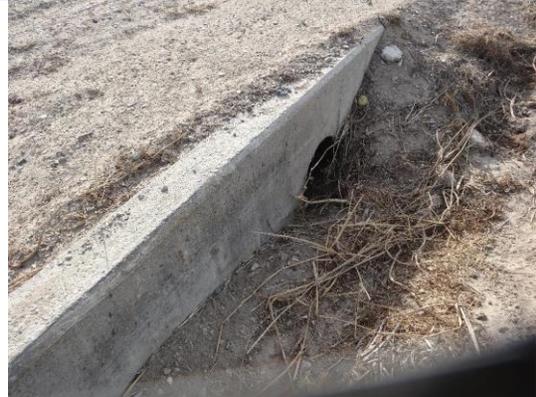
Photo 2 of 2 : UCIP_SP_2016_24645_43987.jpg

LS view: concrete headwall and partially blocked inlet opening.

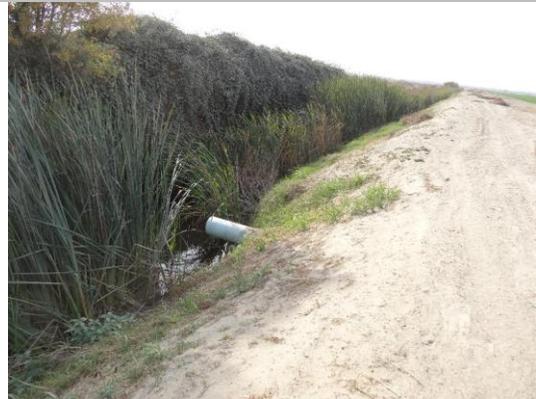
Photo 1 of 2 : UCIP_SP_2016_41366_43990.jpg

WS view: PVC pipe with open end on levee slope.

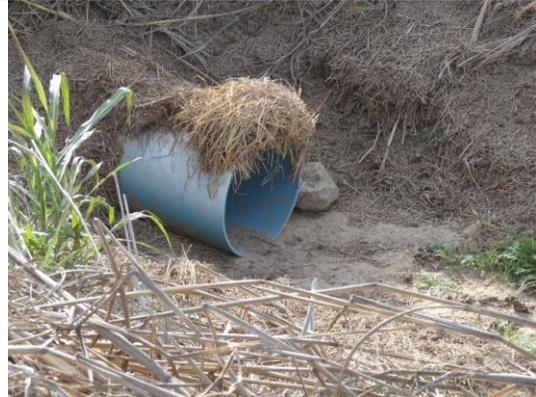
Photo 2 of 2 : UCIP_SP_2016_41366_43989.jpg

LS view: PVC pipe with open end on levee toe.

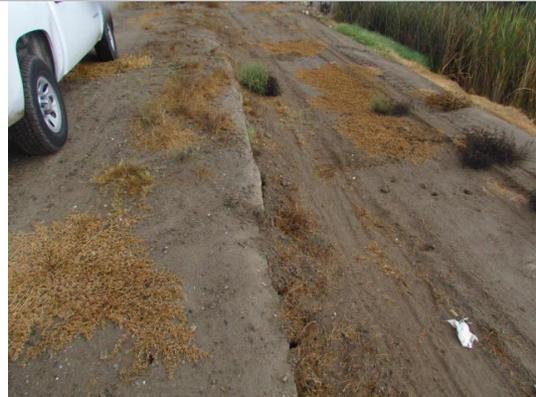
Photo 1 of 2 : SP_2016_RD2063_112_42_20160404_00012.jpg

Looking at erosion on waterward levee shoulder. (Fall 2015)

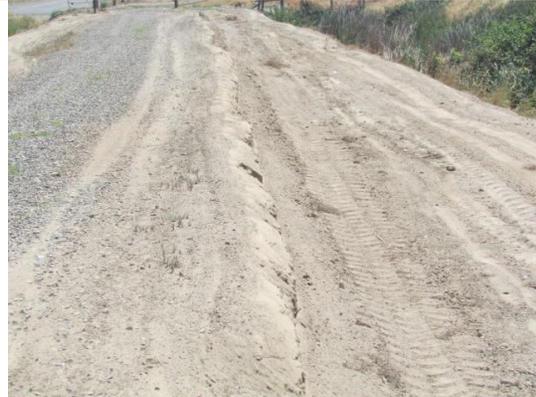
Photo 2 of 2 : SP_2016_RD2063_112_42_20160404_00013.jpg

Looking north at erosion on waterward shoulder. (Spring 2015)
