**Flood Control Project Maintenance  
Levee Inspections**  
**LMA District Cover Sheet**  
**Spring 2016 Levee Inspection Results**

**Reclamation District No. 2092 Dos Rios**

**Spring 2016 Levee Inspection Results**

Waterway		Bank	Unit Miles
Unit No. 01 San Joaquin River		Right	3.71

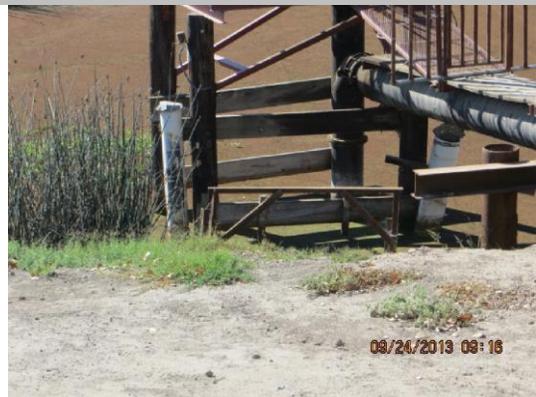
Photo 2 of 2 : UCIP\_SP\_2016\_27123\_50241.jpg

LM Start	<b>0.18</b>	Rating **	M	Issue No.	<b>981</b>
LM End	<b>0.18</b>	Issue Type +	En	Location *	N/A
Category	Supplemental			GPS Latitude/Longitude	
				Start	End
Item	DWR UCIP Field Study			37.602031 °	37.602031 °
				-121.161249 °	-121.161249 °
DWR ID					
Comment Code					
Inspector Comment					
FS_ID:27123 DS_ID:20561 EP_NO: N/A Repair Type: Non-Urgent Crossing Status: Found UCIP Comments: Pipe rusted through at headwall on LS toe. Good candidate for video inspection. FIELD_STRUCT_DESC: 60-inch corrugated metal drainpipe through levee 19.0 feet below crown. Flap gate on the waterward end. Slide gate in 80-inch corrugated metal pipe riser on the waterward slope. Concrete "U" headwalls on both ends. Originally included in the 1961 O&M manual. FS Date: 1/16/2014 12:03:14 PM

Concrete headwall on LS toe in front of pump on pier.

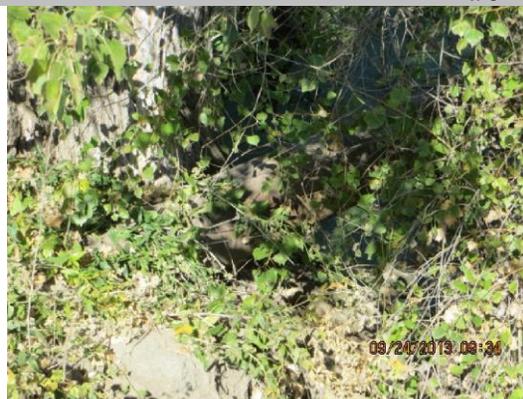
Photo 1 of 2 : UCIP\_SP\_2016\_20885\_35205.jpg

LM Start	<b>0.19</b>	Rating **	M	Issue No.	<b>978</b>
LM End	<b>0.19</b>	Issue Type +	En	Location *	N/A
Category	Supplemental			GPS Latitude/Longitude	
				Start	End
Item	DWR UCIP Field Study			37.601976 °	37.601976 °
				-121.161395 °	-121.161395 °
DWR ID					
Comment Code					
Inspector Comment					
FS_ID:20885 DS_ID:20579 EP_NO: 6254 Repair Type: Non-Urgent Crossing Status: Found UCIP Comments: Verify pipe has been removed from levee. Pipe visible on WS at riverbank. FIELD_STRUCT_DESC: *Abandoned* 16-inch steel pipe over the levee with 3.5 feet of fill on top. Siphon breakers on waterward shoulder. Pad constructed over pipes. This pumping plant was constructed in 1969 during emergency conditions without a permit (Permit No. 6254, 1968). FS Date: 9/24/2013

Pipe visible at rivers edge on WS toe.

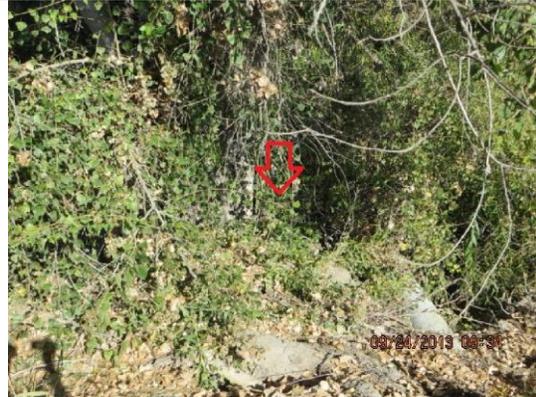
Photo 2 of 2 : UCIP\_SP\_2016\_20885\_35204.jpg

LM Start	<b>0.19</b>	Rating **	M	Issue No.	<b>978 (cont)</b>
LM End	<b>0.19</b>	Issue Type +	En	Location *	N/A
Category	Supplemental			GPS Latitude/Longitude	
				Start	End
Item	DWR UCIP Field Study			37.601976°	37.601976°
				-121.161395°	-121.161395°
DWR ID					
Comment Code					
Inspector Comment					
FS_ID:20885 DS_ID:20579 EP_NO: 6254 Repair Type: Non-Urgent Crossing Status: Found UCIP Comments: Verify pipe has been removed from levee. Pipe visible on WS at riverbank. FIELD_STRUCT_DESC: *Abandoned* 16-inch steel pipe over the levee with 3.5 feet of fill on top. Siphon breakers on waterward shoulder. Pad constructed over pipes. This pumping plant was constructed in 1969 during emergency conditions without a permit (Permit No. 6254, 1968). FS Date: 9/24/2013

Pipe visible at rivers edge on WS toe.

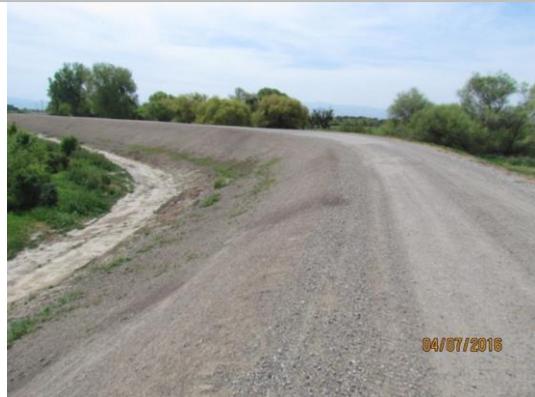
Photo 1 of 1 : SP\_2016\_RD2092\_116\_2\_20160408\_00032.jpg

LM Start	<b>0.47</b>	Rating **	A	Issue No.	<b>2</b>
LM End	<b>0.47</b>	Issue Type +	Ma	Location *	LS
Category	Earthen Levee		GPS Latitude/Longitude		
			Start	End	
Item	Vegetation		37.601056 °	37.601056 °	
			-121.166305 °	-121.166305 °	
DWR ID	DWR_RD2092_01_s_2016_2				
Comment Code					
V1 : Control annual grass and weeds on the levee slopes and easements.					
Inspector Comment

View of acceptable vegetation on the landside of the levee.

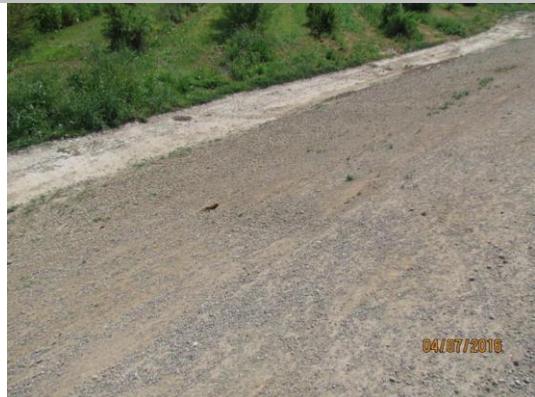
Photo 1 of 1 : SP\_2016\_RD2092\_116\_13\_20160408\_00033.jpg

LM Start	<b>0.65</b>	Rating **	M	Issue No.	<b>13</b>
LM End	<b>0.65</b>	Issue Type +	Ma	Location *	LS
Category	Earthen Levee		GPS Latitude/Longitude		
			Start	End	
Item	Animal Control		37.598640 °	37.598640 °	
			-121.167578 °	-121.167578 °	
DWR ID	DWR_RD2092_01_s_2016_13				
Comment Code					
A3 : No rodents visible, but rodent burrows visible; need to backfill and compact or grout burrows.					
Inspector Comment

View of rodent holes on the landside of the levee looking upstream.

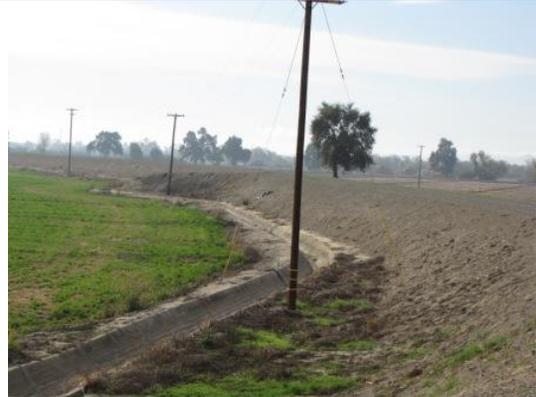
Photo 1 of 1 : SP\_2016\_RD2092\_116\_968\_20160219\_00009.jpg

LM Start	<b>0.76</b>	Rating **	M	Issue No.	<b>968</b>
LM End	<b>1.31</b>	Issue Type +	En	Location *	LS
Category	Earthen Levee		GPS Latitude/Longitude		
			Start	End	
Item	Encroachments		37.597291 °	37.590568 °	
			-121.168496 °	-121.164028 °	
DWR ID	DWR_RD2092_01_s_2012_968				
Comment Code					
DT : Ditch					
Inspector Comment

View of agricultural ditch at the landward toe looking upstream.

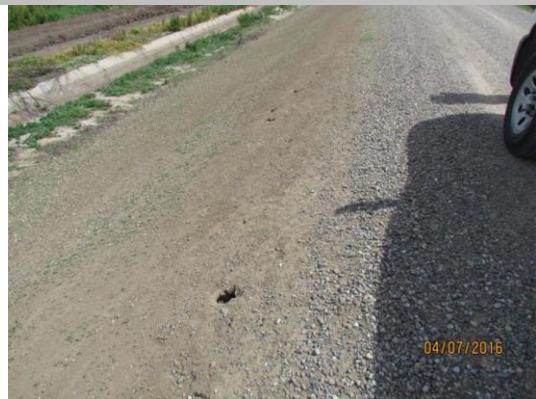
Photo 1 of 1 : SP\_2016\_RD2092\_116\_15\_20160408\_00034.jpg

LM Start	<b>1.21</b>	Rating **	M	Issue No.	<b>15</b>
LM End	<b>1.21</b>	Issue Type +	Ma	Location *	LS
Category	Earthen Levee		GPS Latitude/Longitude		
			Start	End	
Item	Animal Control		37.591293 °	37.591293 °	
			-121.165434 °	-121.165434 °	
DWR ID	DWR_RD2092_01_s_2016_15				
Comment Code					
A3 : No rodents visible, but rodent burrows visible; need to backfill and compact or grout burrows.					
Inspector Comment

View of rodent holes on the landside of the levee.

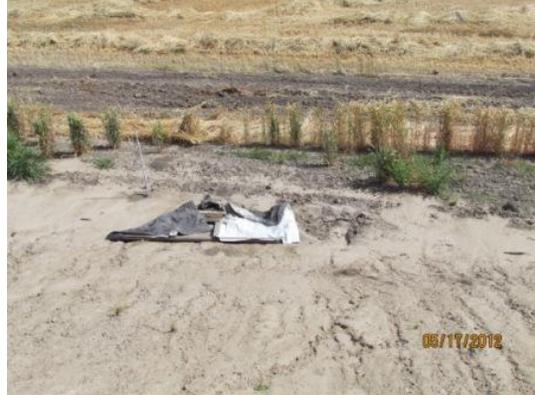
Photo 1 of 2 : SP\_2016\_RD2092\_116\_10\_20160219\_00003.jpg

LM Start	<b>1.32</b>	Rating **	A/W	Issue No.	<b>10</b>
LM End	<b>1.32</b>	Issue Type +	Ma	Location *	LS
Category	Earthen Levee			GPS Latitude/Longitude	
				Start	End
Item	Encroachments			37.590467 °	37.590467 °
				-121.163822 °	-121.163822 °
DWR ID	DWR_RD2092_01_s_2012_10				
Comment Code					
PI : Pipe					
Inspector Comment					
A sand boil appeared on the landside toe of the levee because of an underground pipe leakage. The pipe and boil have been repaired but should be monitored.

During spring inspection 2012, the sand boil was not active but materials were present on the landside toe of the levee. The sand boil occurred due to an underground irrigation pipe leakage. The picture was taken from the crown looking toward the toe of the levee. The area was repaired but should be monitored.

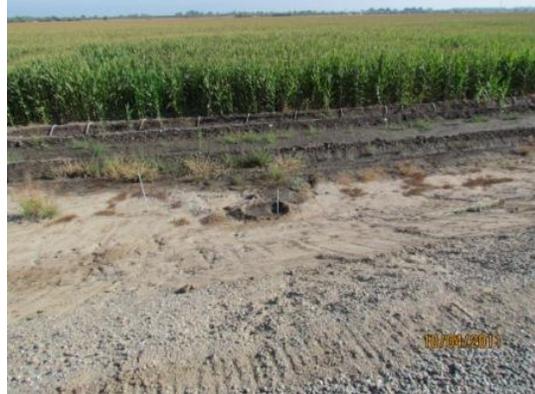
Photo 2 of 2 : SP\_2016\_RD2092\_116\_10\_20160219\_00004.jpg

A sand boil was found on the landside of the levee. It was caused by a pipe leak couple of feet below the boil location. LMA was notified to repair it as soon as possible. The picture was taken from the crown looking upstream.

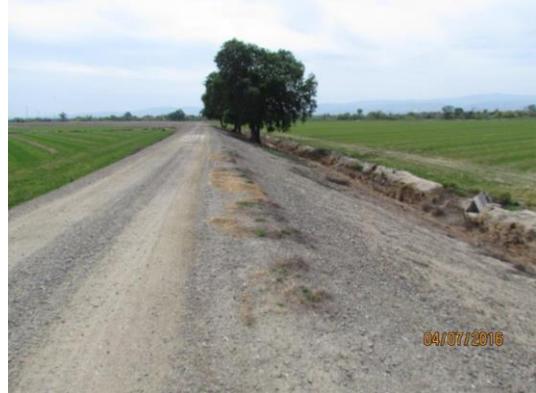
Photo 1 of 1 : SP\_2016\_RD2092\_116\_16\_20160408\_00035.jpg

LM Start	<b>1.56</b>	Rating **	A	Issue No.	<b>16</b>
LM End	<b>1.56</b>	Issue Type +	Ma	Location *	WS
Category	Earthen Levee		GPS Latitude/Longitude		
			Start	End	
Item	Vegetation		37.587590 °	37.587590 °	
			-121.162455 °	-121.162455 °	
DWR ID	DWR_RD2092_01_s_2016_16				
Comment Code					
V1 : Control annual grass and weeds on the levee slopes and easements.					
Inspector Comment

View of the acceptable vegetation on the waterside of the levee.

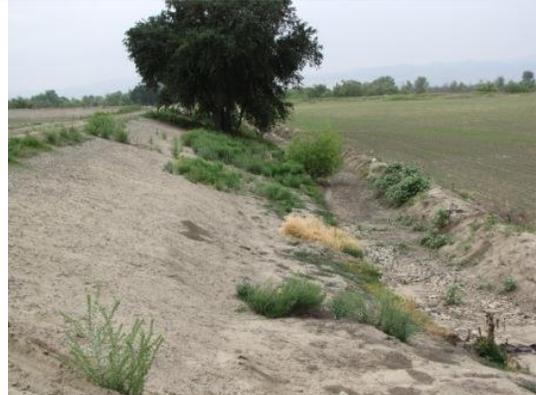
Photo 1 of 1 : SP\_2016\_RD2092\_116\_8\_20160219\_00002.jpg

LM Start	<b>1.56</b>	Rating **	M	Issue No.	<b>8</b>
LM End	<b>1.84</b>	Issue Type +	En	Location *	WS
Category	Earthen Levee		GPS Latitude/Longitude		
			Start	End	
Item	Encroachments		37.587575 °	37.584057 °	
			-121.162454 °	-121.162387 °	
DWR ID	DWR_RD2092_01_s_2012_8				
Comment Code					
DT : Ditch					
Inspector Comment

View of an agricultural ditch at the waterward toe of the slope.

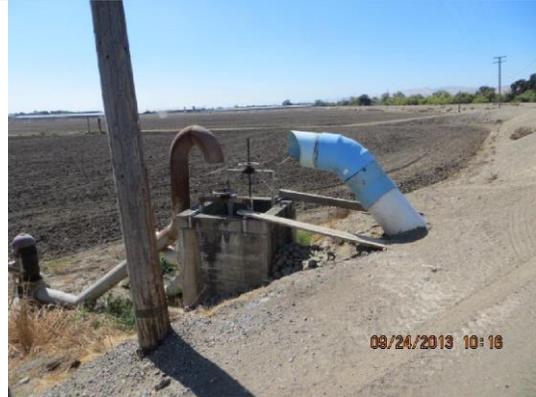
Photo 1 of 2 : UCIP\_SP\_2016\_22916\_39046.jpg

LM Start	<b>2.34</b>	Rating **	M	Issue No.	<b>980</b>
LM End	<b>2.34</b>	Issue Type +	En	Location *	WS
Category	Supplemental			GPS Latitude/Longitude	
				Start	End
Item	DWR UCIP Field Study			37.581226°	37.581226°
				-121.156175°	-121.156175°
DWR ID					
Comment Code					
Inspector Comment					
FS_ID:22916 DS_ID:24680 EP_NO: N/A Repair Type: Non-Urgent Crossing Status: Found UCIP Comments: No permit identified for this crossing. FIELD_STRUCT_DESC: 21-inch PVC irrigation pipe through the levee at an unknown depth below the crown. Pipe discharges into concrete distribution box on LS toe. Pump on pier off WS toe. FS Date: 9/24/2013

21-inch PVC irrigation pipe visible on LS shoulder.

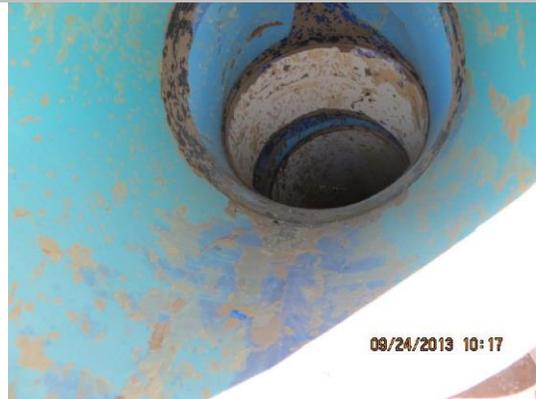
Photo 2 of 2 : UCIP\_SP\_2016\_22916\_39045.jpg

Inside of pipe at LS shoulder.

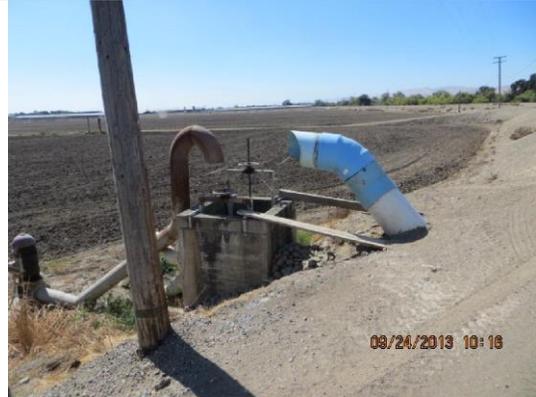
Photo 1 of 2 : UCIP\_SP\_2016\_20908\_35229.jpg

LM Start	<b>2.34</b>	Rating **	M	Issue No.	<b>973</b>
LM End	<b>2.34</b>	Issue Type +	En	Location *	WS
Category	Supplemental			GPS Latitude/Longitude	
				Start	End
Item	DWR UCIP Field Study			37.581213 °	37.581213 °
				-121.156175 °	-121.156175 °
DWR ID					
Comment Code					
Inspector Comment					
FS_ID:20908 DS_ID:20566 EP_NO: N/A Repair Type: Non-Urgent Crossing Status: Found UCIP Comments: Pipe appears abandoned and needs to be verified as having been done so properly. FIELD_STRUCT_DESC: *ABANDONED* 24-inch corrugated metal pipe through levee 11.0 feet below crown. Slide gate in 36-inch corrugated metal pipe riser on the waterward slope. 5'X5' Concrete distribution box on the landward side. Pump on platform in channel. Pipe filled with concrete on LS toe. Originally included in the 1961 O&M manual. FS Date: 9/24/2013

5x5 concrete distribuion box on LS toe.

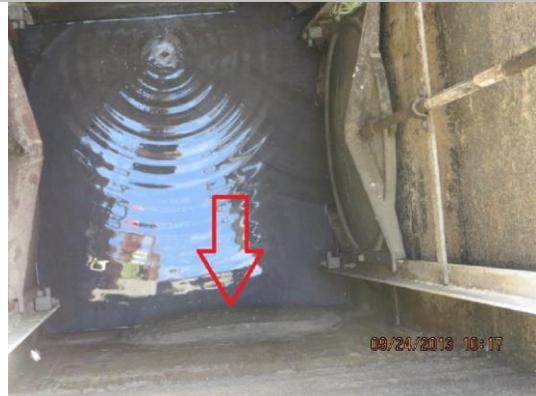
Photo 2 of 2 : UCIP\_SP\_2016\_20908\_35227.jpg

Pipe filled with concrete inside conc. distro box on LS toe.

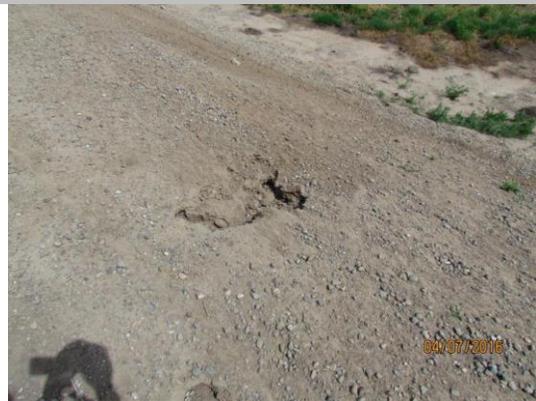
Photo 1 of 1 : SP\_2016\_RD2092\_116\_17\_20160408\_00036.jpg

LM Start	<b>2.39</b>	Rating **	M	Issue No.	<b>17</b>
LM End	<b>2.39</b>	Issue Type +	Ma	Location *	LS
Category	Earthen Levee		GPS Latitude/Longitude		
			Start	End	
Item	Erosion / Bank Caving		37.580628 °	37.580628 °	
			-121.156624 °	-121.156624 °	
DWR ID	DWR_RD2092_01_s_2016_17				
Comment Code					
E2 : Schedule repair of erosion site prior to the next inspection.					
Inspector Comment					
Erosion due to runoff

View of an erosion caused by runoff on the waterside slope of the levee.

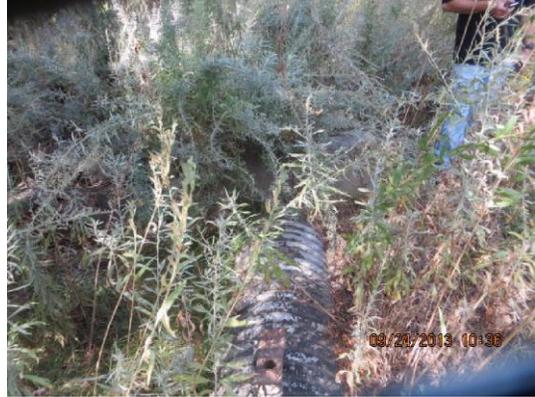
Photo 1 of 2 : UCIP\_SP\_2016\_20943\_35251.jpg

LM Start	<b>2.40</b>	Rating **	M	Issue No.	<b>974</b>
LM End	<b>2.40</b>	Issue Type +	En	Location *	LS
Category	Supplemental			GPS Latitude/Longitude	
				Start	End
Item	DWR UCIP Field Study			37.580426°	37.580426°
				-121.156798°	-121.156798°
DWR ID					
Comment Code					
Inspector Comment					
FS_ID:20943 DS_ID:20567 EP_NO: N/A Repair Type: Non-Urgent Crossing Status: Found UCIP Comments: Appears abandoned and if so should be done so properly. FIELD_STRUCT_DESC: 24-inch corrugated metal drain pipe through levee 15.0 feet below crown. Flap gate on the waterward end. Concrete "U" headwall on the waterward end and concrete headwall on LS toe next to pump. Originally included in the 1961 O&M manual. FS Date: 9/24/2013

24-inch pipe visible on WS berm.

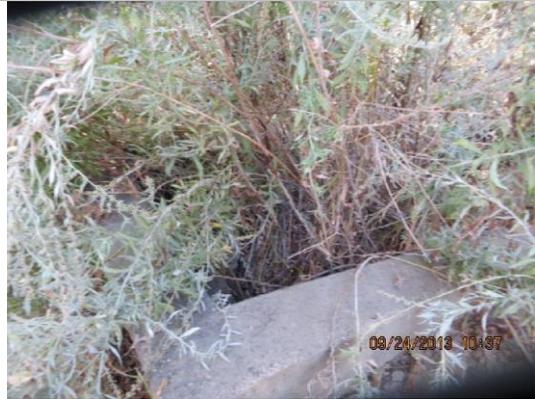
Photo 2 of 2 : UCIP\_SP\_2016\_20943\_35250.jpg

Concrete U-shaped headwall and flapgate on WS berm.

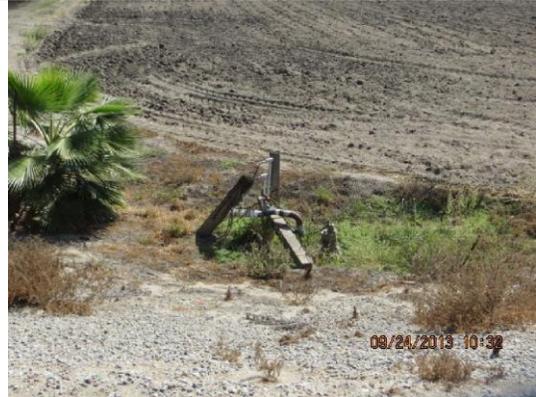
Photo 1 of 2 : UCIP\_SP\_2016\_20923\_35234.jpg

LM Start	<b>2.41</b>	Rating **	M	Issue No.	<b>977</b>
LM End	<b>2.41</b>	Issue Type +	En	Location *	LS
Category	Supplemental			GPS Latitude/Longitude	
				Start	End
Item	DWR UCIP Field Study			37.580405 °	37.580405 °
				-121.156825 °	-121.156825 °
DWR ID					
Comment Code					
Inspector Comment					
FS_ID:20923 DS_ID:20568 EP_NO: N/A Repair Type: Non-Urgent Crossing Status: Indicator Found UCIP Comments: Pipe abandoned and should be verified as having been removed from the levee. FIELD_STRUCT_DESC: 4-inch pipe through levee 1.0 foot below crown. Pump on sump at LS toe. Roadway extending to the landward pump. FS Date: 9/24/2013

Pump and 4-inch pipe visible at LS toe.

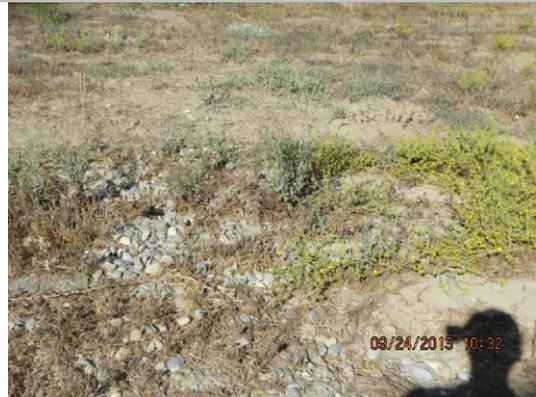
Photo 2 of 2 : UCIP\_SP\_2016\_20923\_35233.jpg

Gravel on WS slope appears to indicate trench.

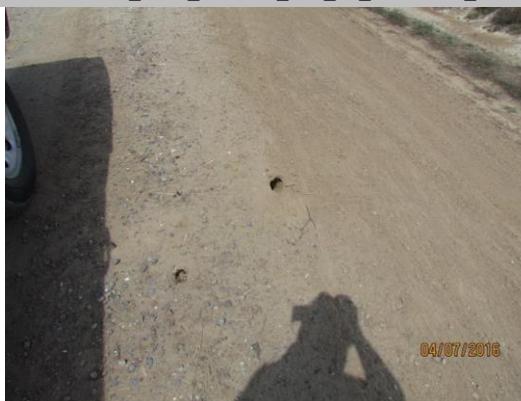
Photo 1 of 1 : SP\_2016\_RD2092\_116\_29\_20160408\_00037.jpg

View of rodent holes on the landside shoulder of the levee looking downstream.

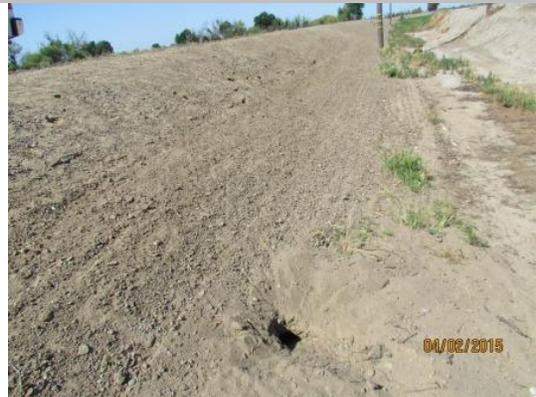
Photo 1 of 1 : SP\_2016\_RD2092\_116\_19\_20160219\_00006.jpg

A rodent hole was found on the landside toe of the levee looking downstream.

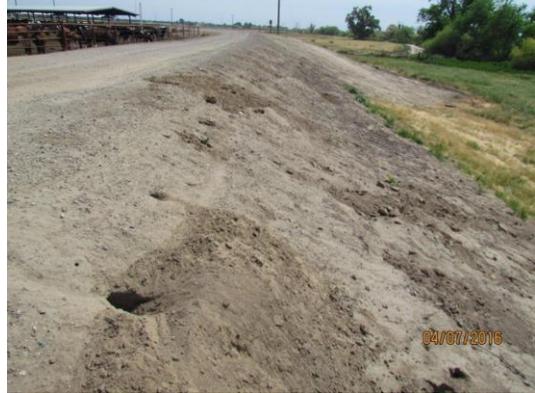
Photo 1 of 1 : SP\_2016\_RD2092\_116\_30\_20160408\_00038.jpg

View of multiple rodent holes on the waterside of the levee looking upstream.

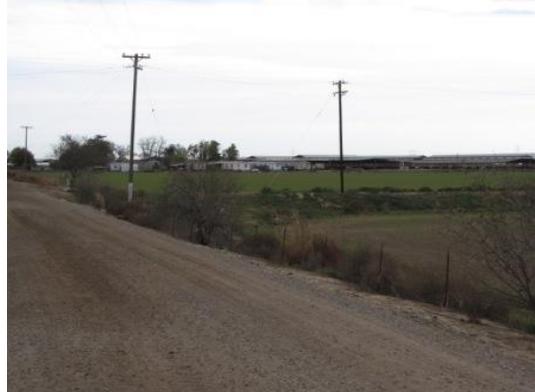
Photo 1 of 1 : SP\_2016\_RD2092\_116\_972\_20160219\_00010.jpg

LM Start	<b>2.79</b>	Rating **	M	Issue No.	<b>972</b>
LM End	<b>3.05</b>	Issue Type +	En	Location *	WS
Category	Earthen Levee			GPS Latitude/Longitude	
				Start	End
Item	Encroachments			37.574973 °	37.574001 °
				-121.156647 °	-121.152183 °
DWR ID	DWR_RD2092_01_s_2012_972				
Comment Code					
FE : Fence					
Inspector Comment					
Barbed wire fence on waterside toe of the levee.

View of barbed wire fence along the waterward slope looking upstream.

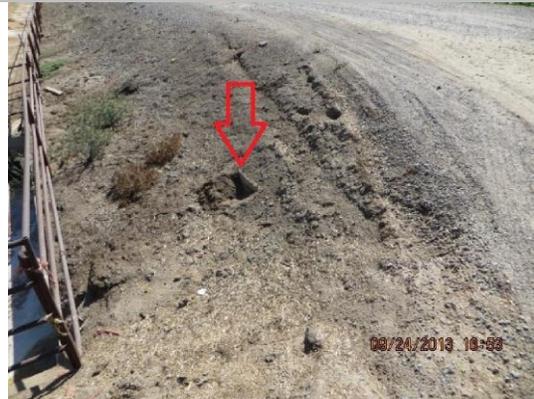
Photo 1 of 1 : UCIP\_SP\_2016\_20944\_35255.jpg

LM Start	<b>2.86</b>	Rating **	M	Issue No.	<b>975</b>
LM End	<b>2.86</b>	Issue Type +	En	Location *	WS
Category	Supplemental			GPS Latitude/Longitude	
				Start	End
Item	DWR UCIP Field Study			37.574741 °	37.574741 °
				-121.155495 °	-121.155495 °
DWR ID					
Comment Code					
Inspector Comment					
FS_ID:20944 DS_ID:20570 EP_NO: N/A Repair Type: Non-Urgent Crossing Status: Indicator Found UCIP Comments: Appears abandoned and if so, should be done so properly. FIELD_STRUCT_DESC: 24-inch corrugated metal pipe through levee 6.5 feet below crown. Concrete "U" headwall and flap gate on the waterward end. Concrete headwall on LS slope. Originally included in the 1961 O&M manual. FS Date: 9/24/2013

Concrete headwall visible on LS slope.

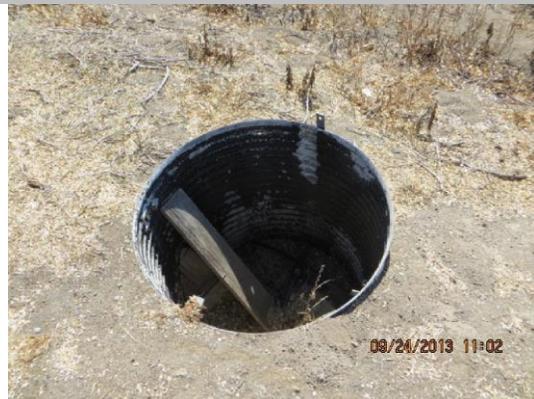
Photo 1 of 2 : UCIP\_SP\_2016\_20945\_35261.jpg

LM Start	<b>3.47</b>	Rating **	M	Issue No.	<b>976</b>
LM End	<b>3.47</b>	Issue Type +	En	Location *	WS
Category	Supplemental			GPS Latitude/Longitude	
				Start	End
Item	DWR UCIP Field Study			37.573304 °	37.573304 °
				-121.144747 °	-121.144747 °
DWR ID					
Comment Code					
Inspector Comment					
FS_ID:20945 DS_ID:20572 EP_NO: N/A Repair Type: Non-Urgent Crossing Status: Found UCIP Comments: This pipe appears abandoned and if so, should be done so properly. FIELD_STRUCT_DESC: 36-inch corrugated metal pipe through levee 11.0 feet below crown. Slide gate in corrugated metal pipe riser on the waterward slope. Concrete headwalls on both ends. Originally included in the 1961 O&M manual. FS Date: 9/24/2013

48-inch CMP riser on WS slope.

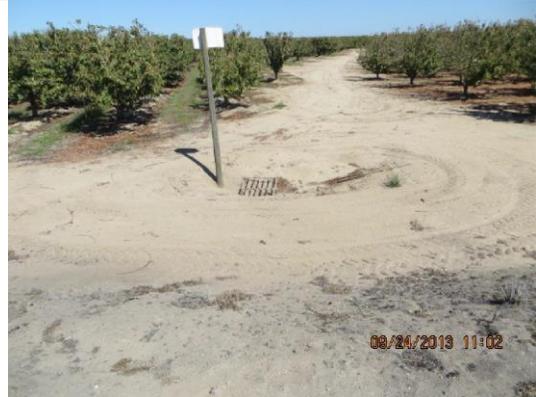
Photo 2 of 2 : UCIP\_SP\_2016\_20945\_35260.jpg

LM Start	<b>3.47</b>	Rating **	M	Issue No.	<b>976 (cont)</b>
LM End	<b>3.47</b>	Issue Type +	En	Location *	WS
Category	Supplemental			GPS Latitude/Longitude	
				Start	End
Item	DWR UCIP Field Study			37.573304 °	37.573304 °
				-121.144747 °	-121.144747 °
DWR ID					
Comment Code					
Inspector Comment					
FS_ID:20945 DS_ID:20572 EP_NO: N/A Repair Type: Non-Urgent Crossing Status: Found UCIP Comments: This pipe appears abandoned and if so, should be done so properly. FIELD_STRUCT_DESC: 36-inch corrugated metal pipe through levee 11.0 feet below crown. Slide gate in corrugated metal pipe riser on the waterward slope. Concrete headwalls on both ends. Originally included in the 1961 O&M manual. FS Date: 9/24/2013

Grate over sump on LS toe.
