**Flood Control Project Maintenance  
Levee Inspections**  
**LMA District Cover Sheet**  
**Spring 2016 Levee Inspection Results**

**Reclamation District No. 2094 Wathal**

**Spring 2016 Levee Inspection Results**

**Levee Inspection Report By Mile - Spring 2016**

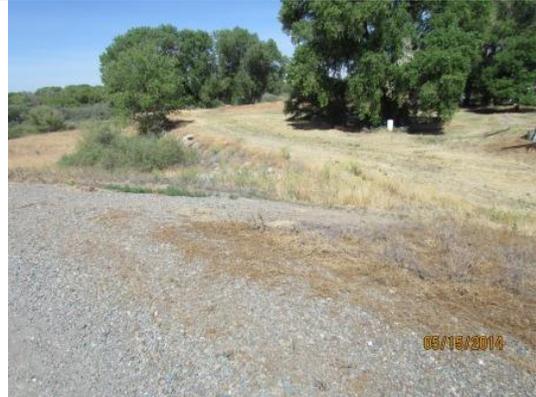
Photo 1 of 1 : SP\_2016\_RD2094\_320\_4\_20160229\_00001.jpg

LM Start	<b>0.10</b>	Rating **	M	Issue No.	<b>4</b>
LM End	<b>0.10</b>	Issue Type +	En	Location *	WS
Category	Earthen Levee		GPS Latitude/Longitude		
			Start	End	
Item	Encroachments		37.771685 °	37.771685 °	
			-121.300239 °	-121.300239 °	
DWR ID	DWR_RD2094_01_s_2012_4				
Comment Code					
RA : Ramp					
Inspector Comment					
An access ramp has been built on the water side and extends into the channel. This could potentially alter the channel capacity. This item was also noted in the USACE comments.

Tire marks shown onto the ramp from levee. Raised area extends to the trees in the background in the center of the photo.

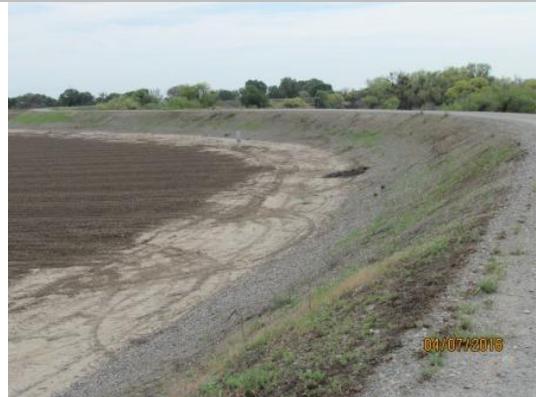
Photo 1 of 1 : SP\_2016\_RD2094\_320\_7\_20160412\_00014.jpg

LM Start	<b>0.34</b>	Rating **	A	Issue No.	<b>7</b>
LM End	<b>0.34</b>	Issue Type +	Ma	Location *	LS
Category	Earthen Levee		GPS Latitude/Longitude		
			Start	End	
Item	Vegetation		37.768761 °	37.768761 °	
			-121.299990 °	-121.299990 °	
DWR ID	DWR_RD2094_01_s_2016_7				
Comment Code					
V1 : Control annual grass and weeds on the levee slopes and easements.					
Inspector Comment

View of the acceptable vegetation on the landside levee slope.

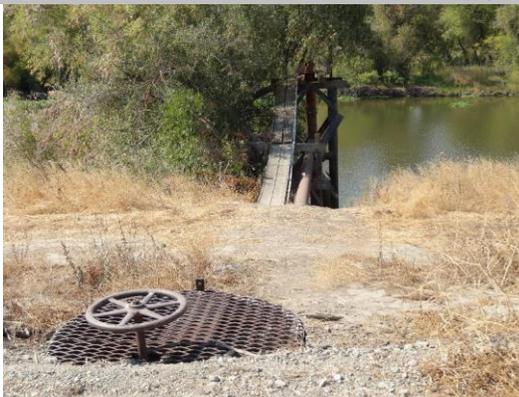
Photo 1 of 2 : UCIP\_SP\_2016\_21464\_36405.jpg

LM Start	<b>0.65</b>	Rating **	M	Issue No.	<b>15</b>
LM End	<b>0.65</b>	Issue Type +	En	Location *	LS
Category	Supplemental			GPS Latitude/Longitude	
				Start	End
Item	DWR UCIP Field Study			37.767514 °	37.767514 °
				-121.294926 °	-121.294926 °
DWR ID					
Comment Code					
Inspector Comment					
FS_ID:21464 DS_ID:23086 EP_NO: N/A Repair Type: Non-Urgent Crossing Status: Found UCIP Comments: - walkway in poor condition and needs repair.- electric conduit on waterside. FIELD_STRUCT_DESC: 14-inch concrete encased steel pipe and GI conduit through the levee, 10.0 feet below the crown, pump mounted on a pile structure in the stream, slide gate, 54-inch corrugated metal pipe riser on the waterward shoulder, concrete distribution box and service pole on the landward toe, installed by USCE, 1962 (O&M Unit No. 3, 1968) FS Date: 9/10/2013

WS view: gate valve in CMP riser (bottom) and pipe & pump (top) on piling structure in the channel.

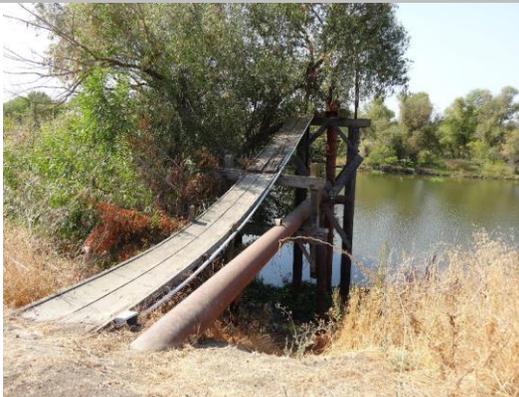
Photo 2 of 2 : UCIP\_SP\_2016\_21464\_36404.jpg

LM Start	<b>0.65</b>	Rating **	M	Issue No.	<b>15 (cont)</b>
LM End	<b>0.65</b>	Issue Type +	En	Location *	LS

WS view: pump on piling structure in the channel. Pipe (right- bottom) and conduit (bottom- left).

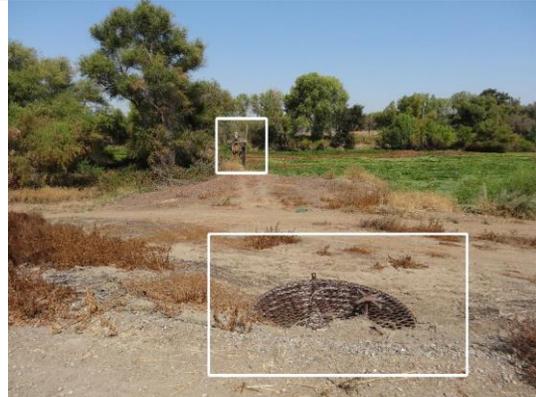
Photo 1 of 2 : UCIP\_SP\_2016\_21544\_36524.jpg

LM Start	<b>1.25</b>	Rating **	M	Issue No.	<b>13</b>
LM End	<b>1.25</b>	Issue Type +	En	Location *	LS
Category	Supplemental		GPS Latitude/Longitude		
			Start	End	
Item	DWR UCIP Field Study		37.760581 °	37.760581 °	
			-121.297373 °	-121.297373 °	
DWR ID					
Comment Code					
Inspector Comment					
FS_ID:21544 DS_ID:23087 EP_NO: N/A Repair Type: Non-Urgent Crossing Status: Found UCIP Comments: - working as drainage system during field visit. Pump was not running.- electric conduit on WS- open pipe end in CMP riser. CMP needs cleaning. FIELD_STRUCT_DESC: 20-inch concrete encased steel pipe through the levee, 10.0 feet below the crown, pump mounted on a pile structure in the stream, gate valve, 54-inch corrugated metal pipe riser on the waterward shoulder, concrete distribution box and service pole on the landward toe (O&M Unit No. 3, 1968) FS Date: 9/10/2013

WS view: overview of pump (top) and CMP riser (bottom)

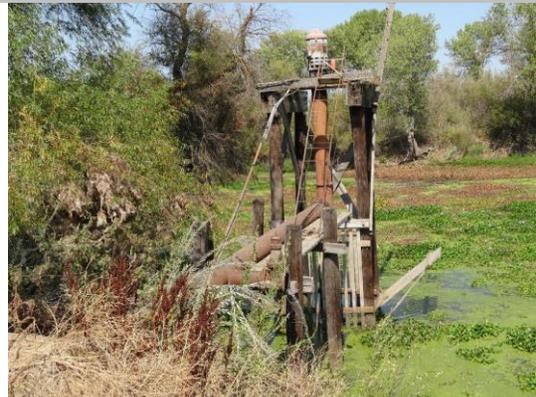
Photo 2 of 2 : UCIP\_SP\_2016\_21544\_36523.jpg

LM Start	<b>1.25</b>	Rating **	M	Issue No.	<b>13 (cont)</b>
LM End	<b>1.25</b>	Issue Type +	En	Location *	LS

WS view: pipe and pump on piling structure in the channel. Walkway in poor condition.

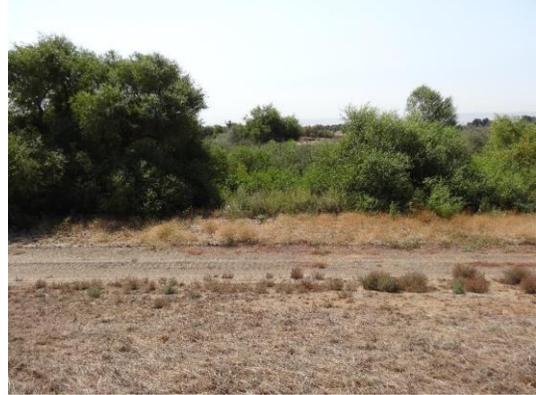
Photo 1 of 2 : UCIP\_SP\_2016\_21545\_36529.jpg

LM Start	<b>2.45</b>	Rating **	M	Issue No.	<b>14</b>
LM End	<b>2.45</b>	Issue Type +	En	Location *	LS
Category	Supplemental			GPS Latitude/Longitude	
				Start	End
Item	DWR UCIP Field Study			37.752308 °	37.752308 °
				-121.293191 °	-121.293191 °
DWR ID					
Comment Code					
Inspector Comment					
FS_ID:21545 DS_ID:23089 EP_NO: N/A Repair Type: Non-Urgent Crossing Status: Found UCIP Comments: - no pipes found on either side of the levee.- concrete distribution box on LS. Soil erosion around distrinution box. FIELD_STRUCT_DESC: Rectangular concrete distribution box on the landward toe FS Date: 9/10/2013

WS view: no pipe found on waterside.

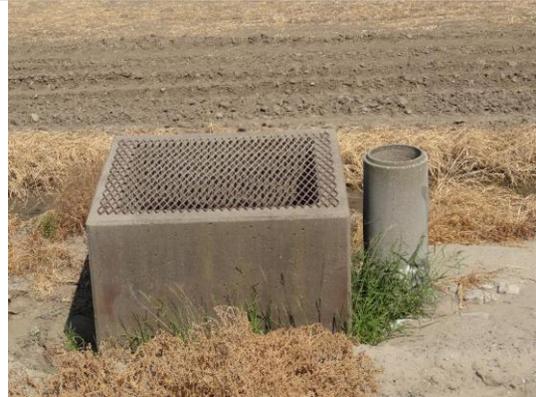
Photo 2 of 2 : UCIP\_SP\_2016\_21545\_36528.jpg

LM Start	<b>2.45</b>	Rating **	M	Issue No.	<b>14 (cont)</b>
LM End	<b>2.45</b>	Issue Type +	En	Location *	LS

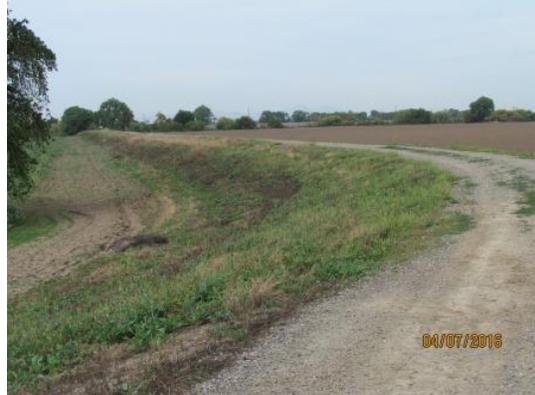
Photo 1 of 1 : SP\_2016\_RD2094\_321\_1\_20160412\_00001.jpg

LM Start	<b>0.16</b>	Rating **	A	Issue No.	<b>1</b>
LM End	<b>0.16</b>	Issue Type +	Ma	Location *	WS
Category	Earthen Levee		GPS Latitude/Longitude		
			Start	End	
Item	Vegetation		37.760472 °	37.760472 °	
			-121.301942 °	-121.301942 °	
DWR ID	DWR_RD2094_02_s_2016_1				
Comment Code					
V1 : Control annual grass and weeds on the levee slopes and easements.					
Inspector Comment

View of the acceptable vegetation on the waterside levee slope.
